An Sguman, Port Henderson.

Kiln Structure NG 74879 73799 GPS Elevation 12m. An Sguman Port Henderson.

INTERPRETATION OF PLANE TABLE SURVEY OF KILN SITUATED ON AN SGUMAN PORT HENDERSON. Ng 74861 73836 GPS ELEVATION 2m. SURVEYED 09-06-10

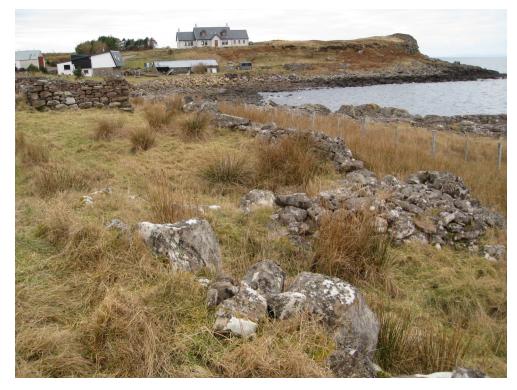
Looking W towards the E side of An Sguman. The new house can be seen on the skyline, with the modernised salmon bothy and reroofed buildings of the fishing village by the shore. An Sguman, Port Henderson.

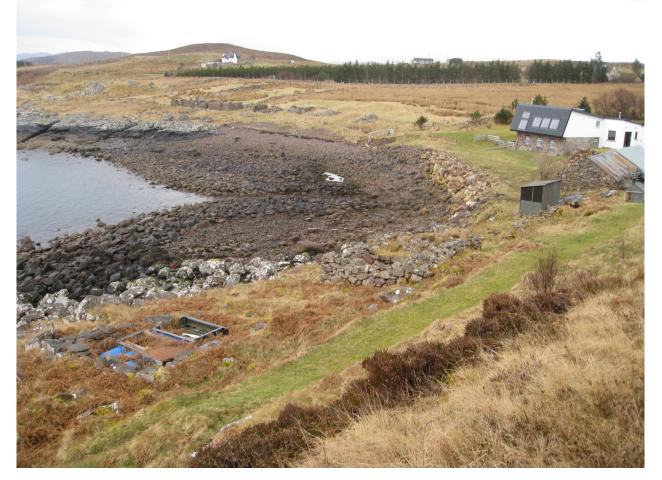
Looking down the slope of the raised beach onto the gardens and ruined fishing village. The disused slipway can be seen and the modernised salmon bothy.

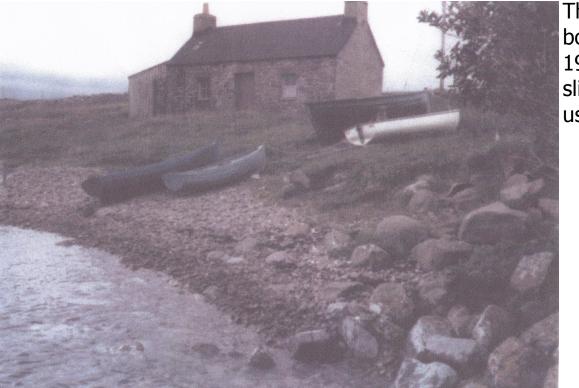
The salmon bothy in the 1970's. The slipway is still in use.

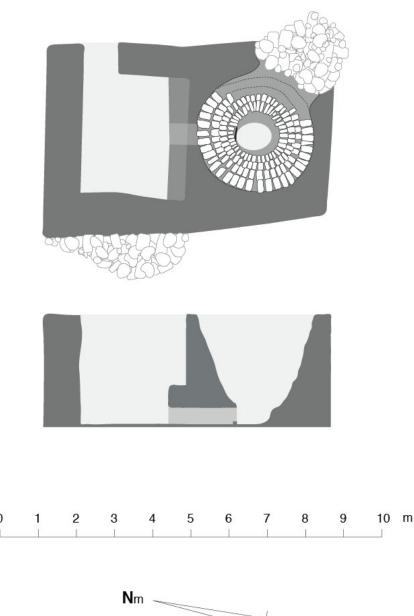
This kiln structure, one of 4 found in Port Henderson, is the least ruinous, with its kiln bowl mostly intact. It was surveyed by the plane table method. 40 m to the N is an older kiln(see separate description) that was ruined by landslip from the raised beach slope. This newer kiln is built further away from the steep raised beach, but still has its W wall dug into the slope running down to the shoreline 10m to the E. The kiln is within the ruins of the fishing village which predate the crofting township. However it is likely that the existing structures were modified and rebuilt to create the kiln.

The structure itself is mostly intact with some tumble on the W and E sides, and unroofed.

The stone is dressed, layered, with infill and some snecking. The walls of the kiln barn average 1m thick, but around the bowl and joining wall, the thickness varies. The bowl is 2.8m high at its highest point. The flue has a lip at the bowl end to stop ash from the peat fire mixing with any fallen grain. In the kiln barn a shelf on the dividing wall allows easy access to the top of the bowl where the grain was dried.

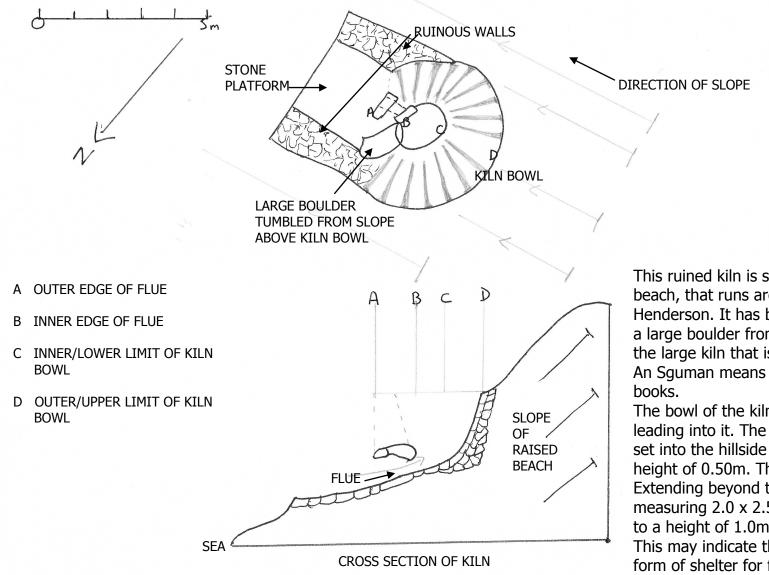
This ruined kiln is set into the slope of the raised beach, that runs around the edge of the bay at Port Henderson. It has been partially covered by debris and a large boulder from the slope, and probably predates the large kiln that is situated further S on An Sguman. An Sguman means 'stack of corn' from the OS name books.

The bowl of the kiln is well made, with a single flue leading into it. The height of the remaining bowl wall set into the hillside is 1.60m, with the flue having a height of 0.50m. The flue has a length of 1.0m. Extending beyond the bowl is a stone platform measuring 2.0 x 2.5m with ruinous walls on each side to a height of 1.0m.

This may indicate the remains of a kiln barn or some form of shelter for fuel and grain.

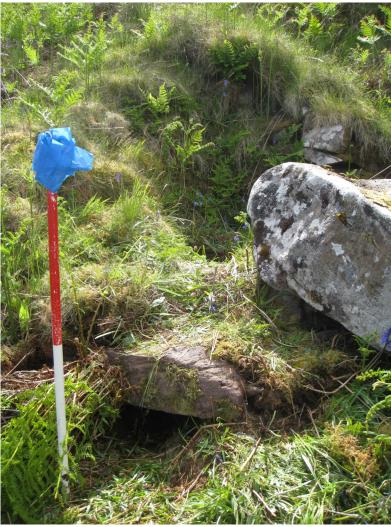
LOOKING AT KILN BOWL, WITH FLUE ENTRANCE, AND LARGE BOULDER OVERLYING PART OF KILN

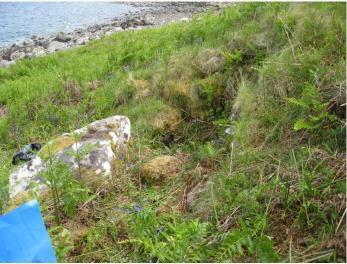
LOOKING SE ACROSS KILN SHOWING ANGLE OF SLOPE, PROXIMITY TO SEA, AND LARGE BOULDER

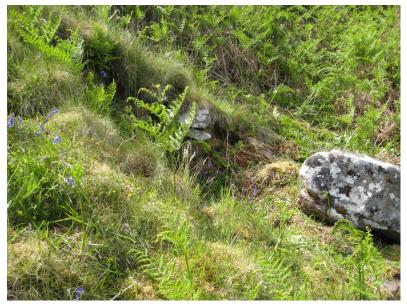
LOOKING N ACROSS KLIN BOWL SHOWING BOWL BUILT INTO SLOPE.
