Plan of Croft 13 known as 'Lot 'an Anndra'  
Port Henderson  
Centred on NGR NG 7557 7404

## Croft 13, Port Henderson

INTERPRETATION OF PLANE TABLE SURVEY OF POSSIBLE KILN STRUCTURE CROFT 13 PORT HENDERSON. NG 75548 74030 GPS.  
ELEVATION 5m. SURVEYED 31-05-10

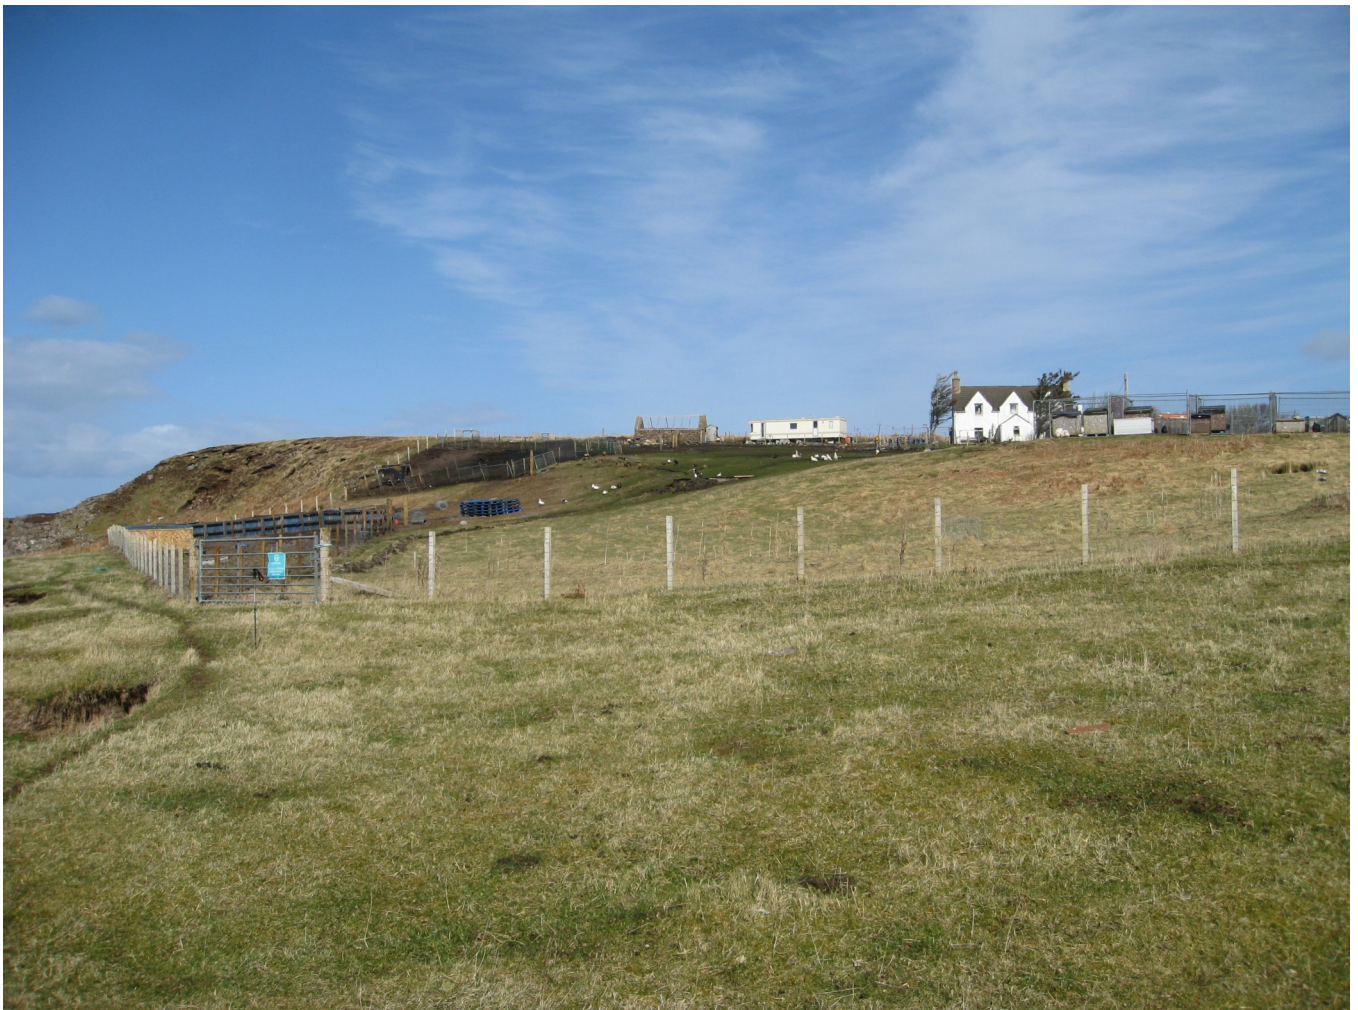
Croft 13 showing the slope of the raised beach, croft house and barn.

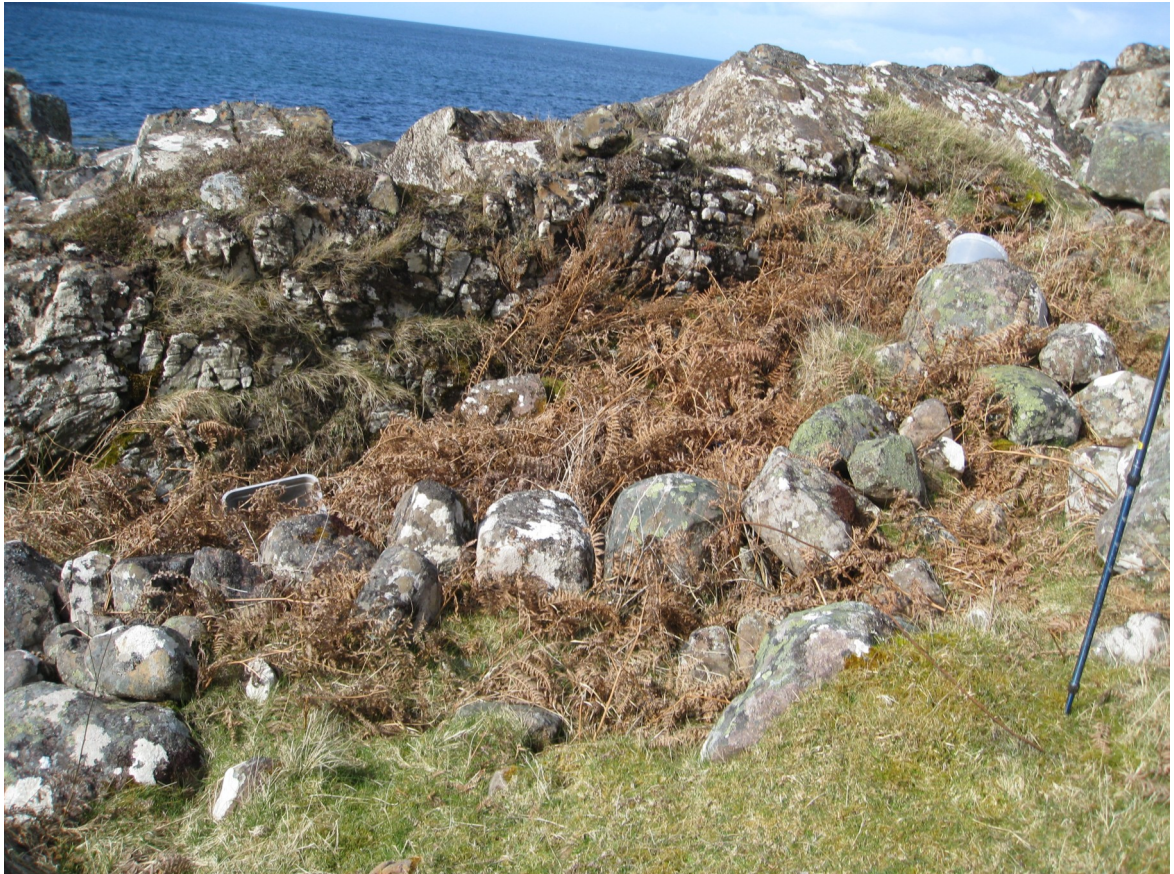
On the N and W boundaries of the croft the footings of stone dykes can be seen, and there is a rough stone dyke forming a small enclosure adjacent to a rock face at the shore.

Stone dyke by shore forming enclosure with adjacent rock face

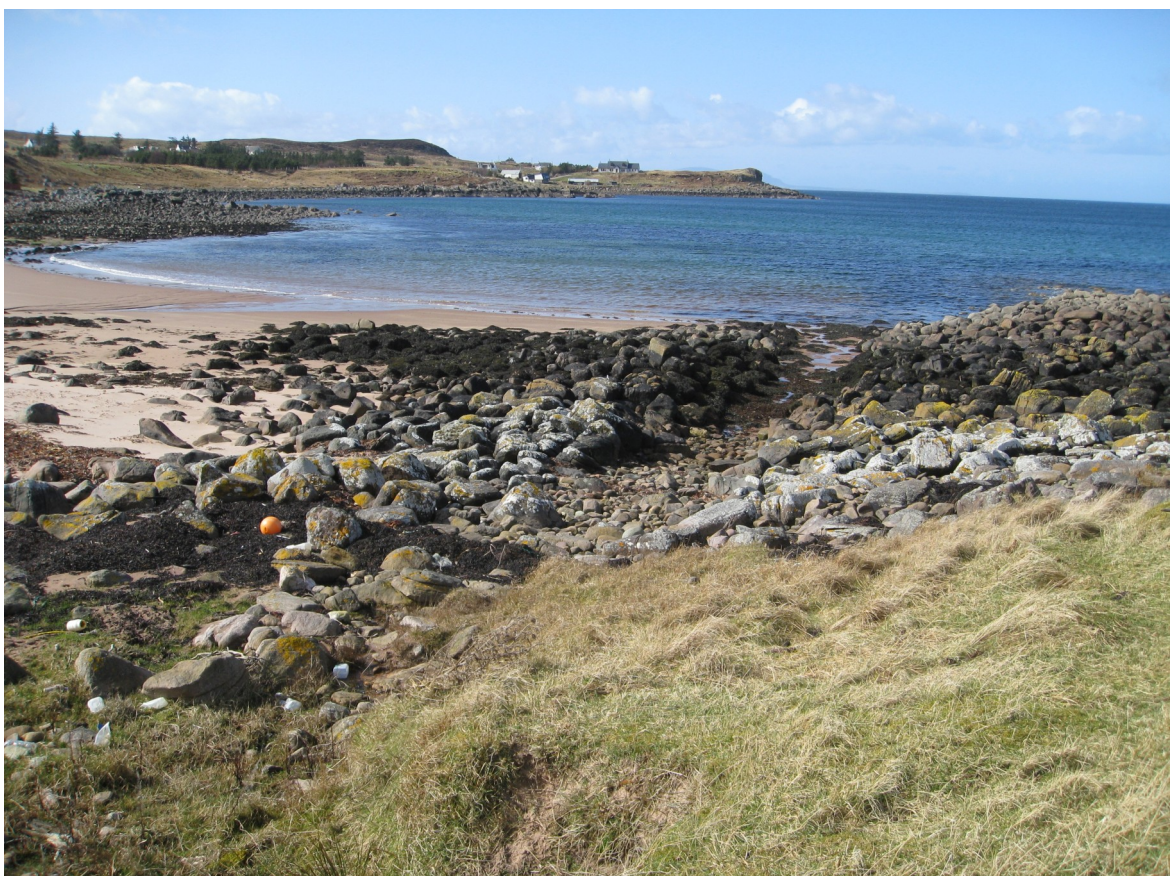
On the shoreline just S of this croft is a ruined slipway.

Ruined slipway on shoreline just S of croft 13

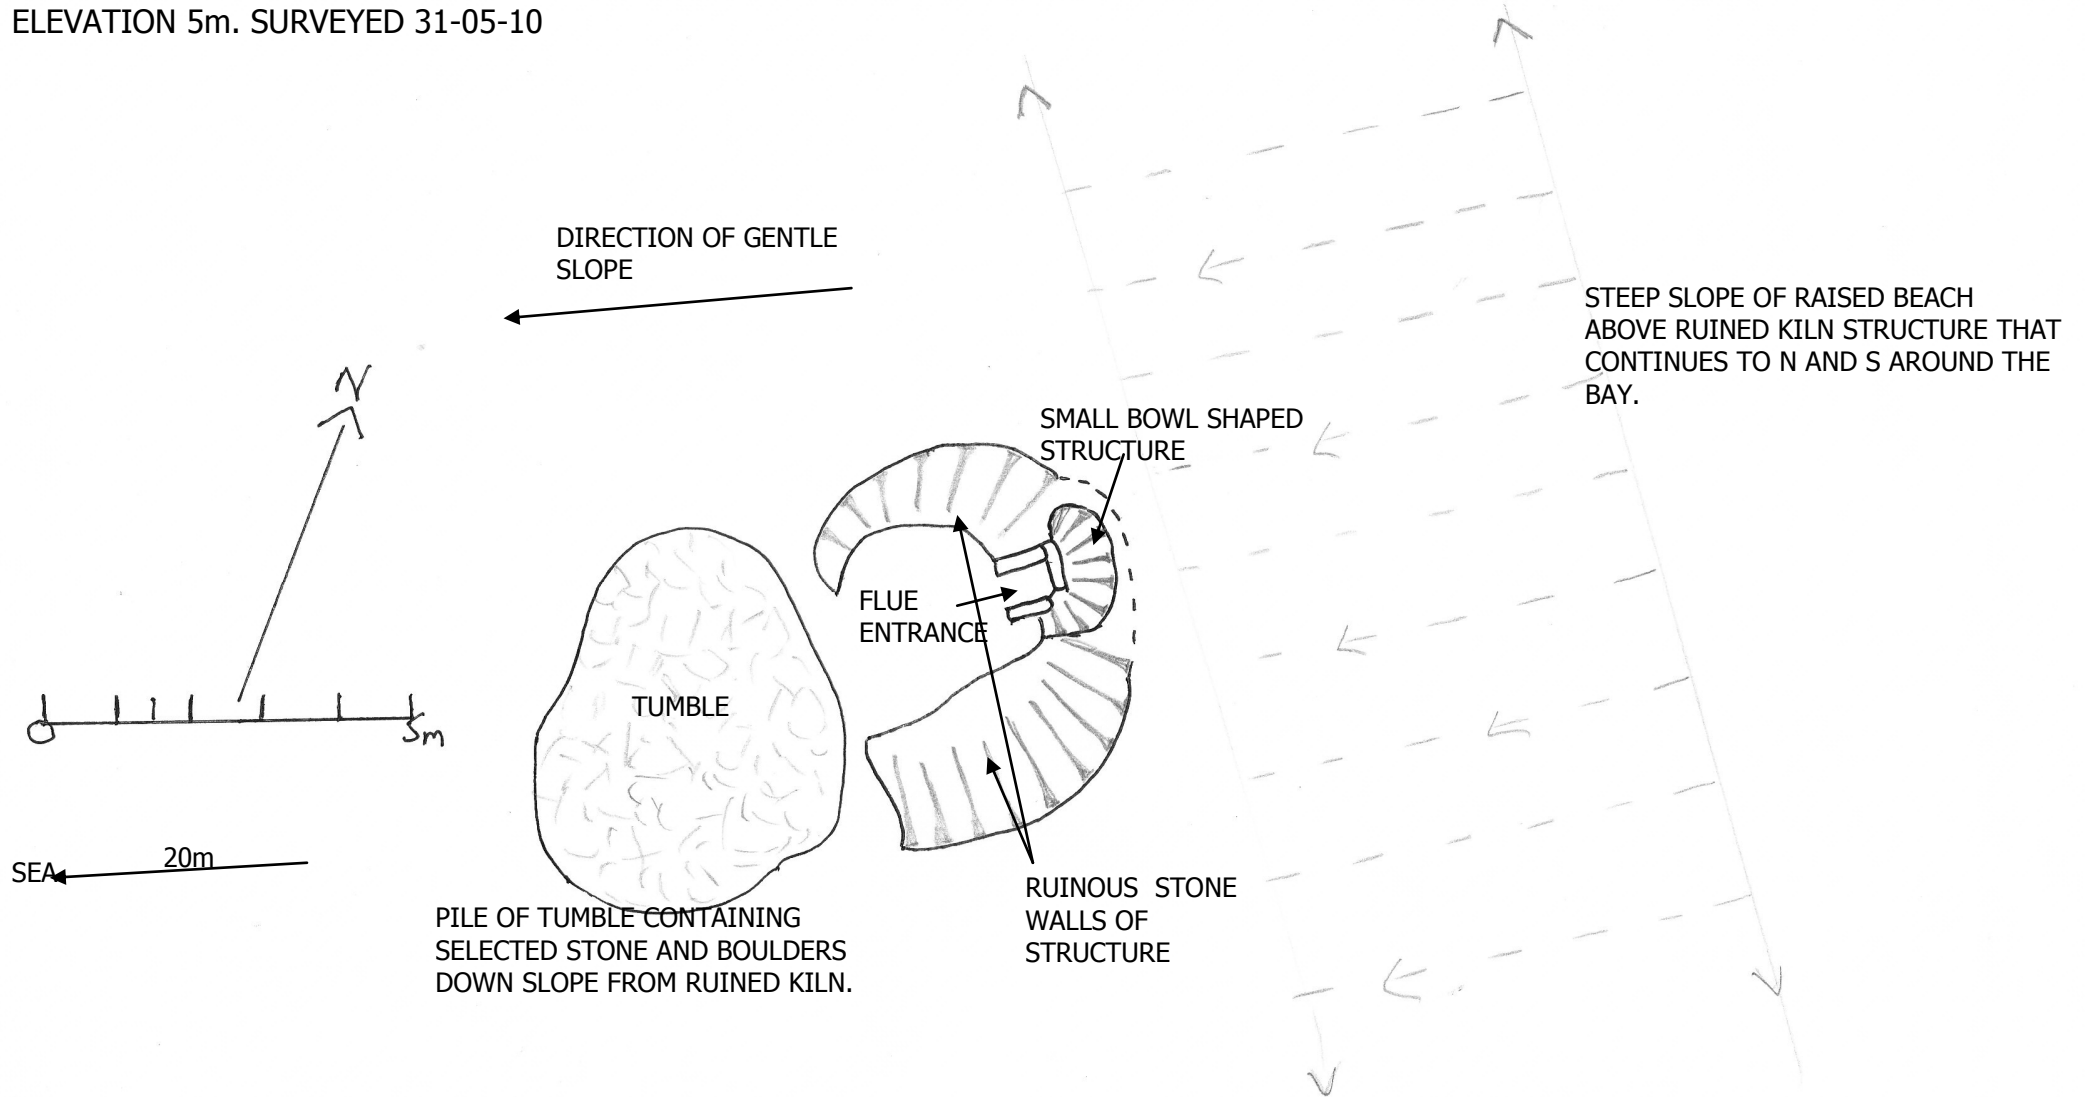
This ruinous structure is situated at the foot of the steep slope of the raised beach and a distance of 20m from the shore. It is shown on the 2nd OS map and is considered locally to be the ruin of a corn drying kiln. The slope above the kiln has collapsed onto the kiln so that it is partially buried. What can be seen is the entrance to a flue, and a small bowl shaped structure within the ruinous walls of an outer structure. These walls are up to 1.3m high and 2.3m wide, but the tumble does not allow an exact measurement. Below the ruin is an area of tumble containing some chosen stone, so may have come from the structure when the landslip occurred.

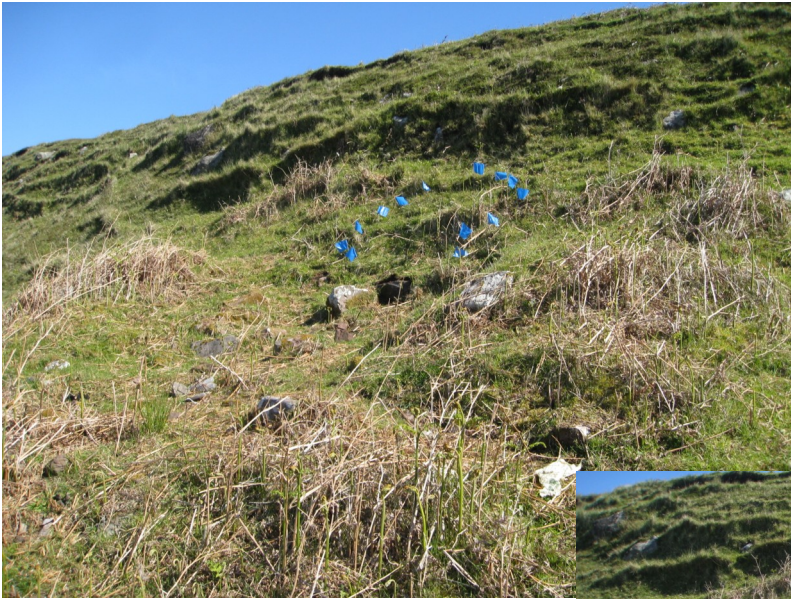
LOOKING N AT KILN STRUCTURE SET INTO BASE OF RAISED BEACH SLOPE. EVIDENCE OF LANDSLIP CAN BE SEEN.

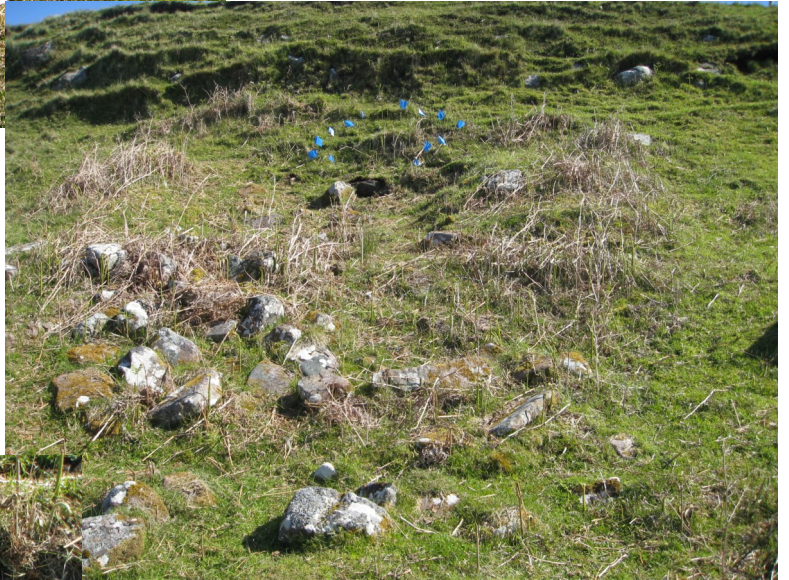
LOOKING E AT KILN STRUCTURE WITH TUMBLE DOWNSLOPE

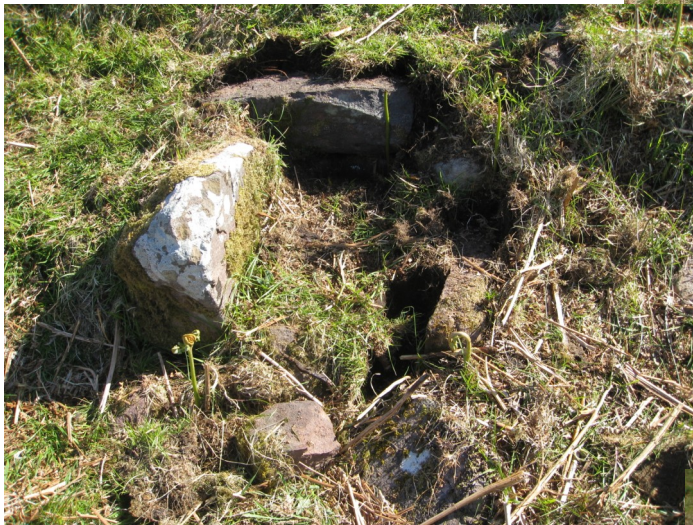
STONES AT POSSIBLE FLUE ENTRANCE

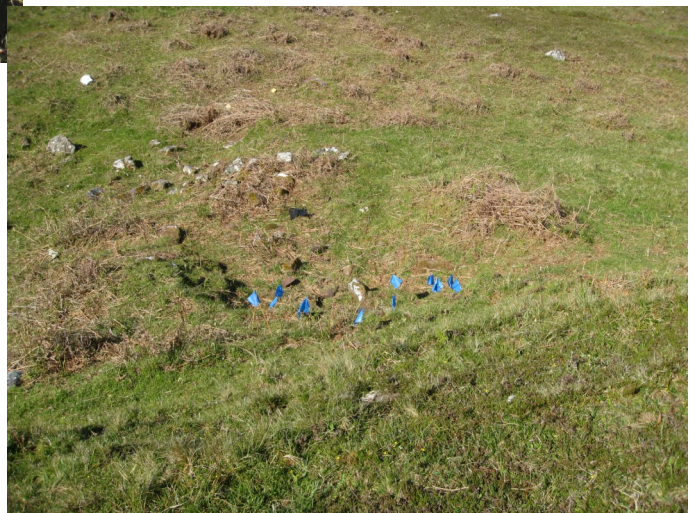
LOOKING DOWN STEEP SLOPE AT KILN STRUCTURE.

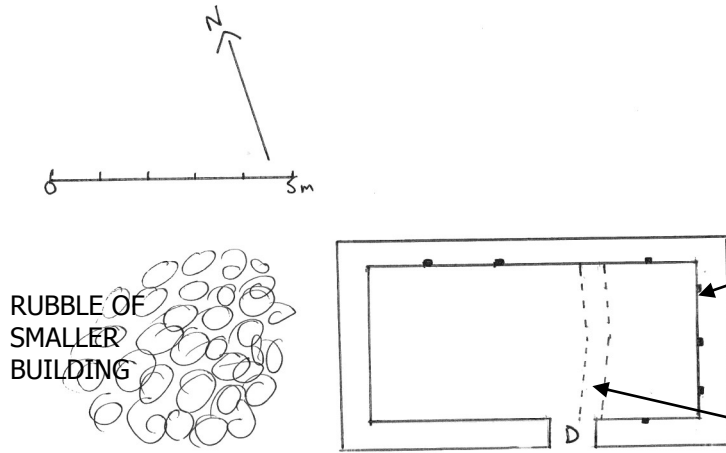
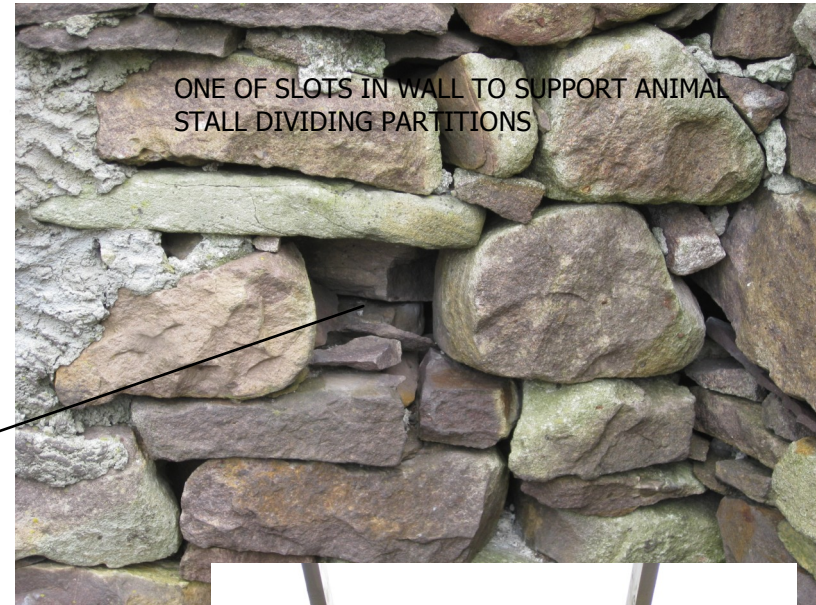
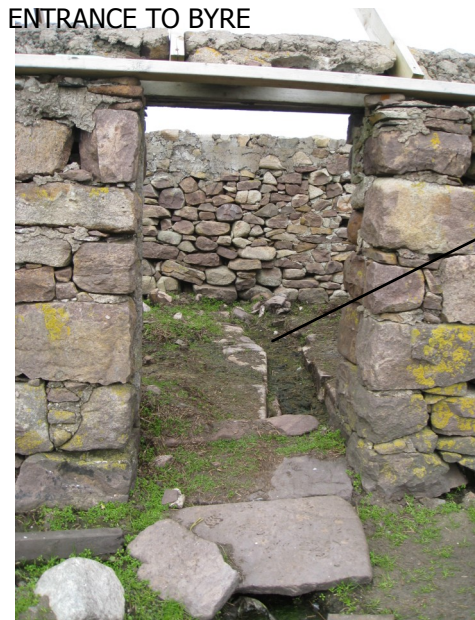
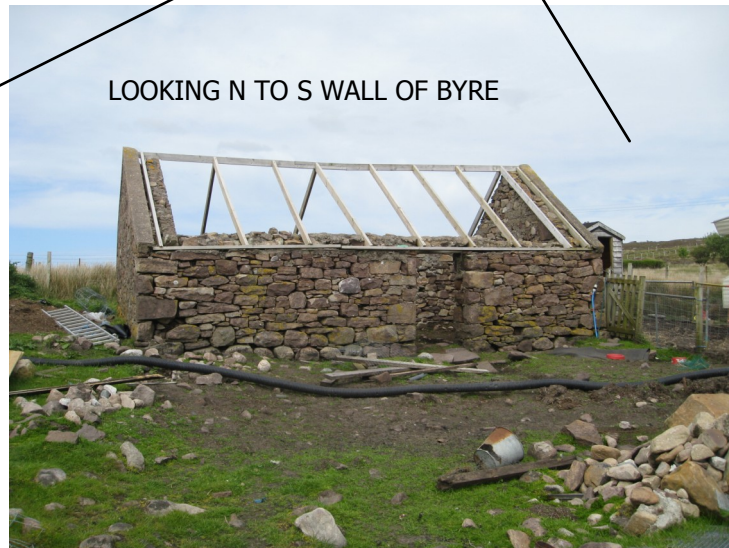
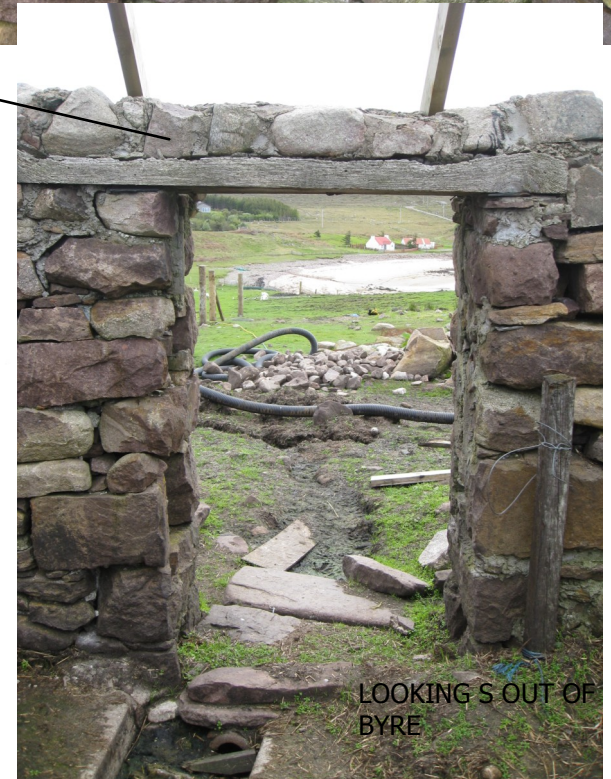
RUINED BYRE ON CROFT 13 PORT HENDERSON.NG 75573 74082 GPS. ELEVATION 18m. SURVEYED ON 03-06-10

This ruined byre that is now partially rebuilt is not shown on any OS map but is roofed on the 1947 aerial photo, with a smaller building beside it. Its walls are 0.60m thick and up to 1.70m high made of mainly dressed and chosen stone with some boulders. There is a byre drain, and remaining wooden lintel above the doorway. Slots show where the stall dividers were. The ground is level.
