Plan of Croft 15 known as 'Lota Chrubaidh'
Port Henderson
Centred on NGR NG 7581 7393

Croft 15, Port Henderson.

DERELICT HOUSE AND FOOTINGS OF BARN/BYRE CROFT 15 PORT HENDERSON.NG 75870 73954. ELEVATION 12m.
 SURVEYED ON 03-06-10.

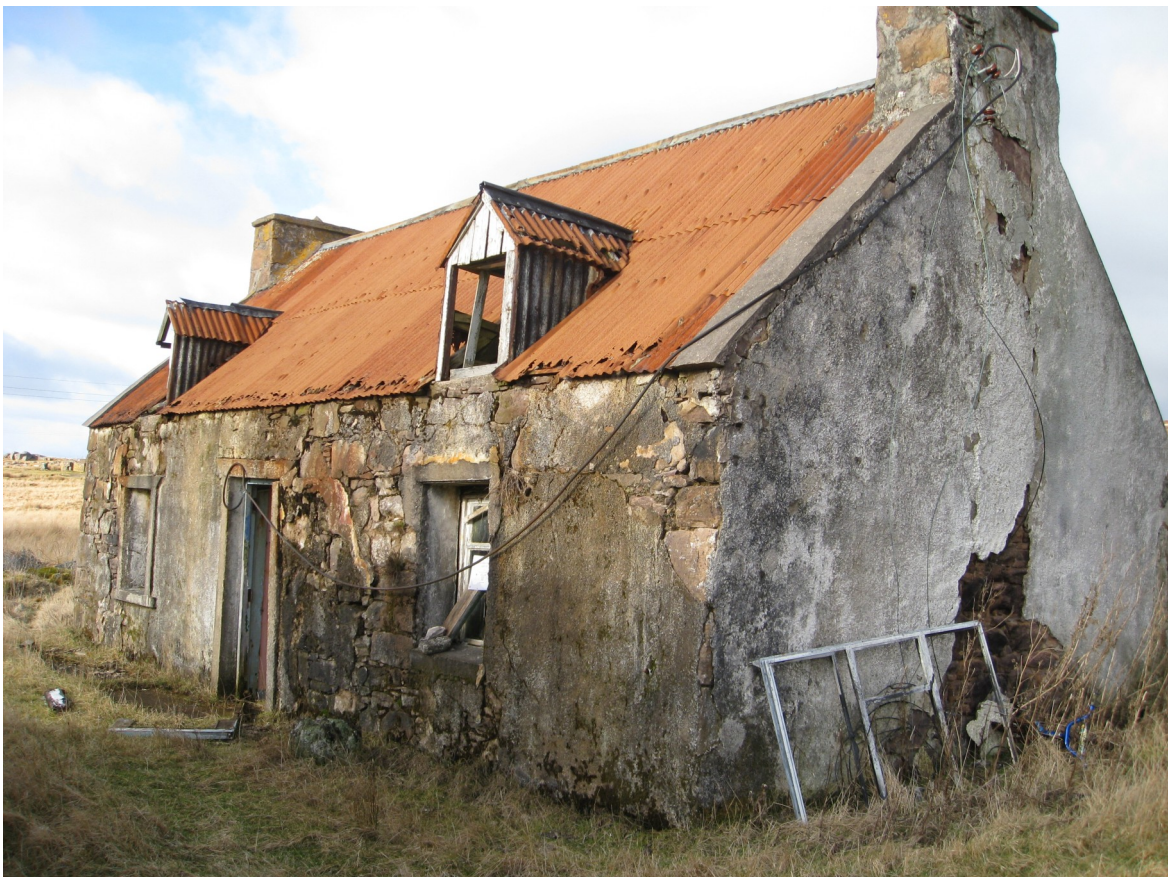
Derelict house on croft 15

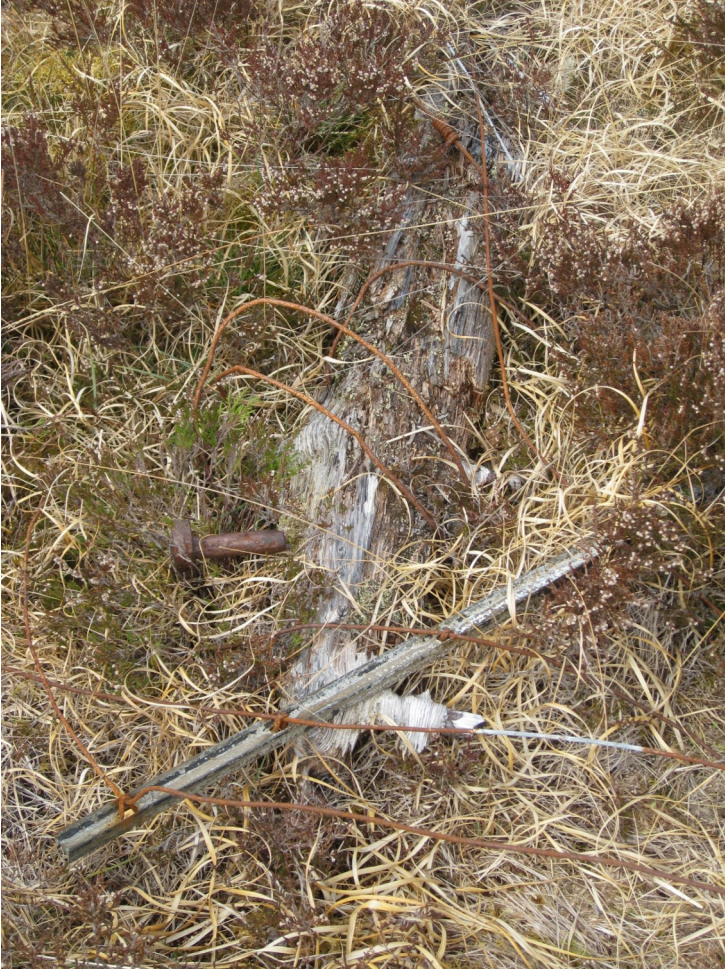
All that remains of the Black Gate are two strainer posts and metal fittings attached to the iron fence.

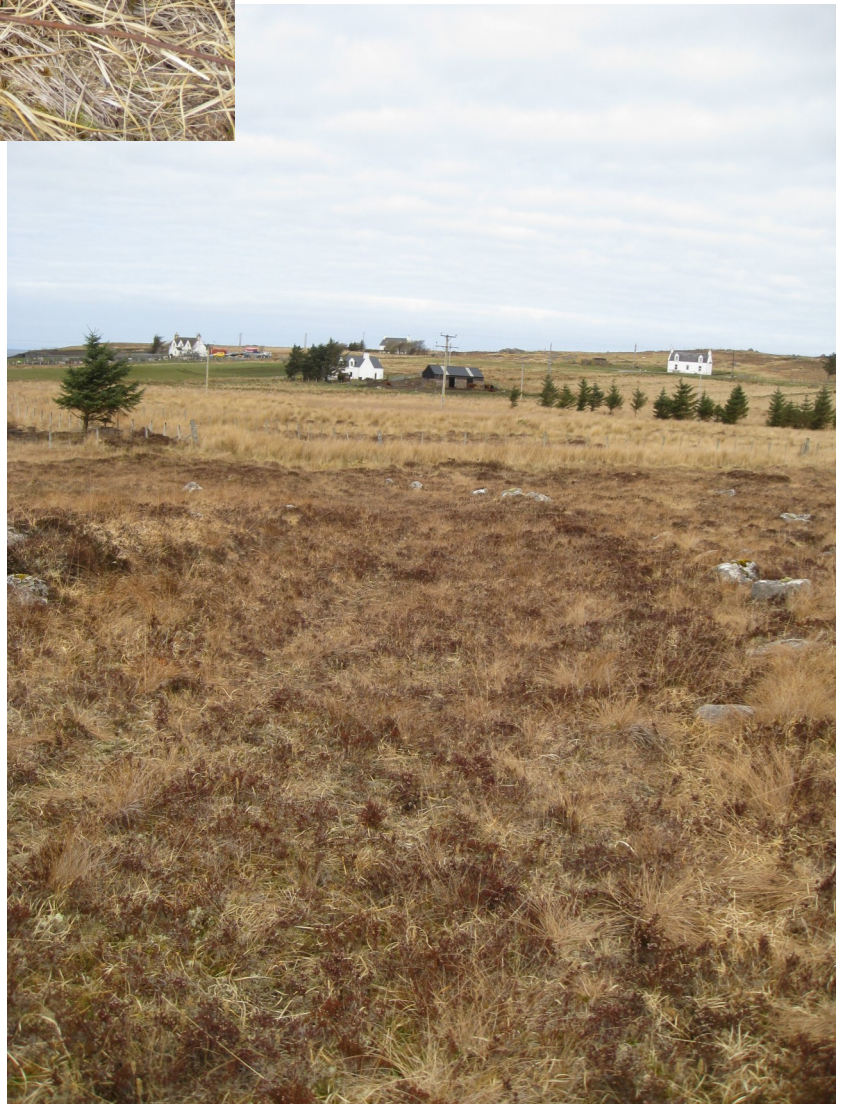
Looking along the old track towards the SE corner of croft 15 where it joins the passage. The rushes on croft 15 can be seen.

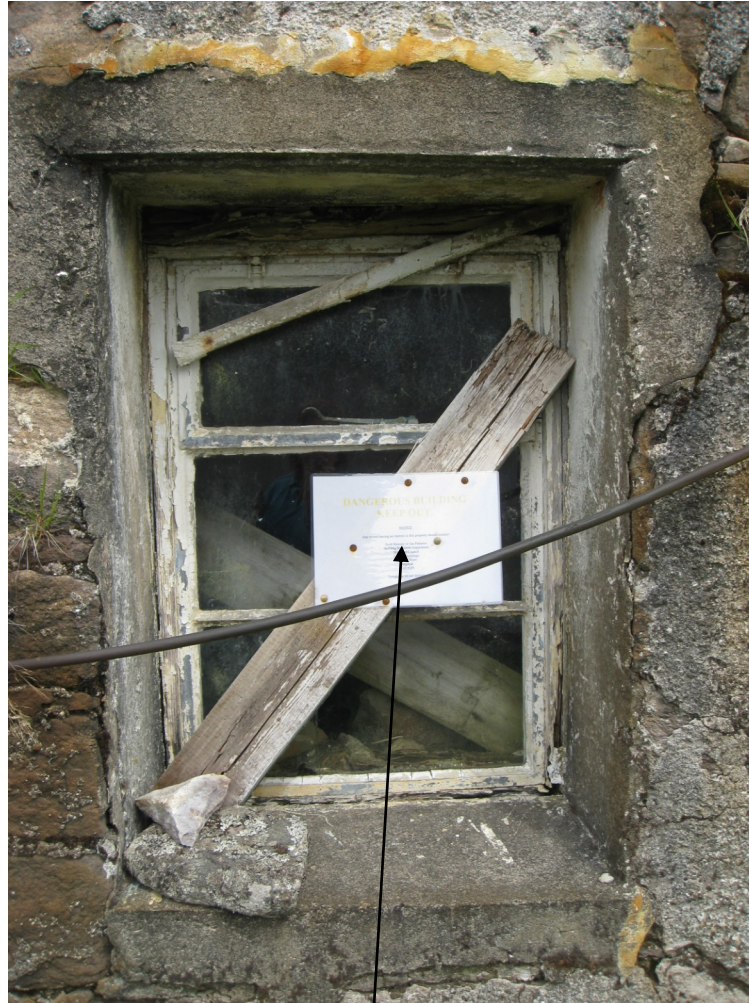
LOWER WINDOW BOARDED UP WITH NOTICE FROM HIGHLAND REGIONAL COUNCIL DECLARING HOUSE AS DANGEROUS.
