**CASTLE FRASER COURTYARD
ABERDEENSHIRE
DRAIN UNBLOCKING
-Archaeological Watching Brief-**

HK Murray

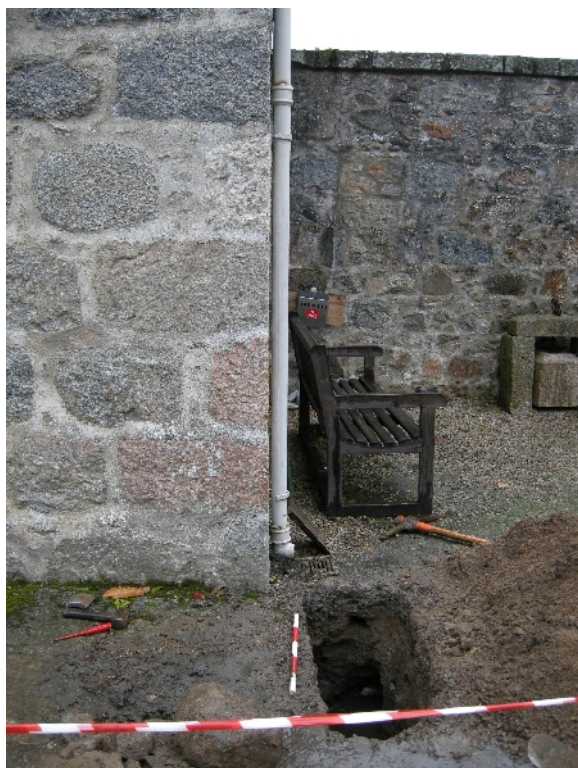
Illus 1 Location of test pit 1, looking E

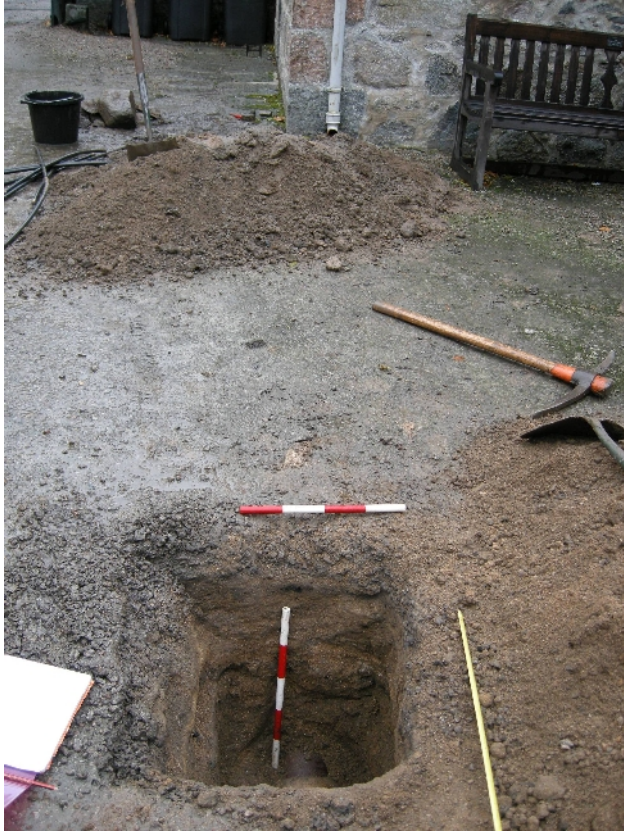
Illus 2 Location of test pit 2, looking N to test pit 1

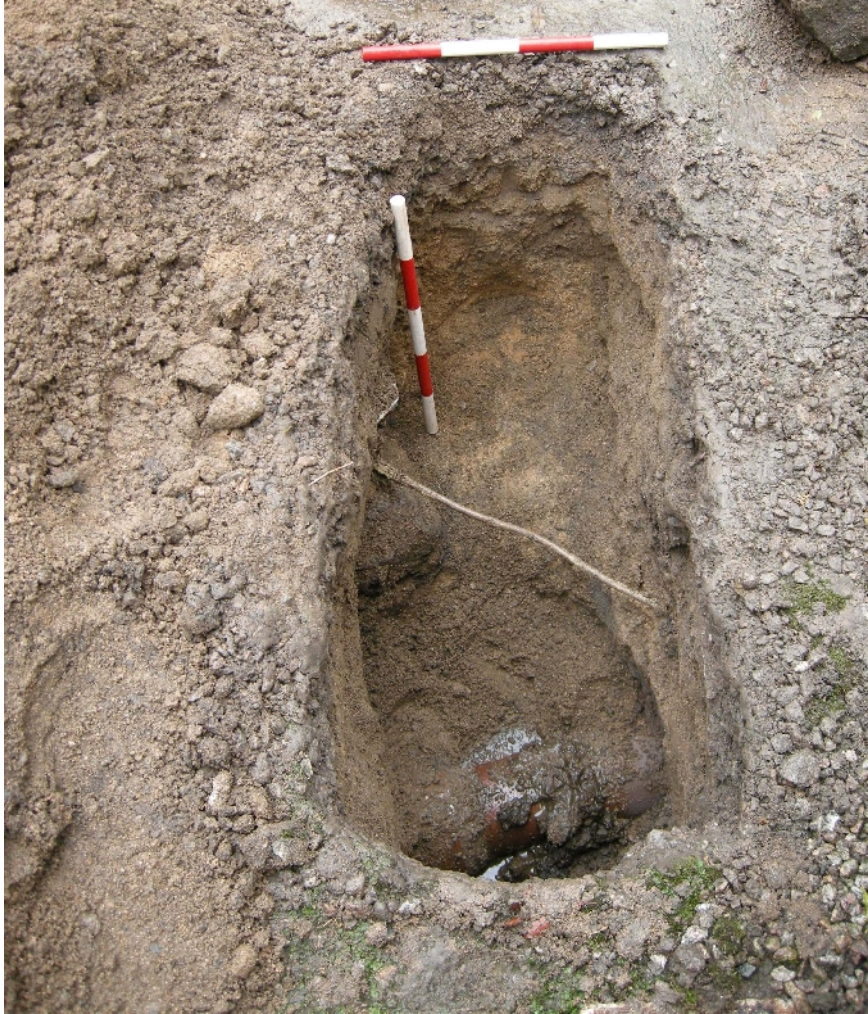
100-150mm gravel (1) overlay loose earthy sand and gravel backfill (2) over the drain. The ceramic drain (5) ran N/S along the E arm of the test pit, with a junction from the nearby downpipe coming in from the E. The drain had been cut into clean hard natural glacial deposits. The W side of the drain cut had cut along the side of two stones (3) placed in a higher cut into the natural. These stones had been partially disturbed by the earlier insertion of a thin pipe (4) for heating oil for the manager's flat.

Illus 3 Test pit 1, looking W to stones (3)

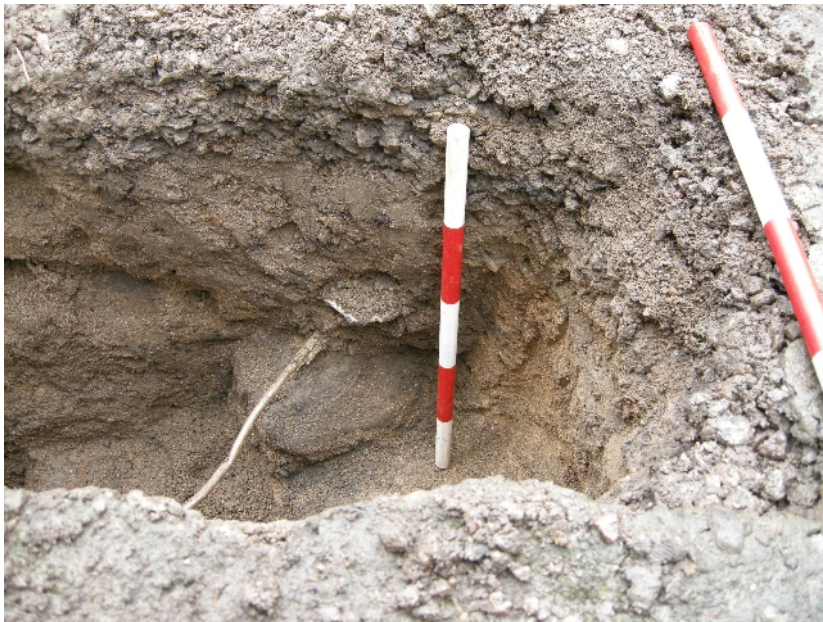
Illus 4 Test pit 1, looking at S section showing stone (3) and cut into natural (3/1)

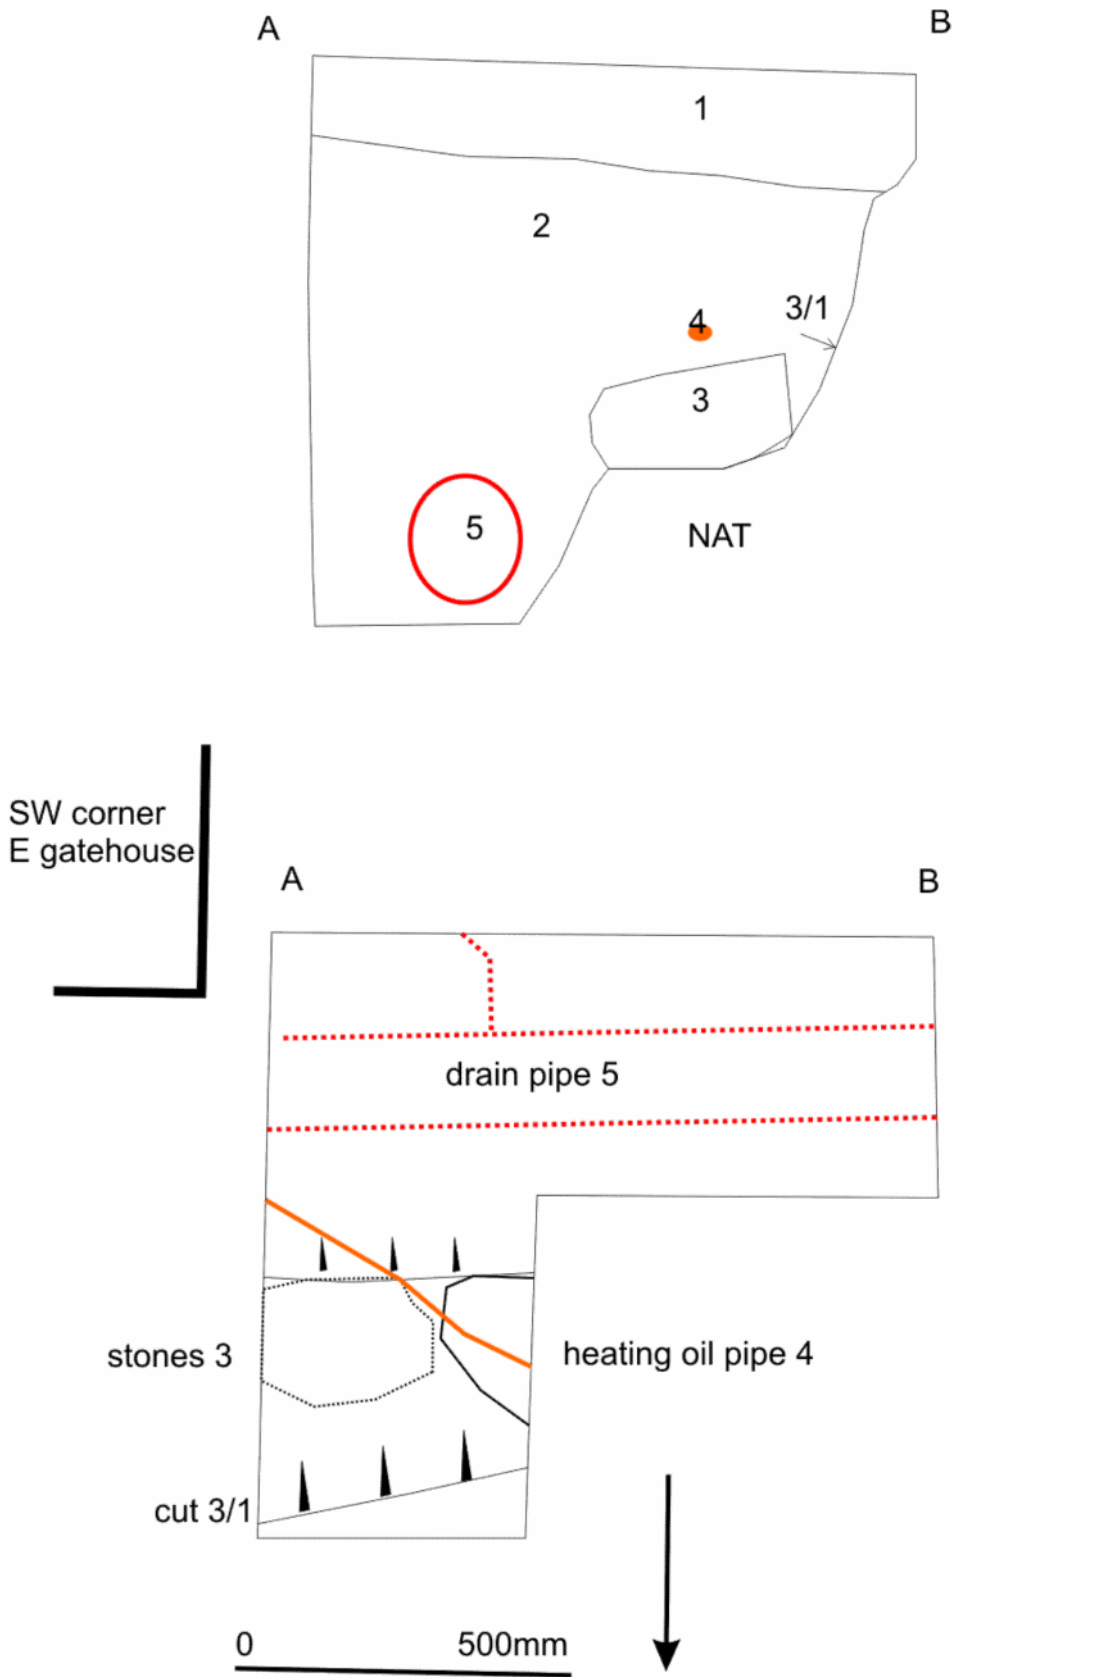
Test Pit 1 (TP1) TP1 was originally 900mm (E/W) x 400mm (N/S) but was later extended to an L-shape by 600 x 400mm at the SE corner. The E edge of the test pit was located 100mm to S and 100mm to the E of the SW corner of the E gatehouse.

Illus 5 TP 1. Plan and S section

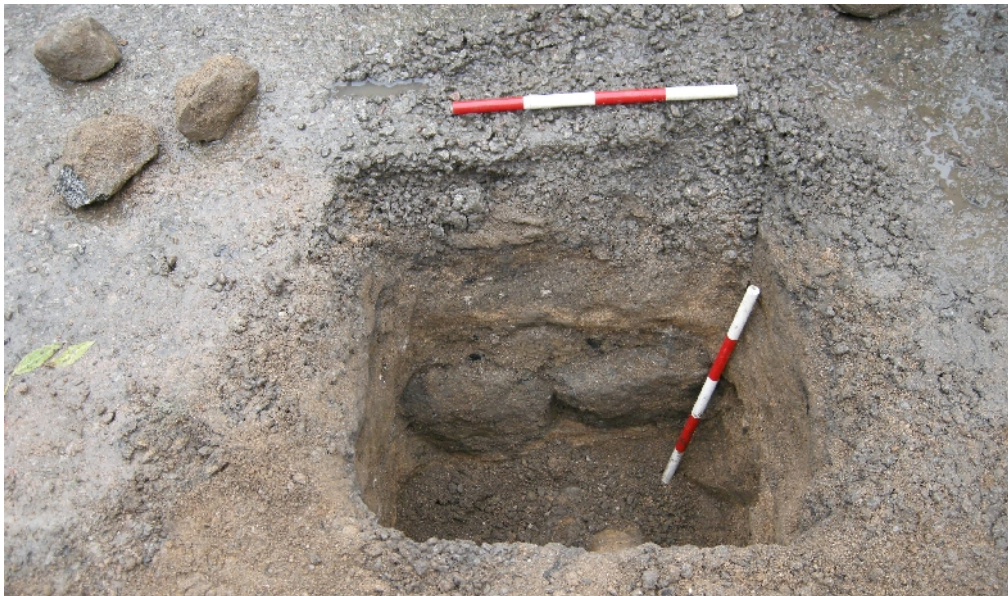
Test Pit 2 (TP2) TP2 was 700mm (N/S) x 500mm E/W). It was located 4m S of the SW corner of the E gatehouse and 4m W of the E wall of the courtyard. 100-150mm gravel (1) overlay loose earthy sand and gravel backfill (2) over the drain. The ceramic drain (5) ran N/S along the centre of the trench, 630mm below the present yard surface, and had been cut into clean hard natural glacial deposits. The W side of the drain trench had cut along the side of two in-situ stones with clay bonding (6) which were sealed by c100mm of grey gritty sand with charcoal in it (7). These stones were undisturbed by the present works and lie 400mm below the present yard surface.

Illus 6 Test pit 2, looking W, showing wall 6 and grey sandy layer 7 above it

5.1. Stones (6) in TP2 and the disturbed stones (3) in TP1 appear to be on the wall line of a small structure on the E side of the entrance as shown on illus 8.

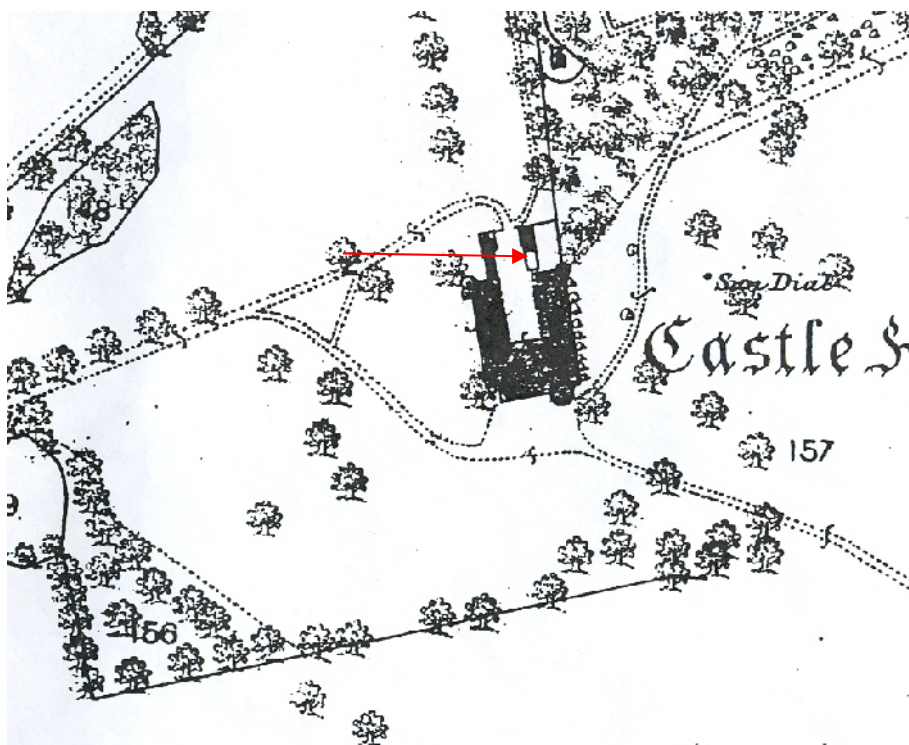
This building- and a similar building on the W side of the entrance - are not on the 1788/9 or 1799 estate plans. They are shown on the 1846 estate plan and on the 1st OS map of 1864/7 and the 2nd edition OS map of 1899. They appear therefore to date to the 19th century.

Illus 8 1st OS map (1864/7) with arrow marking wall shown in test pits

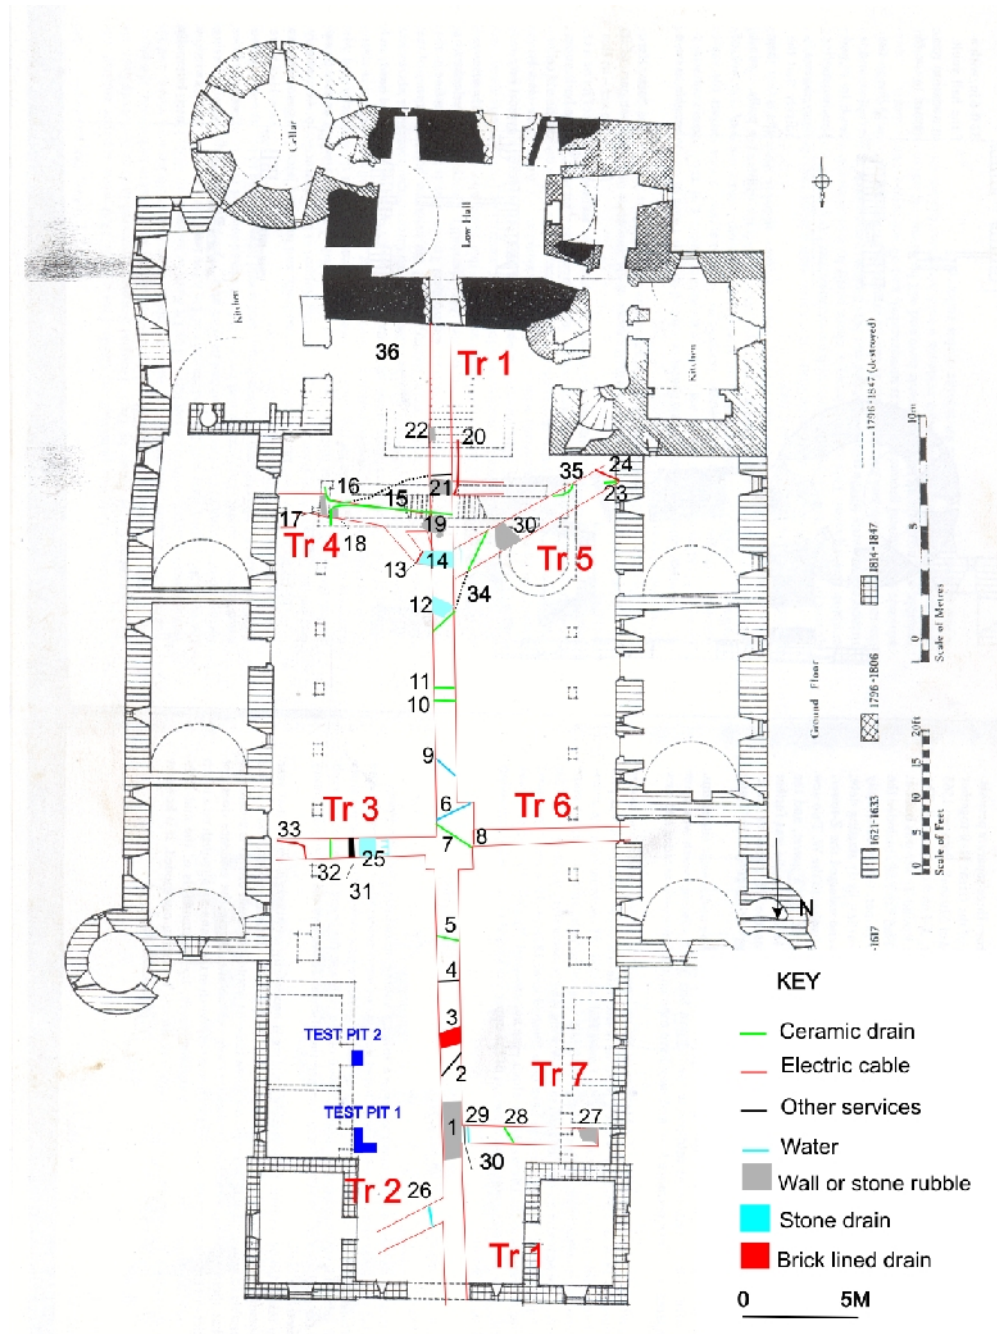
Illus 9 Test pits (blue) superimposed on plan of drains etc recorded in 2005
