Burgie Castle, Moray

Photography and Watching Brief

Client	HBPT
Date (revision)	21 November 2008
Report No.	HAS080903
Project	HAS/BGC08
Planning Ref	
Authors	Benny Malone and John Wood

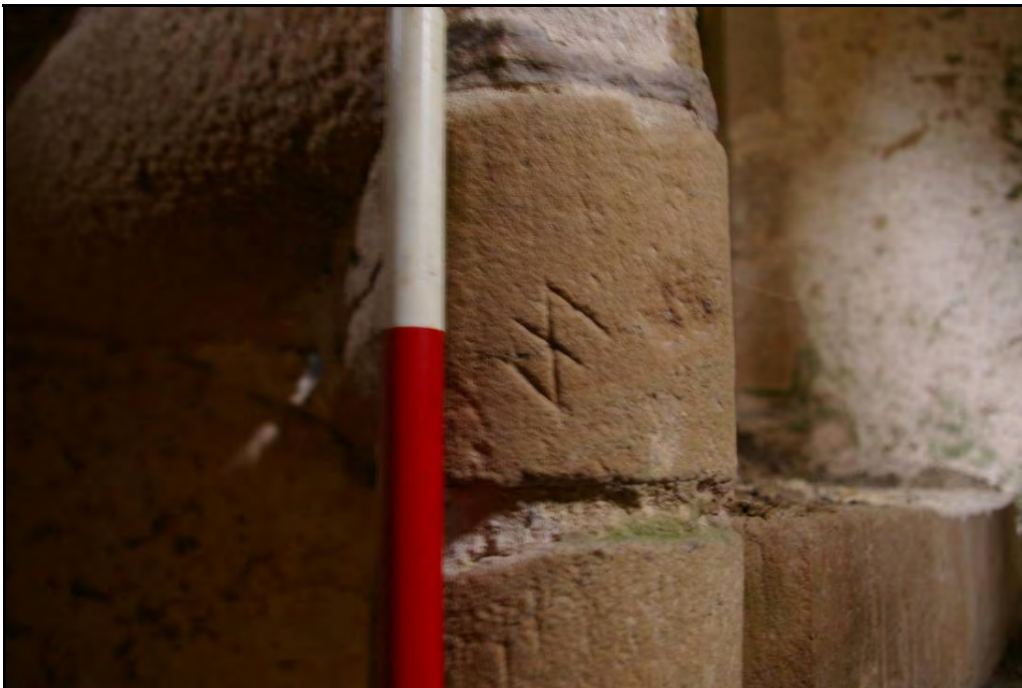
Plate 1 Masons mark on staircase

- a straightforward cross (photos 43, 78, 97, 104, 105, 106, 132, 163,);
- a more elaborate cross with an extra line at 90 degrees down and one at 90 degrees up from the ends of the left and right sides of the cross respectively (Plate 1; photos 75, 79, 90,96, 118, 123, 124, 125, 126, 127).

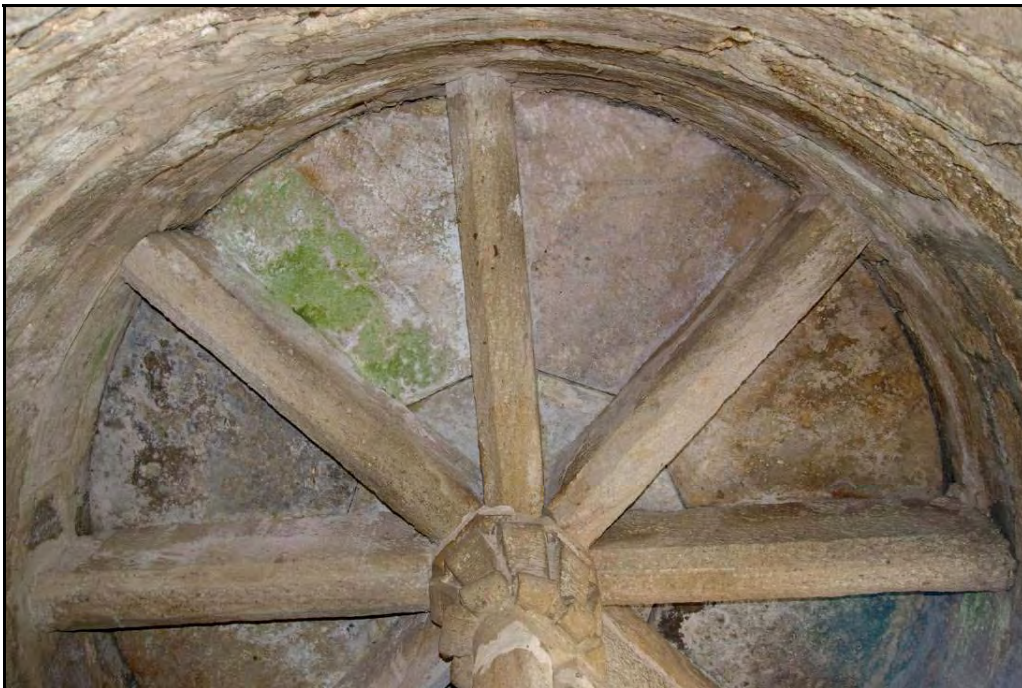
Plate 2 Decorated top to stair

Many decorative features were also noted, including the decorative top to the staircase (Plate 2). However in the absence of scaffolding or other means of access it was impossible to record features high up on the outside of the building.

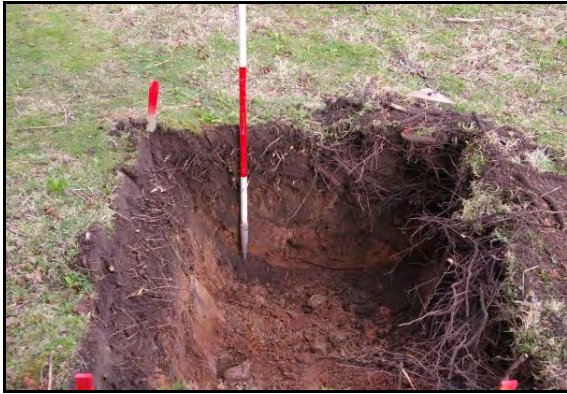
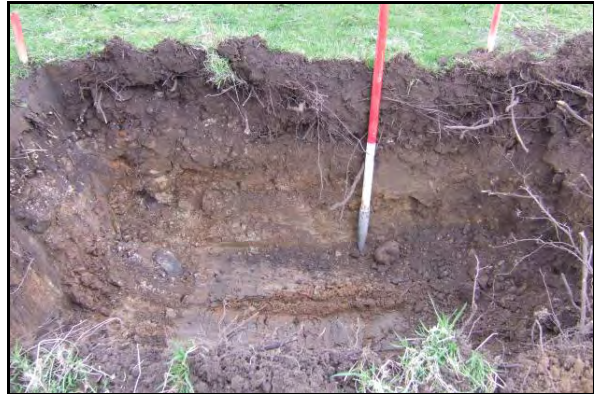
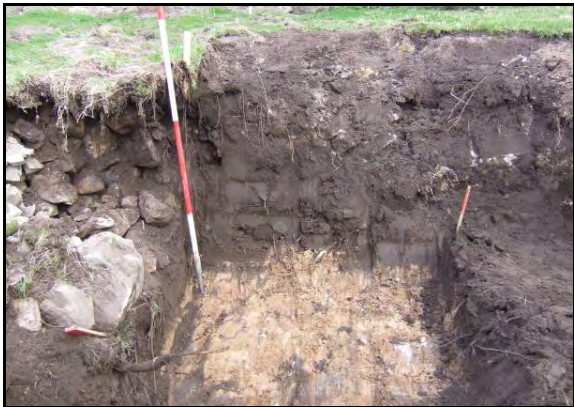
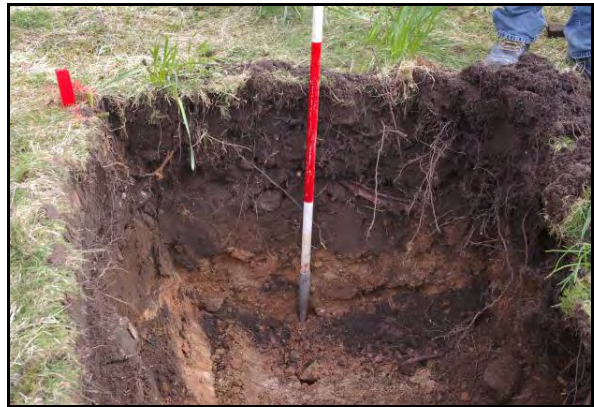
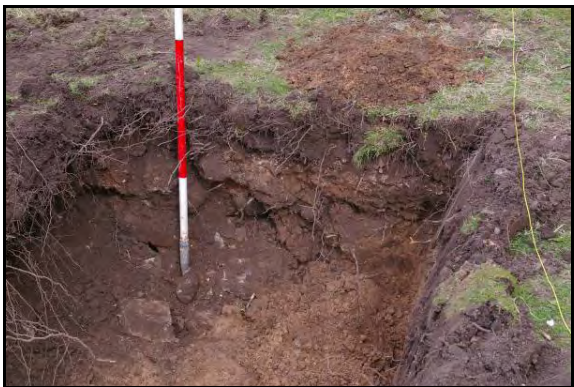
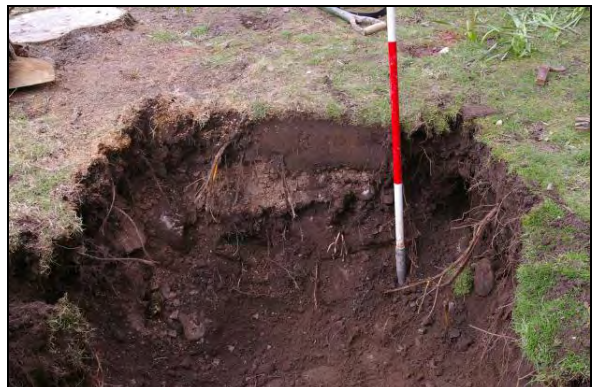
Plate 3 Box trenches 1-6

No archaeological features were identified: a number of large stones, approx. 0.2 – 0.3m diameter, were found scattered without any definable pattern within the top-soil. These stones may represent tumble from the tower walls.

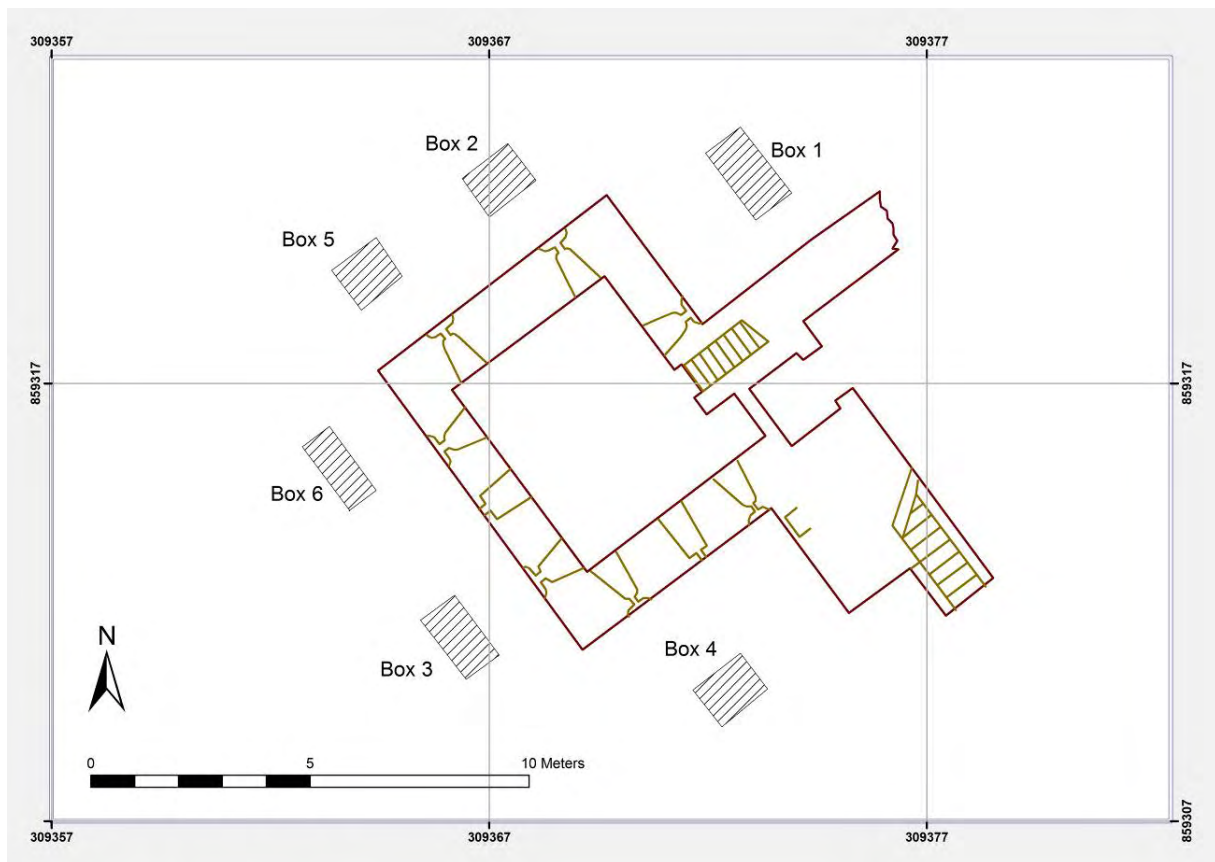
Figure 2 Plan of observed trenches
(derived from a plan by Elliott & Co. GB National Grid)

The watching brief was carried out by Brendan Malone on the 22nd April and on the 6th May 2008. The excavation of 6 box trenches to form the bases for scaffolding was monitored to identify and record any previously undiscovered archaeological features revealed by the work. Approximate dimensions were: Box 1 – 1.0 x 2.0m; Box 2 – 1.2 x 1.2m; Box 3 -1.0 x 1.8m; Box 4 – 1.0 x 1.4m; Box 5 – 1.2 x 1.2m; Box 6 – 1.0 x 1.8m. All these excavations were carried out by the contractor with a back-acting mechanical mini-digger fitted with a flat edged bucket 0.5m wide, working in shallow spits under close archaeological supervision. The trenches were observed to subsoil level, which lay between 0.6m and 1.0m below the present surface. The process was photographed to provide a record.

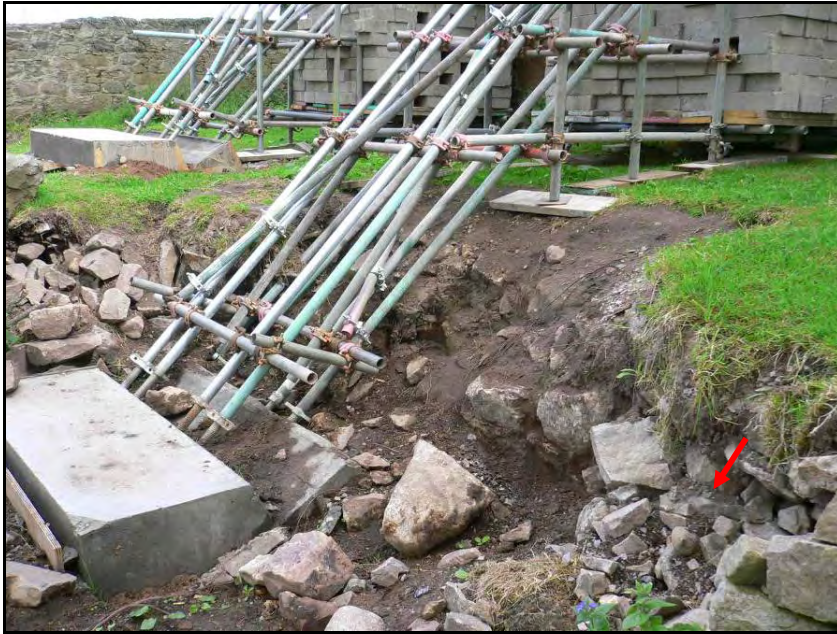
Plate 4 Wall discovered after watching brief following Box 3 enlargement

After the watching brief had been completed, it seems that one of the pits was enlarged by the scaffolding contractors to accommodate diagonal poles, exposing a further section of wall, standing behind the visible modern retaining wall of a horse-jump. A further visit was made to investigate when we were alerted to this. As very little of this could be seen it has not been possible to interpret or date this feature (See Plate 4 below), but it may be associated with the Burgie horse trials rather than the tower.

The erection of scaffold and shoring from each box did not appear to interfere with any archaeology. However, the subsequent appearance of a stone wall in the extension to Box 3 demonstrates the existence of buried archaeological features which should be investigated and recorded when consolidation work to the tower takes place. There are however no recommendations for further archaeological fieldwork at this stage.

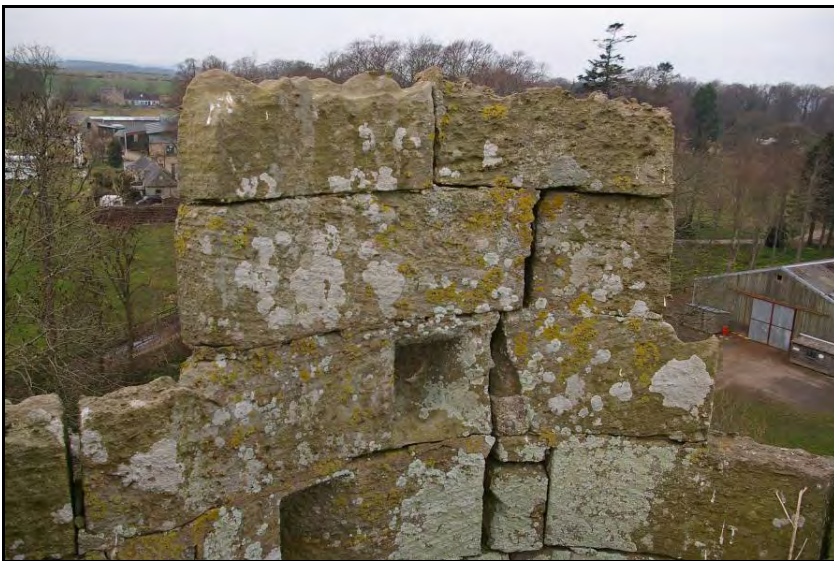
Plate 5 Bartizan: mortar bonding failure

The tower is now in a very serious condition, with substantial cracks running vertically through two wall faces and very unstable masonry in one bartizan. The Highland Buildings Preservation Trust has managed an initial phase of consolidation works to “buy time” until a permanent scheme for the conservation of the tower can be implemented. Scaffolding was fitted to the outside of the lower floors, tied back to the building using existing window openings without damaging the fabric. This required foundations for buttresses, which had to be excavated to a depth of approximately 450mm and were the subject of the watching brief.
