Project Code: FHSU08
Date of report: October 2008
Client: Historic Scotland

Preliminary Survey and Assessment of a wreck on the island of Fuday

Barra, Western Isles

Dr. RGW Prescott
Dr. D Atkinson
S Liscoe

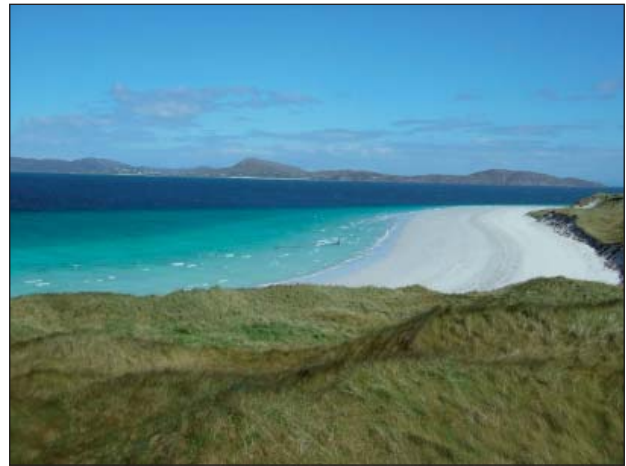
Illus 2

General view of the beach from high on the machair, showing the wreck near the tide-line

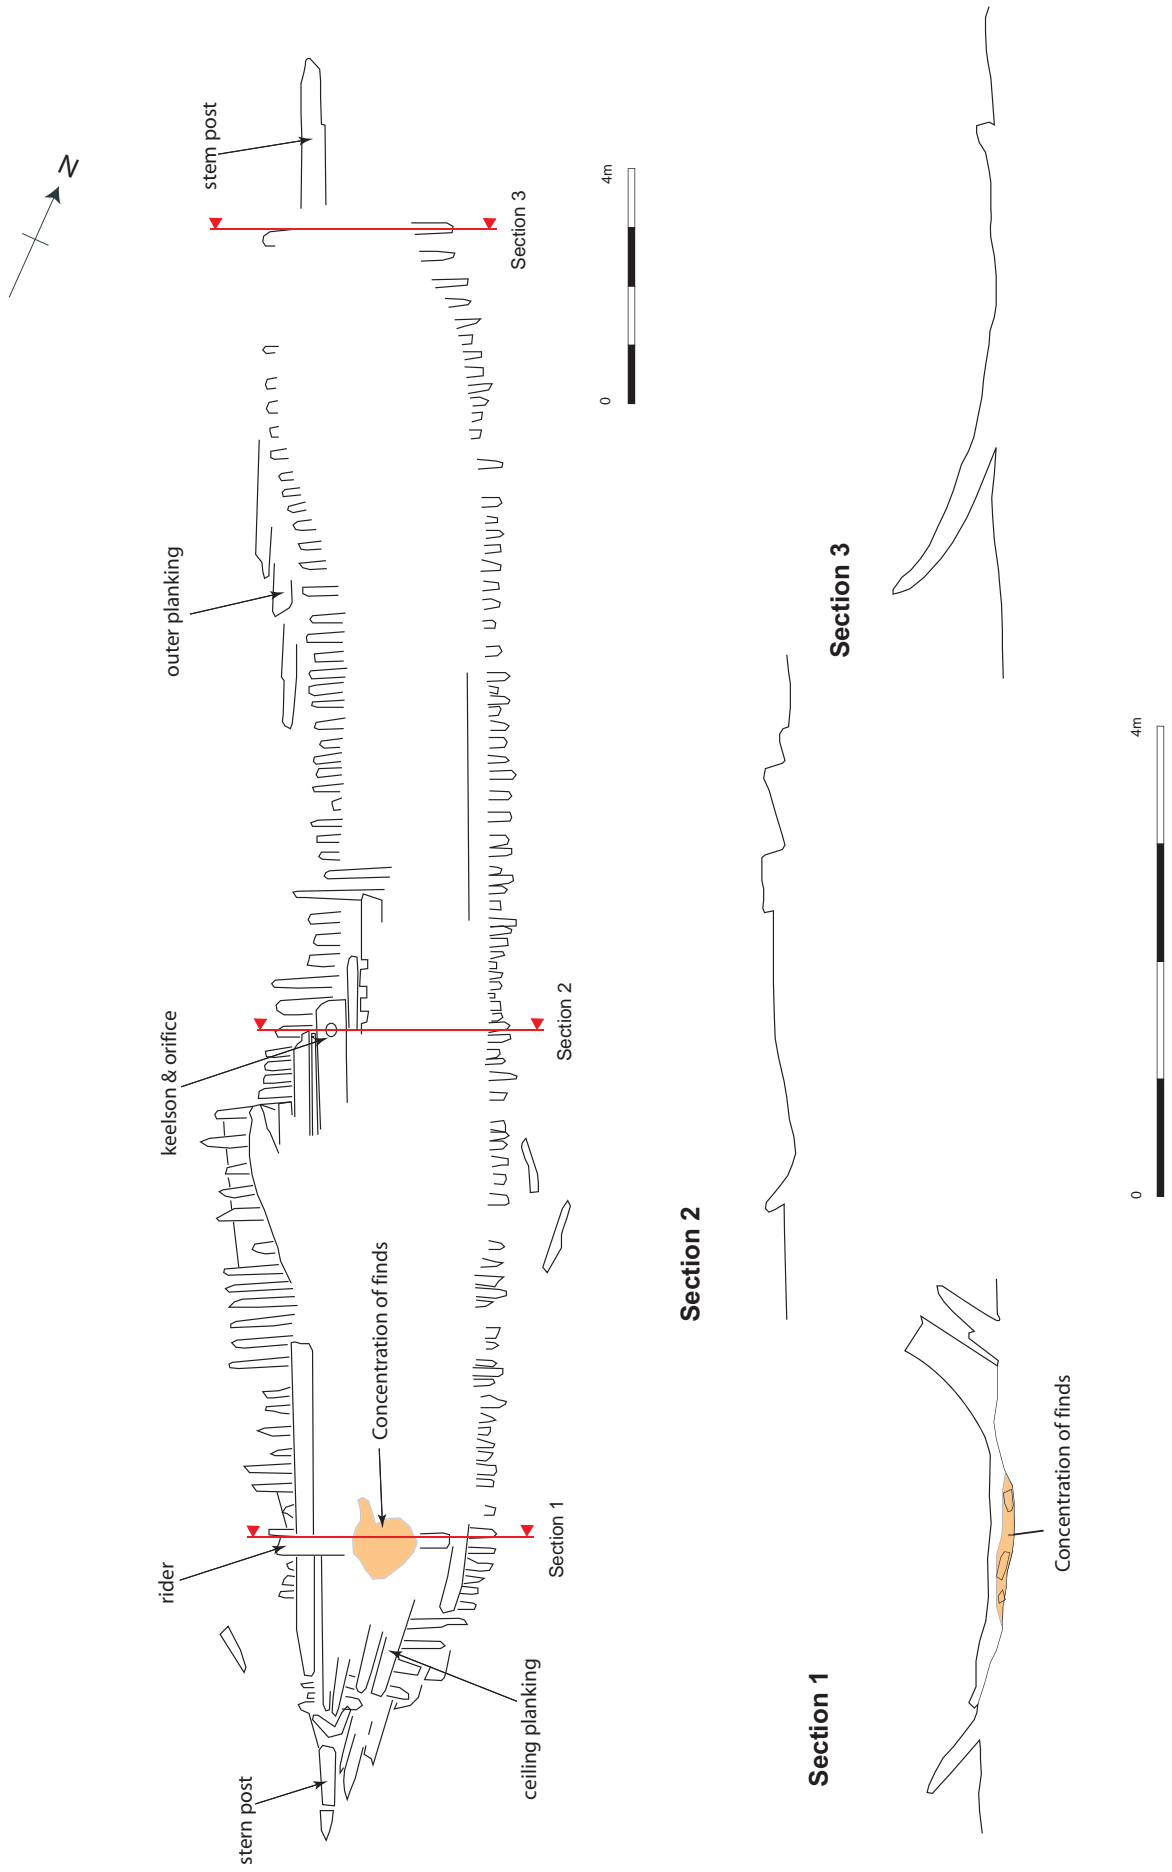
Illus 3
Plan and sections of the vessel

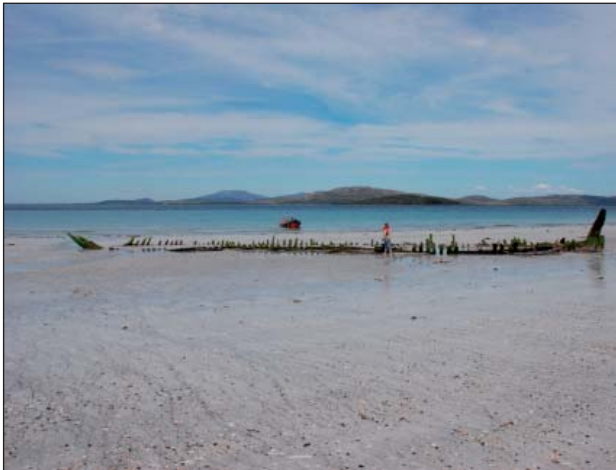
Illus 4

The wreck in close up. From stem to stern

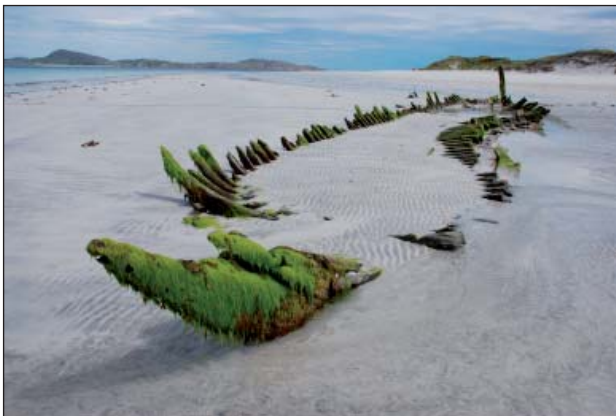
Illus 5

The wreck in close-up. From stem to stern

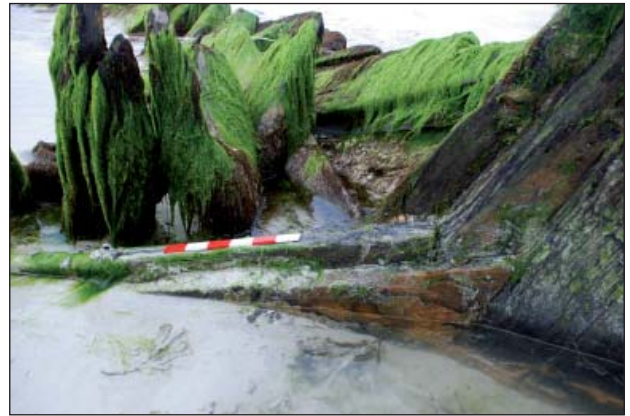
Illus 6

Stern assembly, showing double rabbet

The observation of a double rabbet line on the stern post during the 2002 inspection, reinforced *a fortiori* by the more extensive recent survey, when the forward stem was also shown to have a double rabbet, and both stems were seen to marry up to the hood-ends of a double skin of outer hull planking (the inner, ceiling planking is a single layer) has clear parallels in the archaeological record (Maarleveld, 1994, Probst, 1994). Some half-dozen vessels showing this characteristic have been studied in sites from the Netherlands, Denmark and the Far East. This feature is found in both large ocean-going vessels such as the Dutch East Indiaman *Batavia* (1628) and in smaller, vernacular trading vessels from the North Sea margins. The double skin has been interpreted as an adaptation to strengthen hulls at the time when the technological change from shell-first construction to frame-first construction was taking place in North-west Europe, as a result of cultural influences from Southern Europe. This transition, in the cases reported above, has been dated to the late sixteenth and early seventeenth centuries.

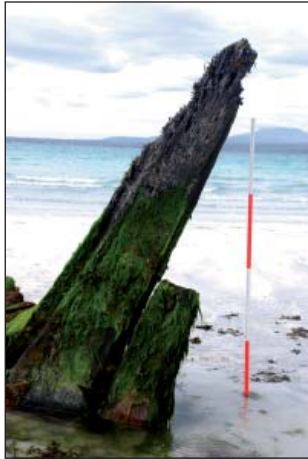
Illus 7
Stern post

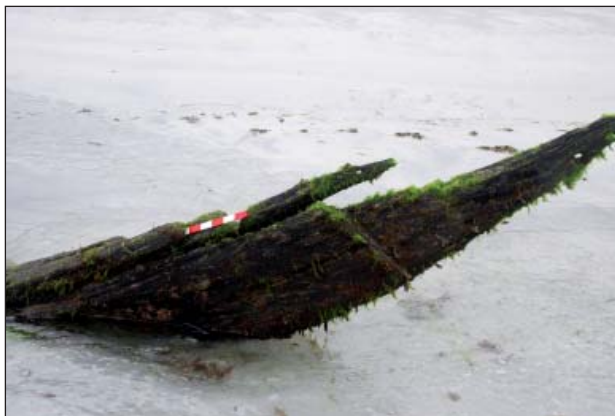
Illus 8
Fore-foot with scarf

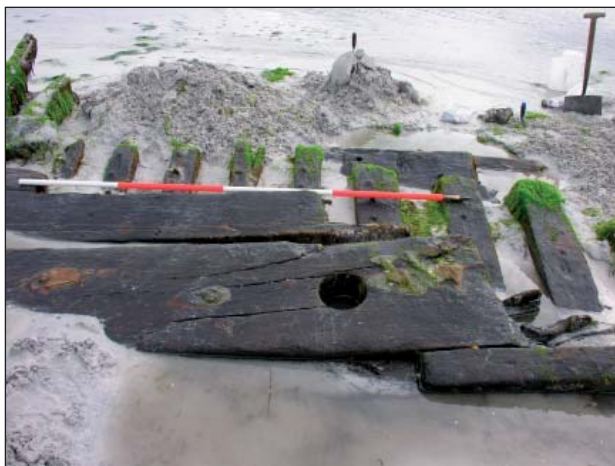
dence of salvaging activity in the past. For example, the fore end of the keelson has been truncated amidships and its damaged end bears tool marks, probably from an axe. Also, the top of the rider on the port side has been sawn off square and the cut surface matches that of a piece of timber previously collected in 2002 from a wood-store in South Kilbride (R G W Prescott) and currently held in St Andrews. Also, during the present visit, a slightly charred timber from the wreck was col-

Illus 9
Keelson, with circular orifice (pump well?)

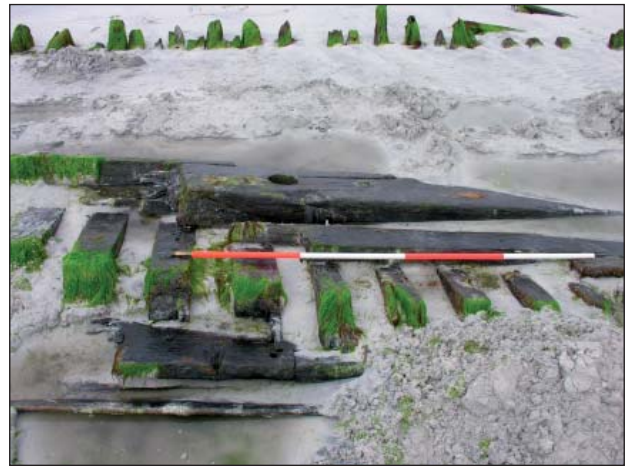
Illus 10
Midship structure including; double outer planking; ceiling planking; keelson; floors and starboard futtocks (top of picture)

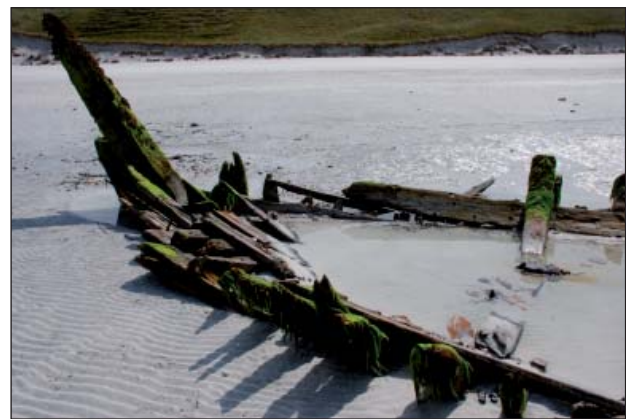
Illus 11
Stern structure including the floor rider and concentration of finds *in situ* (above the rider on the right of the picture)

The ship structure is fairly robust unless attacked by crowbar and saw. It is the remaining contents of the vessel that are under greatest threat from both human action and tidal flow. We therefore suggest that consideration be given to a complete excavation of the contents of the vessel, which have by now been reduced to a relatively small and manageable amount of stratified infill, mostly between the

3. A decision should be made to excavate the remaining contents of the interior of the ship, which are at continual risk from the action of wave and tide. This excavation should progress steadily along the length of the ship, clearing the spaces between the frames to the full depth of the hull. Work on the site would be restricted by the tidal cycle; each excavation session should end with the systematic re-packing of the excavated spaces with Hessian sand-bags, filled with nearby beach sand of the same quality as that within the hull. Thus consolidated, the site would have a measure of homogeneity and similarity to the characteristics prevailing before excavation began. The infill of sand-bags would also safeguard against adversely changing the hydrostatic regime within the wreck.

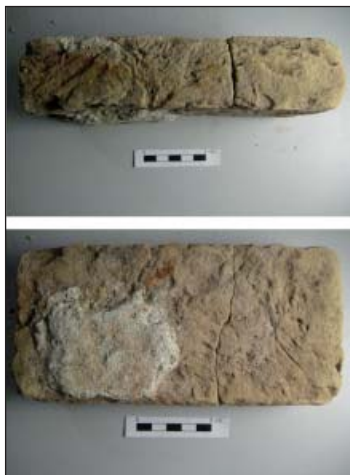
Illus 12
Brick

The bricks recovered from the site by various people and taken to St Andrews in 2002 were tentatively assigned to a Dutch origin. They resemble a group of bricks in the collection at the Montrose Museum, from a Dutch East Indiaman that was wrecked north of Montrose in 1707, and also specimens from the wreck of the *Kennermerlandt* (1669) in Shetland. The bricks collected

in 2008 are similar in character to overijsselse steen, yellow bricks of Dutch origin carried on VOC ships as ballast. A specimen of Terracotta tile was also collected in 2008 and has been assigned to an earlier date in the fifteenth century (J Franklin, personal communication). Some of the bricks and the tile have mortar on them and are clearly re-used. Whether as ballast, a cargo or part of the structure of the galley, these bricks and tile may be older than the ship that carried them.

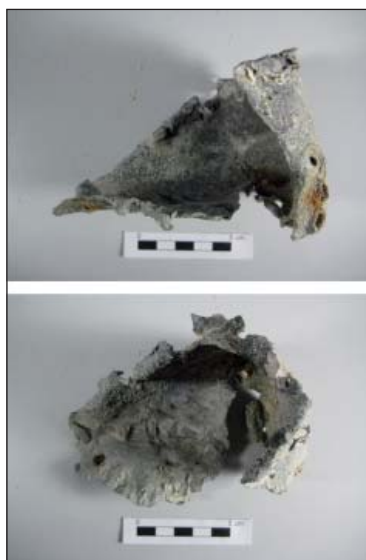
Illus 13
Lead object

The small piece of sheet lead found within the wreck has parallels in finds from the *Dartmouth*, wrecked in the Sound of Mull in 1690 (Martin, 1978). Similar items are mentioned in Sir Henry Mainwaring's seventeenth century *Seaman's Dictionary*, where they are described as tingles for repairing leaks both within and outwith the hull. Their small size would enable their use to repair leaks between the frames.

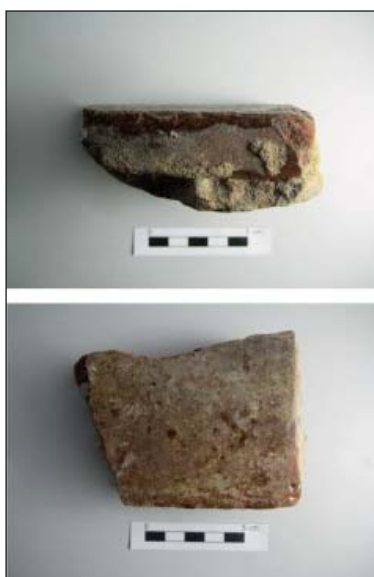
Illus 14
Tile
