Duart Point, Sound of Mull

Designated Site Assessment Full Report

Ref: 53111.03I

March 2004

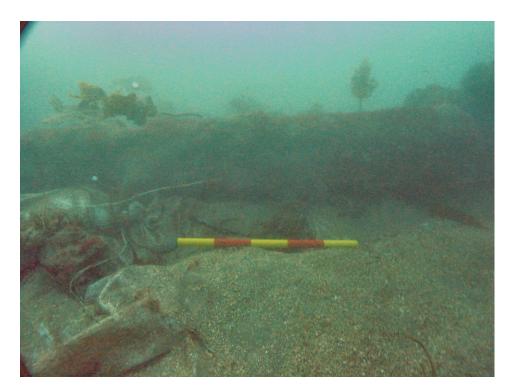
Plate 1: Monitoring photograph 1033

Monitoring Point	Plate No.	Details	Notes
1033	1	Looking WSW from E of Gun 1. The gun is in the background, cascabel to left (out of shot). Sandbags laid in 2003 are foreground left.	No evidence of erosion or other disturbance since the laying of the sandbags is apparent.
1034	2	Looking NW from S of Gun 1. The cascabel of Gun 1 is background centre. Sandbags in foreground laid in 2003.	No evidence of erosion or other disturbance since the laying of the sandbags is apparent.

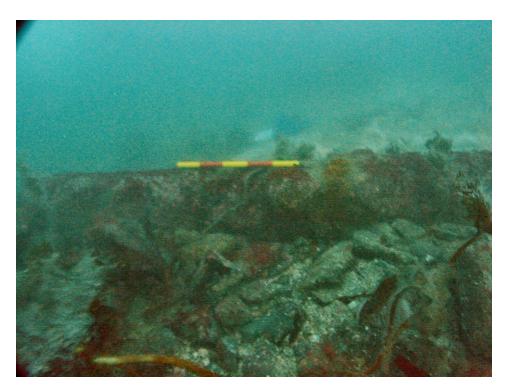
Plate 3: Monitoring photograph 1035

Monitoring Point	Plate No.	Details	Notes
1035	3	Looking ENE from W of Gun 1. The gun is in the background, cascabel to right (out of shot).	No evidence of erosion or other disturbance is apparent.
1036	4	Looking SW from NE of Gun 2. The gun is in the background, muzzle to the right. Ballast stones from E ballast mound are in the foreground.	No evidence of erosion or other disturbance is apparent.
1037	5	Close-up looking SW from NE of Gun 2. The gun is in the background.	The object arrowed (Figure 2) is reported to be a concretion that may have become detached from the gun. This identification is highly uncertain and the diver could not locate the point that it detached from.
1038	6	Close-up looking SE from NNE of Gun 2.	The arrow (Figure 2) identifies the concretion described above.
1039	7	Looking NE from SW of Gun 2. The cascabel of Gun 2 is background right. The E Ballast mound is in the foreground.	No evidence of erosion or other disturbance is apparent.

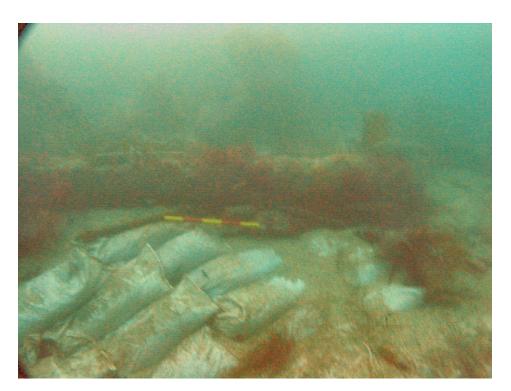
Plate 8: Monitoring photograph 1040

1040	8	Looking SW from NE of Gun 3. The gun is in the background, cascabel to the right. Sandbags covering the 2003 E excavation trench are in the foreground.	The sandbags are not laid flat and are partly buried and in-filled. No evidence of erosion or other disturbance is apparent.
1041	9	Raised elevation view, looking NE from SW of Gun 3. The diver is positioned on the base of the low cliff. Gun 3 is central, with the cascabel to the left.	In the background are sandbags in the 2003 E excavation trench, already in-filled and partly buried.
1044	10	Looking W across northern edge of 2001 excavation trench.	The sandbags only lightly covered are believed to have been laid by the licensee in 2003 as additional protection.
1046	11	Looking SE from NW of the 2003 W excavation trench. In the middle ground is the large boulder shown in the site plan and Gun 5 is in the background.	The sandbags are covering the trench, with a double layer to the right. They are covered with a thin layer of sand but are not yet buried or in-filled. No evidence of erosion or other disturbance is apparent, other than that caused by the excavation.

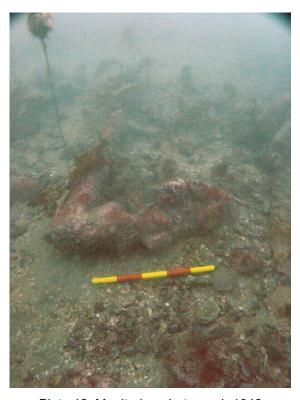
Plate 12: Monitoring photograph 1048

1048	12	Looking SW from NE of the anchor. The anchor is in the middle ground. The seabed is not sandbagged.	No evidence of erosion or other disturbance is apparent. It should be noticed that the anode from the cathodic protection study is no longer attached.
1051	13	Looking SW from NE of Gun 6. The gun is in the background with cascabel to the right. The seabed is not sandbagged.	No evidence of erosion or other disturbance is apparent. The apparent angle of the seabed is caused by camera tilt.

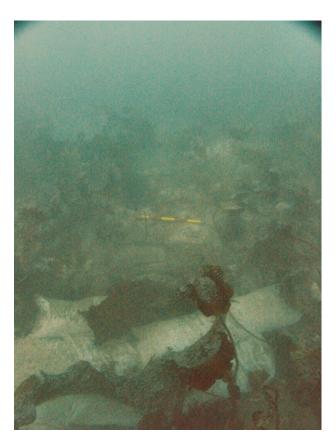
Plate 14: Monitoring photograph 1052

Monitoring Point	Plate No.	Details	Notes
1052	14	Looking S from N of the 2001 excavation trench between the ballast mounds. The sandbagging covers the area excavated in 2001 and the surviving hull structure between the ballast mounds. The unburied sandbags in the foreground were laid by the licensee in 2003 as additional protection.	There is a moderate kelp cover. No evidence of erosion or other disturbance is apparent.
1053	15	Raised elevation view, looking N from S of the same 2001 excavation trench. The sandbags shown were laid in 2001 and are now partly buried and largely, but not entirely, in-filled.	There is a moderate covering of kelp, some growing directly on the sandbags. No evidence of erosion or other disturbance is apparent.
1054	16	Looking W from the 'pink rock'. Gun 1 is barely visible in the far background. The sandbags are a mixture of those laid in 2000/2002, which are largely buried, and those laid in 2003, which are not yet buried or in-filled. The seabed to the right of centre is unprotected.	No evidence of erosion or other disturbance is apparent.

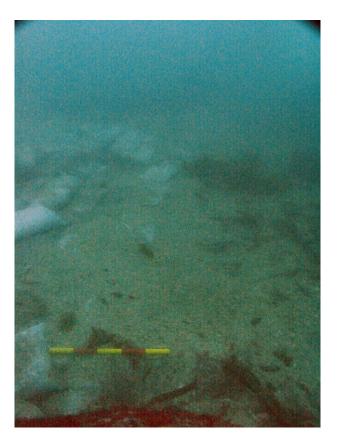
Plate 16: Monitoring photograph 1055

1055	17	Looking N from the 'pink rock', which is in the foreground. The seabed shown is unexcavated and unprotected.	No evidence of erosion or other disturbance is apparent.

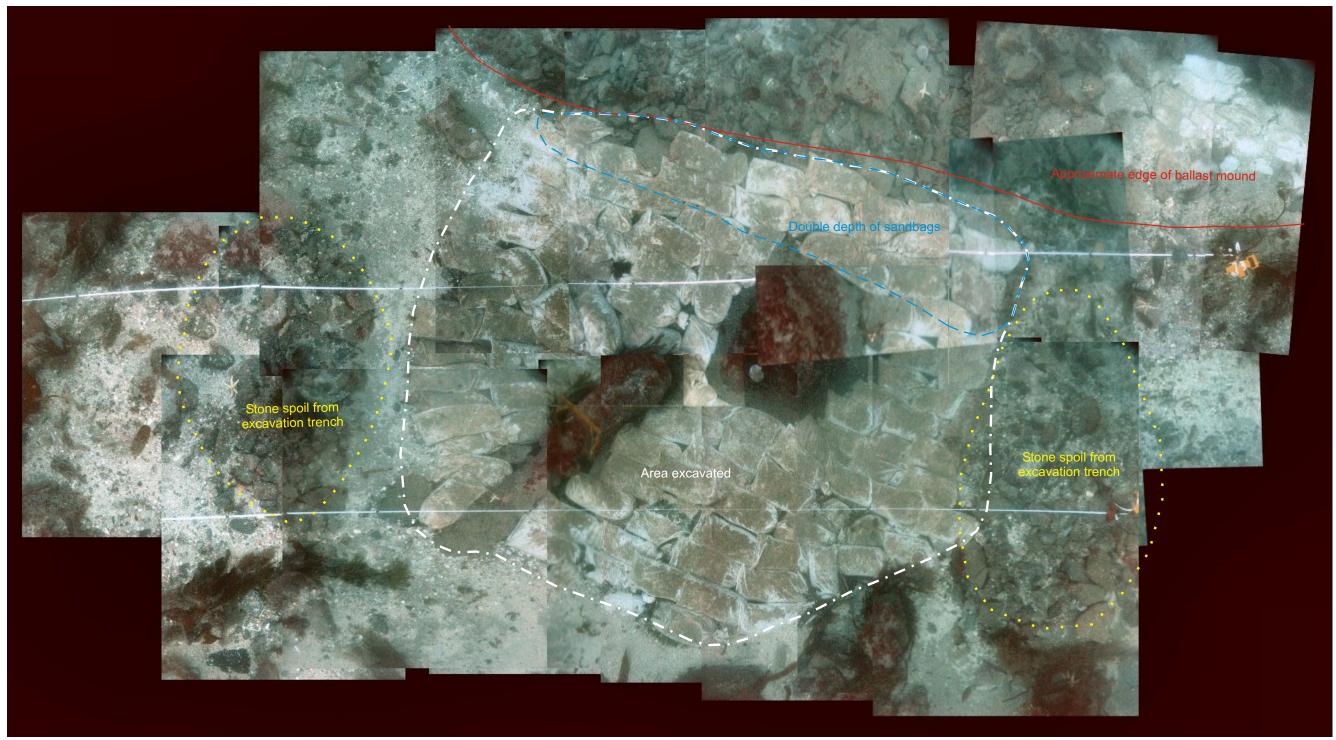
Plate 18: Photo-mosaic showing the 2003 western excavation trench

- 6.5.5. There is a light covering of sand on all of the bags, probably indicating that the process of burial and in-filling has slowly started. Otherwise the sandbags appear to be in an as-laid condition. The diver reported observing a small piece of timber just protruding through the sandbags, but it appeared to be secure. Close visual inspection demonstrated that the fabric of randomly selected sandbags was in good condition and that they appeared to be physically stable (**Plate 18**). The cathodic protection

- measures taken in respect of Gun 5 during the 1990s are now moribund and the connection to the gun is insecure and ineffective. The anode was not observed.

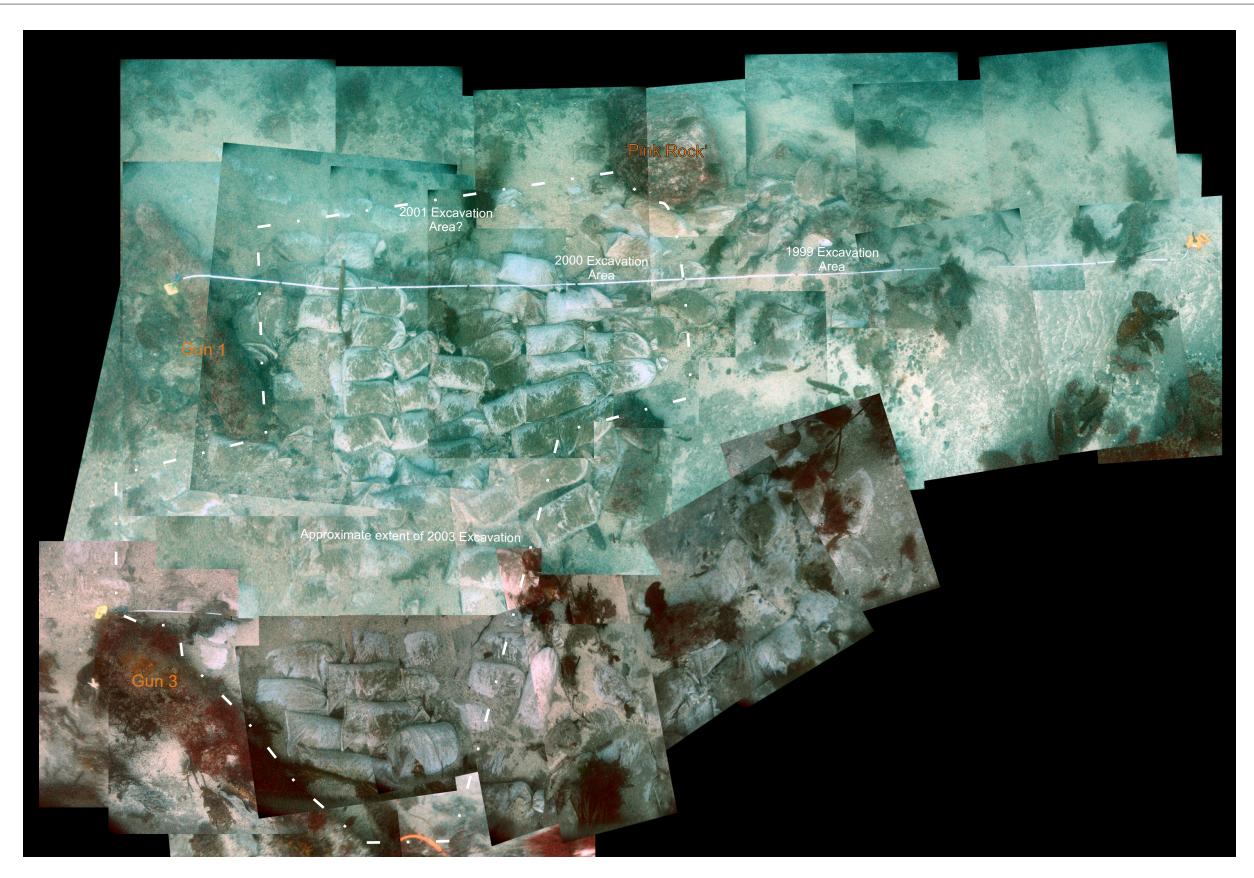
Plate 19: Photo-mosaic showing the 2003 eastern excavation trench

- 6.5.9. In places the sandbags have been fully or partially buried by sand. However, elsewhere, particularly along the northern edge next to Gun 3 and the southern edge where the sandbags appear to have been laid in a less consistent manner, there is little or no covering of sand and no significant in-filling. In these areas the sandbags appear to be in an as-laid condition (**Plate 19**).

- 6.5.10. The sandbags at the southern edge of the trench appear to have created a low ridge where they are overlain by sediment and it is therefore likely that reinstatement has altered the local topography of the seabed in this way. Close visual inspection demonstrated that the fabric of randomly selected sandbags was in good condition and that they appeared to be physically stable.

- 6.5.11. The photo-mosaic (**Plate 19**) shows that the sandbags laid prior to 2003, in particular those laid in 1999 are either fully or partially buried and that gaps are well in-filled. Close visual inspection demonstrated that the fabric of randomly selected sandbags was in moderate to good condition where exposed and that they appeared to be physically stable.

- sandbags resting on the ballast mound and any vulnerable sandbags in the SE trench should be examined for wear and damage and replaced or repositioned if necessary.
