WATERMILL FRASERBURGH ABERDEENSHIRE

Archaeological Evaluation and Standing Building Survey

Carried out 8th January 2009
by
Murray Archaeological Services Ltd

Report No: MAS 2009-1
by
H K Murray

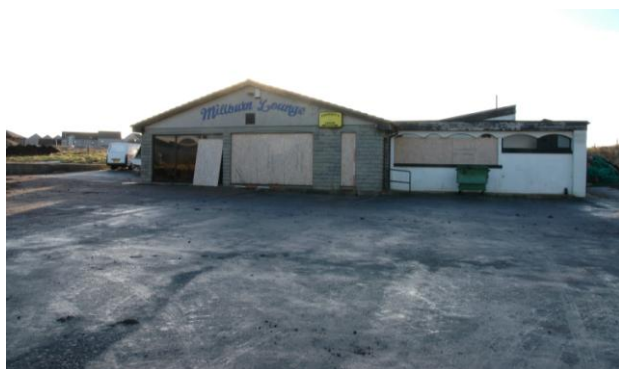
Building 1 was a single-storied building of concrete block construction with a pitched tiled roof over the frontage and a tarred flat roof over the rest of the structure. It had been built as a pub (The Watermill bar) and included bar, lounge, kitchens, toilets etc. It appeared to be of 1960s/ early 1970s construction.

Illus 1 Building 1 from north

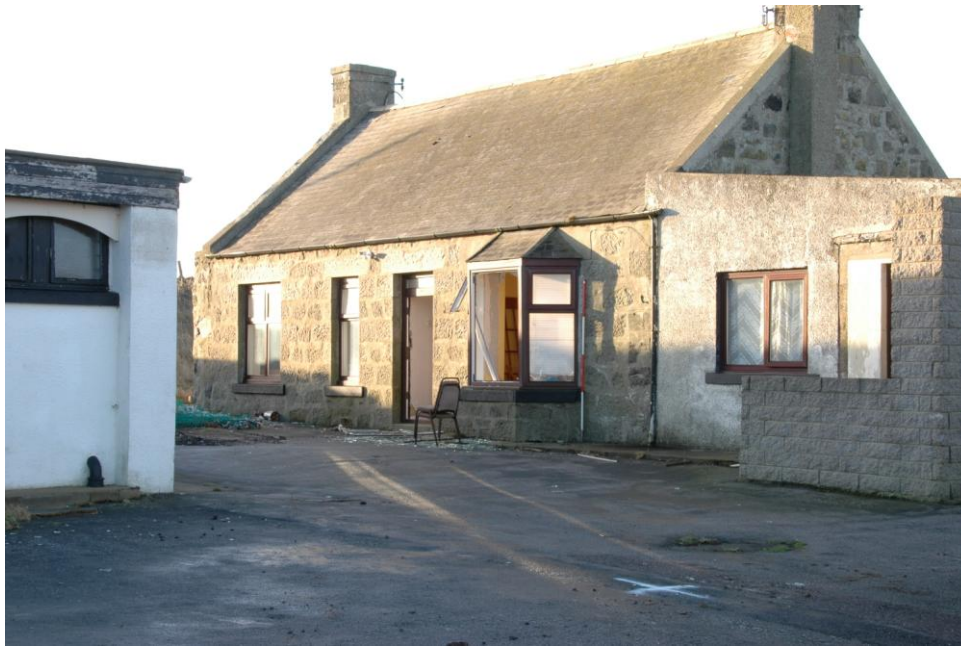
Building 2 was a single storied house with loft above. The front wall on the east was of semi-dressed granite blocks, the other walls being of rubble stone construction. The roof was pitched with granite chimneys at each gable, the present roof covering being of asbestos slates. All the windows were modern replacements. The interior had been restructured and has not therefore been recorded in detail. An extension built of harled concrete blocks had been added to the north side, with a separate brick chimney; this had a separate entrance door but at some stage access had been broken through the north gable of the main cottage. The south gable of the cottage is of interest as it appears to be of double thickness with very large blocks visible in the west wall. It appears likely that the cottage

had been built abutting the original brewery building and that, when the brewery was demolished, its north wall (common to the cottage) was left standing.

Illus 3 Front (east) wall of Building 2

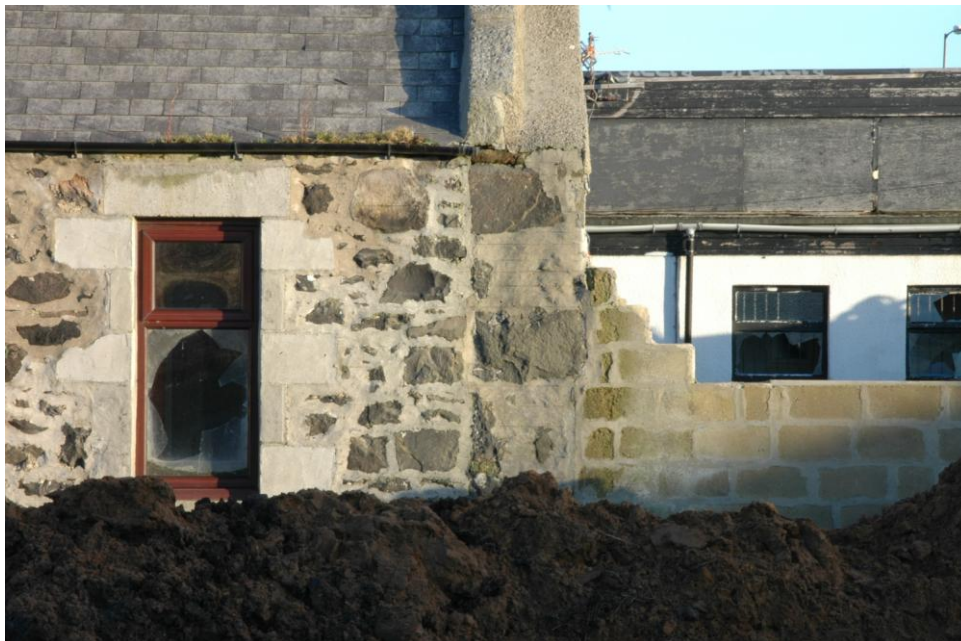
Illus 4 South end of back (west) wall of Building 2 showing double thickness of gable
Walls to the south of building 2. The line of the front wall of the cottage was continued to the south by a low stone wall foundation, 600mm wide (Illus 2: Wall 1).

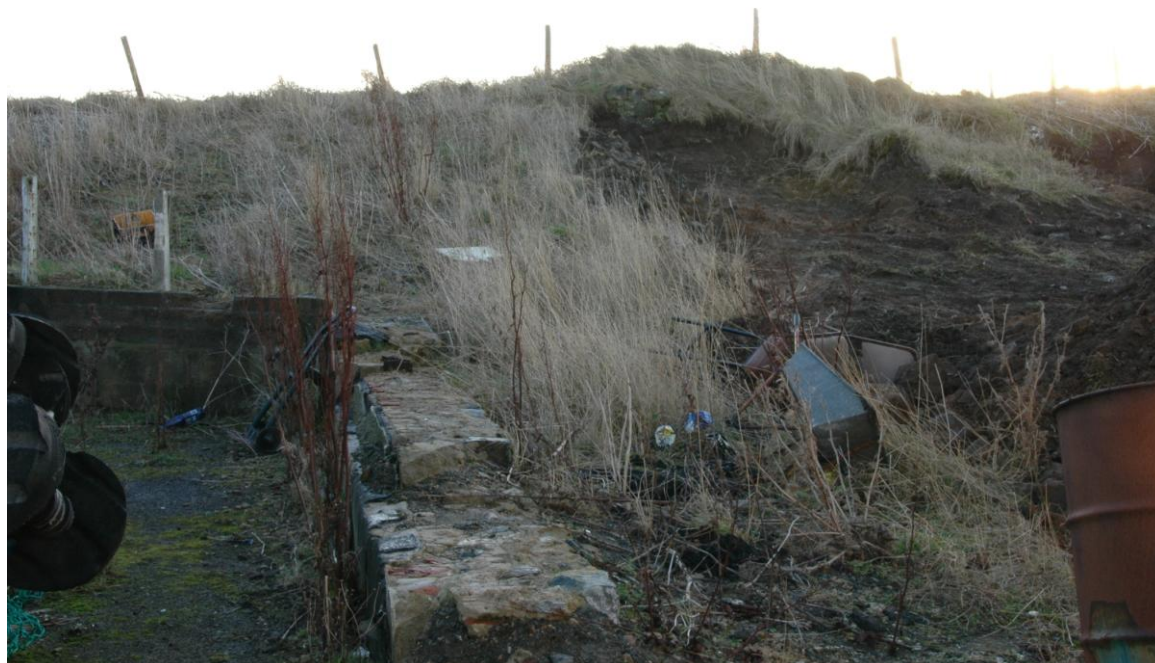
Two vertical iron columns were built into this wall. This is thought to be part of the foundation of the brewery- a wall in the bank at the south of the site (Illus 2: wall 2) may have been the back of the building, with traces of a lighter mortared wall with less substantial foundations being possibly an internal wall at right angles to it. Part of the footprint of this building had been reused as a concrete block built garage or shed of which only part of a wall and the sliding door groove remained. This had abutted the south wall of the cottage.

Illus 5 Wall 1 to the south of the cottage Building 2

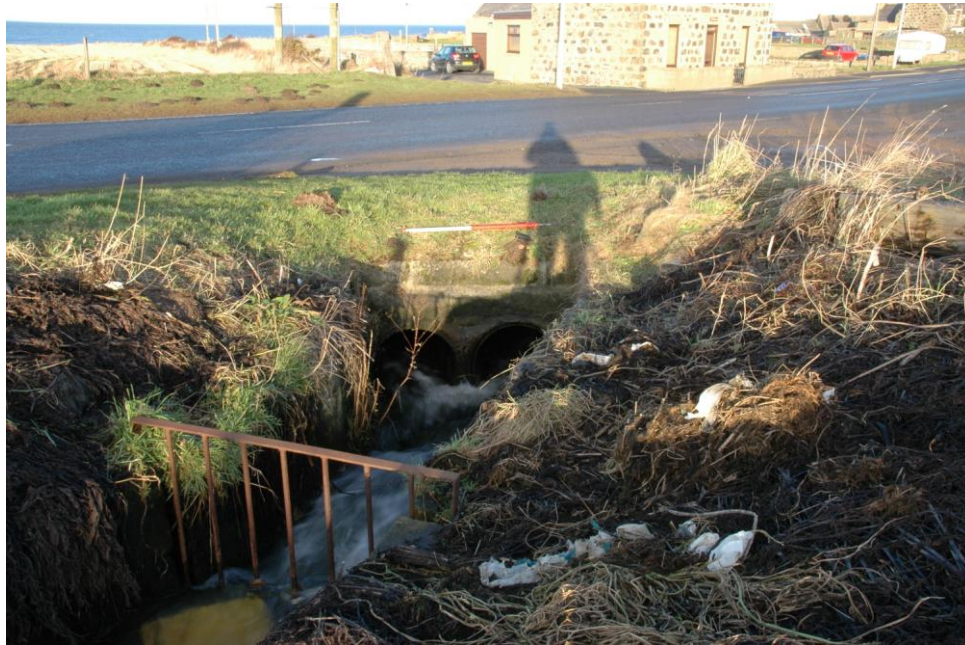
Lade 1, which passed to the west of the mill cottages (A: now in ruins), still exists and was photographed beside the road (E; Illus 6,7) to the west of the present site. At this point it has a well-built stone revetting, a surviving metal sluice and a culvert beneath the road which bifurcates the flow to lade 3 and to the main outflow to the sea

Illus 6 Lade 1 at point E with mill house on opposite side of road

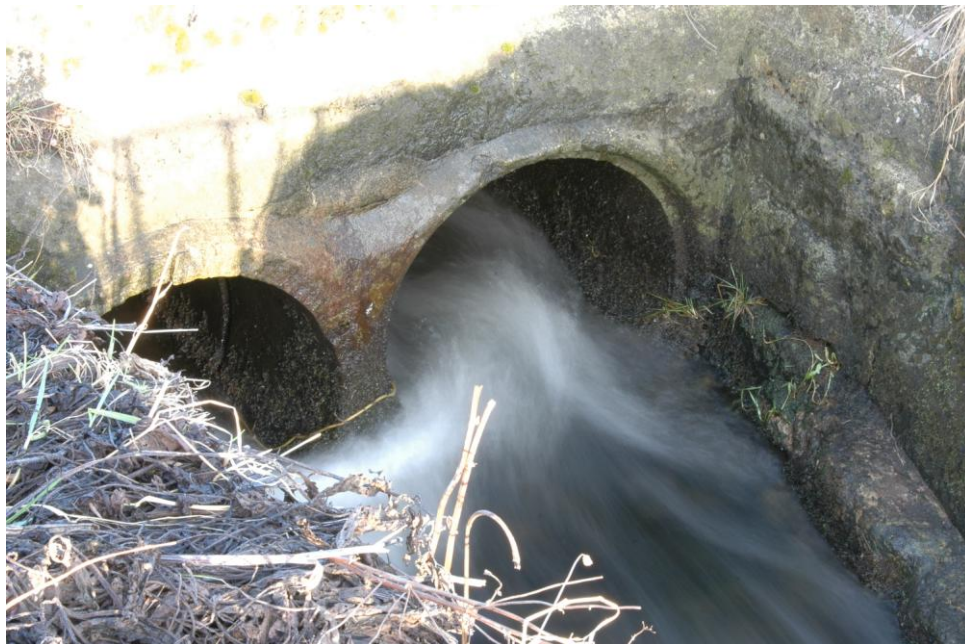
Illus 7 Lade 1 detail of culvert

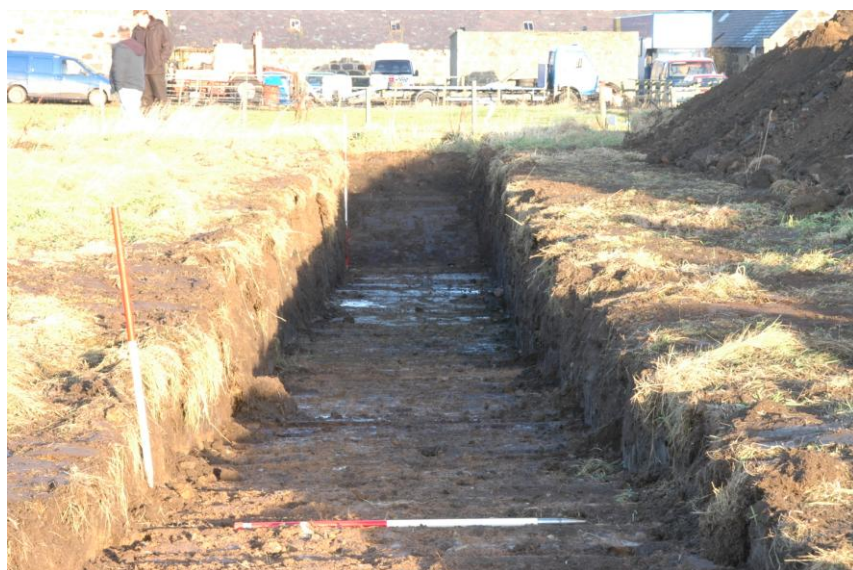
The natural slope of the field had been levelled in this area with considerable dumped material. Nothing related to the brewery or mill was observed.

Illus 10 Trench 1 looking N with farm on opposite side of road

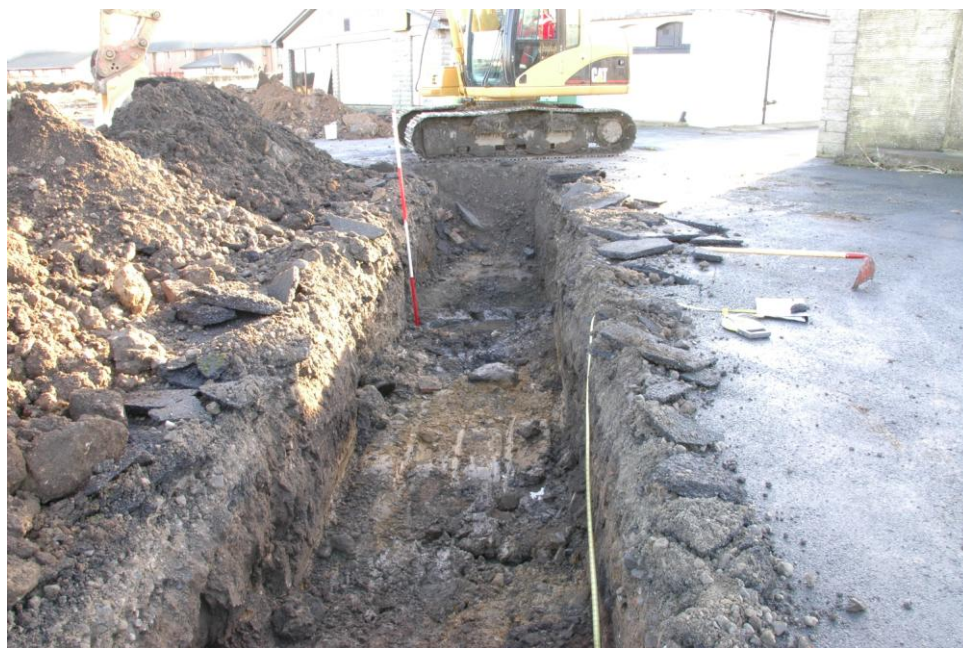
Between 4 and 8 m from the NW end there was a cut for a far larger drain with parts of a ruinous stone lined culvert with a single surviving stone capstone. The culvert appeared to be c 1m wide but could not be recorded in detail as water trapped in it flooded the trench. It had been cut into the natural from the top of the old buried soil. It was sealed by mortary rubble.

This is likely to have been the outflow drain from the lade which fed the mill and/or the brewery.

Illus 11 Trench 2, looking SE. the ranging rod marks the line of the culvert

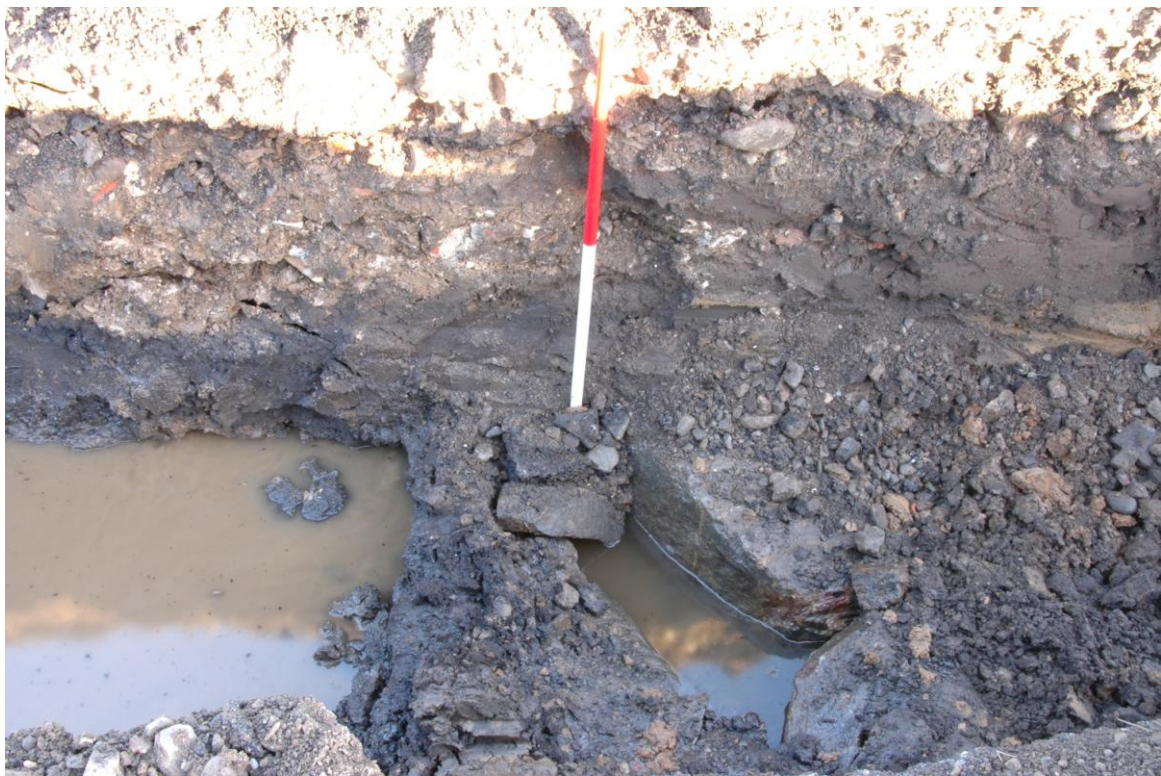
Illus 12 Detail of culvert

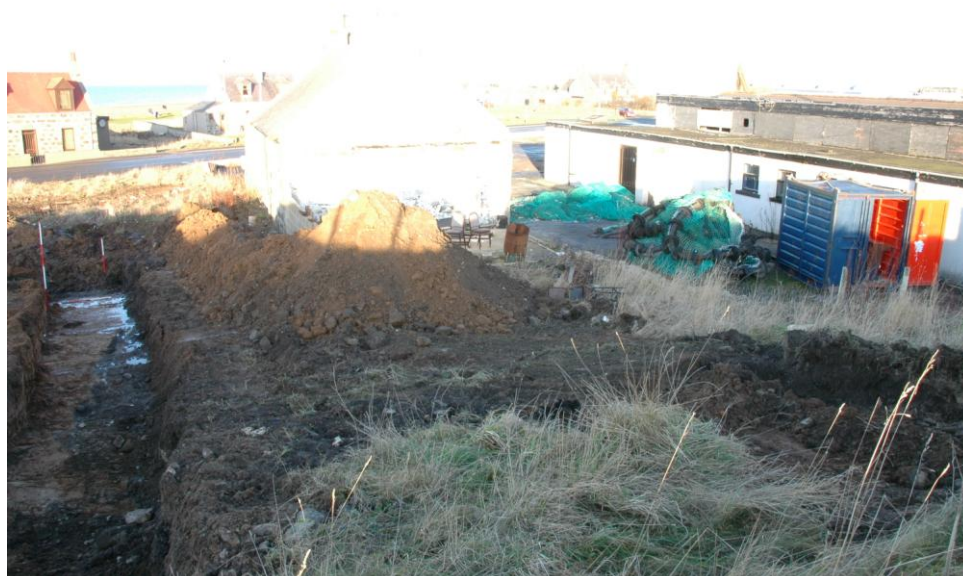
The E side of the N/S section of the trench was of dark midden material and some rubble which appeared to fill a cut in natural. This may be related to the water channel for the brewery or the demolition of the brewery buildings which would have been slightly to the east.

Illus 13 Trench 4 N/S section showing midden material in cut along east side of trench

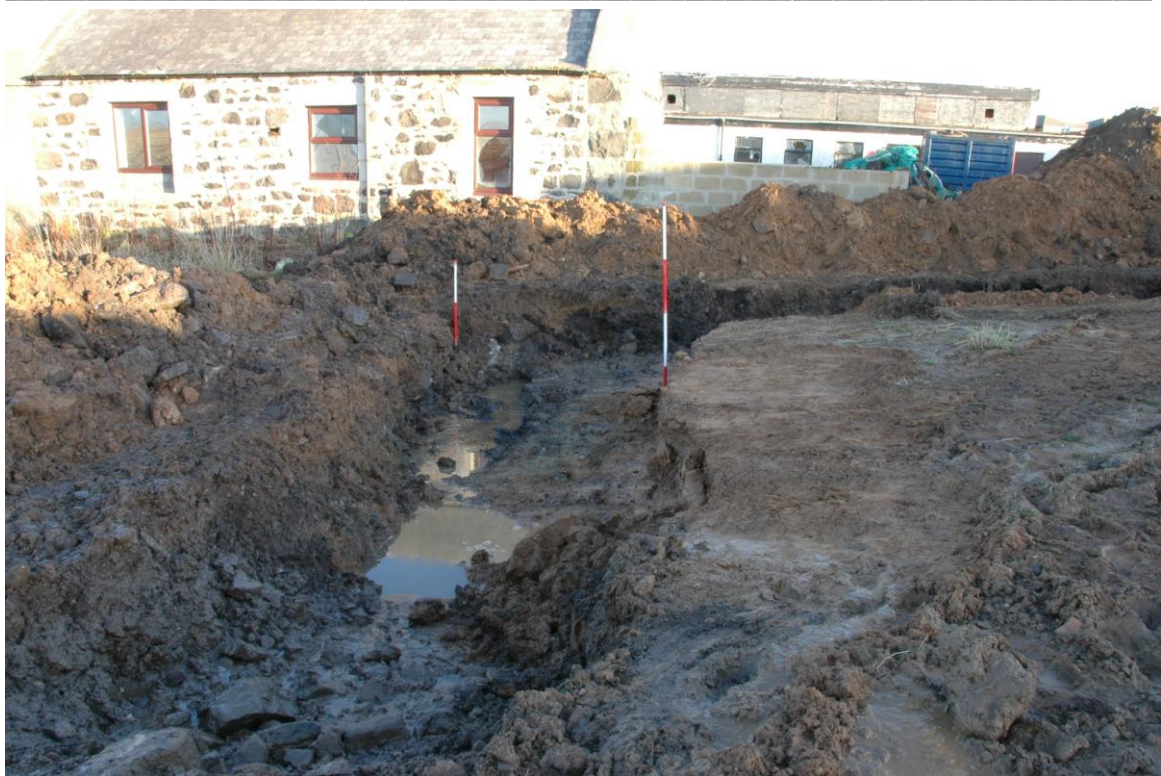
The W side of the E/W section of the trench was deeply disturbed (to below the excavated level) with infill of heavy rubble. Much water flowed through the rubble and flooded the trench.

This is on the line of the mill building and is probably the rubble from the recent demolition filling in the mill lade, wheel pit and foundations. The very disturbed ground suggests that it is unlikely that any coherent foundations survive.

Illus 14 Trench 4 E/W section showing demolition infill from mill
