Project Code: MYRE10
Date of Report: October 2010
Client: OMI Architects on behalf of Mr Callum Ford

HISTORIC BUILDING SURVEY OF MYRETOUN BARN, MENSTRIE

PROJECT SUMMARY SHEET

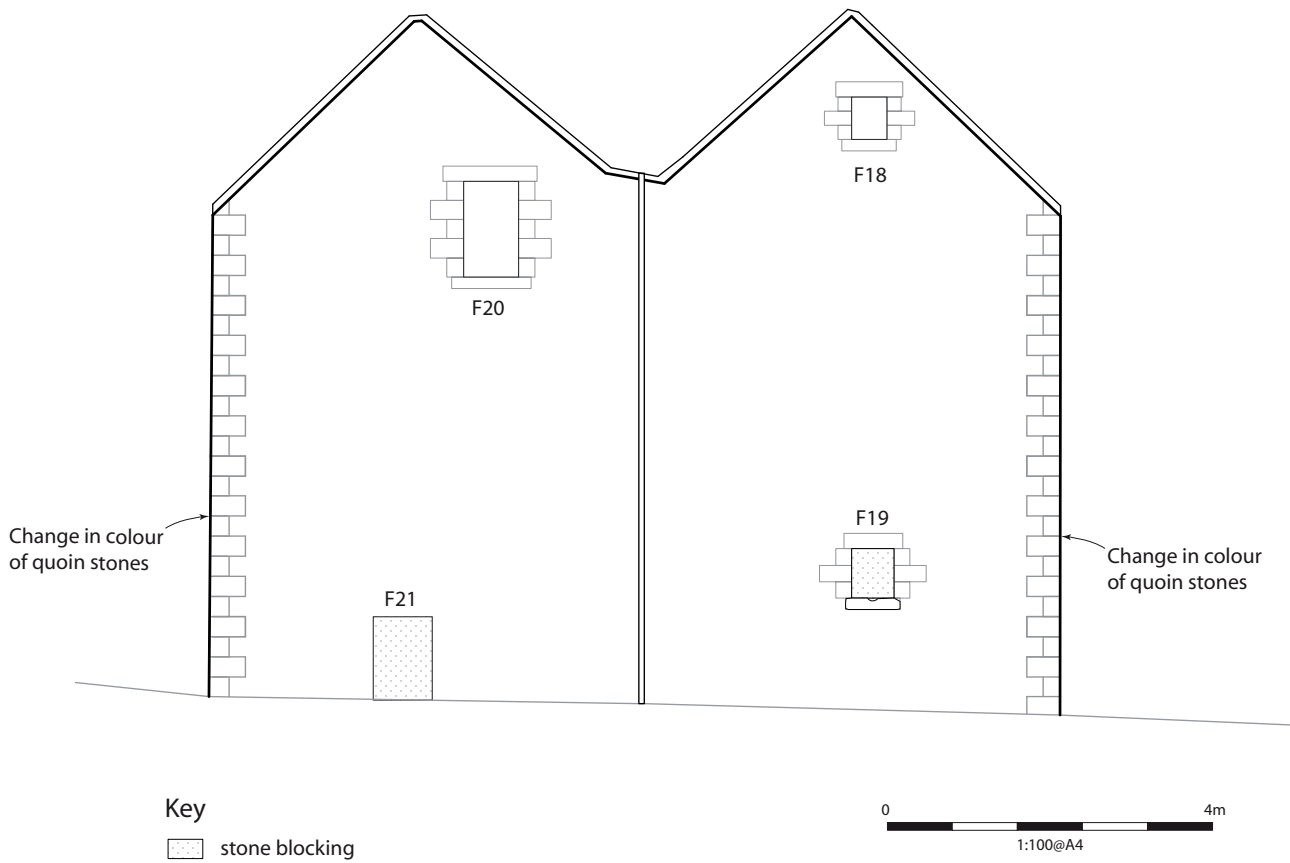
Illus 4
External elevation of south wall

One of the most striking external elevations to the building is on the south wall. Being the lower part of the slope the wall stands very tall here. The rubble masonry comprised the two gables of the double pitched roof with in-out stone quoins to each side (Illus 5). These quoins were of red sandstone to the height of the ground floor and grey sandstone above and could represent an area of repair to the south end of the barn although no construction line or repair could be seen in the actual wall.

Each of the two gables in this elevation supported a high level window with the one to the east lighting Room A (F18), being somewhat smaller and slightly higher than its counterpart (F20) in Room B. This clearly suggests a difference in levels/use of the upper floors in the interior.

Access to the ground floor of Room B was via a now-blocked doorway (F21). The eastern side of this wall also included a window (F19) which incorporated a slop stone (a wide stone with a rounded channel that narrowed towards its end) into the sill (Illus 6). There was evidence that the wall had been repaired, probably in the 20th century, as the central section of the wall included areas of cement mortar.

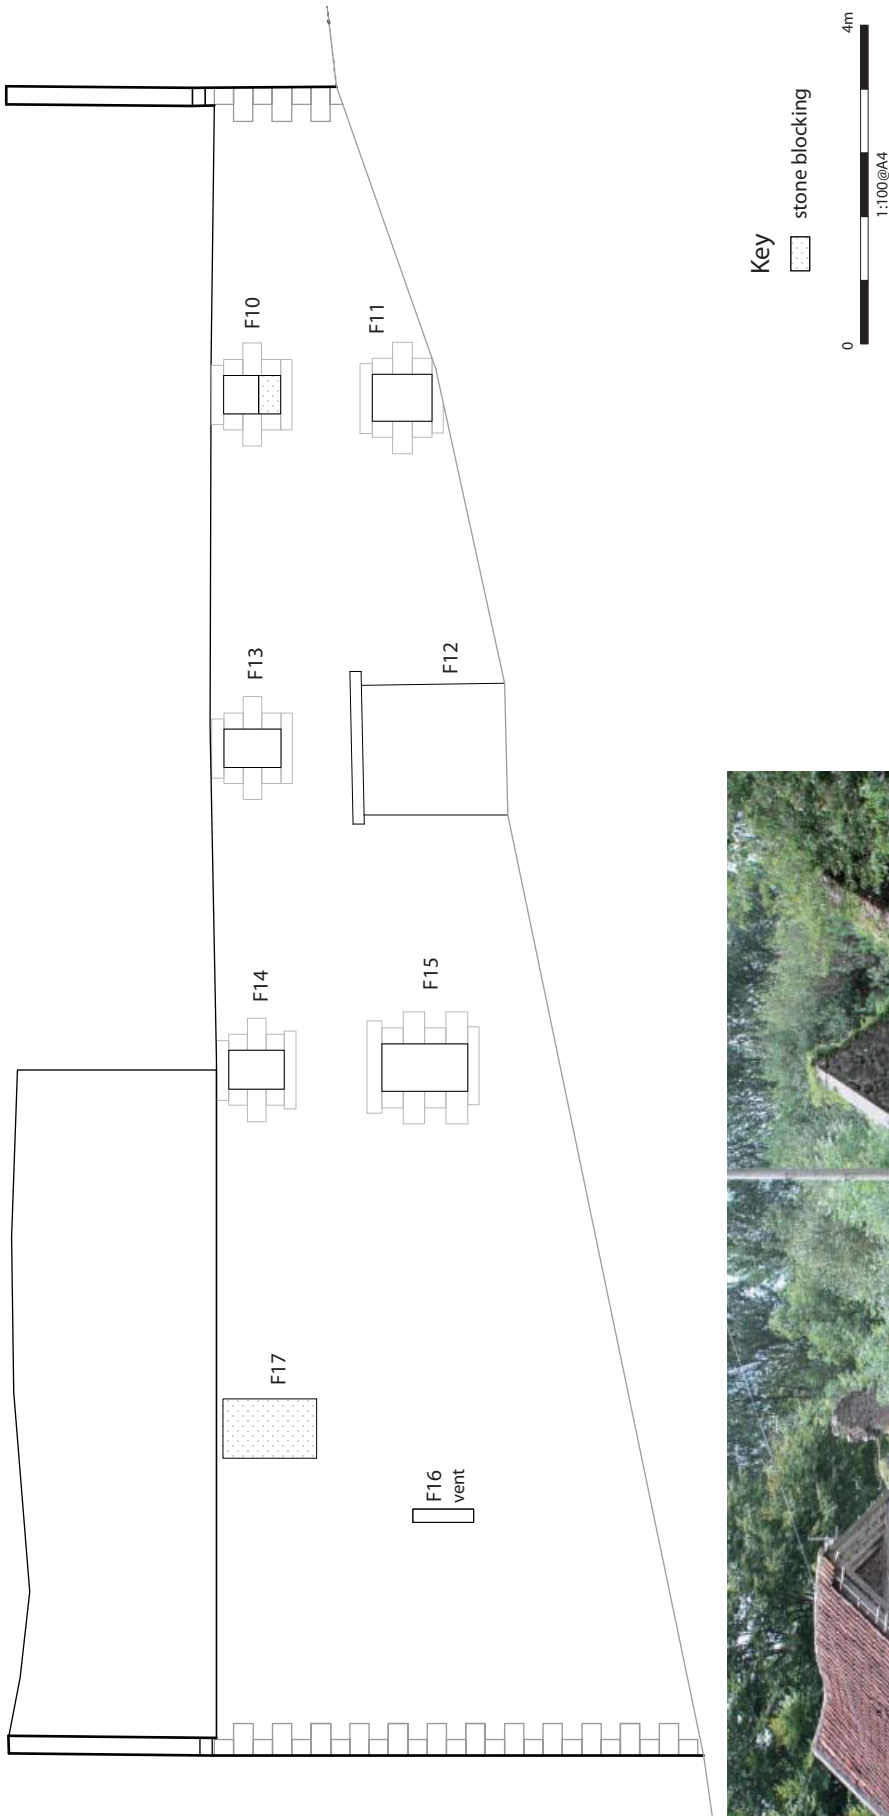
Illus 7
External elevation of the east wall

The eastern external elevation showed the true incline of the slope with the southern end of the barn more than twice the height of the northern end (Illus 8). The northern part of the elevation comprised a symmetrical unit with wide central door (F12) with window above (F13) flanked, on both floors, by windows (F10 & F11 to the north and F14 & F15 to the south). Even though the current door (F12) had clearly been rebuilt, the symmetry of the features on either side would suggest that it replaced an earlier example in the same location. Certainly there is a suggestion that this part could once

The southern part of the elevation was of the same build as the northern part but very different in character. At ground floor level there was a ventilation slit (F16), with the stone-blocked remains of a loading door (F17) above. These clearly point to an agricultural use.

A significant feature of this wall is the closeness of the top of the door and windows to the current wall-head. This suggests that the wall-head had been lowered, presumably to incorporate the later roof design.

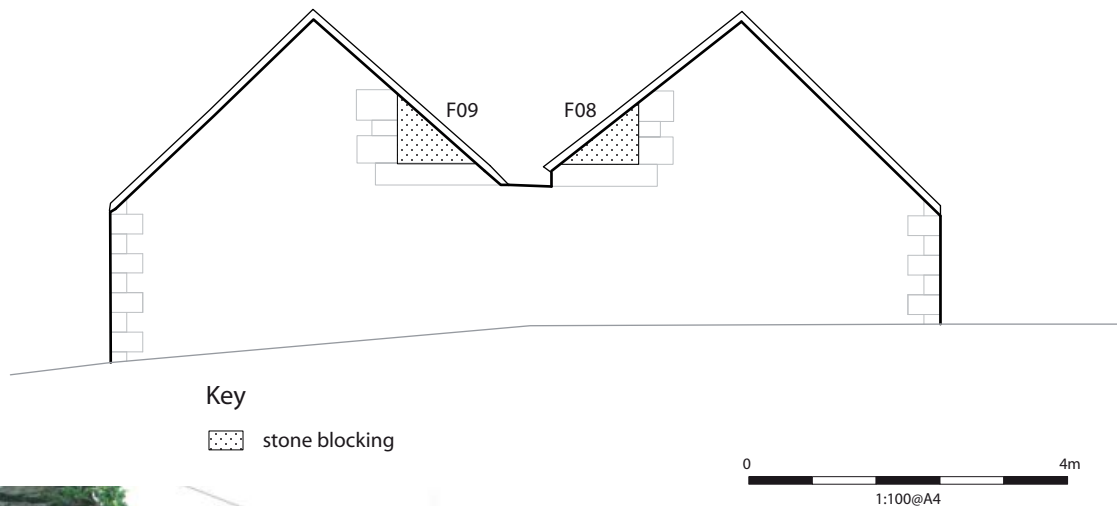
Illus 9

The double gable of the north elevation was very low and included two windows (F8 & F9) that had been truncated by the roof line. These, together with the poorly seated skewputs, indicate that the current structure is not its original form and that there had been a significant change to the roof (Illus 10). In all probability the original build was as a single, wide pitched or hipped roof.

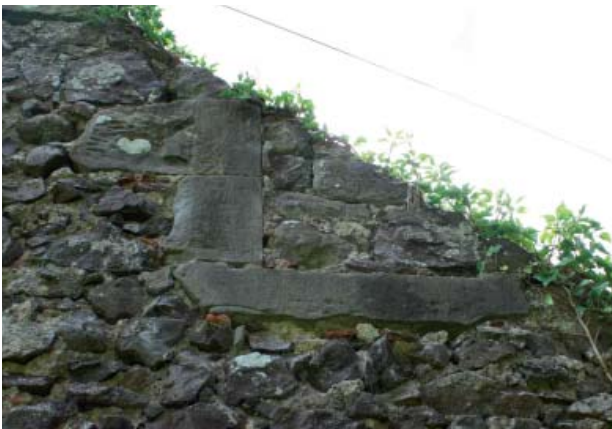
Illus 10

Photograph of window F09 (from the north)

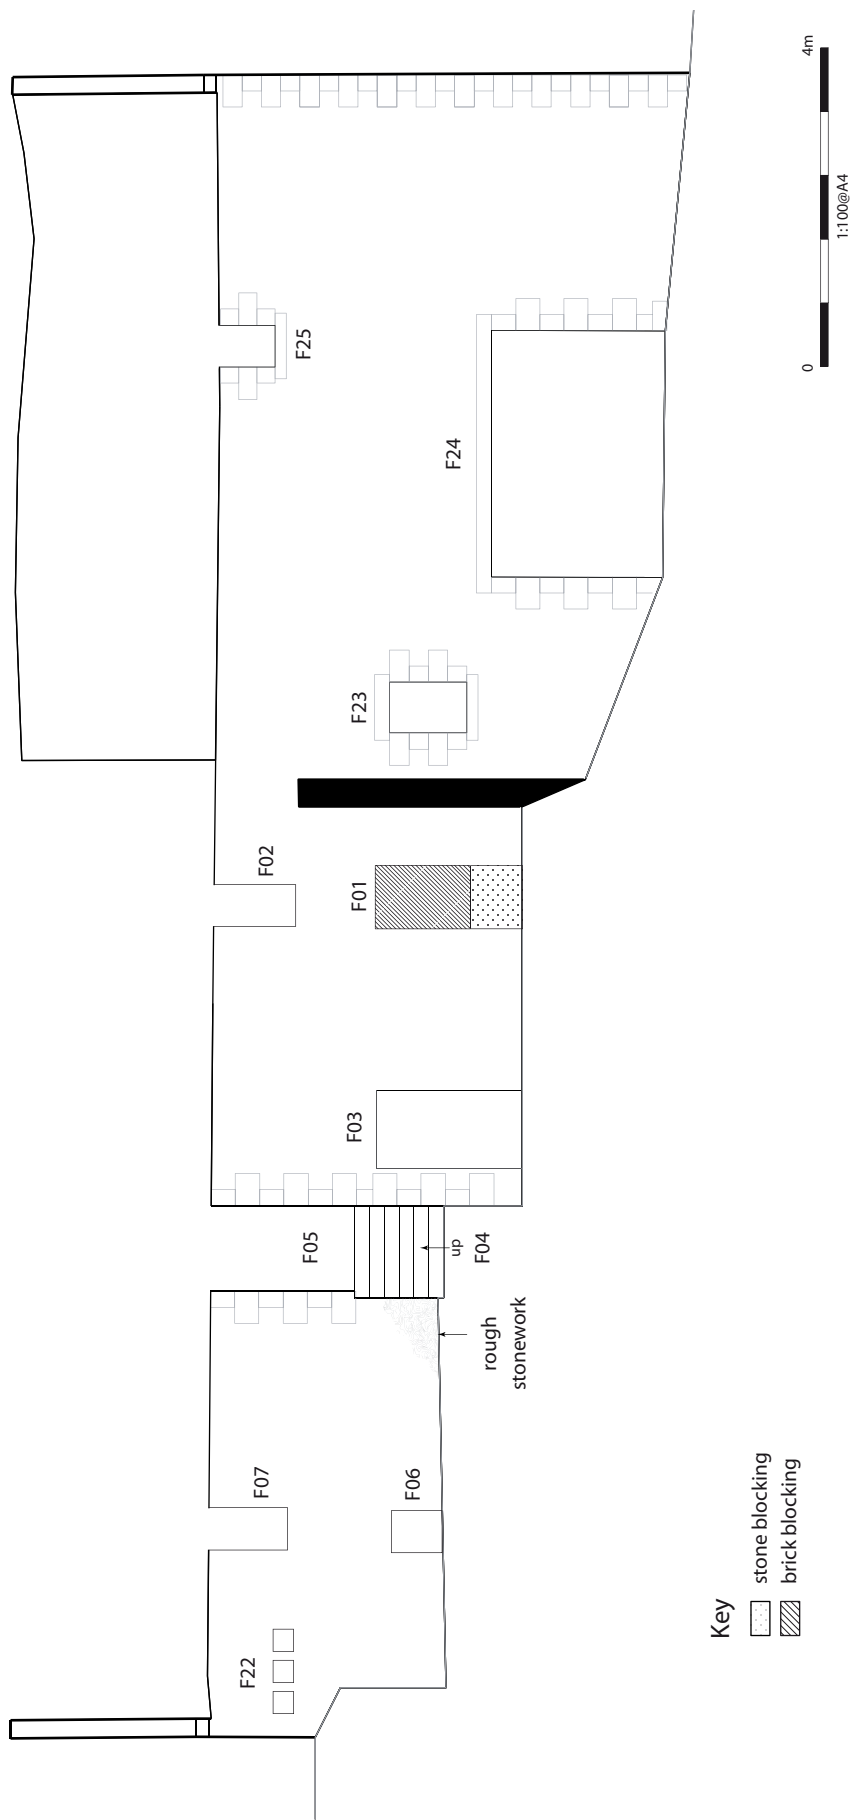
Illus 11
External elevation of the west wall

The west wall is the most complicated elevation with various phases of re-modelling and rebuild. As with the east wall the wall-head has been lowered to accommodate a revised roof structure.

At the southern end of the elevation the wide barn door (F24), albeit somewhat modified, confirmed the evidence from the east wall for an agricultural function as a shed, barn or byre for this southern end of the building.

Further up the slope were a number of doors (F01, part stone-blocked & F03) giving access to the ground floor. There was also an external masonry stair (F04) that gave access, west to east, to the first floor doorway (F05) into Room C. It is clear from scars on the wall to the north of the stairs that these once ran up the side of the wall from north to south.

Other features of note on this elevation were a number of windows (F06, F07, F23, & F25) and a series of beam slots at the far north end of the wall. The slots were probably associated with a now-demolished feature against the west wall.

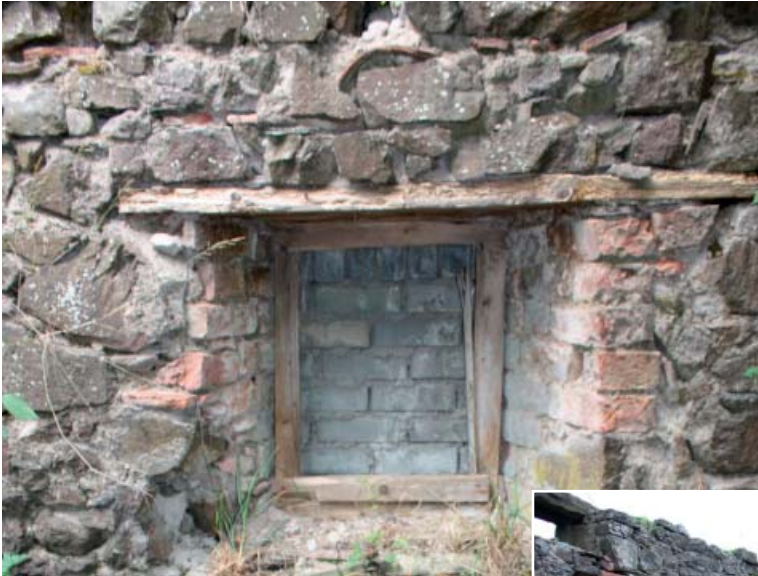
Illus 12
Internal view of the blocked door F01 (from the east)

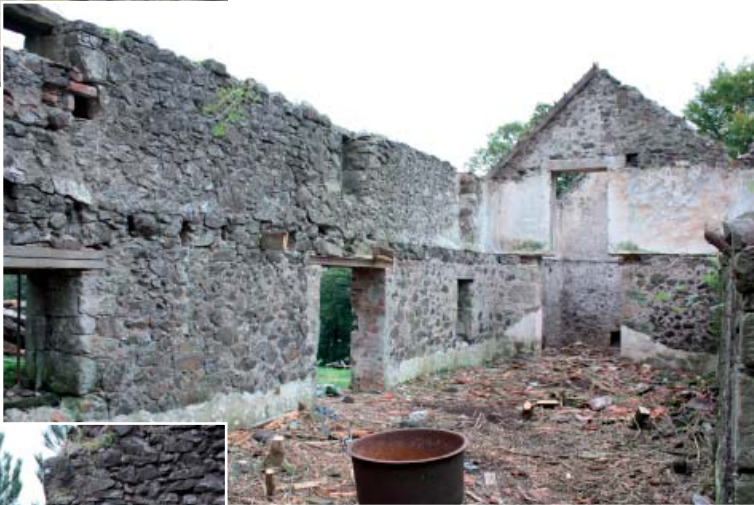
The entrance to Room A on both floors was through a wide opening (F27 – Illus 13) on its north wall. On the south wall the base of window F19 was level with the floor indicating that the original levels were probably much lower. The current arrangement evidently brought the Ground floor in Room A to the same level as that in the north part of the building. The wall separating Rooms

Illus 13
View of Room A & D (from the north)

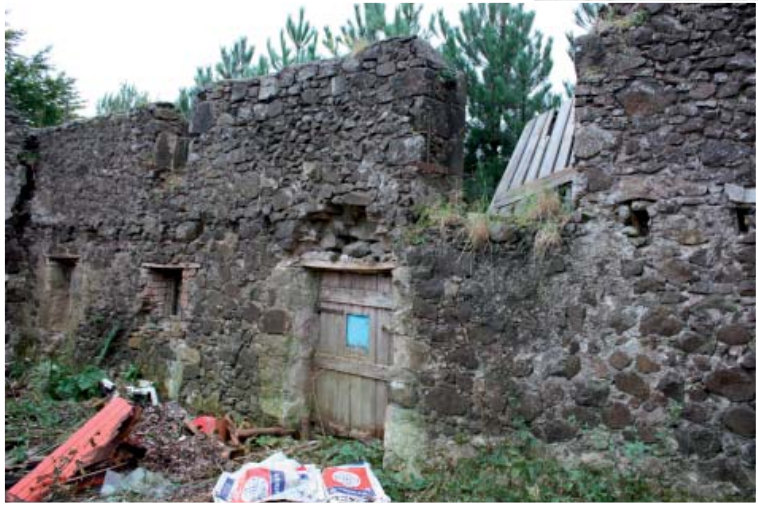
Illus 14
View of the west wall for Room C (from the north-east)

The north half of the barn was divided on the ground floor by a long rubble stone wall that ended quite a way short of the north wall. The end of this wall was constructed of large chisel-dressed stones but it was not clear whether these were original features or had been inserted in order to support the large steel beam (see Illus 1) that continued to the end of the room, the beam being used to support the central pitch of the remodelled roof. Unfortunately the roof in this half of the building did not survive, the beam slots on the east and west walls being the only indication as to the final roof design. The dividing wall to the south side of Room C & D was in a poor condition.

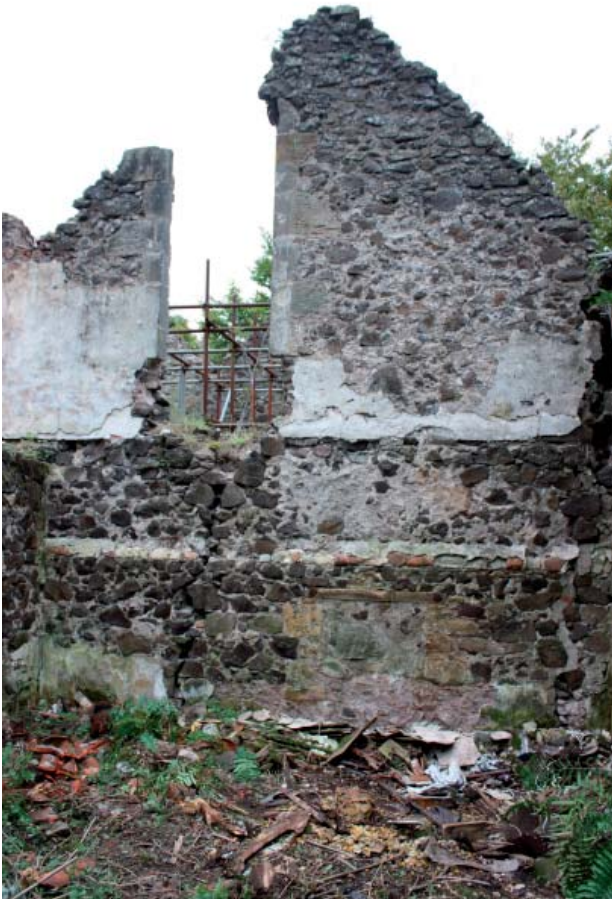
Illus 16

A stone blocked door (F31 – Illus 1) on the ground floor of this wall had rough surround stones suggesting it provided the original access into Room B (Illus 16), although due to the change in floor levels between Rooms B and C it was higher up the north wall of Room B suggesting it may have been accessed by timber steps from this room.

View of Door F31 at the base of the south wall of Room C
(from the north)
