## LAMB'S HOUSE LEITH, EDINBURGH

*Historic Building Recording and Monitoring of Ground Works*

*for Groves-Raines Architects*

*August 2012*

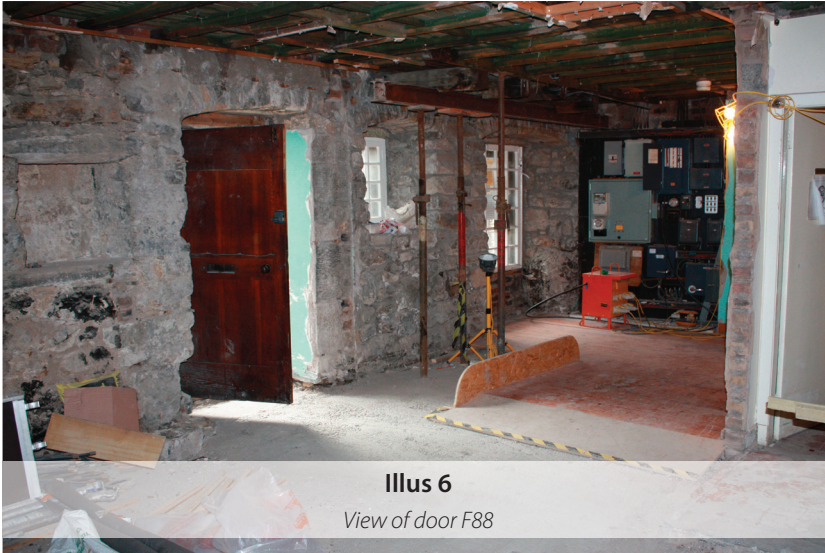
**Illus 6**  
*View of door F88*

Inserted into the east end of the SW wall was a doorway (F88) with a stone surround, the west side of which has been rebuilt (Illus 6). The slightly wider segmented stone arch above indicated that the door had originally been slightly wider. Window F74 was much wider than many of the other windows and was recessed to the floor, the wall below the window being constructed of brick clearly indicating that this opening had originally been a further door.

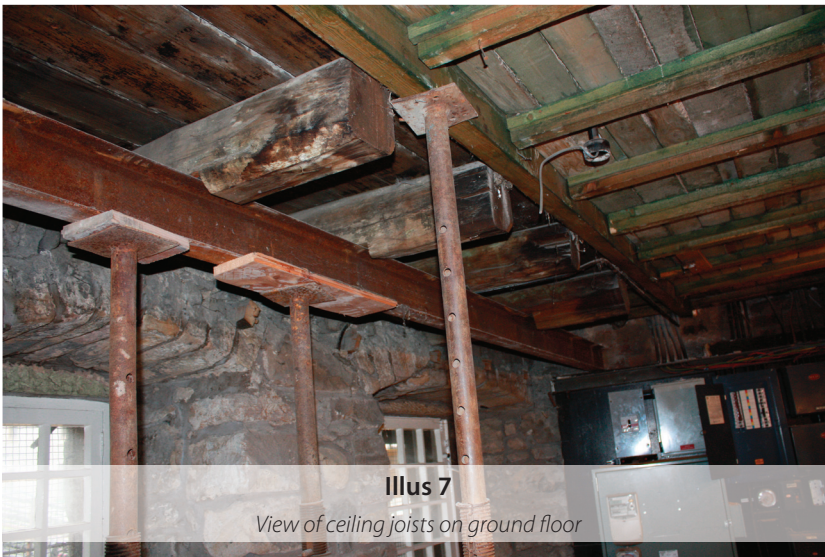
**Illus 7**  
*View of ceiling joists on ground floor*

Of the surviving ceiling timbers on this level only four (G01–G04) were thought to be of any real antiquity and indeed G03 and G04 provided dendrochronological dates for felling of 1601 and 1598 respectively. These were all located above windows F74 and F89 on the SW wall (Illus 7). They all projected about 1m from beam slots in the main wall above the windows across to a modern steel cross beam. The stone turnpike staircase located at the centre of the SW wall led to all the upper floors.

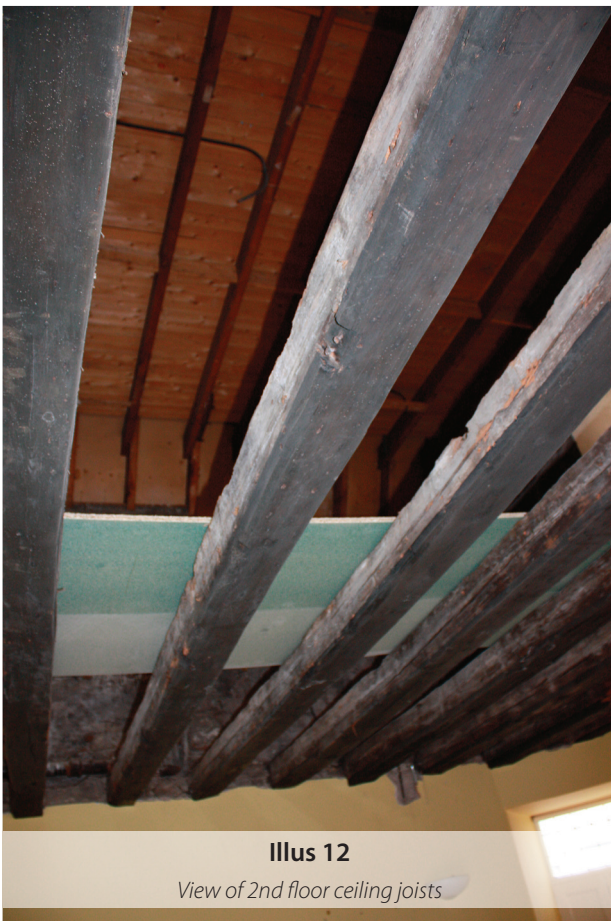
**Illus 12**

Joists 2-33 and 2-16 included a number of small checks in their underside (Illus 12). These probably identify the location of previous partition walls. Also of note were timbers 2-30 to 2-32, all of which had split joints clamped with iron bolts at their SW ends. This may have been due to an alteration/insertion of the fireplace (F25) on the floor above.

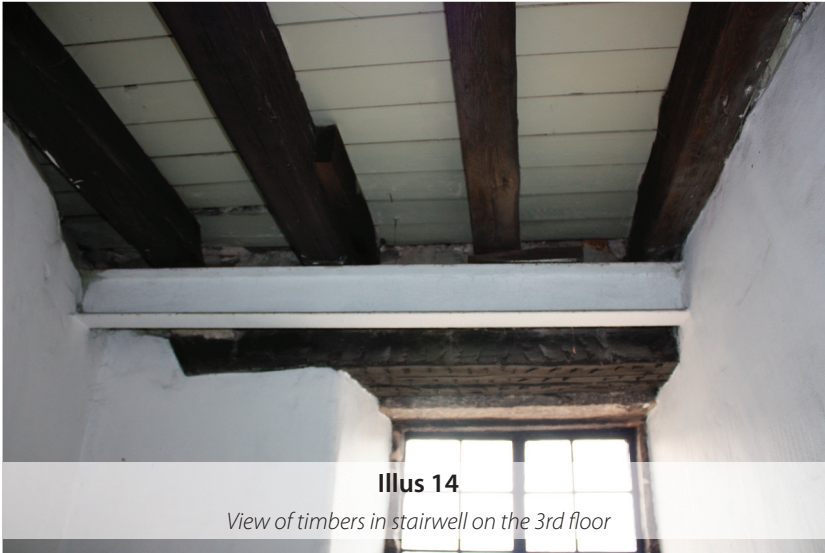
**Illus 14**

The entrance to the third floor (Illus 13) was reached by the top of the main stairwell but also included a smaller stone turnpike stairwell to the SE that led to the a garret room and the attic space above. The treads of the smaller turnpike stair were much less worn than those of the main stairwell, indicating that the third floor was probably less regularly used. It is possible that this floor was originally accessed by ladders or wooden steps although no evidence for this was recorded. The ceiling of the main stairwell included a number of original timber beams (Illus 14), timbers 3-01 to 3-07.

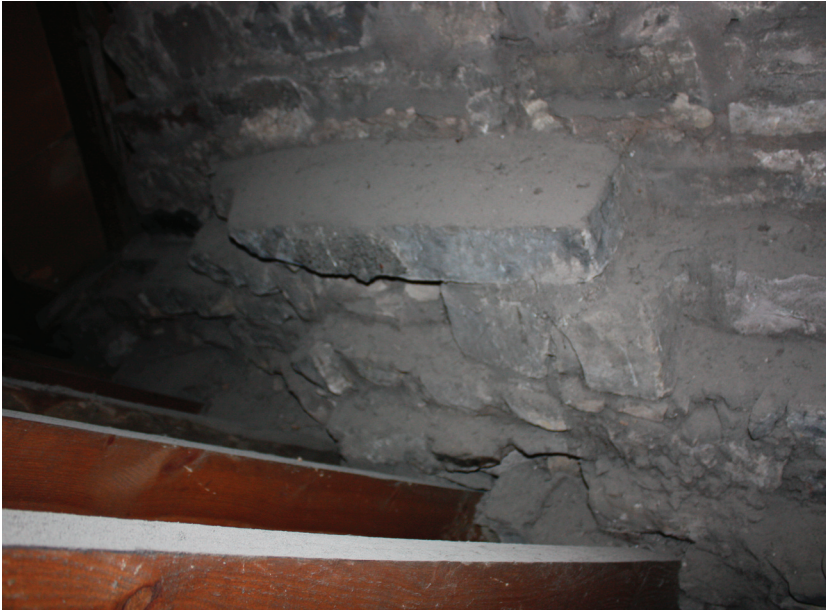
◀ **Illus 17**

due to ongoing restoration making the interpretation of this area difficult. The remaining walls show evidence that they were rebuilt above 1.8m from the current floor level, probably as part of the roof repairs in the 1930s. A re-used oak beam (A-08) spanned the two ante-room walls to support the roof rafters. The beam had roughly chamfered edges and numerous small checks (cut-outs).

*Detail of SW wall-head gable showing the change in thickness*

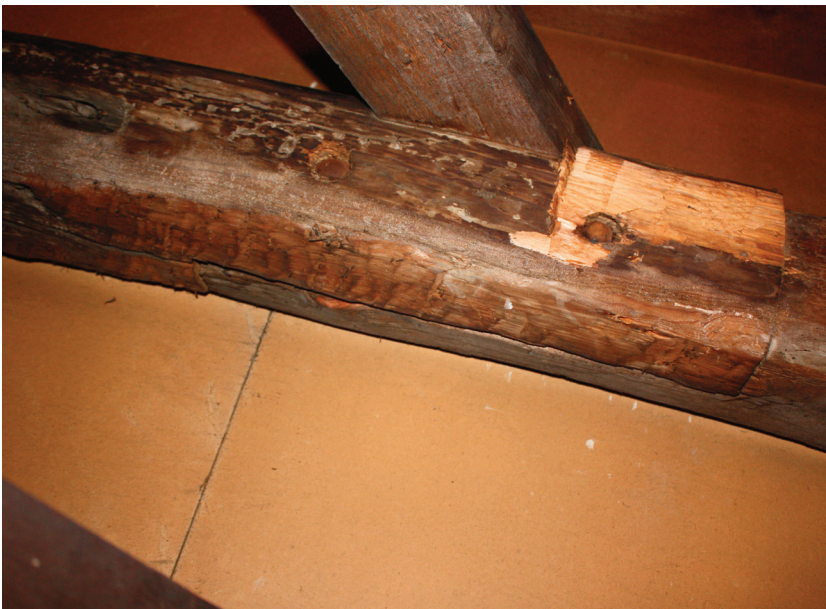
◀ **Illus 18**

The majority of the rafters had been replaced but a number of older and possibly re-used roof timbers were recorded in the attic space. Of these timber rafters A-01 to A-03 included half lap splice joints two of which were top over bottom joints the third having a side by side joint (Illus 18). All three rafters had one or more mortice and tenon joints at various points along the timbers. This may indicate that they are re-used timbers. Rafter A-03 also had a carpenter's mark 'XXIII' (Illus 19).

*Detail of splice joint on timber rafter*

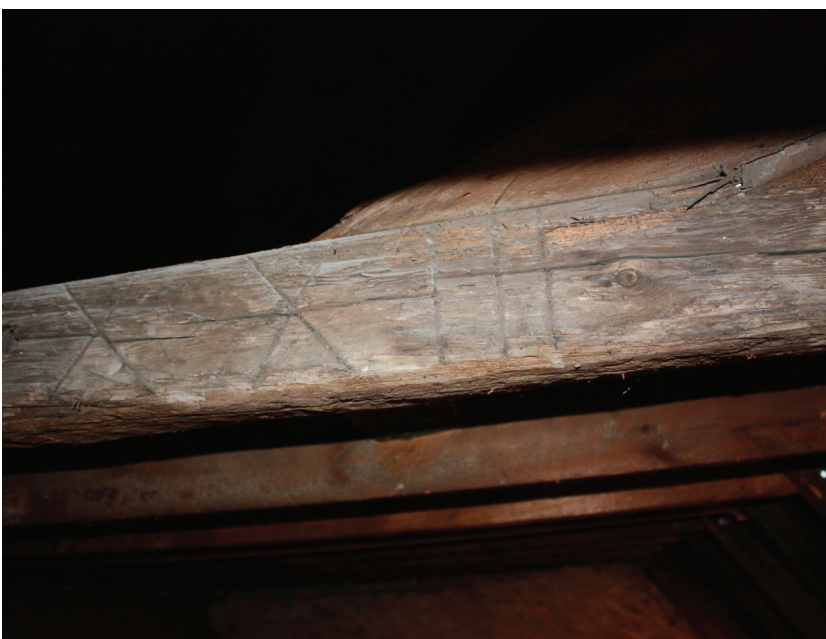
◀ **Illus 19**

*Carpenter's mark on timber rafter*

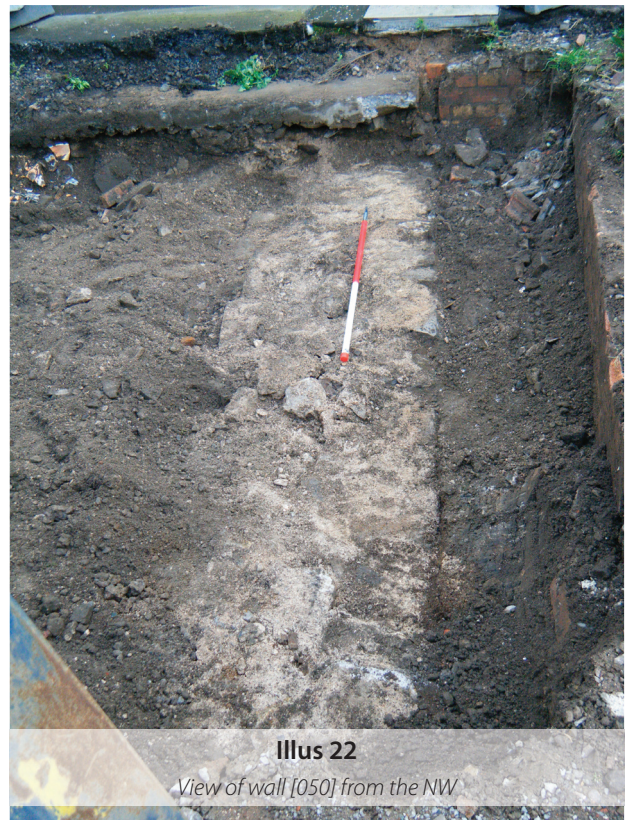
**Illus 22**

*View of wall [050] from the NW*

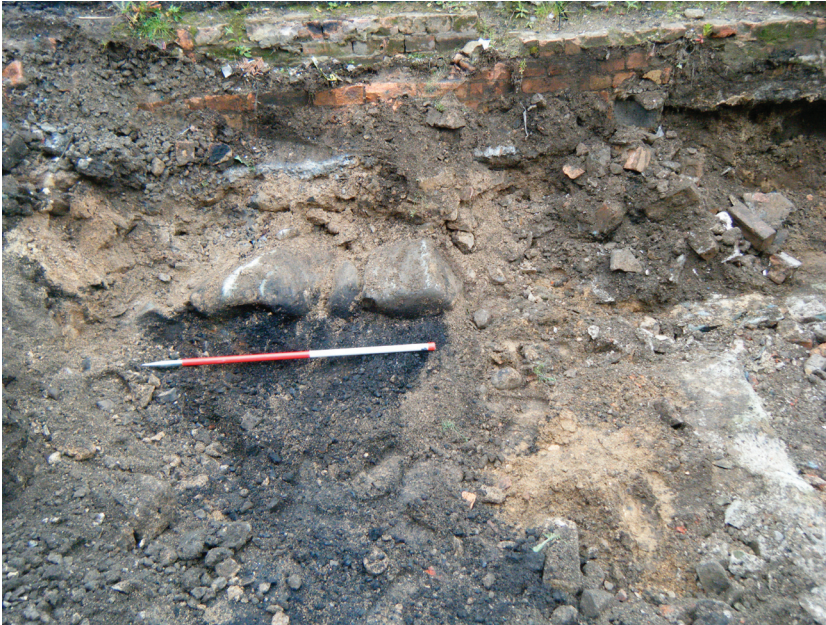
◀ **Illus 23**

*Detail of wall [050] exposed further to the west*

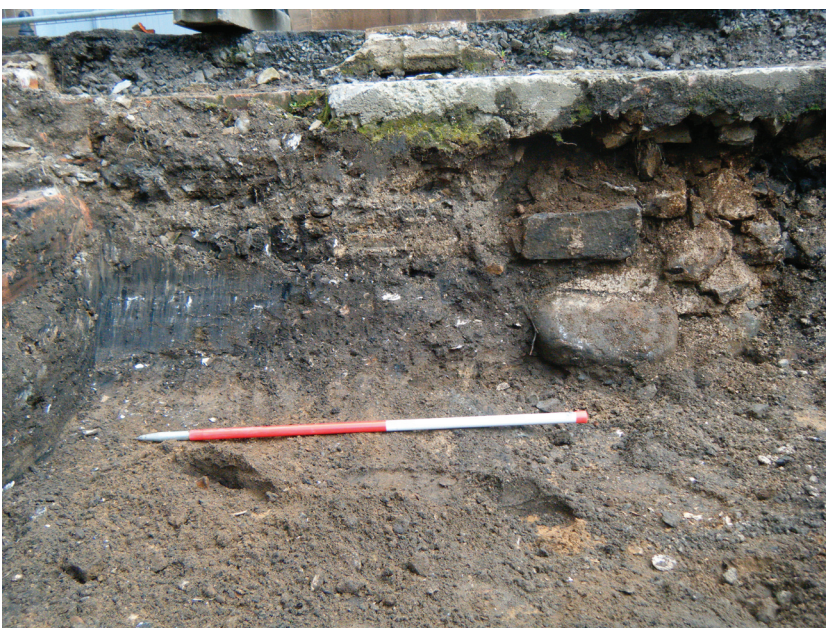
◀ **Illus 25**

*Detail of NW facing section showing the remains of wall [055]*

Disturbed remains were recovered of what are thought to be the footings a further wall [055] running parallel to both Lamb's House to the N and wall [050] to the S. In plan, this was formed of two areas of loose rubble bonded with lime mortar sitting on the alluvial sand. This wall was removed during the ground reduction works but was recorded in the NW facing section (Illus 25) of the development area. This wall along with wall [050] probably represent the remains of the building first clearly depicted on the 1852 Ordnance Survey map but potentially having much earlier origins. This mapped building may even have originally been contemporary with Lamb's House as we know this faced onto a narrow lane leading down to the shore. Immediately N of wall [055] a small spread of dark brown sand [052] with frequent oyster shell and animal bone, possibly represents the remains
