MAINS OF BALNAKETTLE FETTERCAIRN, ABERDEENSHIRE

- Standing Building Survey -

Carried out 24th April 2008
by
Murray Archaeological Services Ltd

Report No: MAS 2008-9

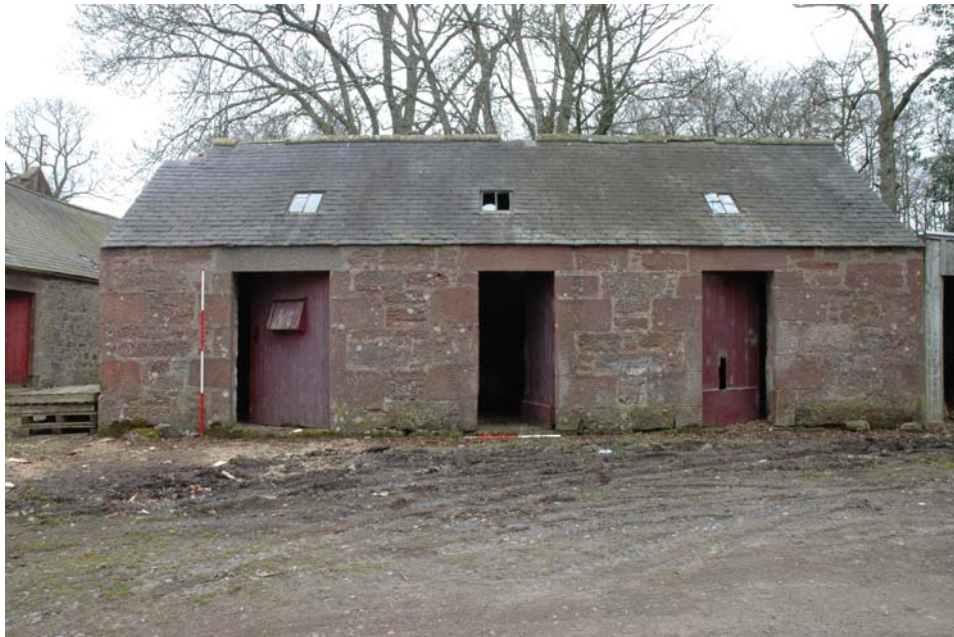
Illus 2 Bothy front view

The bothy is built of red sandstone rubble with roughly dressed sandstone rybats at doors and corners with smoothly dressed margins. The roof is pitched and slated with no skewes. The original sandstone chimney for fireplace F1 had been demolished prior to the survey as it was unstable.

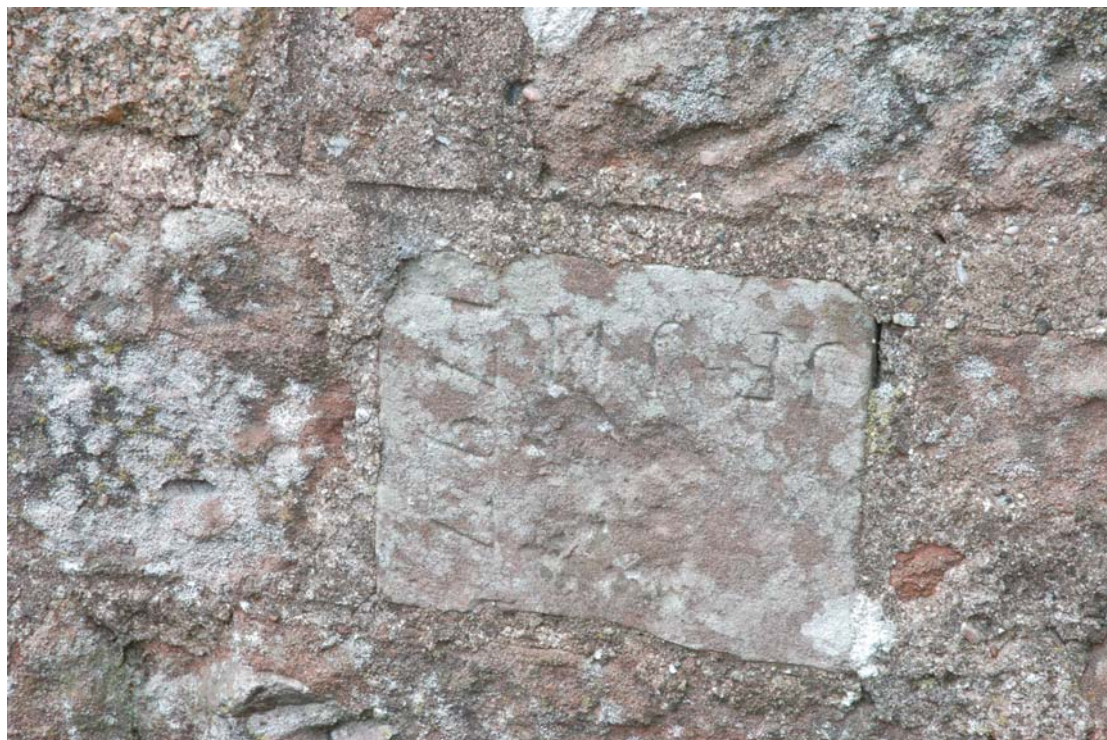
Date stone: A date stone of 1797 with the initials JF and JN (N reversed) was built into the front wall of the bothy. This is not original as the bothy does not appear on the maps until the late 19th/ early 20th century. It is suggested this may have come from an earlier building- possibly the predecessor of the present farmhouse. It does suggest that there were buildings on the site in the late 18th century.

Illus 3 Bothy detail of date stone, probably reused

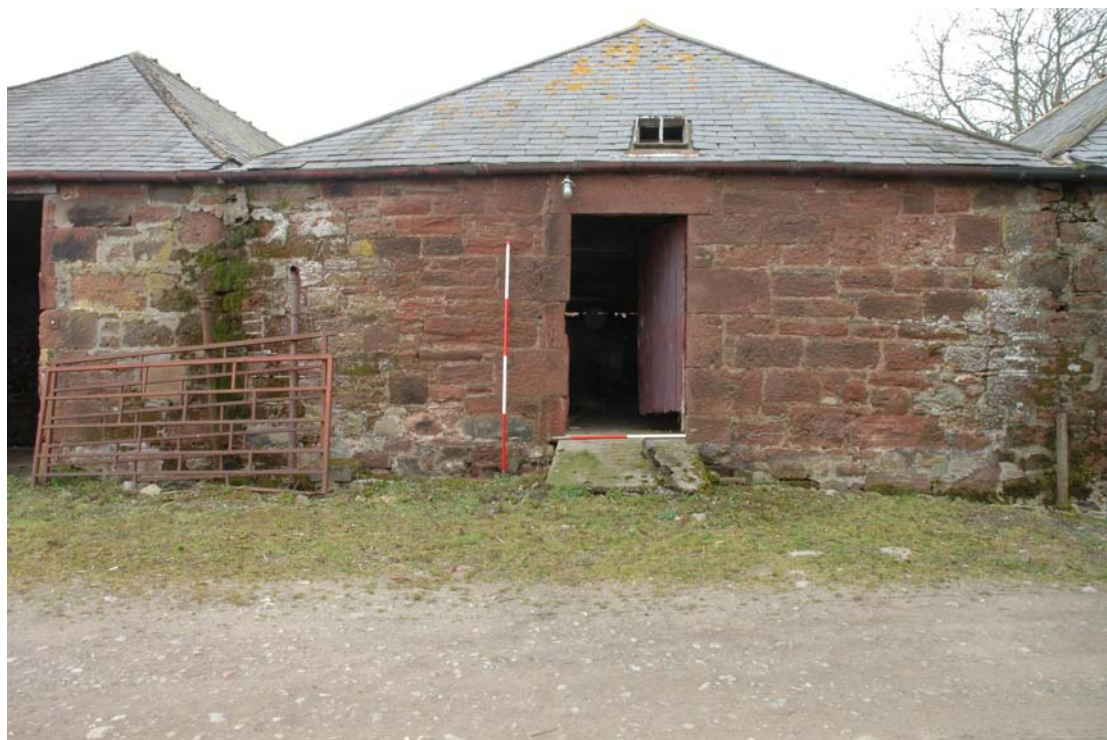
Wall 1 is all of sandstone. The N end (Bays 1 and 2) is of horizontal sandstone rubble with some field stones between and occasional use of this grey stones to level up the courses. This is in contrast to the wall across Bays 3 and 4 which uses larger blocks, set differently – this appears similar to wall 2.

Illus 7 Steading wall 1 detail of change in wall construction (to LHS of ranging rod)

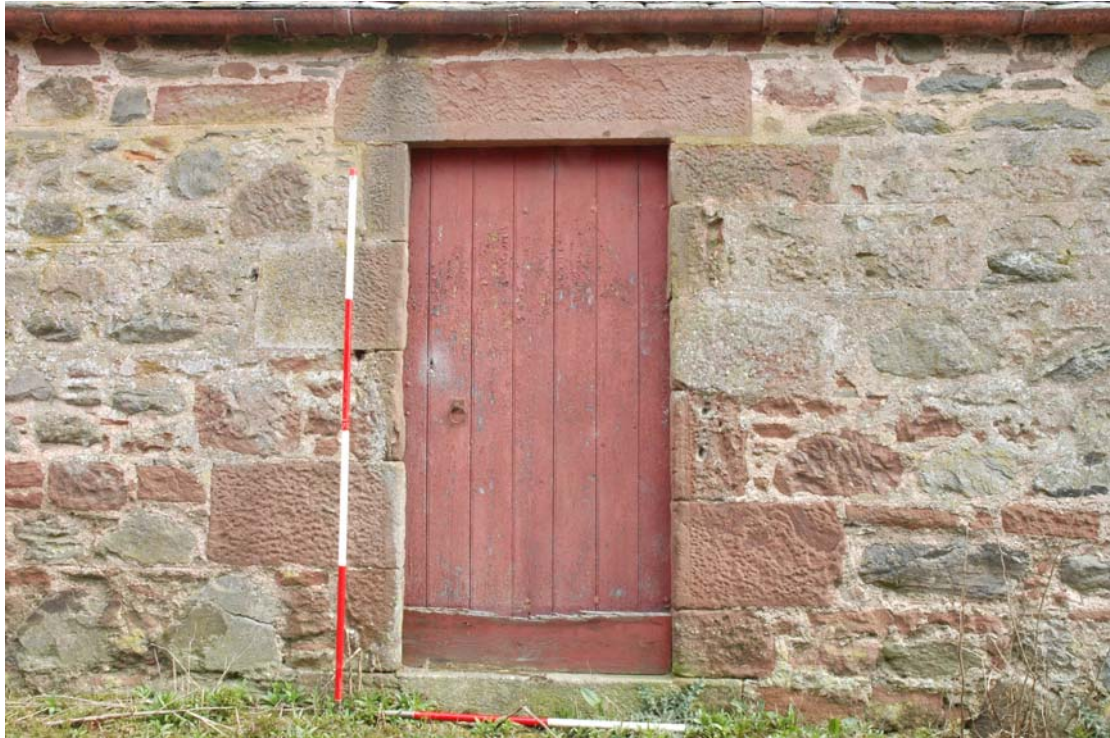
Illus 8 Steading Detail of door D6

D6 Lintel sides and threshold as D5. W: 1.04m H: 2.07m. The door (wooden planks) is set behind the dressed margins (as in bothy).

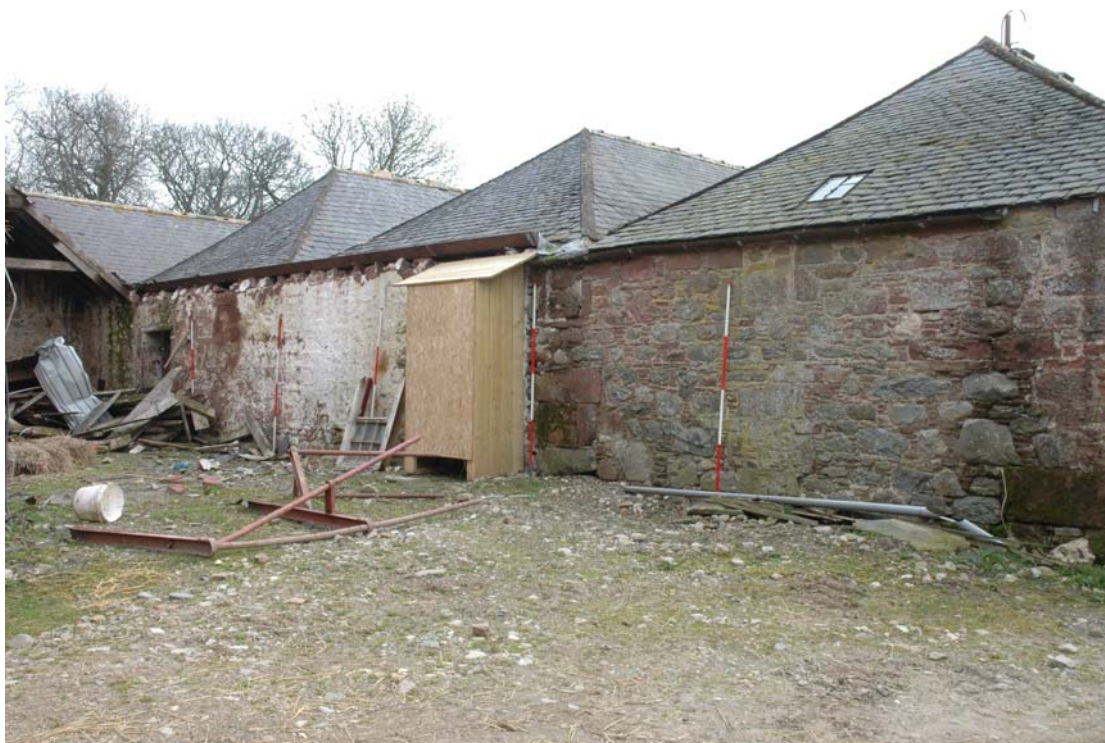
Illus 9 Steading wall 3 with ranging rods indicating vents

V1-5 In wall 3, there are five pairs of blocked vents c. 2.57m apart (centres). Each pair consists of two rectangular openings one above the other and c 950mm apart (edge to edge). Sandstone blocks used for sills and lintels. In V2 the sandstone appeared possibly reused as there was a cut recess that did not appear to fit in its present position. V3-5 each had the remains of two iron fittings above the upper vent – possibly the eyelets to hold swivel pins of a shutter which could be swung up or down. Internally V1,2 and 5 could be seen to have wooden lintels on the lower vent in each pair. Internally there is a ridge along the face of the wall from V2 to V5 at the level of the base of the upper vents. Possibly there was originally a fitting such as a hay rack along this line. Only two could be measured easily:

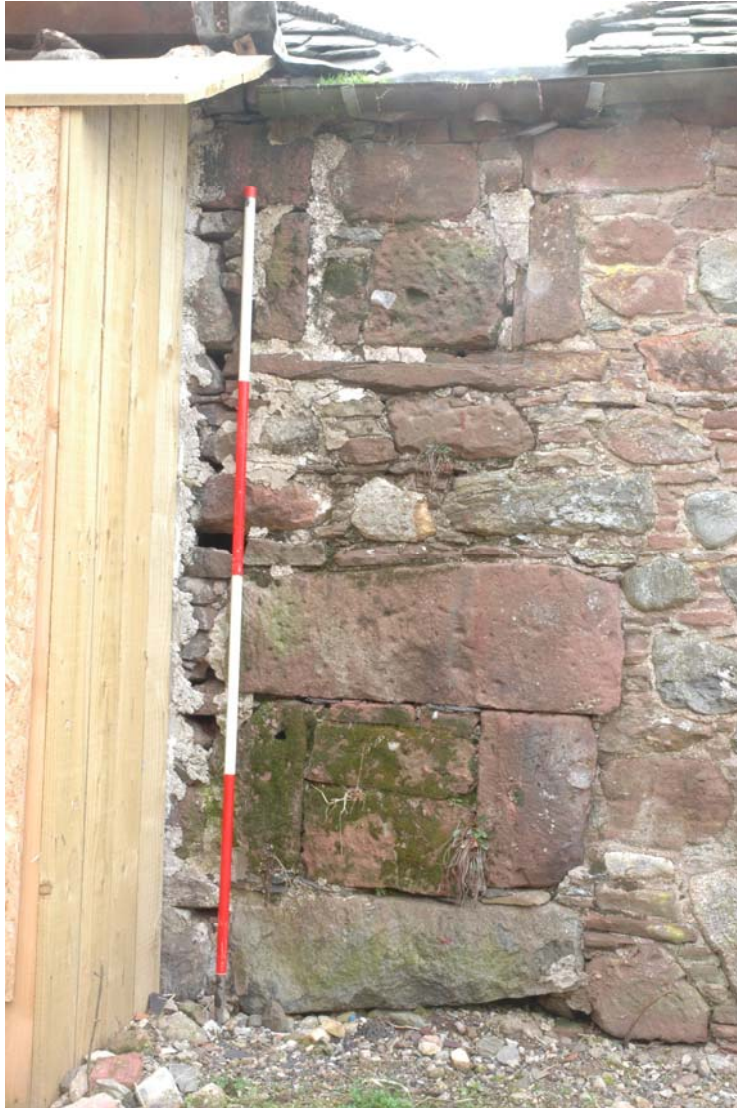
Illus 10 Detail of vents V2

V2 upper W:530mm H: 530mm

V2 lower W: 520mm H: 460mm

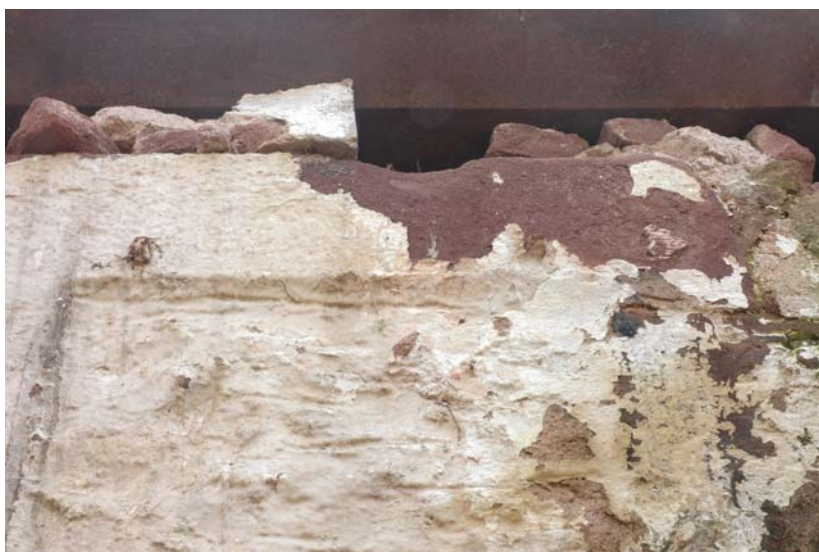
Illus 11 Detail of iron fittings above upper vent

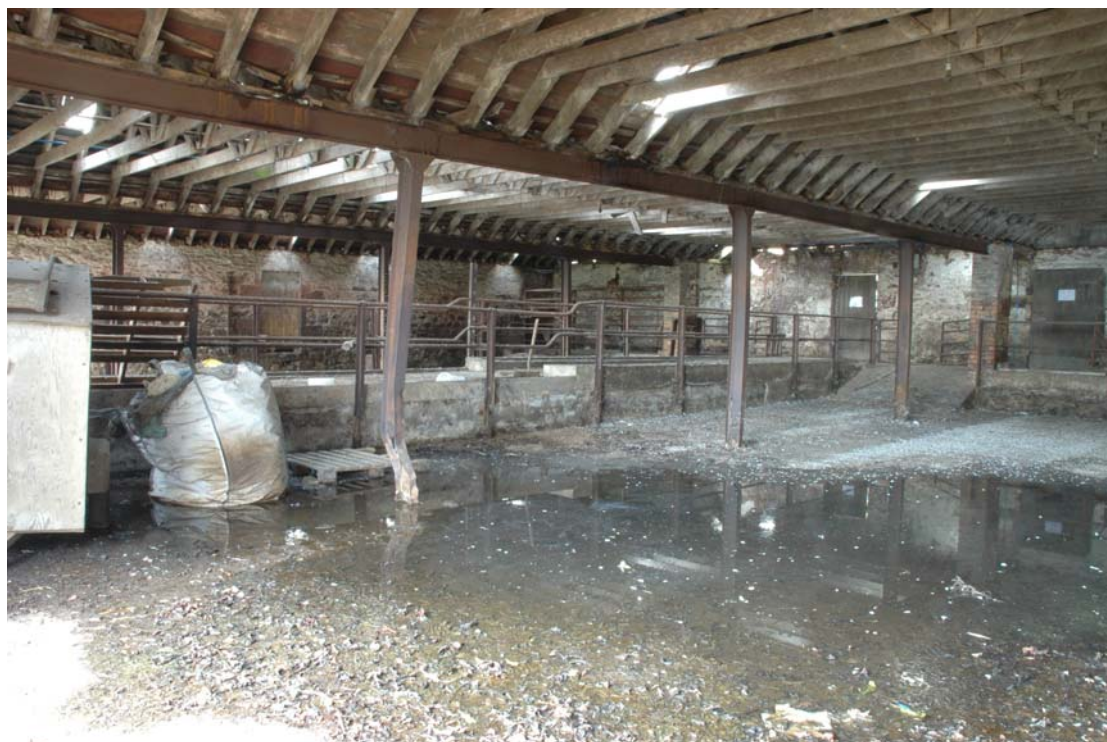
Illus 12 Steading Interior view Area 1

Area 1: The internal arrangements are a fairly recent conversion (at a guess between 1970 and 2000). The floor has been cut down (see the level of D10) and all the earlier internal walls have been removed. The roof has been supported on steel beams. Only two columns at the back of the building are of partly brick and partly sandstone and may derive from the original structure.

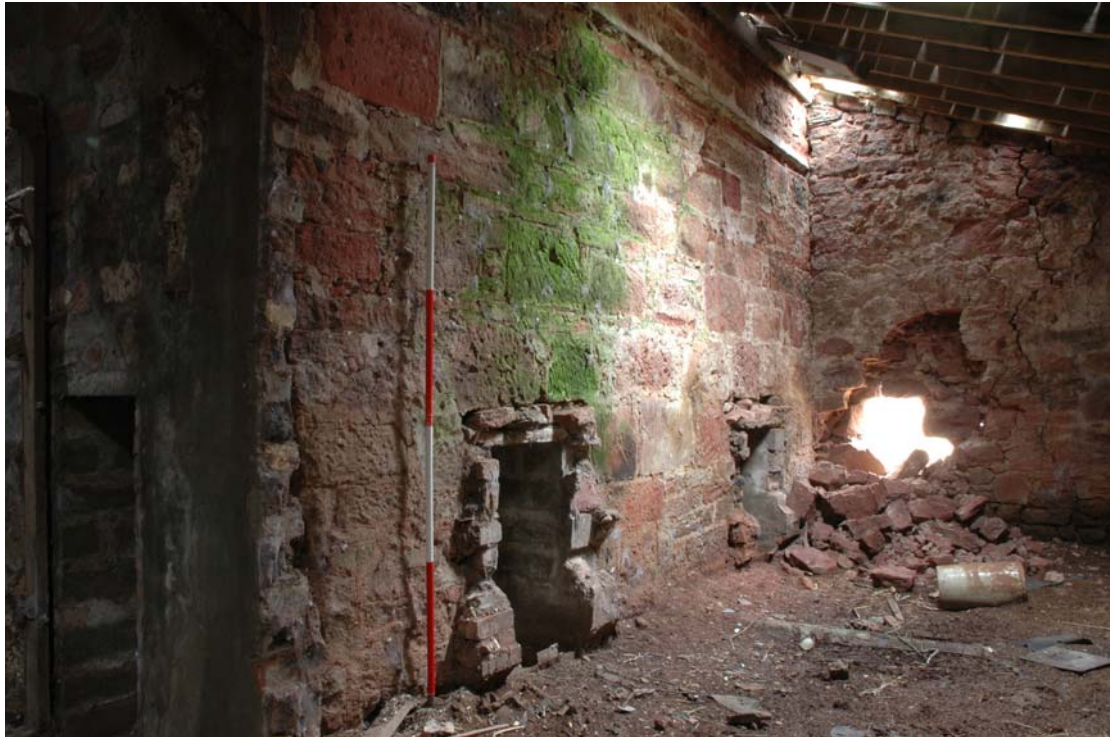
Area 4 and 5: Area 5, and the part of Area 4 nearest to it, have been subdivided by a series of concrete and wooden walls. These appear to have formed a series of grain bins each with an individual chute, on either side of a grain auger set in a concrete trough. The trough runs through into the former mill building. The roof ventilators (of asbestos and corrugated plastic) suggest that there may have been a drier in the mill in its recent use- and possibly a bruiser for the cattle feed. The ruinous state of the mill interior did not allow further examination.

Illus 13 Steading, Area 5 detail of grain chutes broken through mill wall

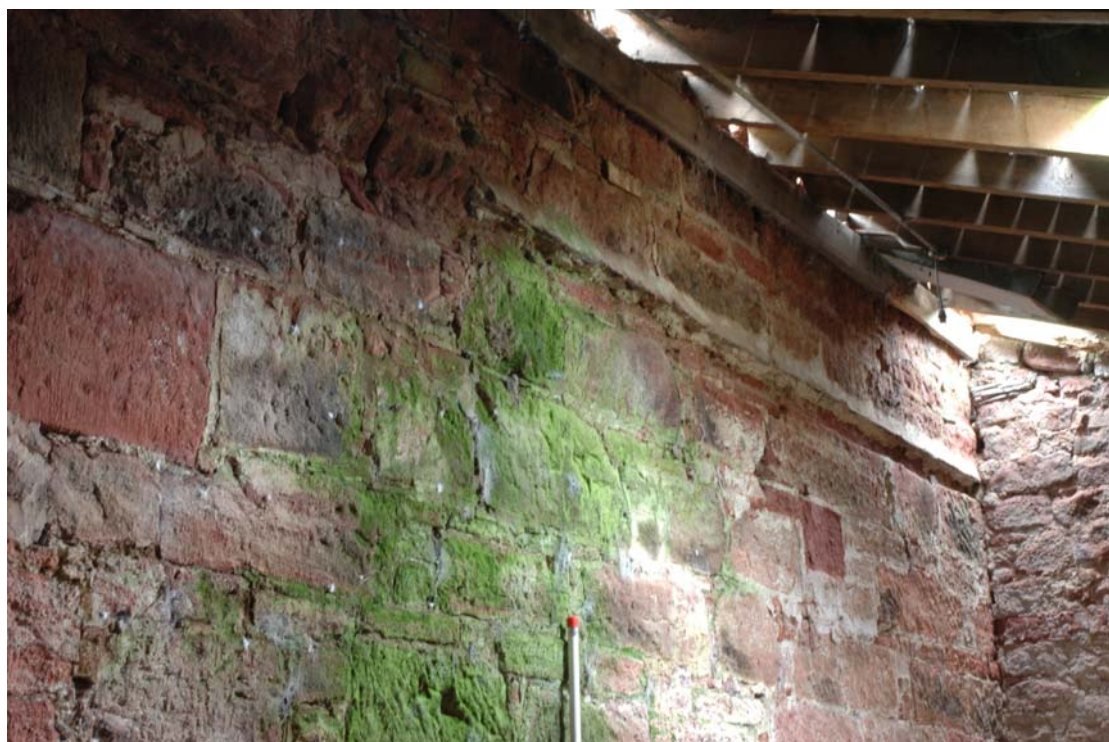
Wall 1: The wall that originally held the wheel now has a lean to built against it (Steading wall 7). This can be proved to be a much later feature and certainly post-dating 1904 (see above). However there is a horizontal raggle and a groove along the sandstone of the outside of the wall which indicates there was an earlier lean-to, possibly the smaller structure shown on the 1904 map- which may have enclosed the

Illus 17 Mill wall showing raggle

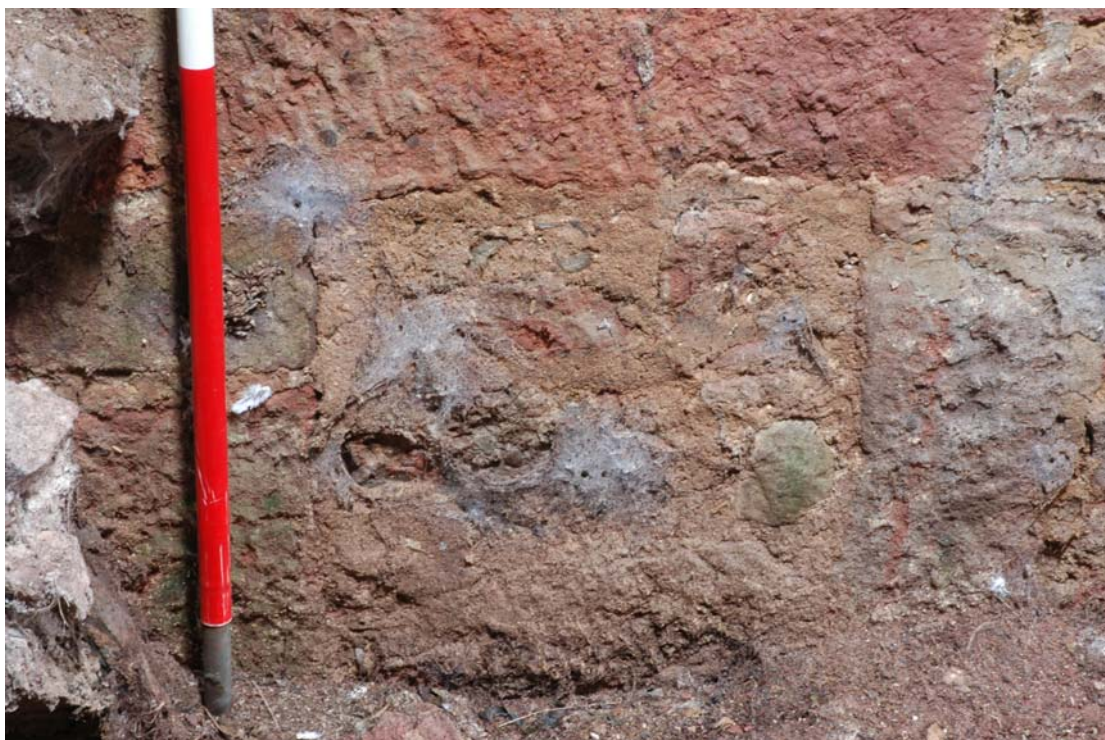
There are at present two recent breaks (W: 570mm H: 1m) in the base of this wall, both being openings for grain chutes into the 20th century grain augur – neither of these is original to the mill. However, between them at 2.29m from the NW corner of the mill building, there is a blocked vent at the base of the wall. W: 460mm H 500mm+ with a sandstone lintel. The size and position indicate that this is likely to have been the hole for the shaft of the original water wheel. This also fits with the position of the mill lade as shown on the 1850 and 1868 maps. This feature could not be seen on the inside of the wall where it is obscured by the cement block channel for the augur. The wheel would have been on the outside of the wall, fed by water from the mill pond – there would have been a lower ground level to allow the wheel to turn – this is obscured by the later levelling and the later lean-to.

Illus 18 Mill wall showing blocked wheel shaft hole

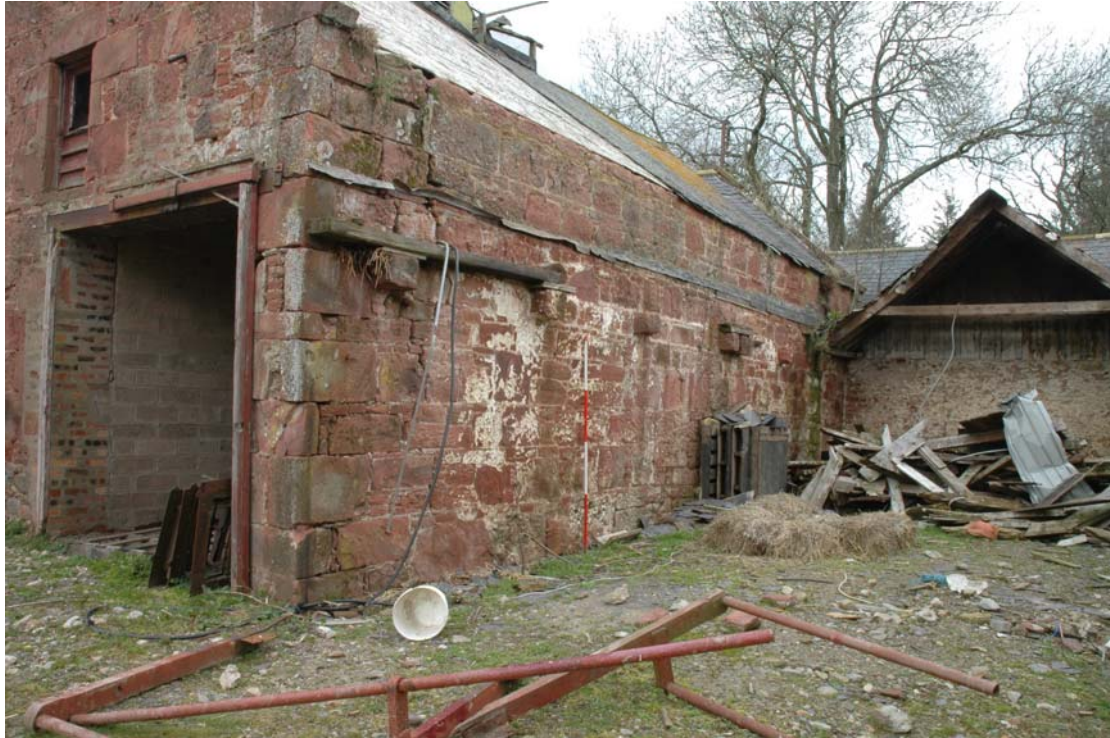
Wall 3: There are a series of six sets (the central set is doubled) of sandstone corbels projecting 250mm from the outer face of the wall at 2.43m above present ground level. These do not project inside the building. Although they had been utilised by an infill building (demolished prior to the survey) between the mill and the steading, this does not appear to have been their original function and they may be an earlier feature of the mill, possibly an earlier lean- to.

Illus 19 Mill wall 3 showing corbels

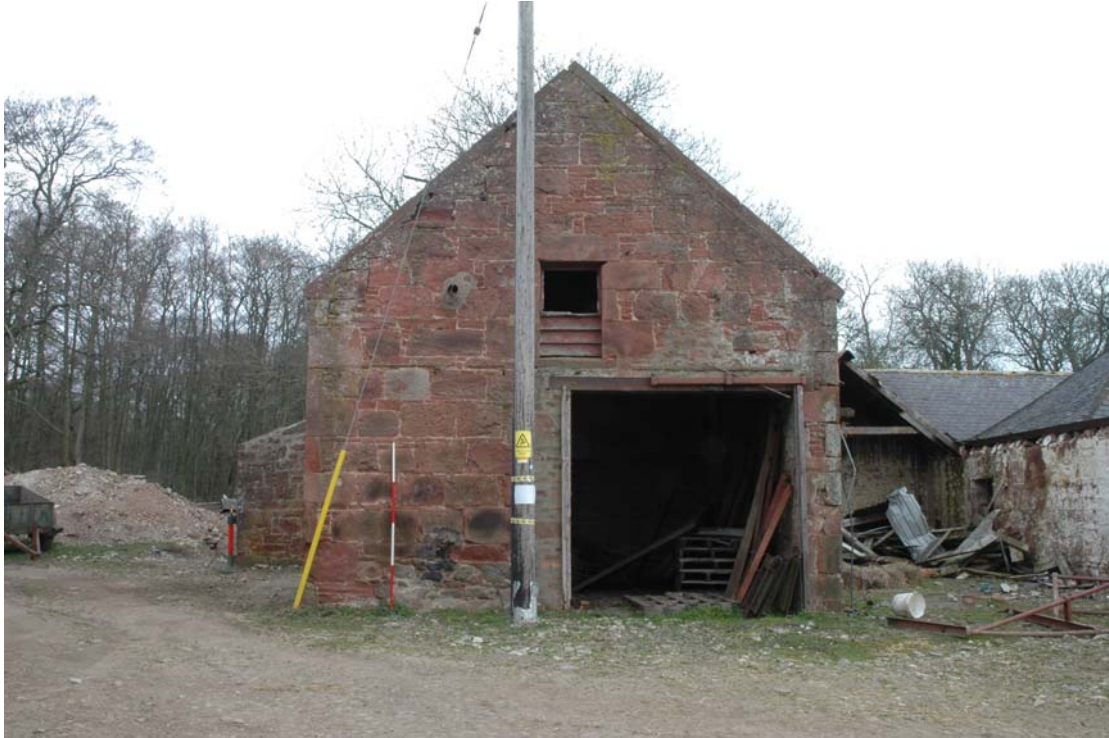
Wall 4: The S gable had a window at 1st floor level (W1- not measured) with very roughly dressed sandstone rybats. The upper part had been glazed with wooden slat ventilation below – this is like the windows in the steading and is likely to have been a re-fenestration within the original opening. At ground floor level there is a cart door. This has clearly been widened on the LHS (bricks) and raised and now has the remnants of a door on a metal runner. This has totally obscured any earlier opening- but it is probable that there was a cart door at this point in the original building.

Illus 20 Mill wall 4

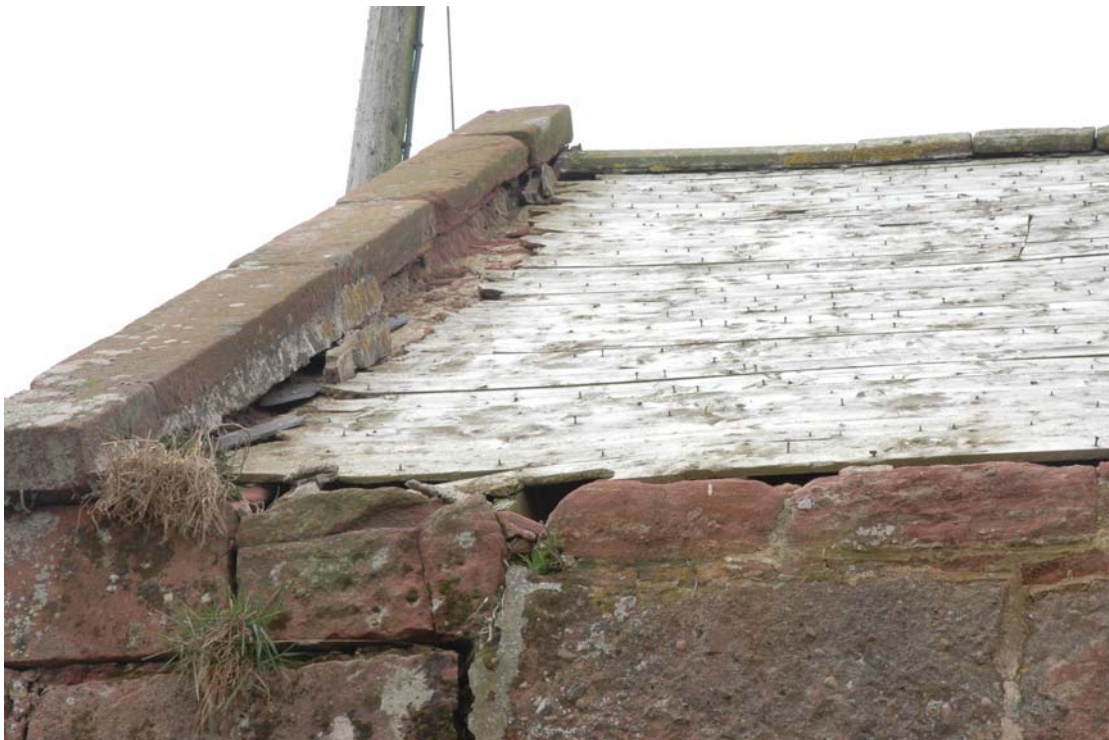
Roof: The roof is slatted and has been pierced by two modern ventilators constructed of asbestos and corrugated plastic. An original feature of the roof is the sandstone skewes at the gables- the use of skewes is not seen elsewhere in the steading and again may indicate an earlier date. The present slates may be a replacement.

Illus 21 Mill Detail of S skew

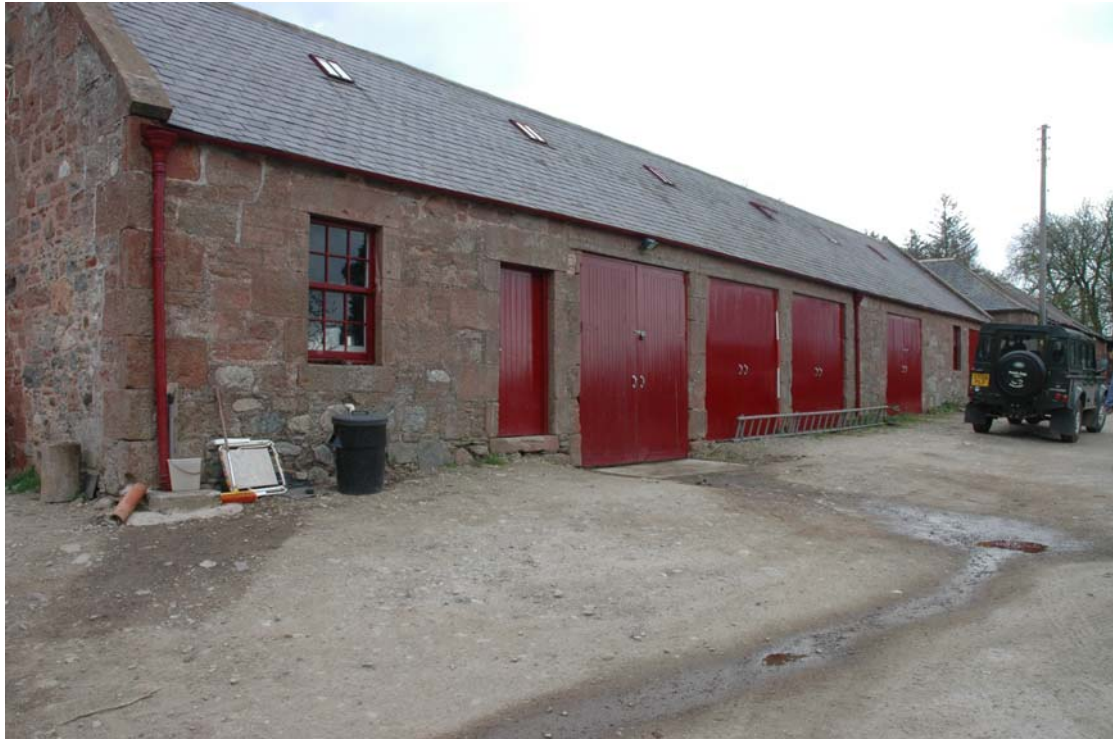
Illus 23 Gamekeeper's steading (Original S range)

The steading in use at present by gamekeepers is not part of the present development and was not surveyed in detail. However as it appears to include elements of the S steading shown in the 1850 Estate map it has briefly been considered. The original surviving features are two parallel buildings (green on plan) built of field rubble with sandstone used as detailing at doors and windows.

Of particular note are three cart openings at the S end- which appear to be the original openings with semi- shaped sandstone at the sides and long sandstone lintels. The room at the S end was originally a bothy- the fireplace still visible inside.
