St Columba's Roman Catholic Chapel and Presbytery, Miùghlaigh

Report 2: Survey.

September 2013

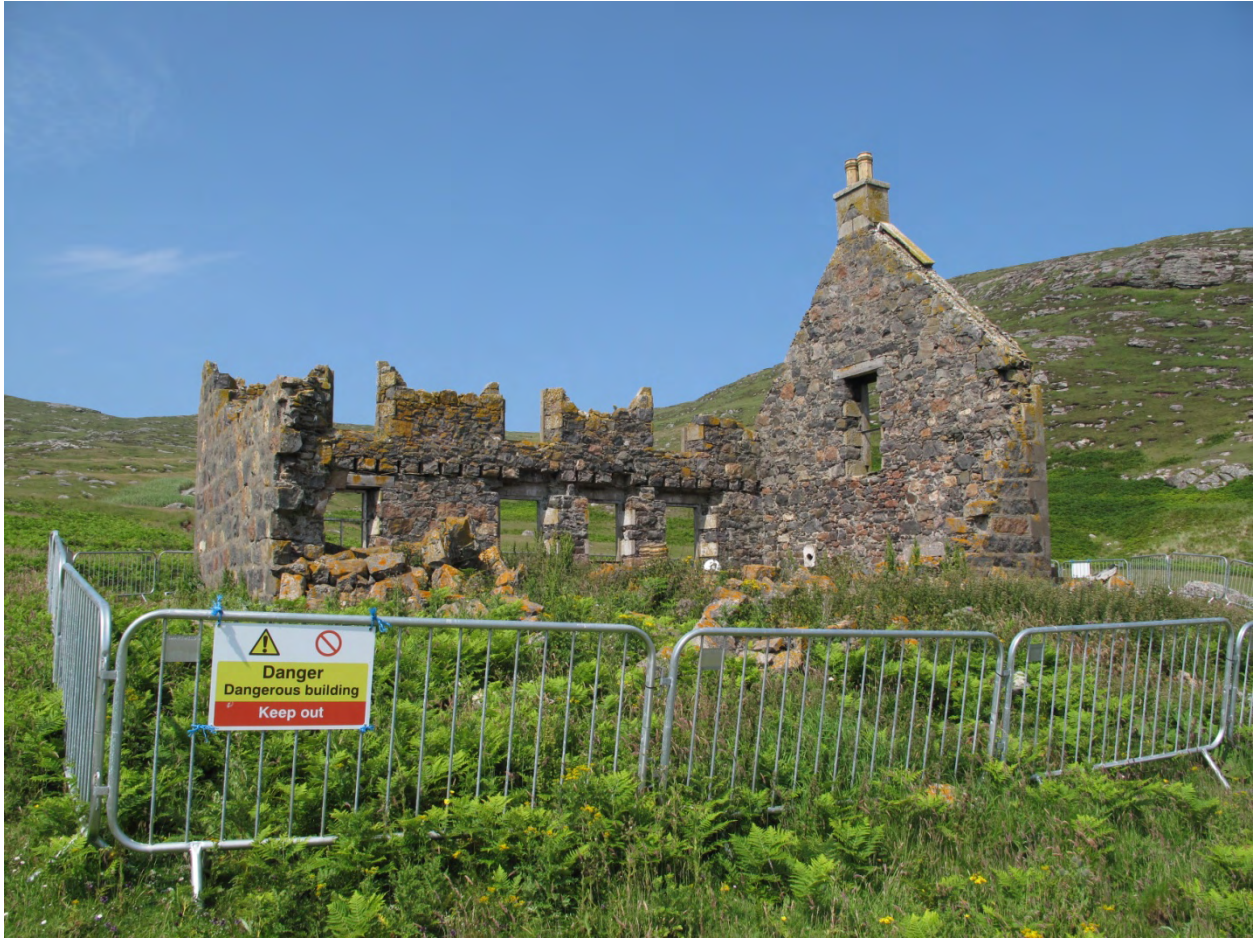
Figure 1 The ruinous chapel house from the south east. In part because of the way that the roof structure moved, bringing on the collapse of the structure, the gable has collapsed into the building, while the front wall has collapsed outwards. The remaining gable is still remarkably straight, as is the back wall.

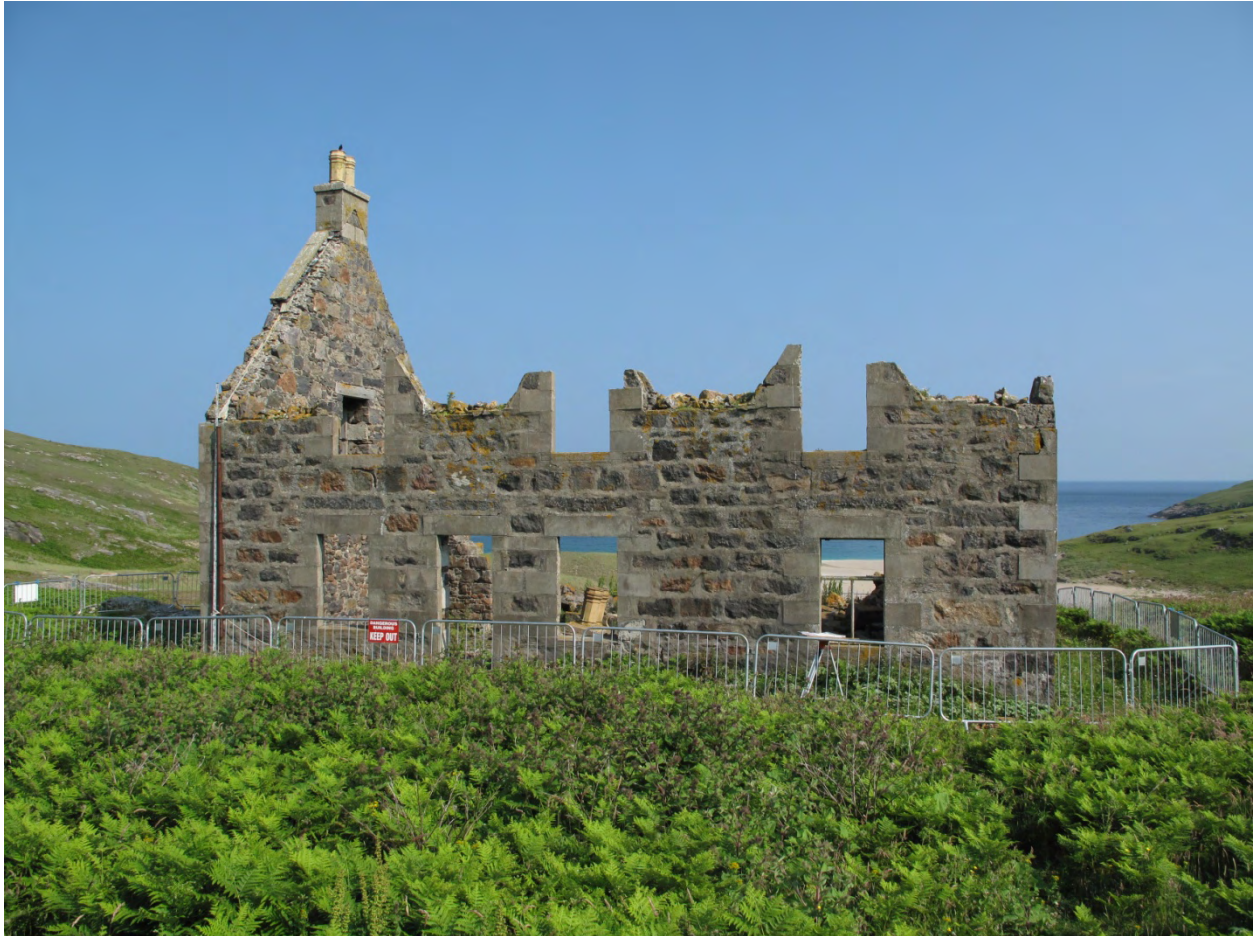
Figure 2 The back wall of the building is still straight, although the small stands of masonry that formed the half-dormers are coming away. Only one of the three drain-pipes is still in position, and much of the cast concrete coping to the gable has fallen off.

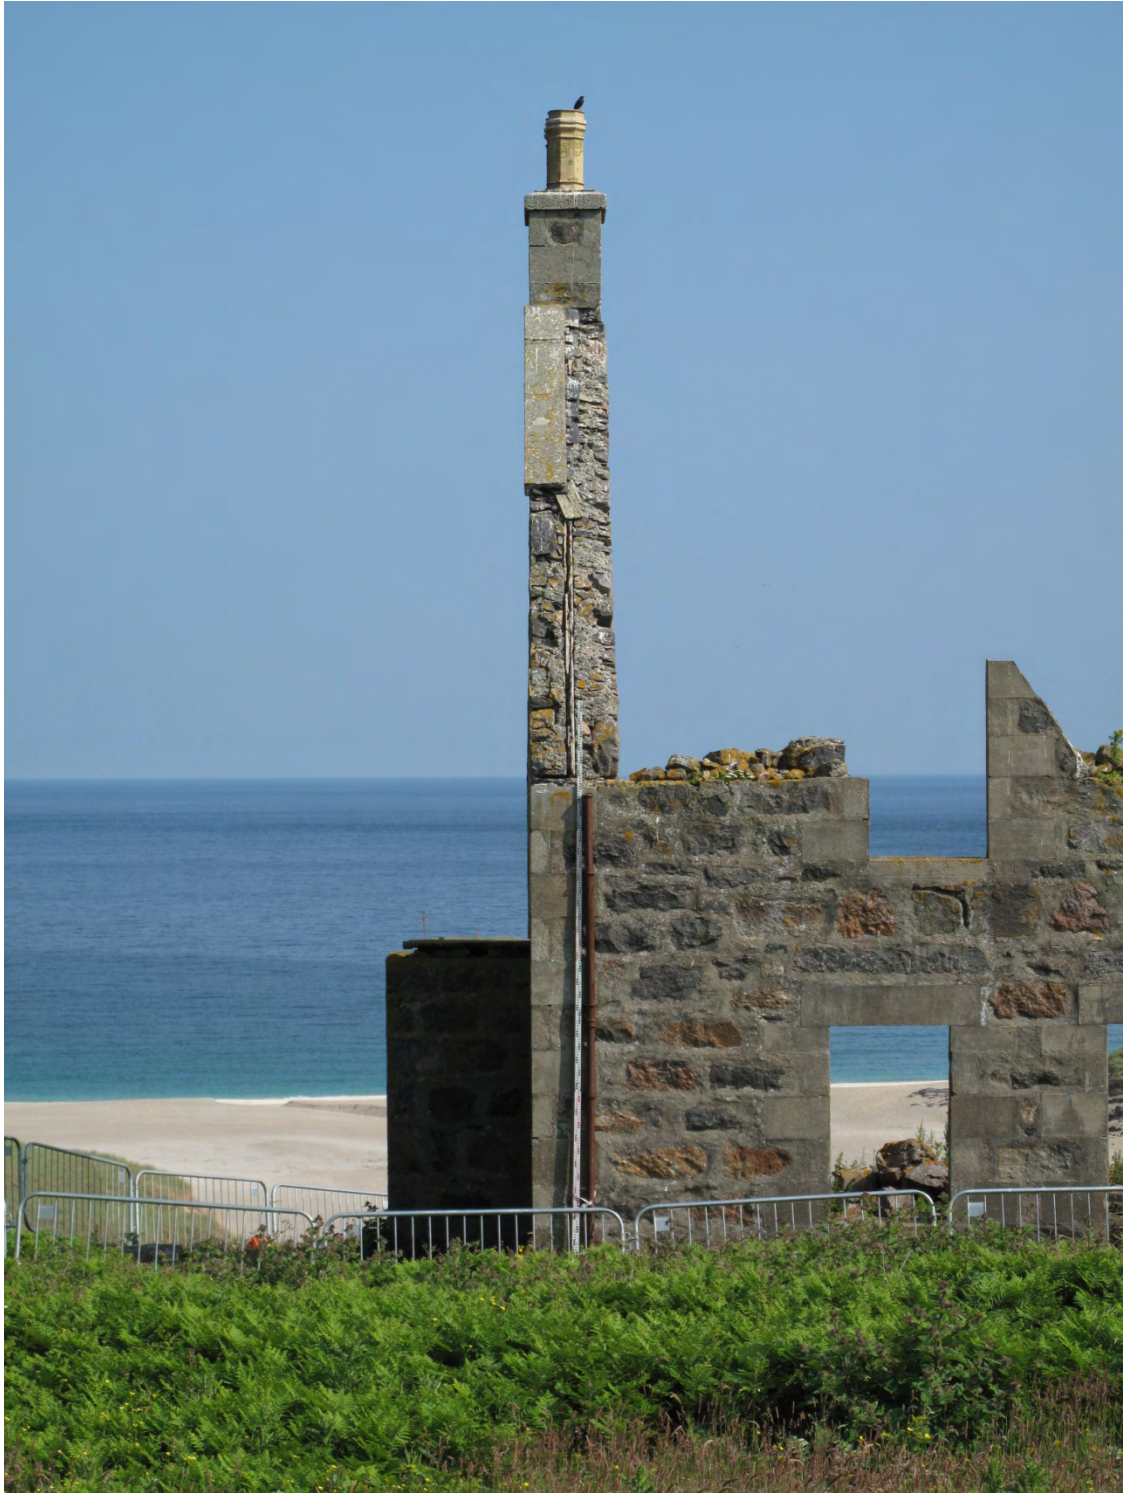
Figure 3 The gable can be seen in detail in this photograph. There is a final joist set into the gable to allow the sarking boards to be fixed to it. The sarking and the slate were tucked under the concrete coping, protecting them from the wind.

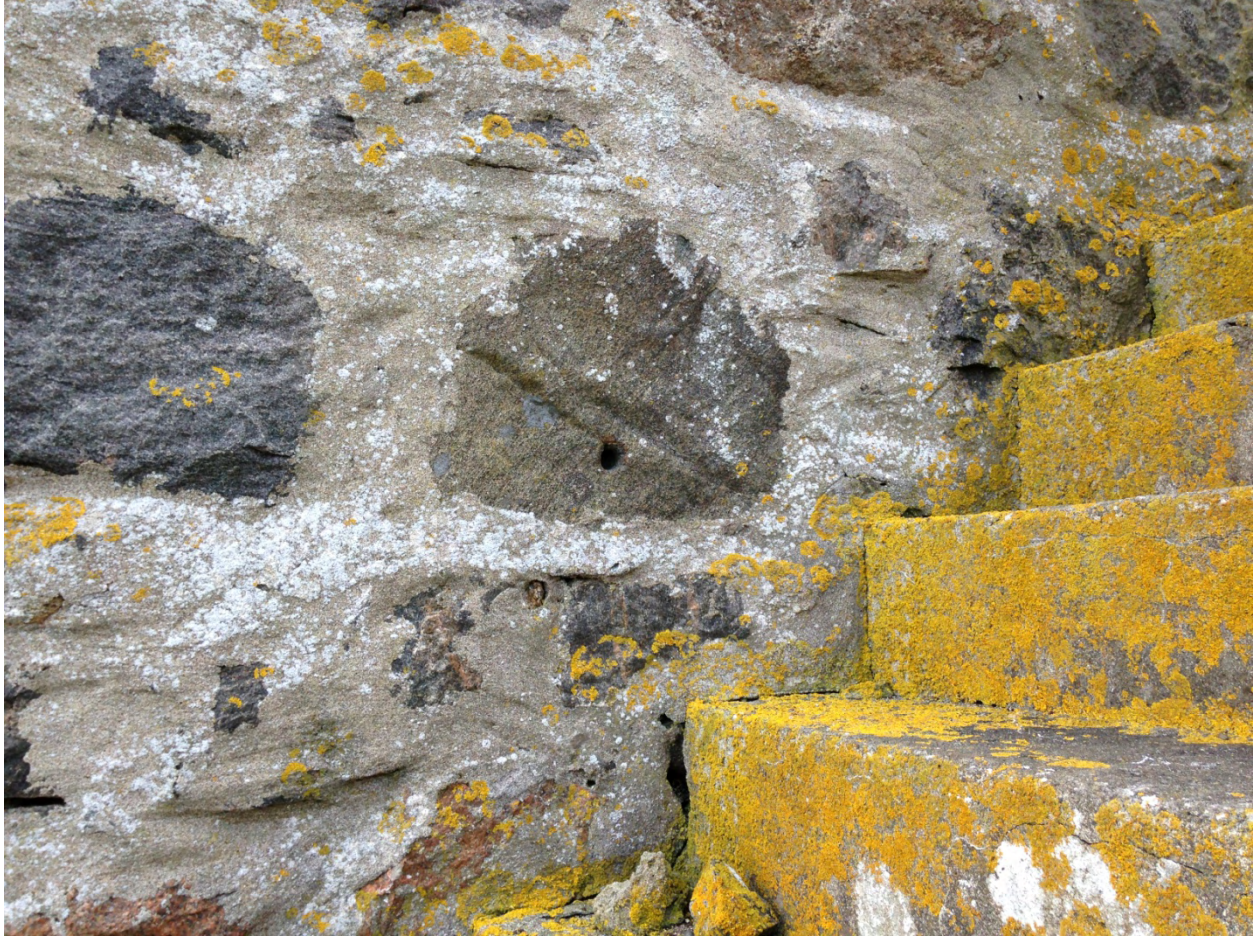
The building is constructed with roughly squared stone that is almost certainly from the island. ‘Jumper-holes’ drilled into the stone in order to allow it to be split with dynamite are visible in a number of places in the building (as well in the school house and enclosure wall) (Fig 4).

Figure 4 The stonework of granite and gneiss is 'sneck-harled' ie there is a mortar coating that covers over all the joints and pinnings (snecking) but does not extend over all the stonework. Holes created by drilling during the quarrying process (known as 'jumpers' are visible on a number of the stones. The staircase is finished in concrete, presumably over a concrete base.

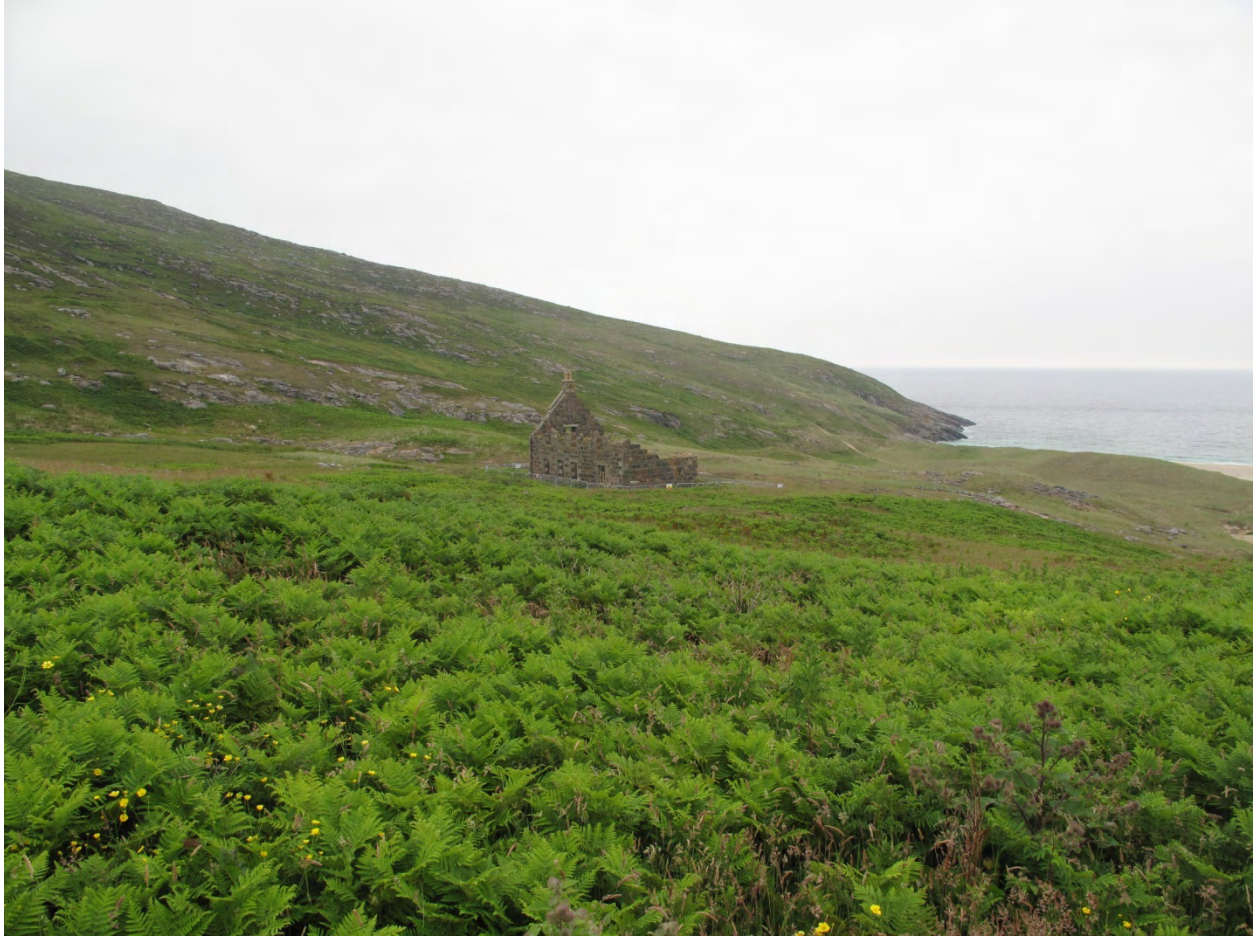
Figure 5 A view of the chapel house from the west. It sits at the end of a low ridge, at a much higher level than the remainder of the settlement. The stone was probably quarried from the exposed bedrock slopes beyond it.

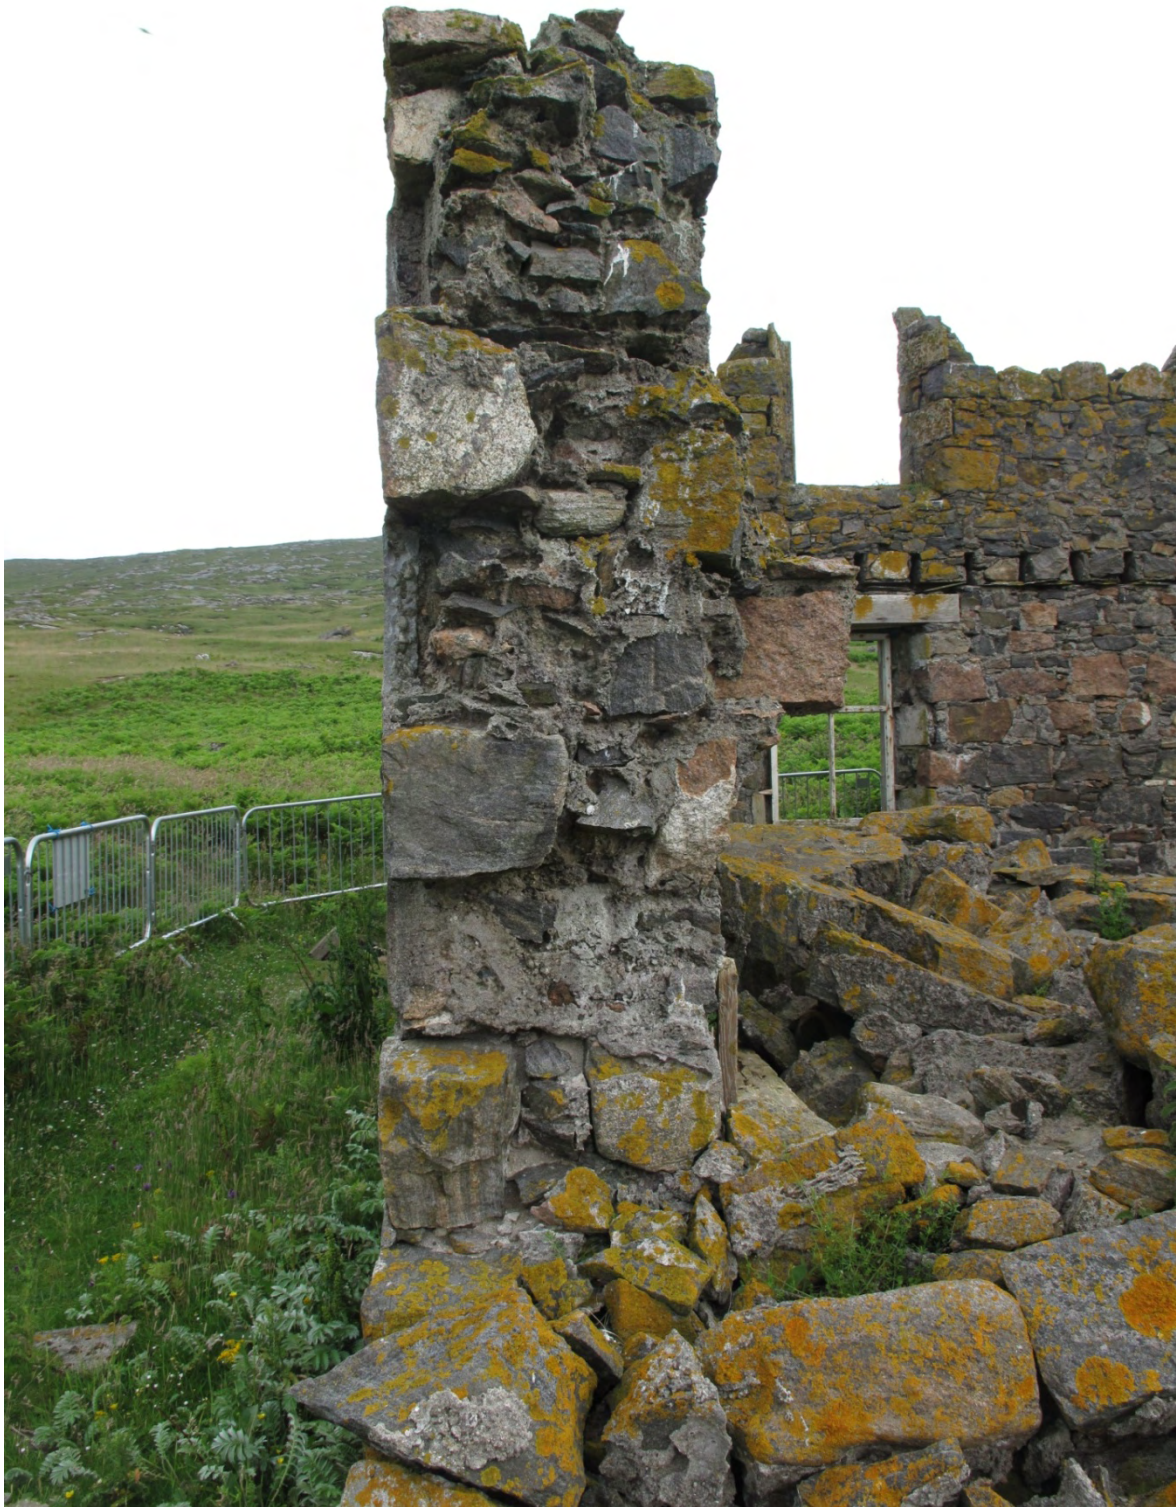
Figure 6 The wall is built with two faces of lime mortared stone, between which there is a filling of smaller stones and mortar. This section, where the concrete quoins have fallen away, one can see how the concrete was set against the wall-fill, and then a cement render was applied to the outside. The inside was lined with timber, held to the wall by timber dooks set into the wall.

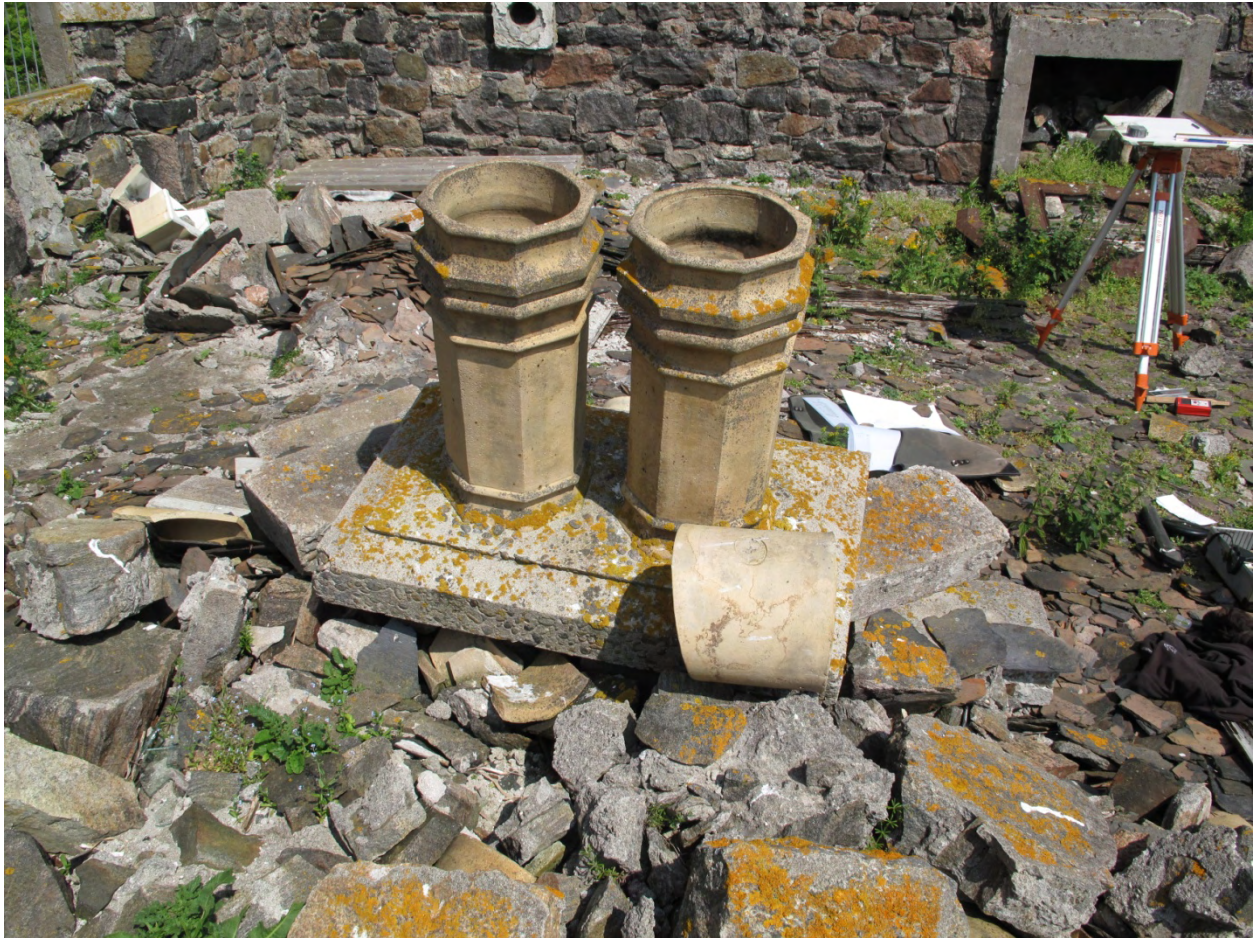
Figure 7 The floor of the building is strewn with collapse. The chimney cans survive, the whole SW gable having collapsed into the building. Beyond, there are slates, reddened by the recent fire, all over the floor. Fragments of the timber joists that held the floor can be seen, as can the flu of the kitchen stove and the fireplace.

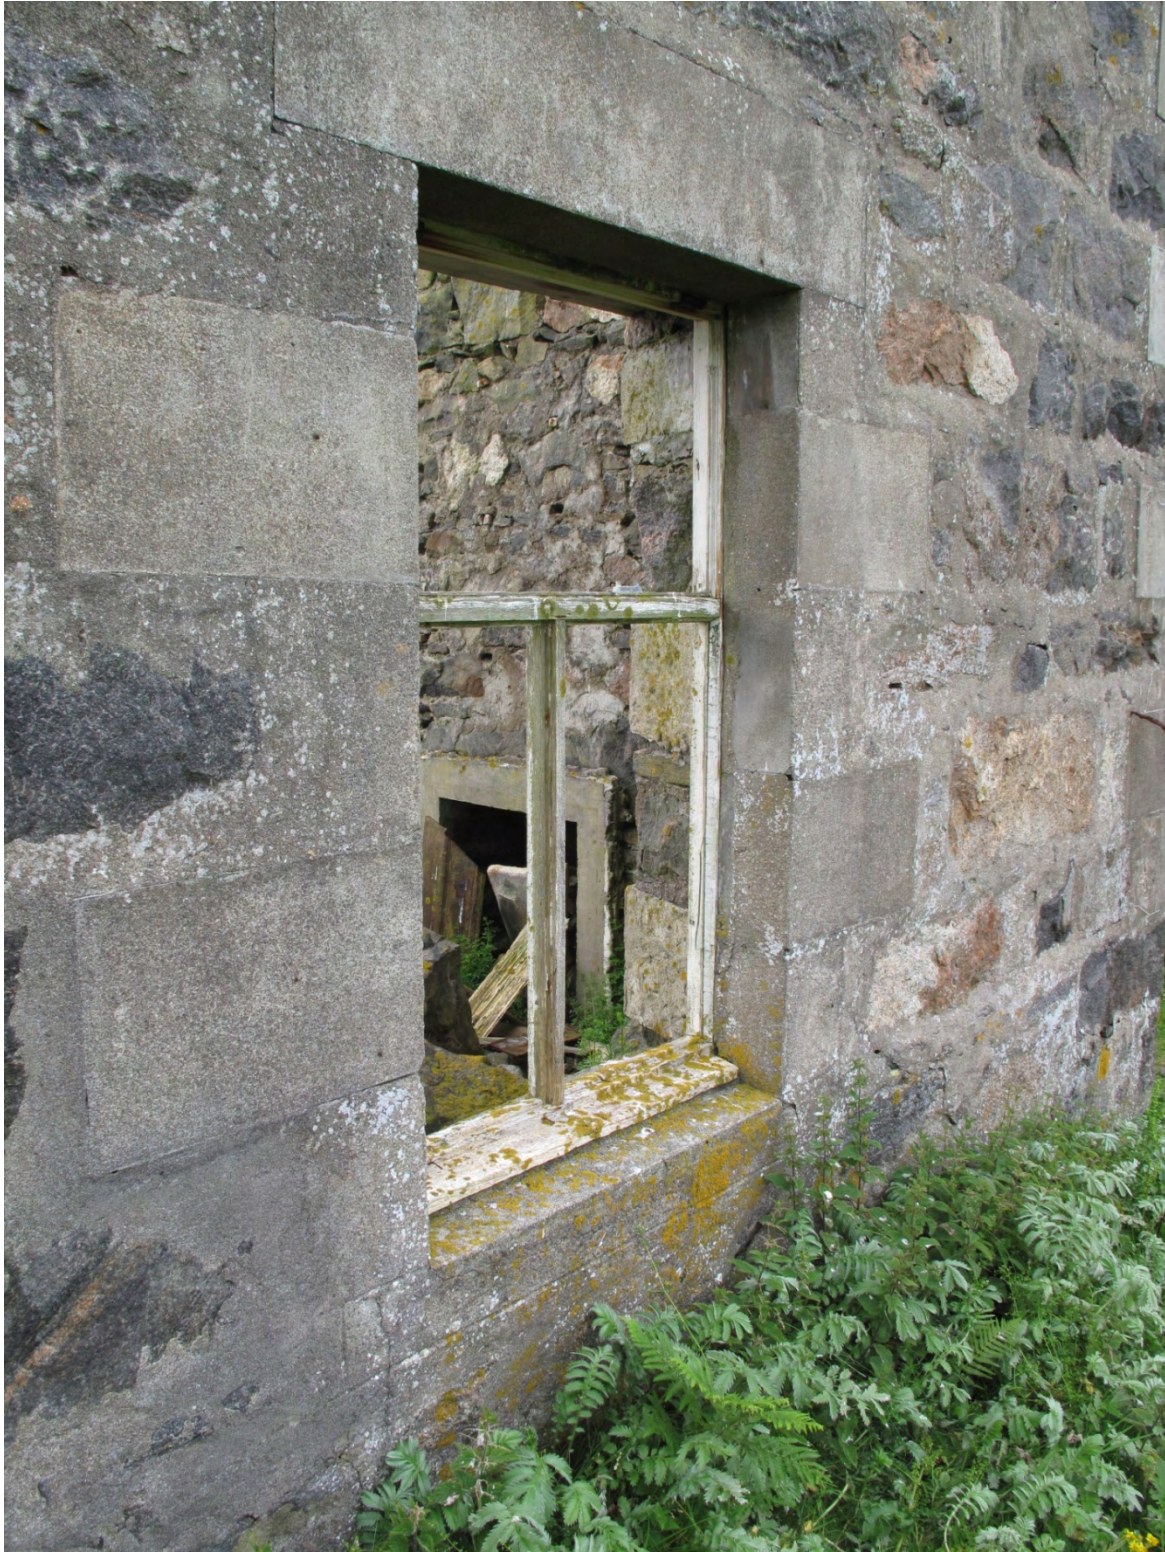
Figure 8 All of the openings are detailed with cast-concrete blocks. The windowsill has a slight fall to encourage water to drain away from the frame. The frame, which had a hopper window in the upper part, is from the 1970s.

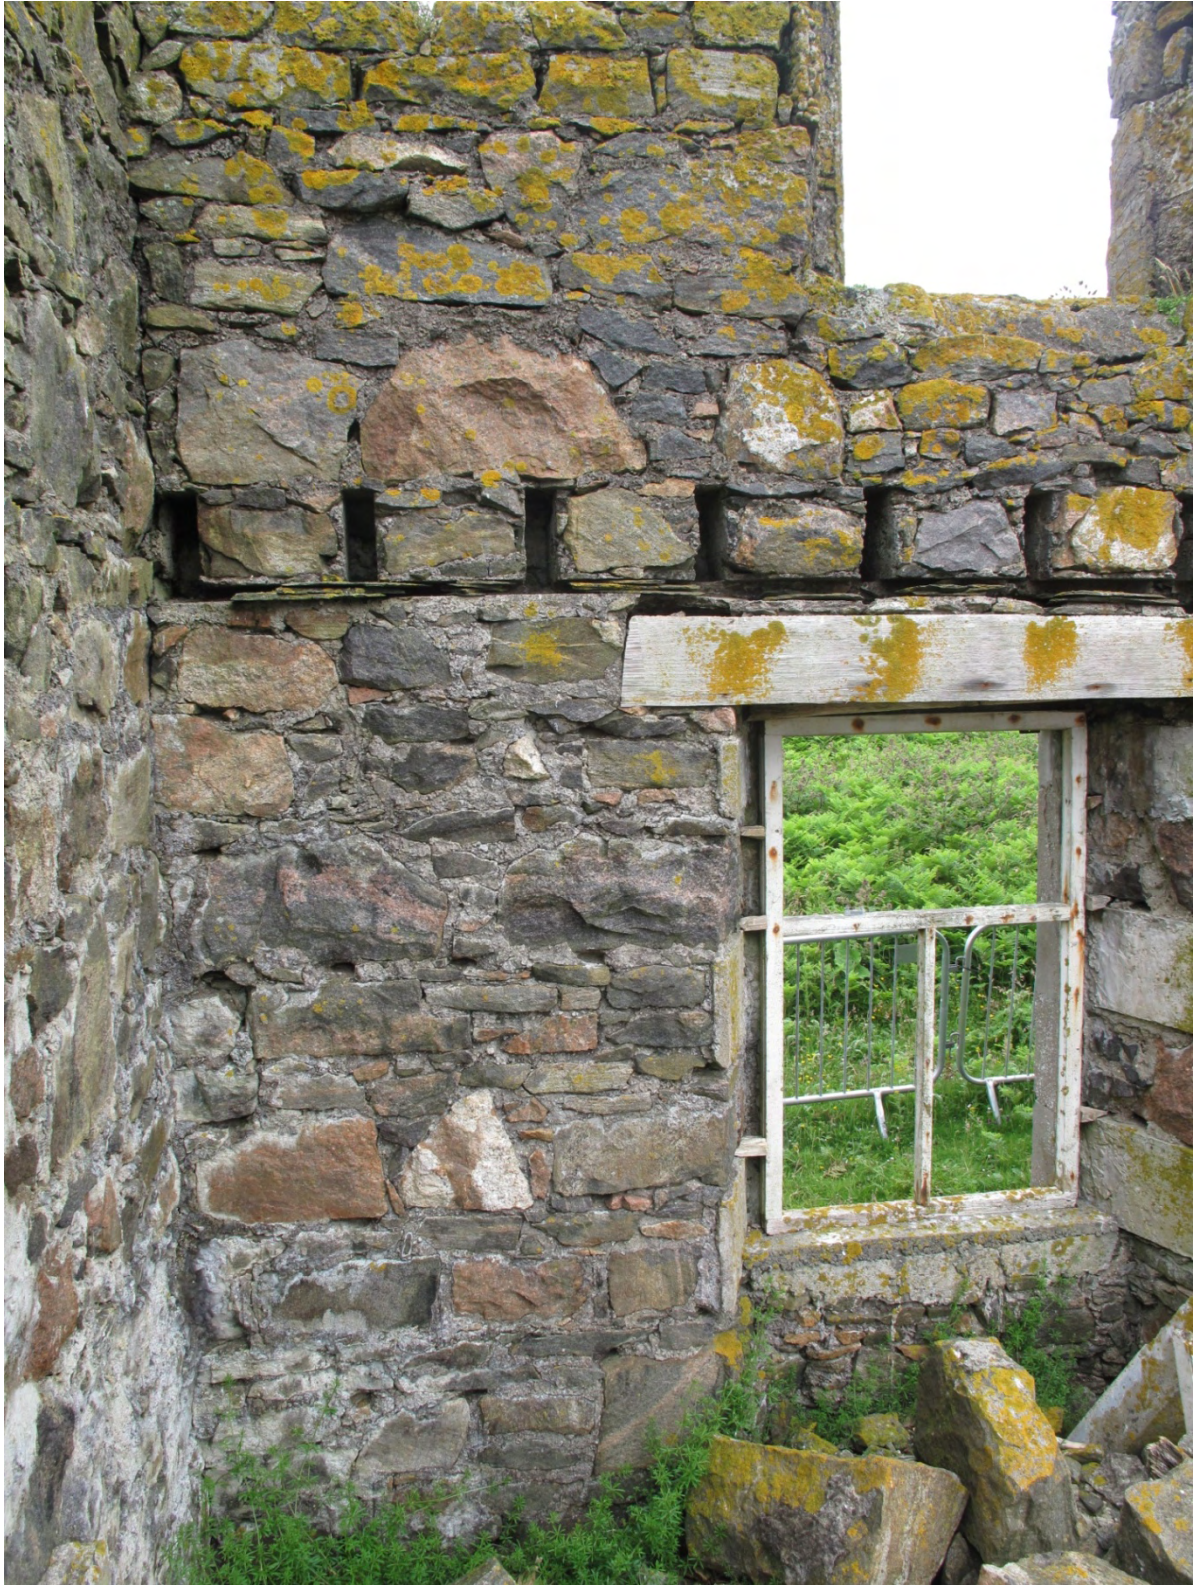
Figure 9 Nothing is left of the timber floor joists that were set in a leveling course of slates. The massive timber safe lintels are certainly of imported sawn softwood. The window frame is one of those put in during the 1970s restoration.

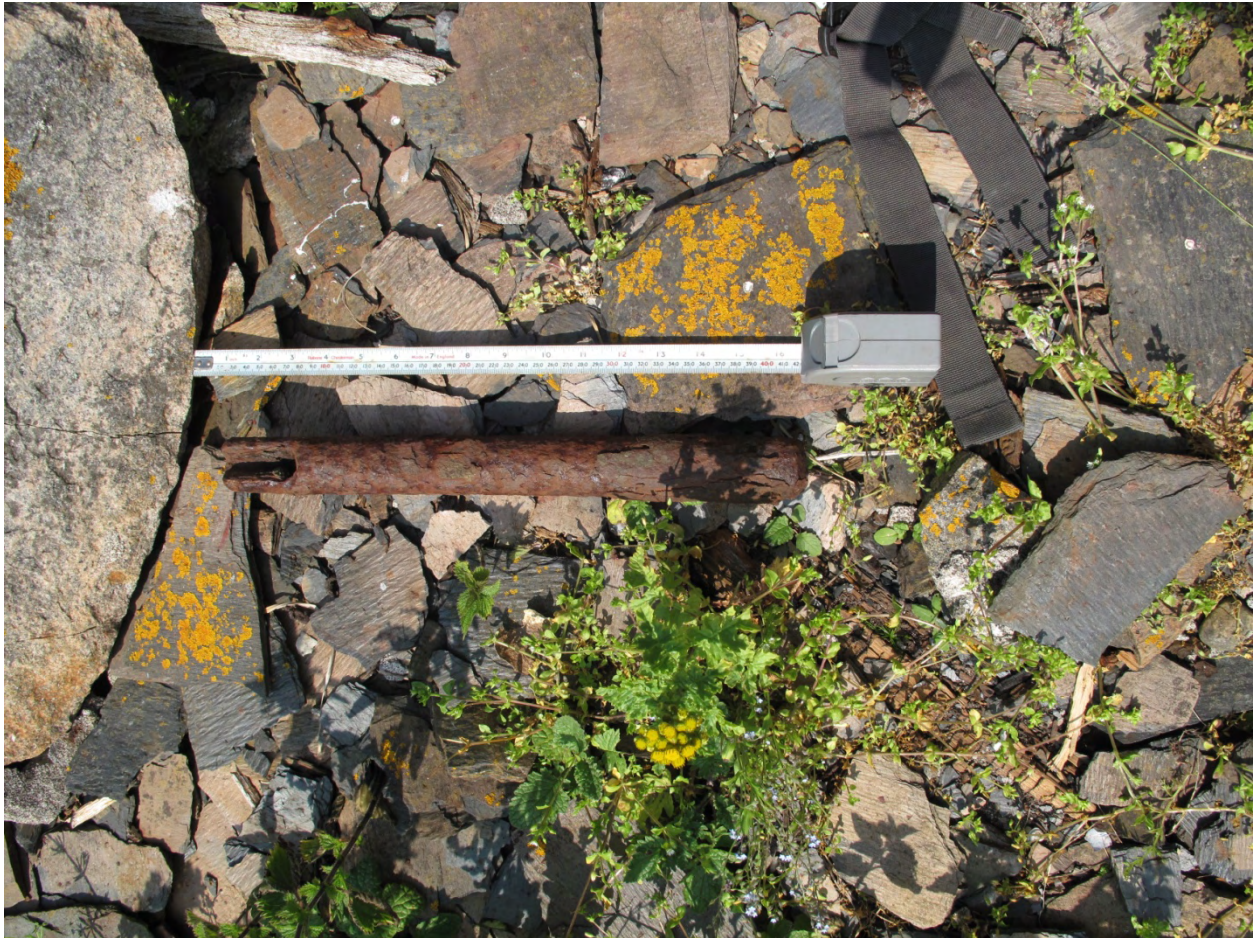
Figure 10 One of the sash weights from the original sash and case windows.

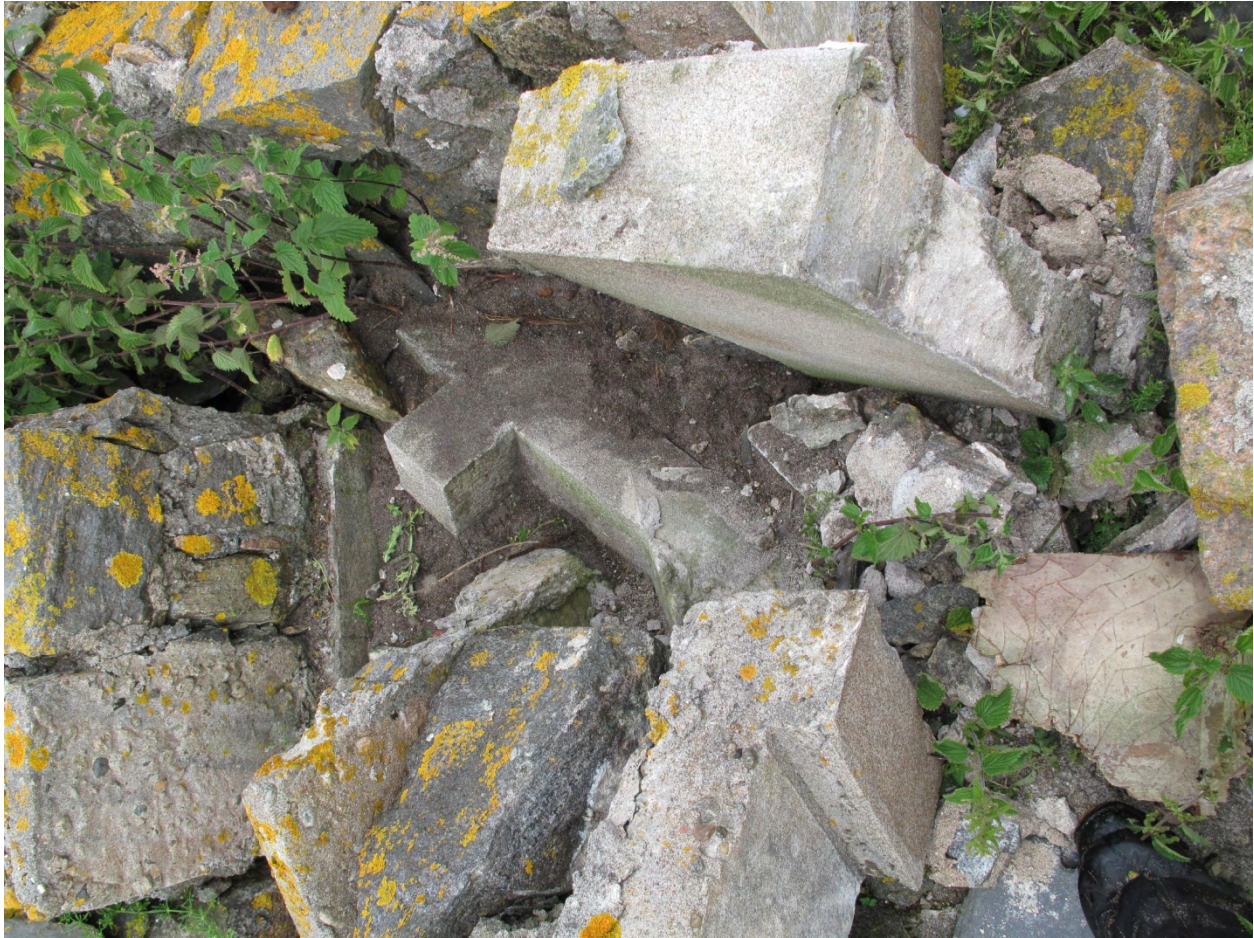
The concrete cross finial that topped the central dormer has fallen intact to lie in the ruins immediately SW of the main door opening. It was exposed for the purposes of drawing but left in situ. It is important that it is not damaged in any works to the building (Fig 11).

Figure 11 The concrete finial fell almost directly downwards from its original position, despite the fact that most of the front wall fell outwards. It was exposed for taking measurements, but left in situ.

There are no further recommendations with respect to the chapel house, but the original suggestion, that the cross should be retained and used for the focus of a small cairn is still proposed. The worked stones at the rear of the building should also be recorded properly, as it is perfectly possible that some of them have a religious rather than agricultural origin. This could be done by preparing drawings at a scale of 1:10 using basic equipment. John Borland at RCAHMS is able to offer advice on the potential ecclesiastical origins, as well as on recording techniques.

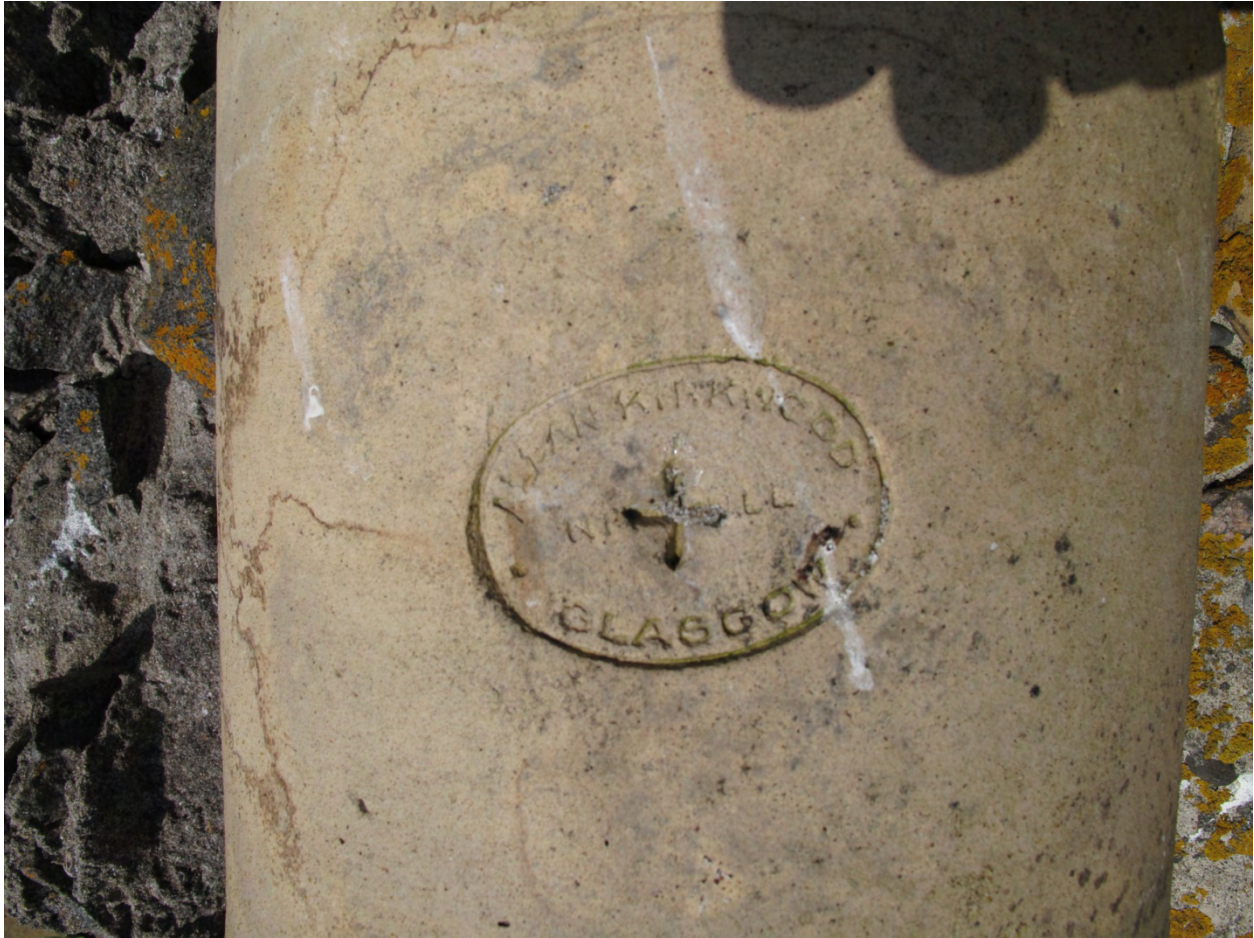
Figure 12 Detail of the stamp on a chimney can. 'Allan Kirkwood, Nitshill, Glasgow'.

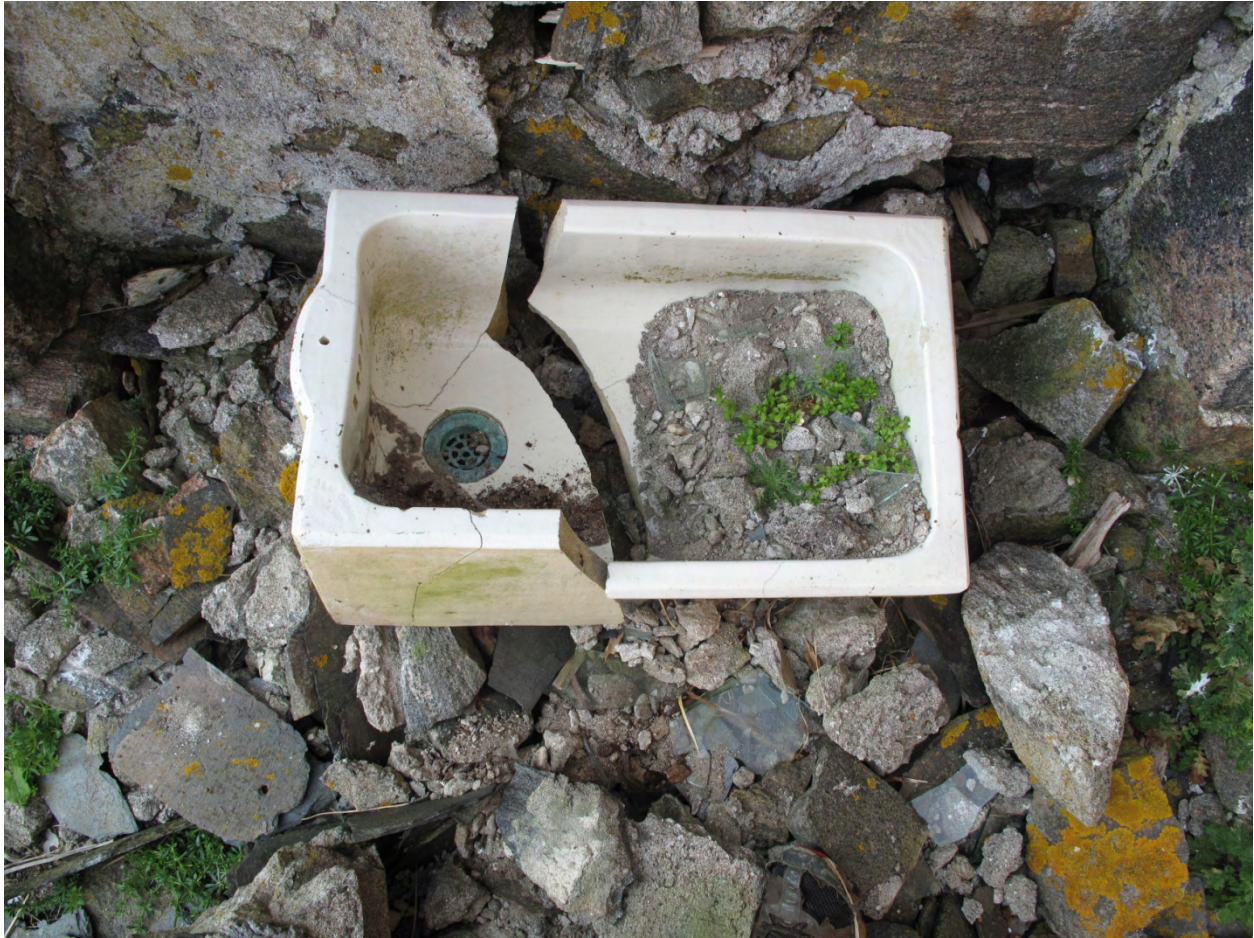
Figure 13 The Belfast kitchen sink, probably fallen at its original position by the window. The makers mark 'J & M Craig, Pearston, Kilmarnock' is cast into the bottom left corner.
