the National Trust
for Scotland
a place for everyone

St Kilda Archaeologist's Annual Report 2007

**Samantha Dennis
October 2007**

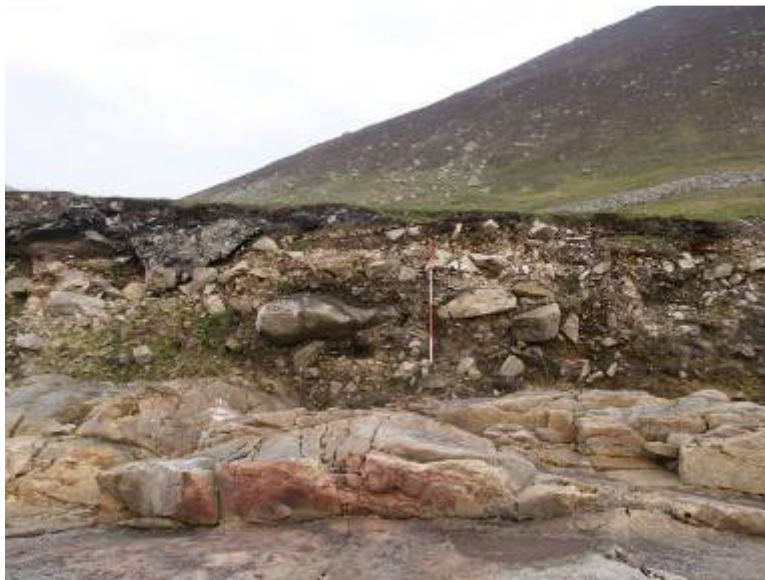
Section C in 2006

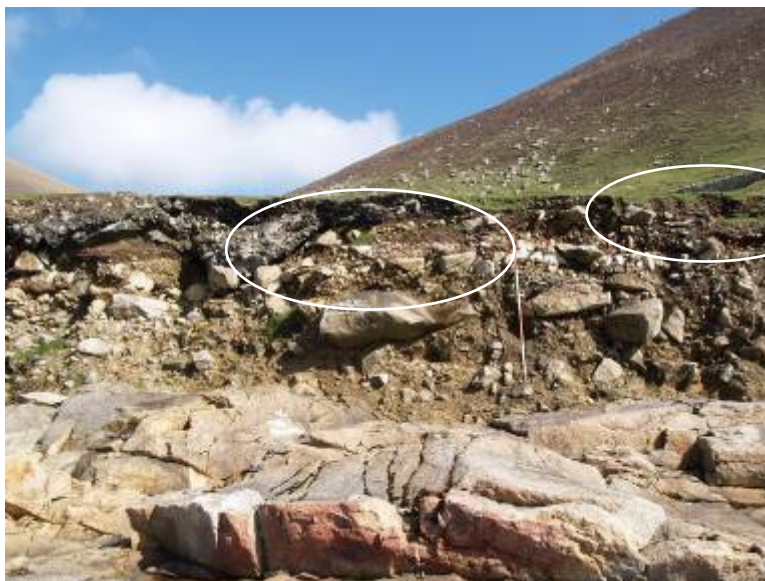
Same section in 2007 showing two areas of erosion caused by sheets of water running off the hills

2006). This is in marked contrast to the heavy erosion recorded after the severe storms in the winter of 2005/2006. The erosion recorded in Sections A, C and E resulted from land-based alluvial processes, in other words heavy rain running off the hills and cliff faces, rather than damage caused by stormy seas battering the coastline.

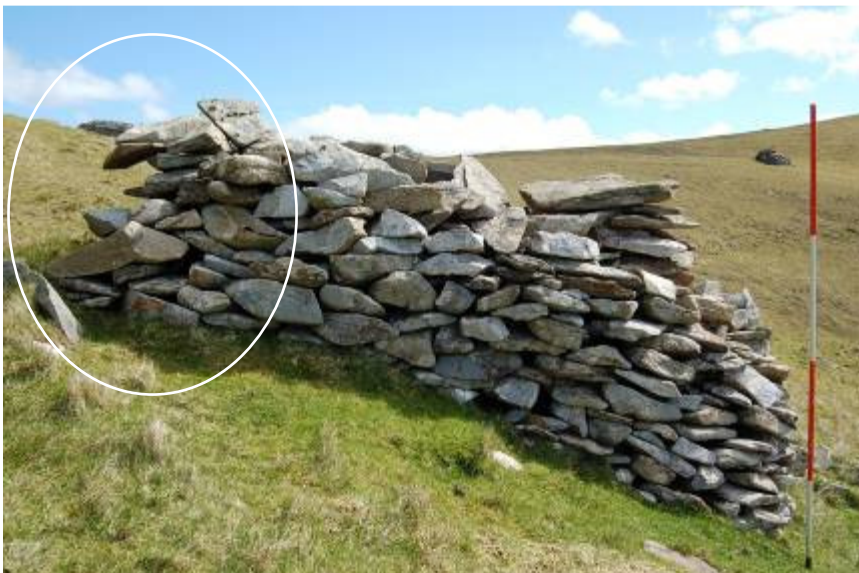
Major collapse to Cleit 486. Stones have fallen at the left-hand side of the photo.

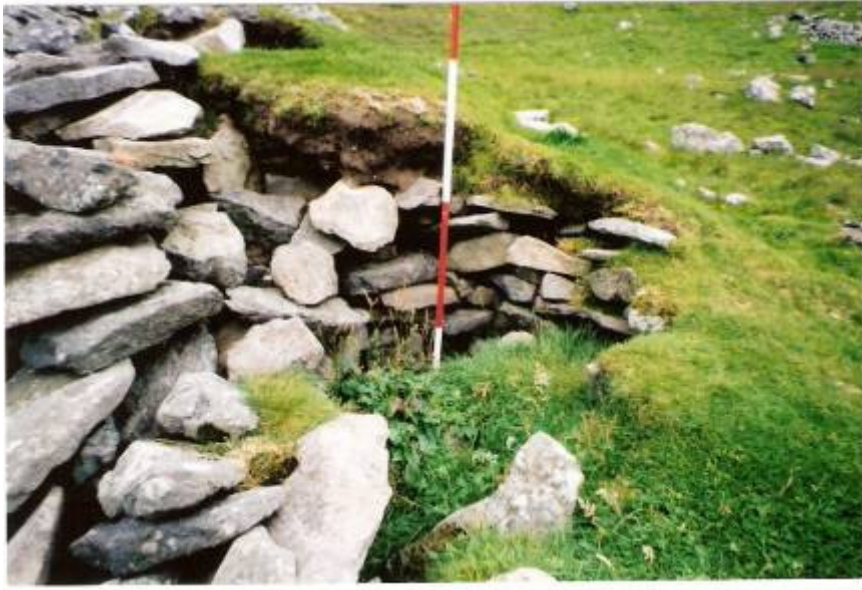
In 2002 the archaeologist noted that there were no major collapses, although a gradual process of deterioration was observed (Bain 2002).

Cell B3 of Structure F seen from the west in 2002

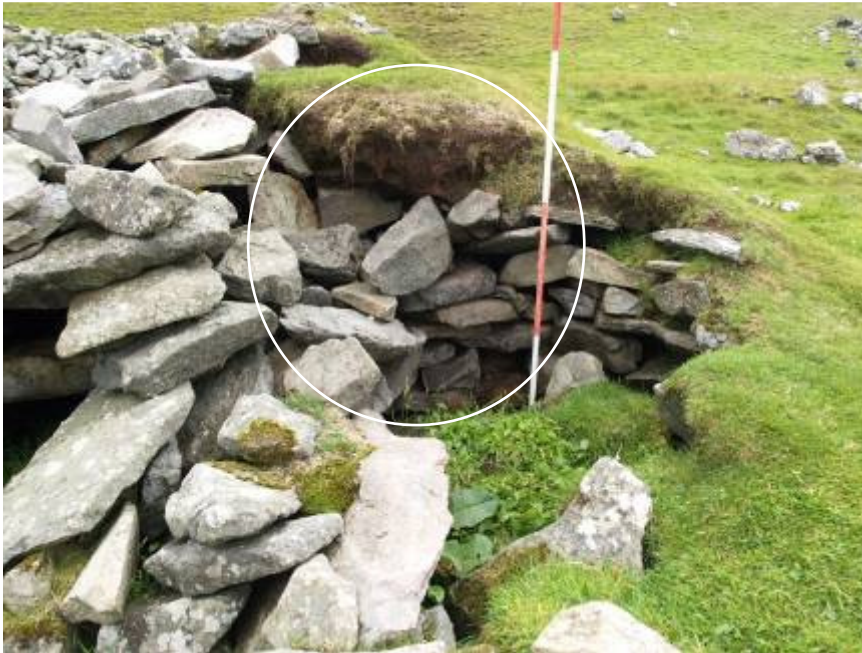
In 2007, the preliminary results of the survey indicate that, similar to observations in 2002, no major collapses have occurred in the past five years. Similarly, there are indications that gradual deterioration is still taking place. For example, the turf on the roof of cell B3 in Structure F (the Amazon's House, also known as Tigh na Banaghaisgeich) has continued to erode causing more stones to become exposed, which has led to more becoming destabilised and ultimately falling.

Cell B3 of Structure F seen from the west in 2007

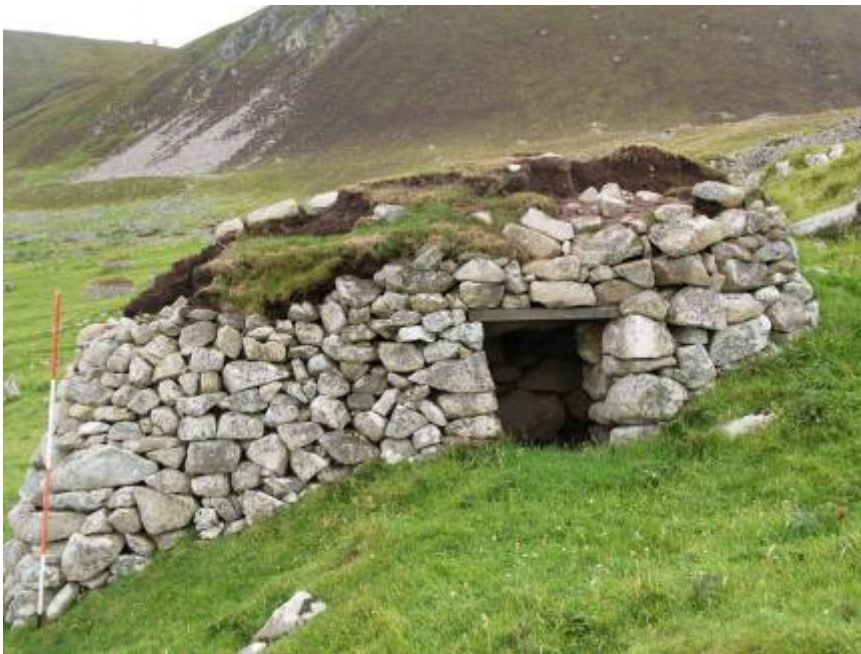
The observations made this summer indicate that the majority of repairs in 1997 and 2002 were unsuccessful. The turf was typically heavily eroded with no signs of regeneration which led to the exposure and loss of underlying layers of soil. My observations echo those made in 2001 (Johnstone 2001) suggesting that repairs failed for two reasons: a) excessive geojute suffocated the vegetation, and b) excessive sheep manure in the soil mix encouraged rapid, but short-lived, growth.

Heavy erosion of turf on cleit 15

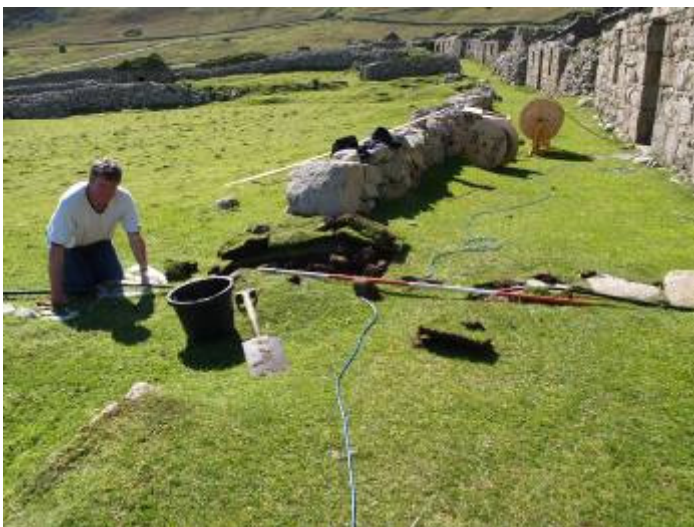
New electricity cables fed into House 6

Further work continued around House 6 in the summer of 2007 when contractors, Jackie Morrison & Co, fed electricity into the building, and installed lights and heaters.

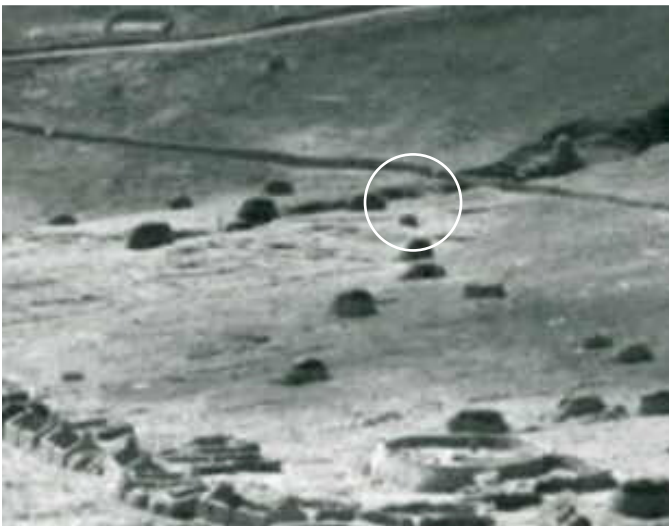
Archive photo (SKA 0496) showing cleit 105 in 1966

Archive photographs from the 1930s and 1960s rule out the possibility that the cleit is a modern construction (there are at least two known cases within the last 30 years of cleits being built by volunteers either from scratch or on earlier foundations). The authenticity of the cleit was first placed in doubt simply because of its irregular size, shape

Following discussions, I believe that Option 1 is the preferred course of action, as any unnecessary modifications and alterations to the cleits should always be avoided. Unnecessary intervention includes carrying out repair work without the knowledge of its original form, size and condition.
