## The St Kilda Archaeologist's Annual Report, May 2008 to January 2009

George Geddes  
26<sup>th</sup> January 2009

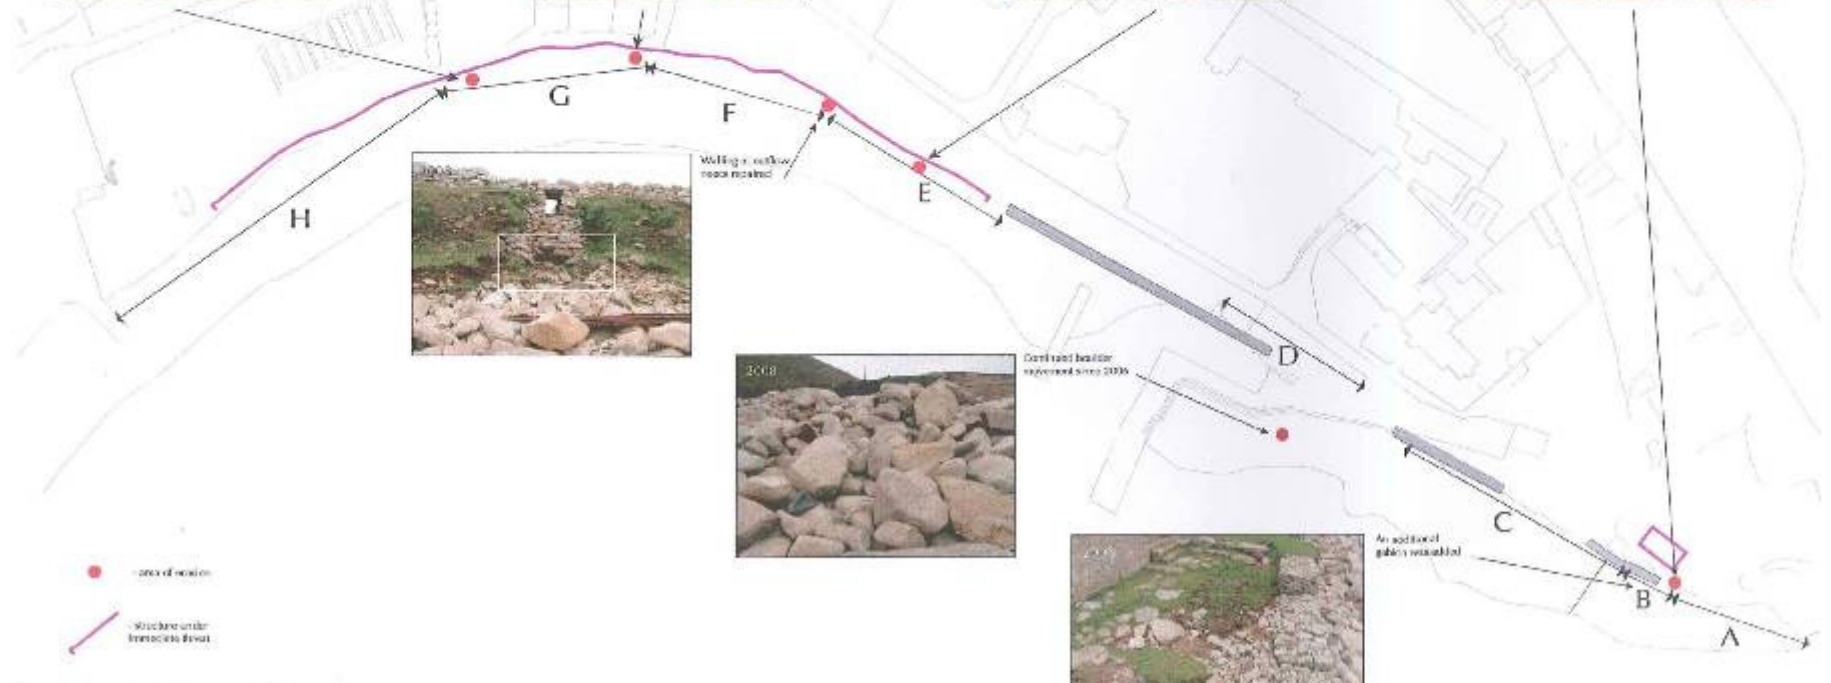
Illustration 7 - Coastal Erosion Survey

In Section A, there had been further erosion in the section immediately east of the Store gabions, where an area of pottery and burning is exposed. Recently dumped material in House 7 (silt and decomposed vegetation from clearing out the open water course nearby in 2007, as well as previously accumulated rubble and broken concrete) was added behind the gabions at the Store (Section B)<sup>2</sup>. An additional gabion was constructed this season (with Scheduled Monument Consent) as part of volunteer conservation works. As happens every year, the area of larger boulders immediately south and east of the slipway has undergone movement, partly due to storm damage and partly to MoD relocation of stone from the pier/slip. As recognised in previous reports (e.g. Dennis 2006b), the outlet for the *Abhainn Illishgill* is in severe need of repair; a

lack of timely repair will result in a major collapse of historic fabric which would make it considerably more difficult to reconstruct in the future. There are also smaller areas of collapse in Section G and H, but neither are indicative of major change.

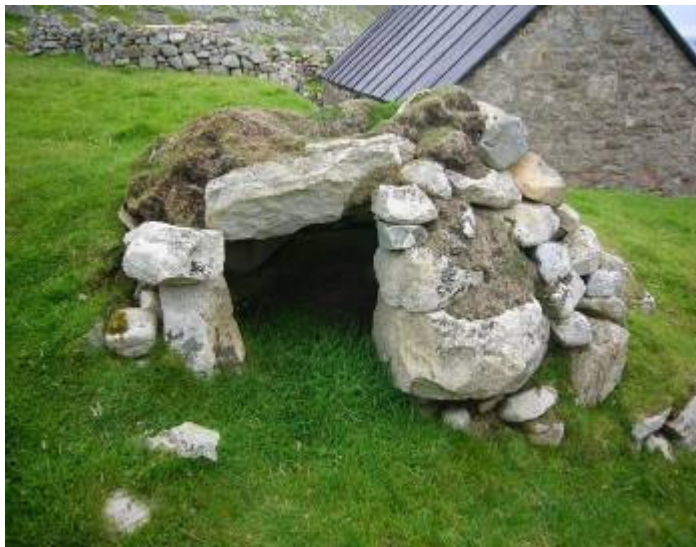
Figure 12 Cleit 26, with collapsed roof above compared with 1996

Major collapses were noted in three cleits: 26 (Figure 12), 27 and 63.

Major repairs are required at cleits 26, 27 and 63. Further work needs to be done to cleit 92.

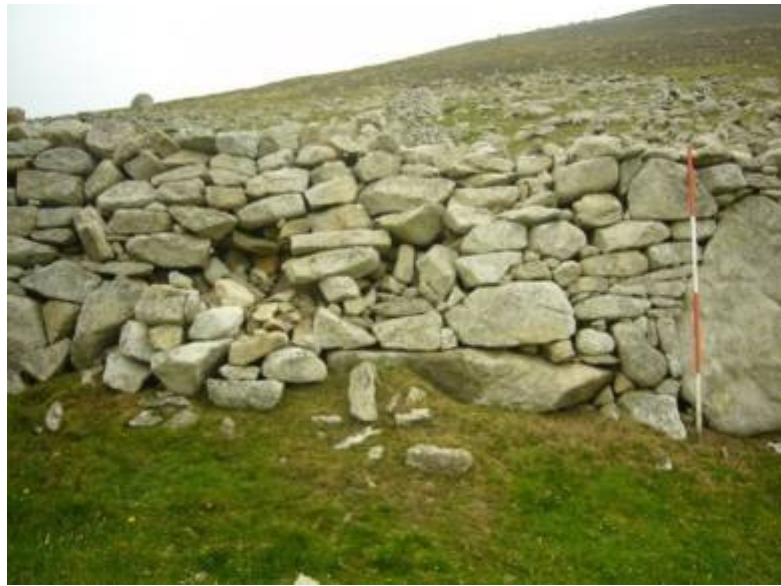
Figure 13 – Enclosure 4 collapse

- The rear wall of the campsite (Enclosure 4) (Figure 13)
- The enclosure wall immediately below Cleit 3
- The *Abhainn Illishgill* exit through the sea dyke (noted previously)

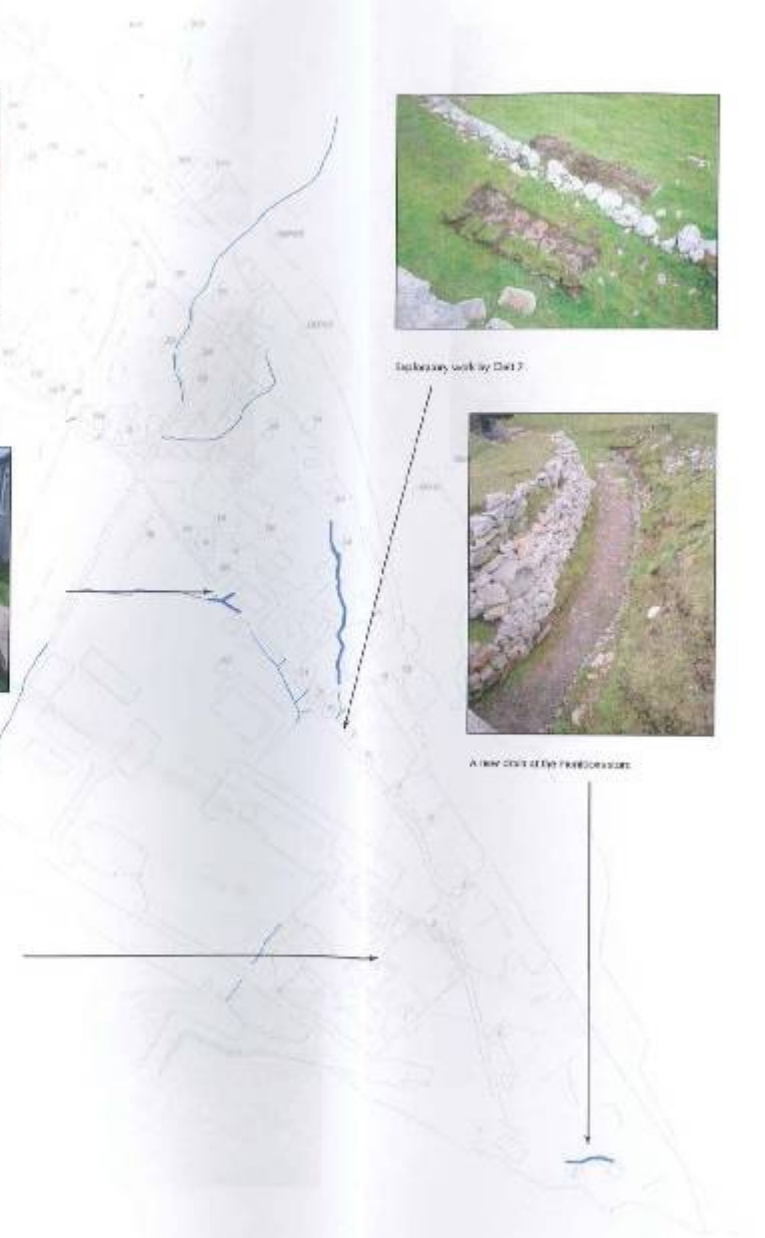
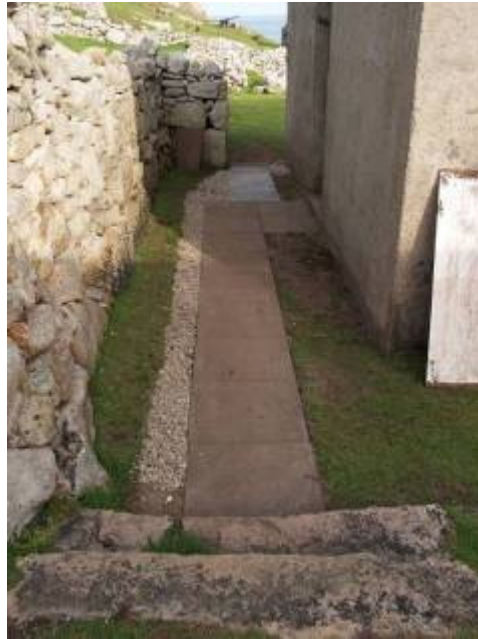
Figure 14 – Church drainage

The Church suffers from dampness and it is hoped that this will be alleviated by the insertion of a French drain along the north-east (rear) gable. A dehumidifier was installed and ran all summer using power from the Manse. This produced around 2 litres of water every 48 hours and its use made the building and its contents noticeably dryer.

The French drain was dug from the steps immediately to the north corner of the church and along the gable to the centre of the enclosed area to the east. The slot was dug to a spade width and approximately 350-400mm deep and checked for a run with a dumpy level. The slot was lined at the base with builder's sand and the main fill of the drain was composed of loose pebbles collected from near the Store, combined with sieved stone from the excavated material. The uppermost layer is composed of gravel to prevent a trip hazard. The water drains away to the east. Paving stones donated by Amey were used to complete and repair the paving along the Church gable.
