St Kilda Archaeologist's Annual Report, February 2009 to January 2010

Glynn Barratt
January 2010

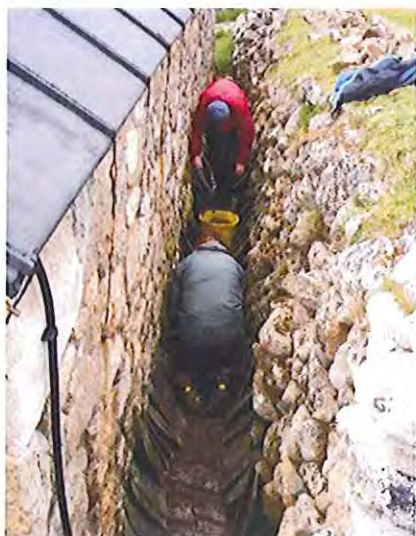
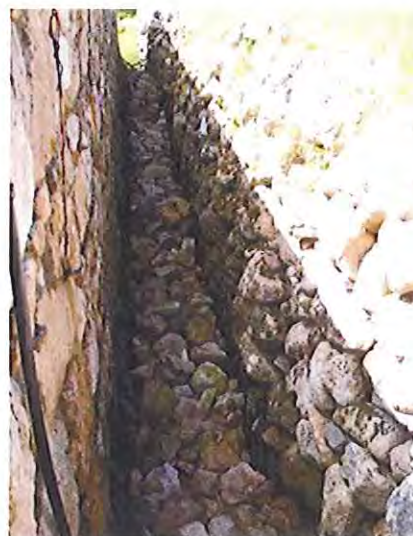
Clearing out the soak-away along the rear of House 6 and the completed task

The maintenance of the surface drainage in and around the village continued. The drainage around Houses 1-6 was checked and cleared as necessary, while the soak-aways along the backs of Houses 4-6 were emptied, cleared of silt and refilled. The open watercourses below the head dyke in the area east of the Dry Burn as far east as Blackhouse Z, as well as the course that runs southwards from Tobar Childa as far as the tarmac road, were re-cut.

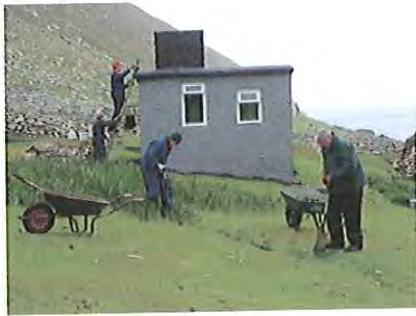
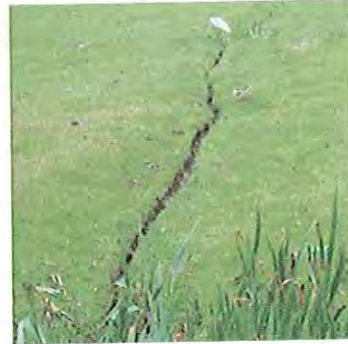
Clearing out the open watercourse from below the Factor's House and across the grazing

Clearing the open drains and watercourses within the head dyke is an annual task, although not all are done every year; perhaps they should be. When there are torrential downpours none of the watercourses are able to cope with the flow, and presumably have never been able to do so. But it may be that the narrowness of the cut currently made to clear the vegetation is too tight to make more than a few months difference; perhaps it could be wider. The blockage or collapse of the culvert from the vicinity of the 'camping field' continues to cause waterlogging of the street below after prolonged rain. The solution to this problem will be a huge task with major health and safety issues as well as considerable archaeological implications.

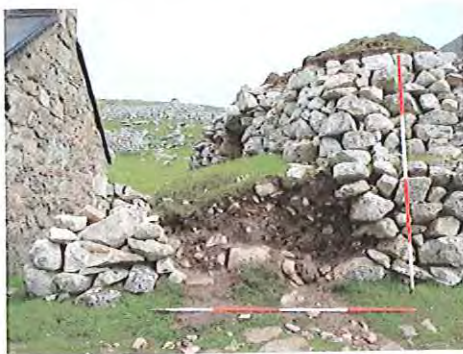
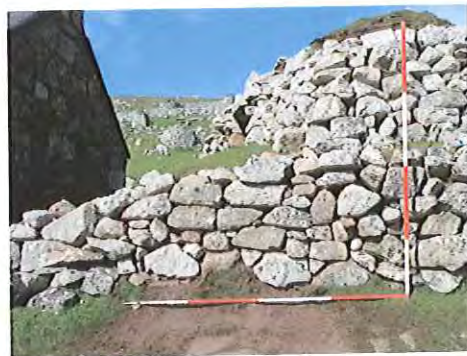
A section of revetment wall between cleit 28 / house 2 and the south end wall of cleit 17, had both collapsed over the street and these had to be repaired on health and safety grounds – further collapses could occur at any time, posing a serious threat to visitors and staff walking along the main village thoroughfare. The repair to cleit 17 was successfully completed using the available record photography. There was no available complete 'before' record photography for the revetment, however part of the wall was visible in the record photography for cleit 28 (side D) which was used as the reference. A good match was achieved, with emphasis placed on achieving a stable and secure repair, in response to its sensitive position.

Repairing the revetment wall by the streets between House 2 and cleit 28

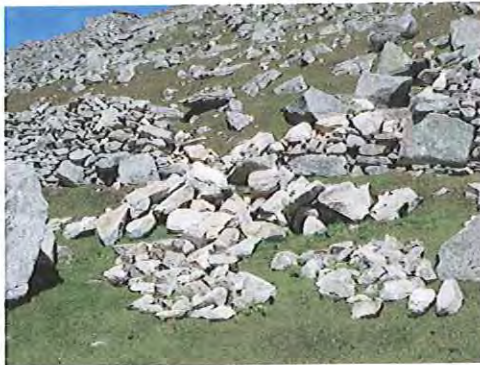
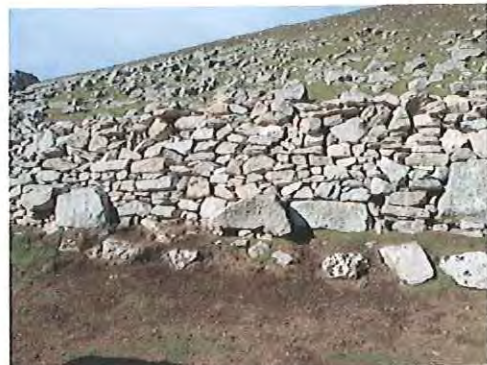
The most substantial length of collapse, some 4m long, was that adjacent to the MacKenzie Slabs and comprised a considerable number of very substantial boulders. Record photography showed that the large boulders were used as through-stones, so that only their smaller end profiles were visible, making identification difficult. The size of the stones also put in question whether the repair could be accomplished by the group in the available time and without lifting equipment. However there was an enthusiasm to attempt it and so work commenced under the direction of WP member John Eden Parkin and supervision of SKA.

Repairing the Head Dyke behind the MacKenzie Slabs, before and after

A digital composite image was made from the separate images of the dyke sides prior to its collapse. Copies of this image were supplied to the team and used to identify as much as was possible of the original fabric. The weather conditions in this period were not ideal and it is a tribute to the enthusiasm and dedication of the team that the repair was completed.

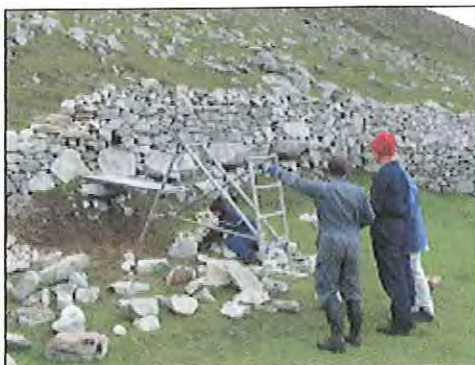
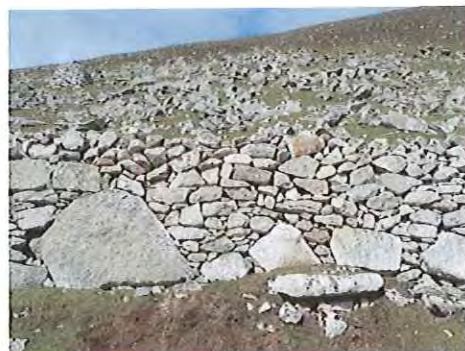
The repair work to the Head Dyke near cleits 4 and 5, during and after

The western-most Head Dyke repair was filmed as an example of good practice for any future work parties. The 2m length of the Head Dyke required considerable effort by the volunteers both to identify the stones and to move and lift stones of a considerable size. The appreciable slope on the downside of this dyke necessitated the use of scaffolding. SKA worked with the team on this repair assisting in the identification of stones, facilitated as per NTS practice by reference to record photography, and lifting them into place. Care was taken to ensure that the lichen faces of stones faced outwards.

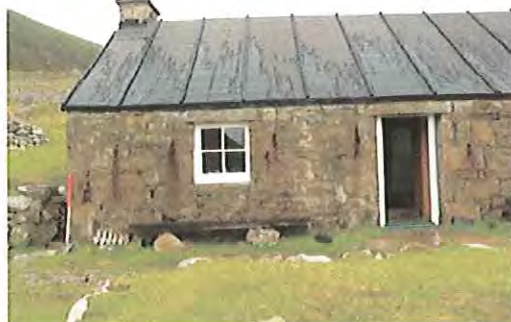
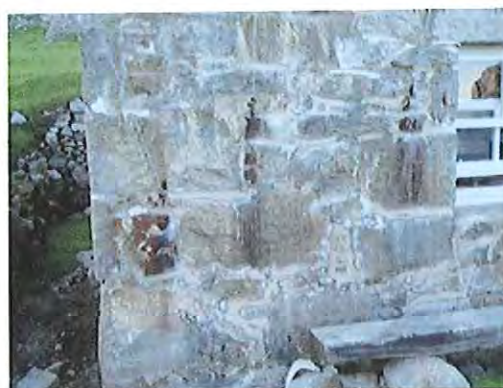
The rear elevation of House 5 was re-pointed by a team under the supervision of WP member David Hewer, who had expertise in lime mortar work. Removal of loose mortar across the whole elevation revealed various large voids in the wall interior. In retrospect the procedure adopted was too thorough and over-invasive. Subsequent monitoring of the lime mortar showed it to be slow in 'going off'. Unfortunately the front far-left elevation of House 1 was similarly pointed.

House 1 before and after pointing work

A separate desk-based assessment of this pointing will be undertaken to inform the decision making-process for future work. Perhaps the way forward is to ensure that lime-pointing is led by a full-time professional mason with contractual obligations to adhere to the agreed methodology.

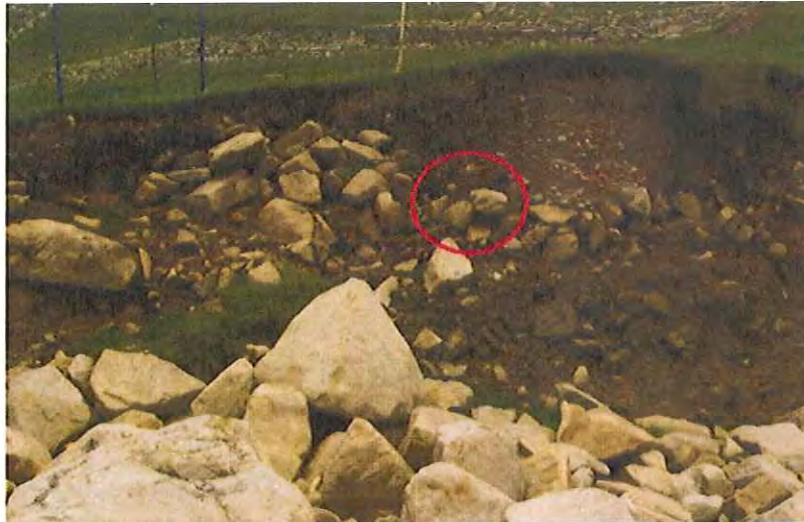
Small stones have been dislodged from the coastal face east of the Store, as recorded in SKA08-25-066 / SKA09-A-015.

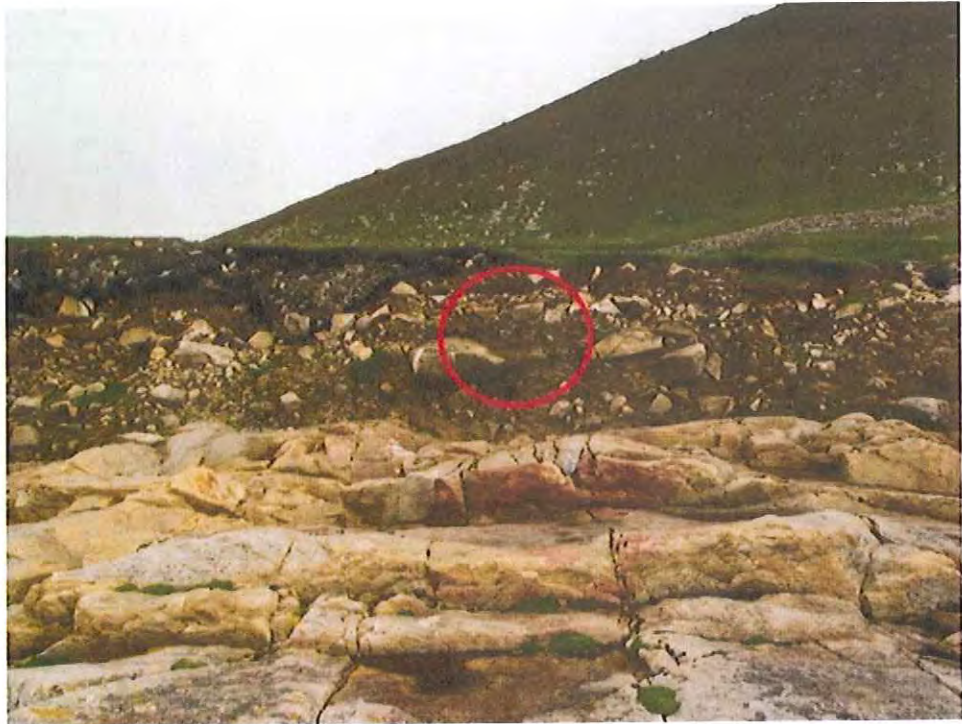
This short length of coastline shows a number of small-scale erosion changes with quite restricted areas of collapse recorded in SKA08-25-036 / SKA09-C-003, SKA08-25-088 / SKA09-C-004, SKA08-25-037 / SKA09-C-006, SKA08-25-090 / SKA09-C-007 and SKA08-25-038 / SKA09-C-008.

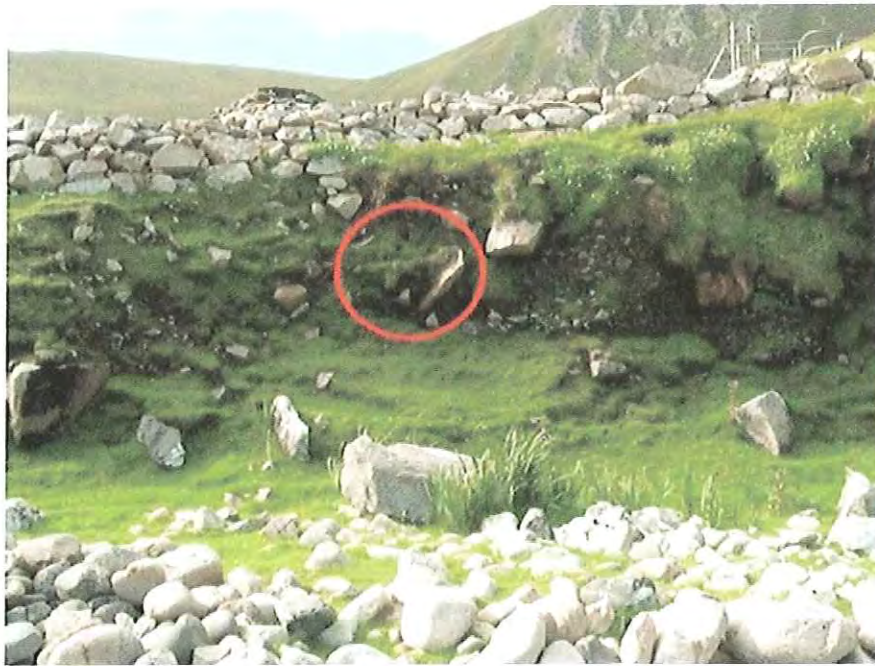
This long monitoring section shows a small area of turf slippage shown in SKA08-25-150 / SKA09-H-001.

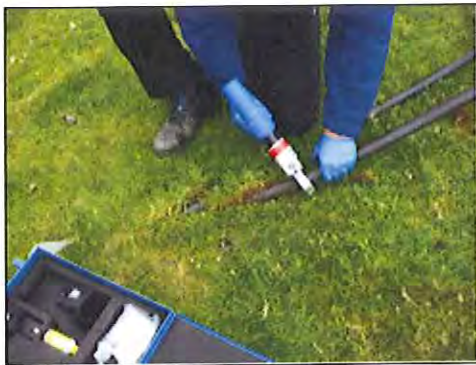
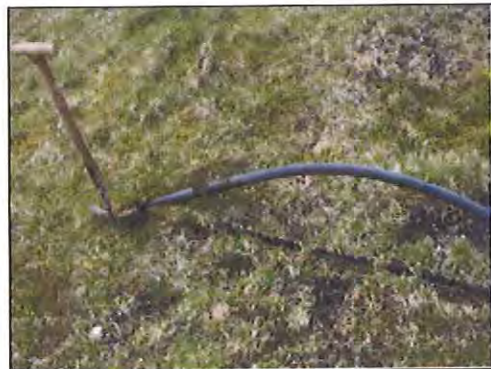
Amey worked on the removal of two redundant power cables running between the MoD base and the two hilltop radar installations, a length of some 2km. SMC was in place with a minimum disturbance methodology. The cables had been laid directly onto the ground surface for most of their length and only buried where they crossed beneath the road. Turf had grown over the cables burying them to a depth of c10cm.

Cutting the visible cable within the Head Dyke, and revealing the cable up towards the hill-top radars

Where possible the cables were cut into short 5m lengths and pulled through from the exposed end, thus not breaking the surface. Where this was not possible the turf or peat was cut as a single line along the cable route, the cable lifted out and the turf tamped back along the cut, with no significant surface disruption. Where the cable crossed the road some limited excavation was necessary, though this was in disturbed ground with no archaeological implications.

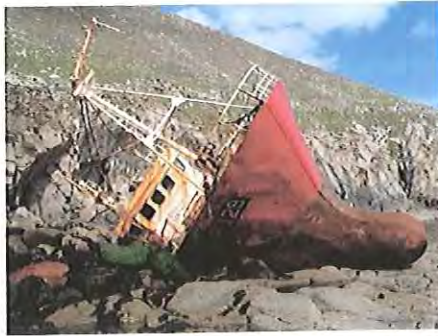
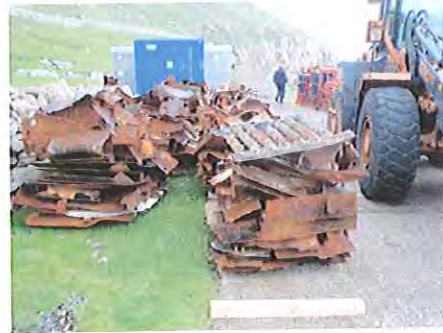
The trawler 'Spinningdale' was wrecked on the N side of Village Bay in January 2007. It was broken up by a Spanish salvage crew during the summer and removed. The boat was cut up into small pieces in situ. It was then winched or man-handled along the shore, and lifted by small crane onto the low cliff top in front of the Manse. The material was then moved and stacked near to the beach ramp for loading onto the landing craft for removal. The SKA maintained a watching brief and photographic monitoring regime through the salvage programme.

The 'Spinningdale' before and after its salvage

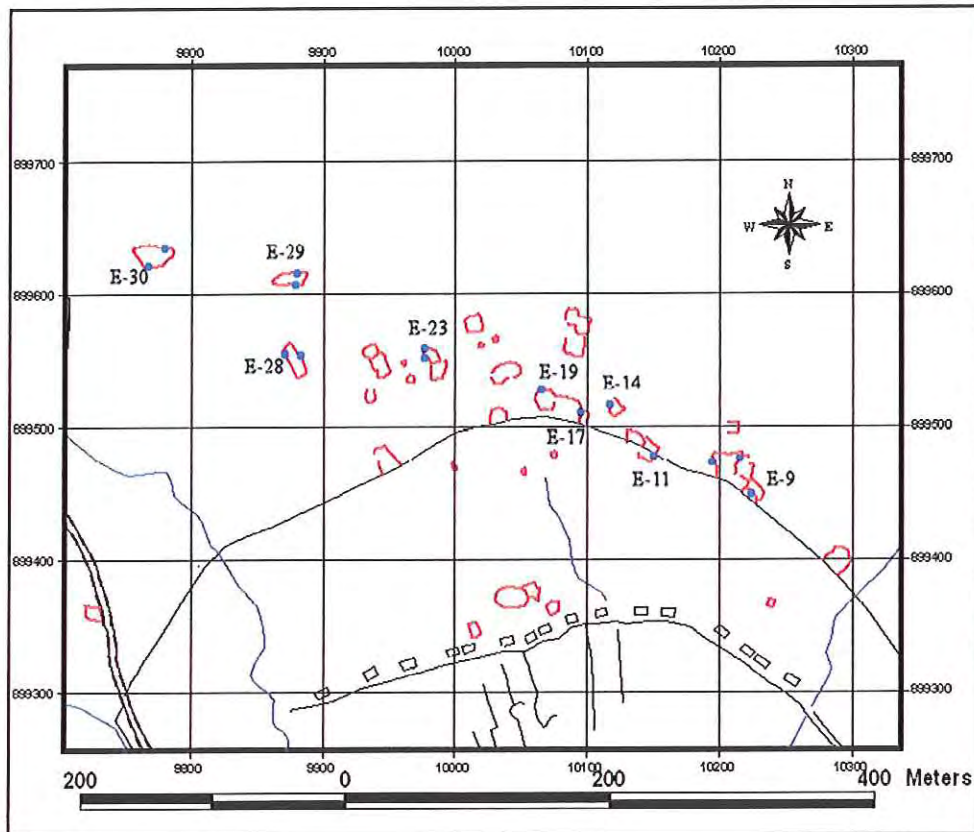
It should be noted that there are areas of substantial dyke collapse at E9, E19, E23, E28, E29, and E30. In addition there are 8 areas of lesser collapse occurring in E9a, E9d, E11, E14, E17, E28 and E29. The areas of collapse appear to have been triggered at or near the dyke tops – the most likely candidate for initiating the falls being sheep accessing and leaving the enclosures. Most of the collapses are within the accepted maintenance zone of intervention. These repairs will be included in the 2010 work programme.
