## The St Kilda Archaeologist's Annual Report, April 2012 to January 2013

Andrew Walsh, February 2013

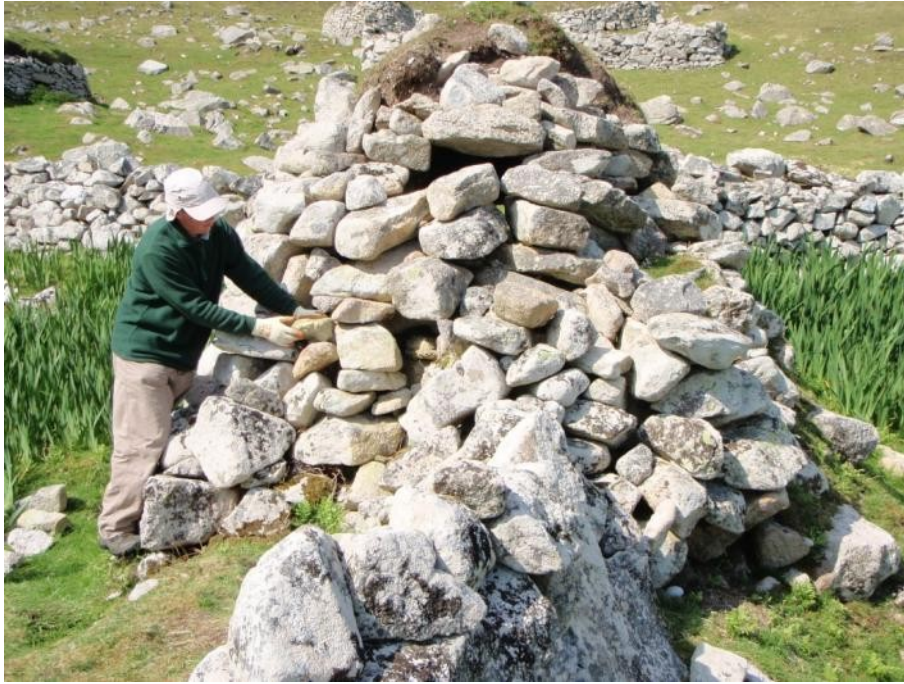
*Figure 1. Repairing a cleit wall*

The majority of the archaeologically sensitive works carried out by the work parties were drystone dyke repairs, cleit wall repairs (Figure 1), and clearing open water courses (Figure 2).

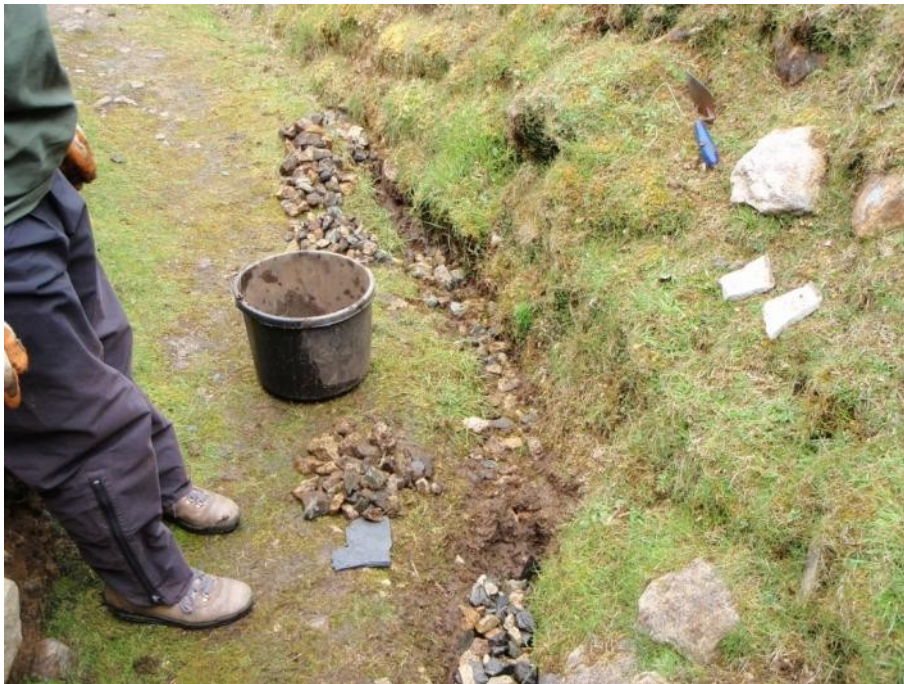
*Figure 2. Clearing out the drain by the Munitions Store*

Removed vegetation and blockages from all open watercourses  
Cleared and replaced gravel in drainage channel next to path to/from the Munitions Store  
Cleared and re-cut drain south of Blackhouse T  
Cleared and re-cut drain south of Blackhouse R

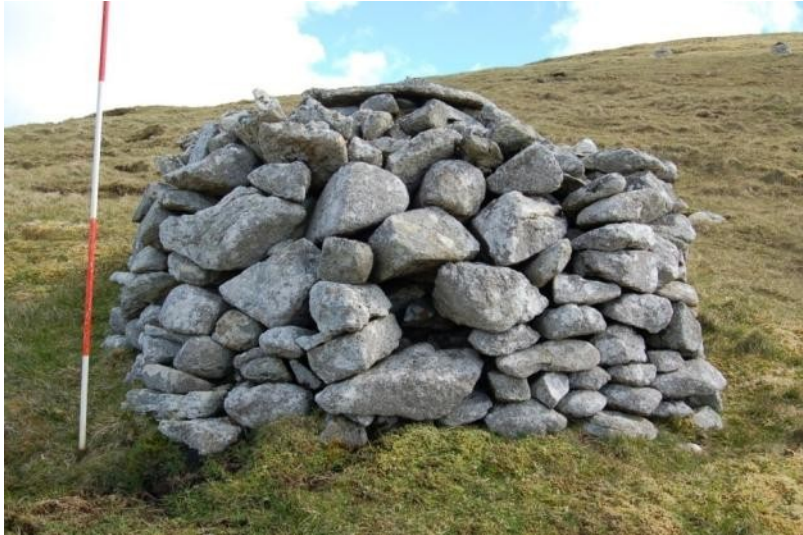
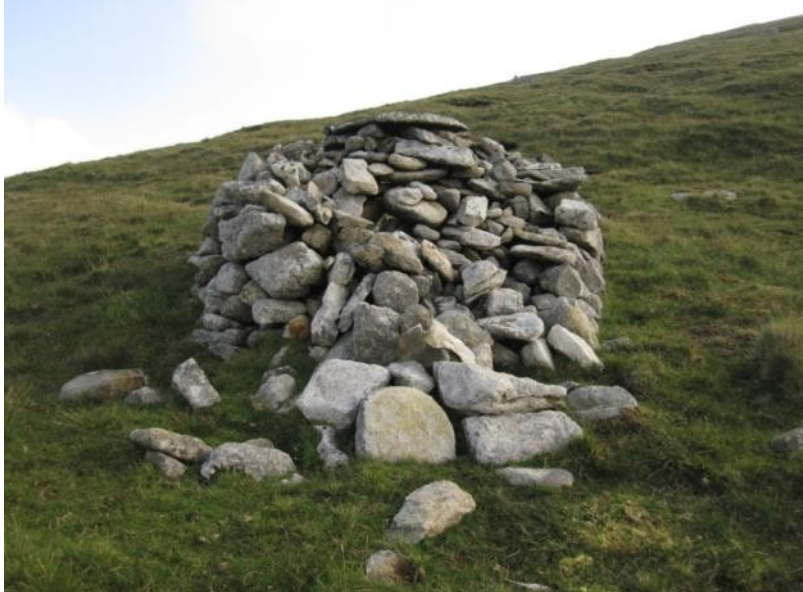
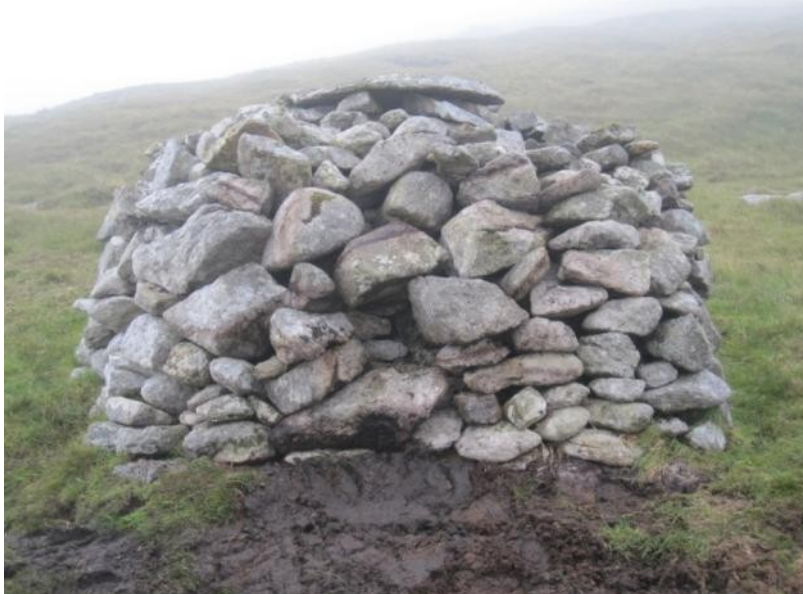
Figure 3. Cleit 686 before (top) and after it collapsed (middle), and after it was repaired by Innes Watson (bottom)

<b>Site name</b>	Cleit 686		
<b>Location</b>	Mullach Mor		
<b>Date work carried out</b>	25 July 2012		
<b>Craftsman</b>	Innes Watson		
<b>Description of defect</b>	90% collapse of external skin of cleit 686 at face C		
<b>Repair methodology</b>	NTS/HS Management Agreement 2007-2012 Appendix 9 – Drystone wall repairs		
<b>Description of work done</b>	<ul style="list-style-type: none"> <li>• Cleared out collapse identifying key stones as work progressed</li> <li>• Rebuilt full height of external skin from foundation to lintel</li> <li>• <u>Rebuilt to a state of collapse</u> as per archive photograph ref. <i>(to be added)</i></li> <li>• <u>Large hole in rebuilt structure. Integrity suspect</u></li> <li>• Could not identify top smaller stone from pictures provided</li> <li>• Used best guess and St Kilda build style to finish off</li> <li>• Record photographs taken of 8 aspects</li> </ul>		
<b>Materials</b>	Original stone

<b>Repairs still to be done</b>	None		
<b>Comment</b>	Recommend inspection in 12 months time to check condition around large hole in rebuilt structure.		
<b>Date of report</b>	23 Sept 2012		
<b>Author</b>	Innes Watson

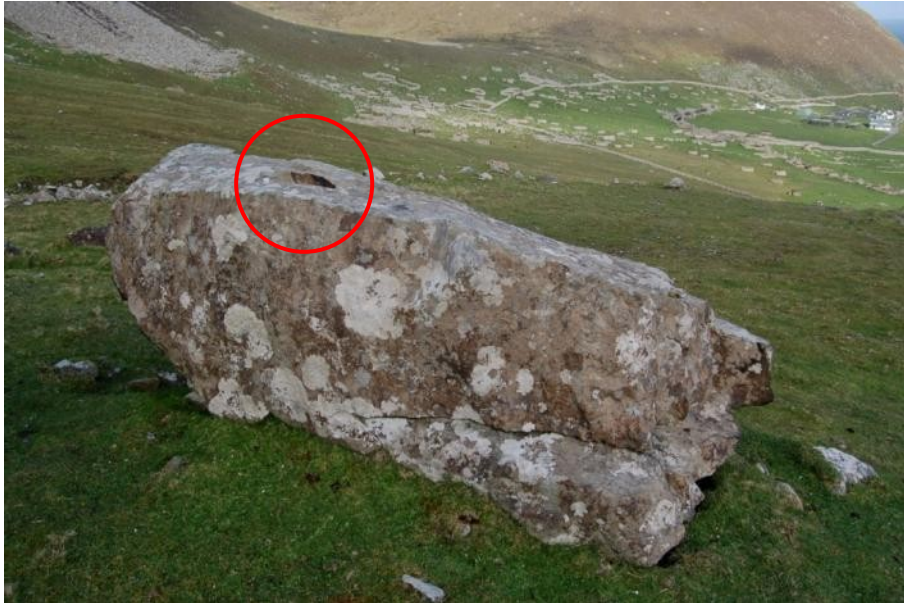
Sylwia Mosko (Graciela Ainsworth Sculpture Conservation) carried out repair and conservation works to the Milking Stone (Clach a' Bhainne; Figure 4). It had been damaged in 2011 by geologists from the University of St Andrews, who were using fieldwork methods contrary to their professional code of practice. A few small stone fragments had been mislaid between taking the samples and returning them to the NTS, but the main pieces of broken stone were successfully re-attached and blended into the surrounding rock (Figure 5). See Appendix 3 for the report on the works.

Figure 4. The Milking Stone (Clach a' Bhainne) with the main area of damage highlighted

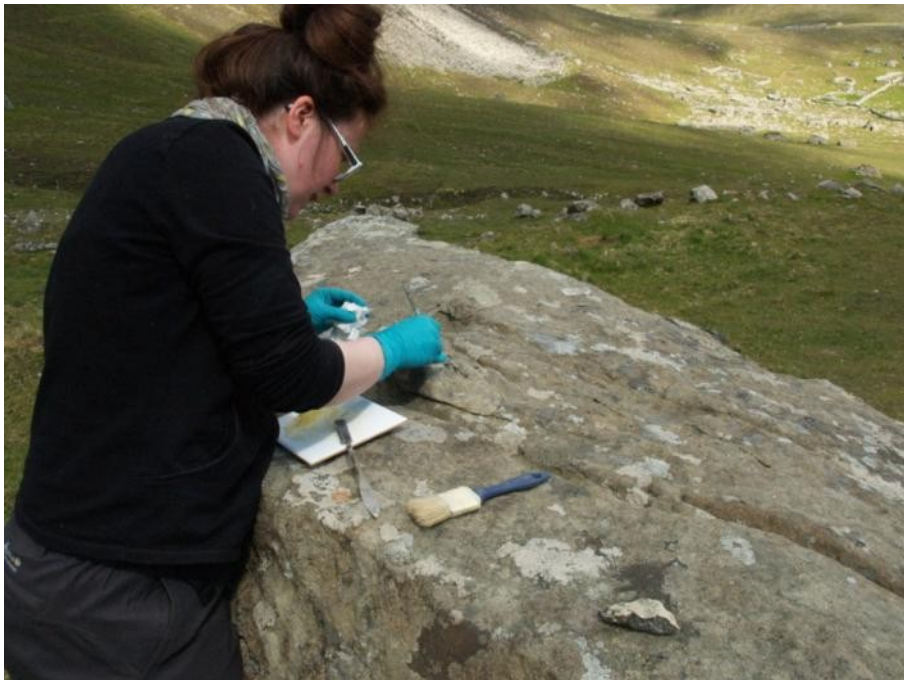
Figure 5. Sylwia Mosko repairing the damaged area

Conserved damaged area of the Milking Stone (Clach a' Bhainne)

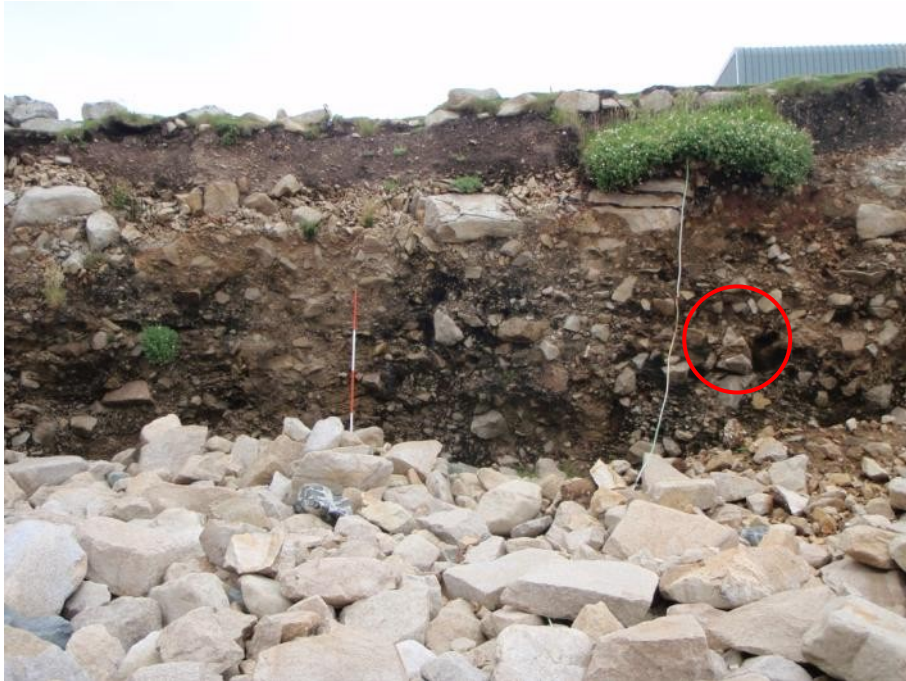
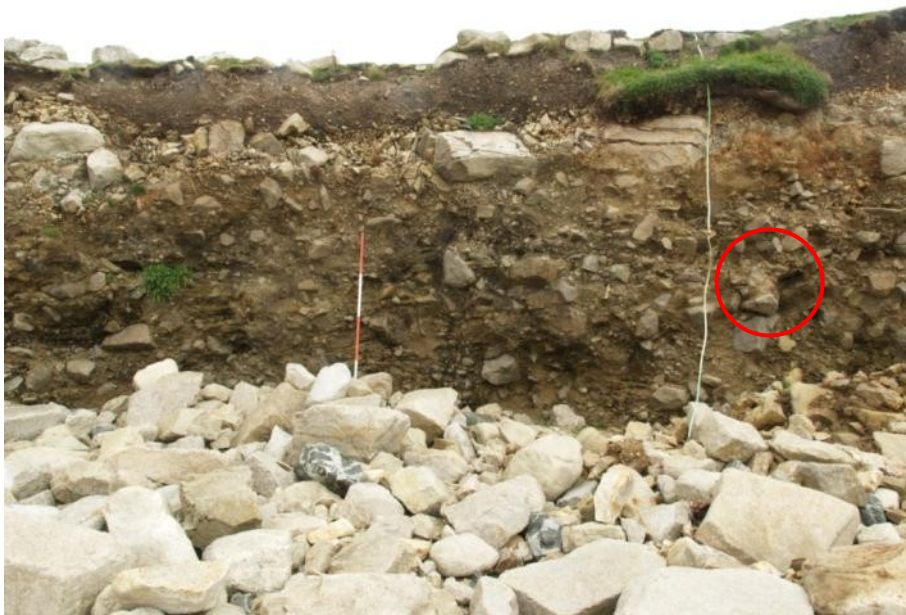
Two areas of change were noted in this section. A small stone and area of surrounding soil has fallen from the soft cliff edge south of the electricity generating station (Figure 7).

*Figure 7. Relatively minor change in Section E involving the loss of a small stone and surrounding soil between 2011 (top) and 2012 (bottom)*

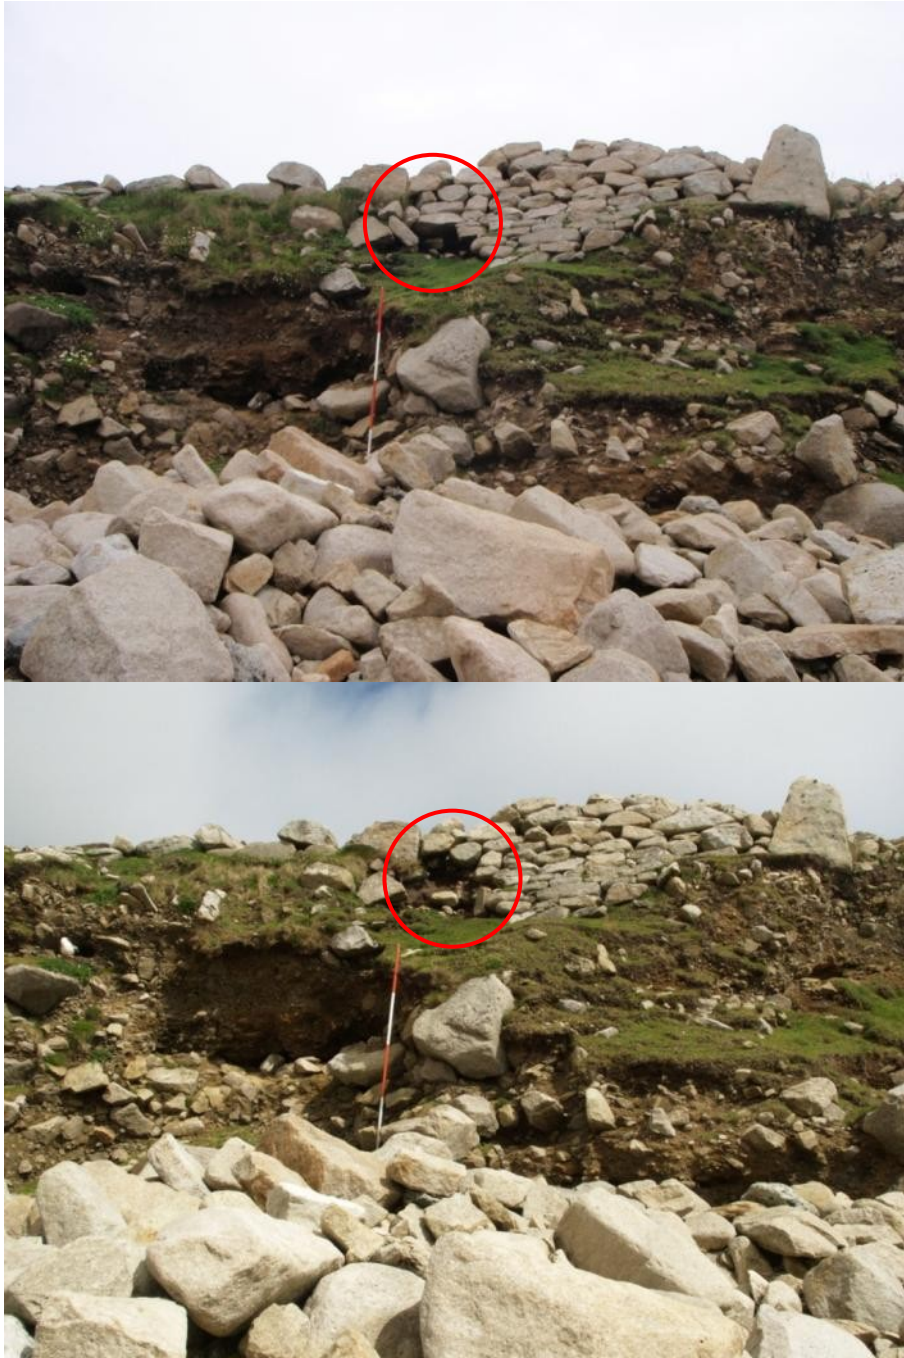
Further west a more significant change has occurred. Stonework from at least three courses near the base of the Sea Dyke has been lost (Figure 8). This is a cause for concern as erosion from wind, rain and sea could undermine this part of the dyke and cause significant further collapse.

Figure 8. Part of the Sea Dyke in Section E has been lost between 2011 (top) and 2012 (bottom)

In general few significant changes to the coastal edge were noted and most of those were the relatively minor loss of individual stones, indicating that the winter of 2011-12 was a comparatively calm one. However in two areas (E and H) losses to the lower course(s) of the Sea Dyke were noted. Given that the winter had apparently been quiet and the rest of the survey yielded little change this is of significant concern and could indicate that sections of the dyke are in imminent danger of being lost. Due to this, emergency repairs were carried out on the fall in Section E by Innes Watson in order to stabilise the structure (see Appendix 2).

<b>Site name</b>	Coastal Dyke		
<b>Location</b>	Opposite side of road from generator		
<b>Date work carried out</b>	29 July 2012		
<b>Craftsman</b>	Innes Watson assisted by SKA Andy		
<b>Description of defect</b>	Small collapse of coastal dyke 1m high x 0.7m wide.		
<b>Repair methodology</b>	NTS/HS Management Agreement 2007-2012 Appendix 9 – Drystone wall repairs		
<b>Description of work done</b>	<ul style="list-style-type: none"> <li>• Removed larger stone from above collapsed area taking note of its position and orientation.</li> <li>• Rebuilt full height of dyke from foundation</li> <li>• Used best guess and St Kilda build style to complete build</li> <li>• Record photographs taken</li> </ul>		
<b>Materials</b>	Original stone and additional lichen faced stone sourced from suitable location 100m along coast advised by SKA		
<b>Photographic record</b>	Archive:	Defect:	After repair:
<i>Digital photographs appended</i>	<i>(to be added)</i>

<b>Repairs still to be done</b>	None		
<b>Comment</b>	Original key stones from collapse smashed on rocks below Built using St Kilda build style – not in keeping with surrounding stone work on reflection maybe not correct method		
<b>Date of report</b>	23 Sept 2012		
<b>Author</b>	Innes Watson

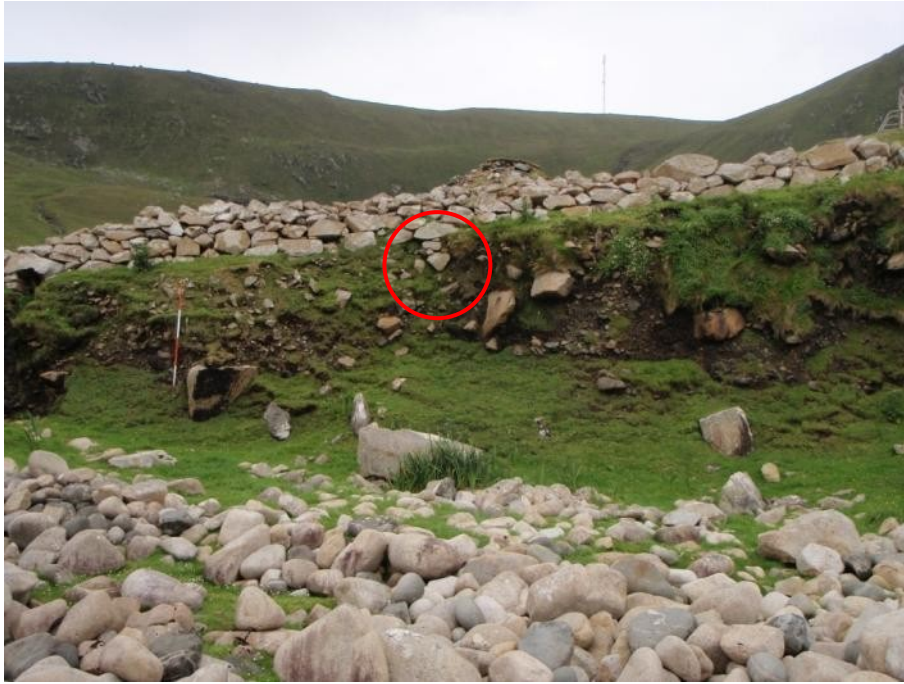
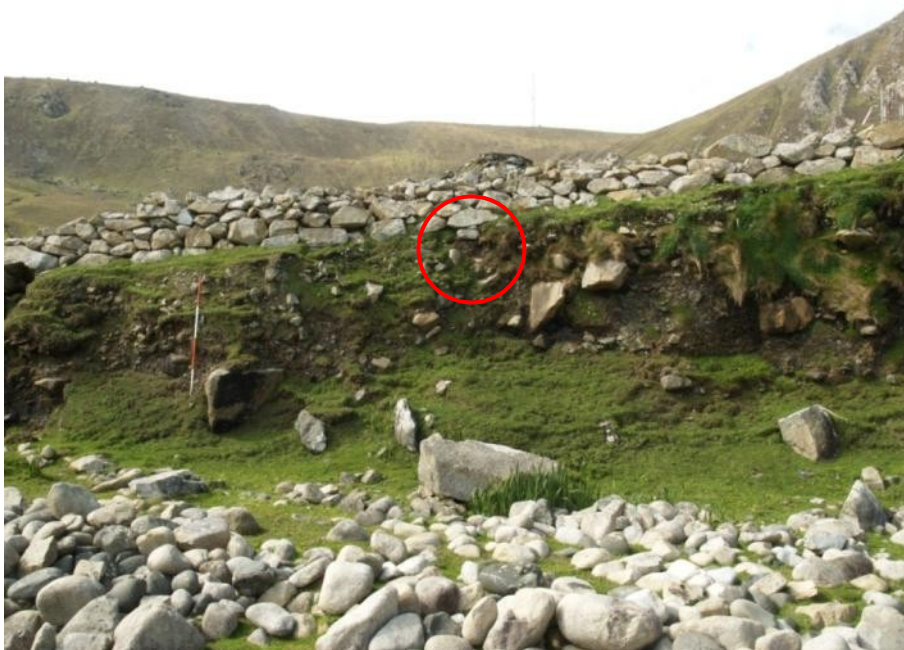
Two areas of change were noted in Section H. A stone near the base of the Sea Dyke below Cleit 93 has been lost (Figure 9). Further west a piece of soil and turf has been dislodged and is visible at the base of the cliff (Figure 10)

*Figure 9. A stone near the base of the Sea Dyke in Section H has been lost between 2011 (top) and 2012 (bottom)*

The fall of a single stone near the base of the Sea Dyke in Section H was deemed less significant and was not repaired. However the same issue of wind, rain and sea erosion attacking the void applies here and detailed monitoring should be carried out in future to check the integrity of the Sea Dyke in this area.

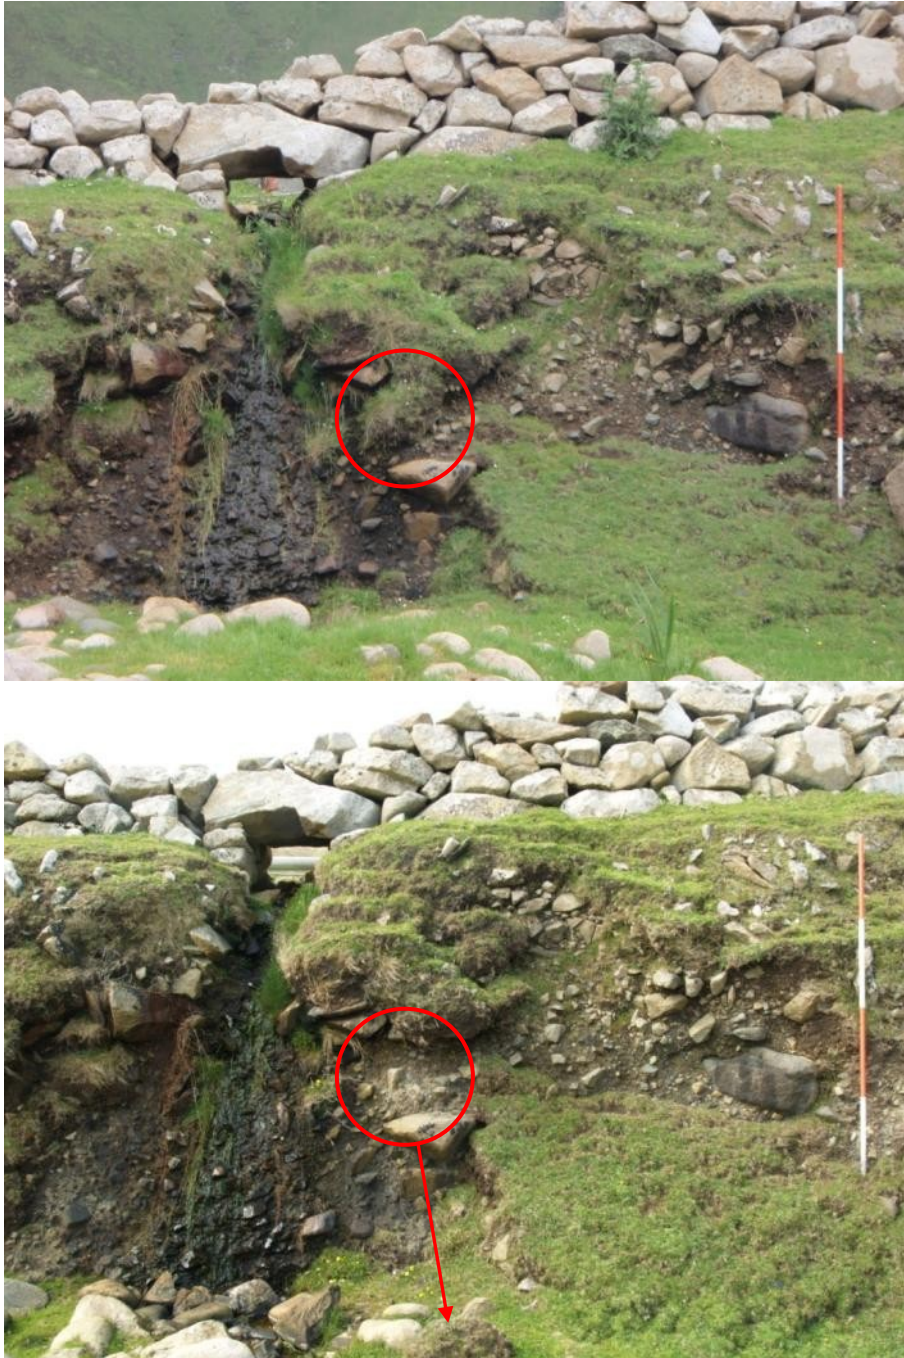
Figure 10. A piece of turf in Section H had been dislodged and is visible at the base of the cliff between 2011 (top) and 2012 (bottom)

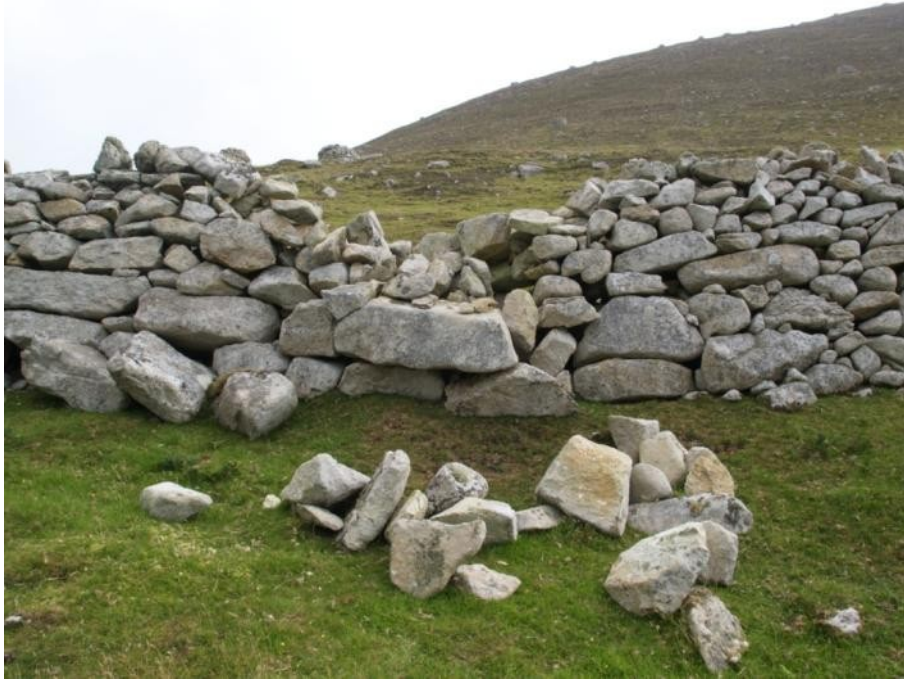
A collapse in the Head Dyke wall (Section B) to the rear of the Factor's House was noted during August (Figure 15). A second collapse to the Head Dyke (above the MacKenzie's Slabs in Enclosure 2) occurred during the sheep catch, to which the SKA was promptly notified by members of the Soay Sheep Project (Figure 16). The collapses will be repaired during the 2013 season.

Figure 15. A collapse to the Head Dyke to the north of the Factor's House

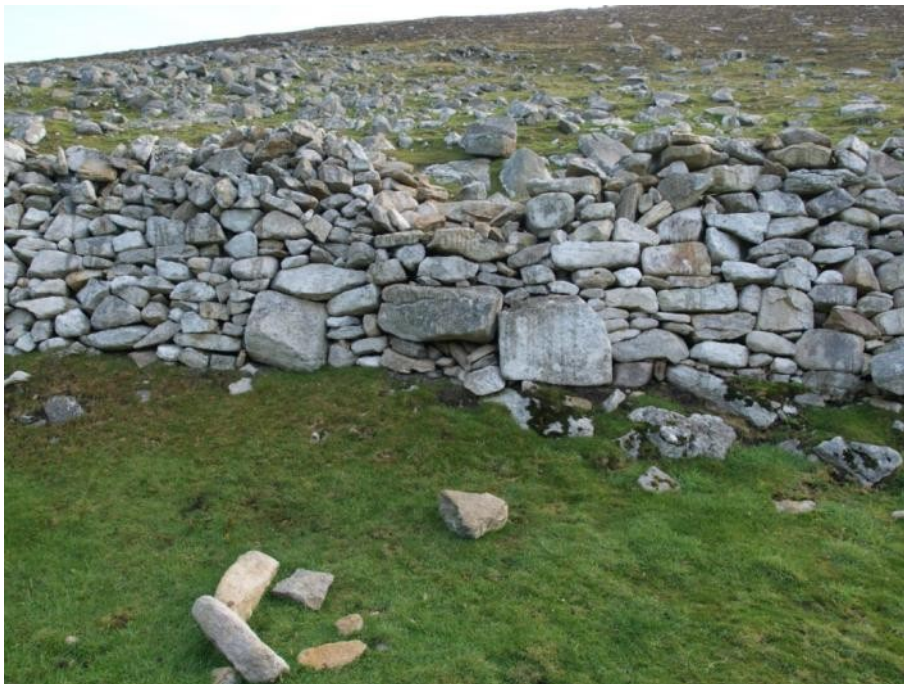
Figure 16. A small collapse to the Head Dyke in Enclosure 2

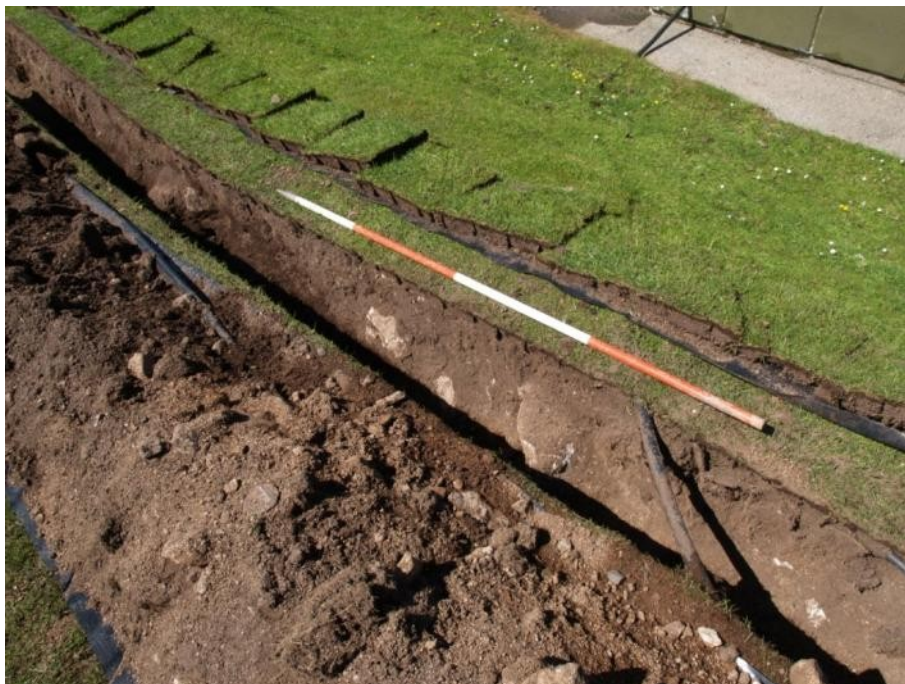
*Figure 19. The pipe trench after excavation. No archaeological features, deposits or finds were identified*

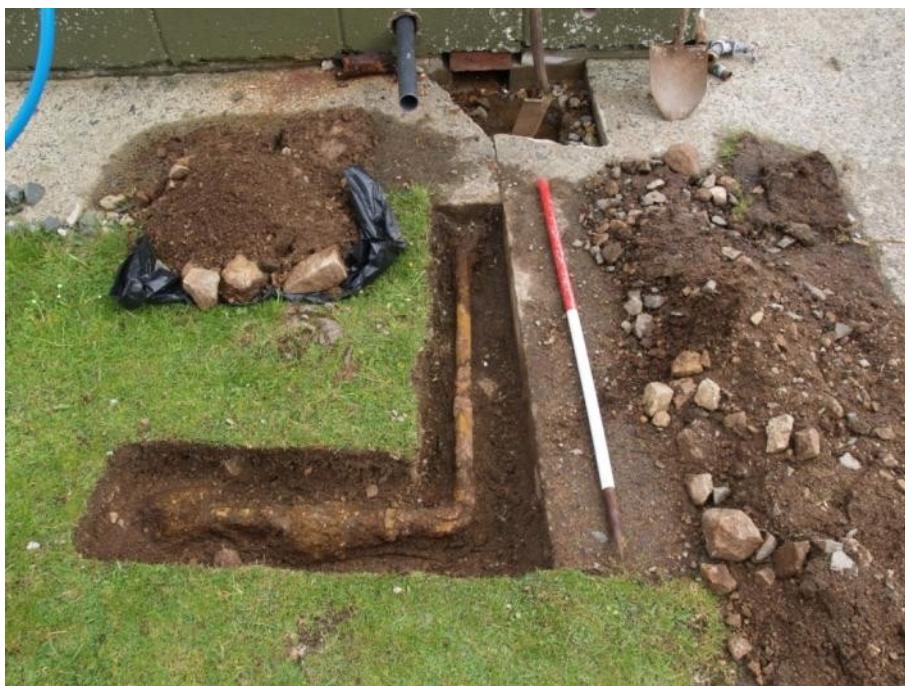
As part of a proposed water pipe replacement, a second small trench was excavated by QinetiQ subcontractors adjacent to the filtration plant (Figure 20). The trench measured 1.1m by 0.9m and was 0.25m in width. It was excavated to a maximum depth of 0.10m. The corroded water pipe targeted by the excavation was exposed but no archaeological features or deposits were identified. The pipe is due to be replaced in summer 2013 and will be fully detailed then.

*Figure 20. A short section of corroded pipe exposed. The pipe is due to be replaced in 2013 and the excavations will be fully detailed then*

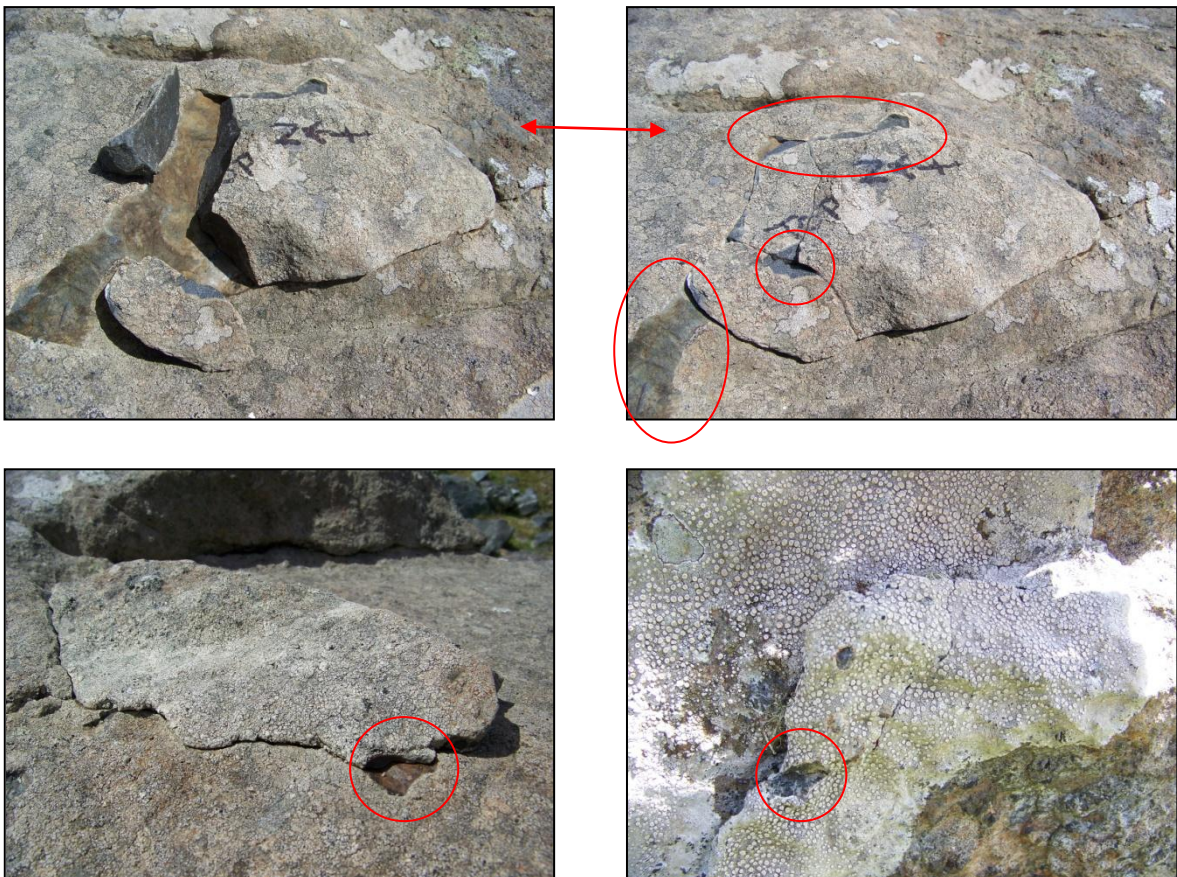
- Following dry cleaning of the detached pieces and the surfaces of the breaks on the Milking Stone, loose fragments were carefully placed on their original position and assessed.
- All of the pieces fitted well, however stone number **2** was broken in to three sections and its top surface was stained with black felt pen. Several fragments, chips to the edges of all three pieces, were missing.

*Chips to the edges of the detached pieces*

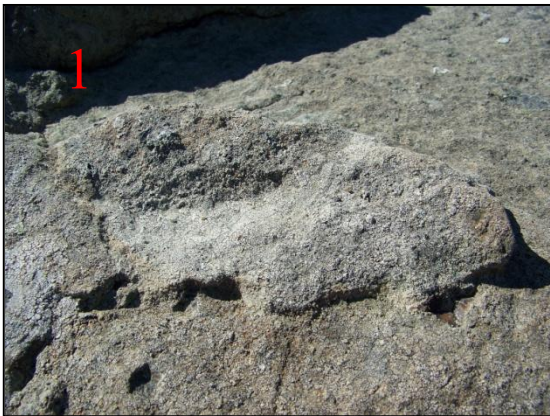
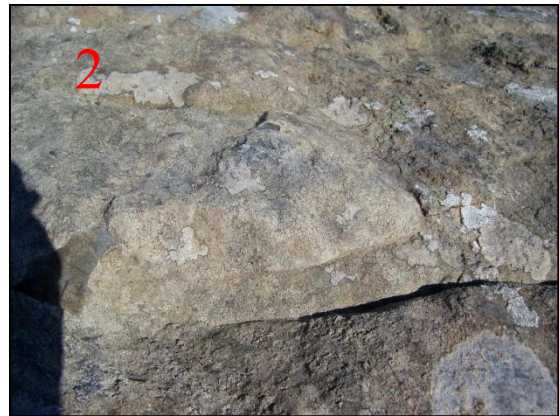
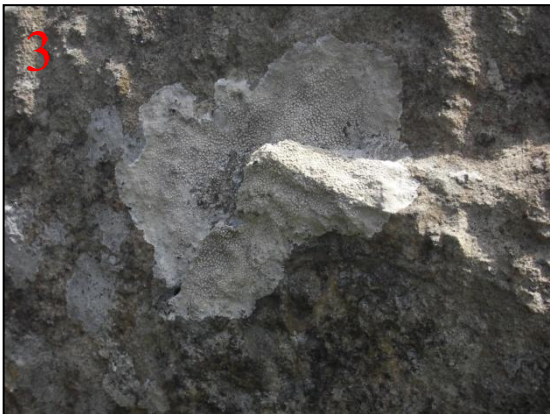
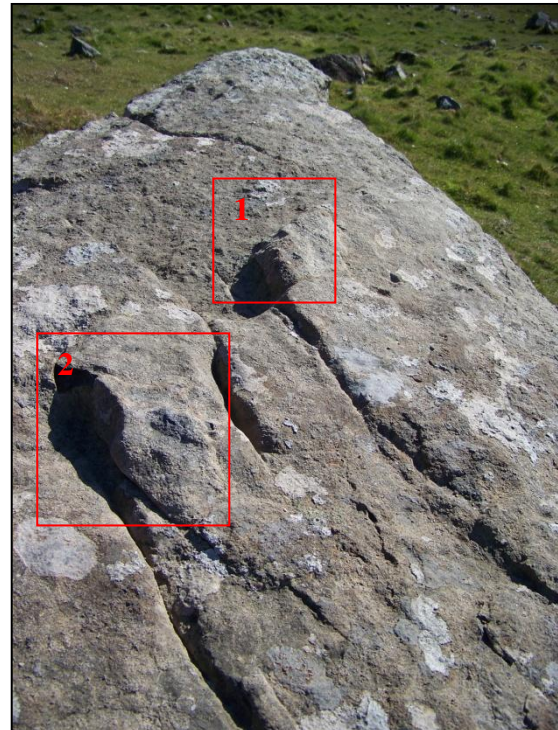
*Milking Stone after conservation*

- Black felt pen marks from the surface of the piece number **2** were removed using acetone and kitchen towels.
- All loose elements of the stone were re-attached using polyester resin applied as a series of pads to allow moisture migration between the main body of the boulder and the fragments.
- Next all fissures and cracks were filled with 20% solution of acrylic resin Paraloid B72 in acetone mixed with sand and natural pigments to match the surrounding colour of the stone and lichen.
