Roan Head, Flotta

Roan Head Boom Buoy Vessel

Project Report

March 2015

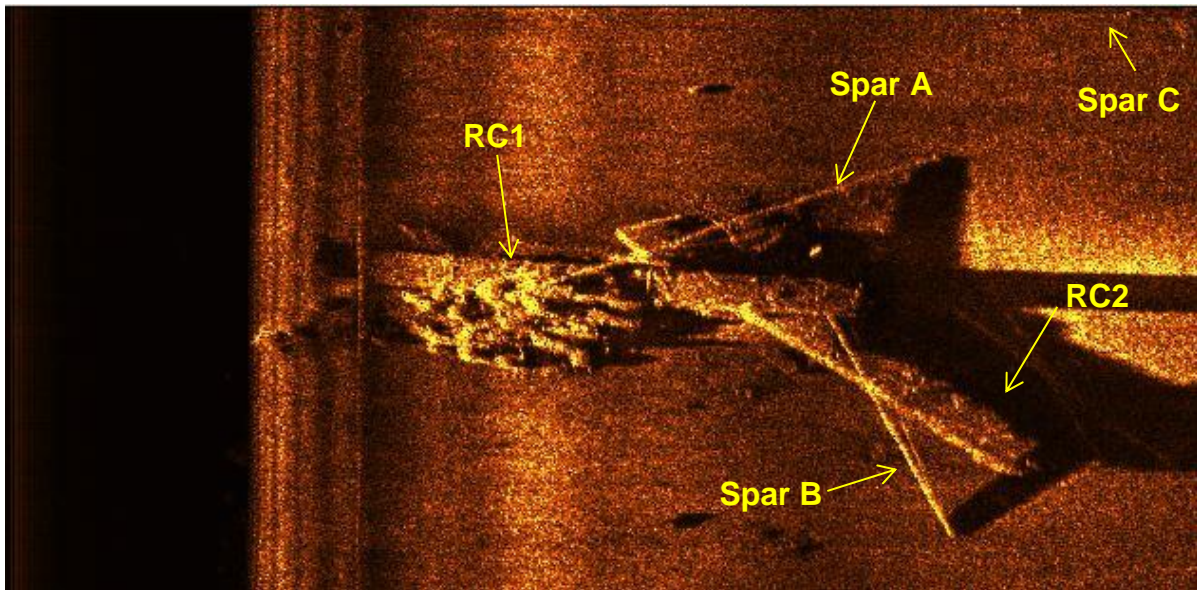
PLATE 1: SIDE SCAN SONAR IMAGE OF THE TARGET SITE (RC1 AND RC2)

The first rectangular contact (RC1) is 30m long by 3m wide, oriented north to south. There is a large pile of boom nets and buoys abutting the northern end of the remains to the west of the contact. This feature overlays a second rectangular contact of the same dimensions (RC2). RC2 is oriented northeast to southwest with RC1 overlaying the northeastern end.

Both contacts lie under two spars (Spar A and Spar B respectively). Spar A is approximately 22.6m and is oriented northwest to southeast; while Spar B is approximately 24.9 and is oriented east-northeast to west-southwest. Subsequent assessment of the survey data following the diver surveys indicates the presence of a third spar (Spar C) approximately 5m to the east of the main target site. This is visible as three strong returns, which mark the position of flanges visible on the spars underwater (**Plate 3**). Spar C is at least 16m long, however the contact extends beyond the range of the side scan runs.

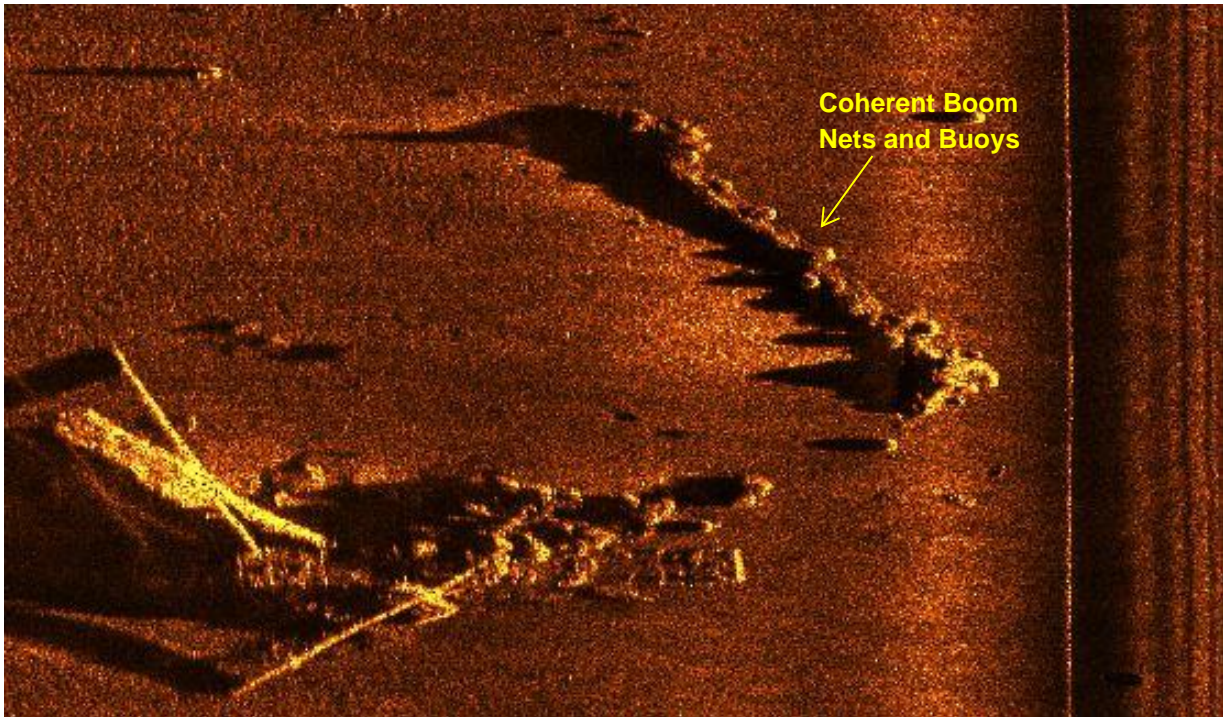
PLATE 2: SIDE SCAN SONAR IMAGE OF ASSOCIATED BOOM DEFENCE DEBRIS

There is a coherent pile of boom net and buoys (30m long by 2m wide and standing between 1m and 2m proud of the seabed) approximately 13m to the northwest of the target site, oriented northeast to southwest.

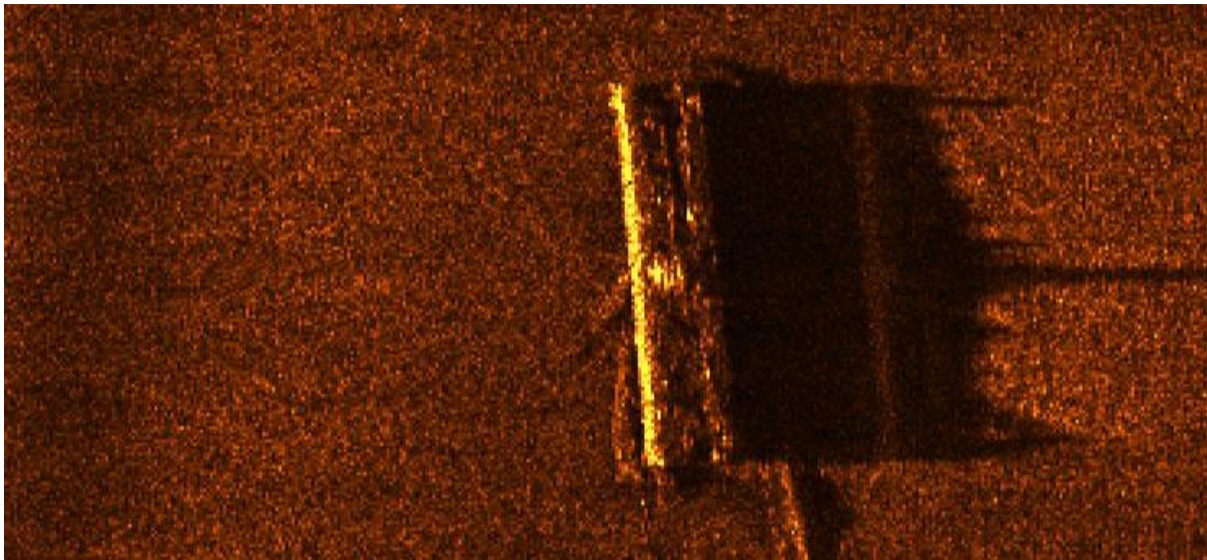
PLATE 4: SIDE SCAN SONAR IMAGE OF RC3

Rectangular Contact 3 (RC3) is an isolated contact to the northwest of the target site in a depth of approximately 26m. Measuring 30m long by 3m wide, the remains stand approximately 1.2m proud of the seabed. The shadow from the image indicates a single high point in the centre of the contact (approximately 2.9m at its highest point) and in addition suggests the presence of numerous smaller features

protruding from it. Some of these smaller features are visible as strong returns on the main contact (**Plate 4**). RC3 is oriented east to west with a slight scour in the seabed at the southwest corner of the remains.

It is recommended that the RC3, RC4, RC5 and the circular feature (CC1) observed in proximity to RC4 and RC5 should be the subject of further investigation to confirm the identity of the remains, to document their condition and to map their configuration. Evidence from historic photographs suggest that the winches on the

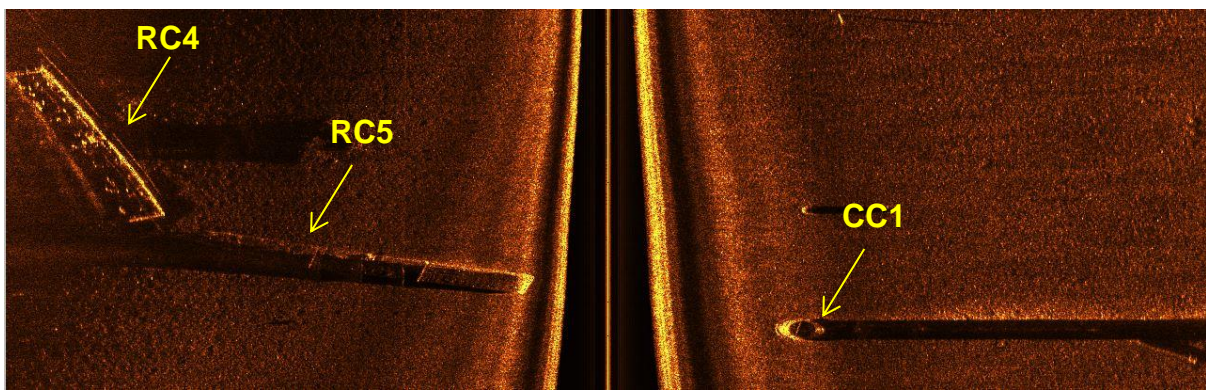
PLATE 5: SIDE SCAN SONAR IMAGE OF RC4, RC5 AND CC1.

Rectangular Contacts 4 and 5 (RC4 and RC5) are located to the west of the target site in a depth of approximately 5m. RC4 measures 30m long by 3m wide and the remains stand approximately 1.2m proud of the seabed. The shadow from the image indicates a single high point in the centre of the contact (approximately 2.4m high). The feature is likely to be slightly higher as the shadow extends beyond the side of the survey record. Similar to RC3 there are a number of strong returns on the main contact suggesting the top of the feature is populated with smaller features (**Plate 5**). RC4 is oriented northeast to southwest.

RC5 is situated approximately 4m to the north of RC4, and has the same dimensions. Unlike RC3 and RC4, there is no high point in the shadows. There are two strong linear returns approximate 10m from either end of the contact (**Plate 5**). RC 5 is oriented north to south. CC1 is situated approximately 6m to the north of the remains of RC5.

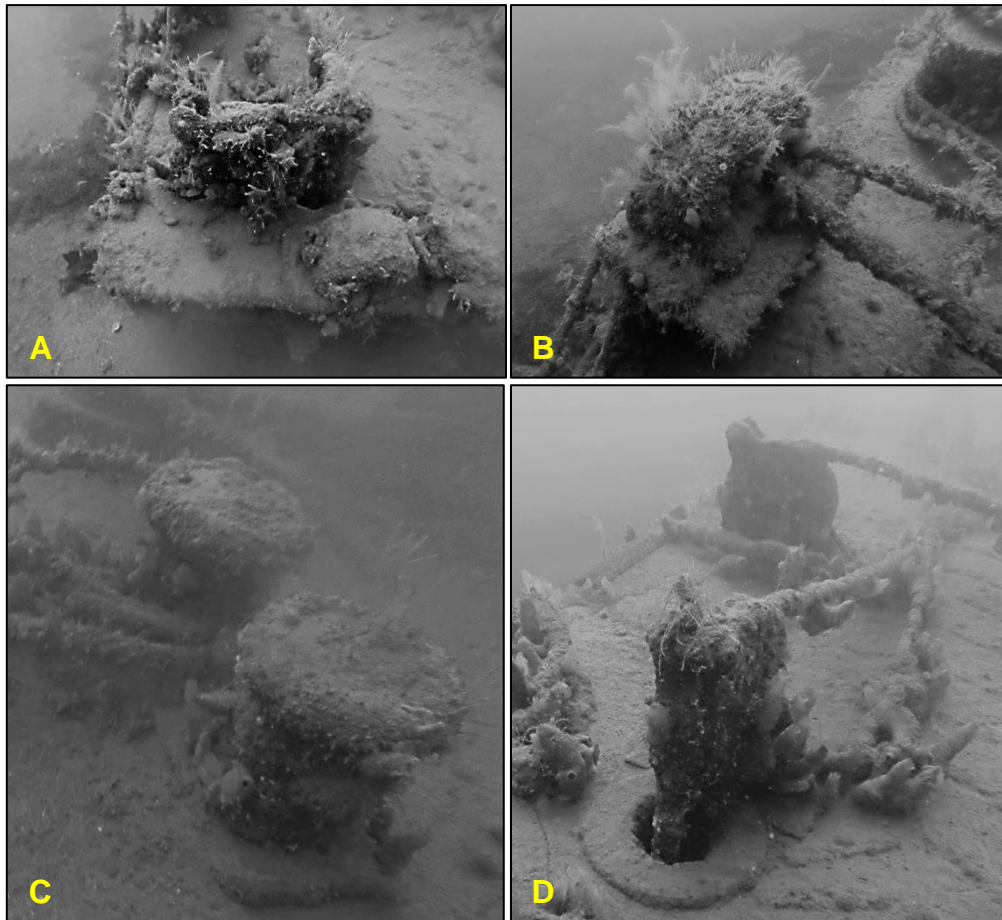
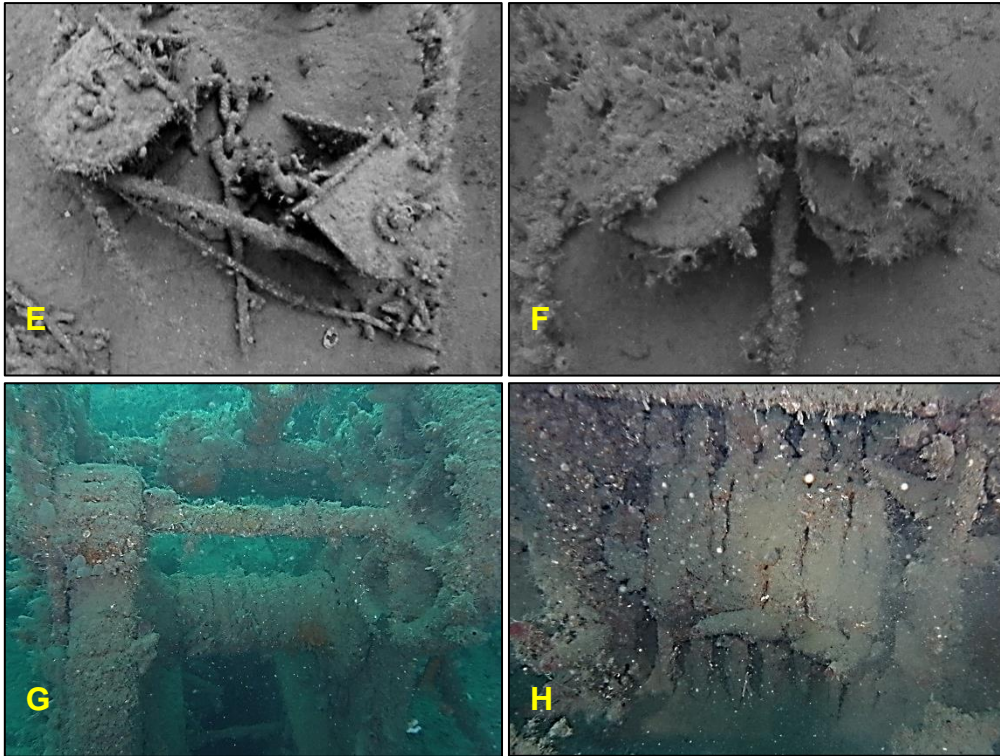
PLATE 6: PHOTOGRAPHS OF VESSEL MACHINERY - A) CLEAT; B) FAIRLEAD; C) BITTS; D) PULLEYS (RUNNING ALONG AND ACROSS THE VESSEL); E) BOLLARDS; F) POSTS WITH WIRE GUIDES; G) PART OF THE WINCH MECHANISM SHOWING CENTRAL MOON-POOL; H) CLOSE UP OF PART OF THE WINCH MECHANISM THAT OPERATE 6 OF THE 12 WIRES.

Upon descent divers encountered the wrecks of two long, narrow vessels. RC1 was upright, and the 'deck' was divided into three 10m sections. The sections at each end were populated with a number of pulleys (running both along and across the vessel), posts (with wire guides), cleats, fairleads, bollards and bits (**Plate 6A – 6F**).

Each of the pulleys was associated with a 0.16m diameter aperture, and wires *in situ* in the pulleys passed through tubes to the underside of the vessel. The central section comprises several other pulleys and posts, surrounding a large winch which has the capacity to operate twelve wires (**Plate 6G and 6H**).

The machinery present on the vessel is in good condition with all elements intact. Networks of wires from various points cover the remains. There are two clear walkways with a tread-plate – either side of the centre line of the vessel, with machinery inboard and outboard of these lines (**Plate 7A**). These features are also present on RC2 (**Plate 7B**).

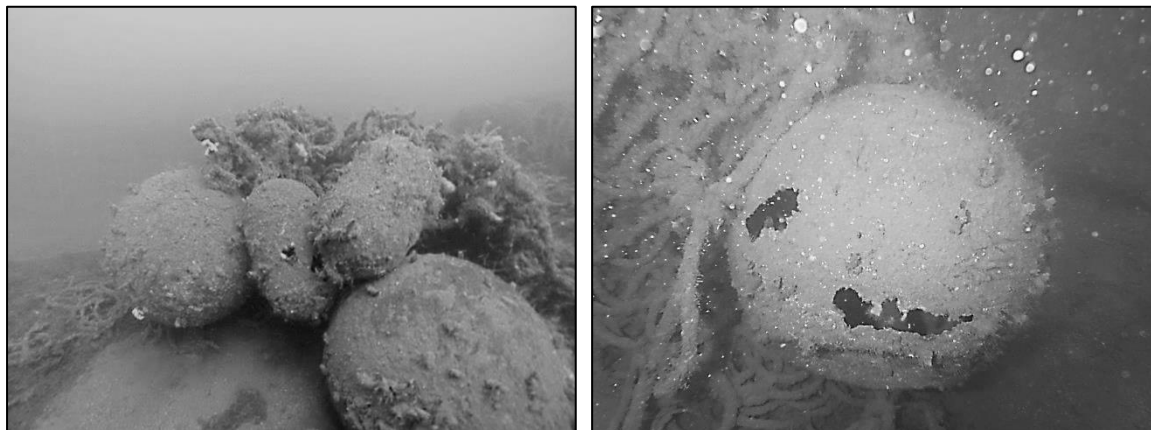
PLATE 8: PHOTOGRAPHS OF BOOM BUOYS AND NETTING IN THE NORTHWEST CORNER OF THE SITE

In the northwest corner of the site, a large pile of circular and ovular boom buoys and associated nets was observed. The buoys showed evidence of corrosion around distinct circular holes but were otherwise intact (**Plate 8**). The circular holes are likely to have been caused by small artillery shells used to sink the buoys. It is probable that these buoys were sunk after RC1 as they overlay the wreckage around the middle section.

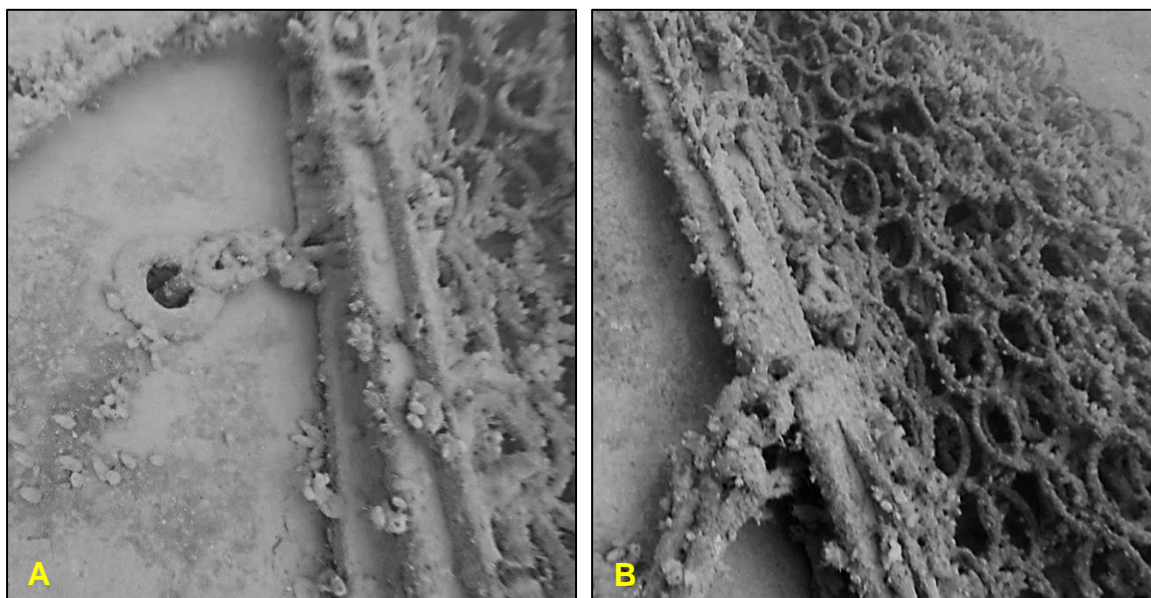
PLATE 9: RC2 BOOM NETTING: A) SHOWING WIRES CONNECTING TO STEEL BEAMS FROM UNDERSIDE OF RC2; B) BOOM NET ATTACHED TO THE STEEL BEAMS

RC1 overlies the remains of RC2. RC2 appears to have been the same type of vessel as RC1, however the wreck has capsized. The joins between the three sections like those observed on RC1 are clearly visible and there are a number of correlating apertures on the underside of the vessel. Several wires protrude from these apertures. These are attached to steel beams onto which linear piles of boom netting are secured (**Plate 9**). This boom netting lies off to the southeast side of RC2.

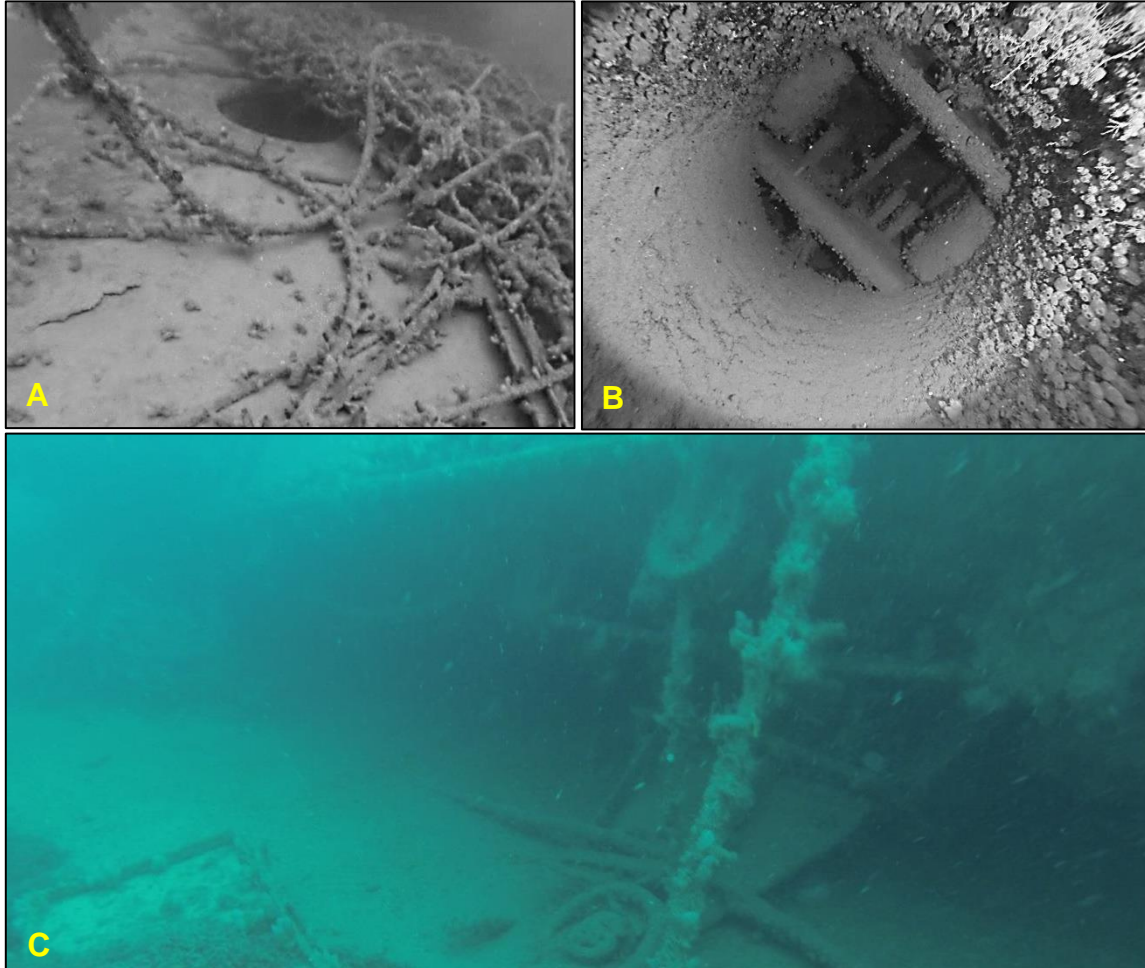
PLATE 10: RC2 WINCH AND MOON-POOL: A) MOON-POOL ON UNDERSIDE OF RC2; B) VIEW INTO MOON-POOL SHOWING PART OF THE WINCH; C) REMAINS OF INVERTED CRUSHED WINCH ON THE 'DECK' OF RC2

In the centre of the middle section there is a large circular aperture (known as a moon-pool, which is a hole in a vessel that provides access to the water). This was directly over the remains of a crushed winch (**Plate 10**) – supporting the above interpretation that the two vessels are likely to be identical.

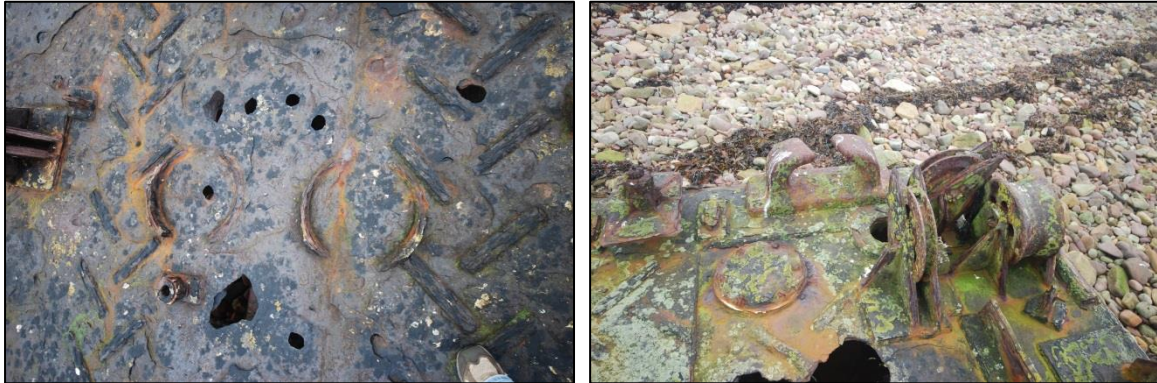
PLATE 17: EVIDENCE OF BURNING INDICATING SALVAGE OF MACHINERY

Two sections of the pontoon currently rest in the inter-tidal zone to the west of a large pile of discarded boom netting and the reported remains of a 20th-century beacon (**Plate 16C**), although it should be noted that there are no charted beacons in the area. It is possible that this is the remains of an anchor for one of the Hoxa booms. The third section has broken away and is resting perpendicular to the midsection in the water. There is evidence to suggest that some salvage has taken place, particularly on the remains of the larger section, as some of the fittings have been removed or partly removed and there is evidence of sections of burning (**Plate 17**).

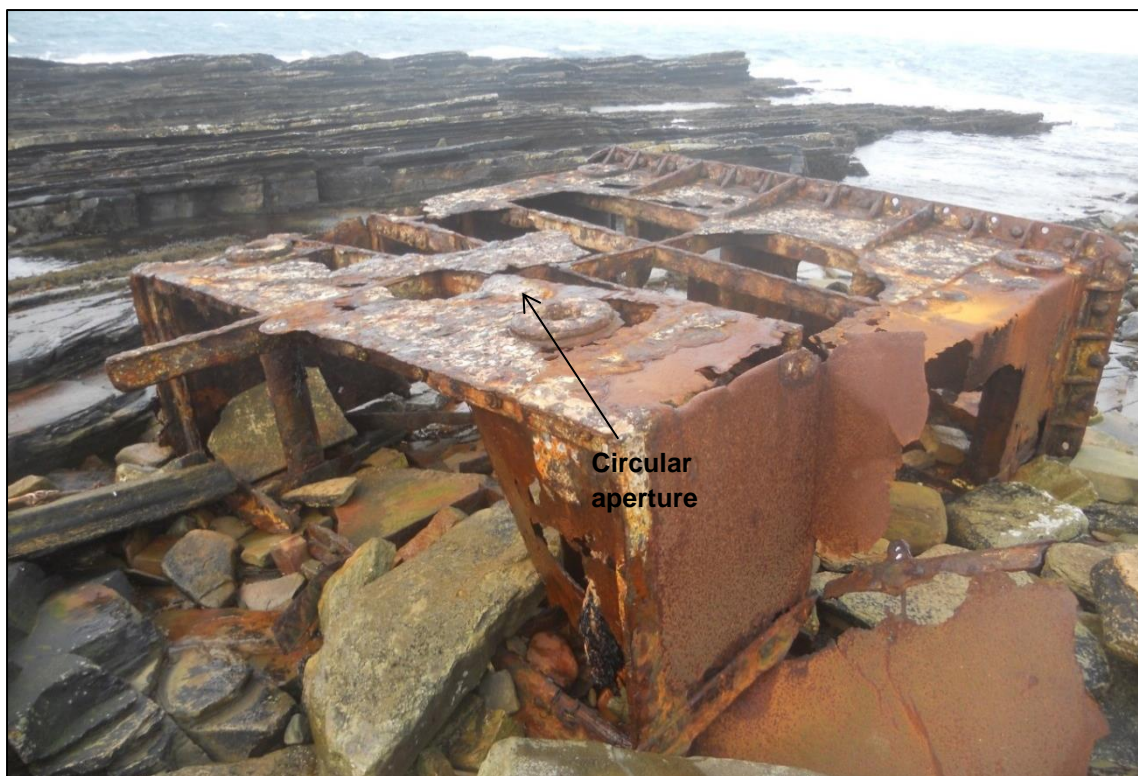
PLATE 20: MORE INTACT PORTION OF PONTOON SECTION AT HOXA

This site includes the remains of at least one section of a pontoon (broken and present in two portions). One large portion measuring 3.13m long by 3m wide with a height of 1.2m is half way up the beach. Four circular apertures and associated tubes can be seen (**Plate 20**).

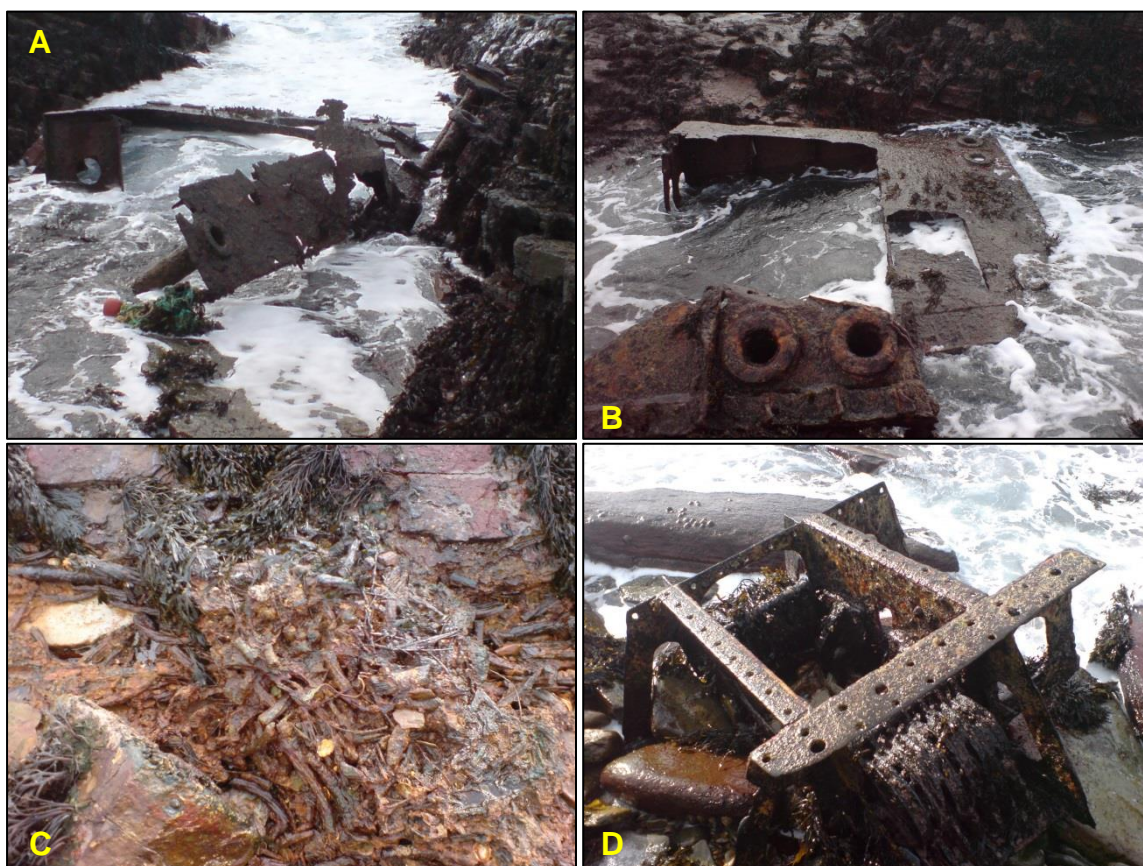
PLATE 21: DISPERSED PONTOON DEBRIS AT HOXA: A AND B) FRAGMENTARY REMAINS OF A PORTION OF PONTOON SECTION; C) CORRODED NET/WIRES; D) WINCH MECHANISM

A second more fragmentary portion, wedged between rocks closer to the low water mark is 3.18m long, but is too broken up to gauge other dimensions (**Plate 21A and 21B**). This is associated with several corroded piles of wire (**Plate 21C**). Although the machinery and fittings from the pontoon are no longer *in situ*, likely a result of the high energy environment they rest in, a winch with the same configuration of those observed on Flotta and on the target wreck sites was observed close to the low water mark in the vicinity of the rest of the wreckage (**Plate 21D**).
