HISTORIC
ENVIRONMENT
SCOTLAND

High Seas Fleet Salvage Sites Report

4th April 2017

Authors: Henry, Sandra; Heath, Kevin and Littlewood, Mark

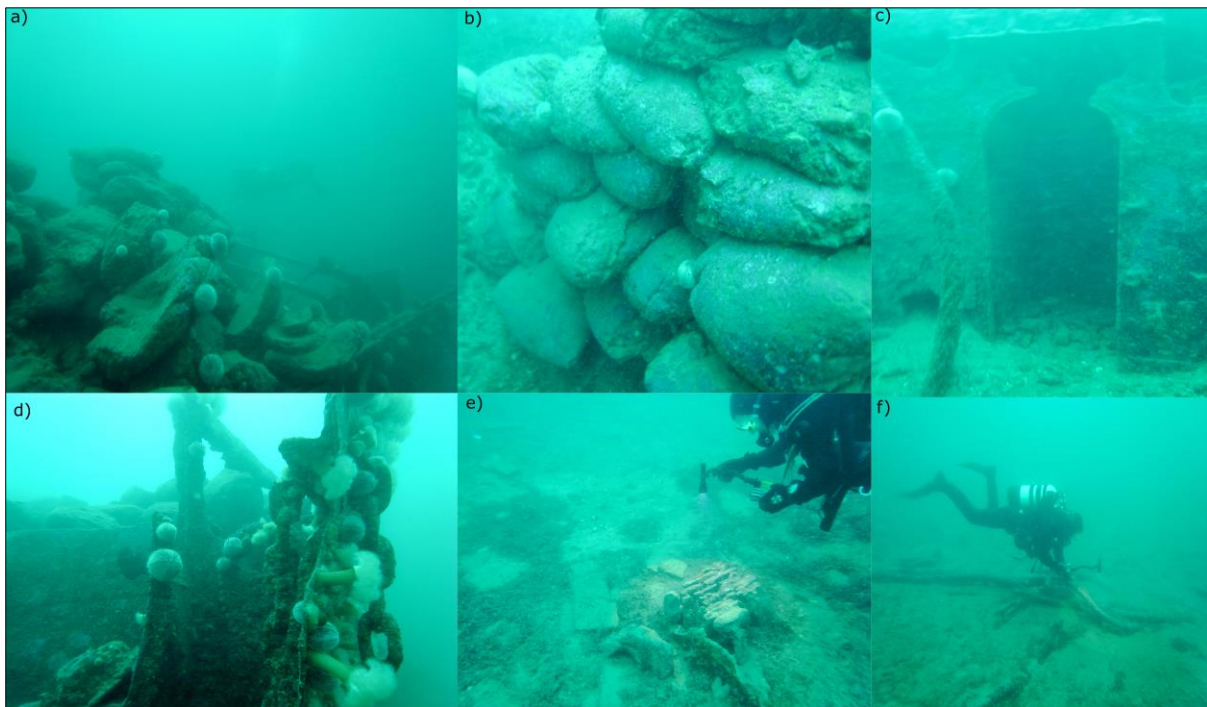
Plate 3 a) Concrete bags in starboard destroyer b) concrete, imprint of the bag is visible on the concrete c) doorway portside destroyer d) cross section portside destroyer e) stacked corking lying to north of the portside destroyer f) lifting wire on the seafloor

Diver survey focused on the two destroyer sections used as supporting blocks for the upright lifting operations. The two destroyer sections sit across the site SW to NE, they supported the *Hindenburg* at the stern as she sat upright on the seabed aligned NW to SE. The portside block was laid first due to her initially developing her list to portside, the starboard support was added before the final lifting operations. The diver survey began by investigating the starboard destroyer section. The sub-oval concrete sacks placed in the destroyers were clearly visible ([Plate 3a; 3b](#)), the saddle shape taken by the concrete is due to the load from overlying concrete bags and the imprint of the bags was visible on the blocks. Chains that were used to secure the concrete bags within the destroyer section were visible along the side of the destroyer section (The Dundee Courier 15th July 1930), and large quantities of lifting wire lay strewn on the seafloor ([Plate 3f](#)). The concrete bags located on the side of the destroyer sections where *Hindenburg* sat were broken down to rubble by her weight, forming heaps on the seafloor between the two destroyer sections.

The portside destroyer section ([Plate 3d](#)) contained a door at the SW end ([Plate 3c](#)), and large quantities of corking were scattered on the seafloor along with contained stacked cork sections ([Plate 3e](#)). This identification of the cork substantiates that it was a destroyer engine room section (George, 1973) used for the portside block, as corking was regularly used in engine rooms for insulation, although it was also used for this purpose in various locations around a vessel. Divers recorded deadlights on the seafloor approximately 75m north of SS025 ([Plate 4c](#)). A deadlight is a protective cover or shutter fitted over a porthole or window on a ship. The deadlights are most likely associated with the site of the *Hindenburg* as due to her upright position, the deadlights were removed and portholes were sealed off ([Plate 4b](#)).

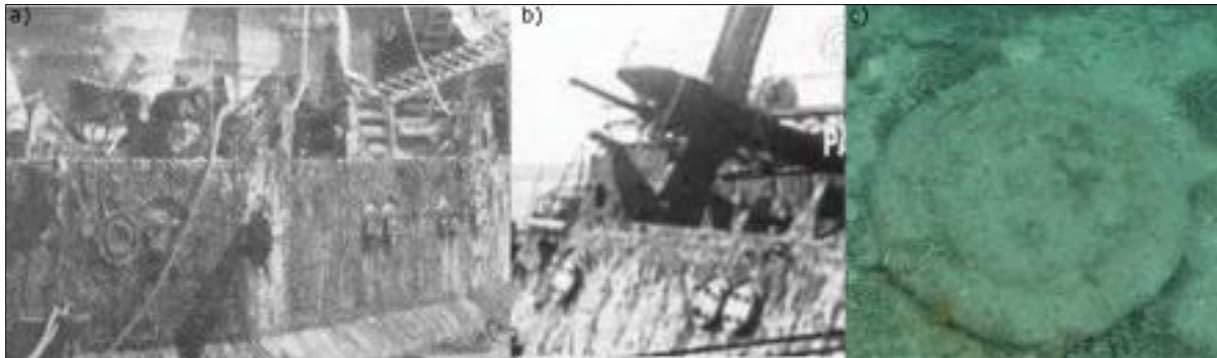
Plate 4 a) Image showing *Hindenburg's* with deadlights b) After lifting *Hindenburg's* portholes can be seen to be blocked, with deadlights removed (British Pathe) c) Deadlights on the seafloor located north of SS025 at approx. 75m.

This is the only vessel recorded as having this practice happening, and the remains on the seafloor are likely from loss overboard. An enamel bathtub was located in the salvaged area that is similar in style to the bathtub found on the site of the *Dresden* (<http://www.scapaflowwrecks.com/wrecks/dresden/diving.php>).

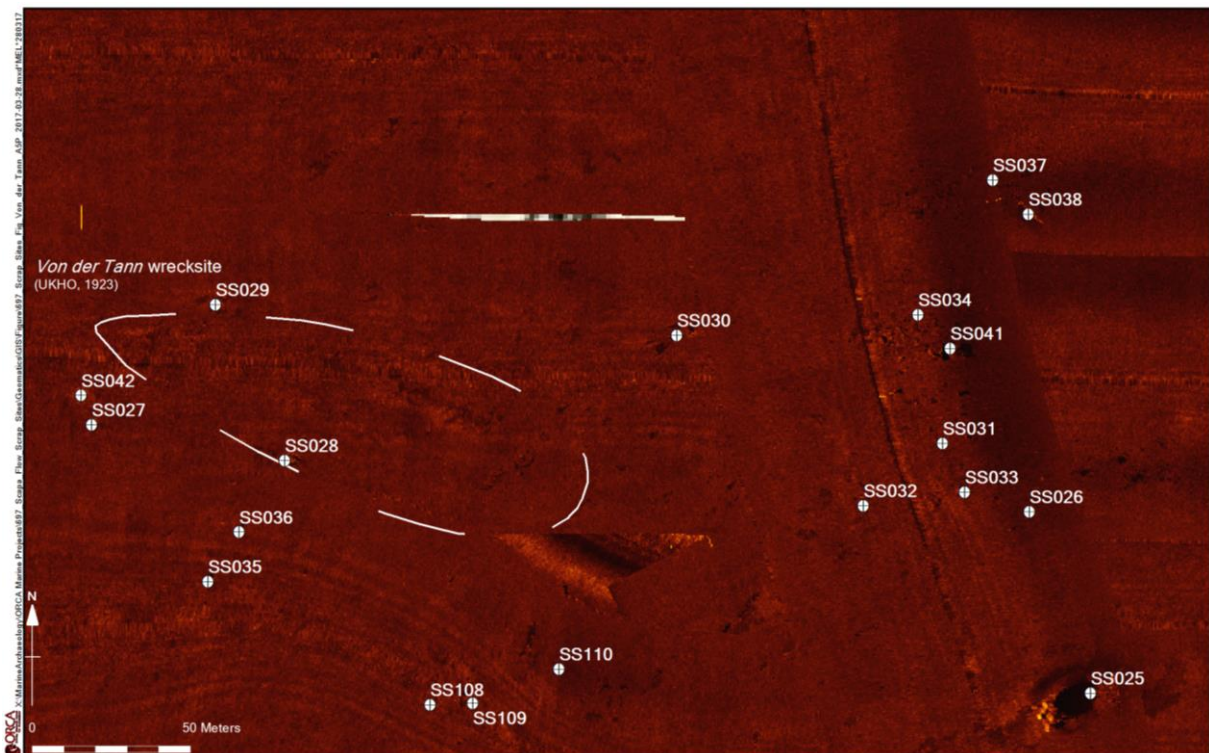
Figure 4 *Von der Tann* anomalies, charted outline of *Von der Tann* (UKHO, 1923)

The side scan sonar survey of *Von der Tann* collected medium frequency data (325KHz) and focused high frequency data (780kHz). This provided an overview of the final scuttled location and salvage area of the battlecruiser. The survey identified anomalies associated with the salvage operations on the *Von der Tann*. Anomaly SS027; SS028; SS029 and SS042 are located in the vicinity of the primary scuttled position of the *Von der Tann* ([Figure 4](#)) (ref. Appendix 1 for full descriptions).

Anomalies SS035; SS036; SS108; SS109; SS026; SS031; SS032; SS033; SS034; SS037; SS038 and SS041 are representative of the movement of the *Von der Tann* after towing into Cava took place ([Figure 4](#)) (see Appendix 1 for full descriptions). The sonar survey results along with archival research indicated the extent of the *Von der Tann* material remains on the seabed, with direct evidence of the salvage operations and movement of the vessel once lifted.

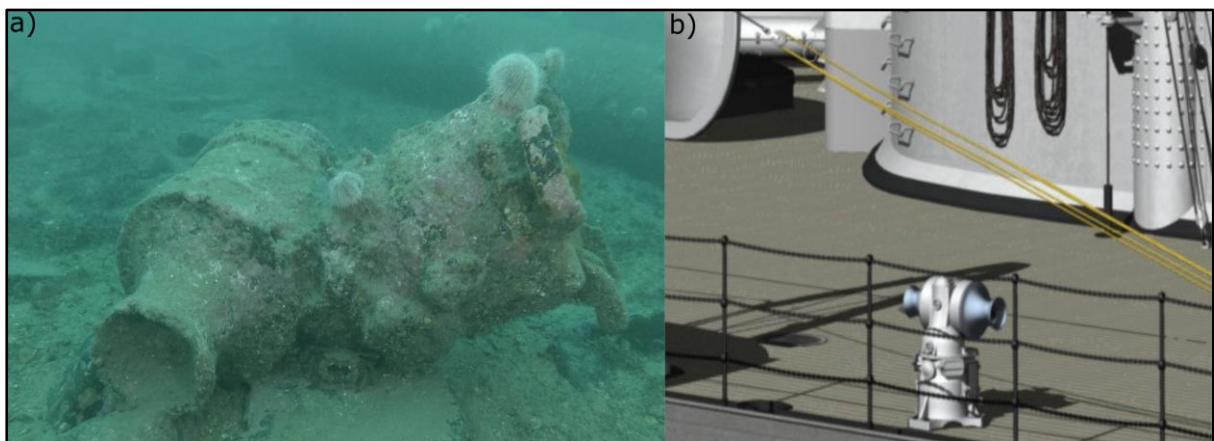
Plate 6 a) coal winch on *Von der Tann* salvage site b) *Von der Tann* 3D model coal winch (Samuel, M., sites.google.com/site/3dwarships/Home)

fitted each side of the upper deck on *Von der Tann* ([Plate 6](#)) (Friedman, 1992). The two rectangular boxes on this site are containers for sub calibre barrel liners; these were used for training to prevent wear on the gun barrels by firing a smaller round. Heavy wear on the ship's main armament when firing means that after approximately 150 rounds the gun liner needs replacement. This big operation involves returning the gun to the manufacturer. The use of these sub calibre gun liners would have been both time saving and cost effective. The rectangular containers had hatches at each end to facilitate cleaning of the barrel without removing it from the box. The two holes in the back of the gun turret were used to insert the sub calibre tubes. The holes line up exactly with the 28 cm gun barrels inside the turret. This type of rectangular sub calibre storage box is rare, and largely unknown as most were cylindrical in shape ([Plate 5a; 5c](#)) (*per com* Marsden Samuel).

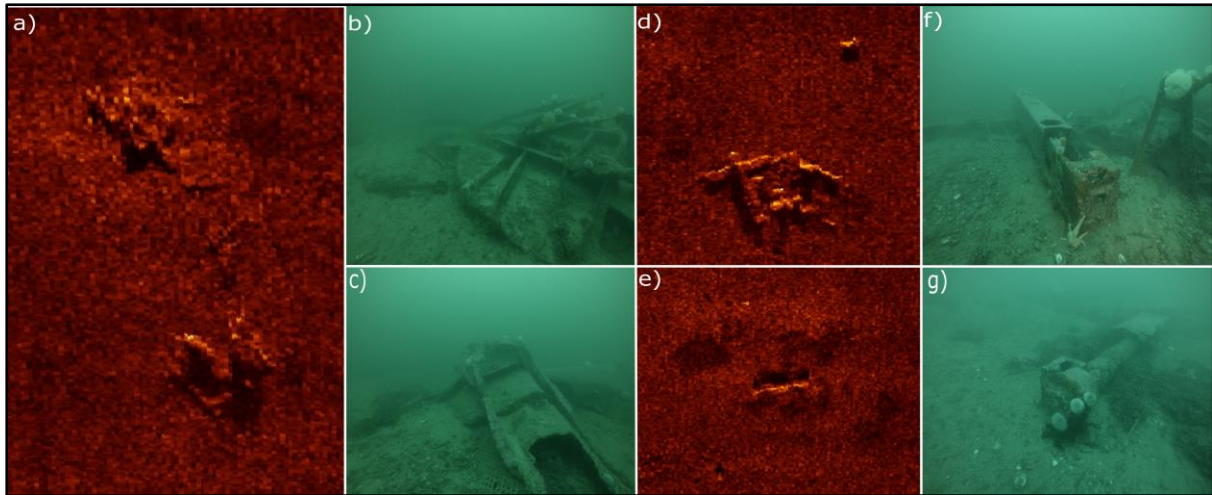
SS029 is a heavily built oval platform that is overlain with piping, bronze gearwheel and various objects. A sub calibre gun barrel liner in its rectangular storage box is located on this site along with an electrical metal box, and steel debris ([Plate 7e; 7g](#)), which is very heavy plating with riveted seams. Alongside this is a brass stand for a repeater compass but the compass is missing ([Plate 8](#)). A short distance away is a large steel door and a quantity of wood. SS042 is an upturned platform with steel girders and wires visible, a circular object with a handle is located underneath the platform, and a small object is located to the edge of the platform ([Plate 7a; 7b](#)). SS027 appears to be the bridge extension with lattice base ([Plate 7a; 7c](#)).

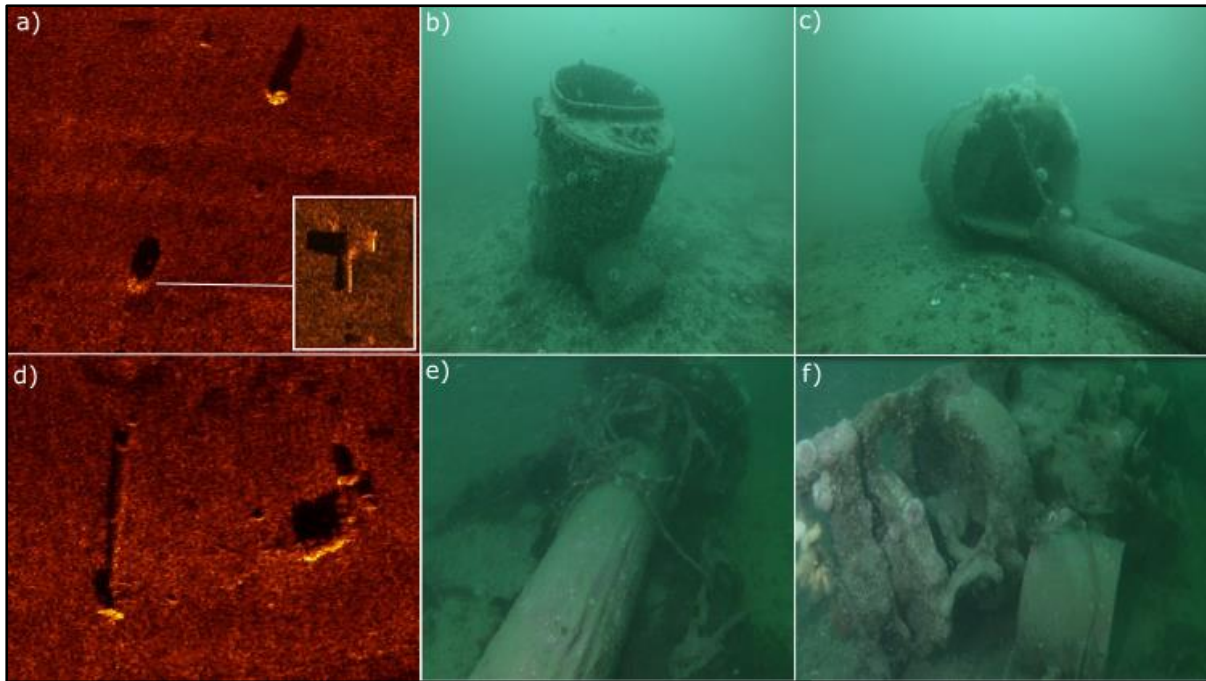
SS036 is a small pinnacle boiler standing on its funnel, with a brass valve located to its right when in normal position, on the underside and on the front inspection and cleaning hatches are located, and boiler grating is visible inside as the end has corroded. Mounting brackets are present on the side of the boiler ([Plate 9a; 9b](#)). SS035 is the upper forward mast section and spotting top of *Von der Tann* ([Plate 9a; 9c](#)). The top of the spotting top is heavily corroded, and a section on the seafloor still shows evidence of the viewing ports. Electrical cables are visible, with no evidence of attachments; there is a corroded hole in the base of the spotting top and a small pipe in the base along with various components on the floor. SS108 is probable

the lower forward mast section from the *Von der Tann* with a crow's nest identifiable by the bent handrails ([Plate 9d; 9e](#)). SS109 is a diesel pinnacle from the *Von der Tann*: the site contains a small engine, copper pipes and fittings ([Plate 9d; 9f](#)). The *Von der Tann*'s smaller motor boats were mounted on the middle two gun turret tops (*per com* Marsden Samuel).

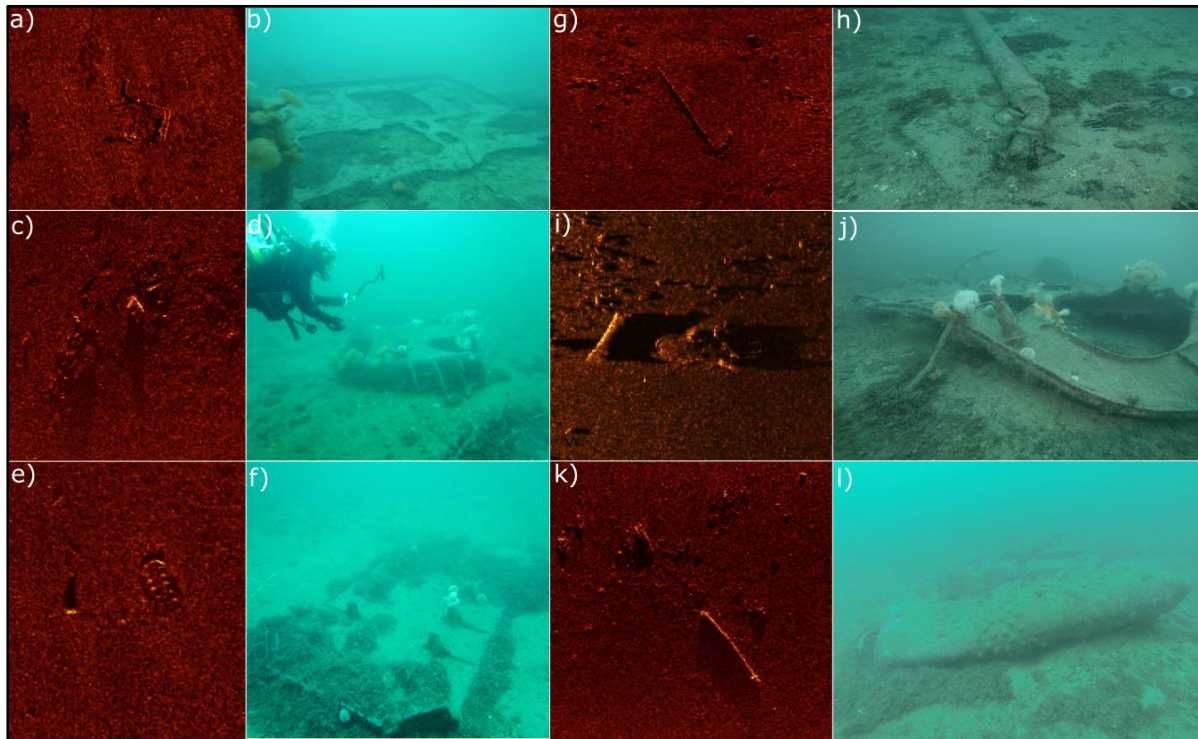
Diver survey ground-truthed the anomalies representative of *Von der Tann* movement overlying the scuttled site of *Hindenburg*. This survey focused on a debris field approximately 100m by 60m that showed the movement of the *Von der Tann* northeast. SS032 is a heavily corroded rectangular platform with two circular mounts visible that may represent the base of a searchlight platform or searchlight control platform ([Plate 10a; 10b](#)). SS033 is a rectangular box structure with cleats on its upper side, possibly part of a ventilation system ([Plate 10c; 10d](#)). SS026 is buried platform of sub oval shape with truncated corners, with the rim and strengthening elements of the platform protruding from the seabed ([Plate 10e; 10f](#)). SS031 is a davit spar with rigging still visible ([Plate 10f; 10g](#)). SS041 is a searchlight platform with the location of where the two searchlights were mounted identifiable as circular apertures alongside a larger circular hole for the mast showing evidence of stress damage and the entrance hatch to allow access to the platform ([Plate 11](#)). Evidence of boltholes for securing the searchlight is visible around the searchlight circular apertures. Cables and a search light base with rubber mounts are located next to the platform. The rubber mounts would protect the searchlight from shock damage when the main guns were fired, and it is one of two types of searchlight mounting systems noted on the various searchlight platform sites recorded during this project. No other evidence of the searchlight is present on the site ([Plate 10i; 10j](#)). The platform is the type present on *Von der Tann* and not the *Hindenburg* type, it was dragged and turned upright as the ship was pulled inshore. The platform shape indicates this is the aft searchlight platform ([Plate 11](#)). To the southwest of the searchlight

platform a second searchlight base with one rubber mount was located. A section of mast lies nearby. SS034 and SS041 are located within a boulder field, and within this area is a mast broken by impact rather than blasting, a coal winch and small anchor. To the west of this lies another section of mast raised off the seabed at its eastern end. SS038 is a derrick arm, with SS037 a heavily riveted samson post of the style found on the *Von der Tann* lying in close proximity ([Plate 5a; 5b; Plate 10k; 10l](#)). Deadlights (as described above) most likely from the *Hindenburg* were noted in a number of locations throughout this debris field.

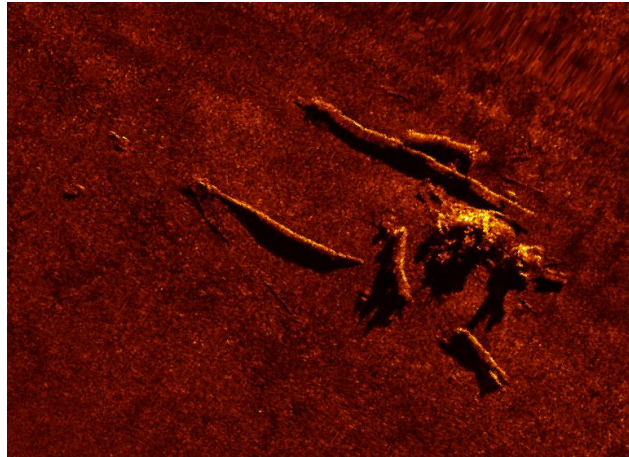
Plate 12 SS080: Grosser Kurfürst superstructure located at Rysa Little secondary site

Anomalies identified off Rysa Little, the secondary location used by Metal Industries Ltd for the removal of superstructure, were assumed (see below) to have come from the *Grosser Kurfürst* (SS080).

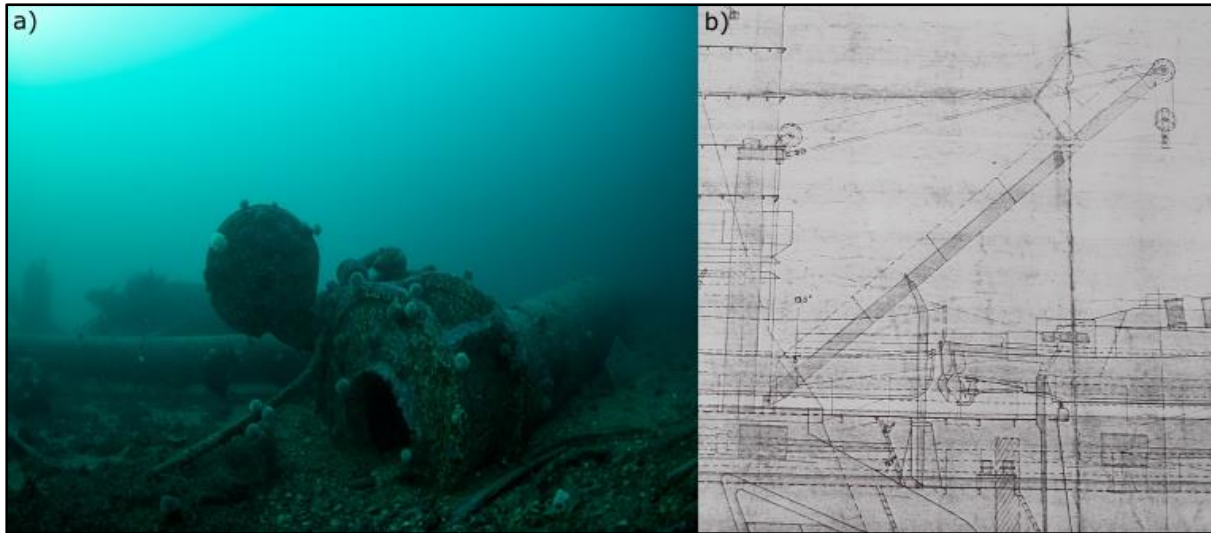
Plate 13 a) derrick arm on seafloor b) ship plans showing the type of derrick on Grosser Kurfürst

The König Class derricks are arranged one each side of the forward funnel. The divers encountered two davit arms lying parallel to each other orientated east to west, one samson post lies parallel to this, while another is lying perpendicular to the davit arms. A pulley wheel is attached to the top of the samson post as is common in the König class but not the Kaiser class ([Plate 13b](#)). This end of the post shows evidence of blasting/cutting. Off the top of the posts at the eastern end of the site, a large quantity of funnel gratings and plating are present on the site of a platform with a mast and a heavy duty supporting structure that the mast passes through. Rungs are visible within the mast that was shredded by blasting. A mast sheared by blasting is located off this wreckage. This structure and the wreckage material located on top of it is more evidence of the working on the aft superstructure including the derricks, funnel and searchlight platforms.

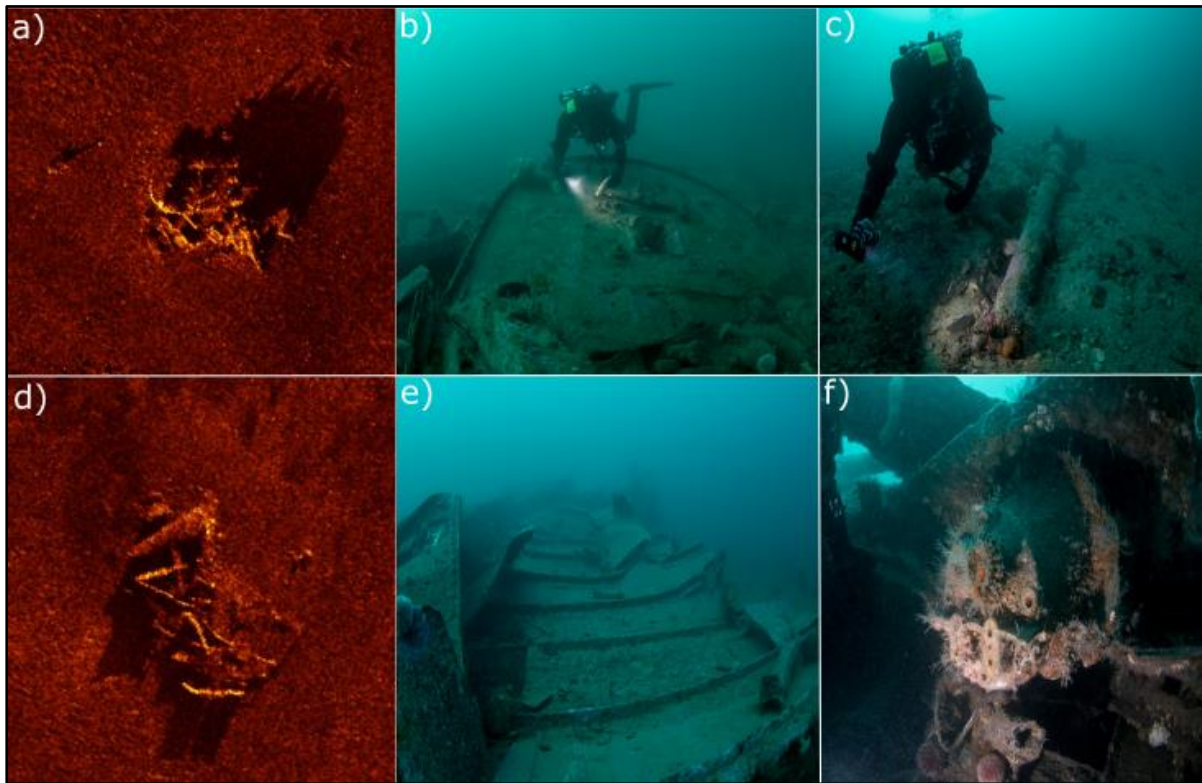
Plate 14 a) side scan sonar image SS070 & SS069 b) SS069 searchlight platform c) SS070 8.8cm L/45 gun d) side scan sonar image SS071 e) SS071 searchlight platform f) SS071 in-situ searchlight controller

SS069 is the upper part of an upright searchlight platform with searchlights missing, electrical cables and plugs protrude through the searchlight apertures, and underneath the platform lies a coal winch and extensive debris ([Plate 14a; 14b](#)). SS071 is a searchlight control platform complete with two searchlight controllers ([Plate 14d; 14e](#)), one in-situ and the other has fallen out from its mounting ([Plate 14d; 14f](#)). The searchlight controller head is missing, and a junction box and morse key were located on this site. The platform shows no evidence for the mast penetrating the platform, indicating that it is a standalone platform typical of the Kaiser Class.

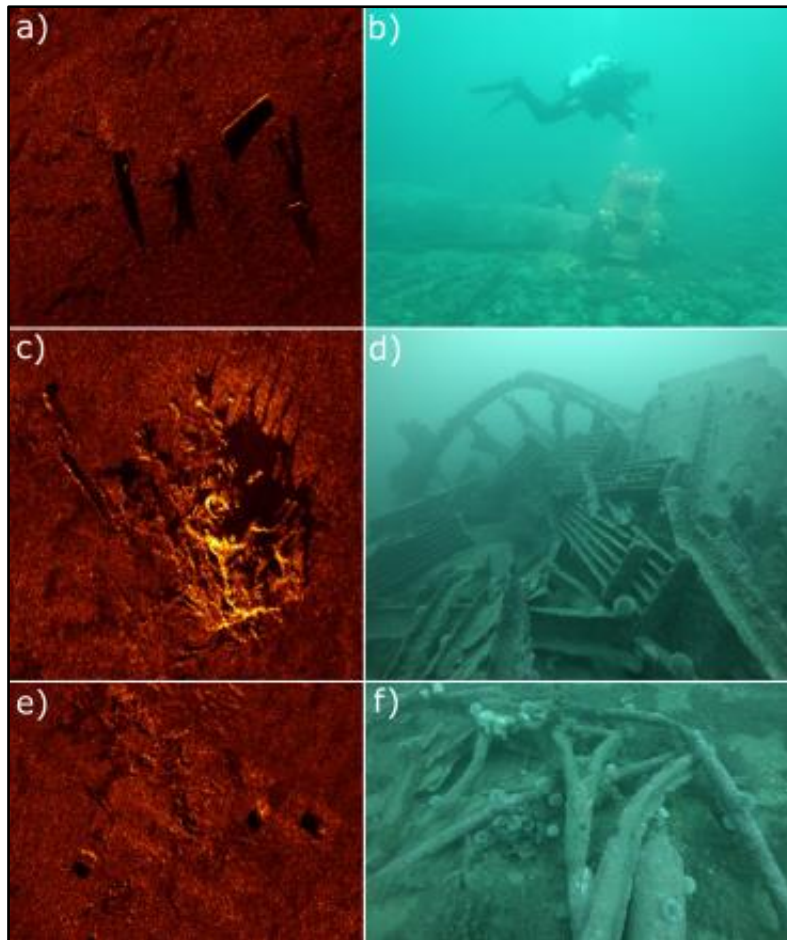
Plate 15 a) side scan sonar image SS068 b) SS068 diver over samson post, partially buried in the seabed at this end c) side scan sonar image SS078 d) SS078 funnel plating and bands e) side scan sonar image SS079 f) SS079 large quantities of wire visible on this site

SS078 is an extensive area of heavily corroded funnel plating and bands, extensive grating and wires are visible ([Plate 15c; 15d](#)). A brass box with two switches and a small whistle is located on the site. Part of a platform is located here, possibly from a searchlight platform. A sub calibre gun barrel liner is visible on this site located inside its partially corroded cylindrical storage container. SS079 is an area of debris with funnel grating and in this area is a brass doorframe ([Plate 15e; 15f](#)). SS078 and SS079 are lying 32.8m apart centre to centre of contact, orientated 185-105 degrees. At SS068 there are two samson posts. One is buried in the seabed at one end and it rises at an angle of 45 degrees from the seabed at the other end ([Plate 15a; 15b](#)). Under this is a platform and beside this is a door with a porthole aperture and two hinges visible. The second samson post runs perpendicular to the previously described samson post and lies flat on the seabed, with copper pipes lying off to one side, which are possibly voice pipes. A mast with a small spotting top is located here, most likely an aft mast. A section of mast protruding at an angle from the seabed is also located on this site.

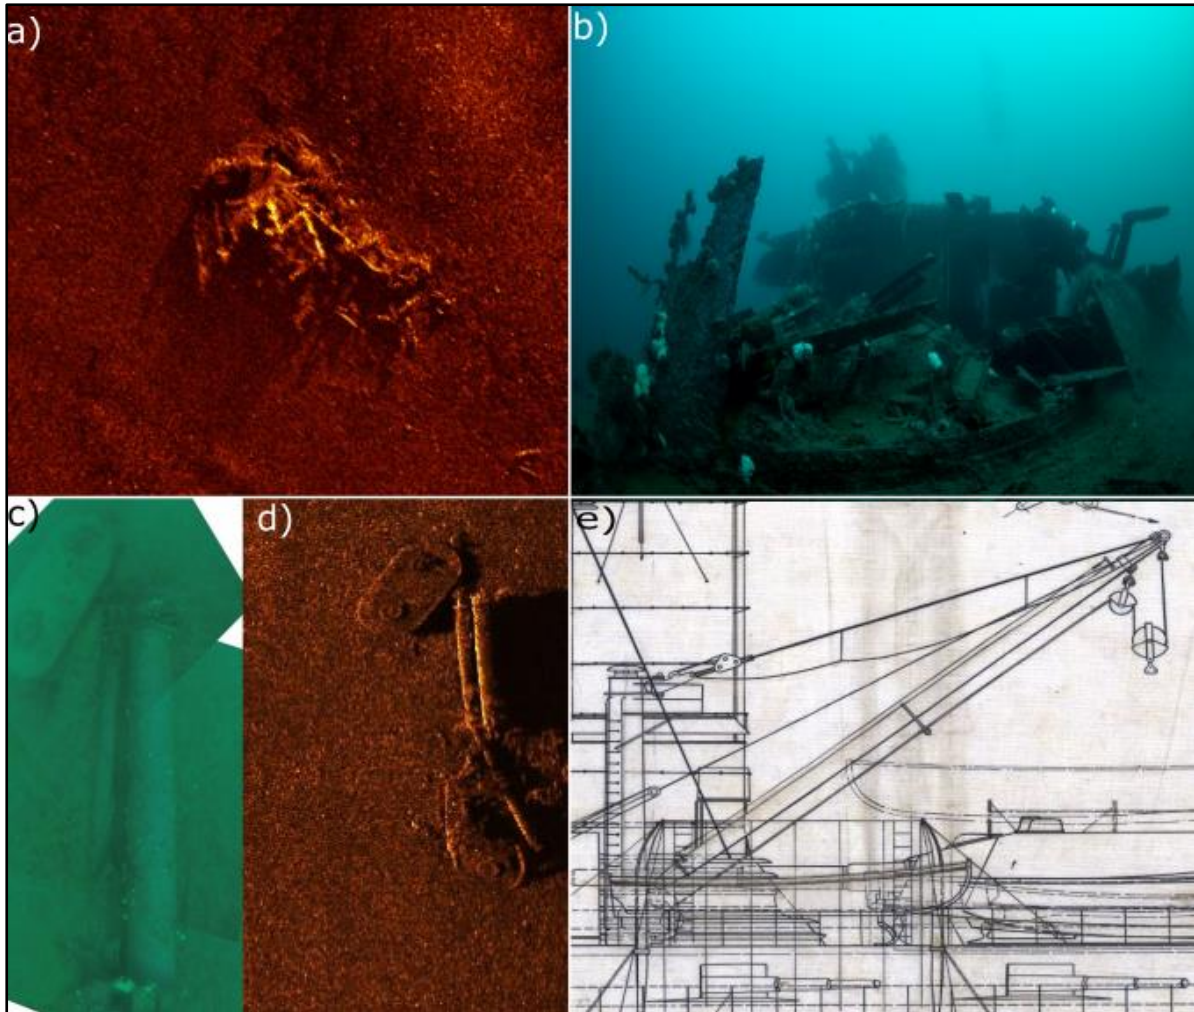
Plate 16 a) side scan sonar image SS085 b) SS085 bridge structure cabin c) side scan sonar image SS066 d) SS066 photographic mosaic of the site showing searchlight platform, samson post and derrick arm e) Kaiser Class derrick

SS085 is bridge structure cabin with a heavily corroded surrounding platform. A sheared mast abuts the front of the cabin, the deck was formed to receive a curved structure, most likely the aft part of the armoured control room; funnel gratings are also present on this site ([Plate 16a; 16b](#)). The cabin is most likely of the Kaiser Class style. SS065 is a top searchlight platform, with a derrick arm and samson post along with a lower searchlight platform. No searchlights are visible ([Plate 16c; 16d](#)). There is a coal winch located to the south of this. In close proximity to SS065 is SS066, a derrick arm and samson post, and the remains of a deck mounted winch. There is an abandoned scallop dredge on this site. SS065 and SS066, because of their positioning on the seafloor, match the layout of a Kaiser Class vessel, which are offset one on the starboard forward funnel and one on the port aft funnel. The Kaiser Class derrick arrangement differs from the Konig Class due to their layout on the ship and pulley arrangement at the top of the samson post ([Plate 16e](#)).
