VANGUARD 100 DIVE TEAM

SS Prudentia, Scapa Flow

Diver site survey 22nd November 2016

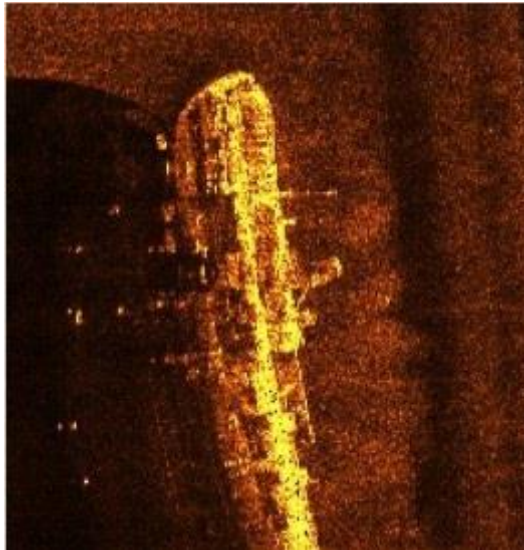
Stern view

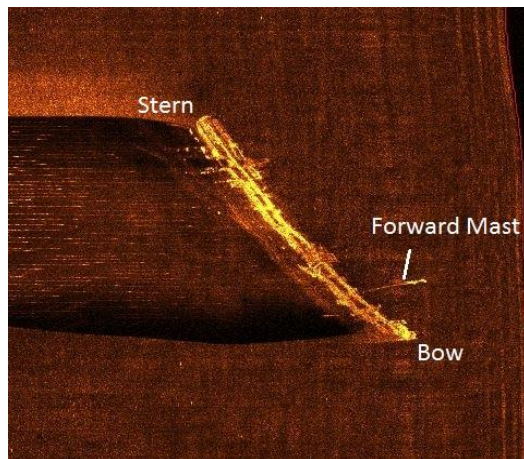
Overall view

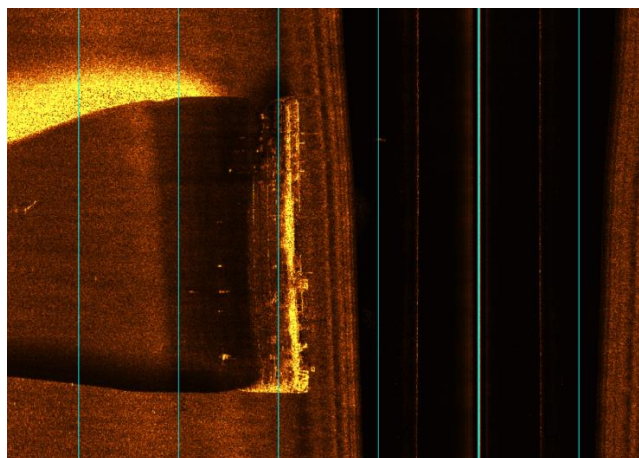
Propeller and rudder view

On the hull side an iron 4 bladed propeller was missing one blade and sitting behind a single rudder still set to midships. The missing blade appears to sit on the seabed below the wreck.

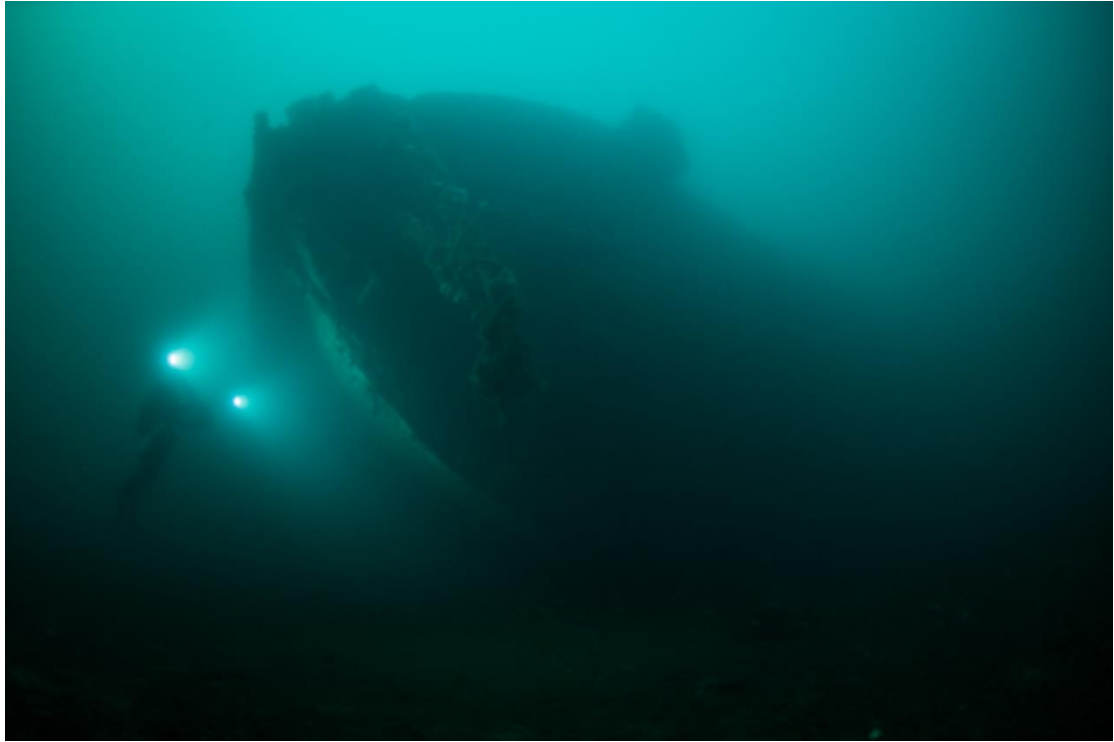
There is obvious evidence of her role as an oiler: a large gantry lies off the bow, presumably hose handling gear. On the starboard side at the stern and running alongside the crew accommodation, an area of deck is dedicated to hose handling terminating in a dedicated cut-away in the stern to allow the hoses to run overboard.

Bow, with hose gantry hanging down

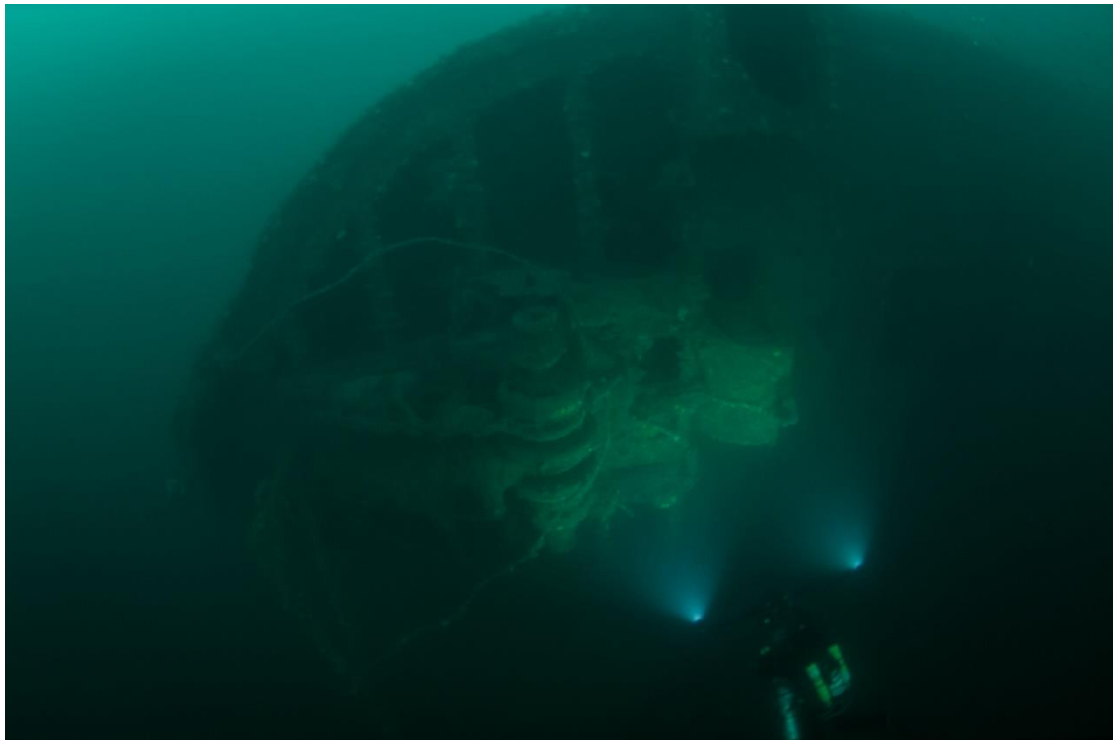
Bow with anchor handling gear on fore deck

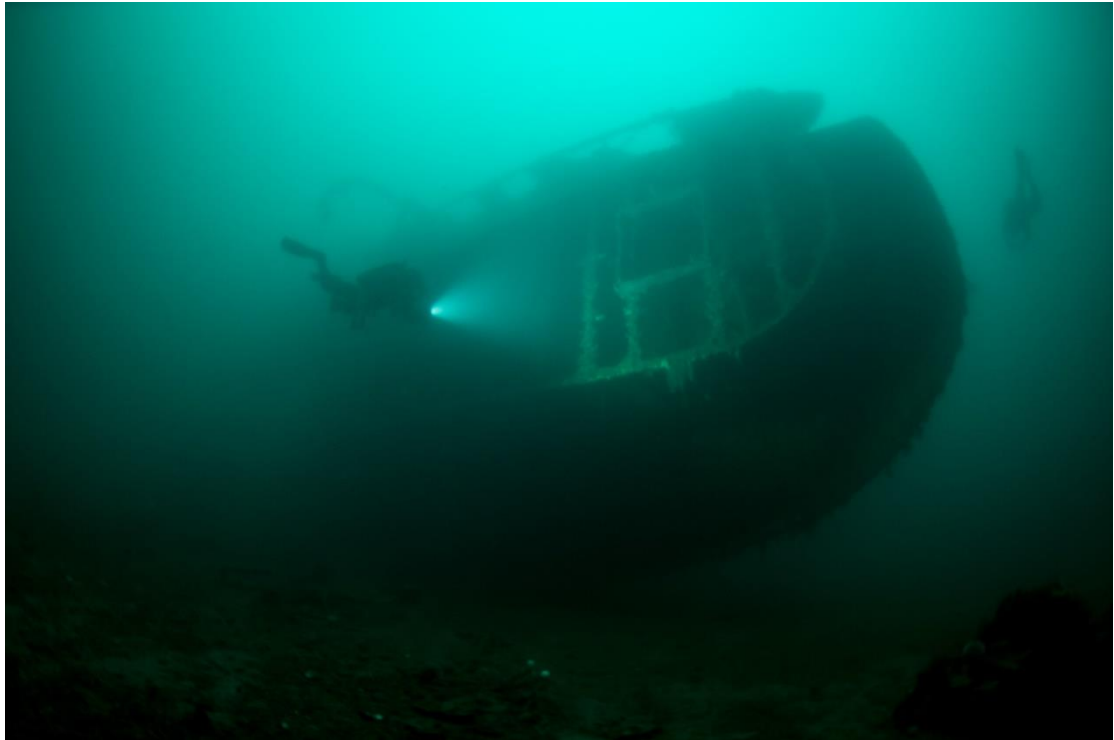
Stern showing through top of accommodation.

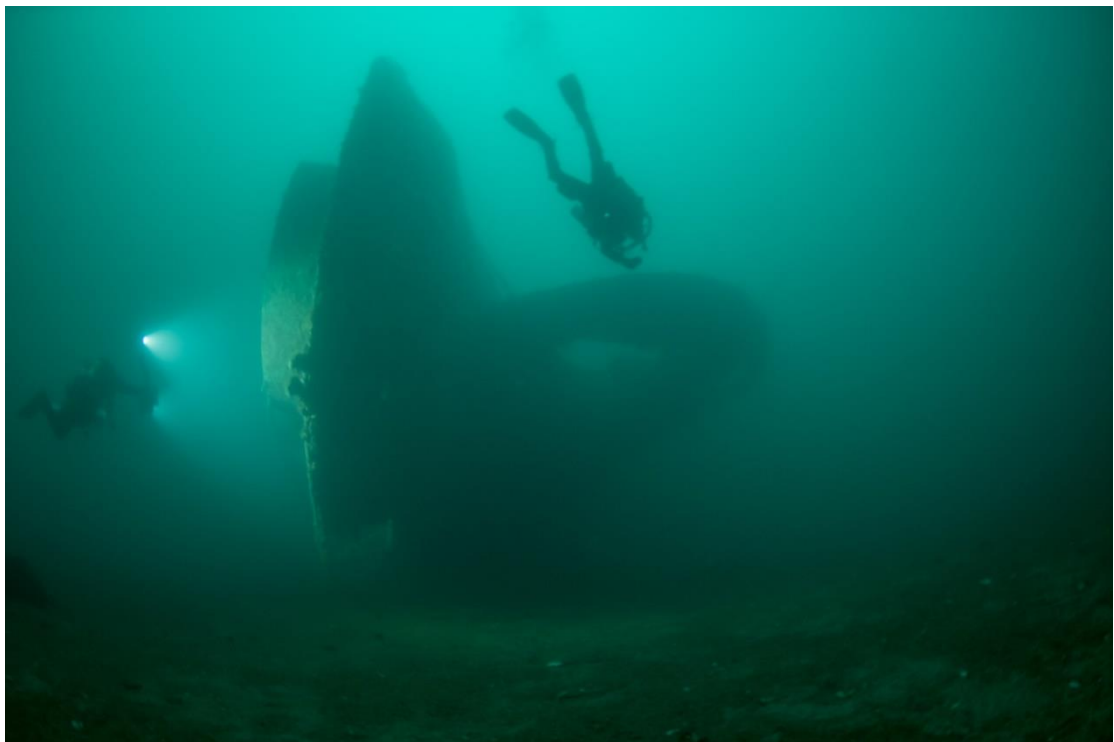
Stern showing rudder

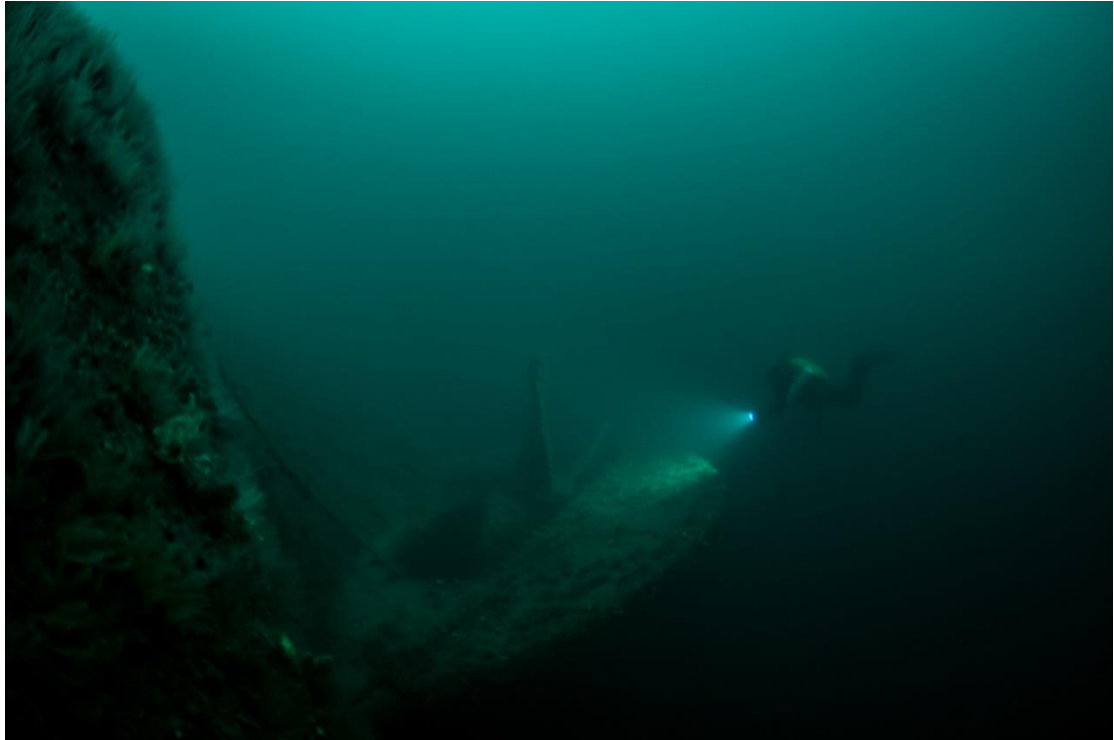
Rudder and propeller

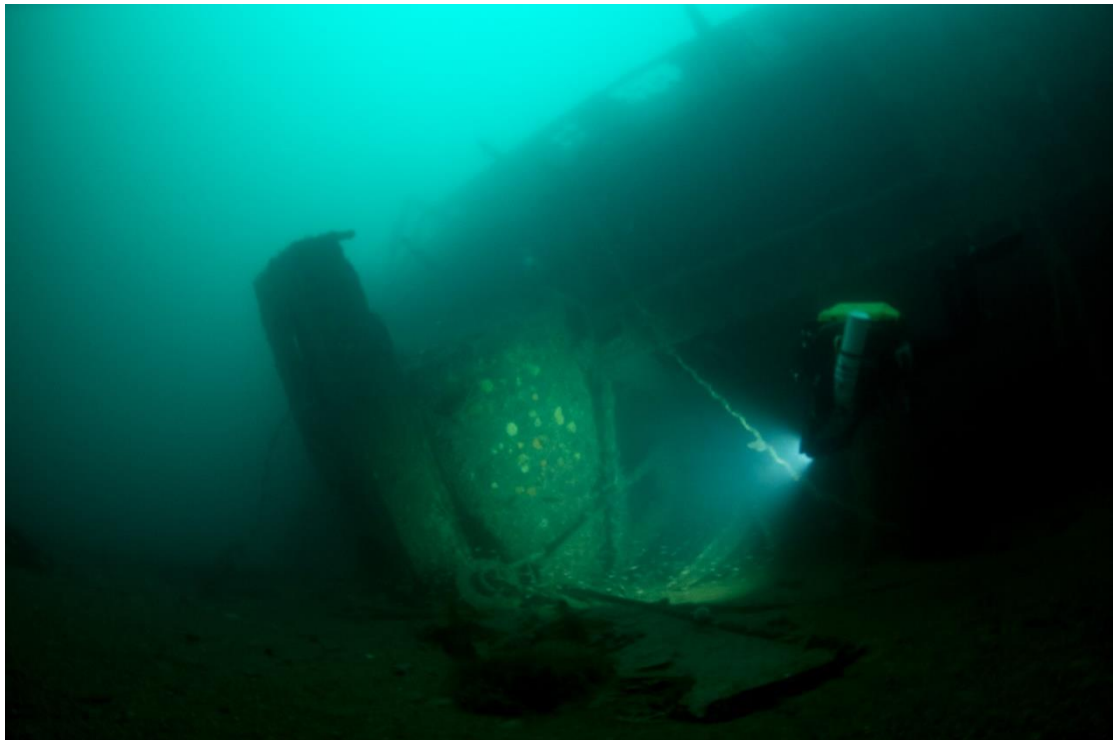
The Prudentia differs from the traditional three castle layout with a triple expansion steam engine located toward the stern rather than midships and the crew accommodation at the very stern. The engine was still in place and easily visible. Curiously, it looked as if there had been a steam boiler mounted above deck which has subsequently fallen from her cradle and lies on the seabed. The auxiliary steering helm was also evident with the central hub of the wheel and spokes still in place. The bridge had collapsed down onto the seabed and bridge wings with associated handrails etc resting on the sand.

Boiler fallen from cradle

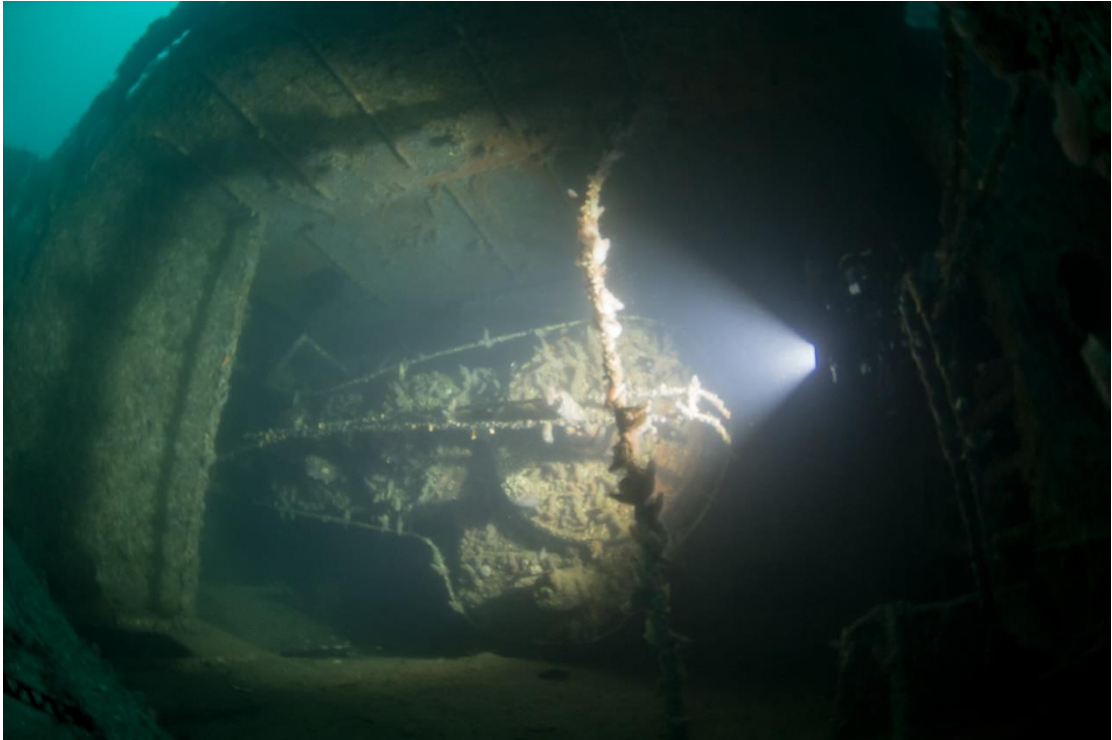
Many artefacts were seen scattered around the wreck including cutlery, crockery and other galley hardware, oil cans, a compass binnacle carcass and the makers plate itself. The wreck is in stunning condition with many features completely undisturbed and almost completely intact. The steam engine in particular was the best preserved example of a triple expansion steam engine that this author has seen in a 20yr diving career.

Top view of steam engine

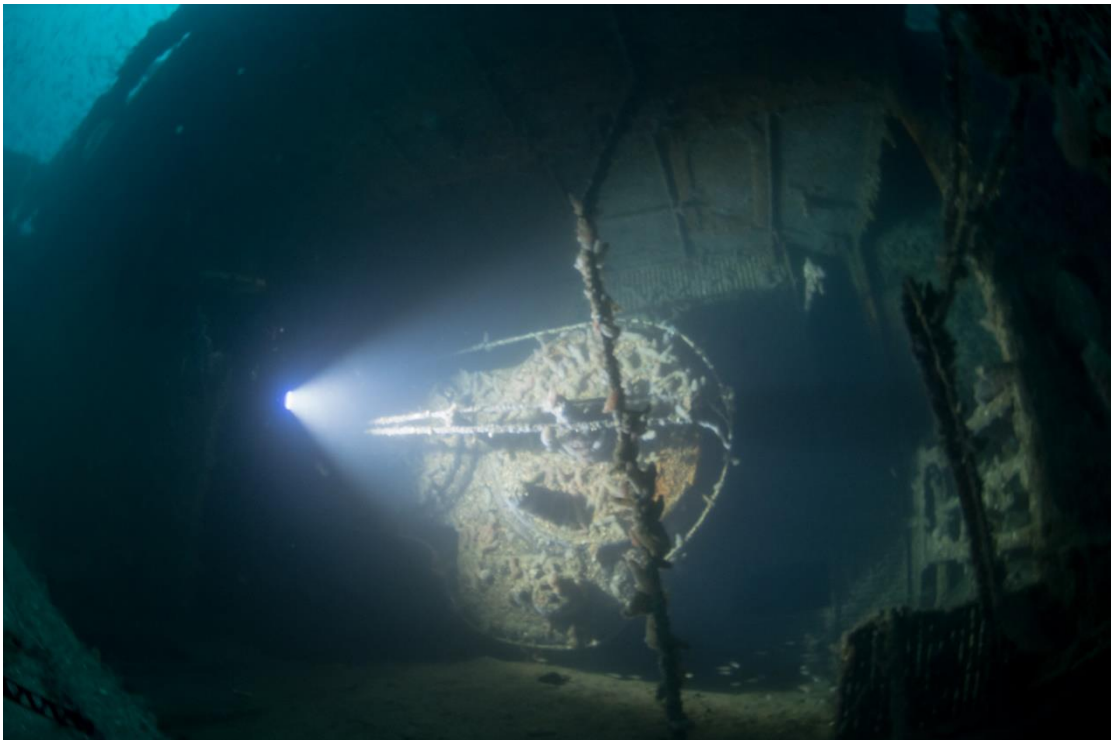
Top view of steam engine showing low pressure piston

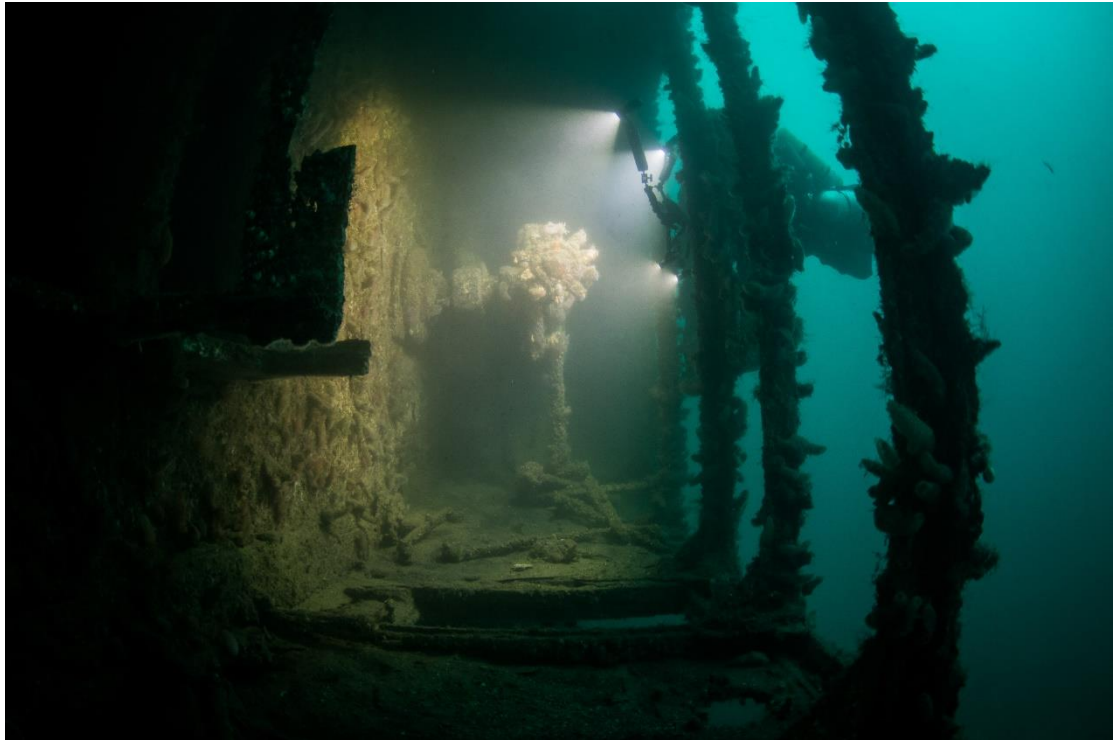
Auxiliary steering gear

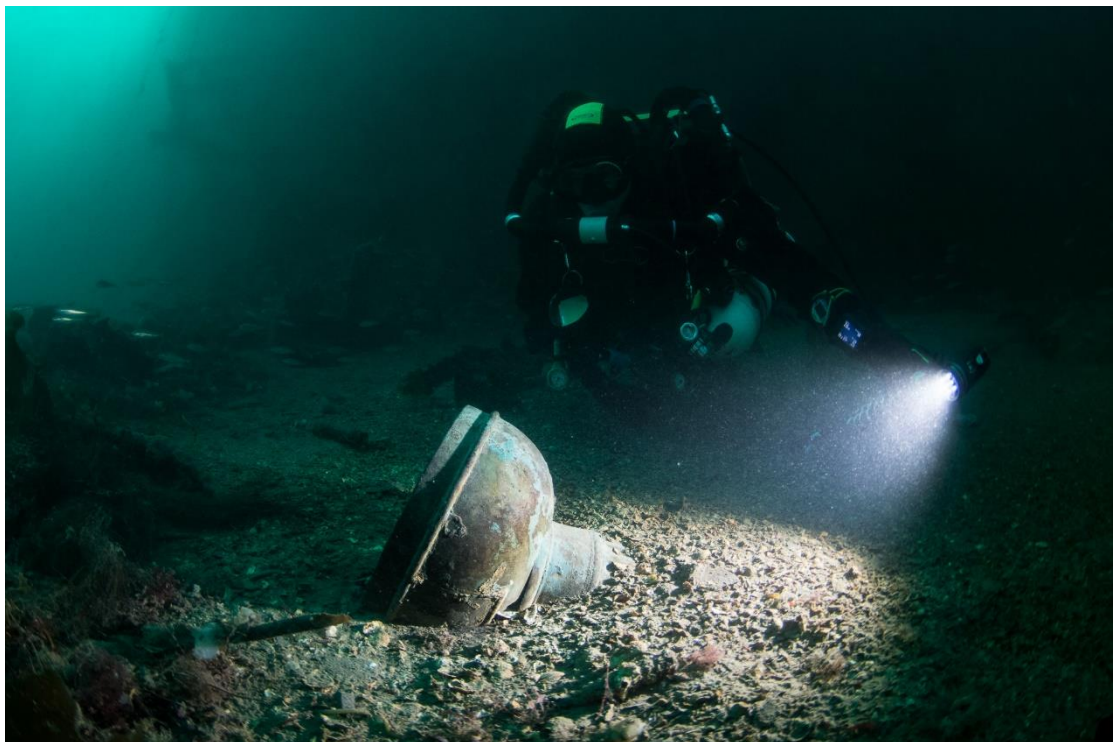
Carcass of compass binnacle

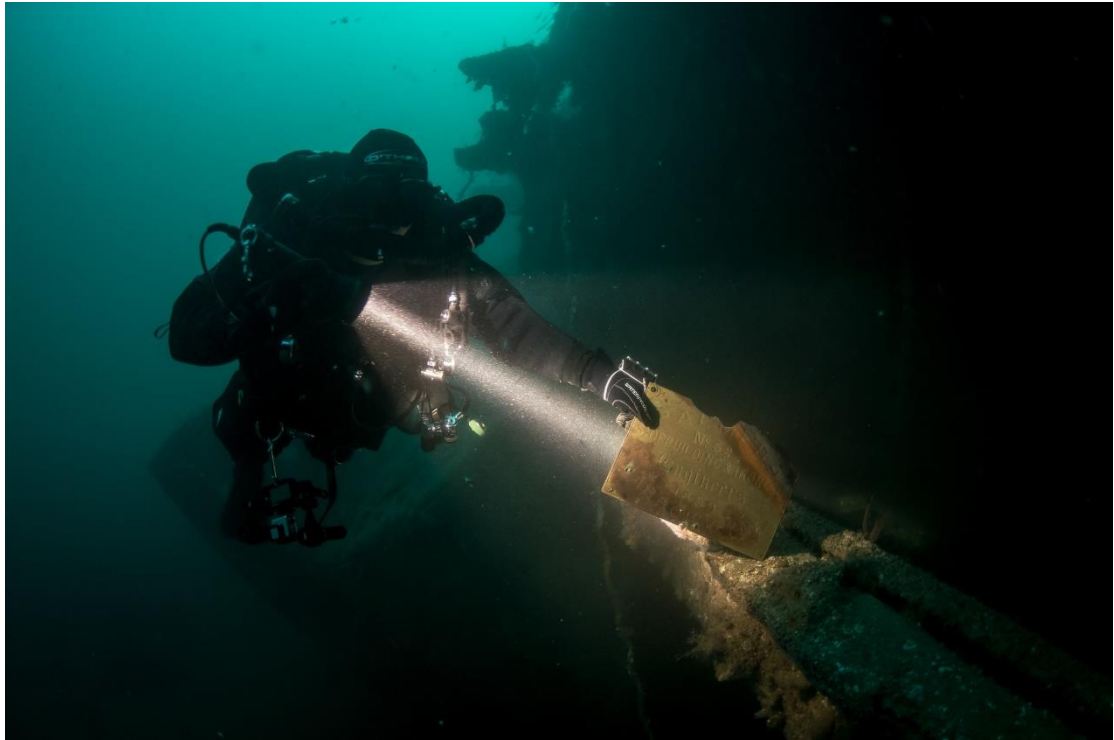
Maker's plate

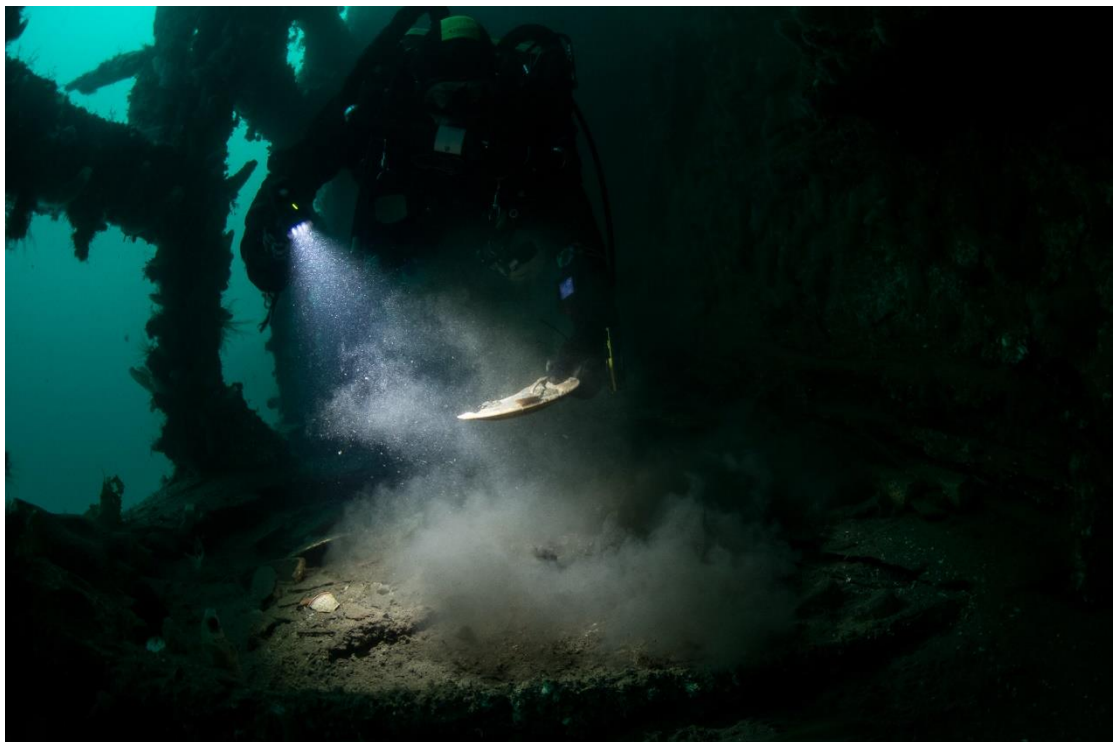
Cutlery and crockery

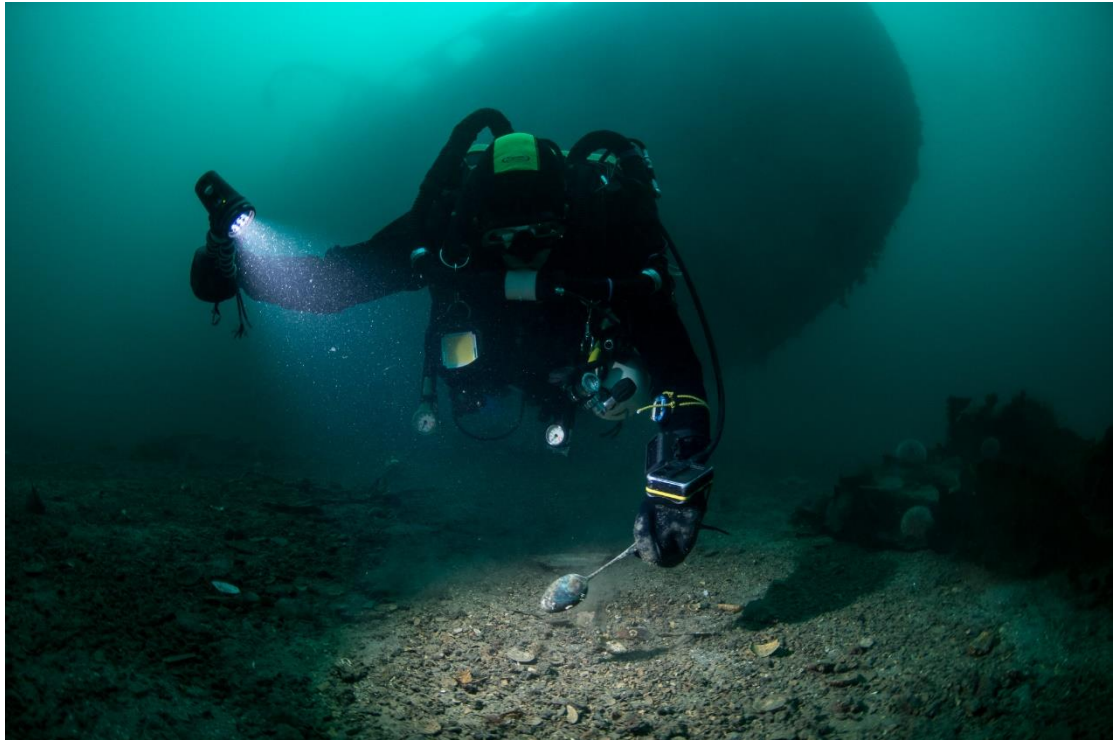
Cutlery on the seabed

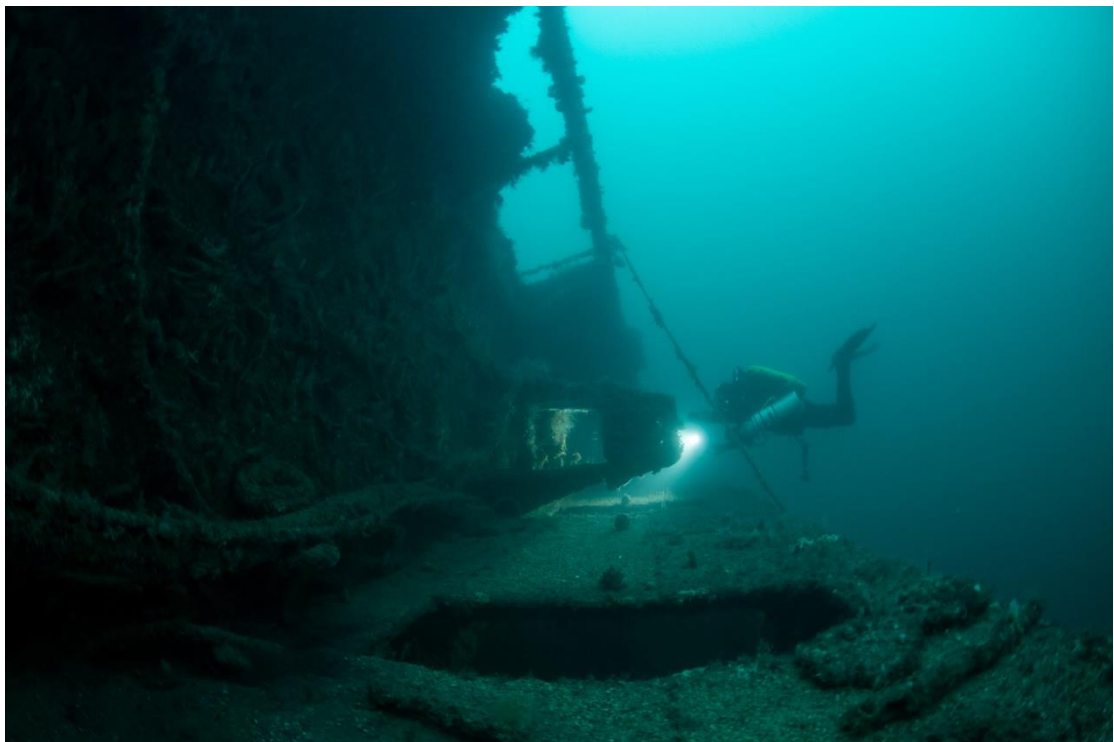
Hose handling gear at stern

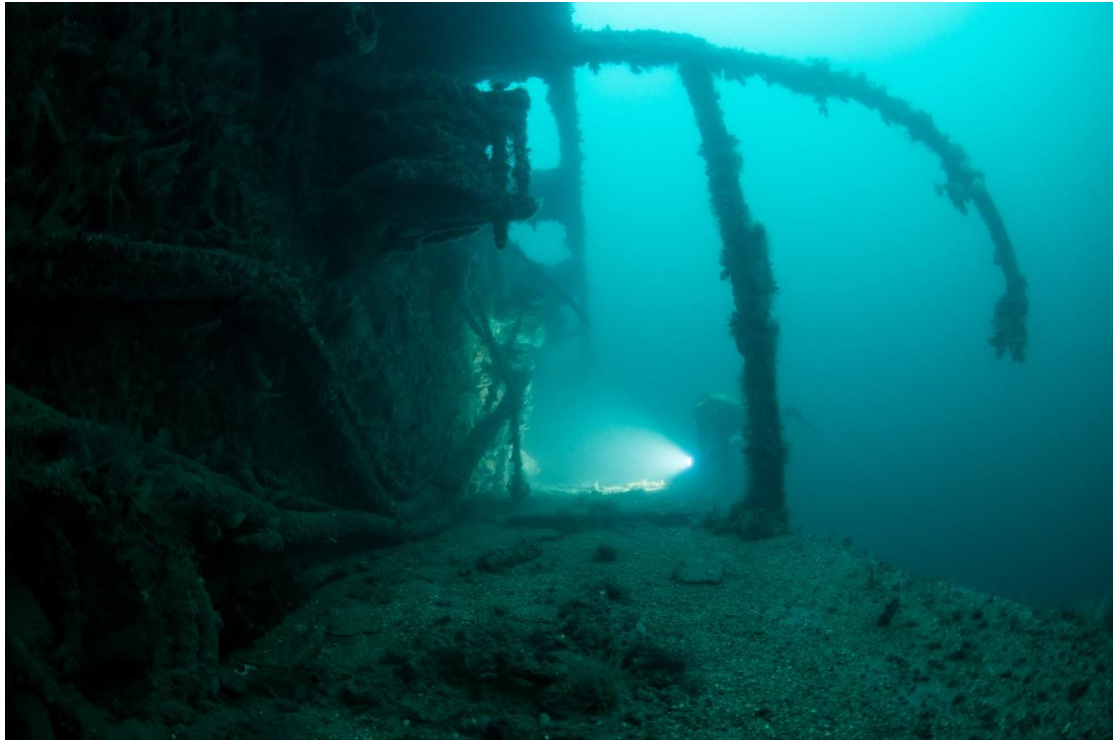
Hose handling gear
