# 32 – 38 MILLHILL, MUSSELBURGH, EAST LoTHIAN

## HISTORIC BUILDING SURVEY

commissioned by Loretto School

January 2017

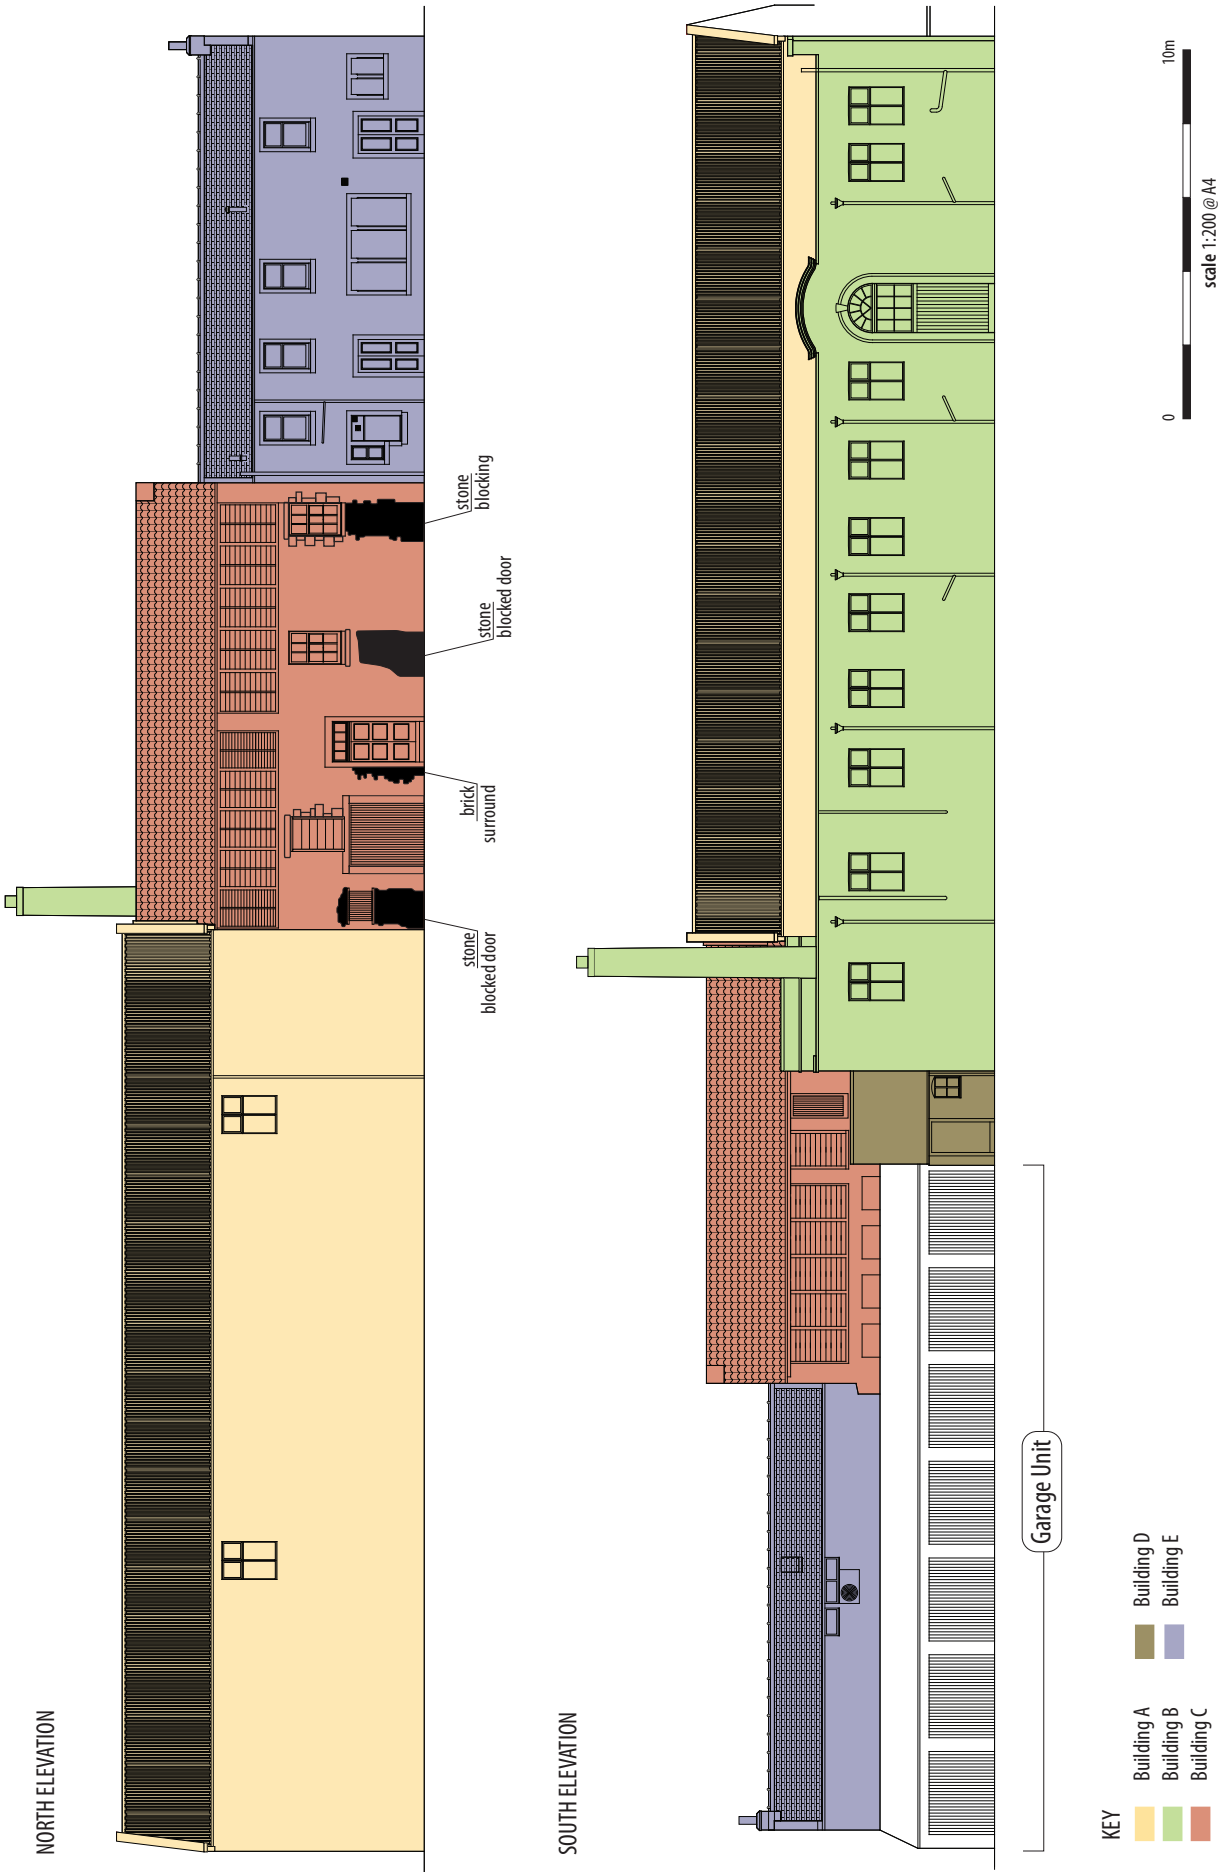
**ILLUS 5**  
North and south external elevations of Buildings A – E

This was a long tall rectangular building with a pitched corrugated roof that abutted Building C to the west and a row of Victorian houses to the east. The external appearance of this building gave little impression as to its present day use. The rendered north wall facing onto Millhill presented a long tall wall with no features or openings. The east and west gables were mostly masked by attached buildings although the tops of the gables were partially exposed. The south elevation was formed by the south wall of Building B that formed the main entrance to the swimming pool. The original south wall of Building A had presumably been demolished (probably during the construction of the swimming baths in 1919). Only the lower courses of the line of the original wall were still present, being recorded in the basement below the pool (Illus 5).

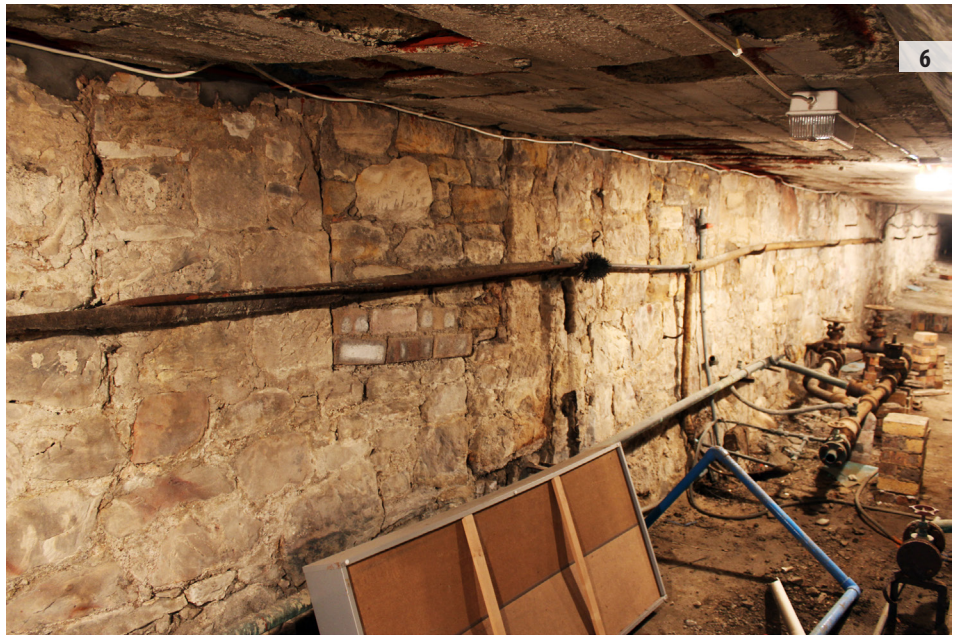
**ILLUS 6**

Although access to the basement area was limited the rubble stone walls recorded below the pool presented a number of features. On the north wall three stone-blocked windows were visible close to the west end. These would have been partially below the present street level. The west wall included a narrow brick-blocked doorway close to the north side. No openings were found on the south wall although in places the wall projected into the building that may present evidence of additional support for the location of heavy machinery (Illus 7).

View of the north foundation wall of Building A

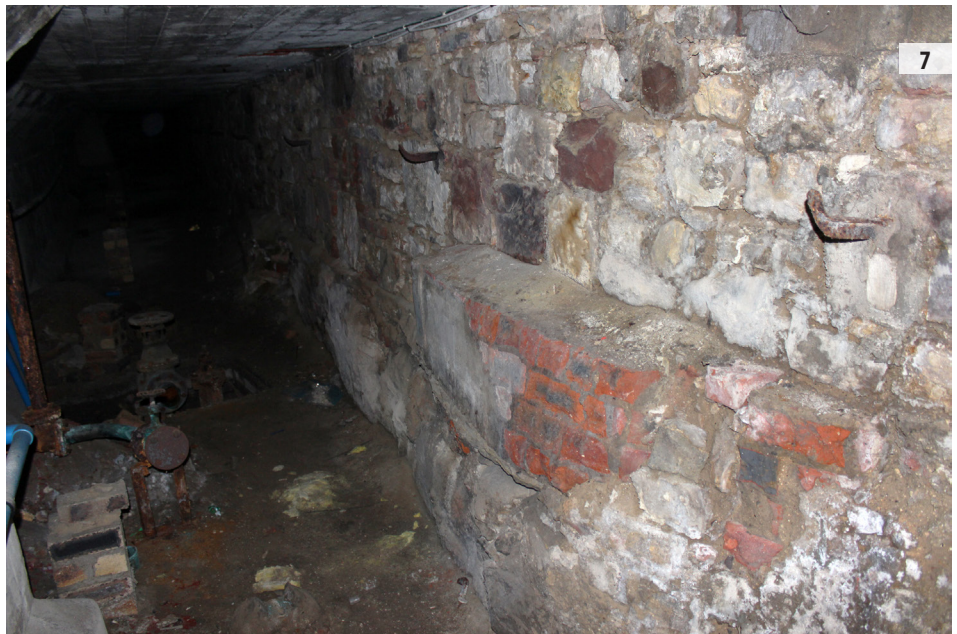
**ILLUS 7**

Detail of the projecting south foundation wall of Building A

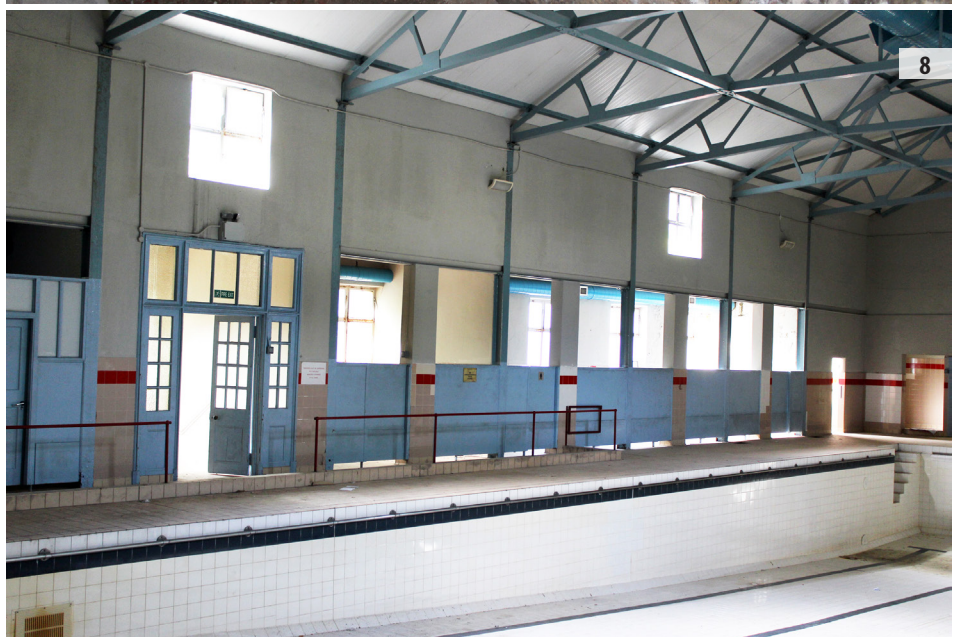
**ILLUS 8**

The internal division between Building A and Building B were marked by the painted timber walls of the changing rooms and shower blocks located to the south side of the swimming pool (Illus 8).

View of the changing room and shower partition walls in Building B

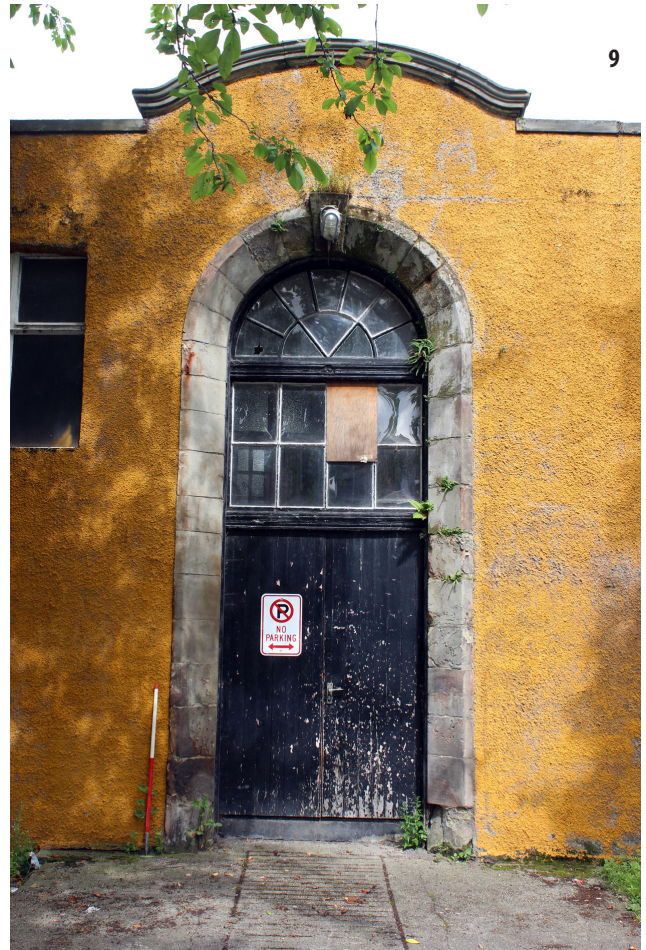
**ILLUS 9**

building into the swimming baths in 1919. The rendered external south wall of this building included a double swing door with an elaborate arched stone surround flanked on both sides by plain casement windows which also continued along its length. The stone surround to the door had a decorated bevelled edge and a projecting key stone with the door itself including a rounded skylight. The top of the wall above the door included an arched pediment topped with a projecting cap stone (Illus 9). The roof of this building was flat and as it wrapped around the west side of Building A it stepped up in height. This part of the building also included a tall square chimney that was thought to be part of the same phase of construction.

Detail of the pool entrance on the external south wall of Building B

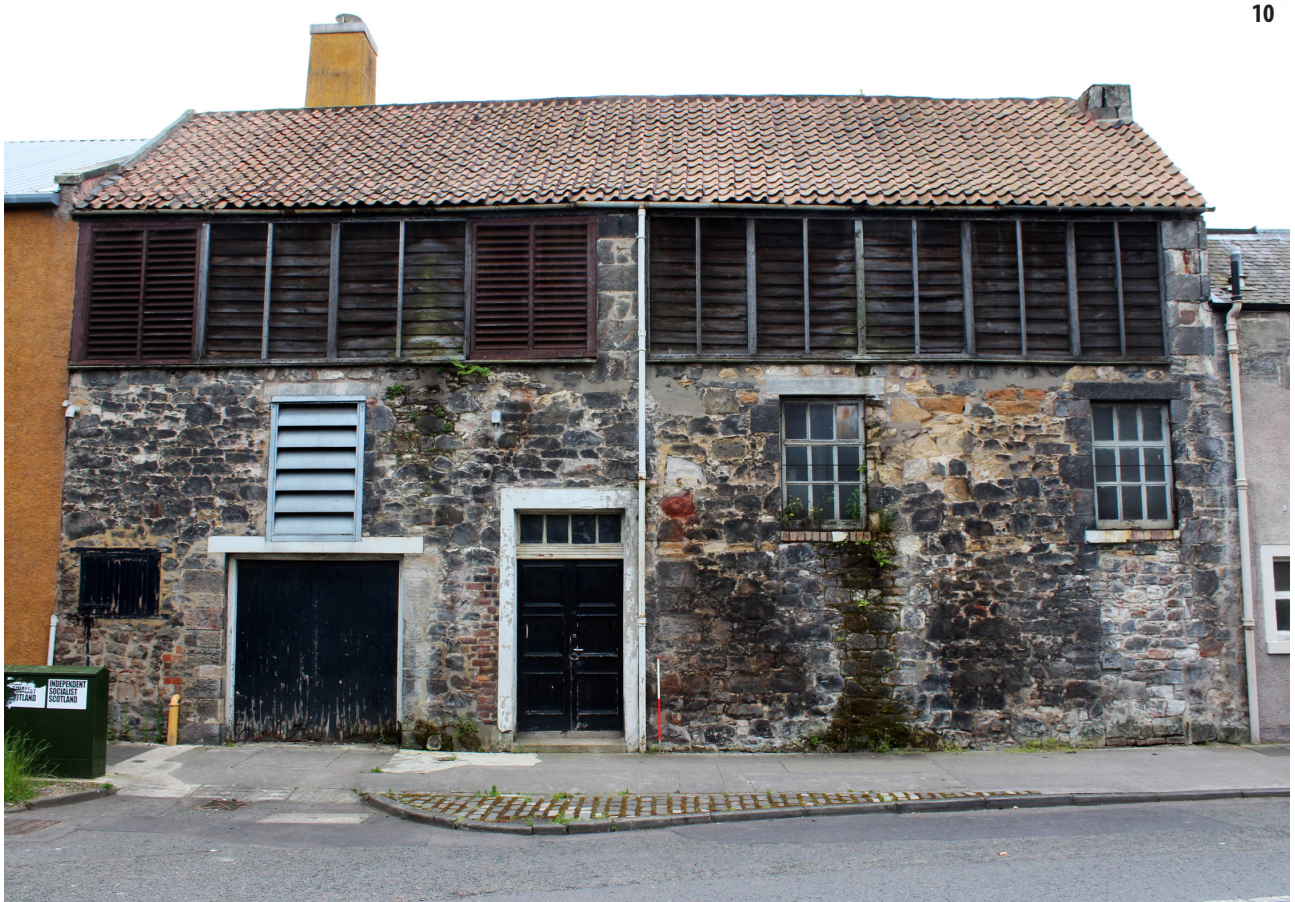
**ILLUS 10**

The external rubble stone north wall displayed a number of features and alterations although the addition of later openings and the application of new cement in places made the interpretation of this wall difficult. In its present state the elevation included a main entrance door, a wider garage door and a timber hatch along with two windows and a steel vent high up on the ground floor level. Above this was a series of timber slatted vents forming the first floor wall. These vents occurred on both main elevations of the building.

View of the north external wall of Building C

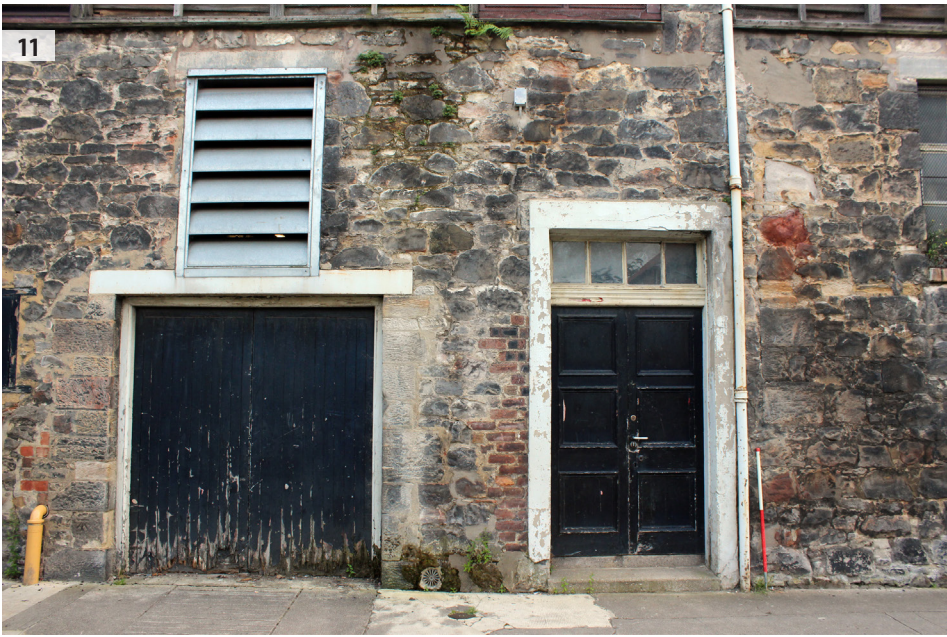
It was clear that the two doors on the north wall were later phase alterations due to the occurrence of brickwork abutting the door surrounds (Illus 11). These features may relate to the conversion of the buildings into baths in 1919. The hatch to the east side of the doors was also probably part of this development. The brick cills and concrete lintels of the two windows indicate a level of alteration. The window to the east side was clearly a later addition, although the window to the west side included tool-marked in-out surround stones that continued below the level of the inserted window. This suggests that although this was the location of an original window a new shorter window had been inserted at a later date contemporary with the window to the east. Further in-out surround stones were present to the west side of the steel vent above the garage door

**ILLUS 11**  
Detail of the doors on the external north wall of Building C

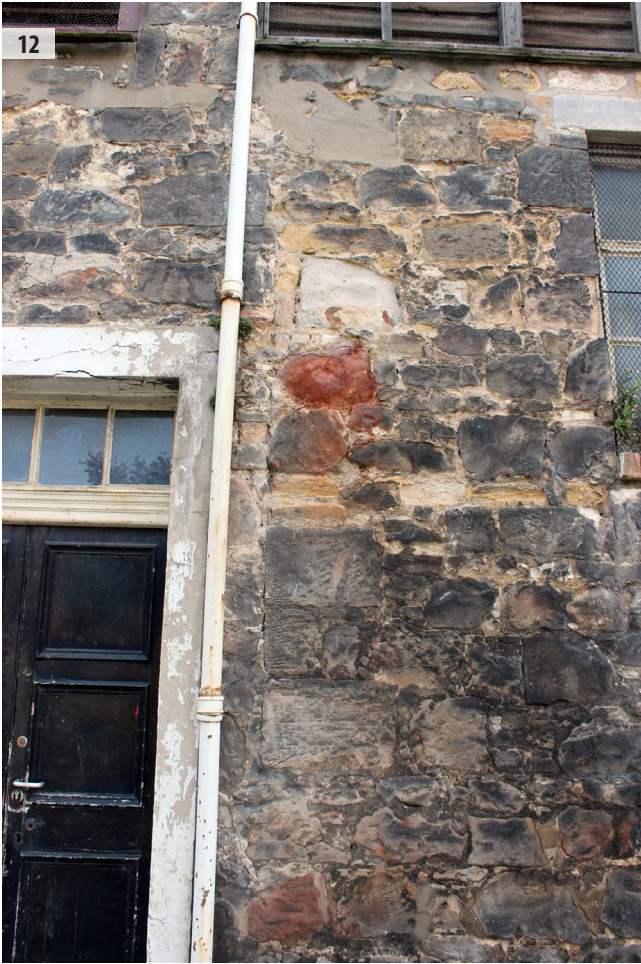
**ILLUS 12**  
Detail of the in-out surround stones to the west of the door on Building C

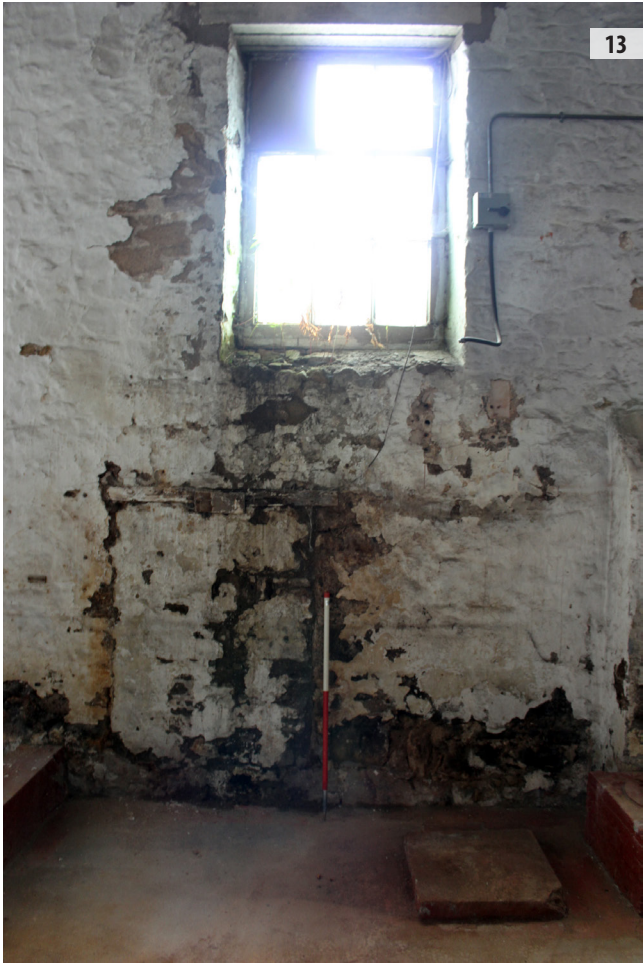
**ILLUS 13**  
Internal view of the stone-blocked door on the north wall of Building C

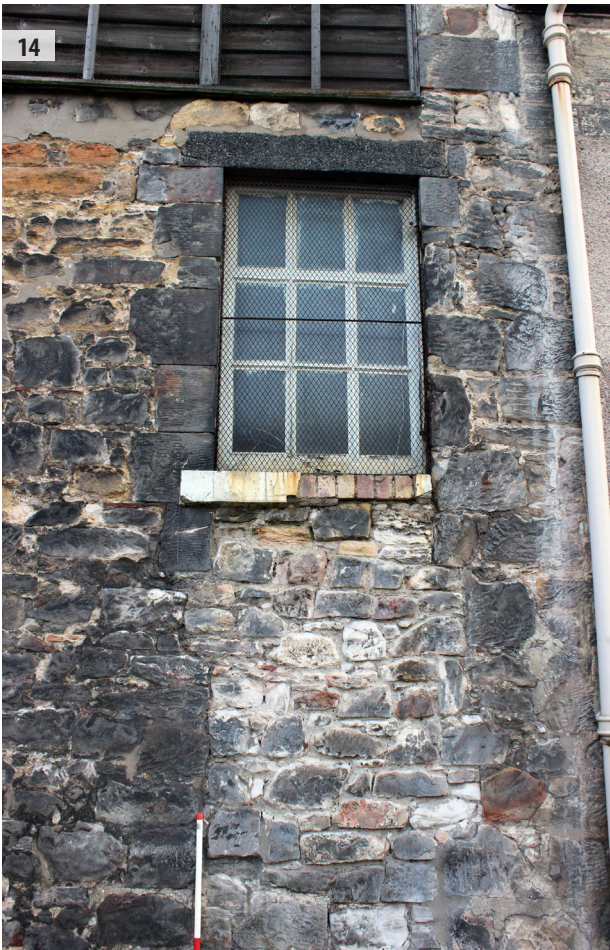
**ILLUS 14**  
Detail of the construction lines on to the west side of Building C

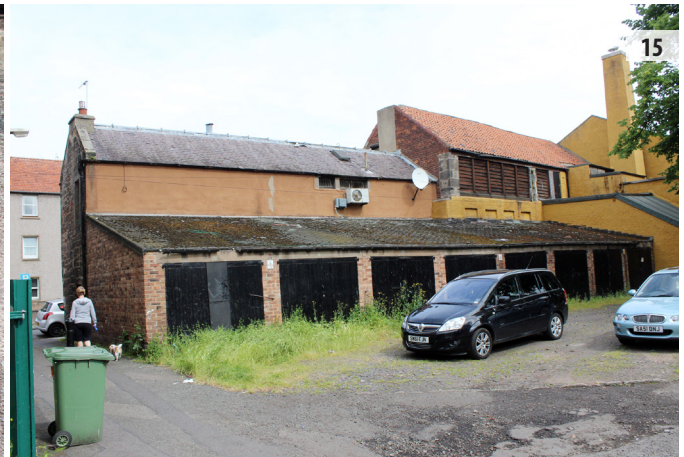
As mentioned above, much of the south external elevation was masked by other buildings including the modern garage unit (Illus 15). The walls on this side of the building had also been covered in the painted render masking the construction material. All that was visible was the top half of four blocked windows on the ground floor and the timber venting on the upper floor. One feature of note on the south wall was recorded at the west end of the wall. Here the wall at ground floor level extended further to the west than the first floor level forming a small step in the wall (Illus 16). This evidence indicated that the whole of the upper floor of the building may have been part of a later phase. The reasonable condition of the timber venting across the upper floor would indicate that it was not that old. Given the ground floor rooms would have held strong chemicals for the swimming pool the ventilation was probably associated with the pool, although a tannery would also have needed good ventilation. The brick gable end of Building C visible above the roofline of the public house (Building E) was further evidence of this later phase construction as it would be expected that the original construction would have been stone.

**ILLUS 15**  
View of the south side of Buildings C, D and E

The only demolition work due to be carried out comprises the removal of the garage units to the rear of the buildings. This may reveal further features of the south elevations of both Building C and E. A photographic record of this once the garage has been removed and prior to any rendering work would be recommended.

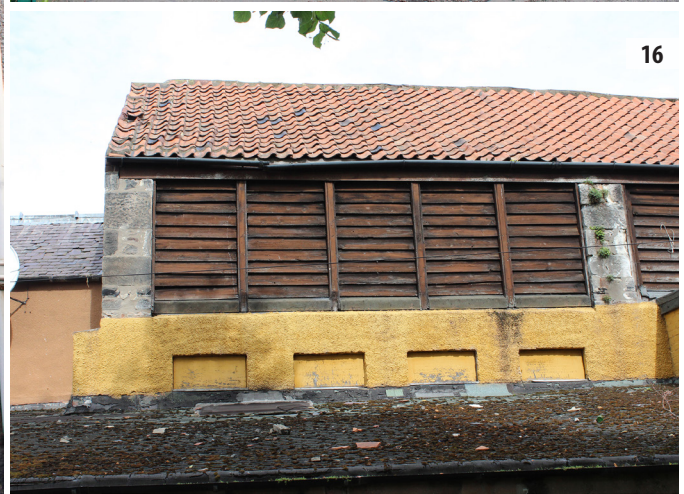
**ILLUS 16**  
Detail of the ground floor north wall of Building C extending to the west

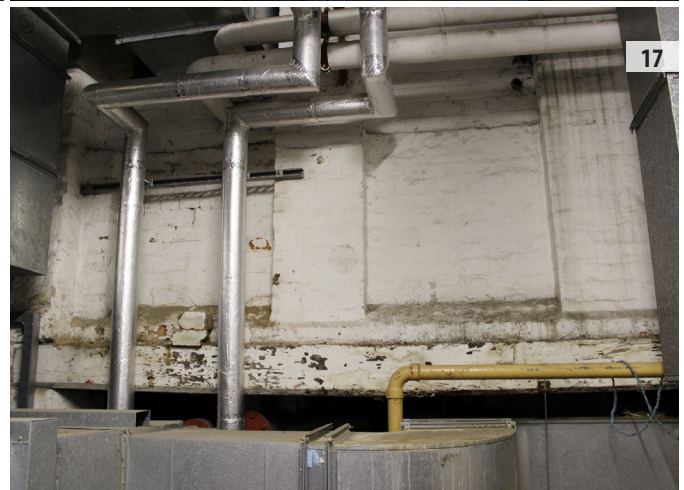
**ILLUS 17**  
Internal view of the south wall of Building C (east side)

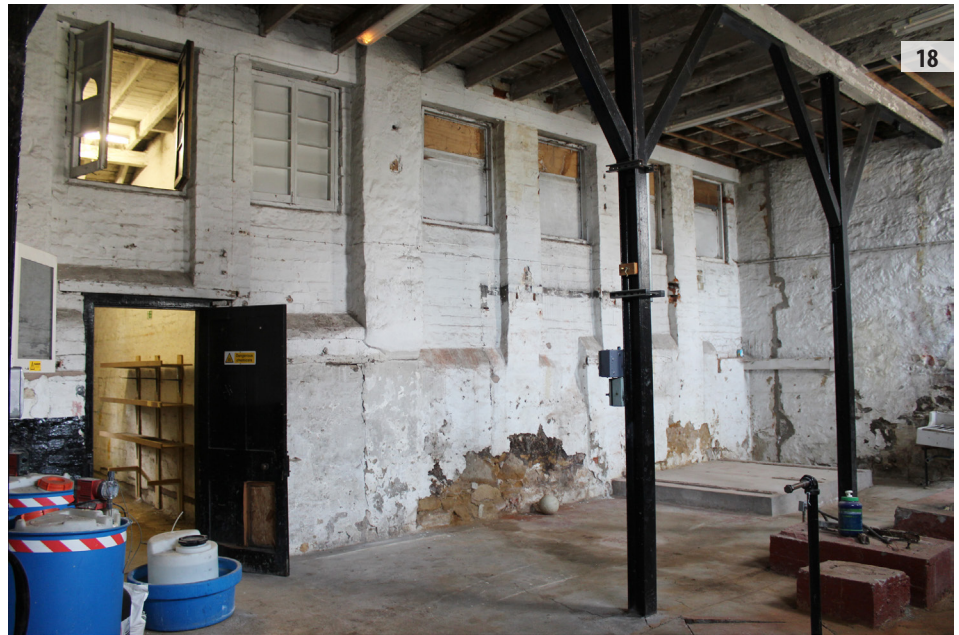
**ILLUS 18**

Internal view of the south wall of Building C (west side)

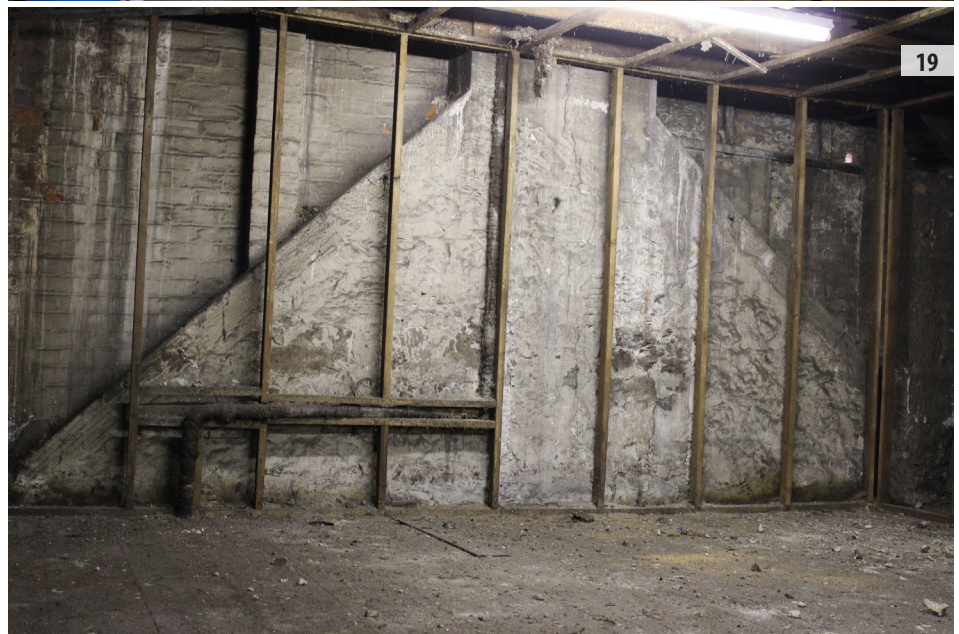
**ILLUS 19**

Access to the attic/upper floor space was gained by a timber stairway located in Building B. Within the attic area the stone gable of Building E extended slightly into the room (Illus 19) with the brick gable of Building C constructed over the top of it. This indicated that the gable of Building E had been constructed earlier than the roof and gable of Building C, providing further evidence for the assumption that the upper floor of building C was a later phase construction. The only other feature of note in this space was a large cast-iron water tank sat on the timber floor.

Detail of the Building E gable in the attic of Building C

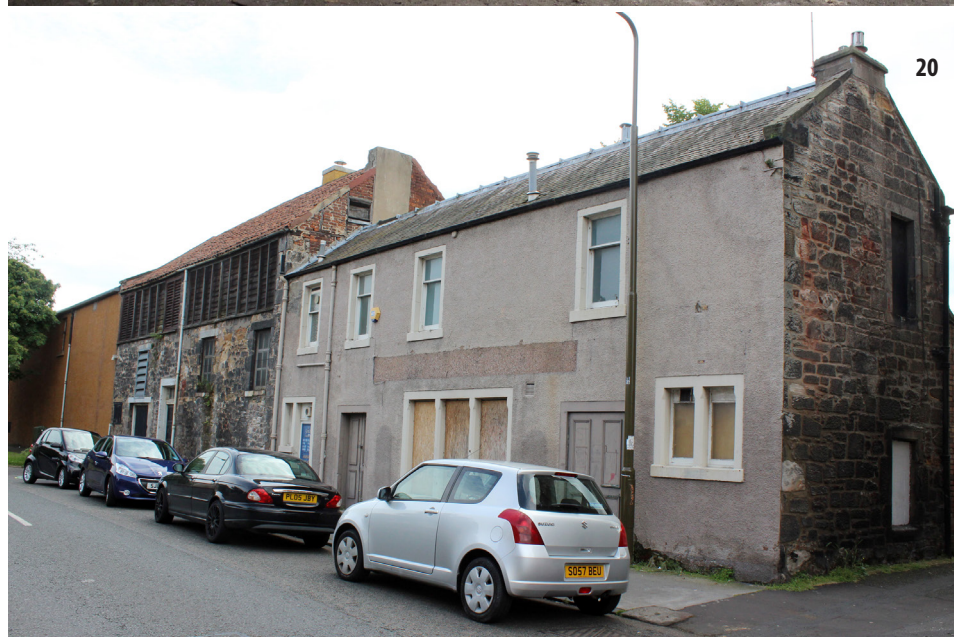
**ILLUS 20**

View of the Golf Tavern
