ROINEACH MHOR, GLEN CLOVA, ANGUS

Historic Building Recording

For KDM Architects on behalf of Mr Hugh Niven

15/00494/FULL

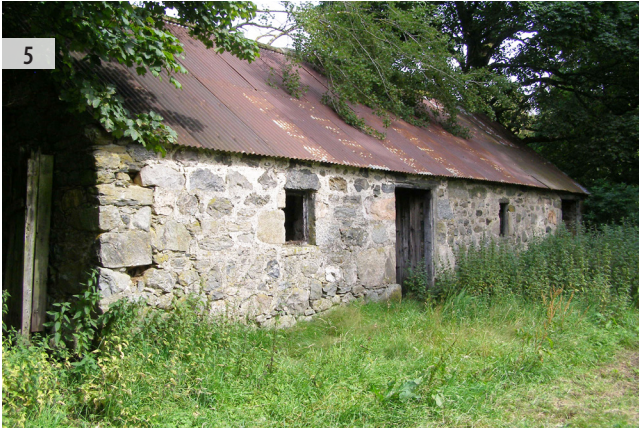
The south elevation of the building measured 13.5m and 2m from the ground to the overhang of the roof (Illus 4, 5). A window (0.6m by 0.7m) and a doorway (1.2m by 1.85m) were present on the western section of the elevation, which provided access to Area B

ILLUS 5 South elevation **ILLUS 6** Window and doorway into Area B in south elevation **ILLUS 7** Window and doorway into Area C in south elevation
ILLUS 8 East elevation with blocked window **ILLUS 9** North elevation **ILLUS 10** West elevation and exterior of enclosure wall of Area A

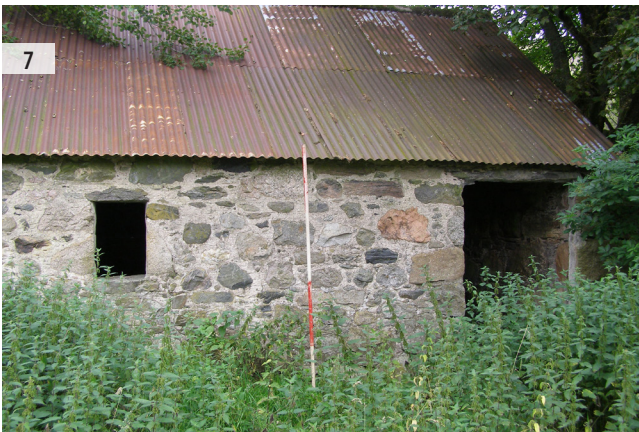
(Illus 6). The eastern section of the south elevation also contained a window (0.4m by 0.7m) and a doorway (1.2m by 1.8m), which provided access to the interior of area C (Illus 7).

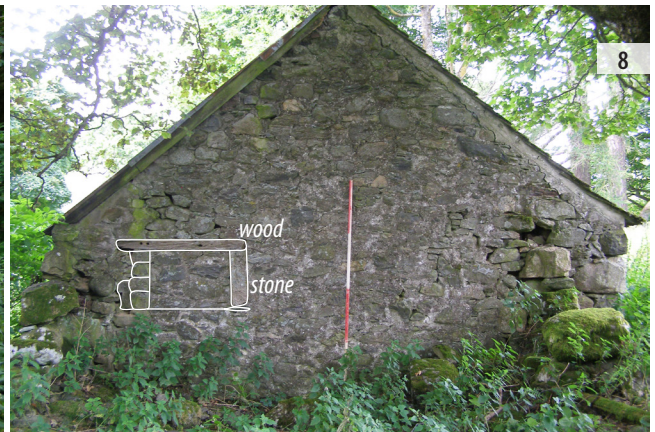
The east elevation of the main structure measured 5.5m in length and c1.75m from the ground to the eaves of the roof and c3.5m high from the ground to the apex of the roof. On the southern half of the elevation was a window which had been blocked with sub-angular stone and lime mortar (Illus 8). A wooden lintel and stone jambs were visible from the original window opening. The eastern elevation had been rebuilt on both north and south corners to incorporate the north and south walls of the enclosure, indicating that these were added at a later date from the main building. It is probable that the window was blocked during this phase of restoration and extension.

It is clear that the building has undergone at least four phases of construction or alteration, with the first being the main construction of the farm building itself. The second phase resulted in the addition of the enclosure to the east elevation and subsequent blocking of a window which would have originally looked out towards the valley to the east. The third phase comprised the building of the enclosure on the west elevation, abutting the main building. It is possible that the enclosures in the east and west were contemporary, however the differences in construction would infer that they were in fact built at different times. Due to the state of disrepair to the eastern enclosure, it is more likely that this is earlier than that in the west.

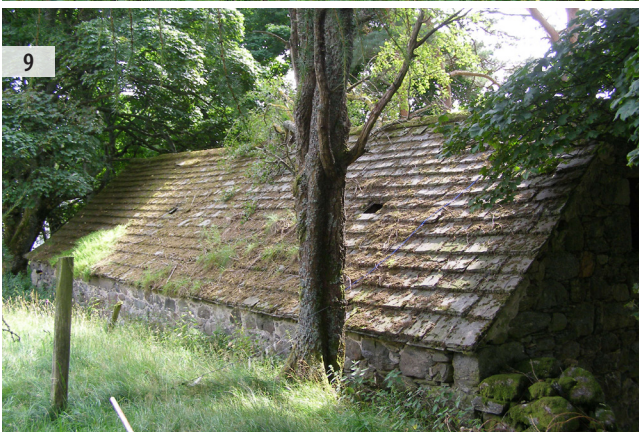
The northern elevation of the main building was partially built into a grassy bank, therefore no features were present in the c. 0.75m which was visible above the ground to the eaves of the roof (Illus 9). Where the eastern enclosure (Area D) joined the main structure, the wall had been rebuilt and it was not possible to see the join. This section of the wall runs eastwards for approximately 22m, but is extensively collapsed, possibly due to the dry-stone construction. Around 11m from the join with the main structure, a large stone block was visible in the elevation, which marks an internal north-south division within Area D.

At the western end, the north elevation shows the north wall of the western enclosure (Area A) abuts the main building, and is evident that it is a later addition (Illus 9). Part of this section of the northern elevation has collapsed, especially where it extends above being built into the slope to the north. The difference in techniques used to join the eastern and western enclosures to the main building (abutting in

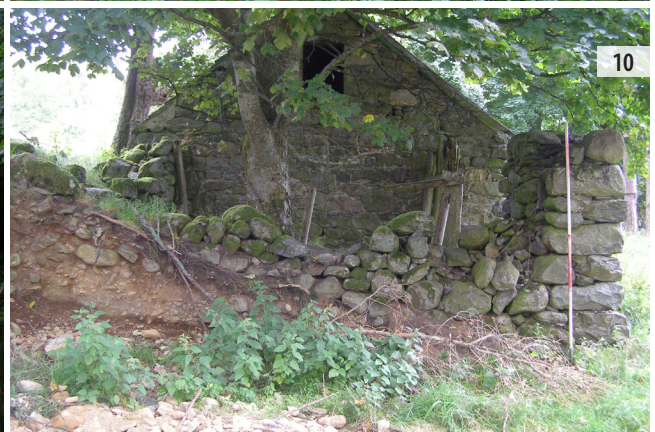
The west elevation of the main building measured 5.5m long by 2.1m high from the ground to the eaves of the roof and c3.5m to the apex of the roof. An unglazed window was present in the middle of the elevation, approximately 2.5m from the ground, measuring c0.6m by c0.7m (Illus 10).

The elevation of the extreme western wall of Area A had largely collapsed. Overburden and vegetation had been removed from the side of this wall in the recent past, and from the cleared section it was apparent that the wall was poorly constructed of drystone rubble, sitting directly on the topsoil of the natural slope, with no foundation layer or formal structure.

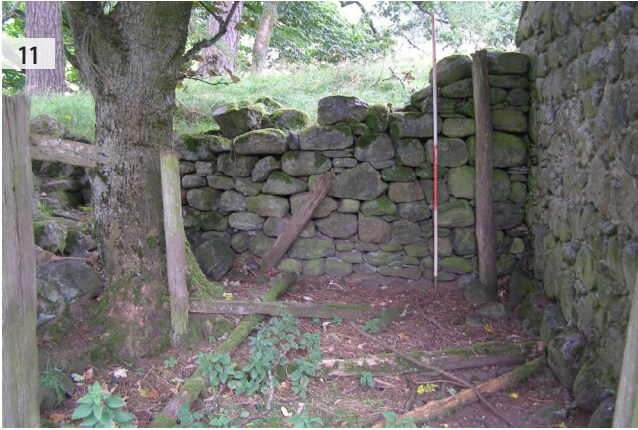
Area A was a later enclosure which was added onto the west elevation of the building, using similar materials to that of the main building. This rectangular area comprised three walls on the north, west and south, measuring 4m, 5.5m and 1.7m in length respectively. The wall survived to original height in the south, and in the north-east corner, but had collapsed elsewhere. An entranceway measuring 2.5m was present in the southern side, and was flanked by posts, probably for a gate (Illus 11). The internal area was 23.1m². Six wooden posts remained upright and *in-situ*, in a rectangular shape, and five further posts had collapsed. These posts may have divided the area into pens and could suggest Area A was used as an animal enclosure. There was no evidence that this area had ever been roofed.

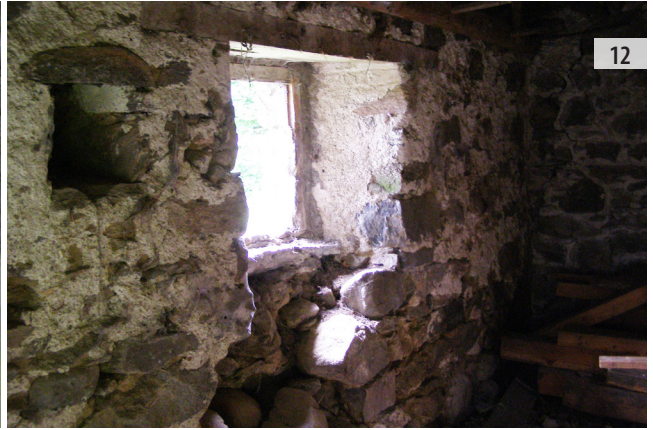
Area B was the western room within the main building and had an overall area of c 23m². The southern wall contained the doorway and a window, described above. The wall below the window had partially collapsed. To the east of the window was a small niche measuring (0.25m x 0.23m x 0.15m) 1.4m from the floor level (Illus 12). The room was roofed with wooden cross beams which supported wooden planks, forming the floor of the attic above. The wooden cross beams rested on top of the internal walls. Another niche of similar proportions to that in the southern wall was visible in the western wall (Illus 13).

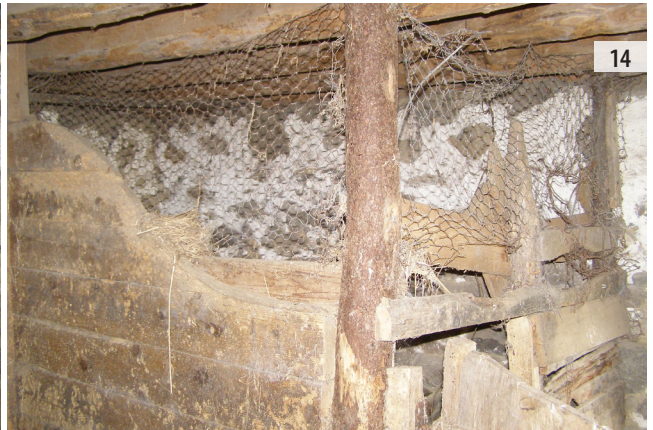
doorway and were constructed from wooden planks, posts and chicken wire to create pens. The western example measured 1m by 3m and the eastern 1.5m by 3m. The eastern pen also had a wooden door 1.3m in height, which suggests that it was used for animals (Illus 14). The other may have been used for storage.

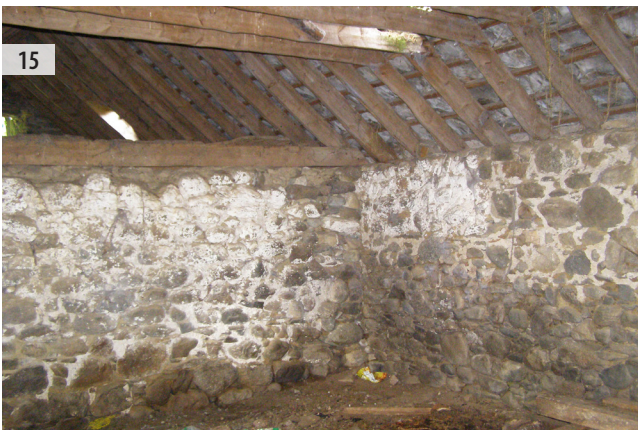
The internal walls of both Area B and C were plastered in lime, although this only survived patchily across the walls. A rectangular concentration of lime survived in the north-west corner of the northern wall of Area C (Illus 15), possible an indication of the location of internal furniture or divisions which no longer survive.

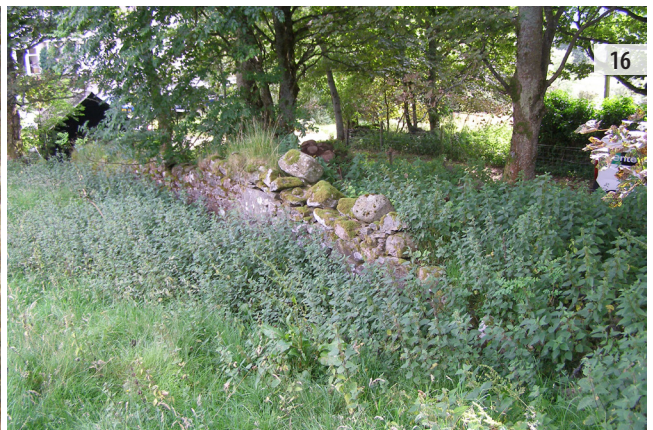
Area D comprised another external enclosure on the east end of the building. The area contained extensive amounts of rubble from collapse of the enclosure walls and was heavily overgrown with vegetation (Illus 16). As discussed above, the north and south walls of Area D appear to have been built into the east elevation at a later phase. Subsequently, the enclosure walls have collapsed, resulting in the extensive rubble. A line of rubble running north-south, approximately 11m from the eastern wall of the main building divided this enclosure into two areas. The far eastern wall of Area D had collapsed and was also heavily overgrown with vegetation (Illus 17).
