Project Code: SNCS09
Date of report: March 2010
Client: McEachern MacDuff Architects

STANDING STRUCTURE RECORDING

St. Ninian's Chancel, St. Ninian's (Stirling)

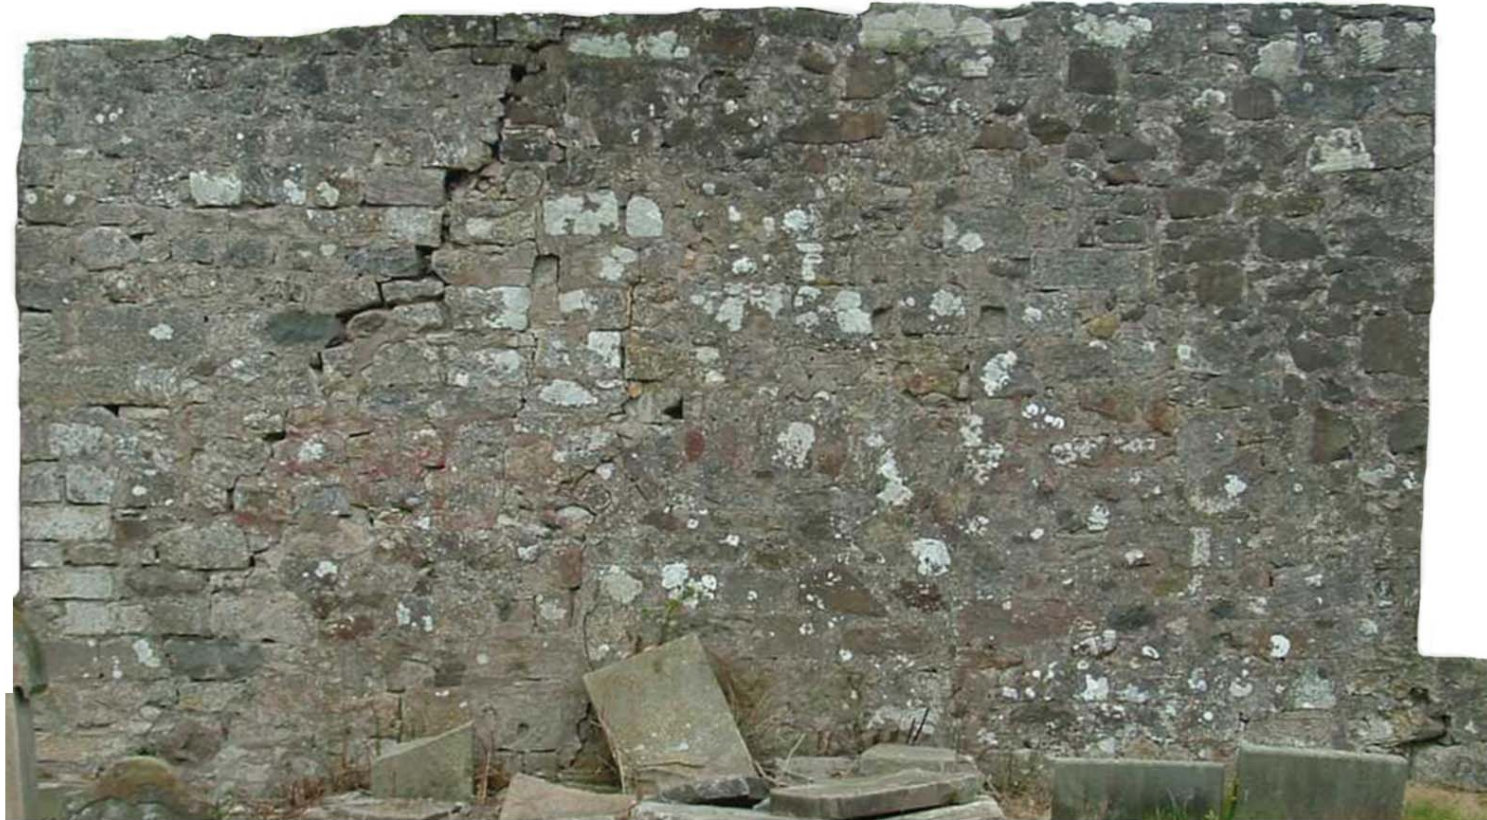
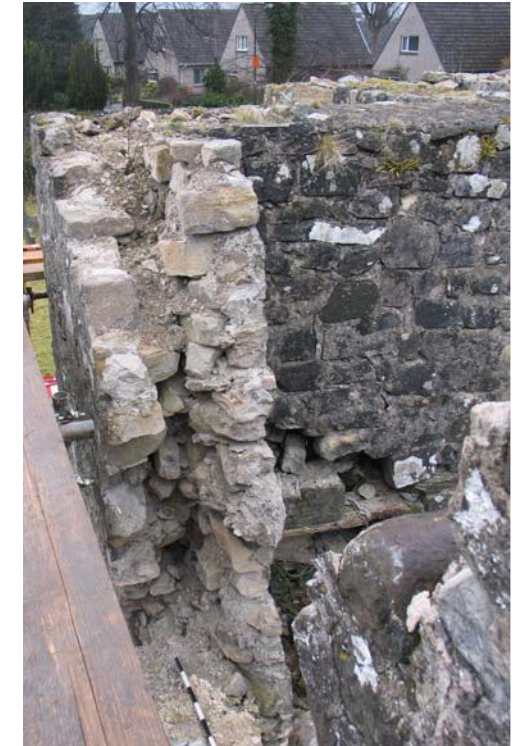
North side of damaged area

The only other features visible on the exterior of the wall are two small depressions (see Illus 4), one immediately adjacent to it to the west just above ground level and one above and slightly east of the arch's extent. The depression near ground level is roughly 10cm by 6cm and only 1cm deep. The depression higher on the wall is 17cm by 15 cm. It is 2cm deep.

Damage to the wall began when removal of a tree that had grown into the inside face of the wall resulted in almost parallel structural cracks running diagonally from south to North down the wall, the furthest east of these running into the North side of the arch (see Illus 4). These cracks precipitated a partial wall collapse in this area. The line of damage is not identical on both the interior and exterior faces of the wall, so its rubble core and the normally unseen back sides of the facing stones are visible (see Illus 4 and 5).

This record of the damaged wall and fallen stones should assist in planning for the stabilisation and possible consolidation of the west wall in line with the requirements of the Historic Scotland.

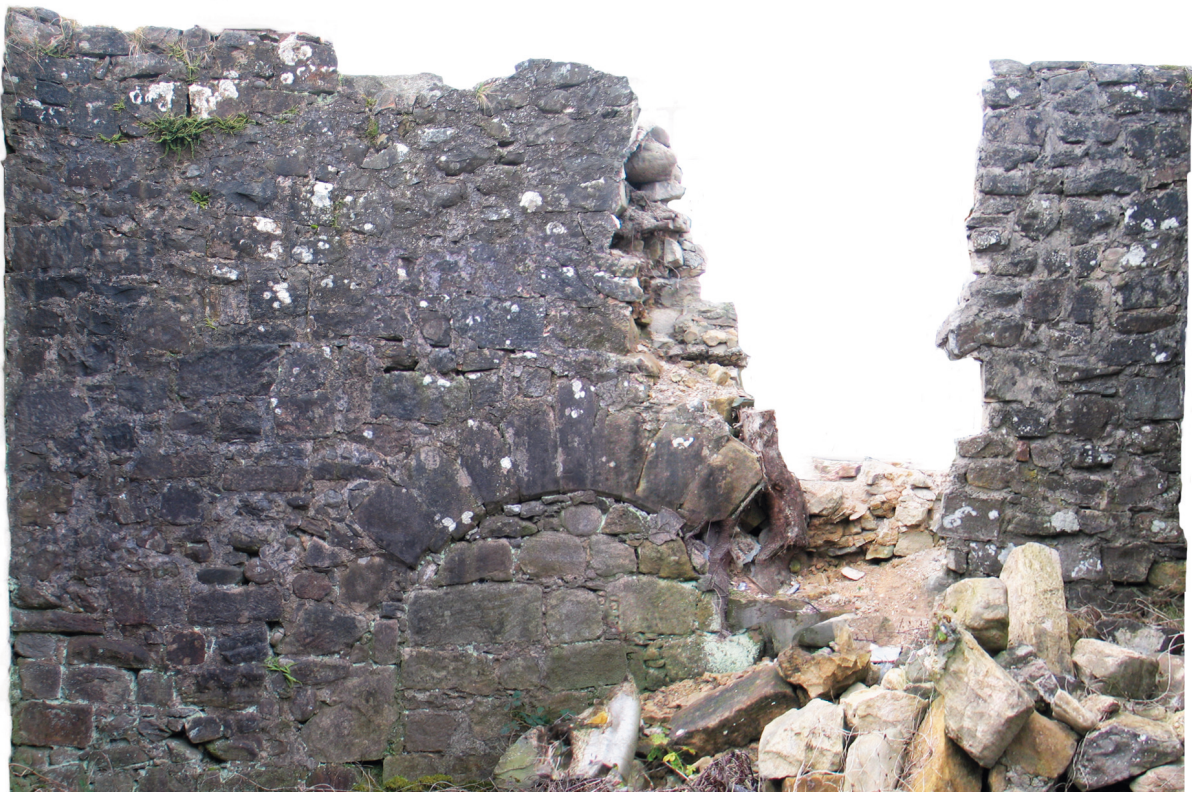
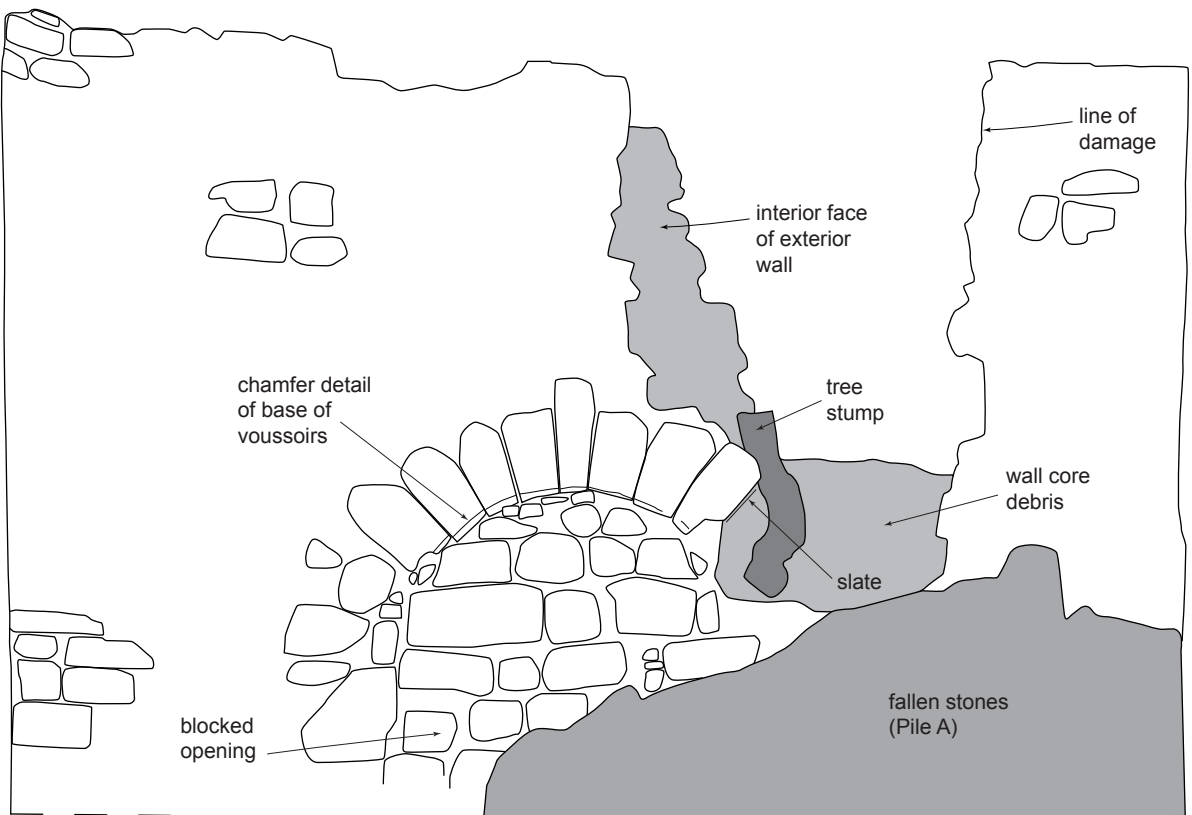
Illus 5
Photorectified interior elevation of west wall of chancel

There are a number of loose stones in three piles near the ruin, one to the inside (east) of the damaged section and two piles to the west of the ruin, which have been roughly stacked. The piles have been labelled A-C. See Appendix 2 for photographs of their rough locations. (Pile A is also visible on the interior elevation of the west wall, just below the damaged section of wall (see Illus 5).

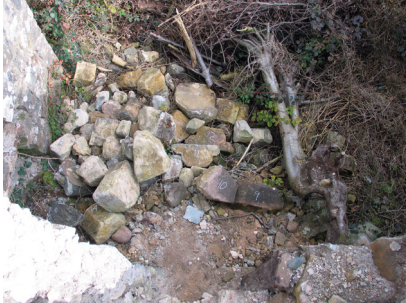
Pile No. A
Stone No. 1-15
Direction E
Description View of pile from above (to west) - stone 15 Not visible (under fallen tree).

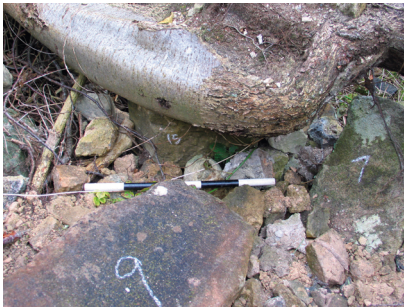
Pile No. A
Stone No. 15
Direction SE
Description Grey block of ashlar under tree - No.t fully visible/accessible, but appears carved in shape of 2 or 5.

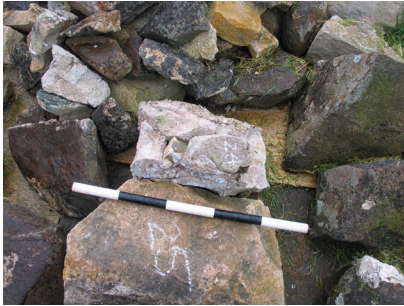
Pile No. C
Stone No. 24
Direction S
Description Broken off astragal moulding in grey ashlar (embedded in a block of concrete).
