Balnaglack Farmstead, Castle Stewart, Highland Level 1 Standing Building Survey Report No. 1234

September 2006

Commissioned by Cornerstone Golf Development International

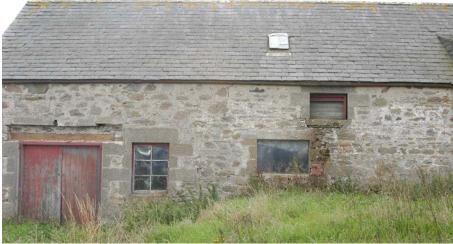
North Range (north facing elevation). Single aisle barn (Plate 1)

The north range comprises a single aisled barn which is one-and-a-half-storeys with a pitched slate roof. The building is built of coursed random rubble with ashlar quoins and surrounds. Two centrally positioned planked pitching doorways occupy the centre of the building. A large plank-built doorway is situated at the east end of the building, to the right of the door there is a square-headed window and two smaller rectangular windows. At the west end of the elevation there is a blocked doorway below a series of roof-joist sockets. Above the sockets there is a cement roof raggle which marks the position of a rectangular building. The remains of its walls are visible. The building is depicted on the 1906 Ordnance survey map and appears to have been removed recently. The main access to the barn is on the west elevation where a large sliding plank door still survives. The door surrounds have been recently repaired.

Plate 1 North range, north facing elevation, east end

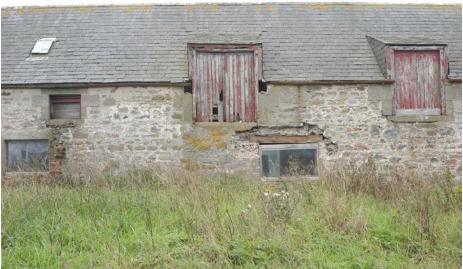
Plate 2 North range, north facing elevation, middle section

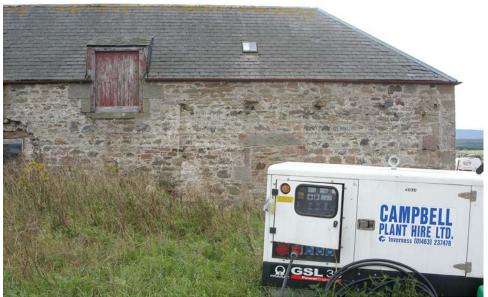
Plate 3 North range, north facing elevation, west end

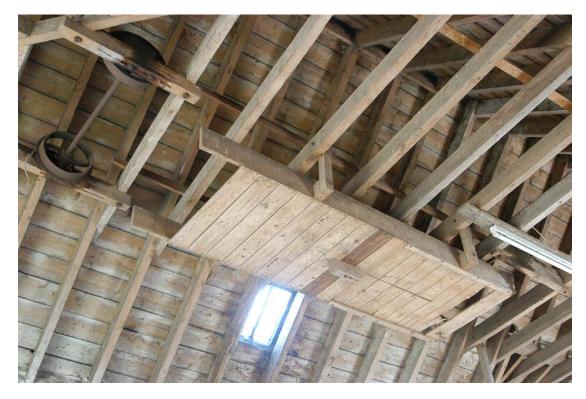
Plate 4 Tie beams and belt-drive wheels in the roof space of the barn

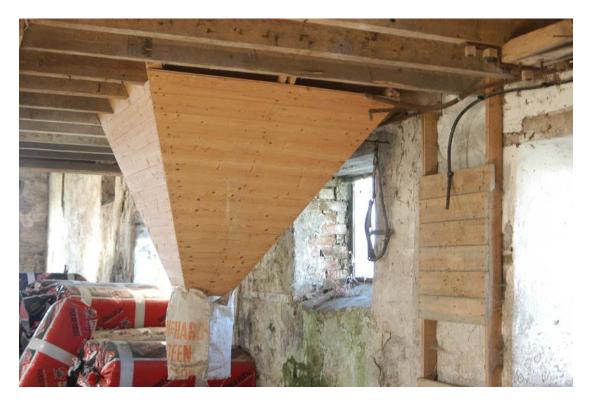
The barn measures 25m long and 5m wide and has a scarfe-jointed A-framed softwood timber tie-beams that rest within the wall heads. A loft is present part way along the building but has been removed at the level of the two pitching doors. A series of drive belt wheels are within the roof space (Plate 4). These belt drives continue over the loft balcony that is accessed by a wooden staircase. The staircase also provides access to a loft at the east-end of the barn. A wooden door on the plank partition wall leads into the loft area. The loft area has a series of wooden ducts that allowed corn to be fed to the loft floor for drying. The corn was gravity fed into a bagging chute located above the ground floor. The bagging chute is visible in Plate 5.

Plate 5 A Sack-filling hopper below the grain store loft

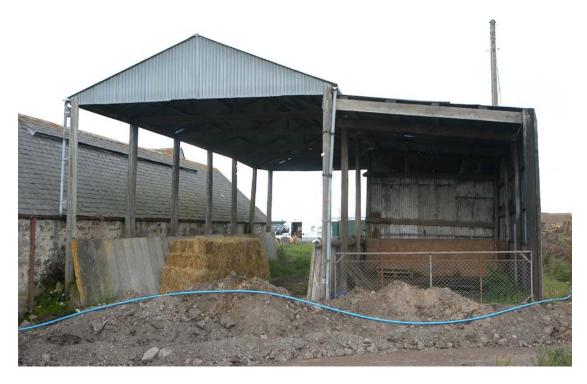
Plate 6 East range masked by the timber-framed barns

East range. colonnaded cattle shed (Plate 6)

The east range is a cattle shed measures 23m long and 5m wide and its east facing elevation is masked by the dutch barn. The building is rubble built with ashlar quoins and is featureless with the exception of a series of square ashlar vents situated towards the wall head. The building was longer at the north end and has been shortned by the removal of the gable wall which has been replaced by breeze blocks. A large bay opening is present on the south gable.

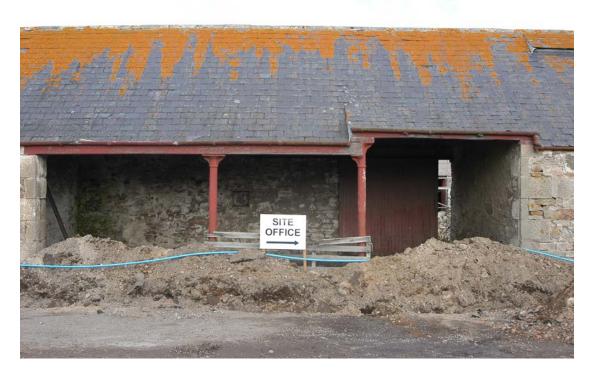
Plate 7 Three-bay cart shed in the middle of the south range

Cart-shed (Plate 7)

The cartshed measures 18m by 5m and has two cast-iron columns situated on its south-facing elevation. These carry a large timber lintel the full length of the shed. The lintel is stepped towards the east end and is raised upwards carried by the easternmost column which has a bracket fixed to support the higher lintel. The cart-shed is 23m long and 5m wide and is built of random coursed rubble. The slate roof is supported by A-frame tie-beams which rest on the wall head. The roof has a vent above the position of the small stable. The interior of the cartshed has been rendered with wet-dash cement render. The only feature present on the south facing elevation is a small recess for holding a lantern.

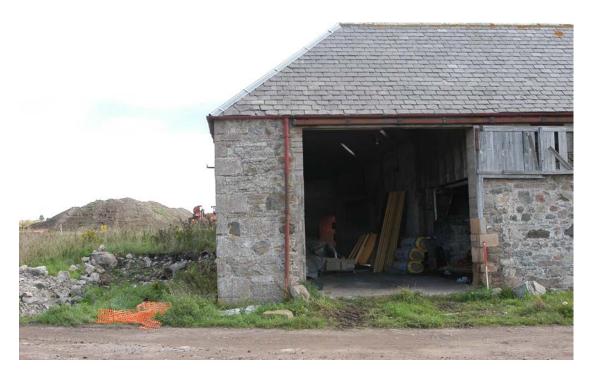
Plate 8 Main entrance to the single-ailed barn on the west range

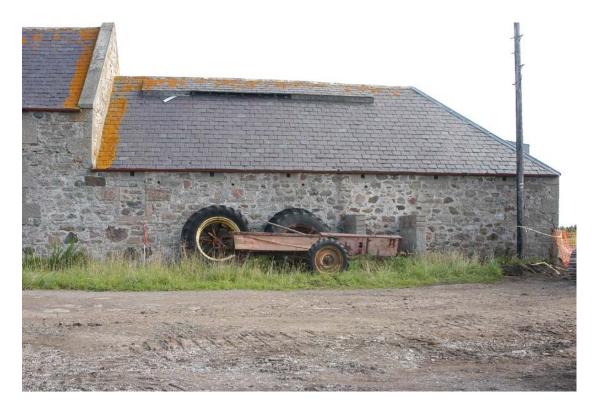
Plate 9 South end of the west range, former cattle shed

The west elevation measures 25m by 5m and is rubble-built with ashlar surrounds and has a stepped roofline. There are two compartments within this range, the southern unit is a tractor shed or garage and the larger northern unit was a former two storey building which has had its loft removed (Plate 8). A party wall separates the two units. This northern part of building was originally a stable which itself was partitioned by stalling. Scars from the stalls can be seen on the rubble floor. Hooks for hanging tack can be seen on the wall. Two blocked doorways are present on the east elevation which allowed horses to be led into the courtyard. The building was vented through the roof and along its wall head, the latter using ceramic drainage pipes (Plate 9).

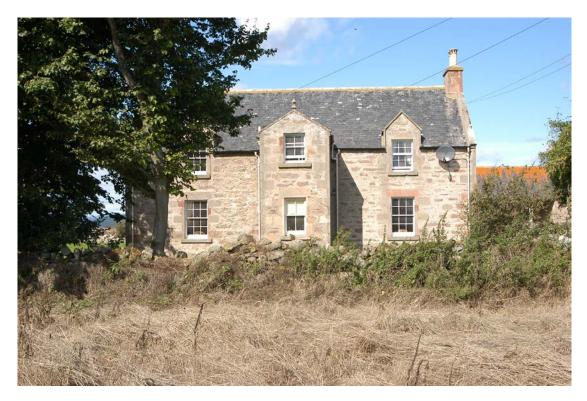
Plate 10 Balnaglack farmhouse, south elevation

Balnaglack is a two-storey farmhouse (Plate 10-11) constructed of coursed sandstone with ashlar quoins and fenestration surrounds. The south elevation has three bays, the central bay being an extension incorporating a vestibule with bathroom above. The roof is slated with sandstone chimney stacks. Two dormer windows occupy the top floor. The extension has a carved finial at the centre of its pitched roof. The exterior walls are harled with a wet-dash render.

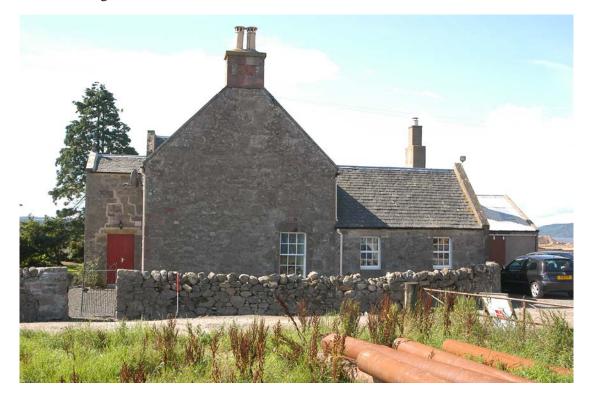
Plate 11 Balnaglack farmhouse, north elevation

The east elevation comprises the gable and east wing, the latter houses a modern kitchen. The north elevation contains the rear access to the farmhouses. There is a small yard covered with cobblestones between the east and west wings. The east wing has been extended in recent times and is used as an ancillary room. The west elevation compises a single storey building and the main gable. The workshop has two rooms that open out into the small cobbled yard.
