Scapa Flow Orkney

Scapa Flow 2013 Marine Archaeology Survey Final Report

March 2014

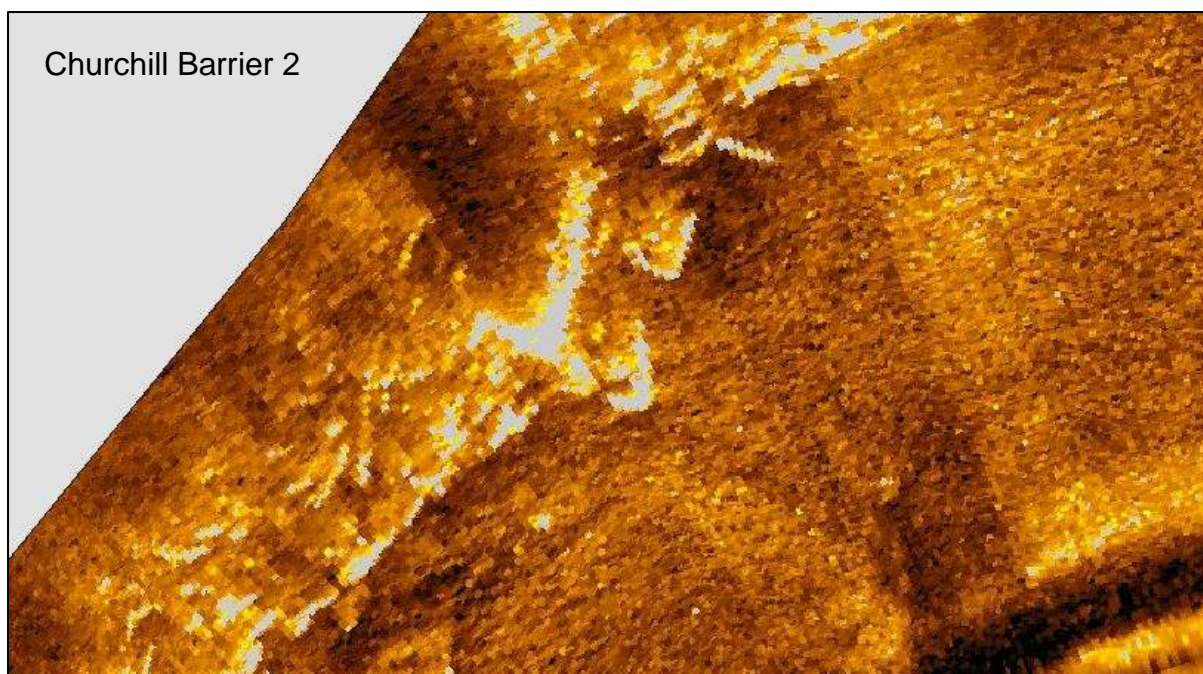
While several of the wrecks that protrude from the water at various states of the tide were surveyed, the vessel completely blocks the sonar. This results in a very strong, narrow linear contact with a shadow that masks any features behind the vertical remains (**Plate 1**). The tidal range in Scapa Flow is an average of 3m with spring tides reaching 4m.

PLATE 1:SIDE SCAN IMAGE OF A VESSEL THAT PROTRUDES FROM THE WATER AT VARIOUS TIDAL STATES

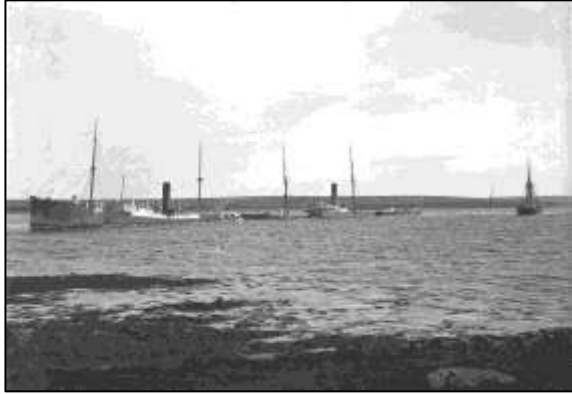
PLATE 2: SS NUMIDIAN IN POSITION AS A BLOCKSHIP (COPYRIGHT ORKNEY LIBRARY AND ARCHIVE – TK255)

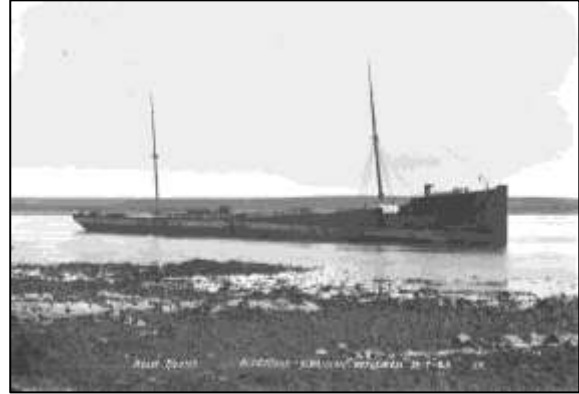
The channel was reopened after World War I, and in 1923 the extensively salvaged remains of the SS Numidian were turned to the current position of the remains lying parallel to Holm Shore with the stern towards what is now Churchill Barrier 1 (**Plate 3**).

PLATE 3: NUMIDIAN AFTER THE VESSEL WAS MOVED TO REOPEN THE CHANNEL IN 1923 (COPYRIGHT ORKNEY LIBRARY AND ARCHIVE – TK268)

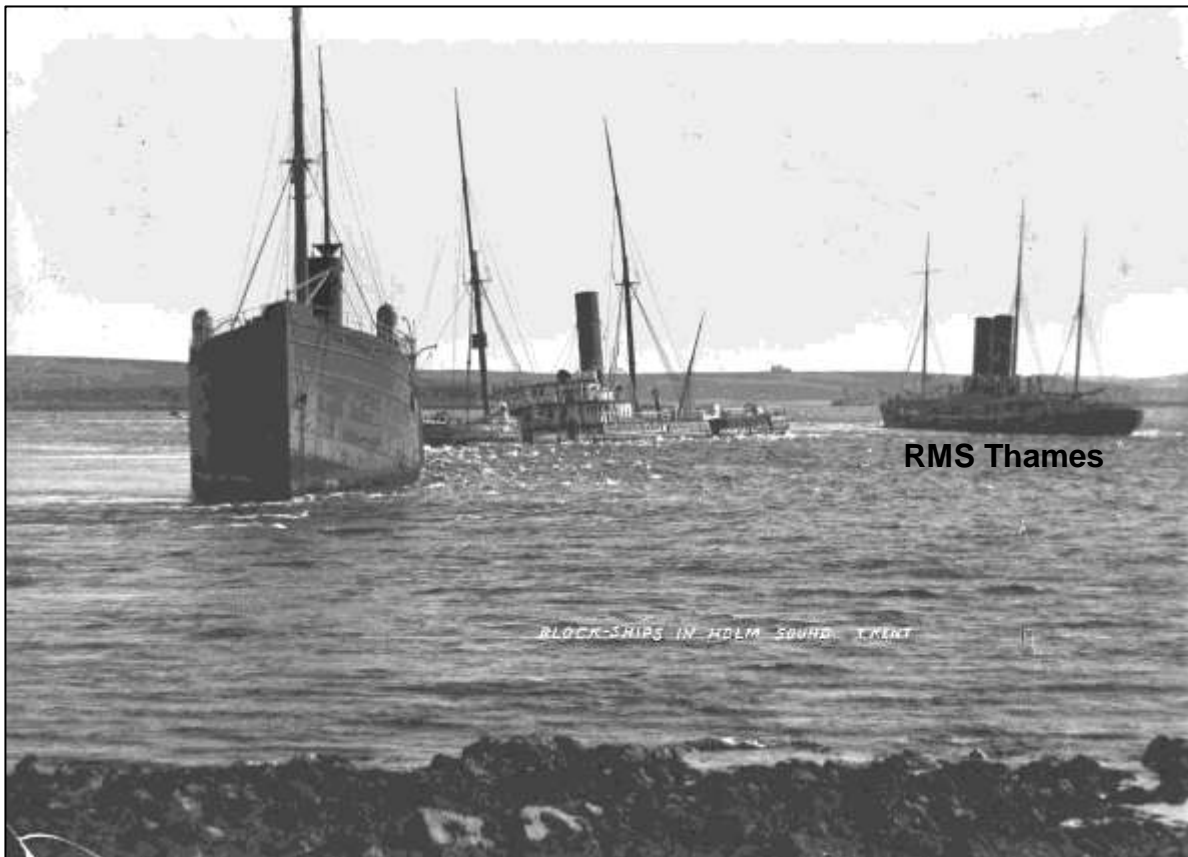
PLATE 4: THAMES IN POSITION AS A BLOCKSHIP (COPYRIGHT ORKNEY LIBRARY AND ARCHIVE – TK259)

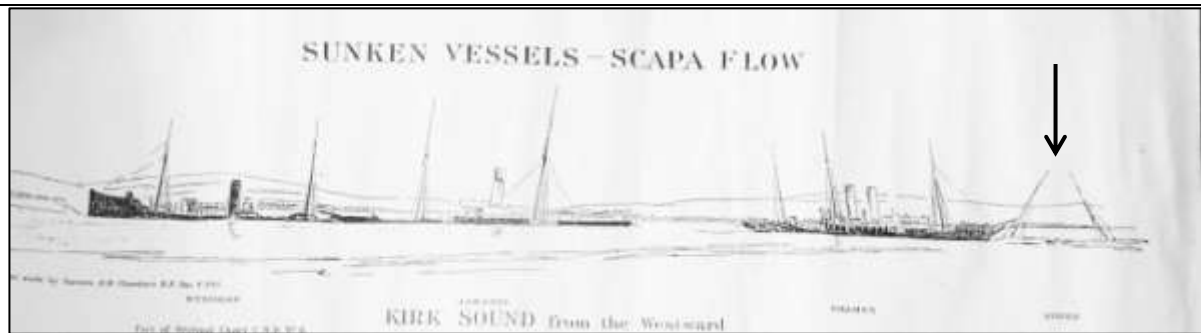
Built as the SS Alsatia in 1876 by D.&E. Henderson and Co Ltd, Meadowside, Glasgow for Henderson Brothers, Glasgow, the SS Minieh is a British iron steamship. Renamed as the SS Minieh when purchased by Khedivial Mail and SS and Graving Doc Co. Ltd, London in 1901, the vessel was sold to the Admiralty in 1915 and was sunk as a blockship in Kirk Sound on the 27th February 1915. Documents report that the scuttled blockship broke its back shortly after the sinking but note that the remains were left in place. Historical images from the Admiralty reports (**Plate 5**) clearly show the fore and aft masts leaning towards each other the archival sources from 1915 describe the remains as "broken and twisted" and likely to "break in half" (ADM X96-2).

PLATE 5: SKETCH OF THE WW1 BLOCKSHIPS FROM THE BOWS OF ROSEWOOD DRAWN IN 1915. IMAGE CLEARLY SHOWS THE MASTS OF THE MINIEH LEAN TOWARDS EACH OTHER (INDICATED) SUPPORTING THE DESCRIPTION OF A VESSEL WITH A BROKEN BACK (ADM X96-2)

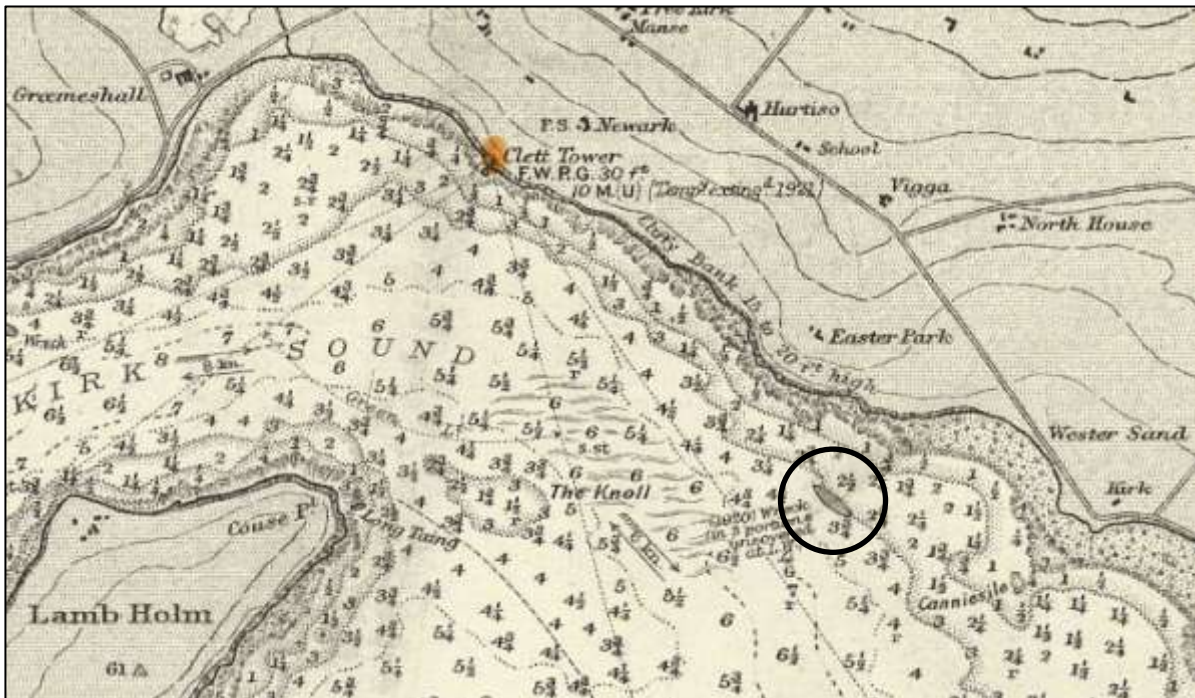
Historical documents and images confirm that these are the remains of the SS Aorangi, supported by the presence of a wreck in present location of the Aorangi on the 1923 chart (**Plate 6**).

PLATE 6: ADMIRALTY CHART FROM 1923 SHOWING WRECK IN CURRENT POSITION OF THE AORANGI (COPYRIGHT UKHO)

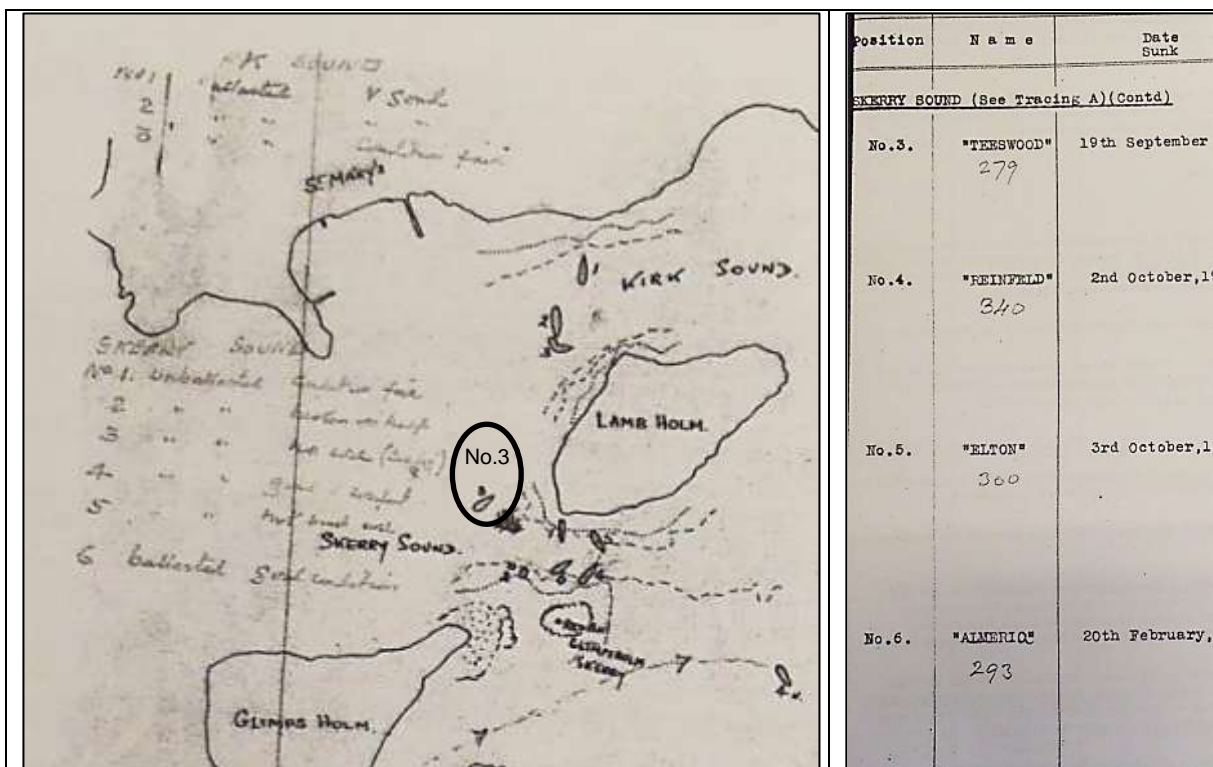
Historical documents and photographs confirm that these are the remains of the SS Rosewood (ADM X96-3). It should be noted that there is some discrepancy in this document between the drawings of the blockships in the hydrographic record of Skerry Sound, with the positions and descriptions of SS Rosewood and SS Teeswood being mis-assigned. In the sketch of the blockships the remains described in the text as SS Rosewood are in this location are noted as Teeswood. This is based on the ADM 1-8428-216 document which makes the same error, referring to the remains in this location as SS Teeswood. This mistake is replicated in the sketch map of the remains (**Plate 9**).

PLATE 9: SKETCH MAP OF WW1 BLOCKSHIPS SHOWING MIS-IDENTIFICATION OF ROSEWOOD AS TEESWOOD

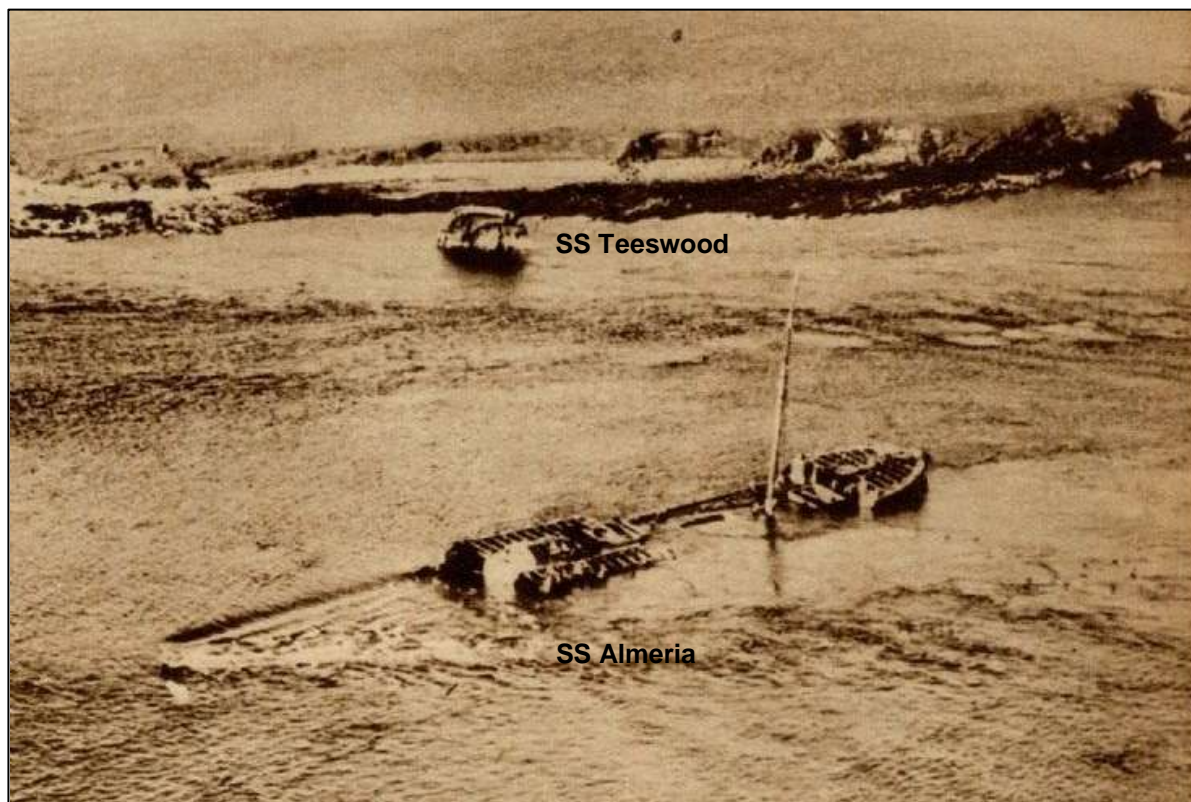
PLATE 10: AERIAL PHOTOGRAPH SHOWING WWI VESSELS VISIBLE IN 1938. THIS CLEARLY SHOWS THE ALMERIA INTACT AND IN POSITION WHERE THE CAPE ORTEGAL IS THOUGHT TO HAVE BEEN LOCATED (COPYRIGHT KEVIN HEATH COLLECTION).

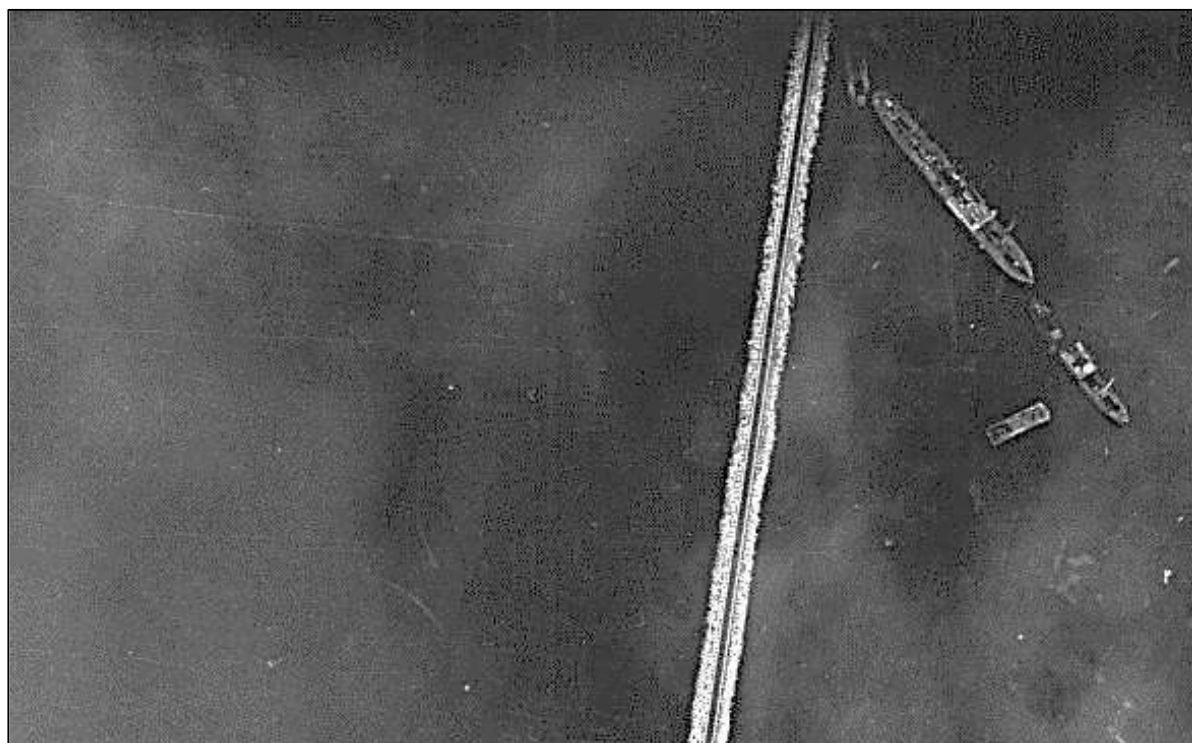
dries, smashed and spread, but mast still standing”. In the 1938 aerial photograph of the blockships (**Plate 10**) only show the visible remains of two WW1 vessels – The SS Almeria which had an upstanding forward mast and which was comparatively well intact, and the stern of the SS Teeswood. The Almeria breaks down very quickly after the installation of the WWII blockships, likely due to the altered tidal regime, and by 1940s the mast of the SS Almeria is no longer visible (**Plate 12**).

PLATE 12: HISTORIC PHOTOGRAPH SHOWING THE SKERRY SOUND BLOCKSHIPS AFTER THE CONSTRUCTION OF CHURCHILL BARRIER 2. FROM TOP TO BOTTOM THE REMAINS OF THE LYCIA, SS ILSENSTEIN, SS EMERALD WING AND AC6 ARE VISIBLE. THE MAST OF THE ALMERIA NO LONGER PROTRUDES FROM THE WATER

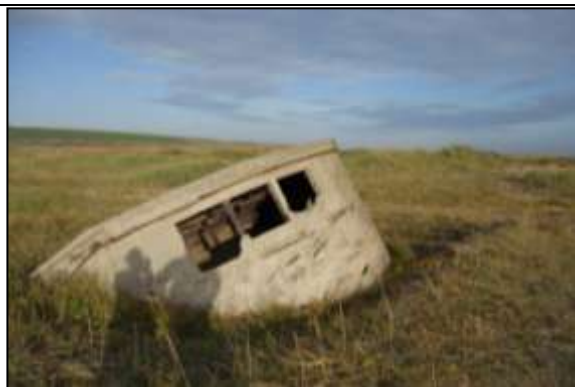
PLATE 16: MODERN PHOTOGRAPH OF THE COLLINDOC SHOWING LIMITED VISIBLE REMAINS (COPYRIGHT ANNALISA CHRISTIE)

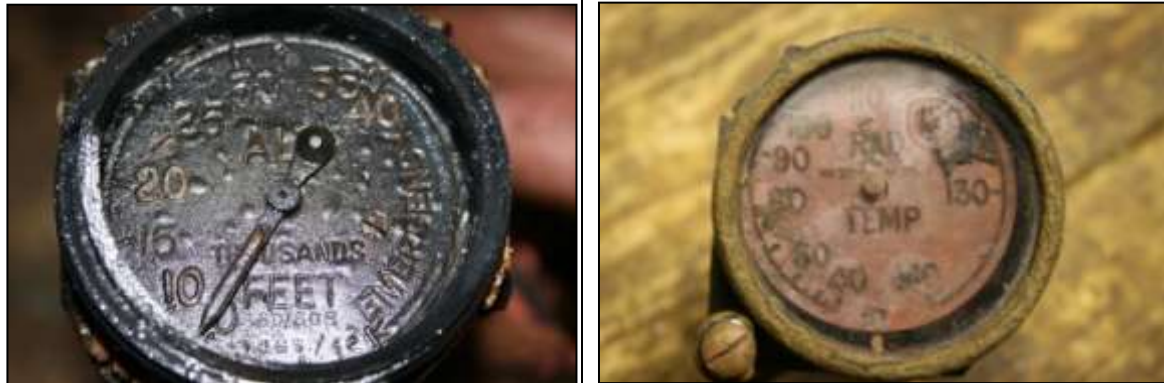
PLATE 19: GAUGES RECOVERED FROM THE SPITFIRE, DECLARED TO THE RECEIVER OF WRECK (COPYRIGHT A.R.G.O.S). LEFT: ALTIMETER SHOWING DATE /42. RIGHT: TEMPERATURE GAUGE

These correlate to gauges from a Spitfire and indicate a date of 1942. If these come from the same remains these could provide a *Terminus Post Quem* suggesting that the plane crashed after 1942. It is possible that the engine and armaments raised and deposited by the Royal Navy at Lyness Museum in 1987 may be from the same wreckage, but this cannot be confirmed for another two years. The logbooks of the ship that raised the remains and brought them to Lyness, is currently secured under the 30 year rule. As the remains were lifted in 1986 the ships log book for that year will become available in 2016.

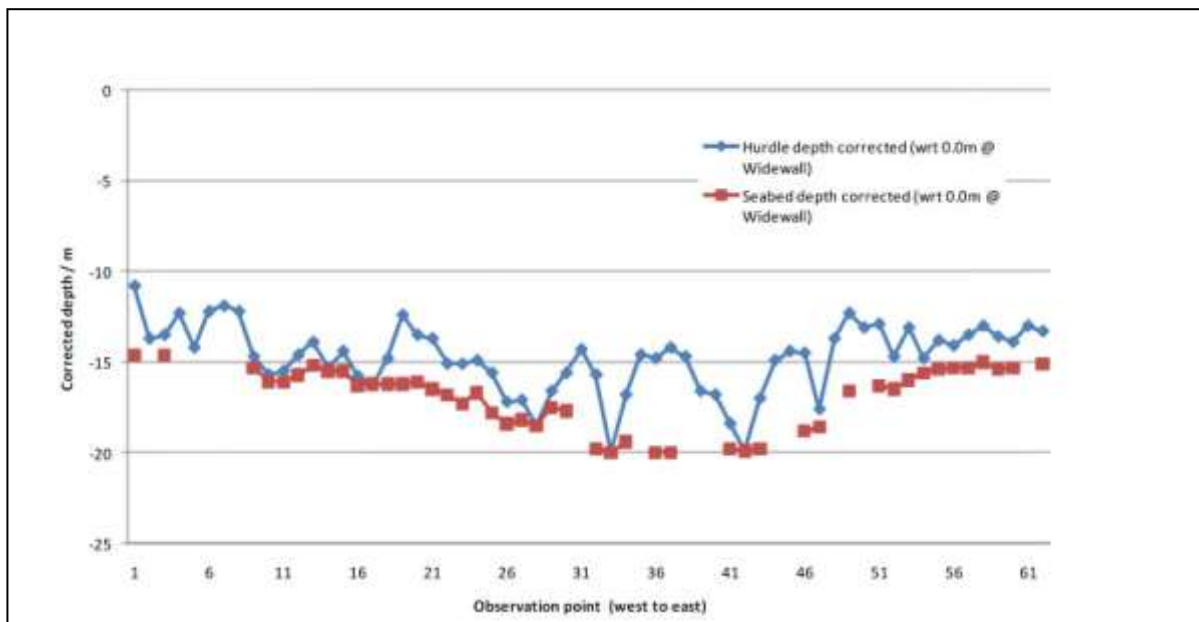
PLATE 20: CHART SHOWING THE DEPTHS OF THE HURDLES AT VARIOUS POINTS ALONG THE BLOCKADE, RELATIVE TO THE SEABED DEPTH (SULA 2010: FIGURE 1)

The SULA report records that the structures form an almost continuous barrier along the seabed with few gaps. As noted in the side scan surveys as part of this project, their assessment confirms a gap of approximately 60m in the middle of the Sound, though it is unclear whether this resulted from post war clearance or whether it was deliberately positioned. Their report notes that the hurdles remain fixed to the seabed but are “twisted and broken and little of the original structure remain recognisable” (OHA Report: 3). There are numerous creels, ropes and buoys tangled in the remains.

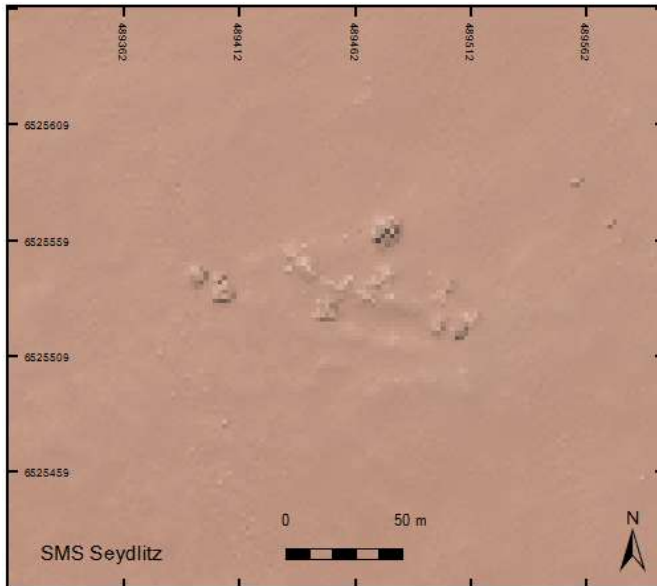
PLATE 23: MBES DATA FROM THE SCAPAMAP PROJECT 2006 SHOWING DEBRIS AT THE SMS SEYDLITZ SALVAGE SITE (COPYRIGHT HISTORIC SCOTLAND)
