Investigation of an uncharted wreck located in Scapa Flow, Orkney.

Final Report

Submitted to: Historic Environment Scotland
- Philip Robertson

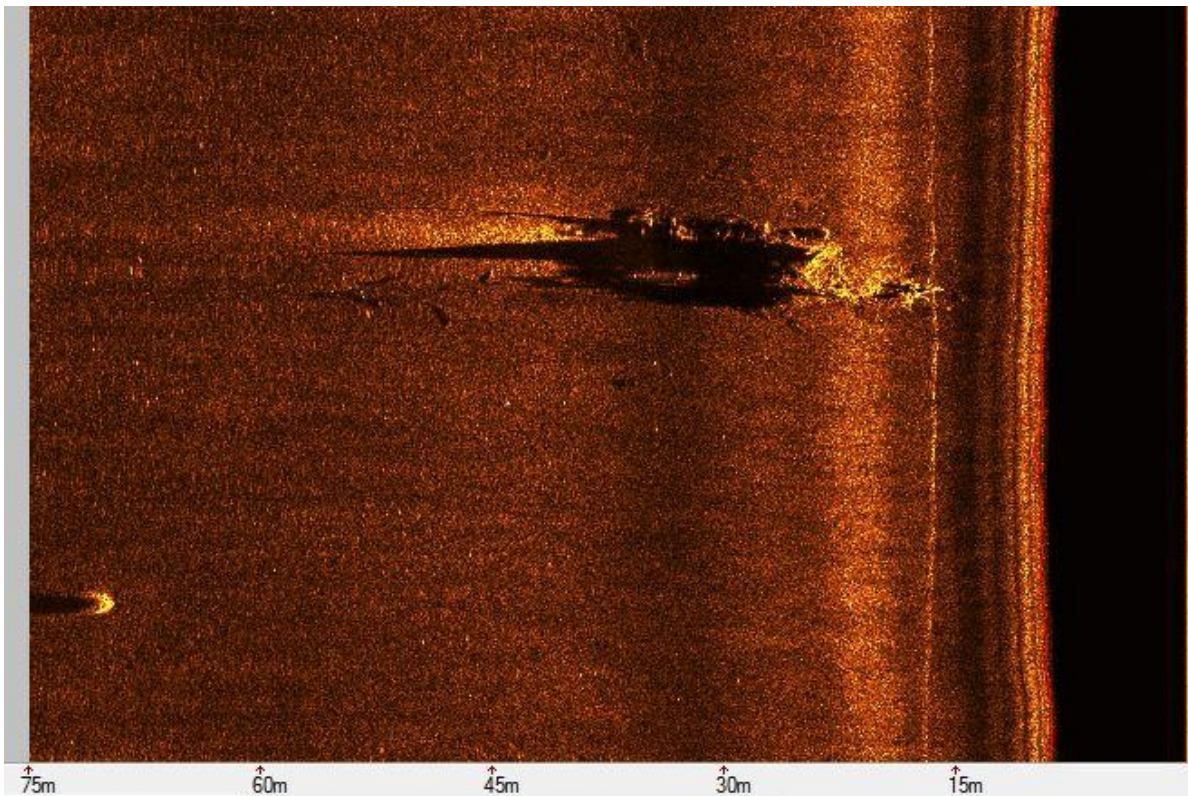
A side scan survey was carried out on the 18th June 2016, prior to the dive survey. The location of the site and the side scan survey coverage is shown in Figure 1. The sonar image is shown in Figure 2 and illustrated what appeared to be wreckage on the seabed of approximately 30m in length by 10m wide and standing approximately 4m off the seabed. No distinctive features could be distinguished in the sonar image.

The site lay approximately 100m to the west of the wreck of the SS Prudentia, where recreational diving is prohibited due to the remaining presence of heavy fuel oil. The side scan survey also revealed the presence of a circular object 2m in diameter located 60m to the north-east of the site at position 58° 50.855' N, 003° 08.087' W (Figure 2).

Figure 2: Sonar image of the site showing an unknown contact to the north.

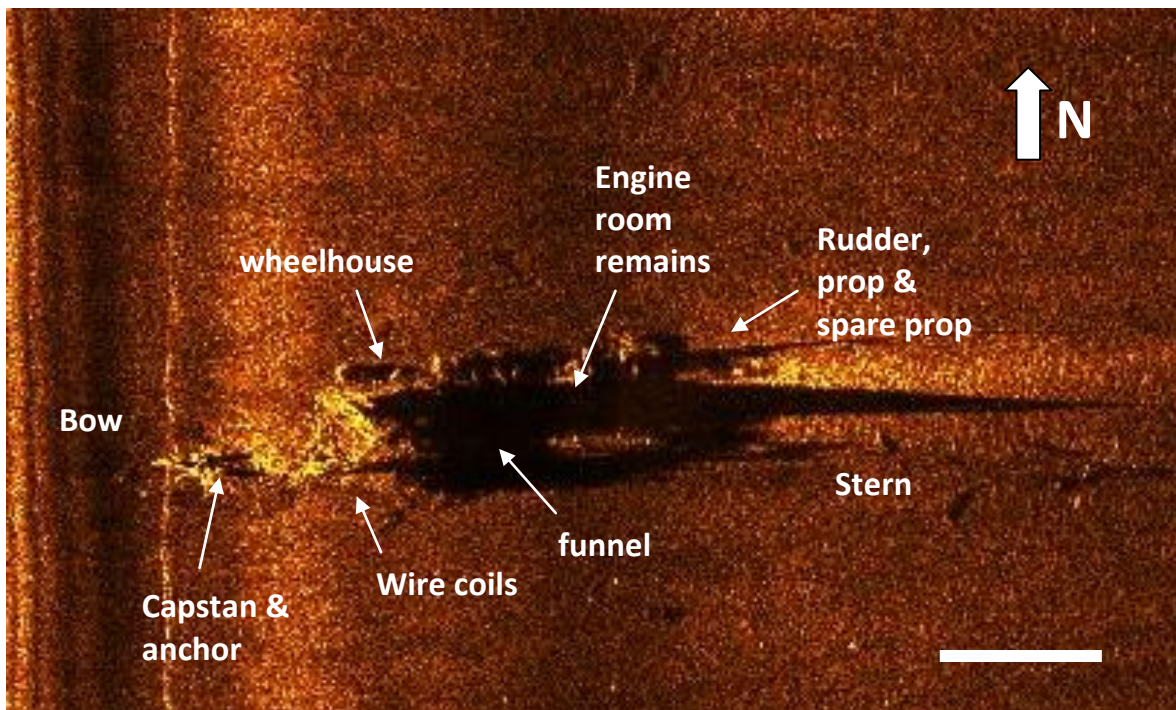
The wreckage was that of a vessel, resting almost upright on the seabed, with bow pointing approximately westwards (heading 260° M). The positions of the main features of the wreck are shown below in Figure 3. The hull appeared to have been wooden and largely rotted away to leave minimal remains. The propeller and rudder were present at the stern, as well as the propeller shaft which ran forward through a substantial stern tube to the engine. A second propeller, presumably a spare, was located on the seabed next to the propeller shaft. The engine however could not be seen clearly due to the wreckage of the engine room housing that had collapsed on top. Moving forward, a boiler was located approximately half way along the vessel and underneath the wheelhouse. The steel base of the wheelhouse was intact although the upper half and roof were absent. Moving forward, a large pile of cable was draped across the foredeck and spilled onto the adjacent seabed. Towards the bow the capstan winch was present and a fisherman's type anchor lay nearby. More detail on each section of the wreck is provided below.

Figure 3: Sonar image of the site. White bar = 10m approx.

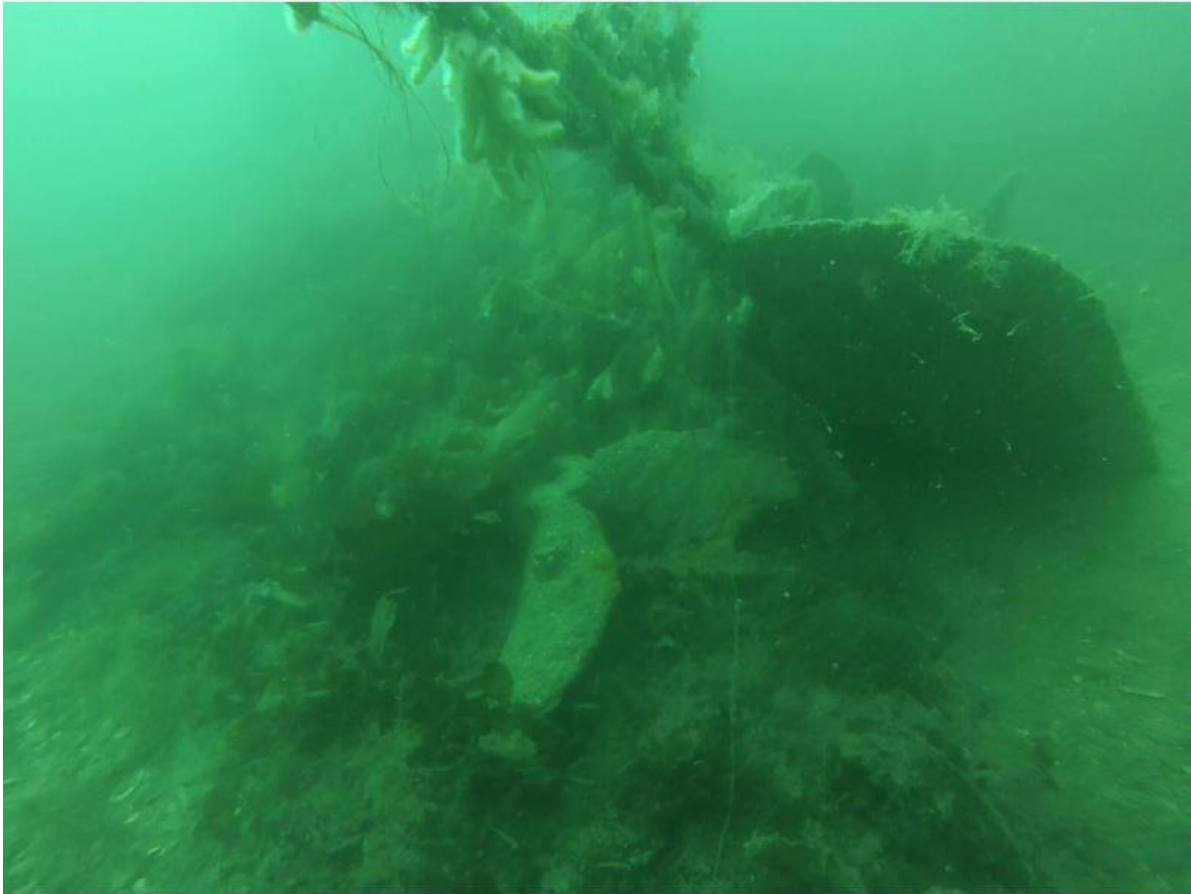
The rudder, propeller and shaft were the main features of the stern area as the hull in this area had almost completely disintegrated. The four-bladed propeller was approximately 1m in diameter and still attached to the shaft which ran forward through a substantial brass stern tube. The steel rudder was standing upright on the seabed and listing slightly to port.

The spare propeller, of similar size, was lying flat on the seabed right next to the rudder. Still images are shown in Figures 4 & 5.

Figure 4: Stern of the vessel showing the rudder and stock. A spare propeller is lying flat on the seabed in the middle of the picture while the tips of the in service propeller can be seen behind the top edge of the rudder.

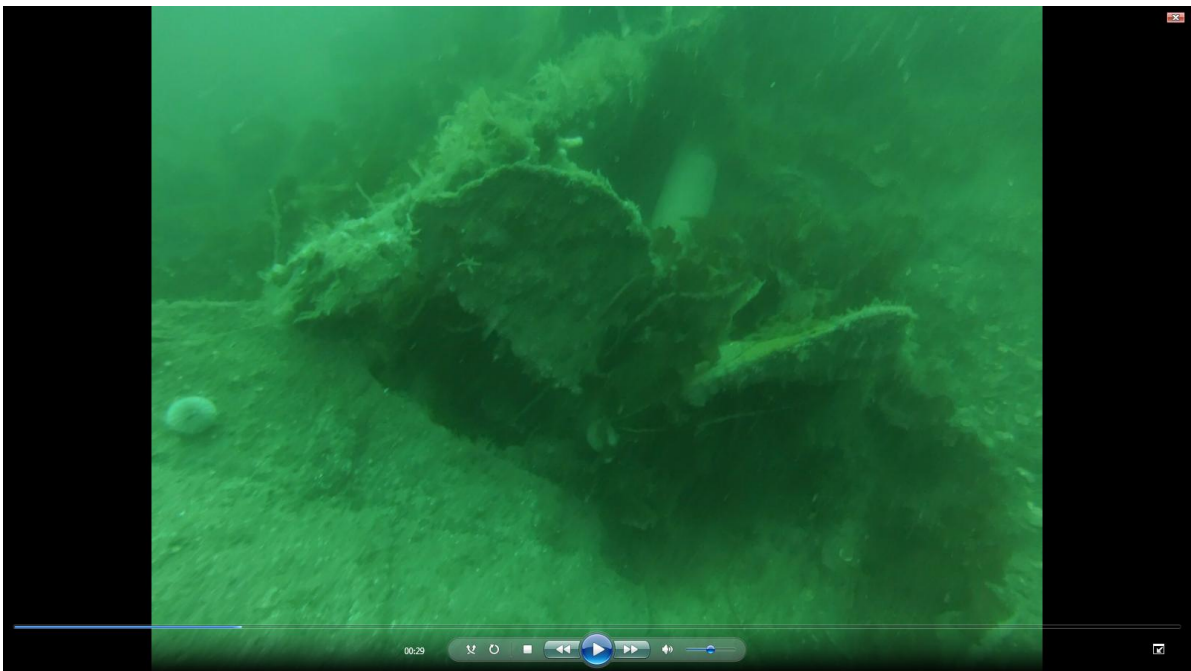
Figure 5: Main propeller with stern tube visible behind.

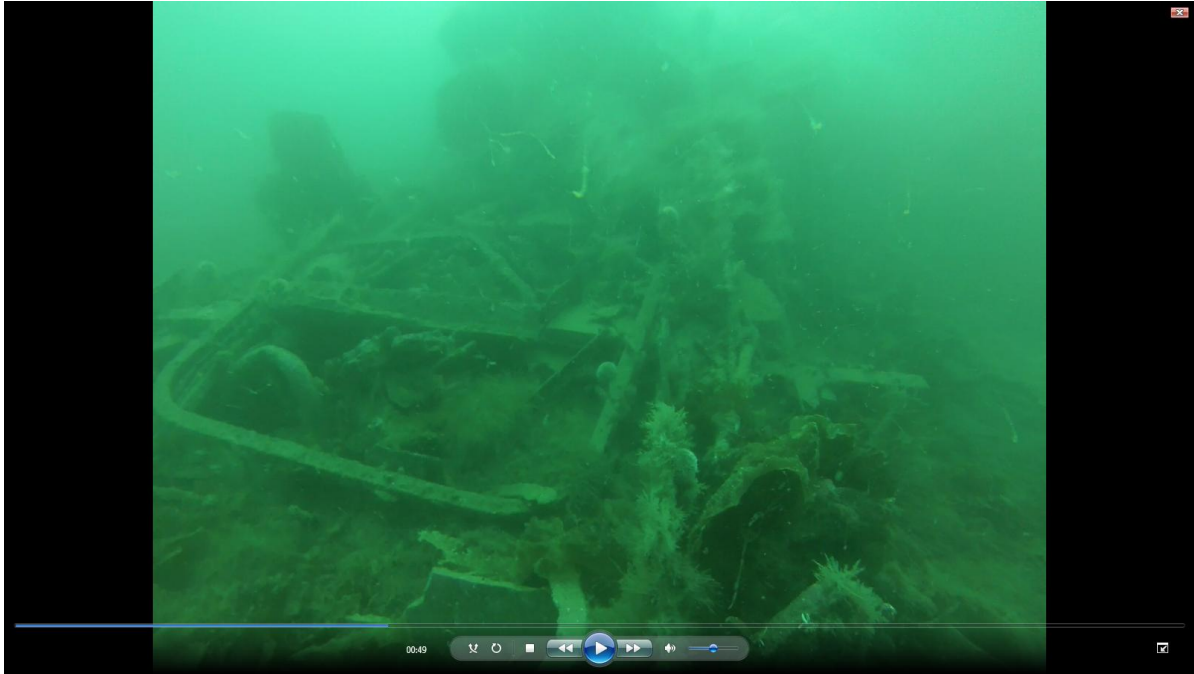
The engine room casing appeared to be constructed from metal but had largely collapsed, with the result that the engine itself was obscured. The presence of a boiler indicated that it was a steam engine, but no further evidence could be gathered that would indicate its type. Engine components observed included valves and gauges.

Figure 6: Collapsed wreckage in the engine room area, looking forward from the stern area. The back of the wheelhouse is visible at top middle of image.

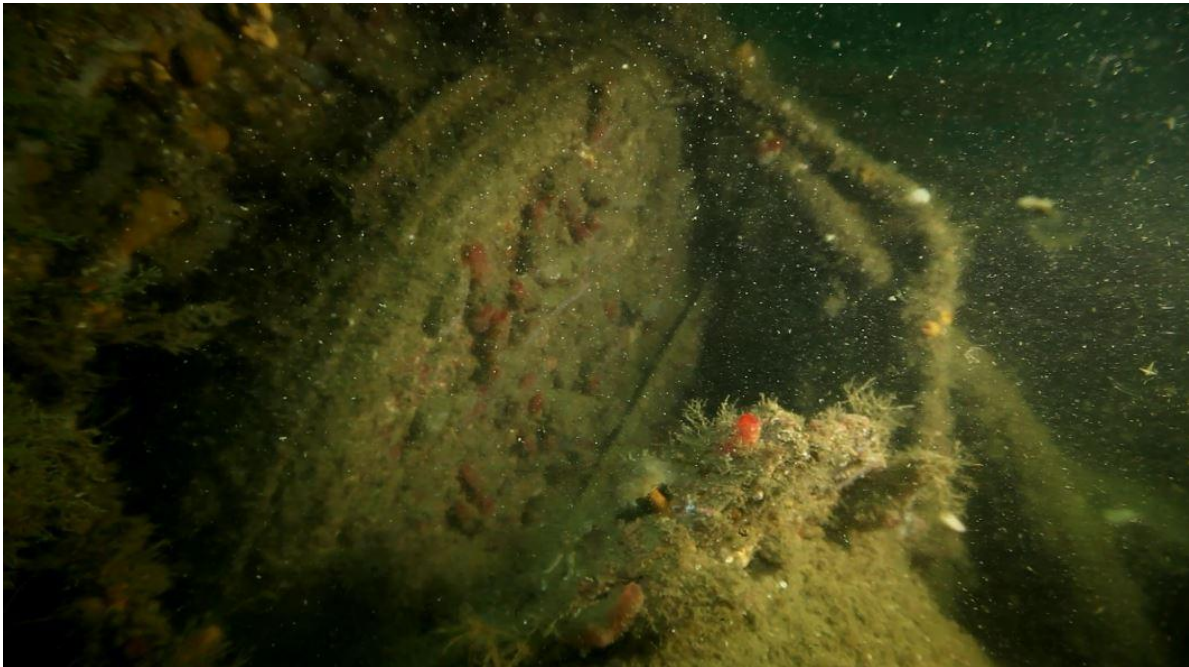
The boiler (approximately 2m in diameter) was intact and situated just forward of the engine room casing. It was installed within a steel frame that supported the bridge above. Access to the boiler was restricted due to the surrounding steelwork and debris, although two sight gauges were observed at the front end. Coal was also observed scattered around the area. Images of the area are shown in Figure 6 – 10.

Figure 7: Front side of the boiler, located under the wheelhouse. Image courtesy of Marjo Pauliina Tynkkynen.

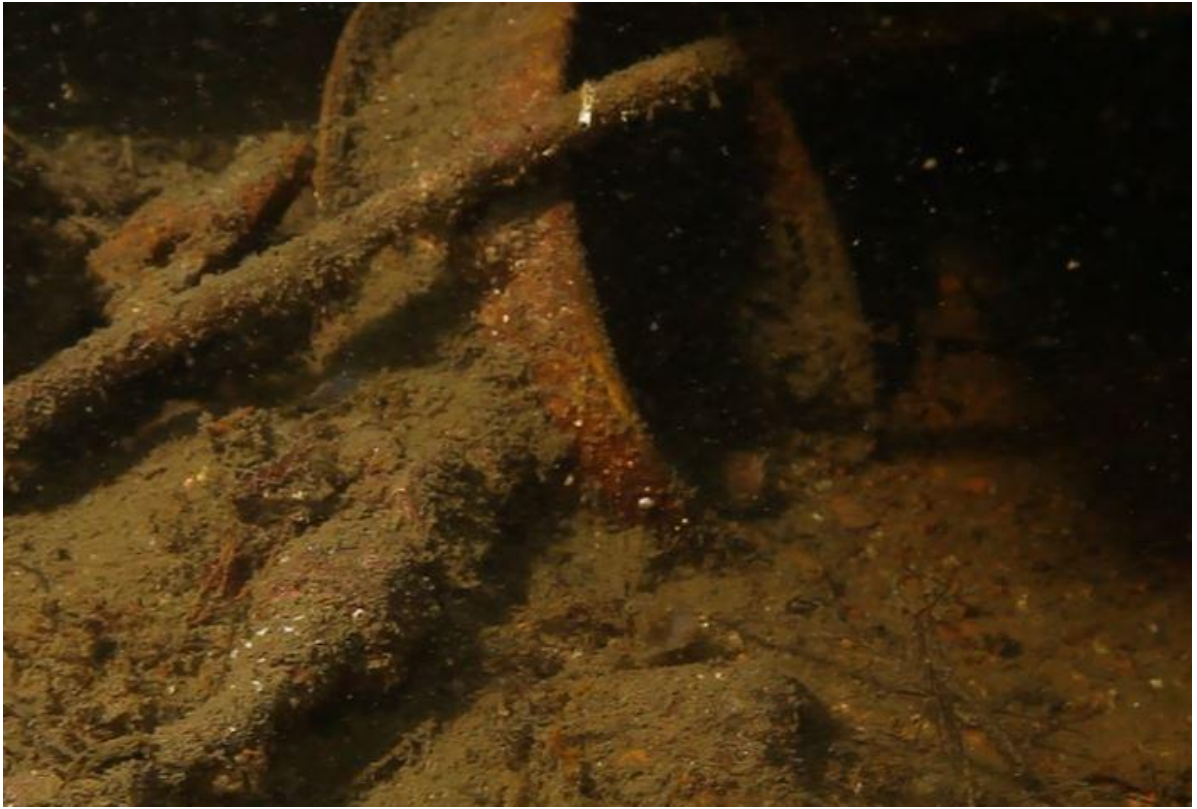
Figure 8: Engine gauge lying among the engine room wreckage. Image courtesy of Marjo Pauliina Tynkkynen.

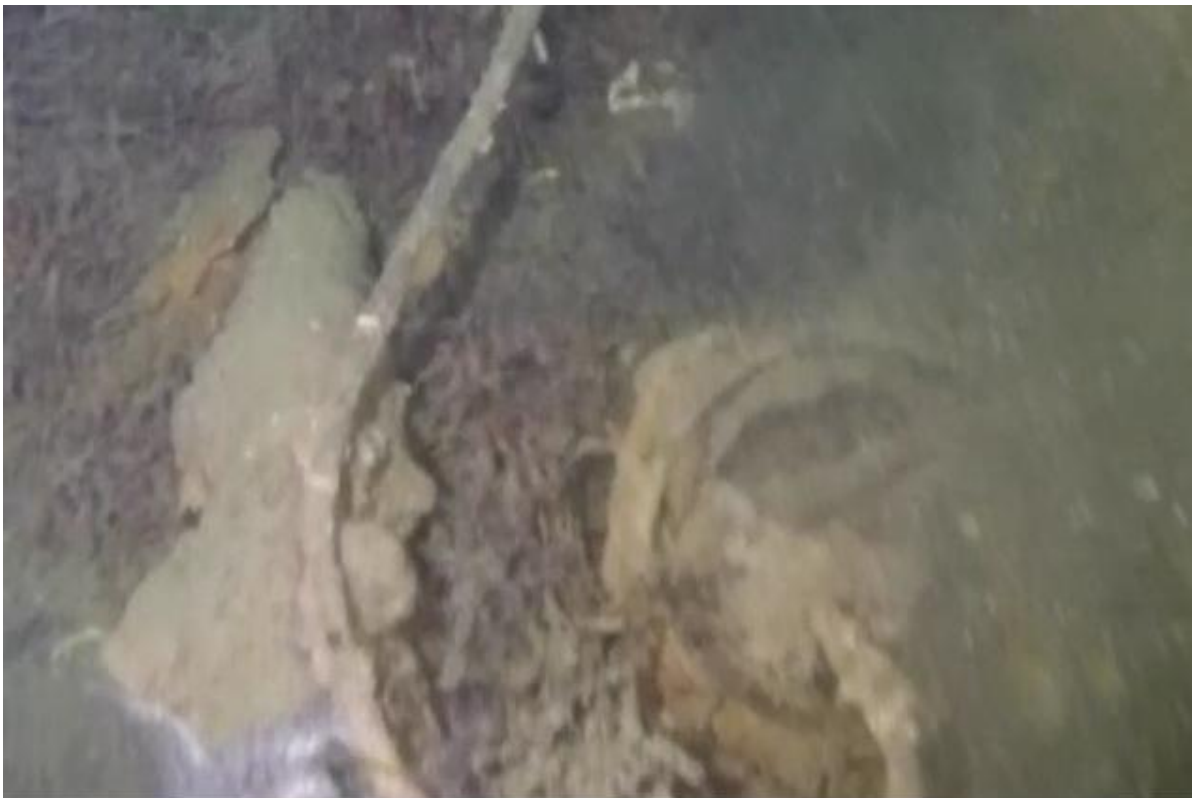
Figure 9: Second gauge located within the engine room wreckage.

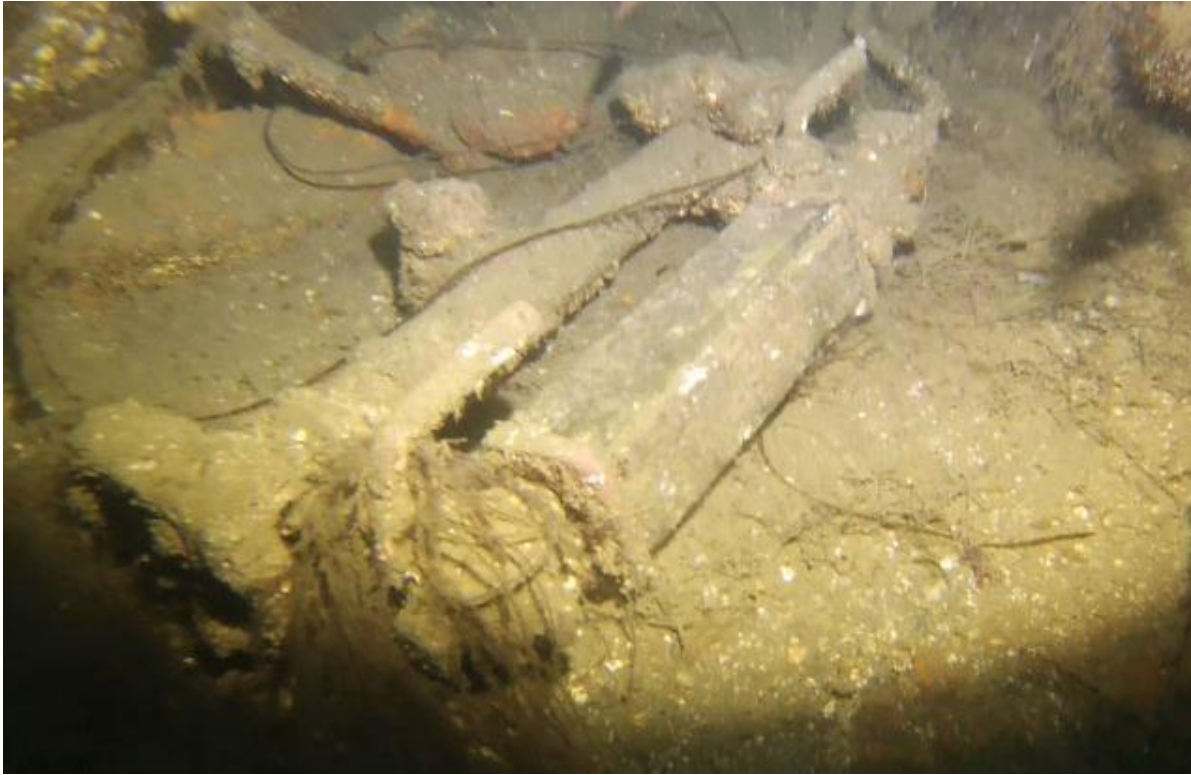
Figure 10: Sight gauge, lying among the engine room wreckage.

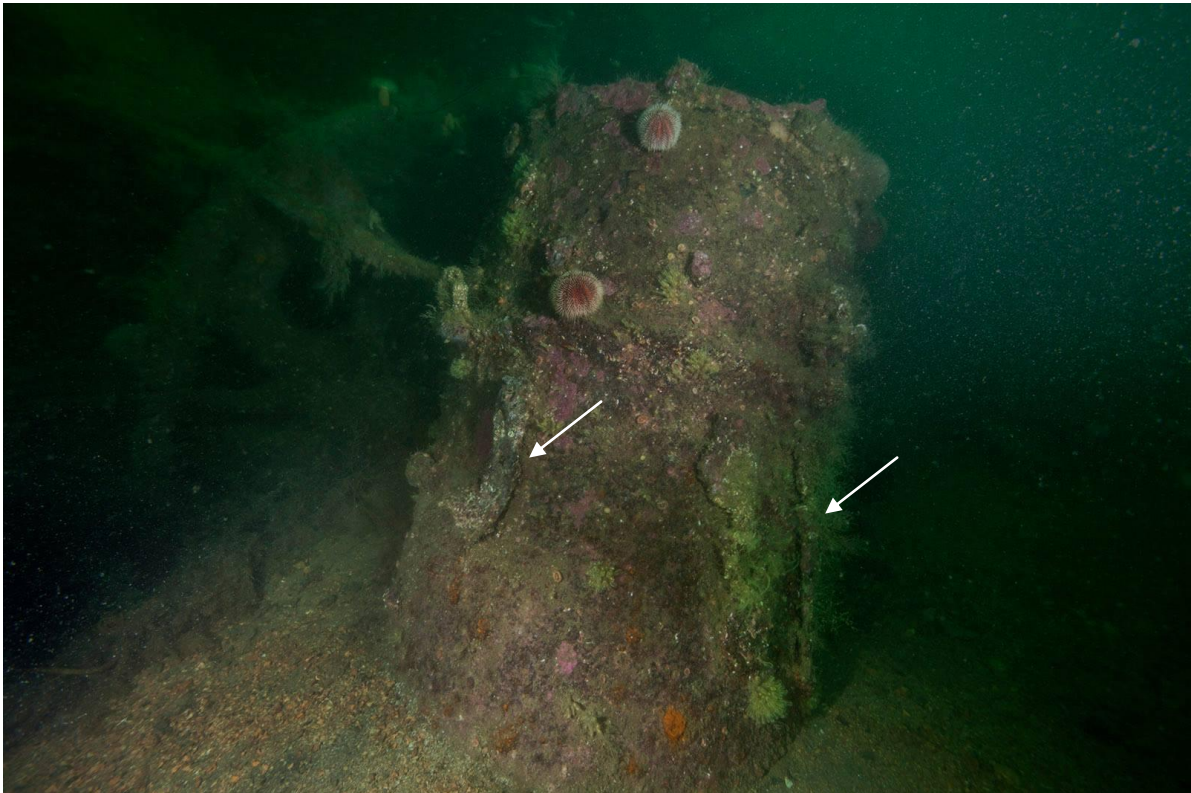
The remains of a funnel were present. While the base was attached to the top of the boiler, the remaining parts had fallen off to the port side (north) of the wreck. The middle sections had largely disintegrated but the top section (~1m in length) was sitting upright (but upside down) on the seabed. On the side of this section were the remains of what appeared to be steel letters and/or numbers. These were attached by short studs which raised them off the funnel surface. Shackles were also present on the outer face of the funnel. The funnel remains are considered further in the discussion, below. The top section of the funnel is shown in Figure 11.

Figure 11: The top section of the funnel (~1m long) lying upside down on the seabed to the port side (south) of the wreck. The remains of raised lettering are indicated by the white arrows. Image courtesy of Marjo Pauliina Tynkkynen.

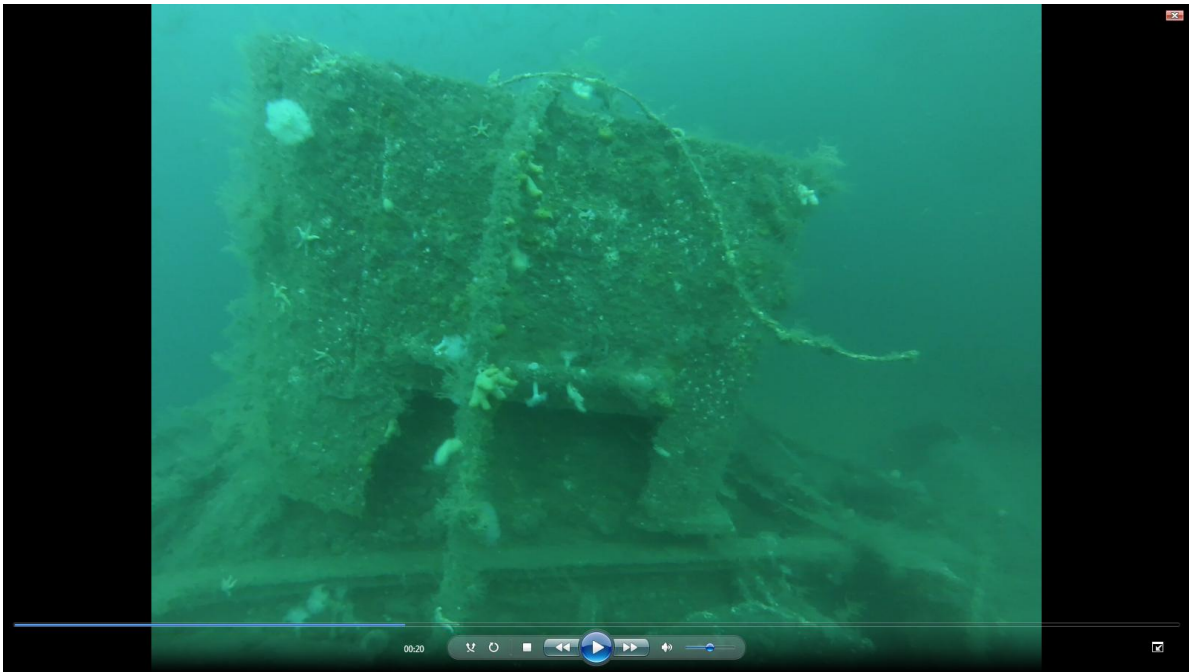
The lower half of the wheelhouse, which was made from steel, was intact. The upper section was missing. Inside the wheelhouse, the steering wheel and helm were in place but severely eroded. The telegraph was not observed. There were large glass fragments on the wheelhouse floor, presumably from the windows. One of these fragments was curved. A maker's plate was mounted on the steel plate on the outside of the wheelhouse, facing forward. The plate was rectangular and covered in encrusting marine growth and no characters or writing were visible. It was unclear what material the plate was made from, but probably steel or wood. In either case, no attempt was made to remove the growth in case the plate and/or any writing was damaged. It was also possible that the plate on the wheelhouse was a backing plate and that the name plate had fallen off. No other plates were found in the vicinity however. A brass cover, possibly from a navigation light, was also seen in this area. Images are shown in Figures 12 – 15 & 21.

Figure 12: Front of the wheel house (constructed of steel) showing a length of cable draped over the top. Upper section of wheelhouse missing. Makers plate located on the front wall, located just to the right of the cable.

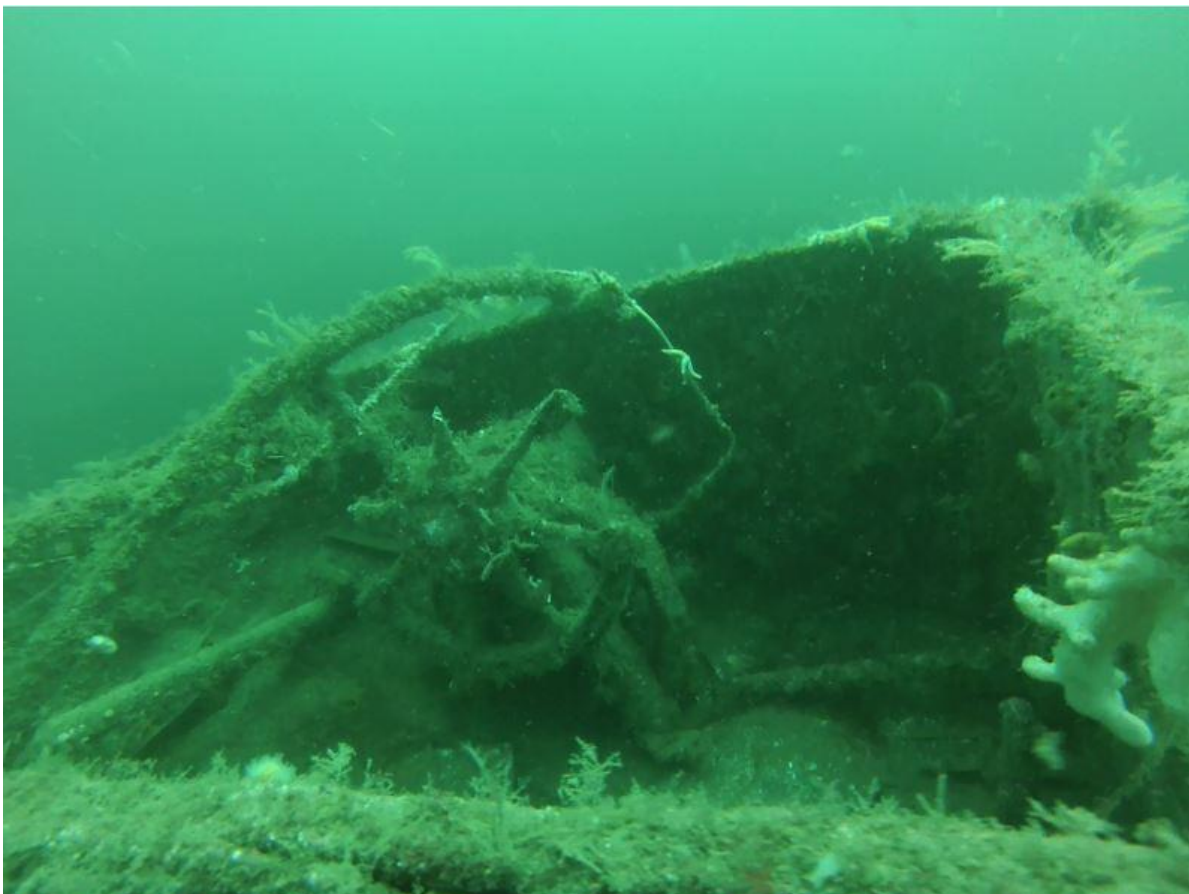
Figure 13: Interior of the wheelhouse show the steering wheel and helm as well as the cable draped over the top.

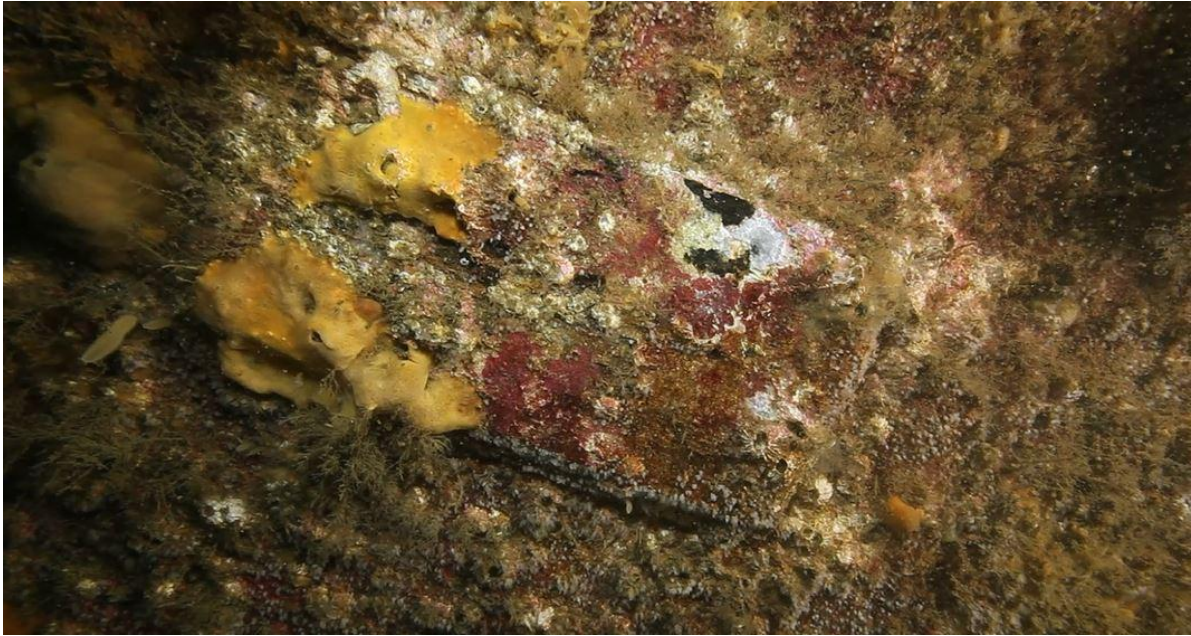
Figure 14: Makers plate on the front of the wheelhouse. Material was either steel or wood. Writing was obscured by encrusting marine growth.

No direct evidence of the vessel's identity was found during this initial survey. While the maker's plate was present on the wheelhouse, marine growth obscured any details and no attempt was made to remove the growth in case of irreversible damage. No engine or boiler plates were found which might have contained information that could have identified the vessel. However, the remains on funnel provided clues as to the identity of this vessel, as these were most likely the registered fishing number of the vessel, comprising letters followed by numbers. In this case the characters were made from steel and attached to the funnel exterior by metal bolts or studs. Their remains and the location of studs on the funnel provided an indication of their original form. The reconstruction of the top two characters is illustrated in Figure 24, which suggests that they may originally have been the letters "W" and "K". The characters below were similarly corroded and the process of reconstruction was more difficult (Figure 25). The first character had some remains and based on these and the stud pattern may have been a "2". The second character had completely disappeared but the remaining stud pattern in a triangle strongly suggested it was a "7". The final character exhibited remains on each of its four studs, which were shaped in a diamond pattern and could confidently be identified as a "0". The overall suggestion therefore is that the registration number was WK 270, which corresponds to that

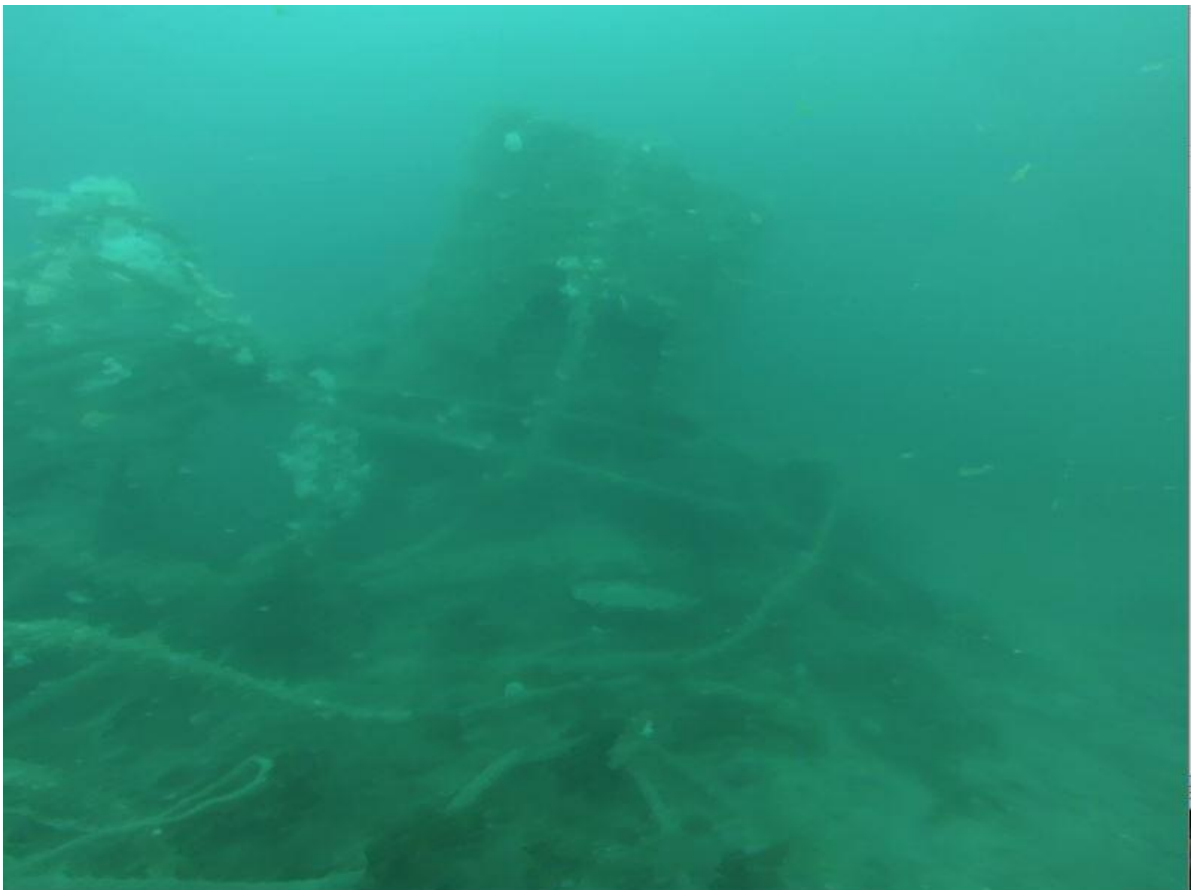
Figure 15: View from the bow area looking aft towards the wheelhouse. Pile of cable is just visible to left of image.

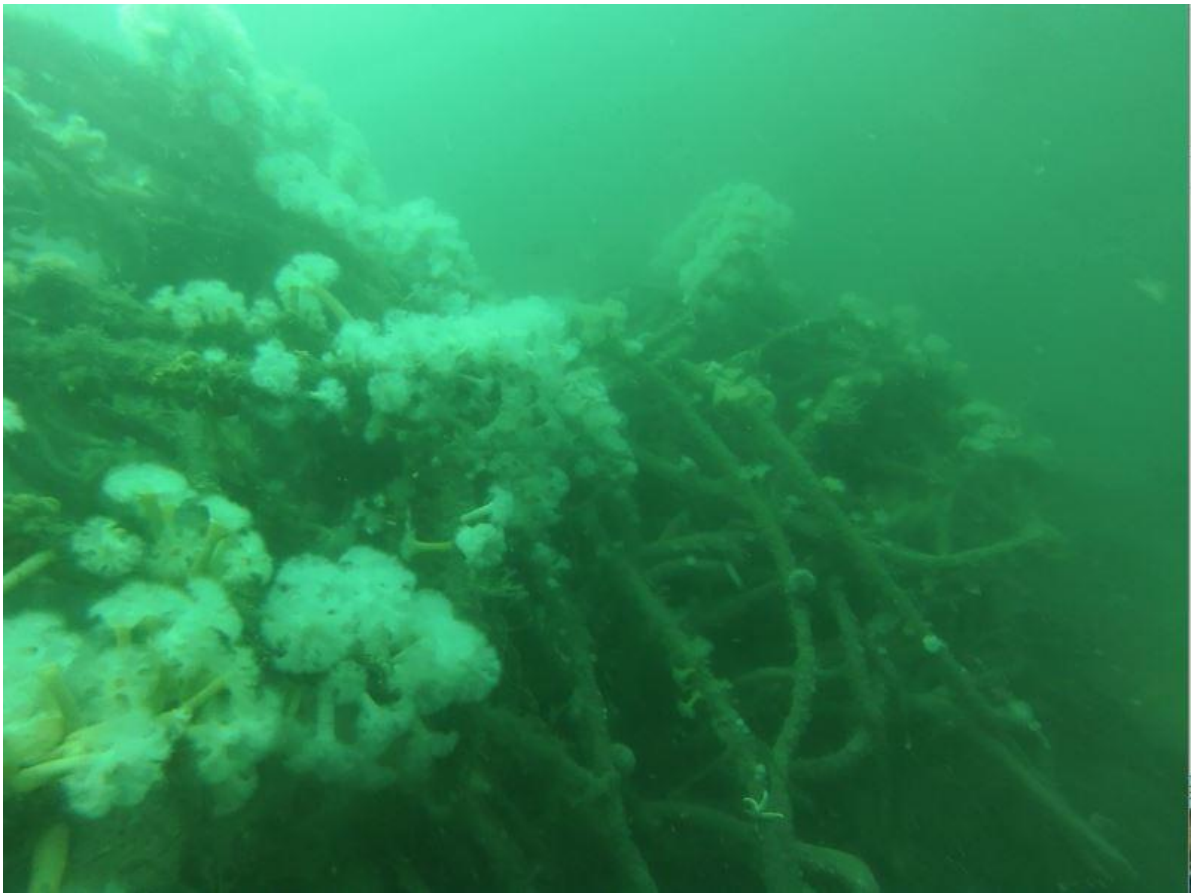
A large amount of cable was located forward of the wheelhouse, mostly spilled over the starboard side onto the seabed. The cable appeared to comprise an outer steel sheath, which was severely eroded, with multiple, plastic-coated copper wires within. These were white-gray in colour. The cable is shown in Figures 16 & 17.

Figure 16: Pile of cable located forward of the wheelhouse on the starboard side of the vessel.

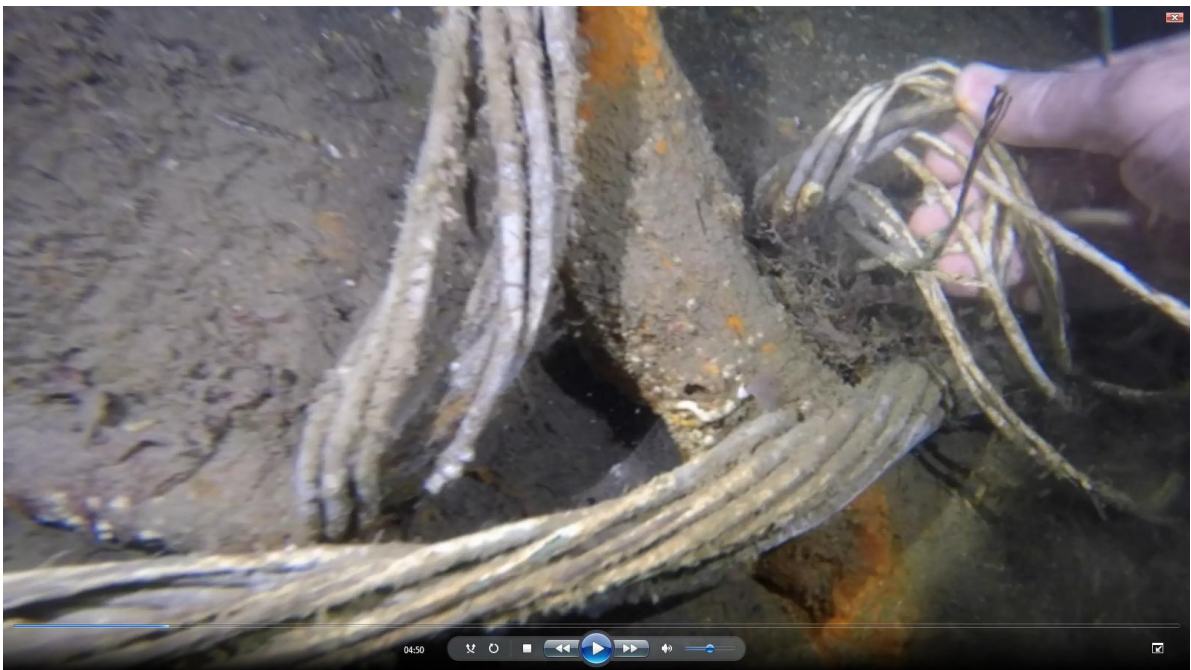
Figure 17: Close up shot of cable showing multiple cores of plastic insulated wires. The corroding steel sheathing on the cable is evident behind.

The significant length of cable located forward of the wheelhouse was an interesting feature of the site. Its steel reinforcing contained seven or eight, plastic coated wires. One possibility is that this was a communications cable, several of which were known to be deployed in that area by the British Navy during World War 2. These were deployed from land, out along the seabed to an offshore buoy, where naval vessels could literally "plug in" to get telephone communications. A map showing two of these cables located to the north-west of Flotta, along with the area covered by the side scan survey during this project, is shown in Figure 22. The cable seen at the wreck site was clearly coiled up however and what it was doing on the vessel is unclear. The vessel may have been in the process of deploying or recovering the cable, although its disorganised state is not typical of a deployment or recovery operation. The possibility also exists that the cable has simply been dumped and landed on the wreck coincidentally. Further survey work might focus on the cable and whether or not it runs away from the wreck site and if this was a WW2 communications cable, could the circular object located 60m north of the wreck site be the offshore communications buoy?

If this is the wreck of HMD Chance, lost in 1916, then it would mean that the cable found on the site must have been deposited there many years after its loss, as plastic coating wiring was rare during WW1. The area was also a known anchorage for oilers (oil tankers) using Scapa Flow in WW1, so it is very unlikely that there were any cables laid on the seabed there at the time of the loss of HMD Chance. The presence of telecommunications cables in the area during World War 2 was discussed earlier. Modern Admiralty charts do not show their presence so presumably they have been recovered but it is unclear when this took place or whether there is any association with the cable found at the wrecksite.

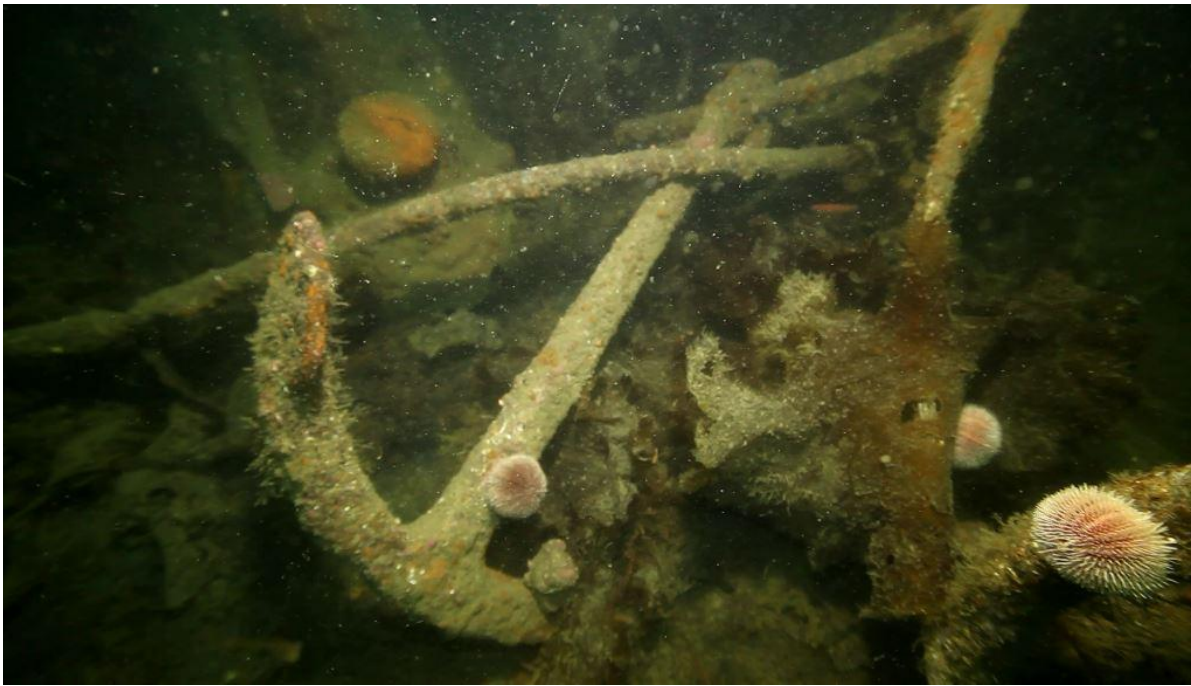
The foredeck had largely collapsed leaving a mixture of steel and timber wreckage. Concrete ballast was visible there that contained voids where the ship's timber ribs were once located. A capstan winch (drifter type) was located near the bow as well as a fisherman's type anchor. A steel tank was also noticed within the wreckage which may have been for freshwater storage. A timber box was also observed with some contents, possibly paint tins. Images from this area are shown in Figures 18 – 20.

Figure 18: Fisherman's type anchor lying at the bow. Image courtesy of Marjo Pauliina Tynkkynen.

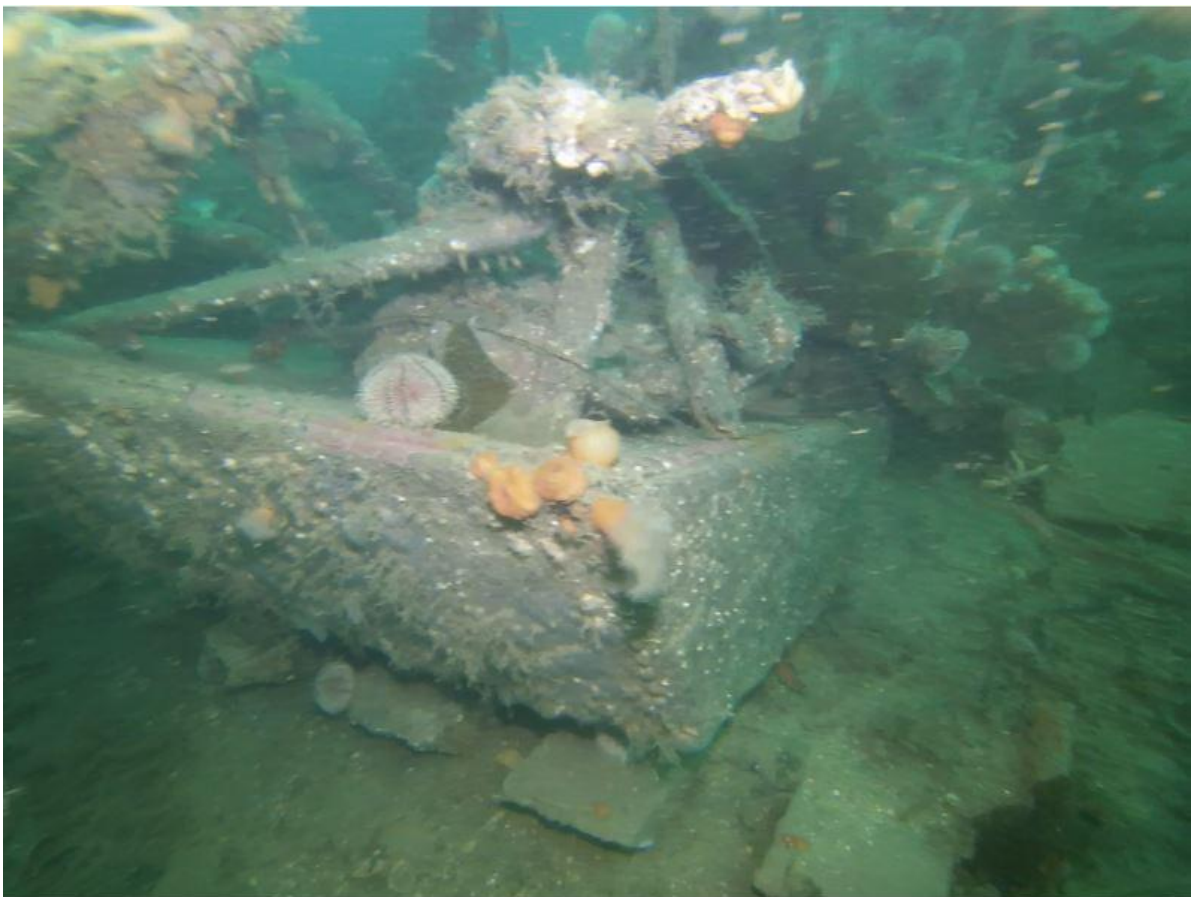
Figure 19: Water tank located at the bow of the vessel. Concrete ballast is evident below with regular spaces where the ribs would have been originally.

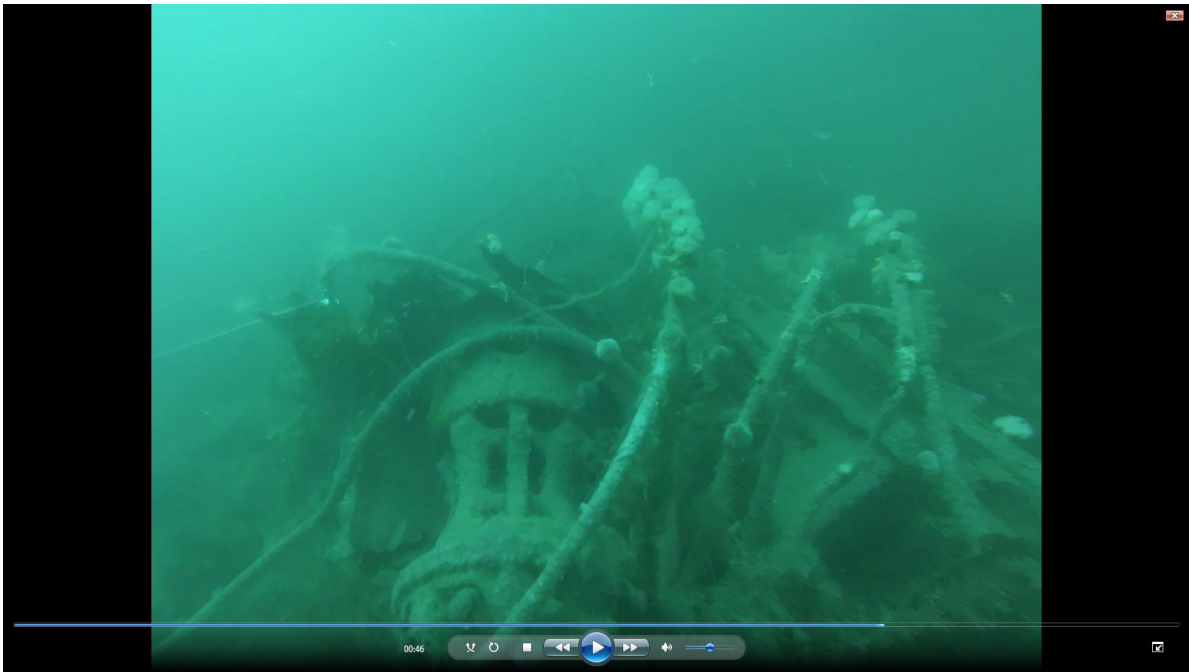
Figure 20: Capstan winch lying in the bow wreckage. It is lying upside down with remains of the timber decking still attached to its base.

The timber parts of the vessel were significantly degraded, although some parts remained, such as the deck boards still attached to the capstan winch at the bow. The metal components exhibited corrosion but were in moderately good condition. The rudder, propeller, stern tube, boiler and wheelhouse were all easily recognisable. A number of smaller metal items were also found, such as pressure gauges, sight gauges, brass fittings and the steering helm. The presence of the wreck was not known to local dive boat operators or scallop divers, both of whom work extensively around Scapa Flow. Consequently it is possible that the site has never been dived until it was found this year. It is possible that its location in a shipping channel and proximity to the wreck of the SS Prudentia, where diving is restricted, may have caused the wreck to remain undiscovered until now.

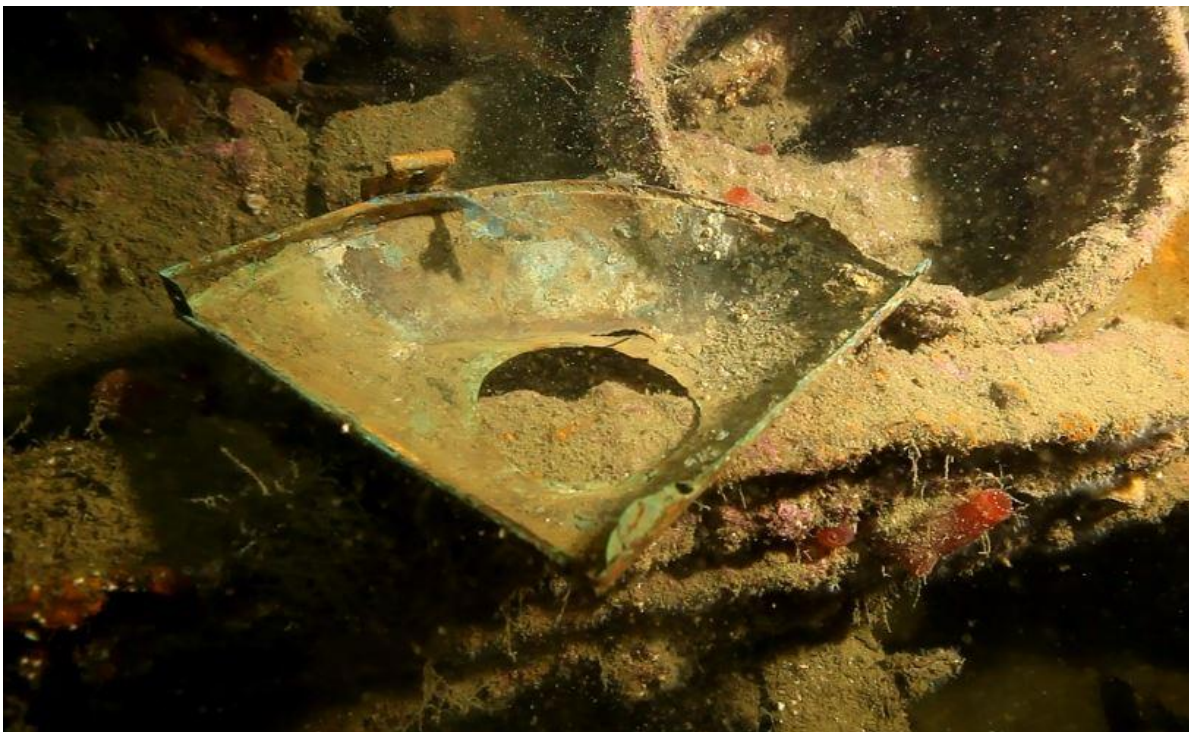
Figure 21: Brass cover, possibly from a navigation light. Image courtesy of Marjo Pauliina Tynkkynen.

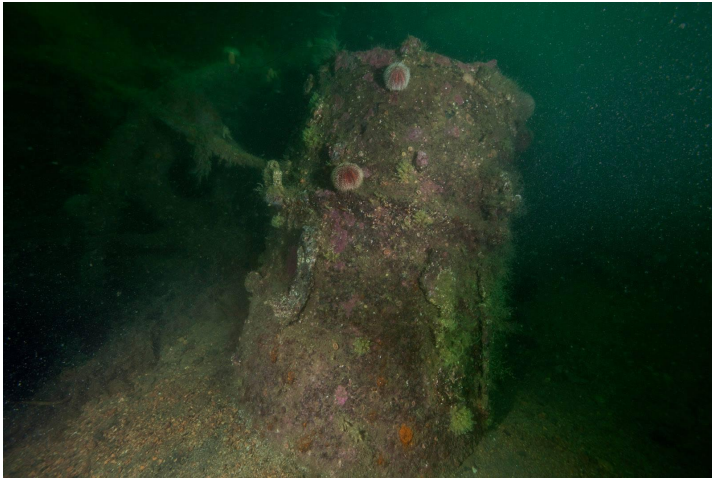
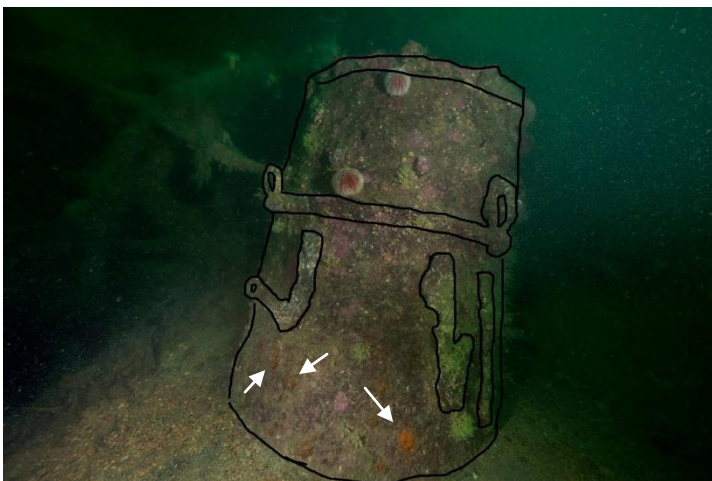
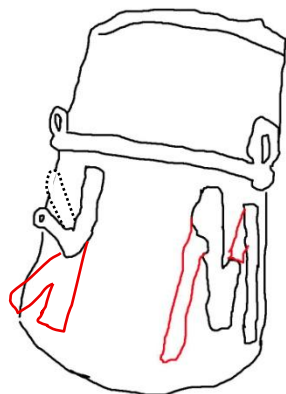
Figure 24: Series of images showing a possible reconstruction of the top two characters attached to the funnel remains. Top image: funnel section lying upside down on seabed. Middle image: remains of characters outlined in black. White arrows show possible stud locations used to attach characters to funnel. Lower image: Based on the remains and the stud pattern, the missing character parts (red lines) as they may have appeared originally, spelling "WK". The dotted black line represents the original line of the lower leg of the "K", which is bent. Images courtesy of Marjo Pauliina Tynkkynen.
