Investigation of an uncharted wreck located in Scapa Flow, Orkney.

Final Report

Submitted to: Historic Environment Scotland
- Philip Robertson

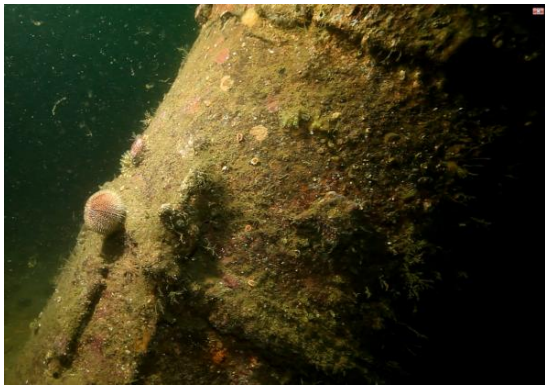
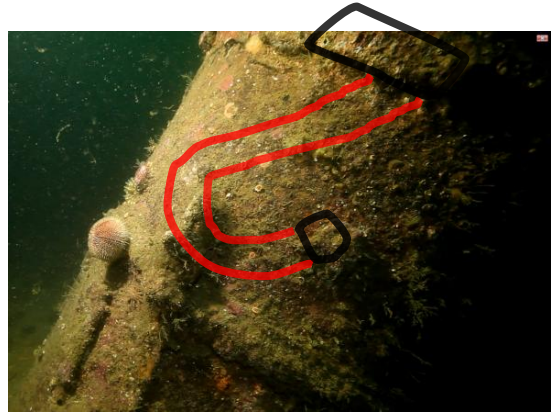
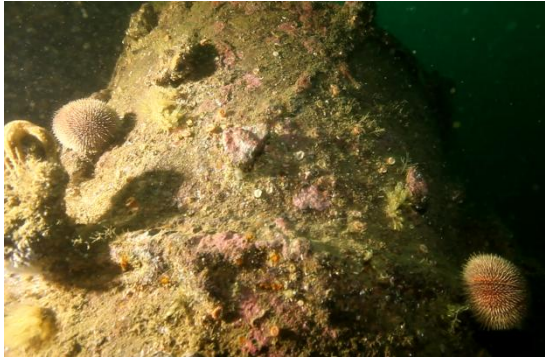
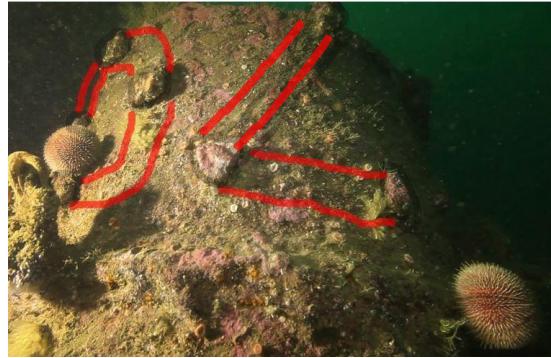
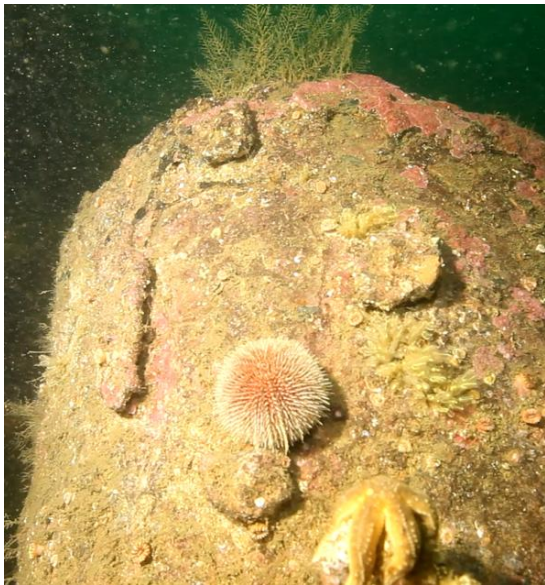
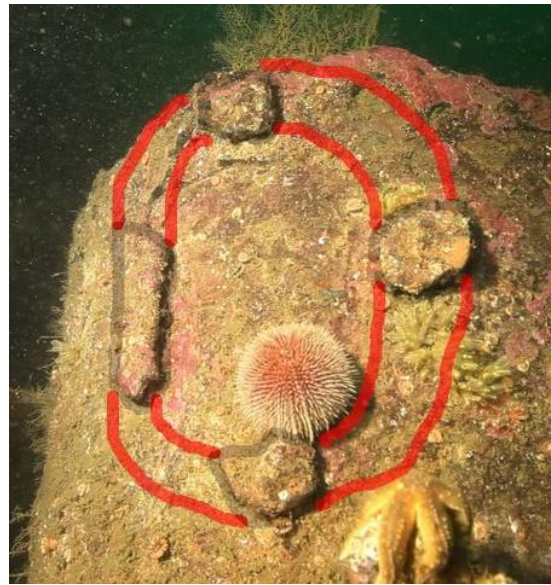
Figure 25: Reconstructions the three characters which form the second line on the funnel. Bear in mind all characters are upside down. Black lines show character remains and red lines show the possible original forms of each character. Top image: first character in the sequence is possible a "2". Middle image: very little remains of the second character but the triangular stud pattern would correspond to a "7". The "0" is shown beside it for context. Bottom image: third character, stud pattern and remains suggest a "0". Images courtesy of Marjo Pauliina Tynkkynen.
