Scapa Flow Underwater Salvage Sites Survey: Phase 2 Report

This report was compiled by SULA Diving and ORCA Marine (University of the Highlands and Islands) on behalf of Historic Environment Scotland.

15th January 2019

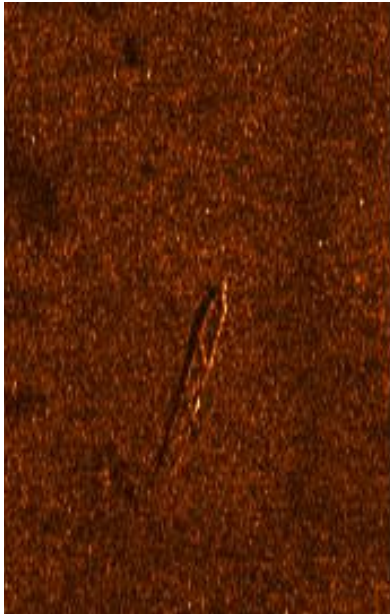
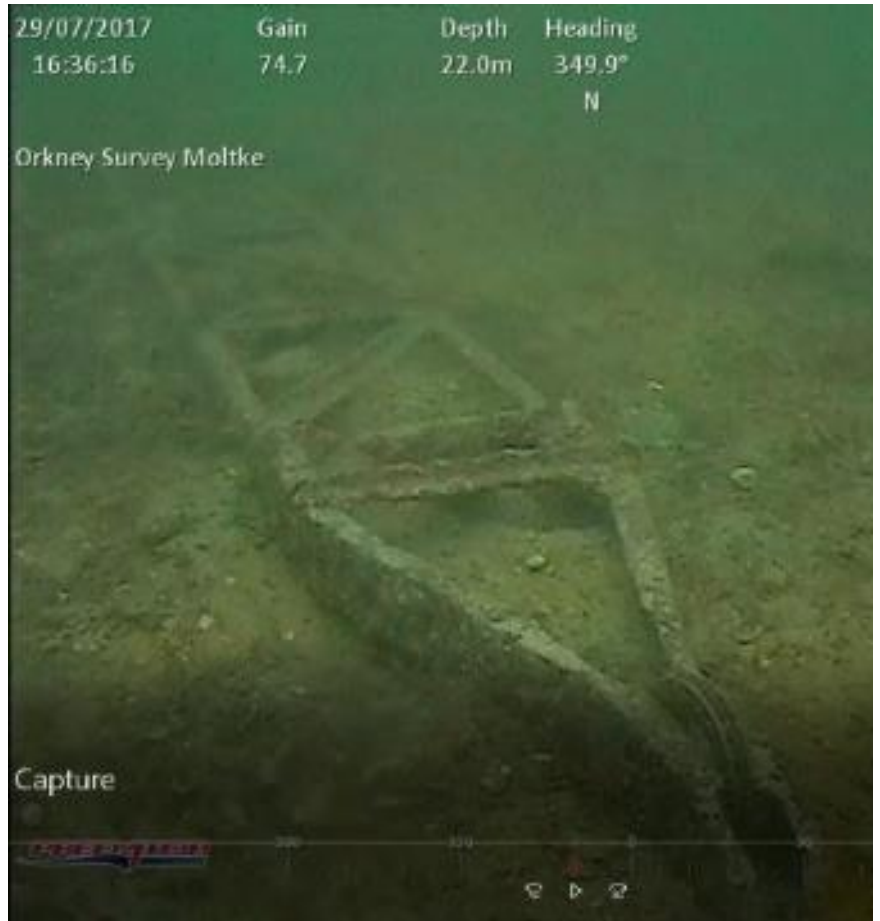
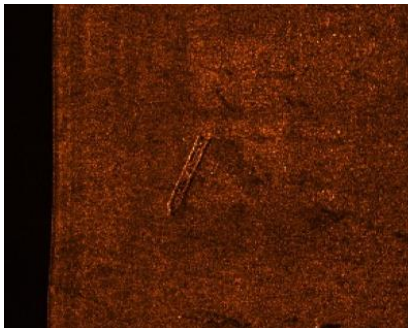
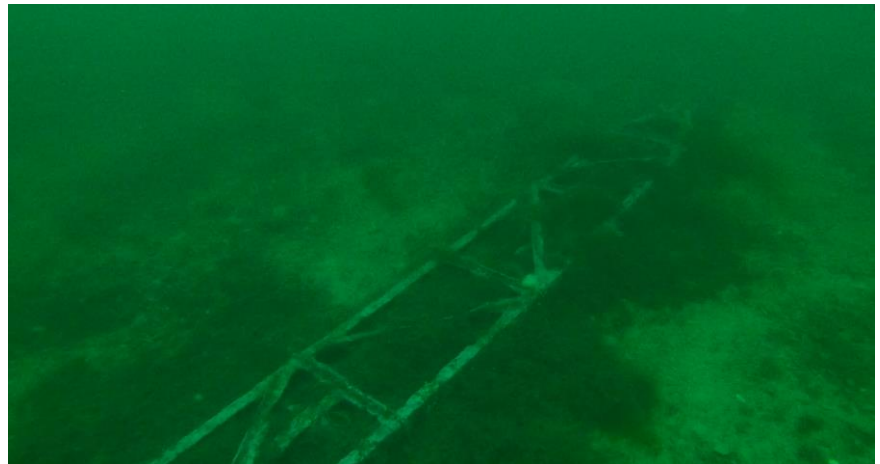
Plate 8: Sonar images of Moltke contacts SS002 (top left) and SS021 (bottom left) with corresponding ground-truthing images at right.

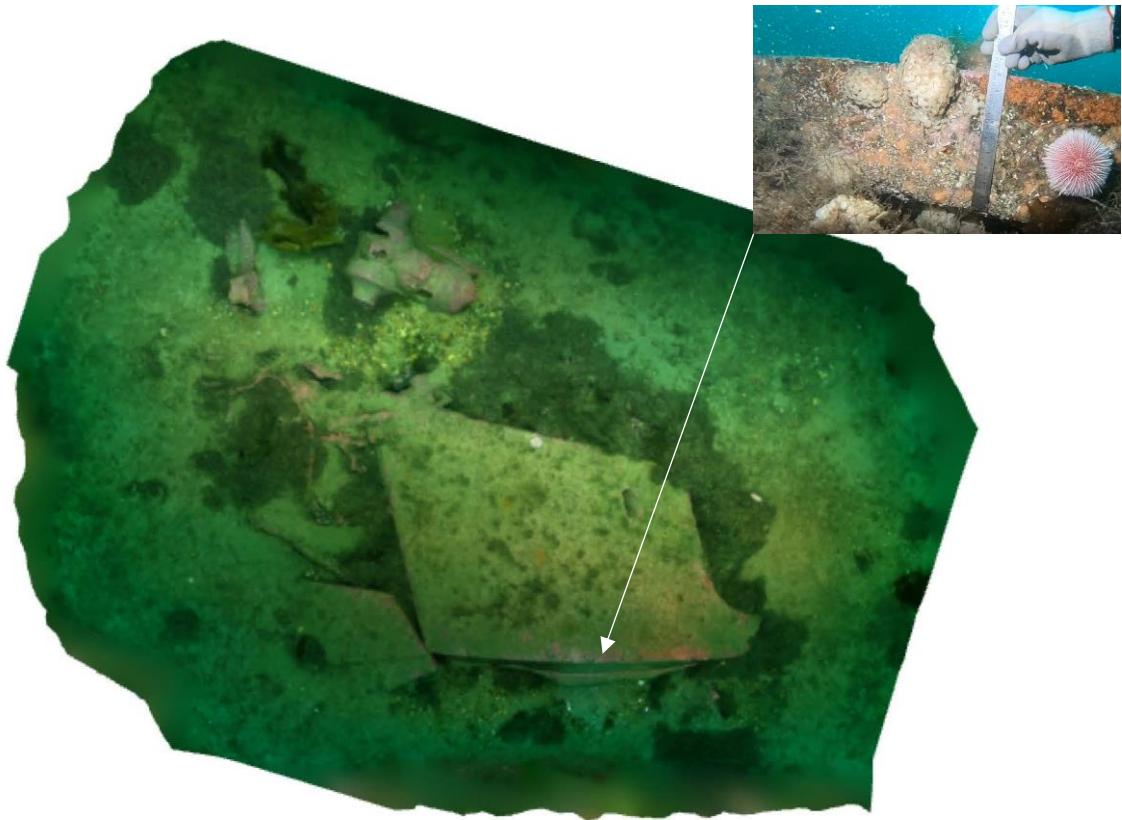
Plate 16: Mosaic image showing the section of armour plate, measured 2.9m x 2.2m and was 9" thick (inset) found on the site of SMS Moltke. The shape of the artefact matches that of the side armour plating on the gun turrets as shown below.

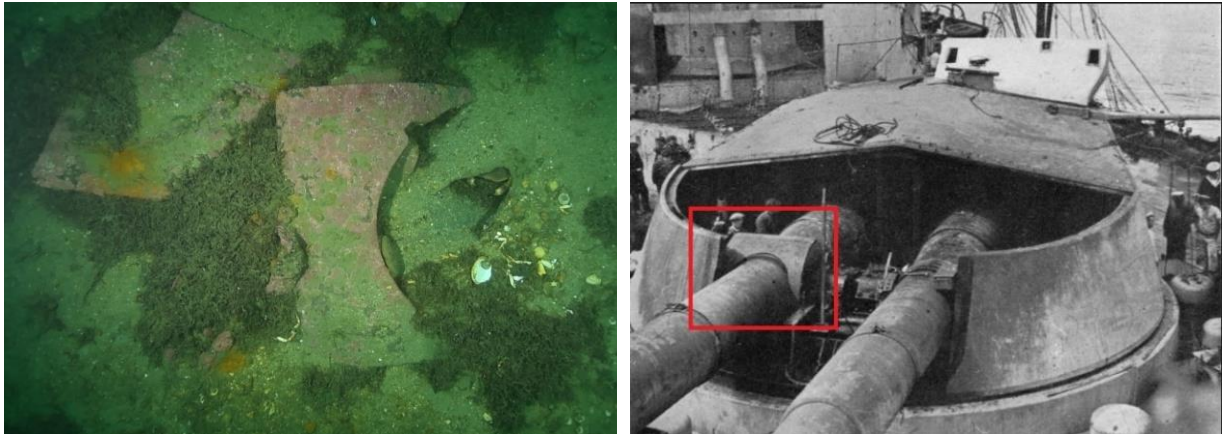
Plate 18: Additional sections of armour plate (left) lying close to the piece of turret armour, with an example shown from HMS Lion (right). These items may also have originated from the turret area, being similar in shape to small armour sections installed around the gun barrels.

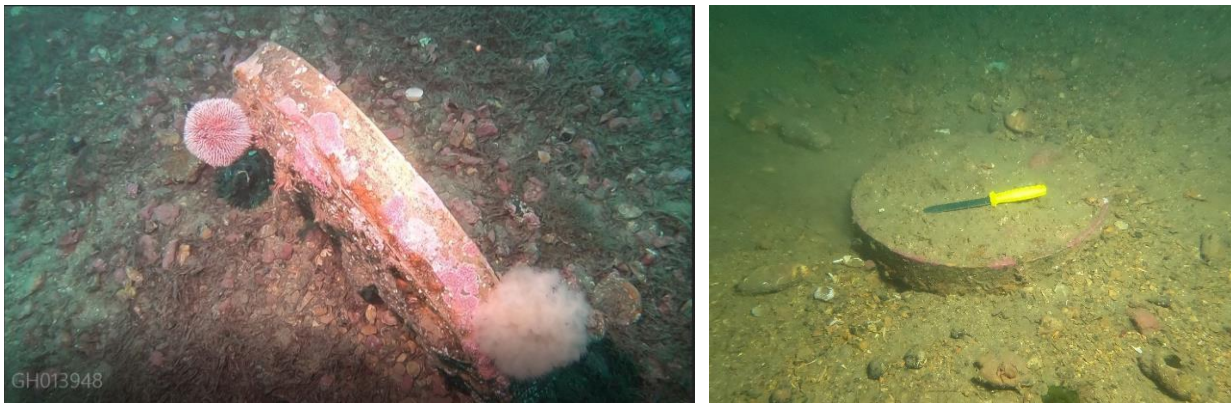
Plate 19: Circular artefact found at SMS Moltke site, lodged firmly in the seabed (left). The one shown on the right was recorded on the site of SMS Prinzregent Luitpold. Circular artefacts, thought to be deck coal hatches, were found at several locations. They were constructed from a brass ring with a timber insert.

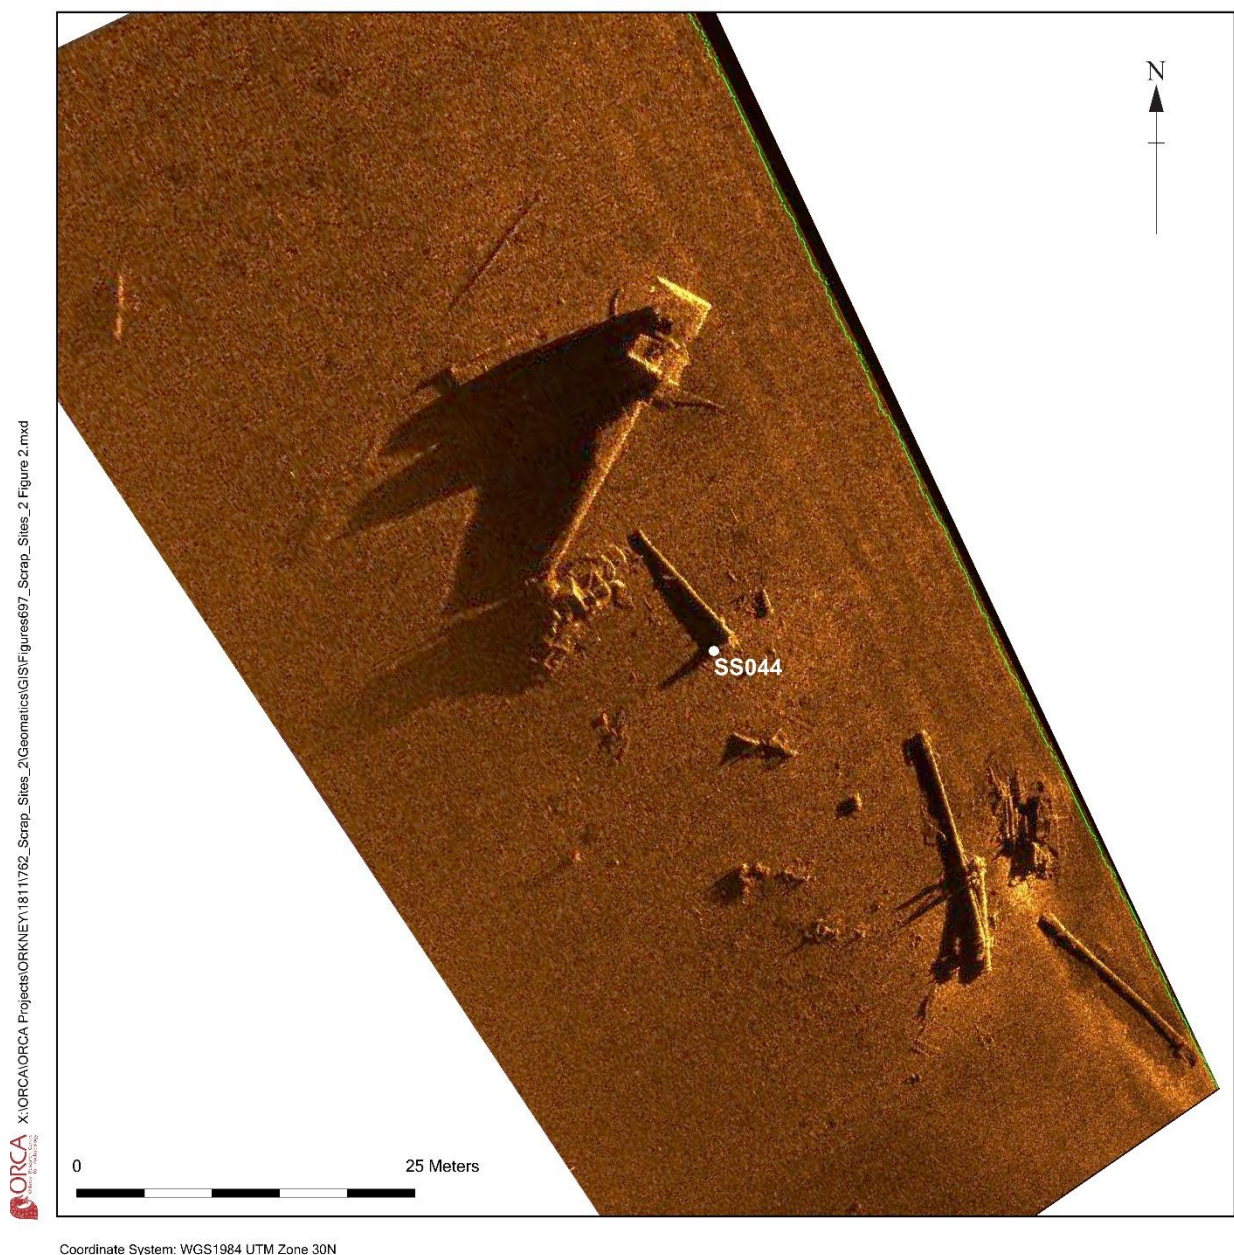
Ground-truthing focussed on the main salvage site located where the *Kaiser* was scuttled and subsequently raised. The side scan image (SS044) of the site collected in Phase 1 showed a number of masts and other wreckage (Figure 6). No evidence of a depression was observed in the sonar data, indicating a relatively hard seabed in this area.

Figure 6: Side scan image of SMS Kaiser primary salvage site (SS044).

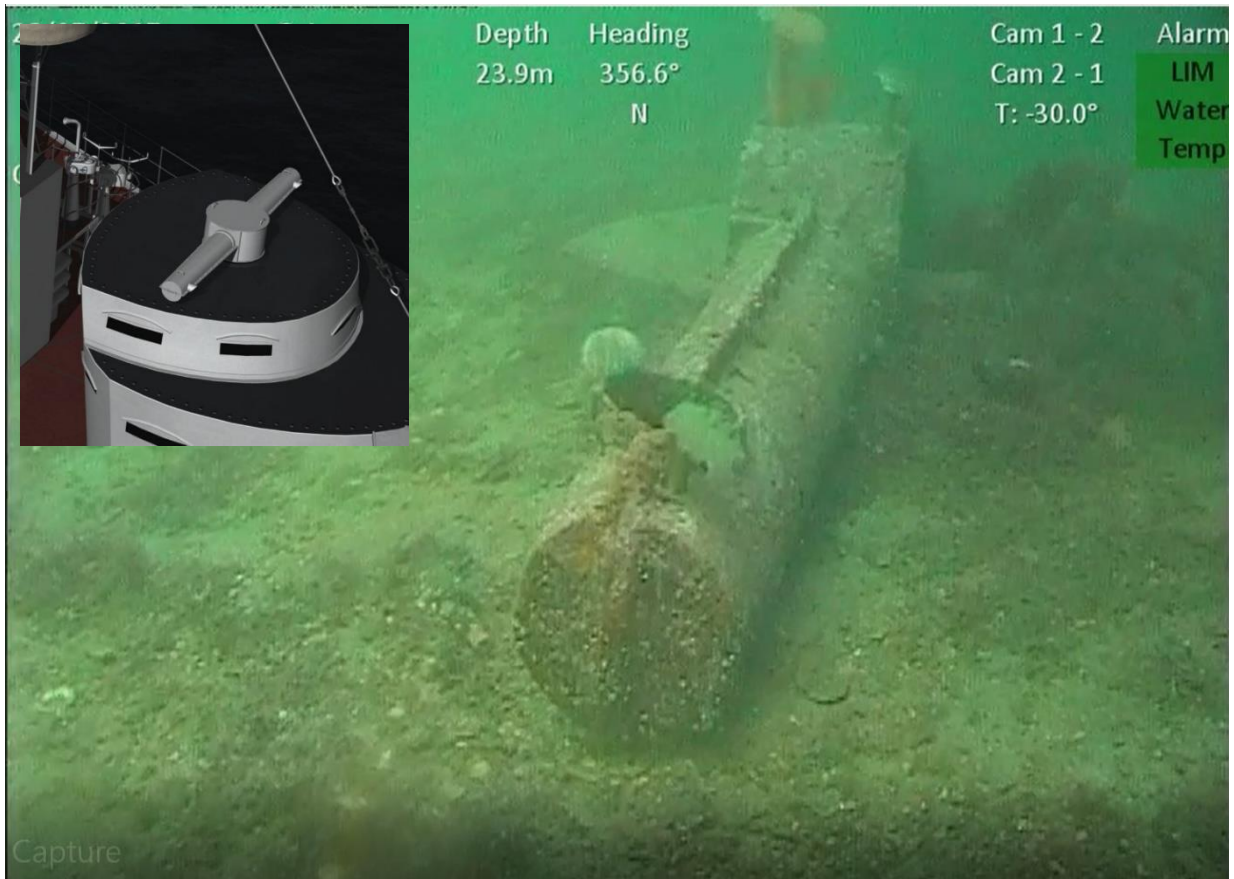
Plate 23: Left, rangefinder located just off the primary salvage site of SMS Kaiser (Shiptime Project), with animated reconstruction of rangefinder (inset, image courtesy of M. Samuel).

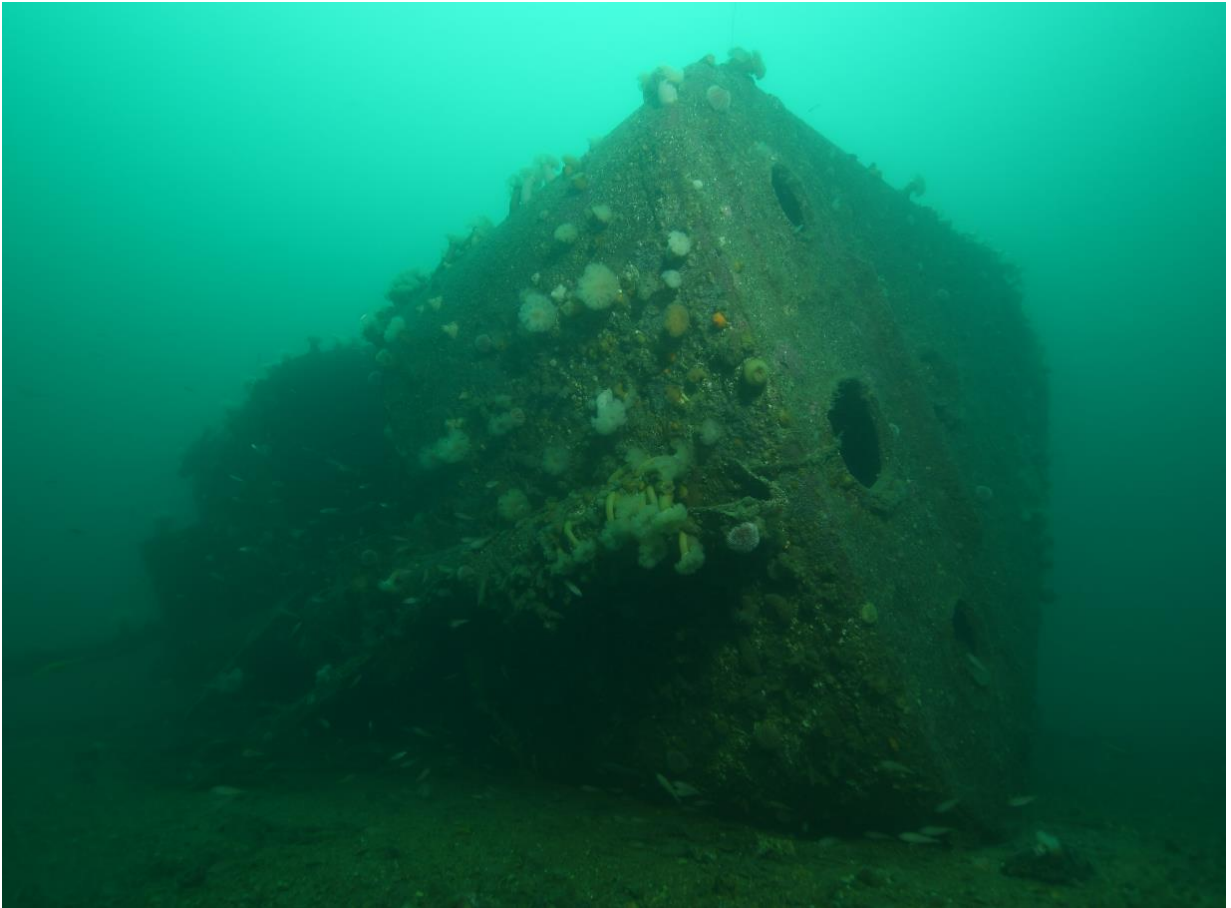
Plate 24: SMS Kaiser forward mast showing splinter proof control room (top) and underside of spotting top (bottom).

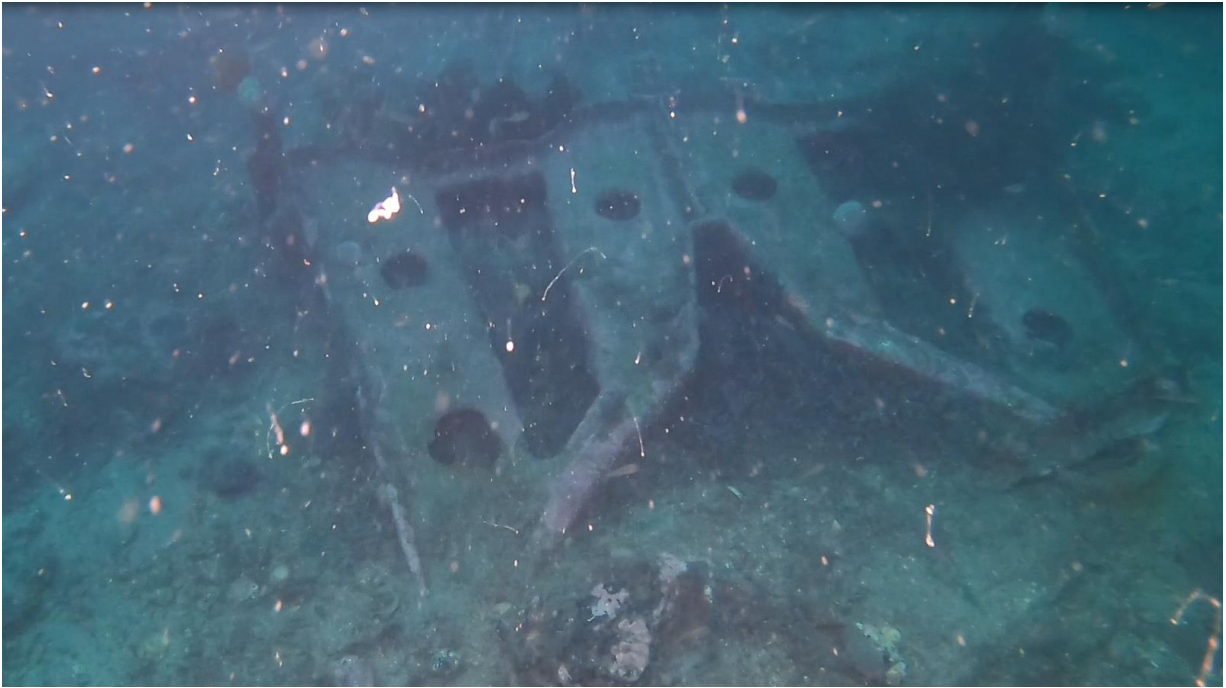
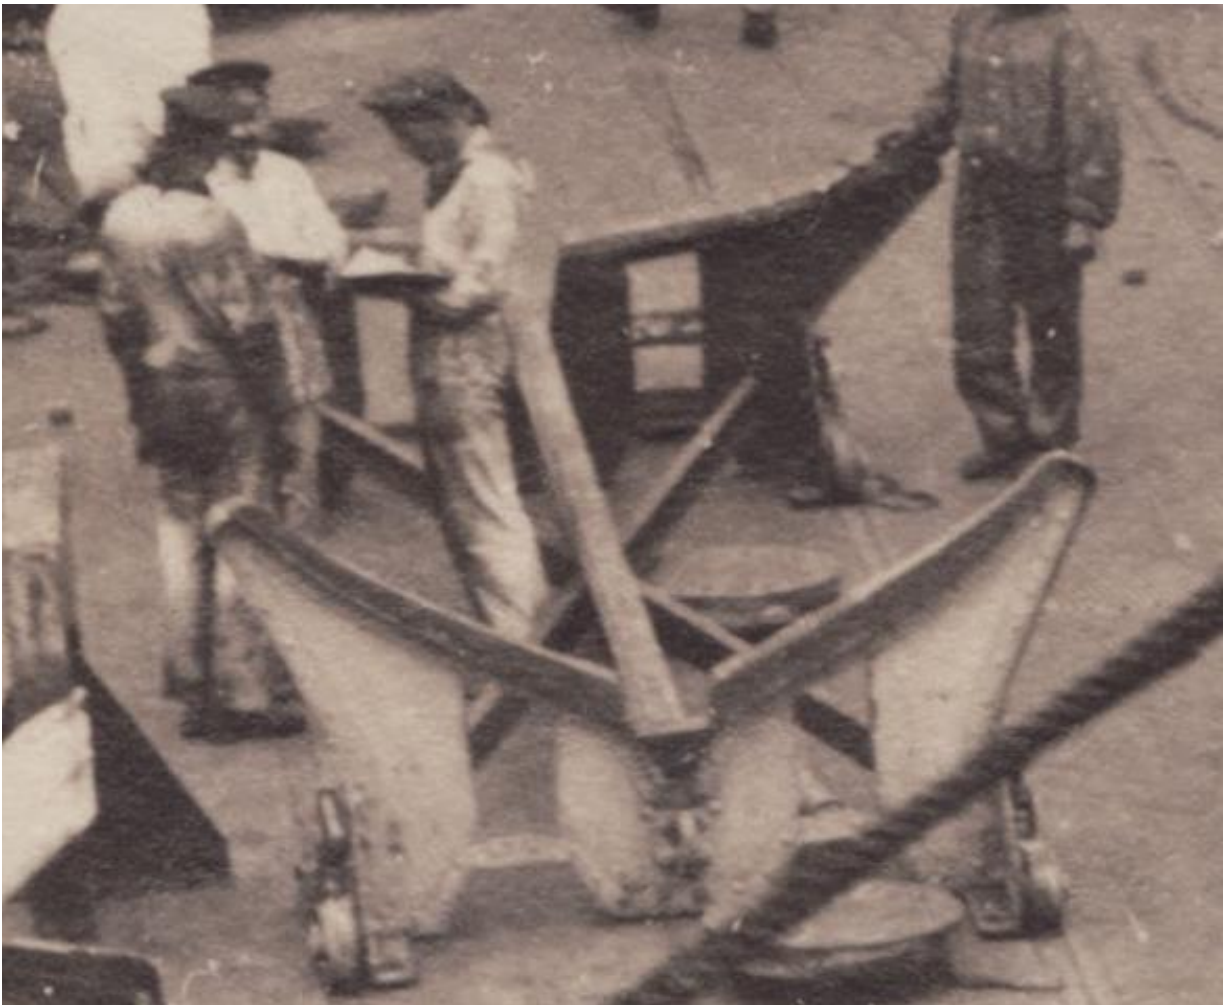
Plate 26: Boat supports found on the Kaiser primary salvage site (left) alongside an archive image (G. Staff Collection) of boat supports on the deck of a German battleship (right).

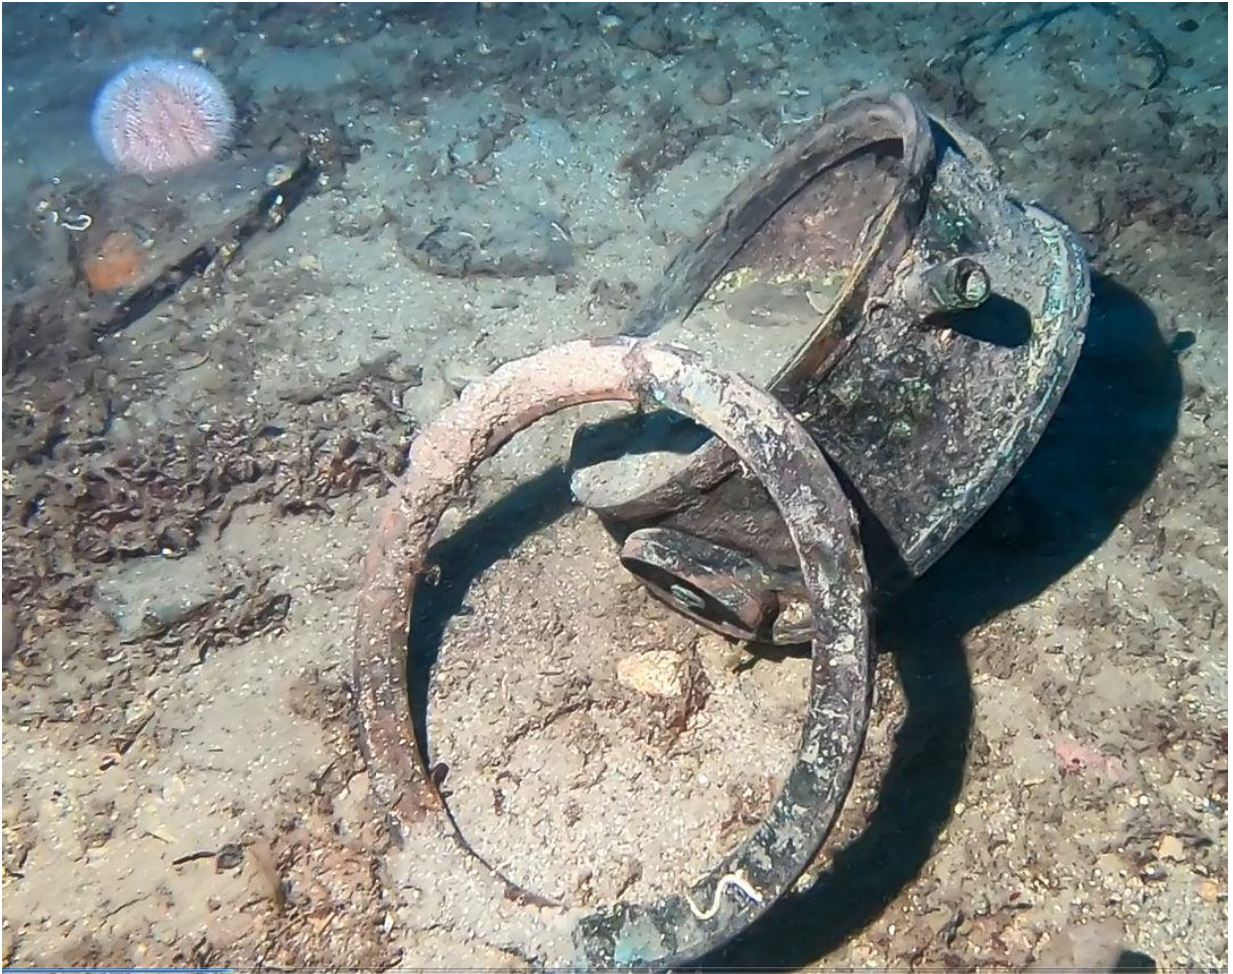
A volunteer dive survey carried out on the 26th November 2018 investigated two additional sonar contacts lying to the south-east of the *Kaiser's* primary salvage site. SS129 proved to be the remains of a searchlight along with what appeared to be a large fairlead and probably originated from the *Kaiser*. SS124 was an anchor of Danforth-type anchor approximately 2m in length and is not thought to be linked to the *Kaiser*. However, the isolated remains of a gyrocompass were found to the north-east of the anchor in a location close to the route taken by the *Kaiser* when it was towed into Cava (Plate 27). The exact location of the gyrocompass remains was not recorded at the time of discovery.

Plate 27: Gyrocompass remains found on the seabed to the south-east of SMS Kaiser's primary salvage site.

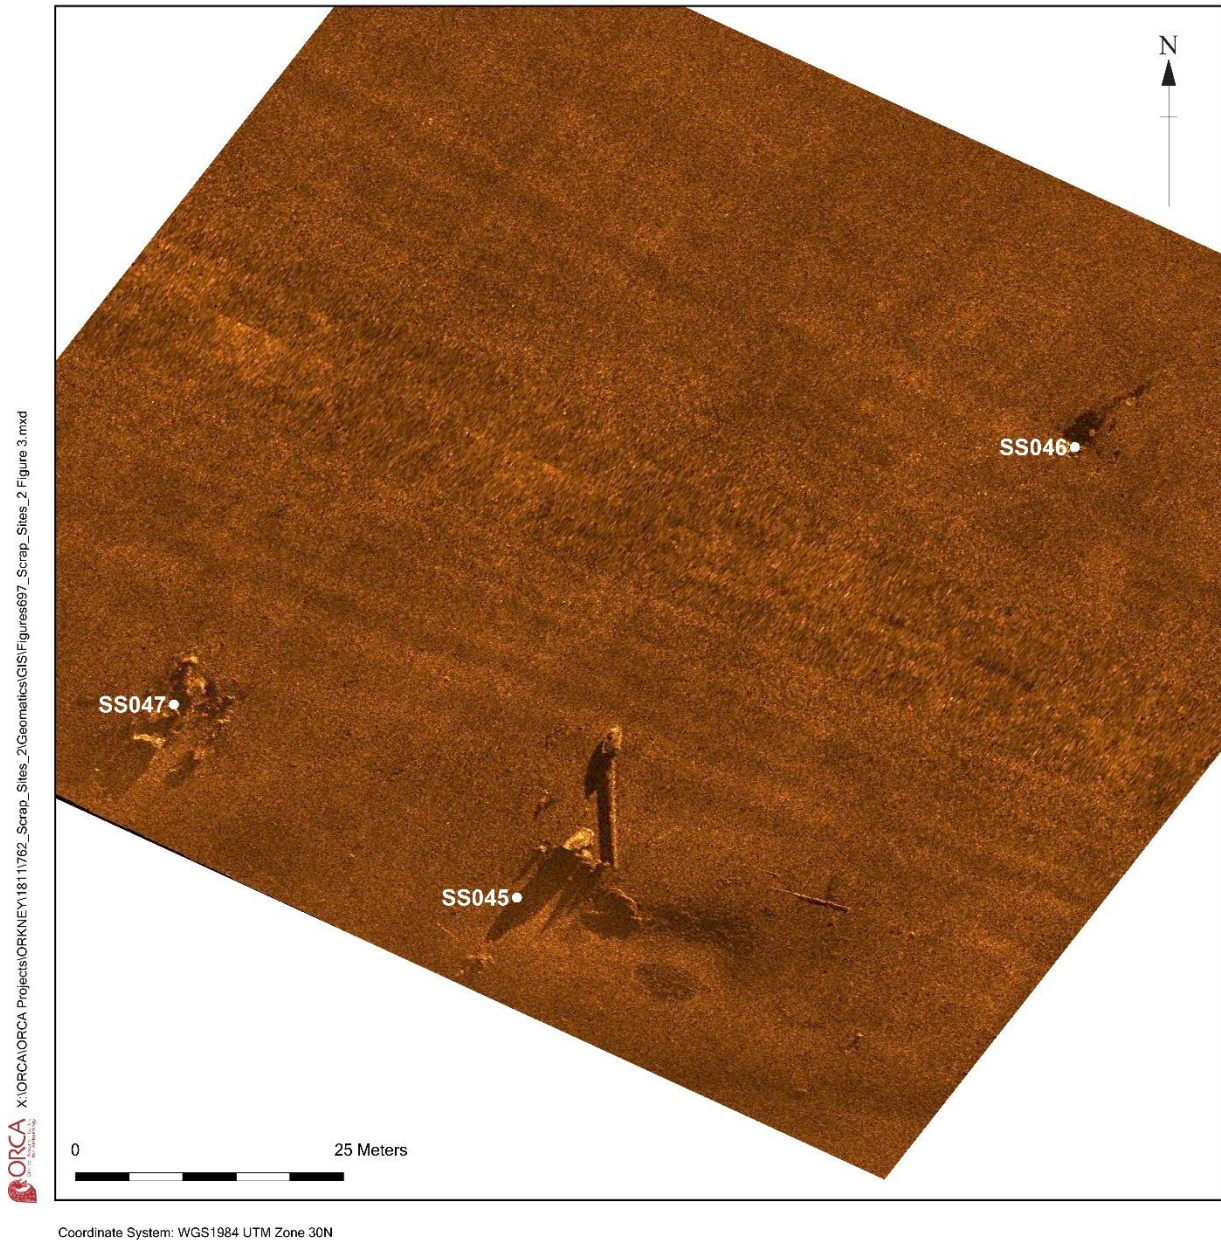
Diving surveys were carried out on the 13th & 16th July and again on the 12th November 2018. Further inspection of SS047 found searchlight platforms amongst the wreckage as well as a section of the aft mast with degraded crow’s nest remains, comprising just the floor and entry hatch. A large detached tube found by the mast may have been part of the spotting top but this is uncertain. Further inspection of the metal box recorded in the ROV survey found it to be a brass room with a door (possibly steel) on one side (Plate 29). The room measured 4m wide by 1.8m long and 2.0m high (it was lying partially buried, so length and height measurements were minimum estimates) and was lying upside down with cables present inside. A repeater compass was also found on the seabed nearby (Plate 30). An archive image of SMS *Prinzregent Luitpold* (Plate 30) shows a small room and repeater compass located on the platform behind the aft control tower, the only *Kaiser*-class vessel that appeared to have this feature. No evidence was found that definitively confirmed the room’s function but the fact it is made of brass suggests it may have been used to house compass equipment.

Figure 7: SMS *Prinzregent Luitpold* primary salvage site (SS045, SS046 & SS047).

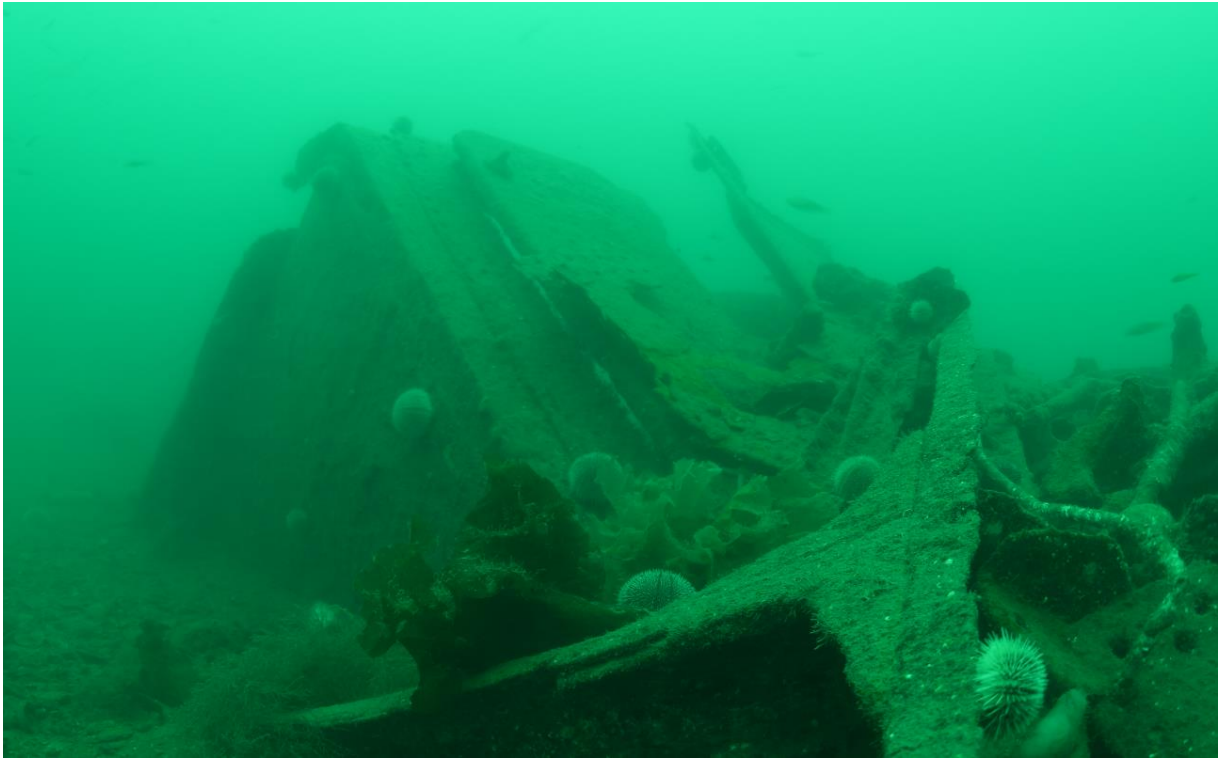
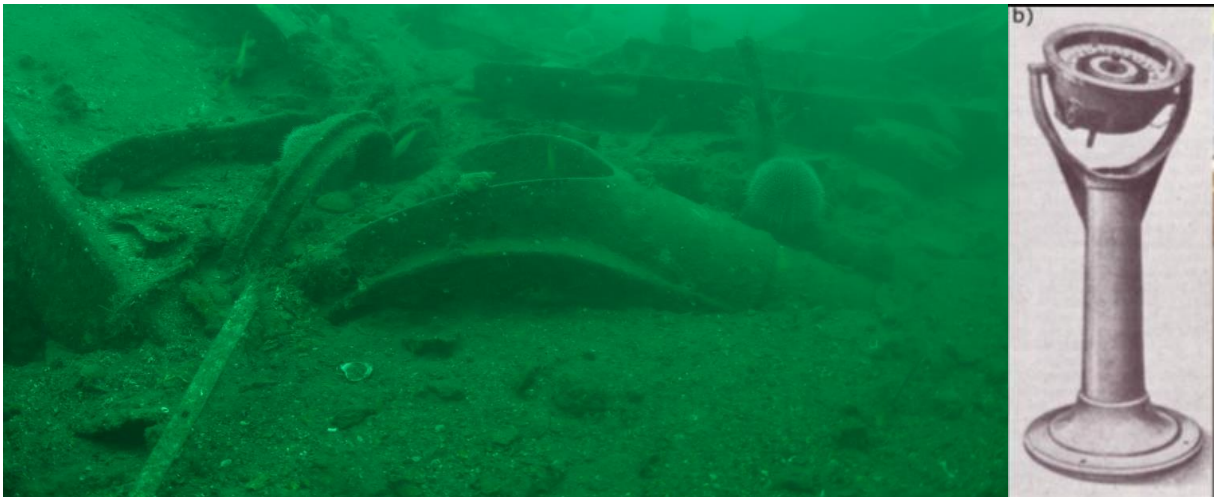
Plate 29: Prinzregent Luitpold primary salvage site, showing mixed wreckage (SS047) including a brass "room" (top) and repeater-type compass alongside an archive image of a German repeater compass (bottom).

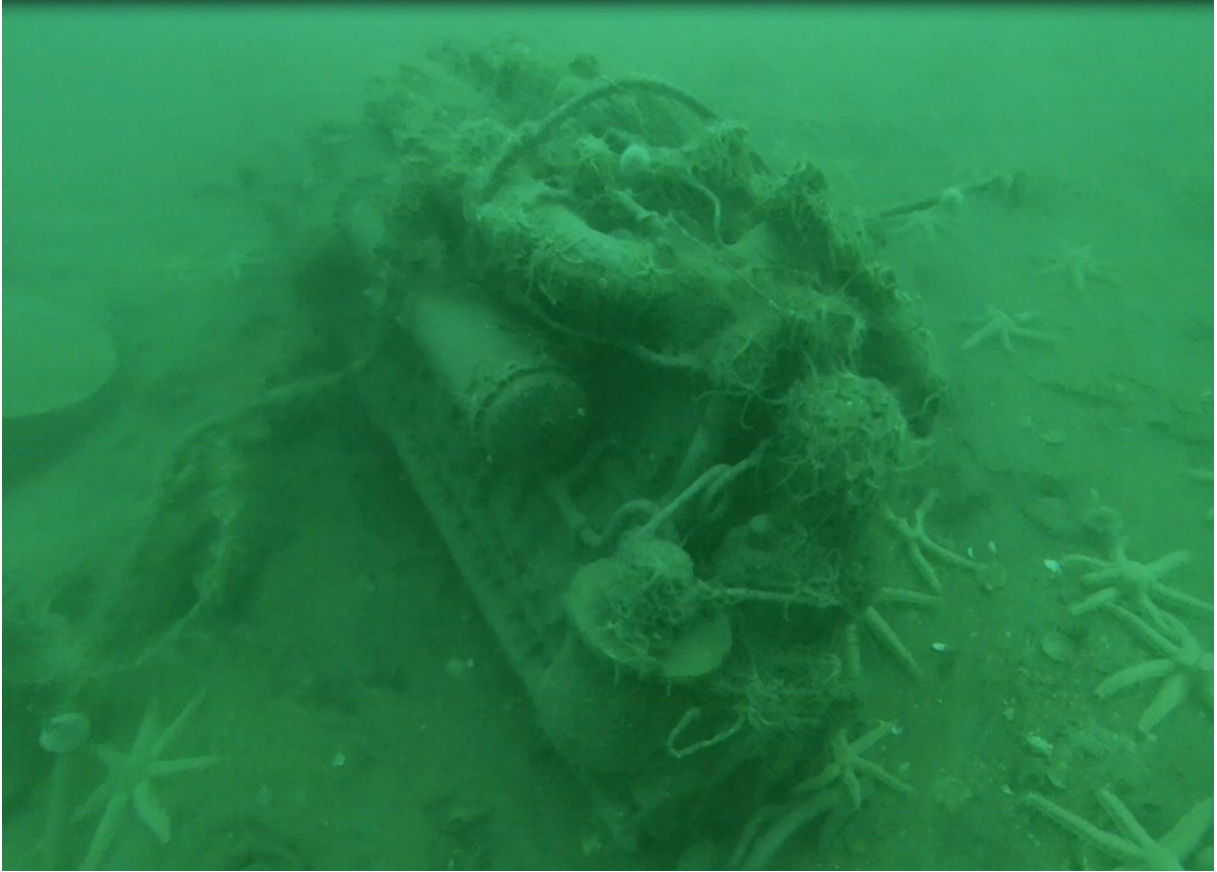
Plate 33: Prinzregent Luitpold, primary salvage site (SS046), diesel engine (image courtesy of I. Houston, OSAC).

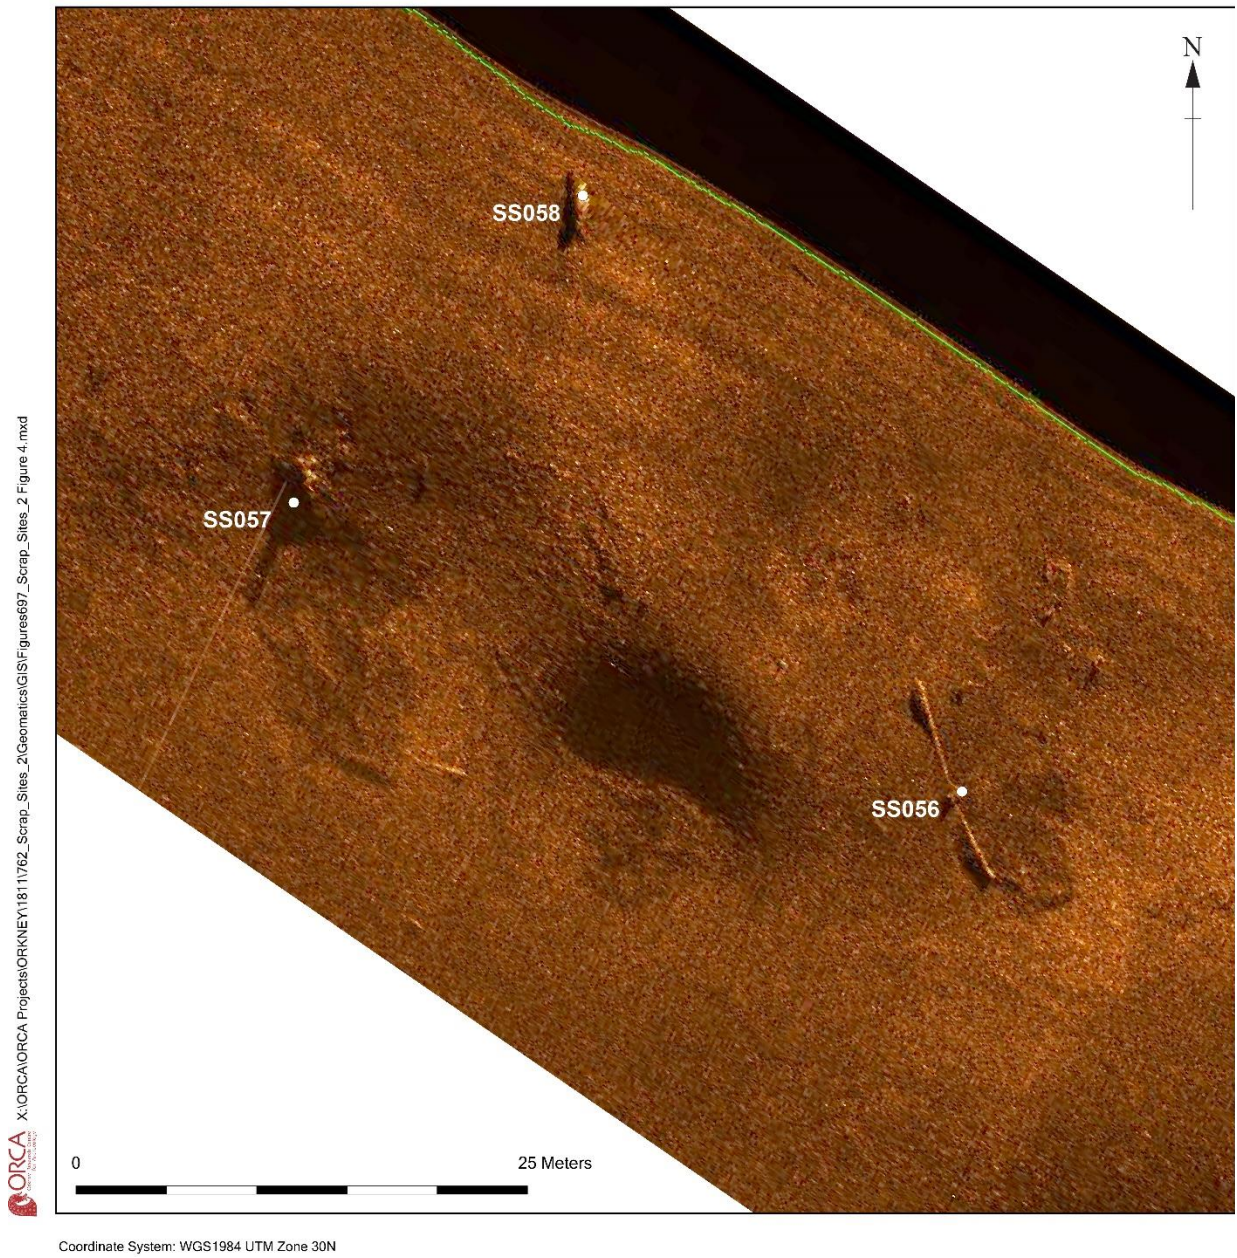
The side scan image collected in Phase 1 shows a depression on the seabed in a WNW to ESE orientation and relatively few objects were visible across the site (Figure 8). Ground-truthing data was limited to remote video surveys carried out on the 3rd July and 28th September 2018 (the Shiptime Project did not survey the SMS *König Albert* site) and found three main features on the site. The first appeared to be the remains of a mast and spotting top (SS057), most likely from the forward mast (Plate 36). The spotting top appeared to be crushed and lying upside down with just the floor still attached to a short (1-2m) section of mast protruding up off the seabed. The second object was a long tubular structure that formed the most obvious sonar contact (SS056). It carried no external fittings or rigging, which suggested it may have been a samson post boom (Plate 37). A coal winch was found lying on top. The third main target was a diesel engine (SS058) lying upside down on the seabed (Plate 38). This was probably from one of the *König Albert*'s diesel boats that, given its orientation, was still attached to the deck when it sank. Other small targets seen in the area included coal hatches and other small items of non-descript wreckage.

Figure 8: SMS König Albert primary salvage site (SS056, SS057 & SS058).

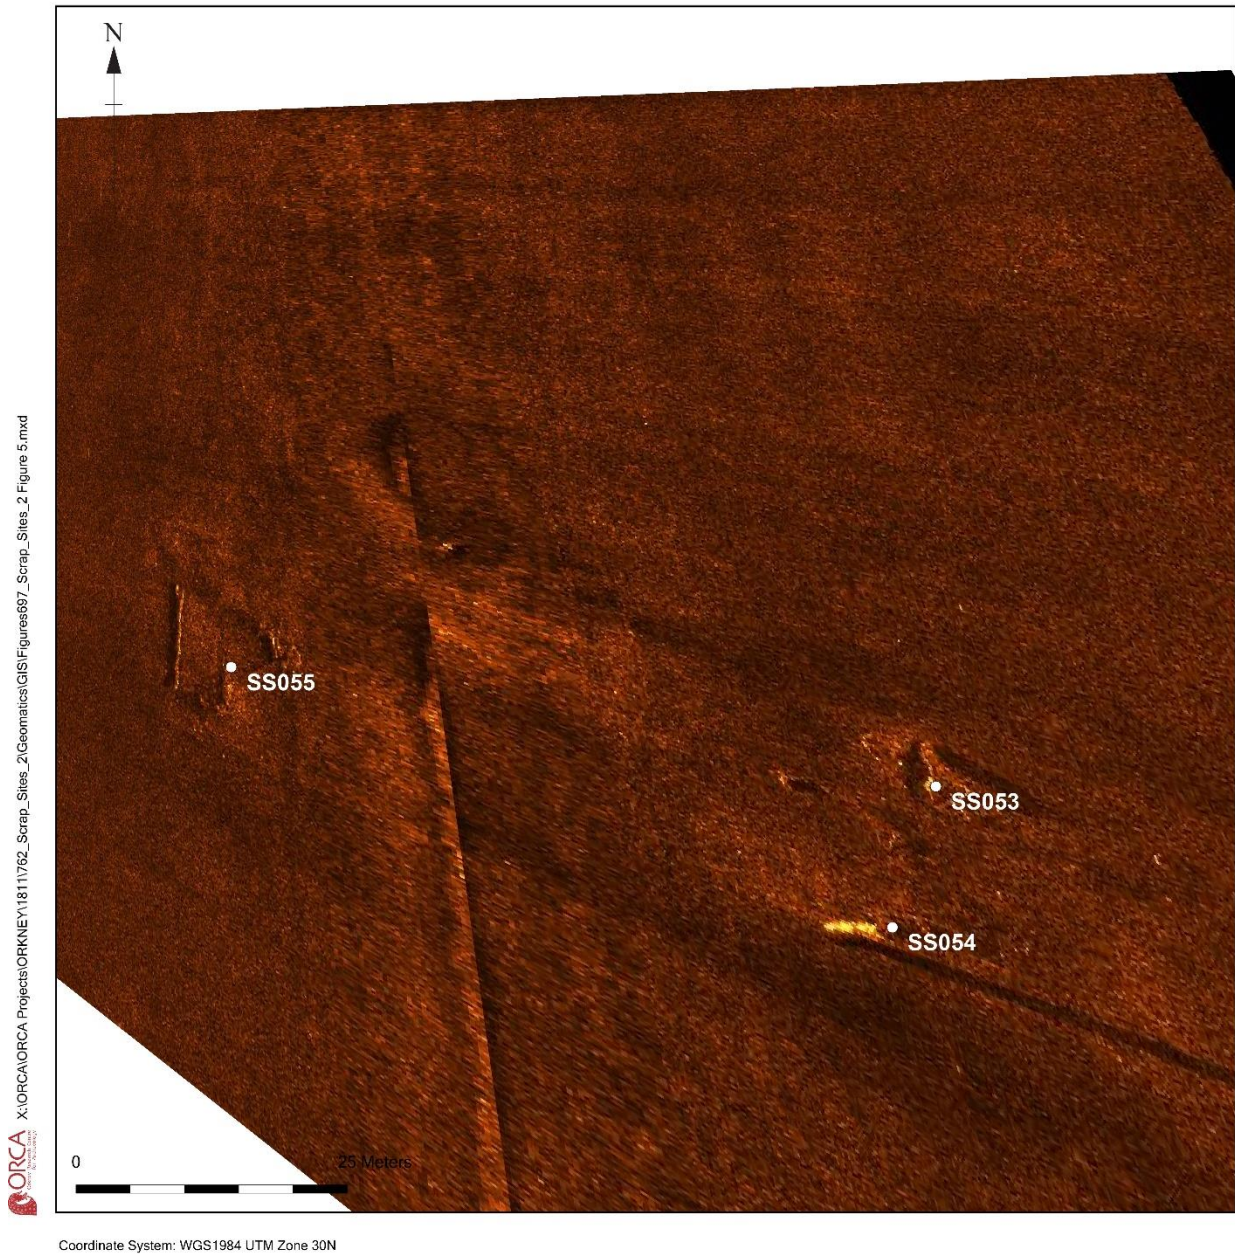
Figure 9: SMS Kaiserin primary salvage site (SS053, SS054 & SS055).

The aft wreckage to the south-east (SS053 & SS054) included another long tubular artefact that was protruding out of the seabed and several meters up into the water column (Plate 45). Again, its origin was uncertain as it had no features that would identify it as a boom or mast. No samson post was observed in this area. Underneath lay a pile of twisted metal framework. A short distance away were two searchlight platforms where searchlight mounts, wiring and brass pipes (possibly voice pipes) were also present (Plate 46). Several smaller items were scattered around the searchlight platforms, including a coal winch, a coil of wire on a drum, a brass tube sticking out of the seabed with shaped end pieces. Perhaps the most interesting feature was the remains of a searchlight with an intact front grill that lay partially buried in the seabed (Plate 48). The ROV survey also located a torpedo mast, lying some way off the forward wreckage to the west.

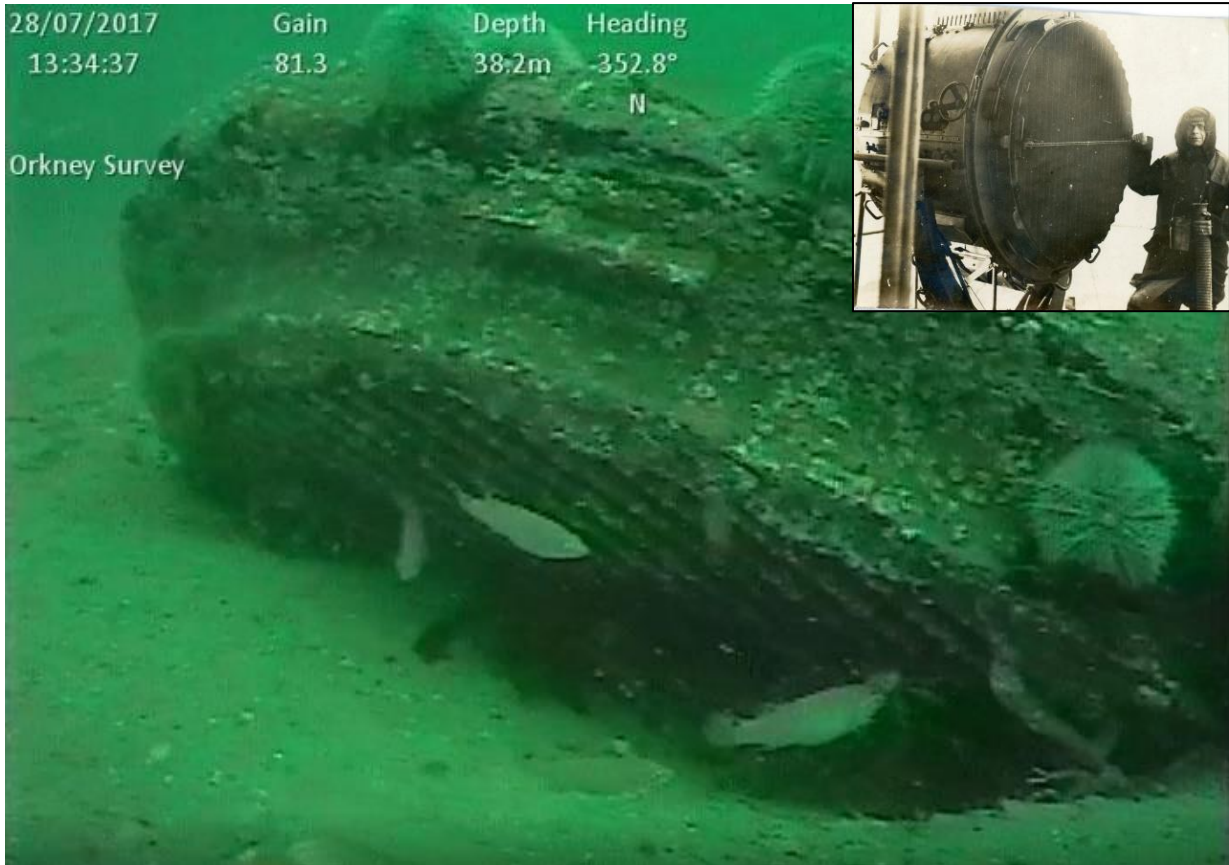
Plate 48: SMS Kaiserin primary site, searchlight remains, partially buried with intact front grill with inset of (top) and iris (bottom). A similar searchlight unit from a German ship is also shown (top right) (G. Staff Collection).

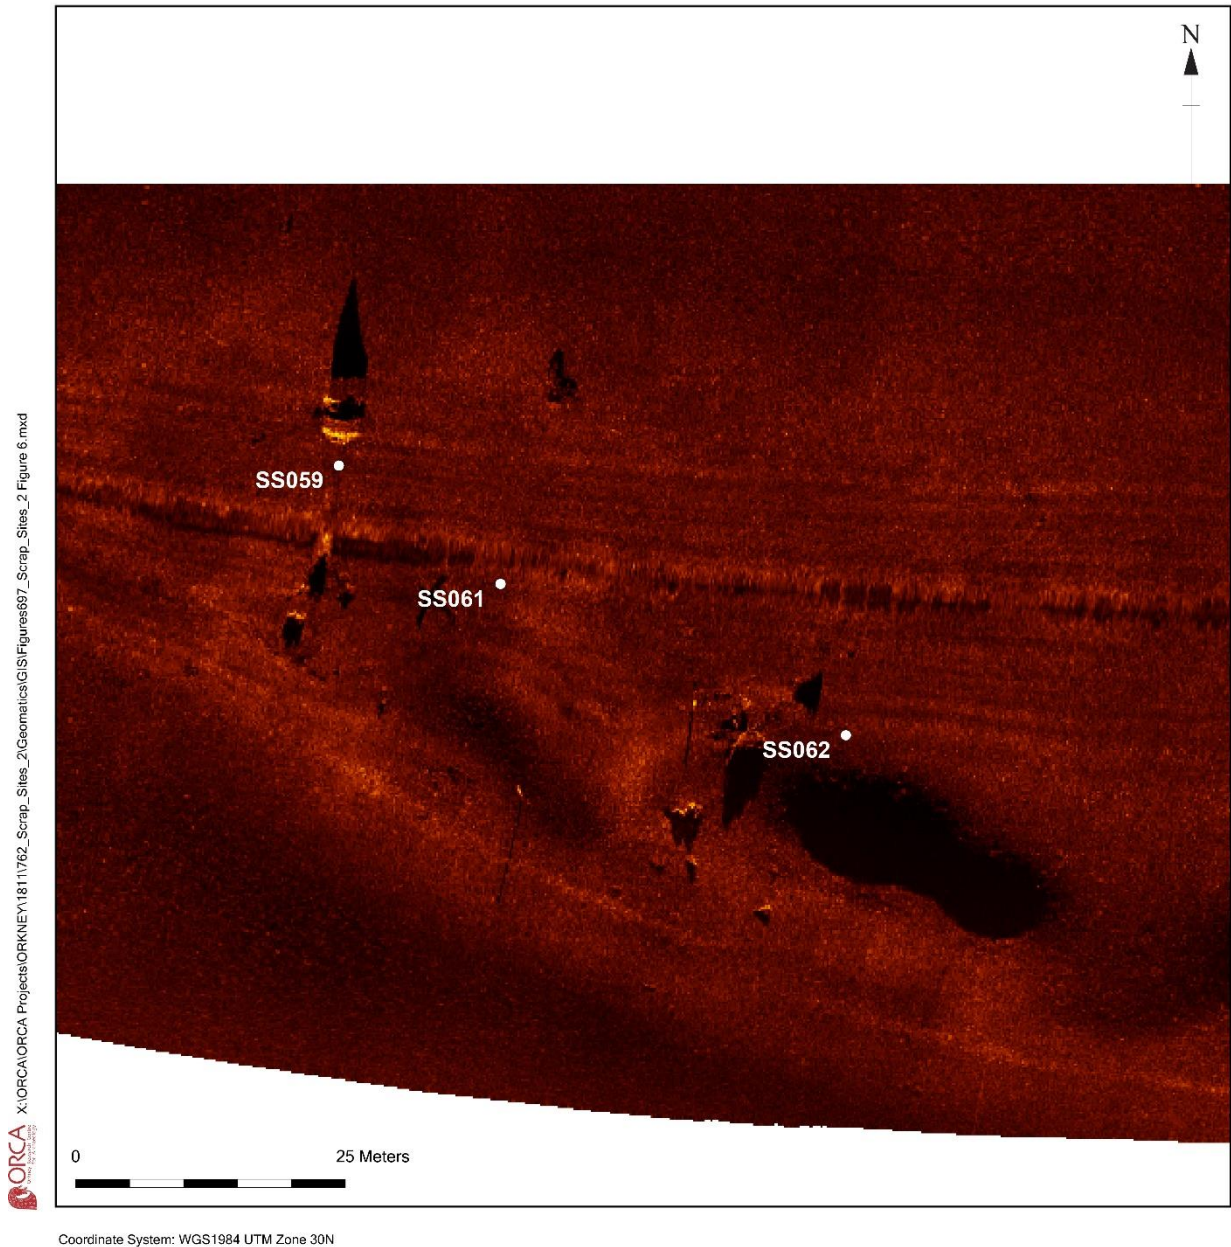
Ground-truthing of the site was carried out during the Shiptime Project on the 30th July 2018 and later by remote video survey during the Phase 2 project. The Shiptime survey¹⁵ focussed on the group of targets (SS062) to the south-east of the site. The presence of searchlight platforms here was confirmed with at least two platform sections seen lying together along with extensive cabling and control mechanisms (Plate 50). A short distance away to the north-east a tubular structure, at least 6m in length, was found sticking out of the seabed at an angle of approximately 30 degrees (Plate 51). The origin of this artefact was unclear as it carried no distinguishing features. It may be one of the samson post booms (the salvage diver reported that both booms had “slipped” prior to arrival at Rysa (Metal Industries Ltd Salvage Logbook D1/59/2/3) or a section of the aft mast. The ROV moved west from the platforms and located a sub-calibre liner box, partially buried in the seabed (Plate 52). At this point the ROV returned to the searchlight platforms and the survey was terminated after its umbilical became snagged in wreckage.

A remote video survey was carried out on 3rd July 2018 and covered the north-west area of the site. Starting in the same area that was covered in the Shiptime survey, the remote video worked in a north-west direction, passing two metal beams projecting from the seabed before coming to another tubular structure sticking out of the seabed (SS061). This artefact had broken off about 1m above the seabed and its main length (several meters) was lying on the seabed (Plate 53). The absence of features along its length suggest this was a samson post boom. Further to the north-west, the large diameter forward mast was found lying half buried including a well-preserved spotting top and armoured control tower (SS059) (Plate 54 & Plate 55). There was a small amount of debris around the base of the mast, which had ragged edges indicative of blasting. A number of small indistinguishable items were seen on the seabed.

Figure 10: SMS *Friedrich der Grosse* primary salvage site (SS059, SS061 & SS062).
