Scapa Flow Underwater Salvage Sites Survey: Phase 2 Report

This report was compiled by SULA Diving and ORCA Marine (University of the Highlands and Islands) on behalf of Historic Environment Scotland.

15th January 2019

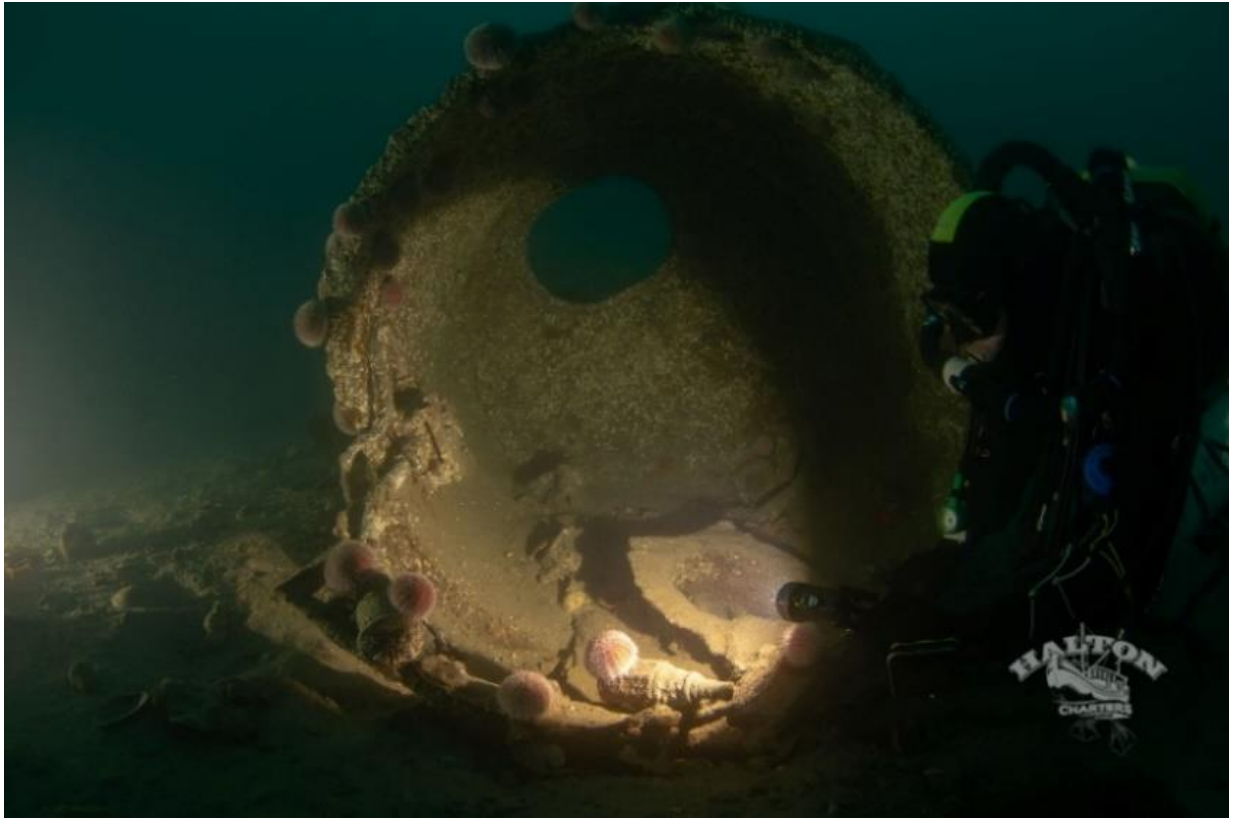
Plate 65: SMS Derfflinger, aft mast spotting top, primary salvage site (image courtesy of B. Anderson).

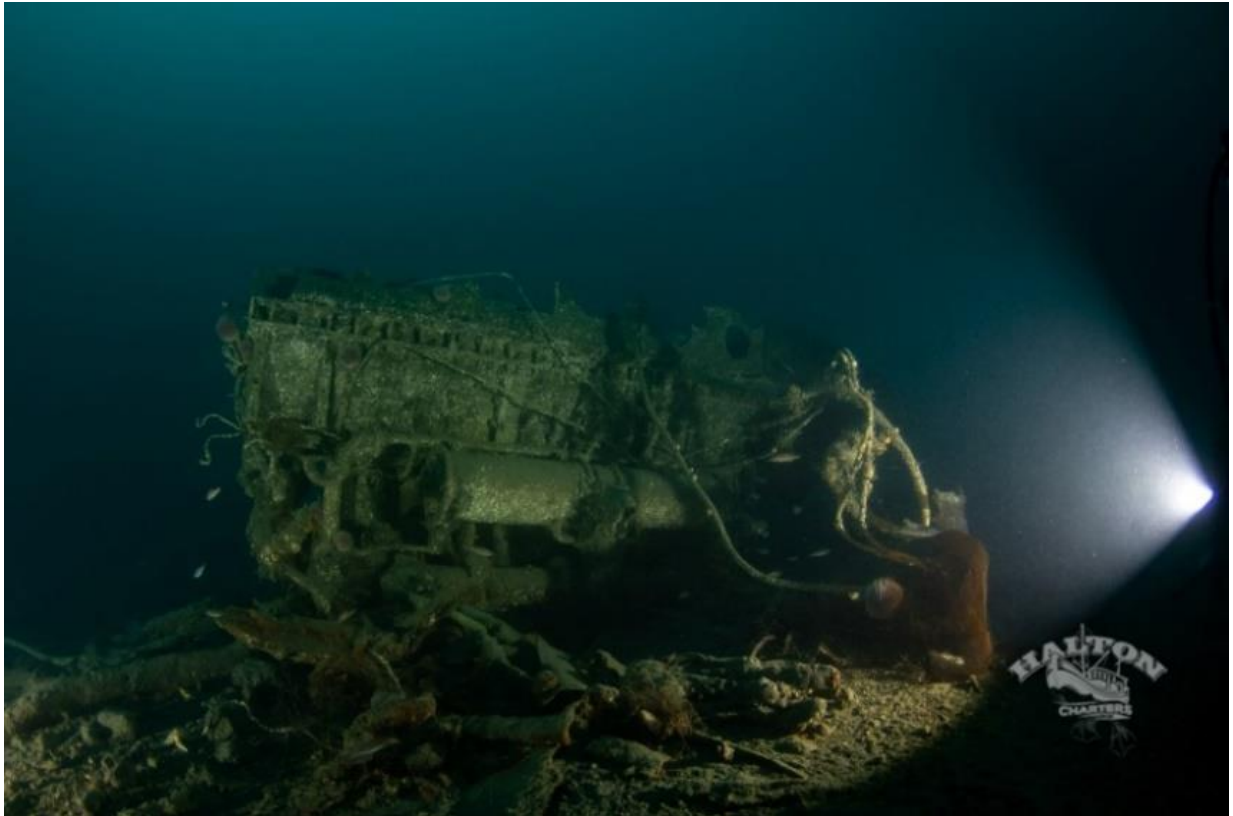
Plate 66: SMS Derfflinger, diesel pinnace engine, primary salvage site (image courtesy of B. Anderson).

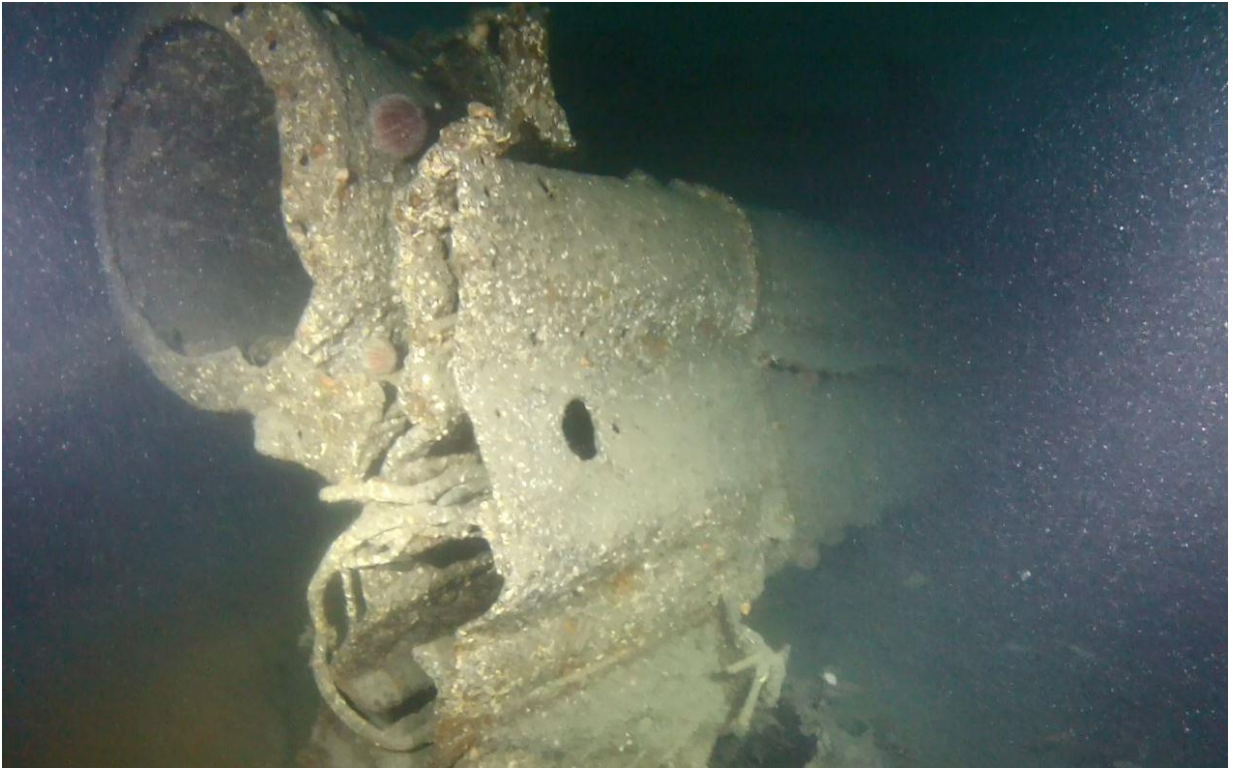
Plate 67: SMS Derfflinger, top of tripod mast showing centre and side (port) leg, primary site. Starboard leg missing (image courtesy of W. Allen).

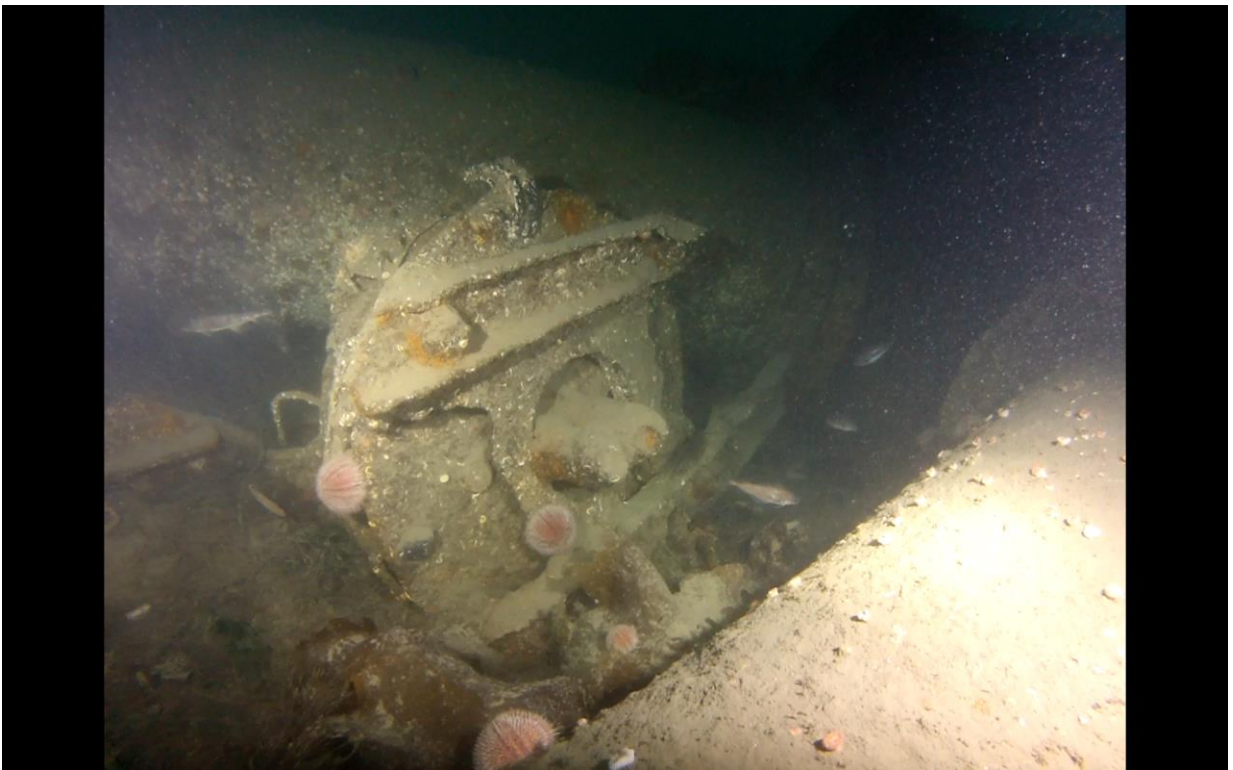
Plate 68: SMS Derfflinger, searchlight mount near top of tripod mast, primary site (image courtesy of W. Allen).

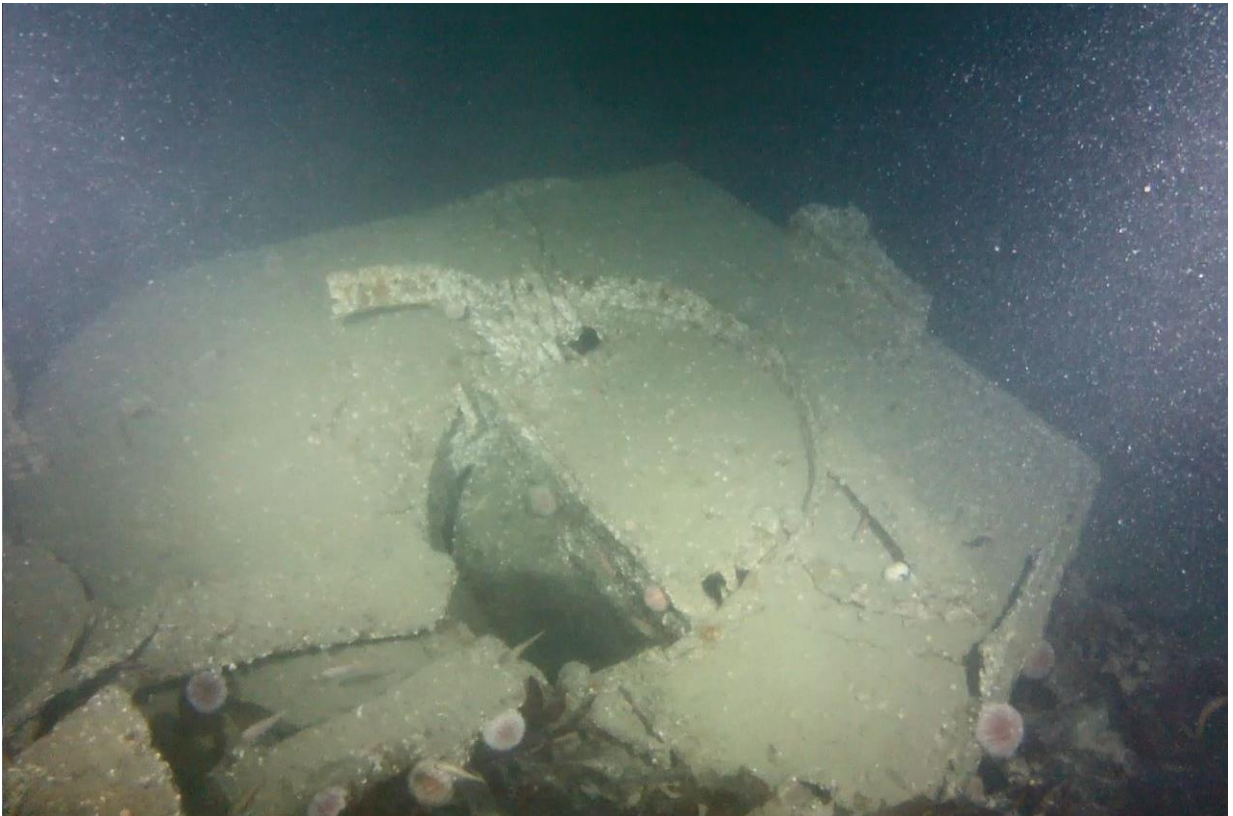
Plate 70: SMS Derfflinger, underside of splinter proof control room, partially buried, primary site (image courtesy of W. Allen).

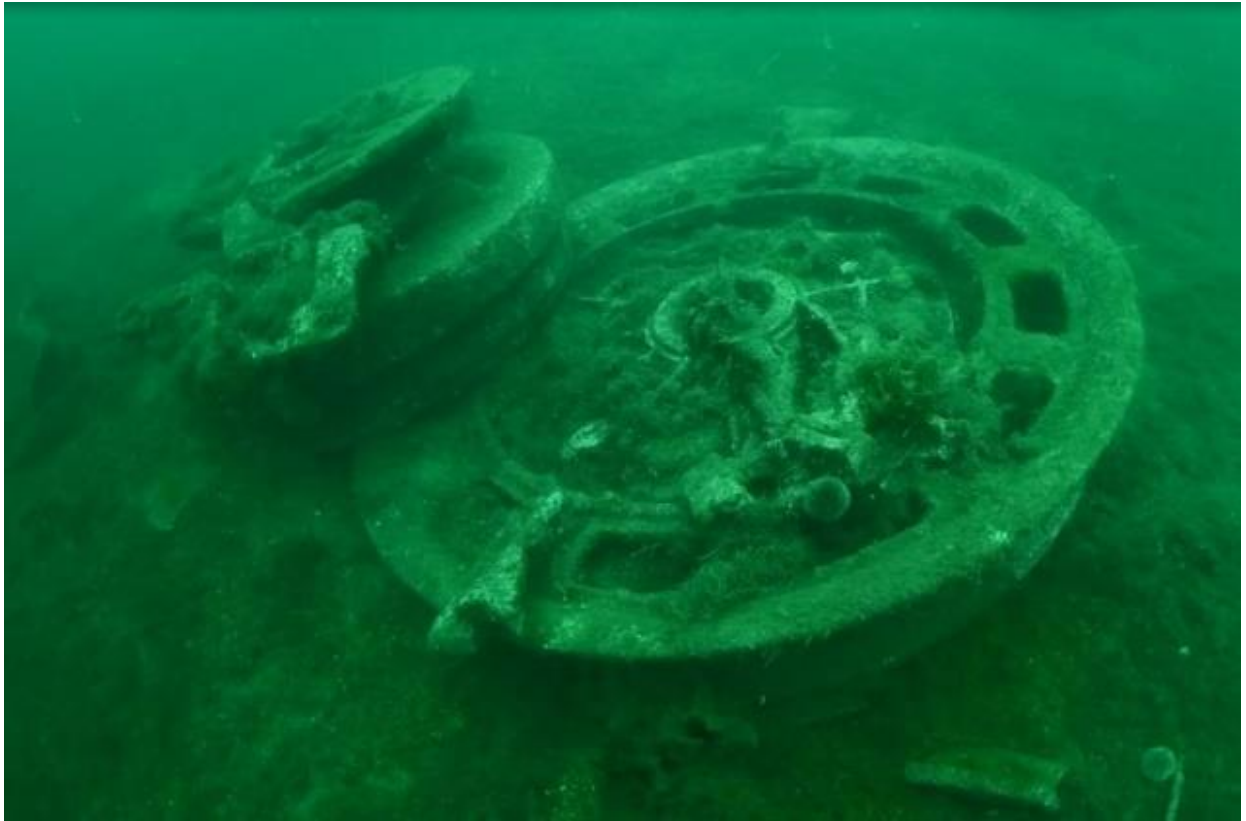
Plate 71: SMS Derfflinger, tertiary site, main anchor capstans (SS087). The chain pipe cover is visible in the foreground of the lower image.

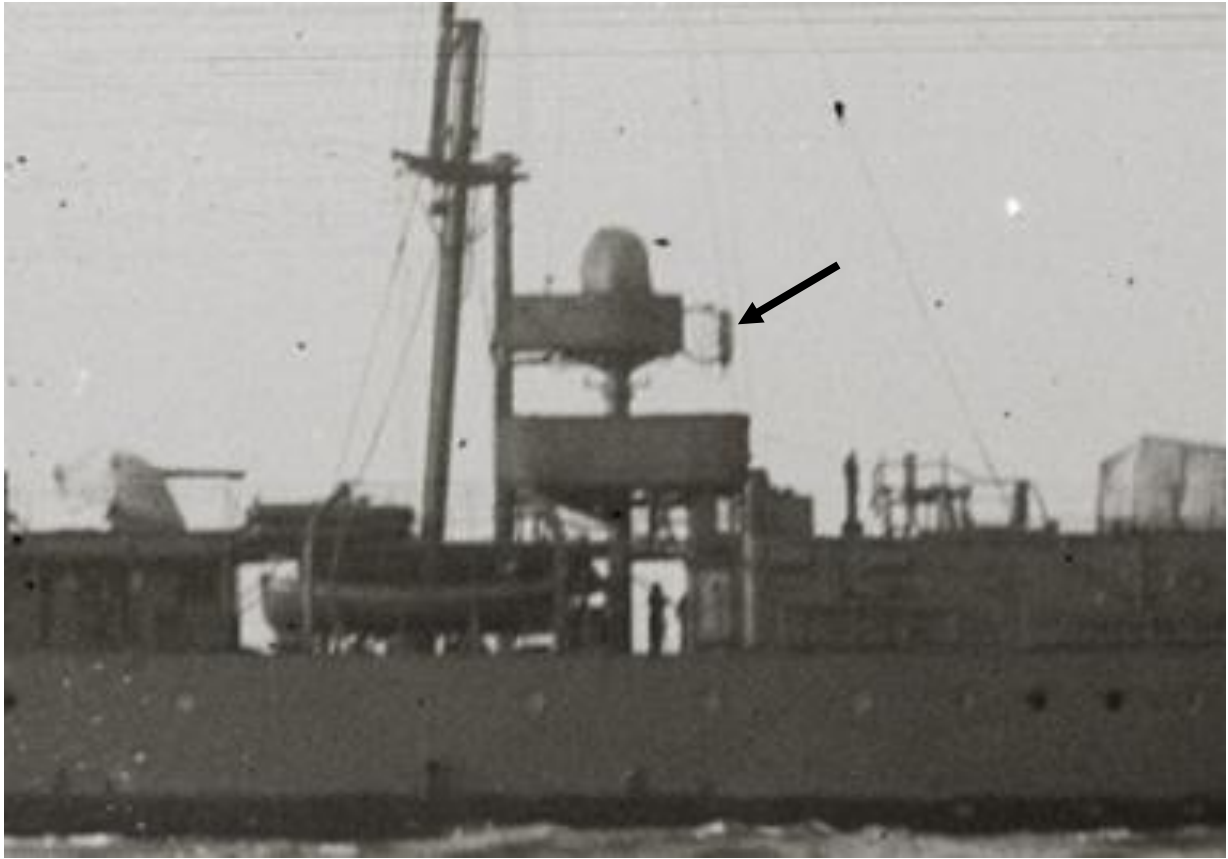
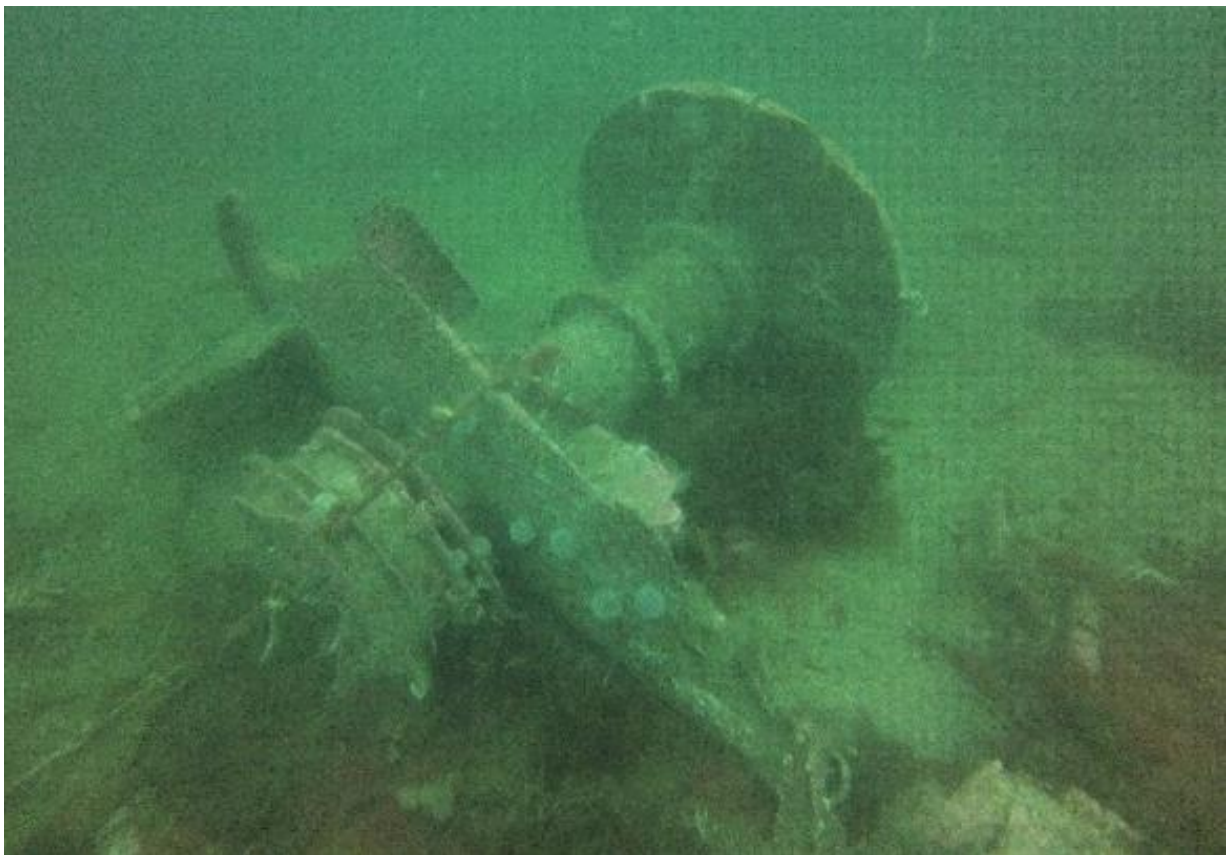
Plate 75: SMS Bremse, archive image showing the aft searchlight platform (top) and its remains on the salvage site (bottom). Note the structure in place on the aft end on the searchlight platform in the archive image (arrow).

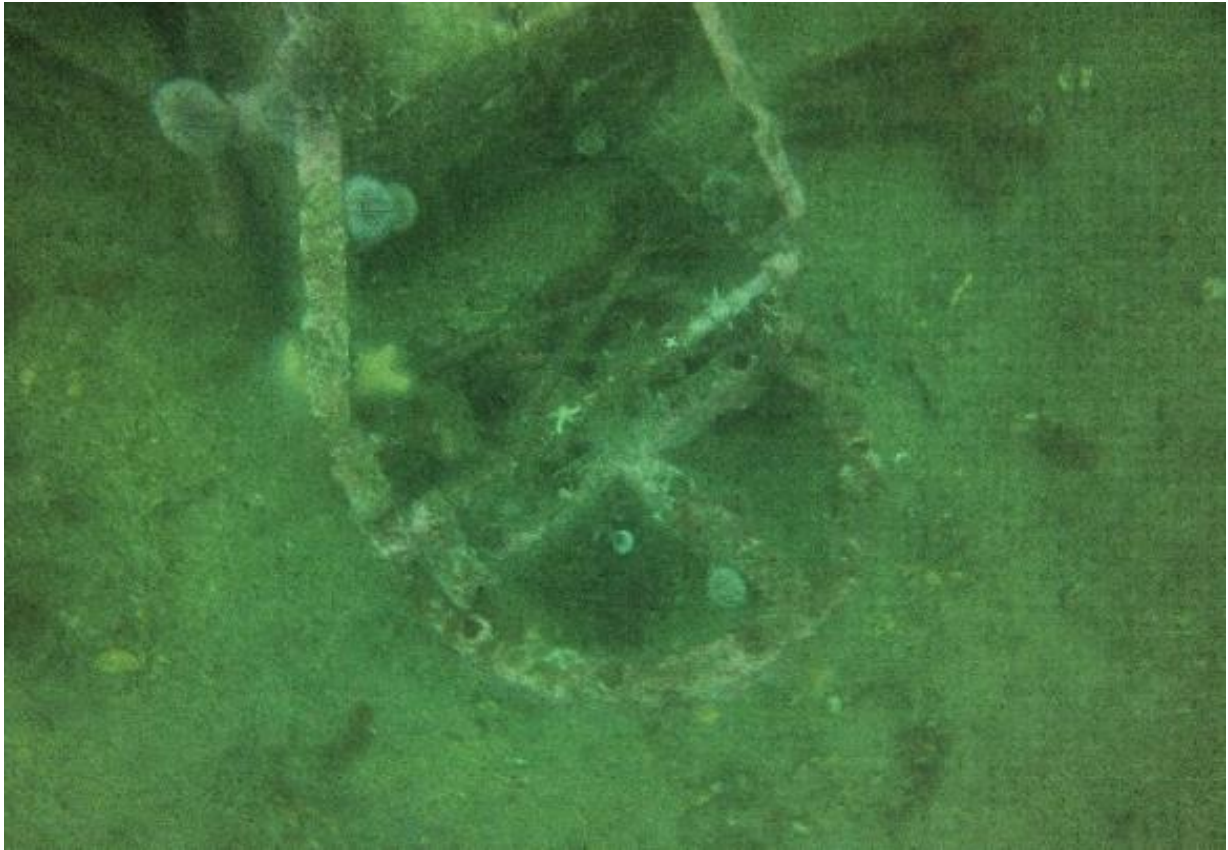
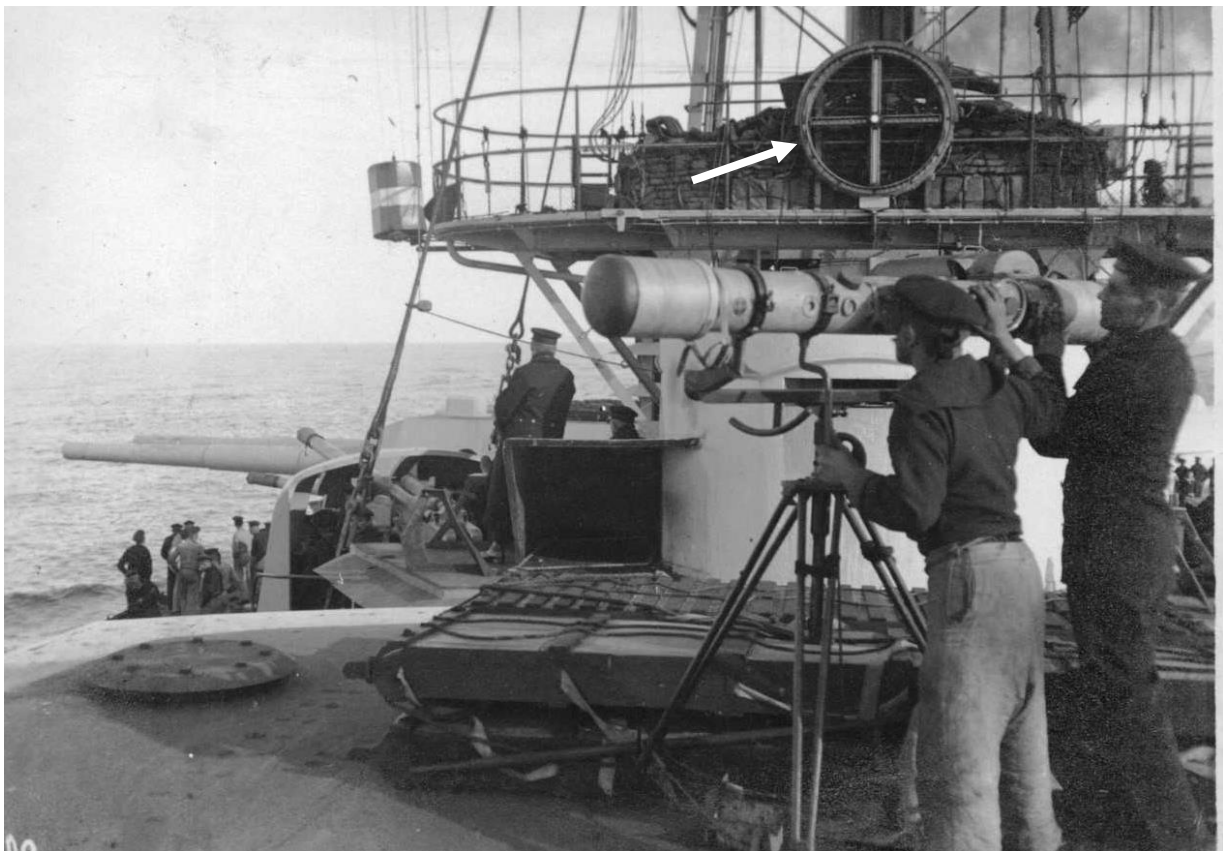
Plate 76: Remains of a night speed indicator (top) attached to the remains of the aft searchlight platform (top). A similar unit (arrow) installed on SMS Moltke is also shown (bottom) (images courtesy of OSAC and G. Staff).

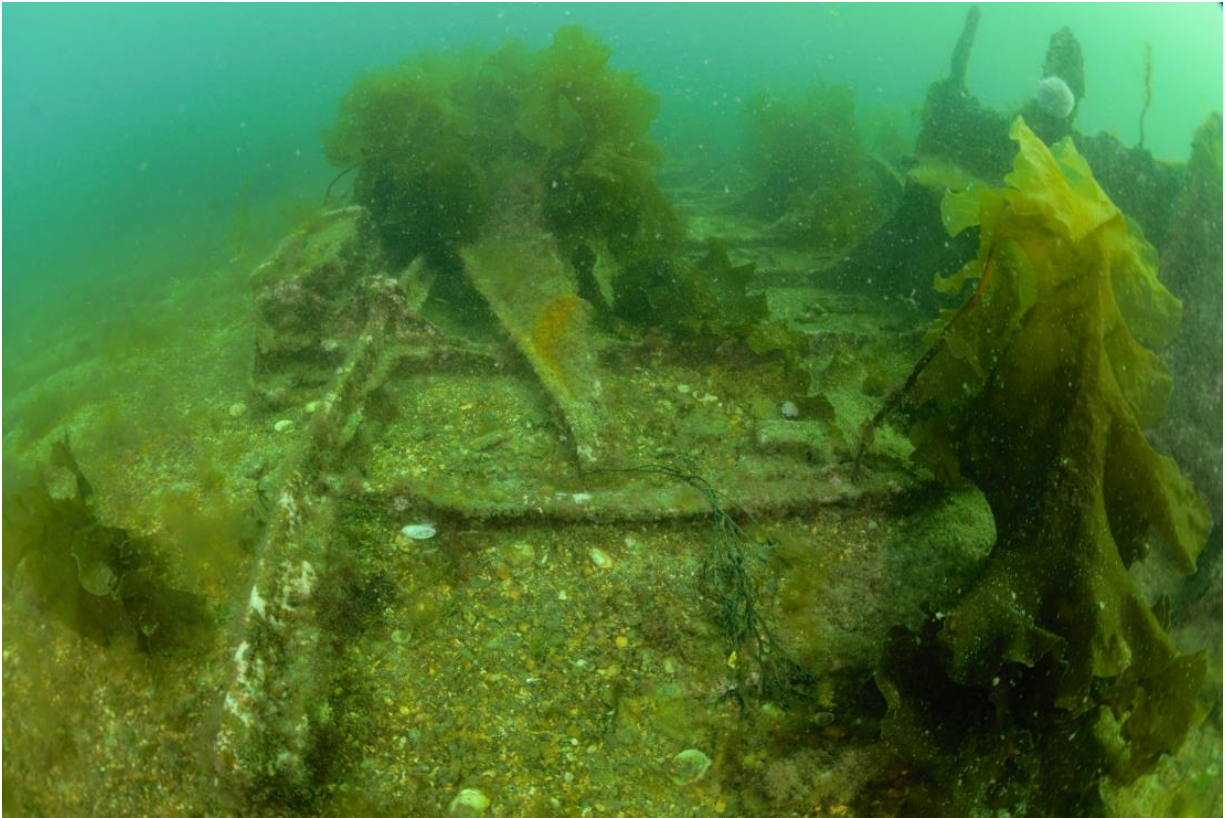
Plate 79: SMS S36, hull plating on the seabed (image courtesy of BSAC).

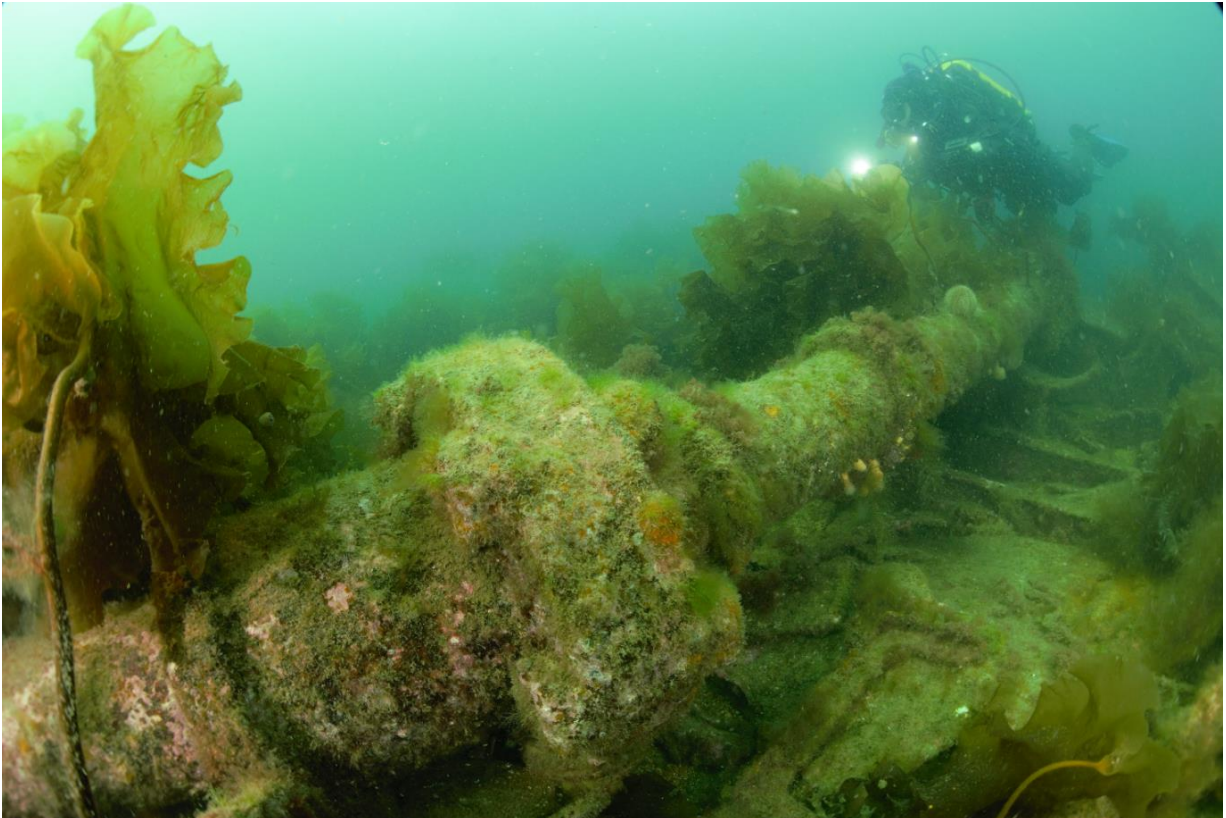
Plate 80: SMS S36, propeller shaft (image courtesy of BSAC).

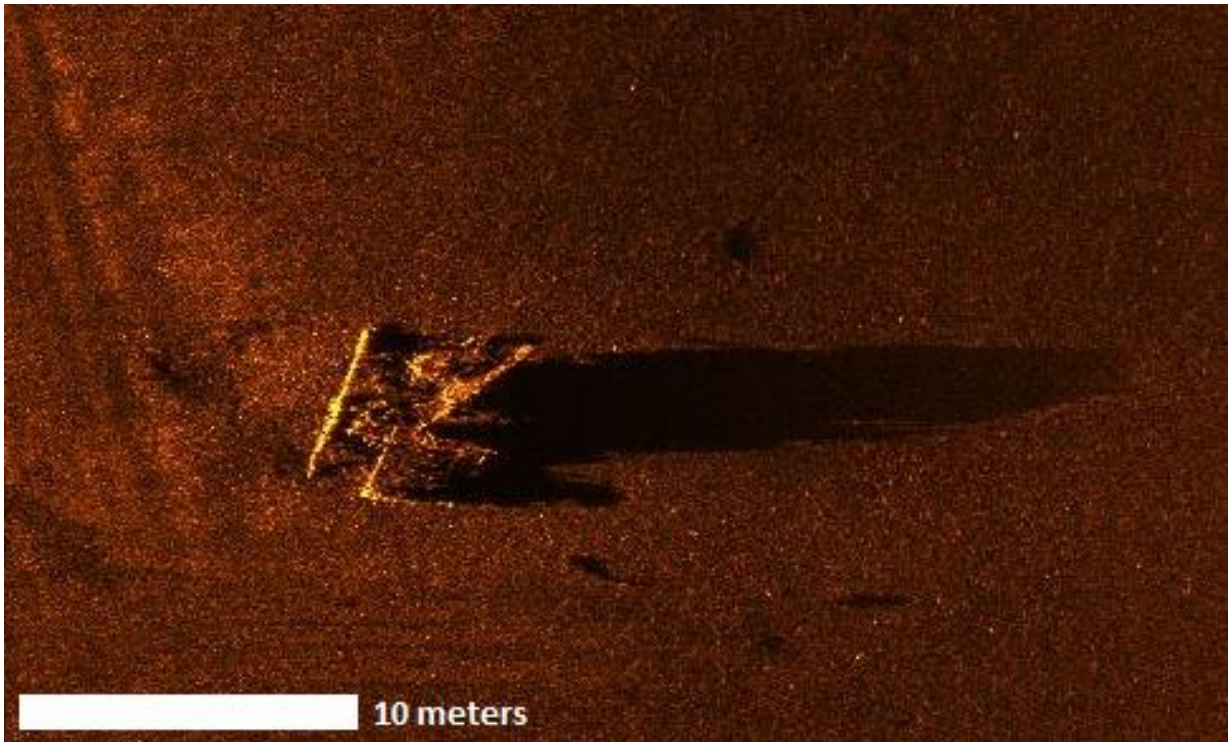
Figure 17: Side scan image of wreckage in Mill Bay, Hoy (SS105). It is thought that the chart entry for the site, which states it is the remains of B109, is incorrect.

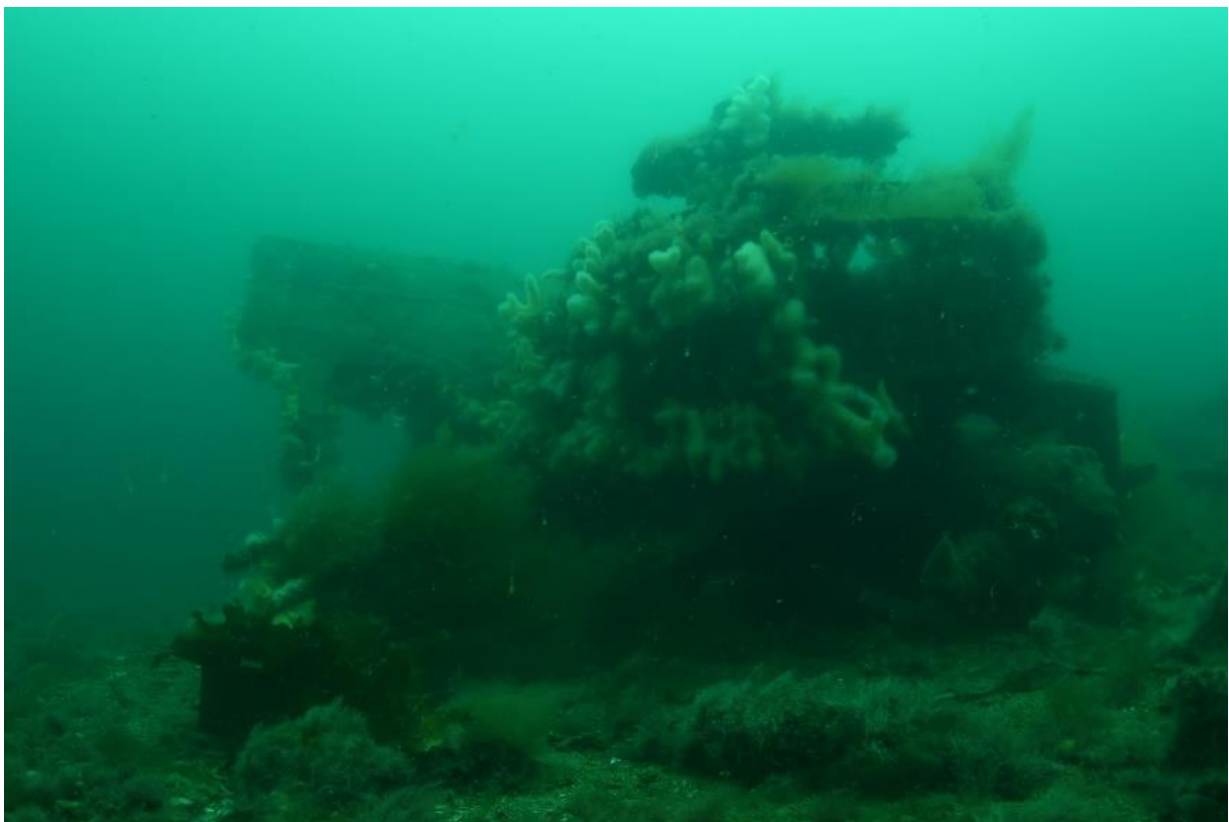
Plate 82: Wreckage in Mill Bay, on incorrectly charted site of B109.

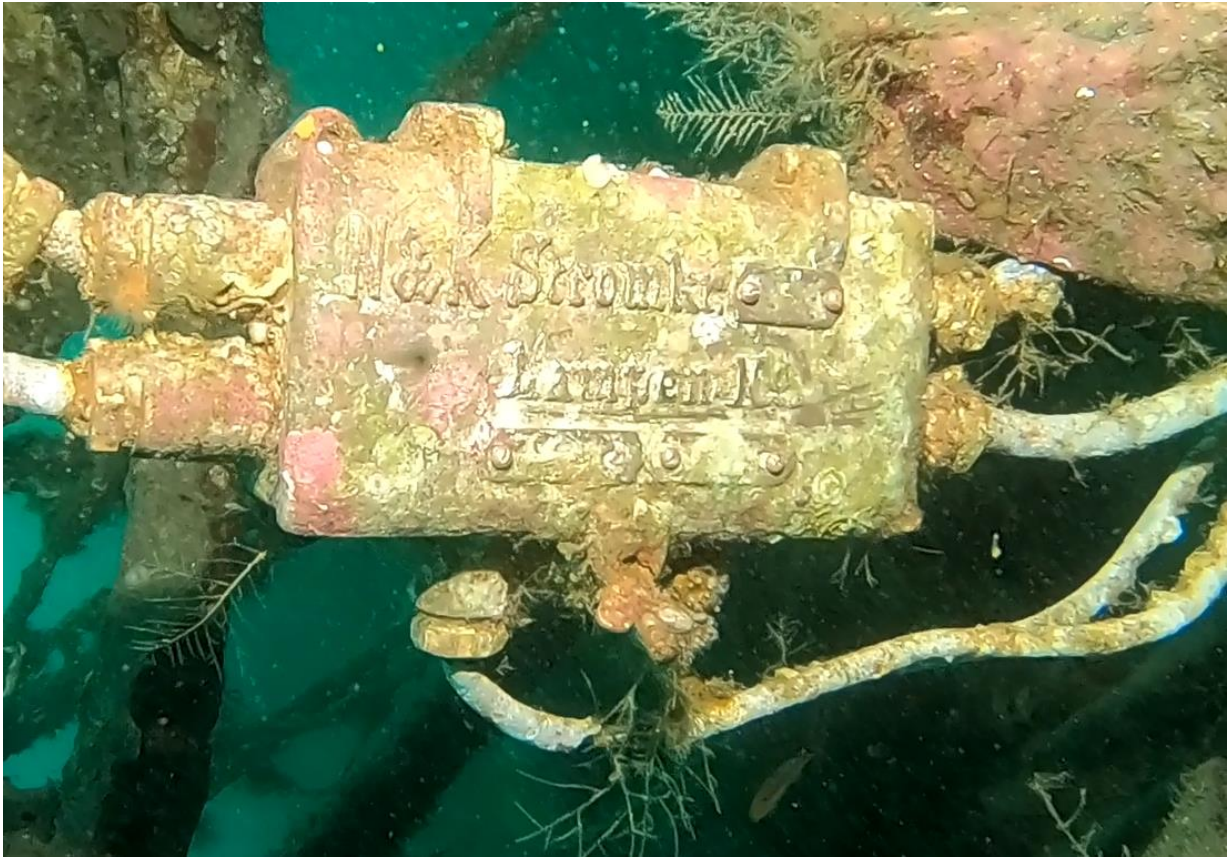
Plate 83: Electrical box with the wording "N&K Stromkr Lampen" at incorrectly charted site of B109 in Mill Bay.

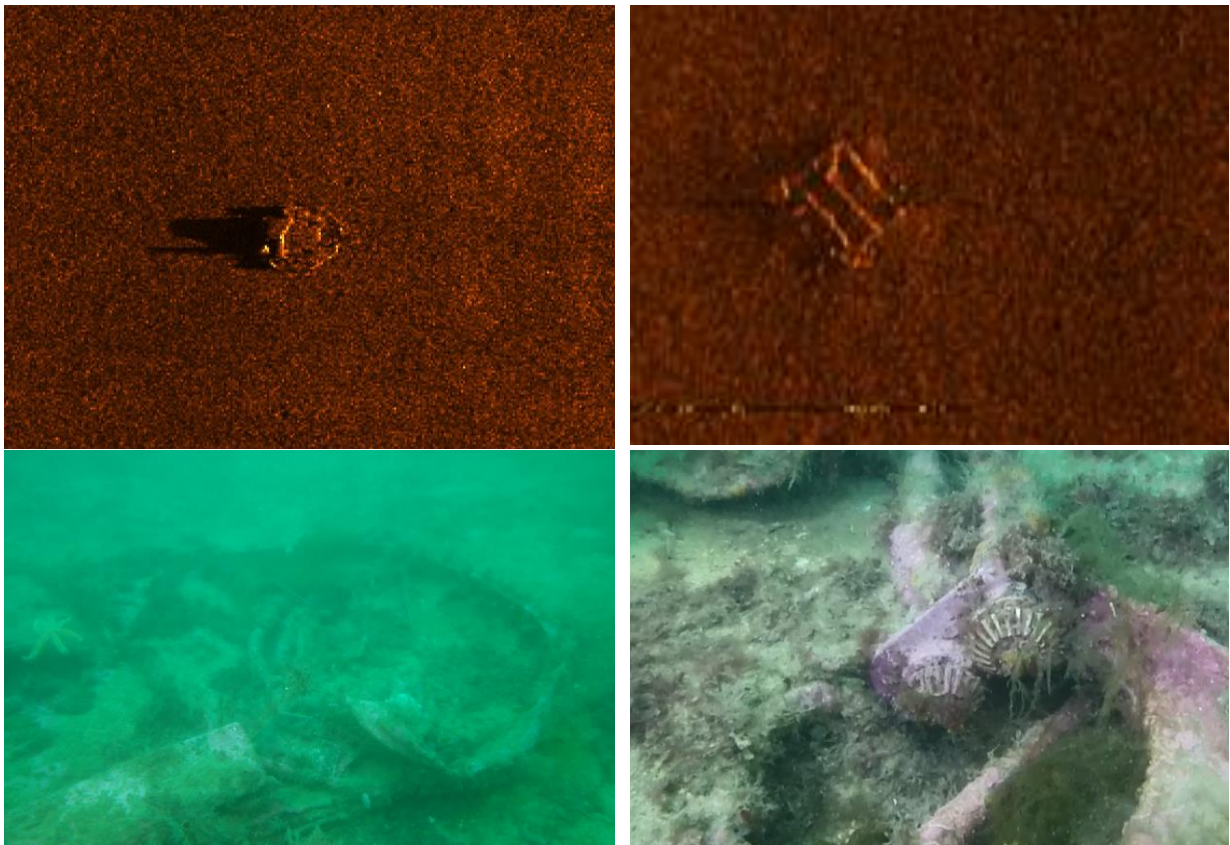
Plate 85: Side scan images SS042 (top left) and SS049 (top right) proved to be isolated searchlight platforms. Photographs of SS042 show the platform (bottom left) and remains of a searchlight control (bottom right) (images courtesy of BSAC).

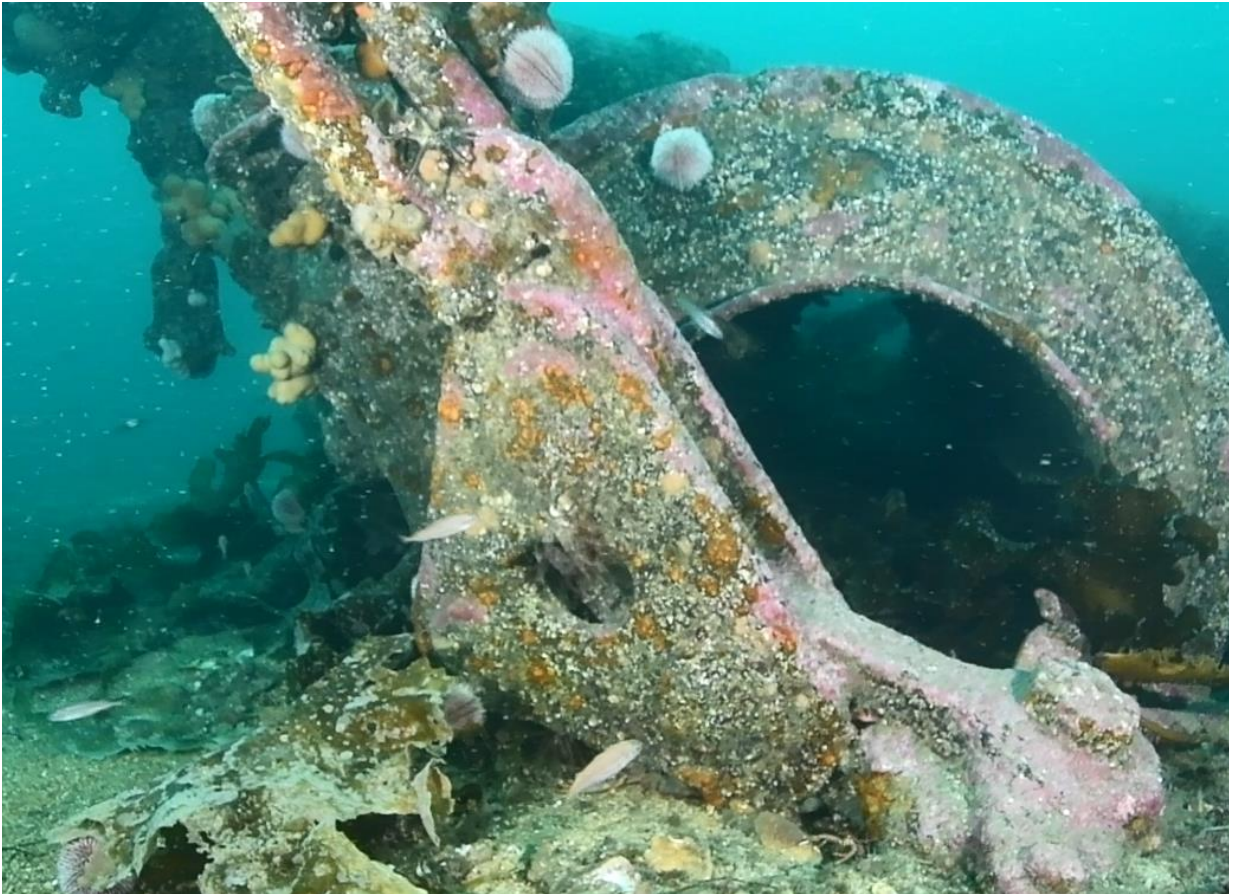
Plate 87: Top of samson post showing tri-plate arrangement, Gutter Sound.

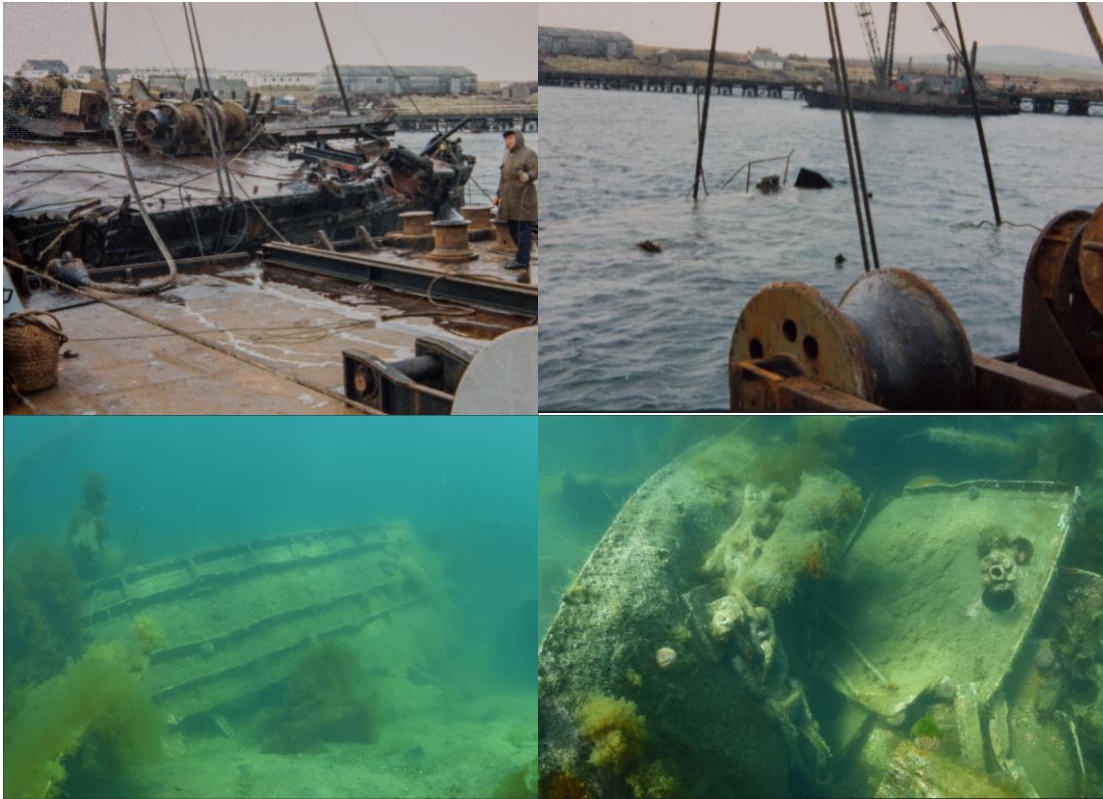
Plate 89: Archive images (top) of the barge being sunk by Rinnigal pier in 1976 (Image courtesy of D. Campbell via Huskylan Charters). The pier can be seen in the top right image. Images of the barge in its current condition (bottom).

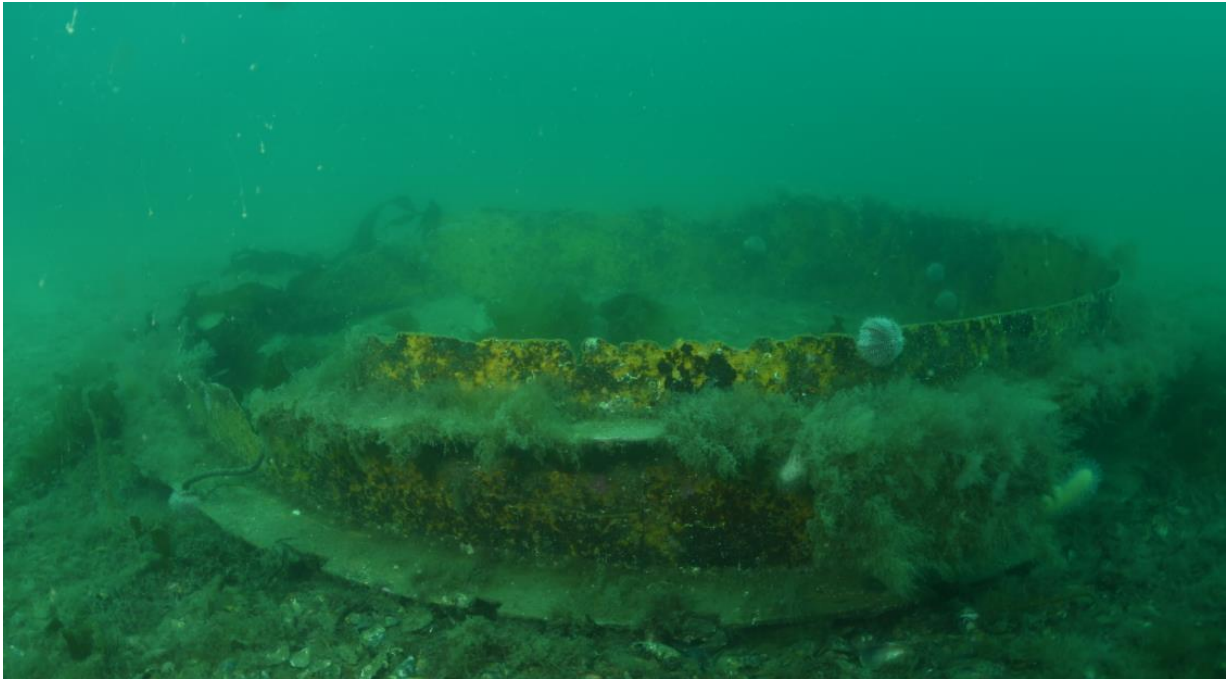
Plate 90: Circular ring found off Rinnigal pier composed of steel (SS115).

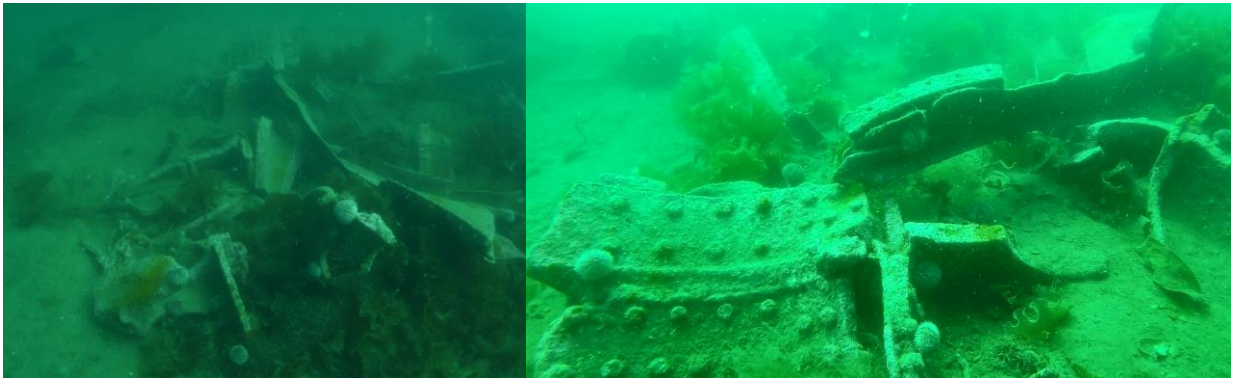
Plate 91: Turbine casings to the west of Rinnigal Pier (SS116).

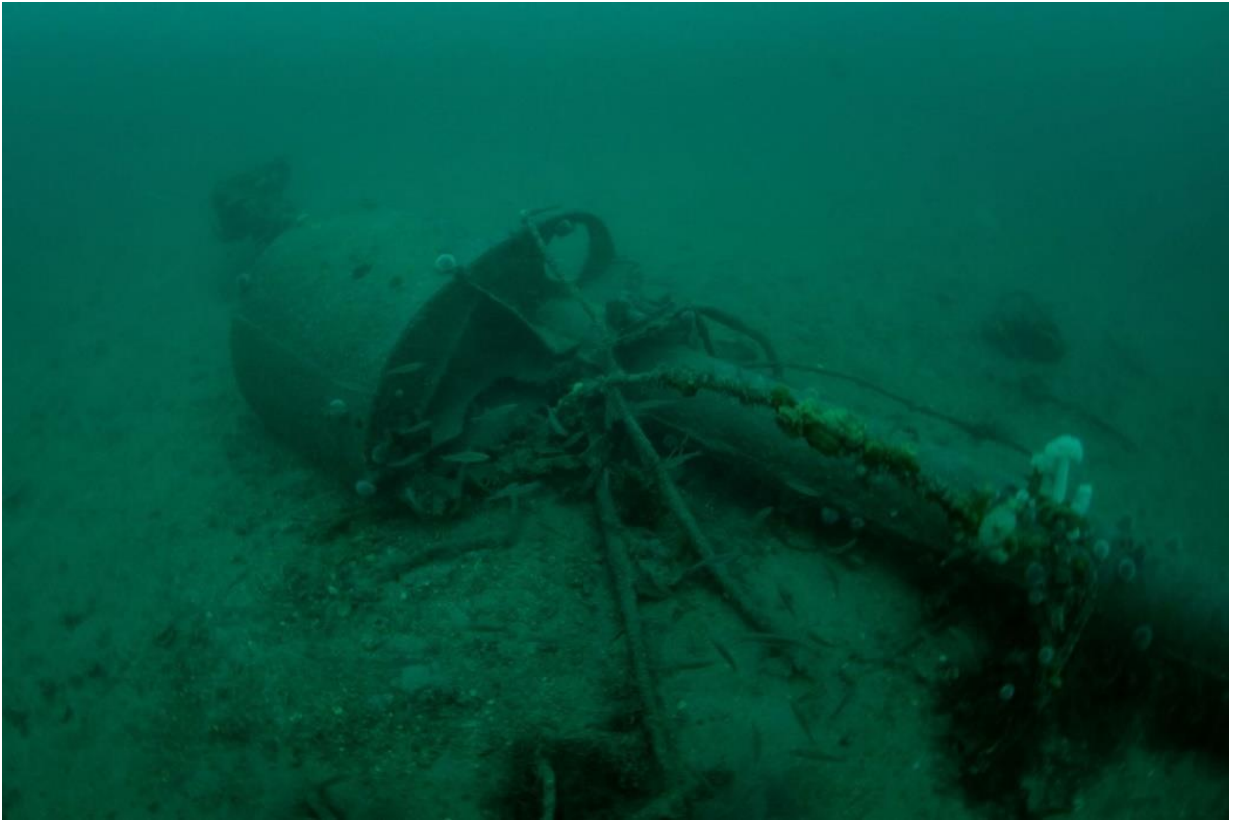
Plate 94: SS118, isolated aft mast and crow's nest (image courtesy of B. Anderson).
