Scapa Discovery: Archaeology in the Flow

A survey of the site of the remains of an unknown pinnace near Lyness.

Author: Bob Anderson, Jo Porter

December 2014

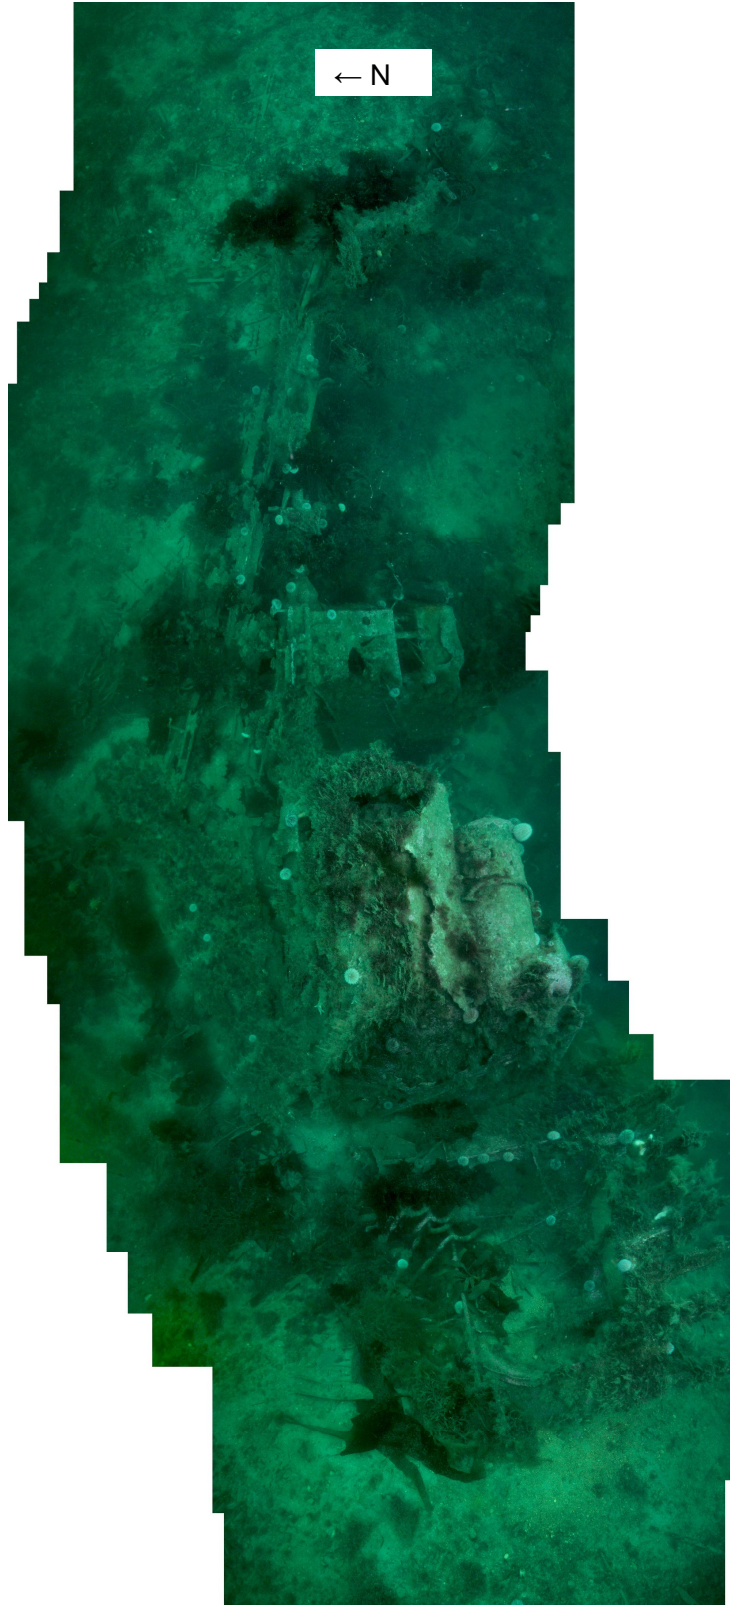
The final composite image clearly shows the pinnacle lying on its side and the major components are easily identified. One issue to highlight is that the final image is 166cm long at its widest point and so is not easily scaled to A4 size for insertion into this report. A large copy has been put online for proper investigation.

Image 6. A photomosaic to show the pinnacle wreck site

Seaweed has obscured some of the detail and some effort should be put into clearing the site of loose weed prior to photography in future sessions.

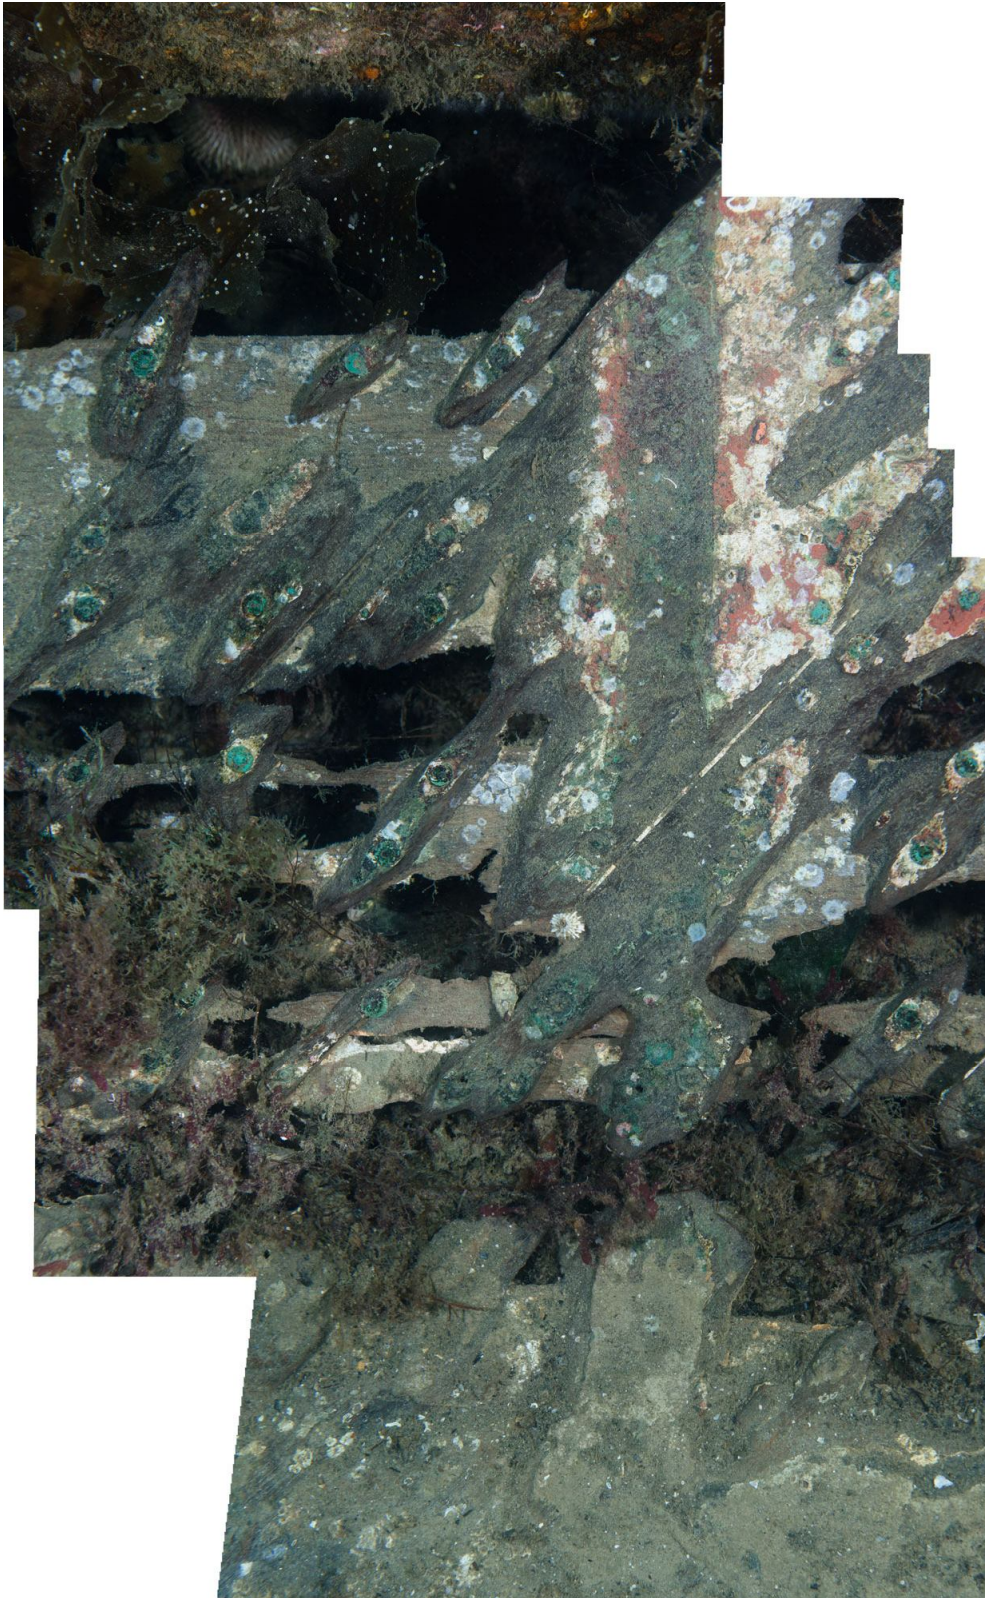
Image 7. A photomosaic of 12 stitched images to show the diagonal planking construction of the hull.

This form of hull absorbs bumps well and gives a relatively lightweight robust construction. In addition, the hull stays watertight despite the boat remaining out of the water for considerable periods of time and in often in hot weather which would have caused the planks to shrink and thus leak in other forms of construction. However, when damage is done, it is complicated both to find and to repair.

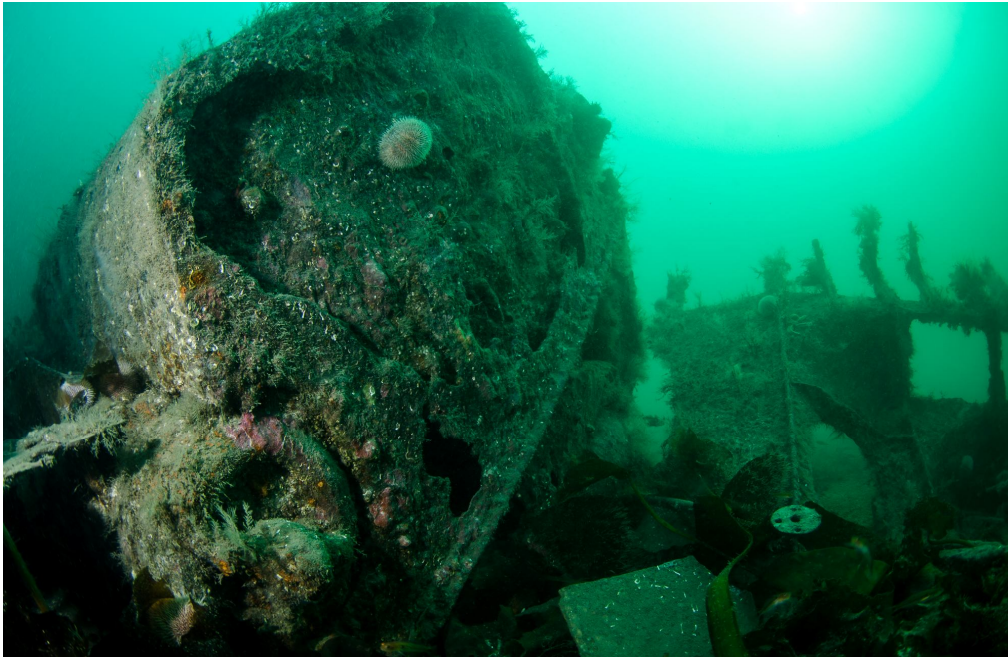
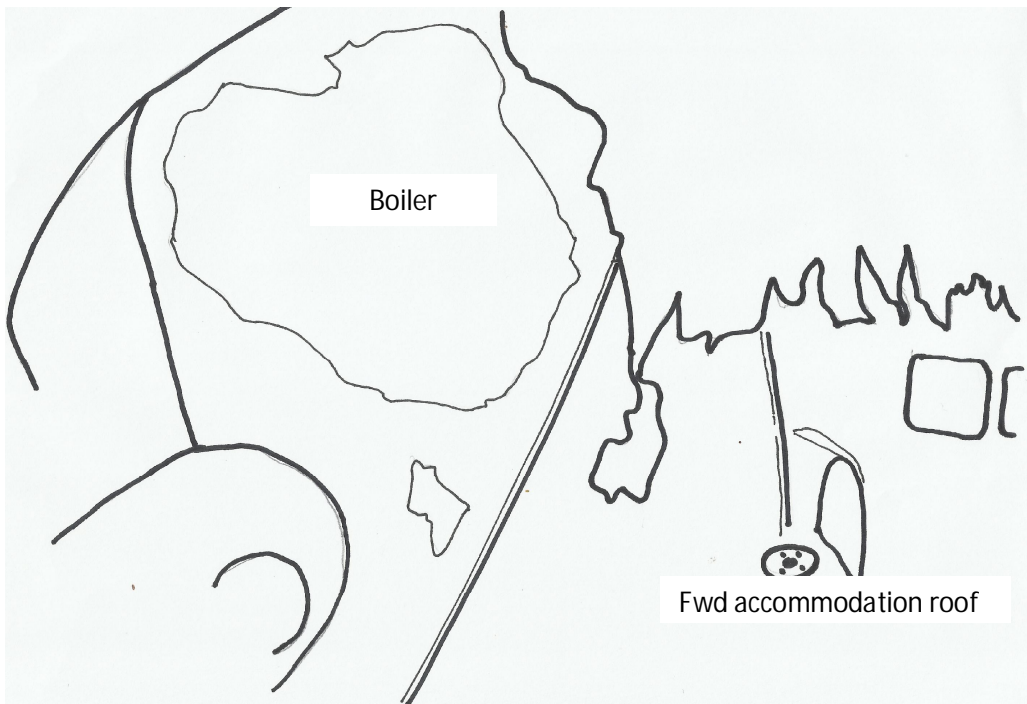
Plate 1

Image 14. This shows the forward end of the boiler to the left and the underside of the accommodation roof to the right. There are obvious holes in the roof that presumably would have held windows. The roof can be seen to be made from one formed shape with internal strengthening ribs. There is a broken flange from a pipe bottom right.

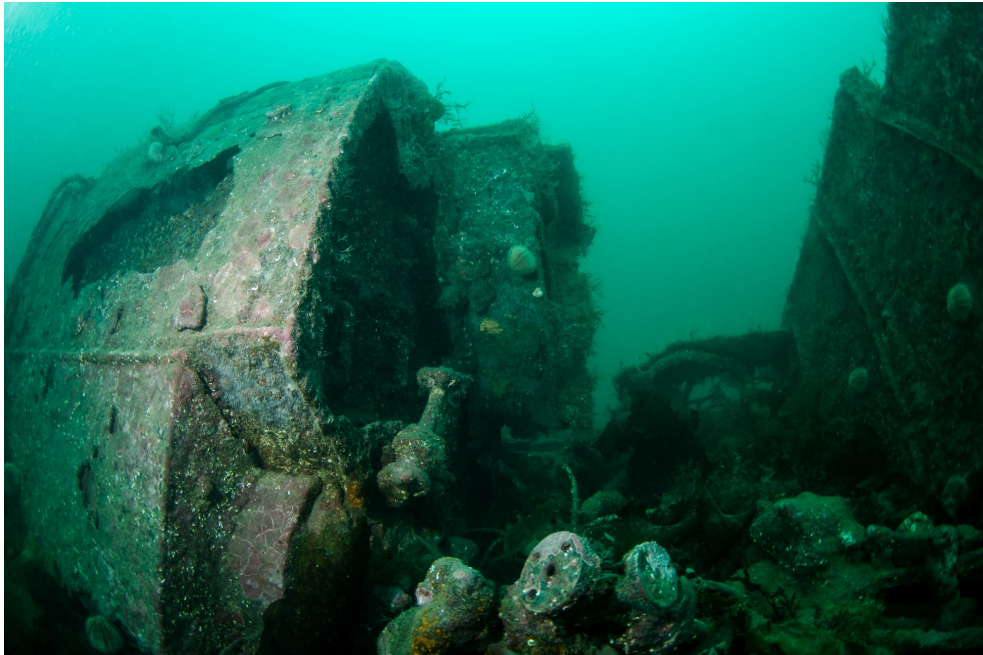
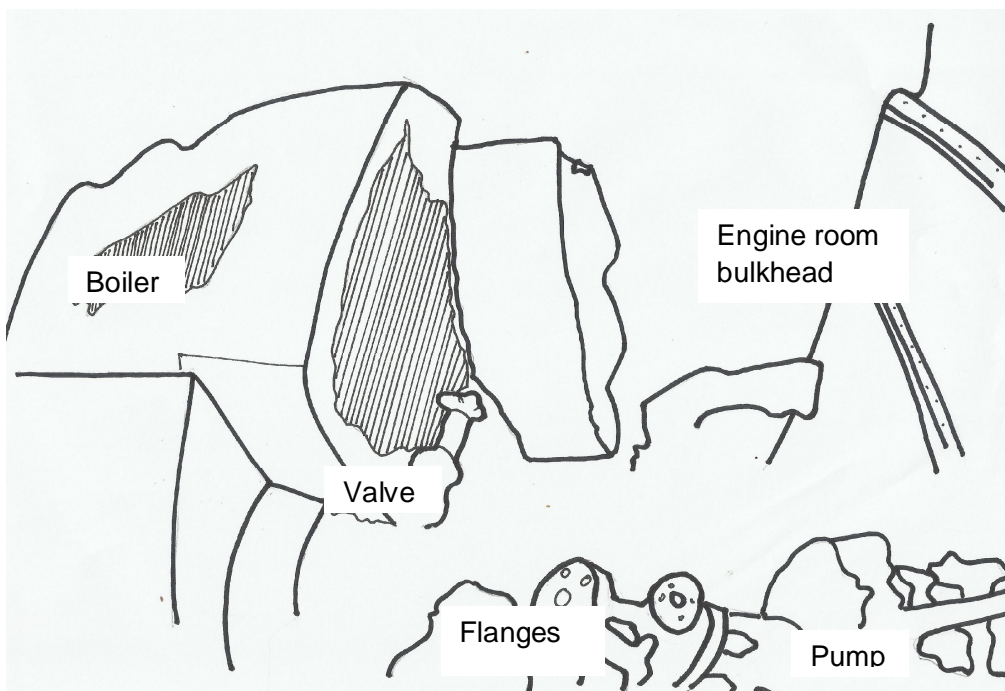
Plate 2

Image 15. This shows the aft end of the boiler to the left and the engine room bulkhead to the right. In the foreground are a numbers of valves and pumps (named (c) Image 13, Site map above).

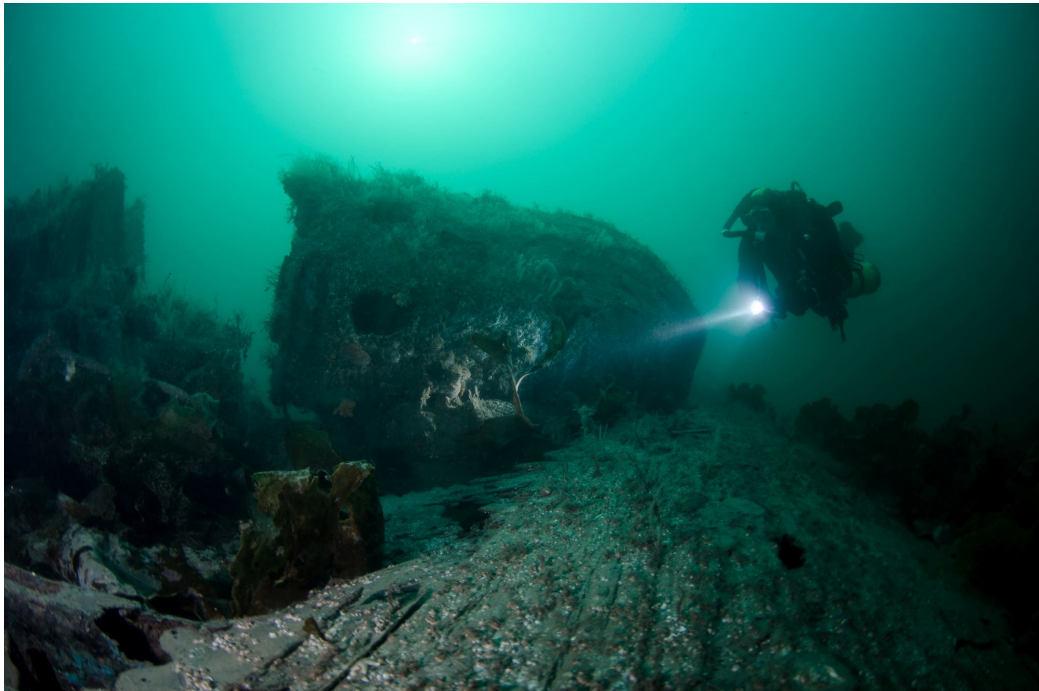
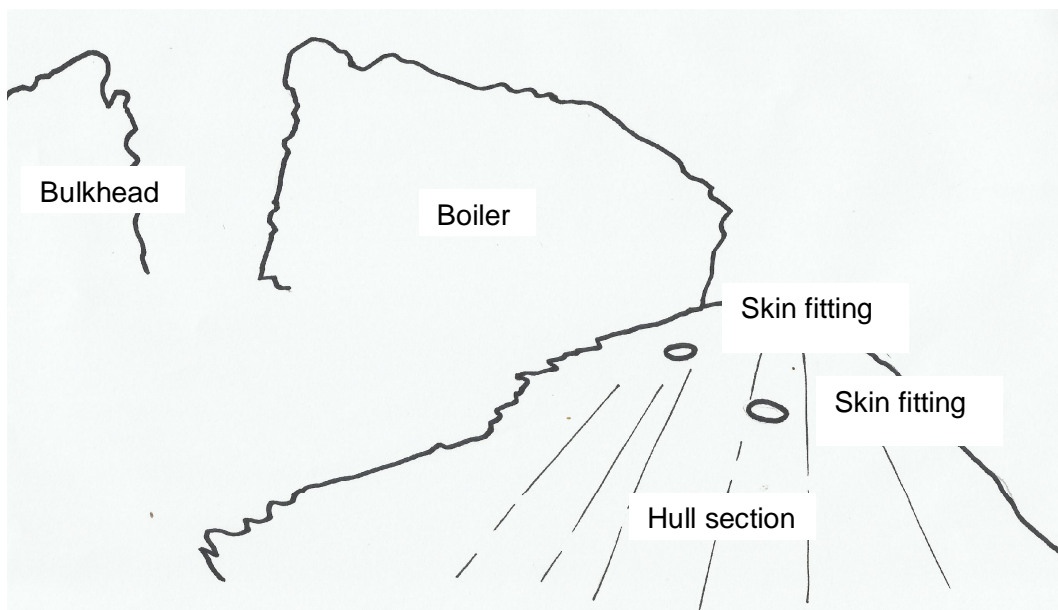
Plate 3

The boiler sits with a list to port of about 45°. The boiler case has a few corrosion holes allowing sight of the boiler tubes within. There are no small brass taps, sight gauges or other components also pointing to a light salvage. The boiler differs from the boiler documented on Pinnacle 199 as the water pipes on either side of the Rinnigal pinnacle are round not oval.

Image 16. This shows the boiler illuminated by the diver's torch with a section of hull in the foreground.

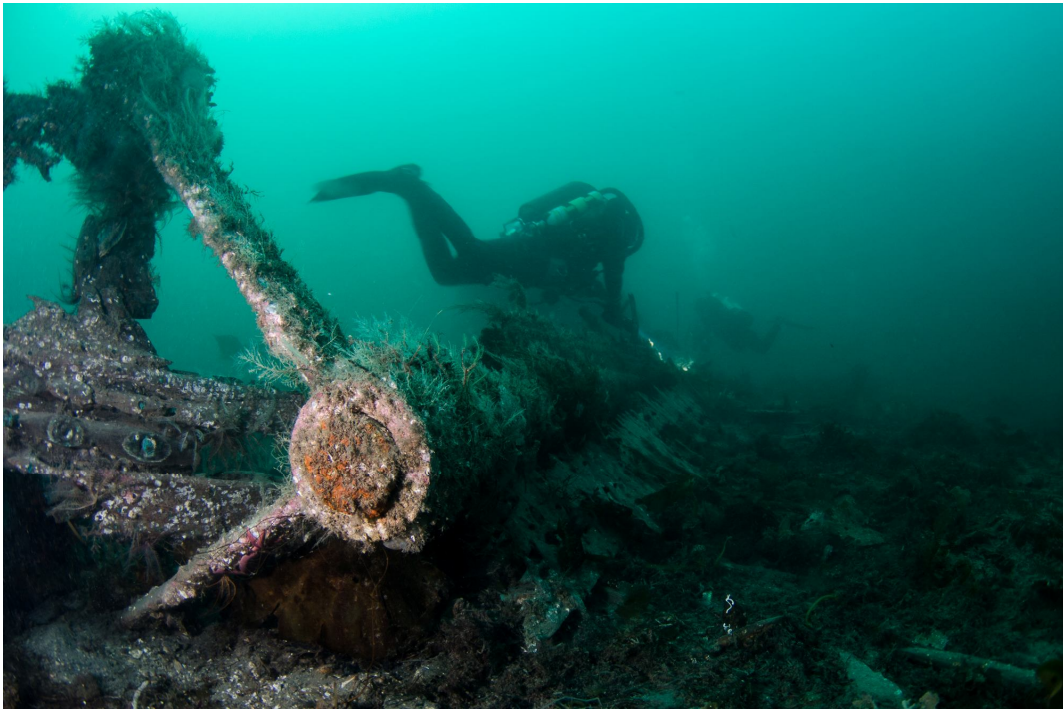
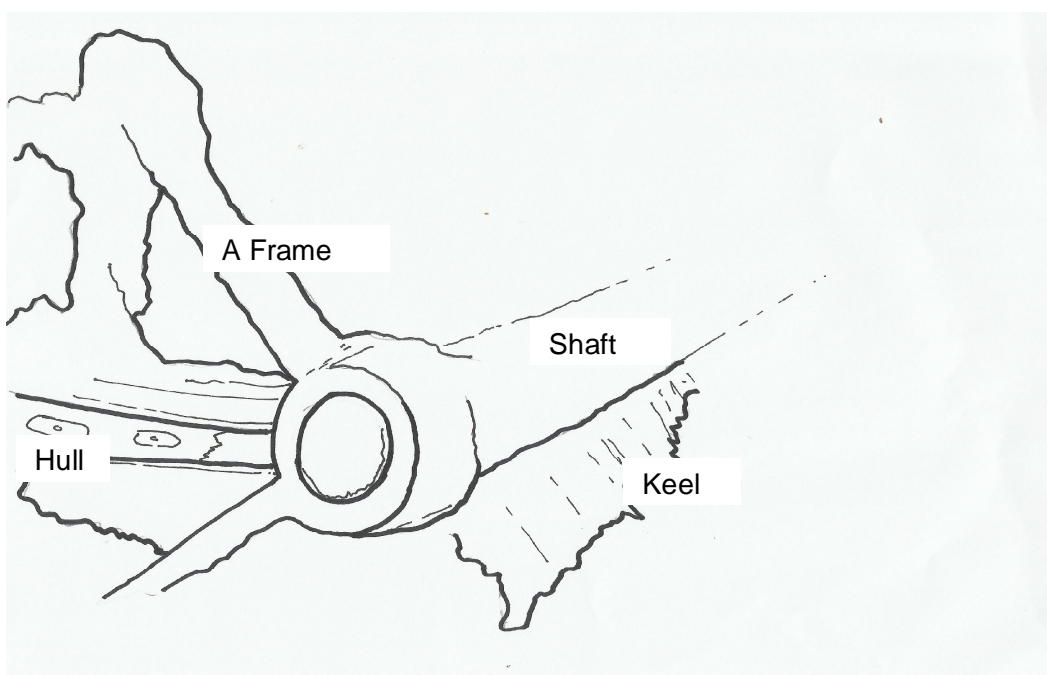
Plate 4

Image 17. This is the view from the aft of the boat looking toward the bow. To the left is the A frame, the cut shaft where the prop has been removed and the line of the keel to the right. Two divers give a sense of scale.

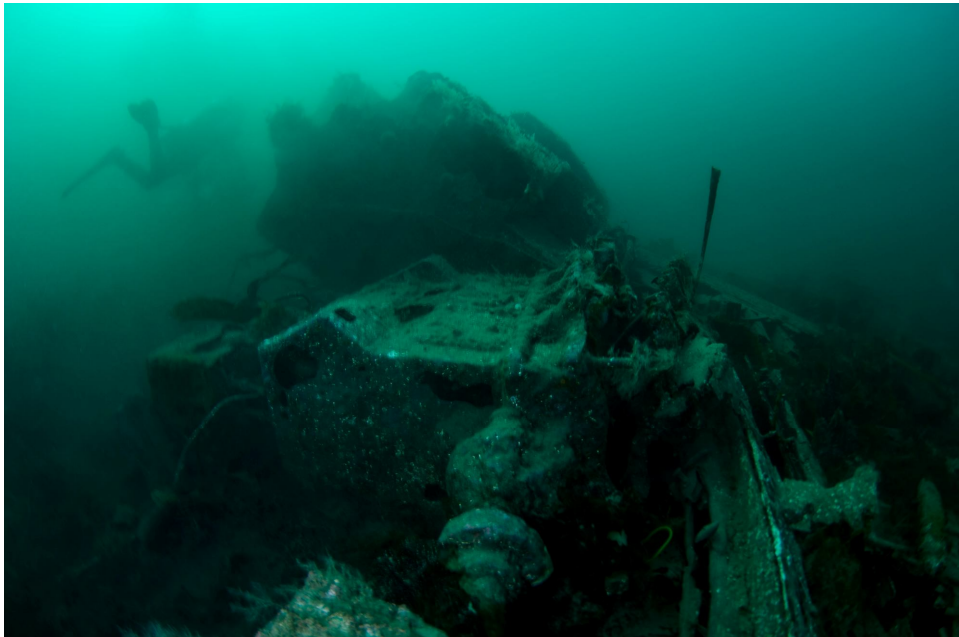
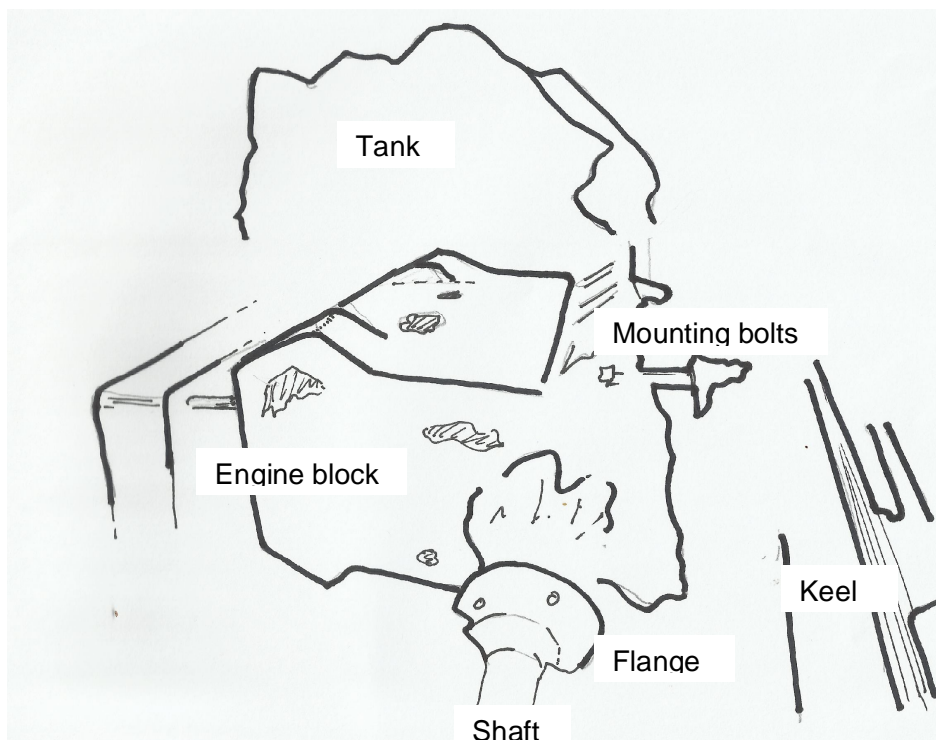
Plate 5

Image 18. This is the view of the engine lying on its side. The shaft flange can be seen in the foreground. To the right is the base of the engine with the mounting bolts. To the left is the head with the pistons. In the background the silhouette of the fuel tank nearly obscures the diver.

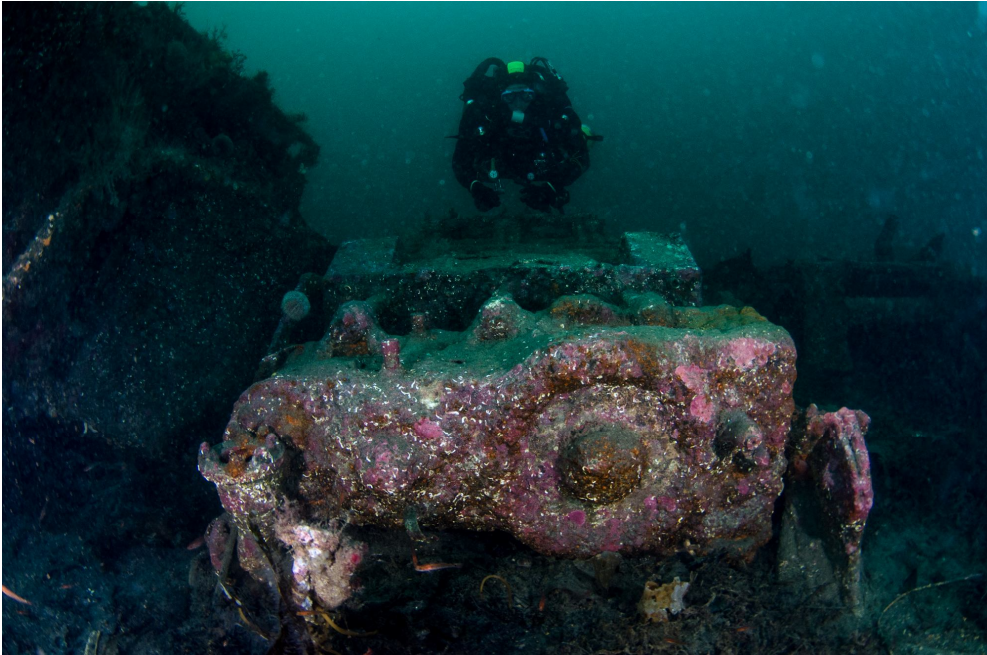
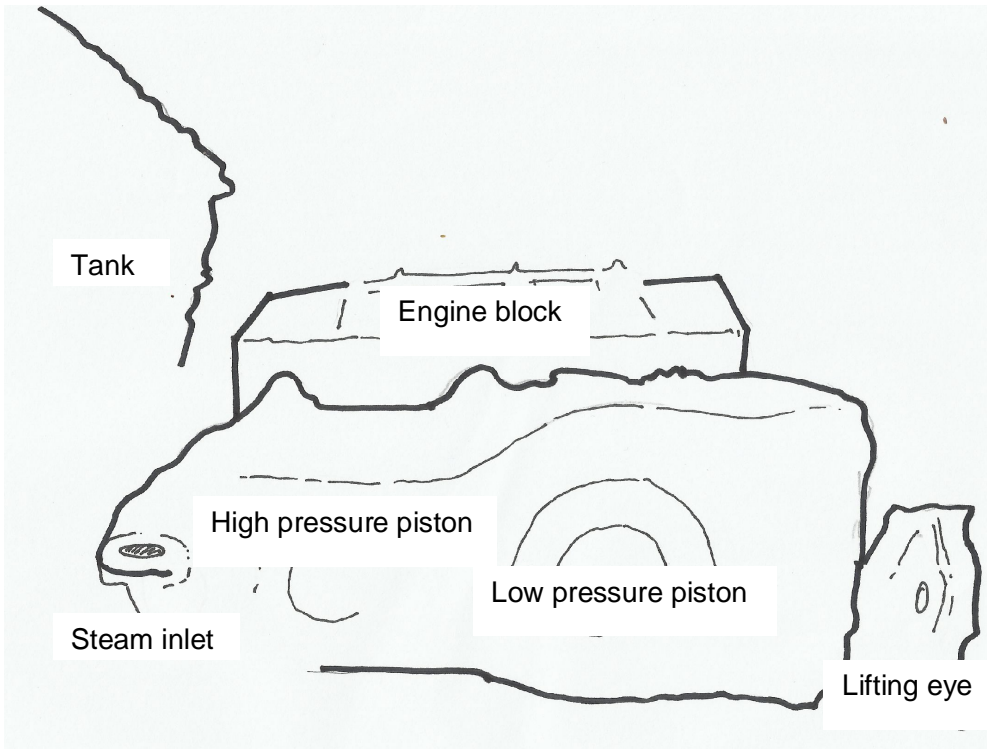
Plate 6

Image 19. This is the view looking down on top of the engine. To the left is the steam in pipe, next the top of the high pressure piston, then the low pressure piston then a lifting pad/eye on the end. A diver hovers over the keel of the boat at the base of the engine to give scale.

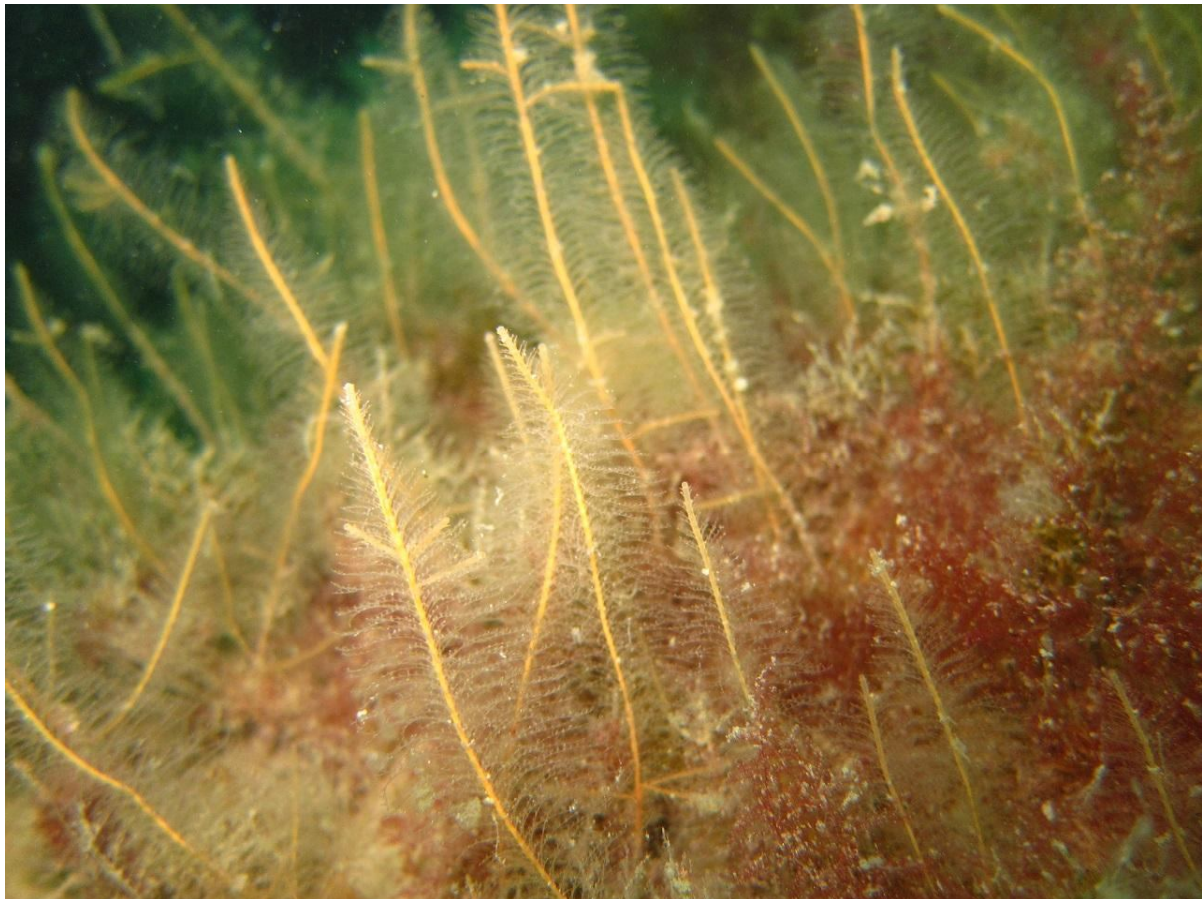
Image 20. Clumps of the branching hydroid *Nemertesia ramosa* on the upper surfaces of the wreck (RG)

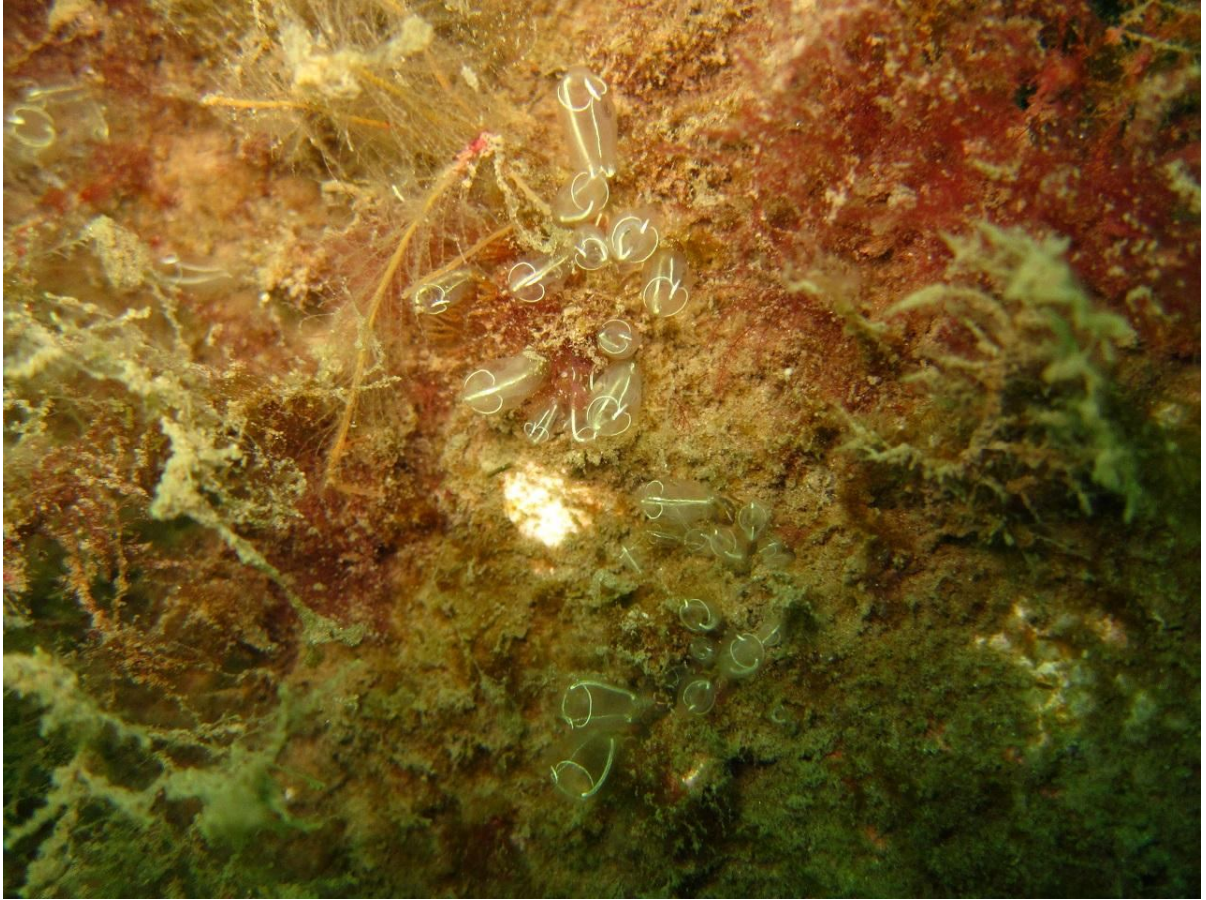
Image 21. Clumps of the light bulb sea squirt *Clavellina lepadiformis* growing on the vertical surfaces of the wreck (RG).

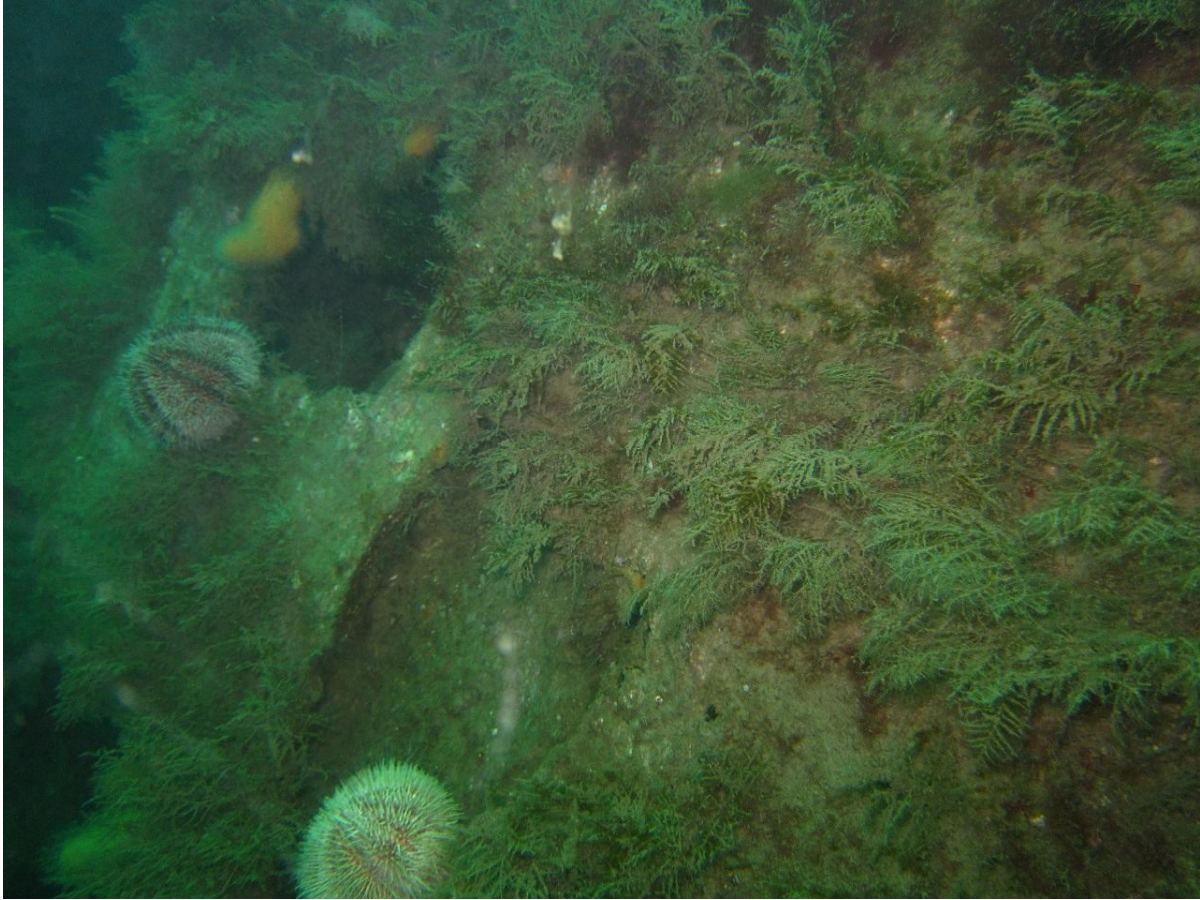
Image 22. Upper surface of the wreck with abundant clumps of the Herringbone hydroid *Halecium halecinum*, and grazing Edible sea urchins, *Echinus esculentus*. Occasional patches of Dead Men's Fingers, *Alcyonium digitatum* were also present and are indicative of areas where current flows more strongly over the wreck surface. There is a dense understorey of short red algal turf, indicating that light levels are sufficient for some algal growth. (RG)

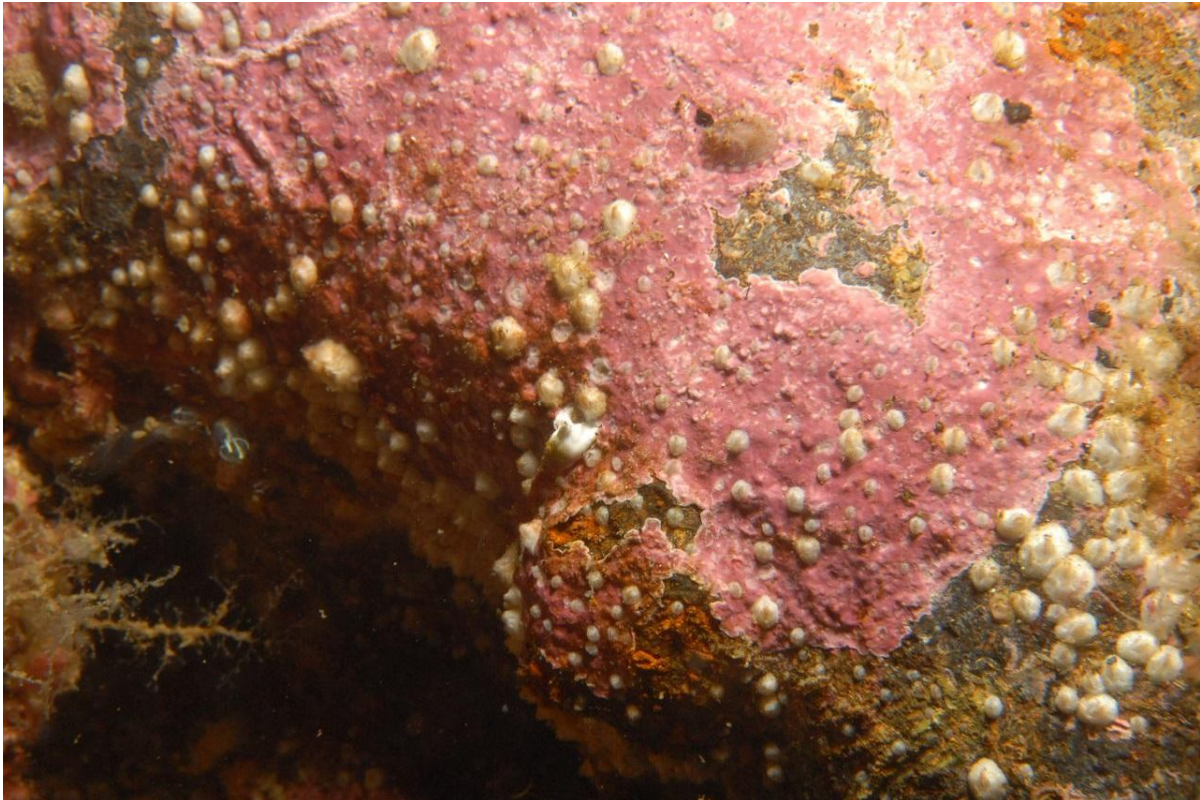
Image 23. Encrusting pink algae growing over the surface of the wreck, with abundant barnacles and rare occurrence of the china limpet *Tectura testudinalis*.(RG)
