TAYNISH MILL

AN ARCHAEOLOGICAL EXCAVATION

Data Structure Report

May 2012

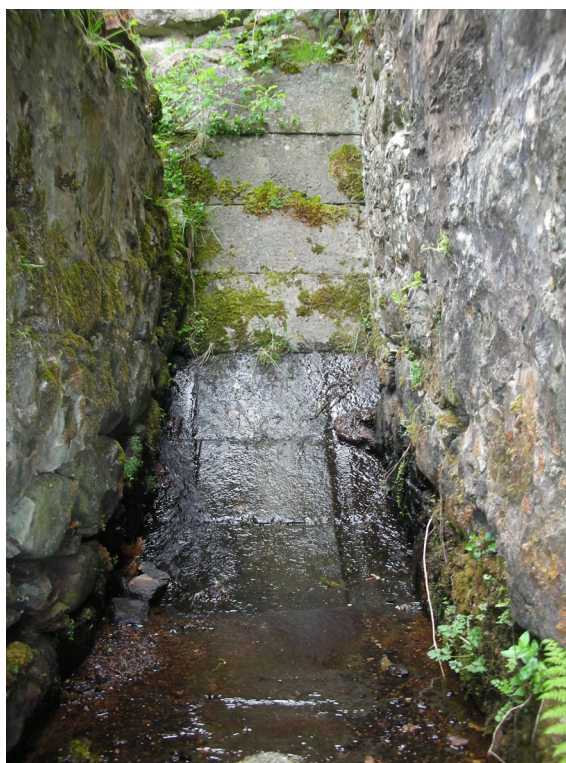
Wheel grooves worn in stone lined lade

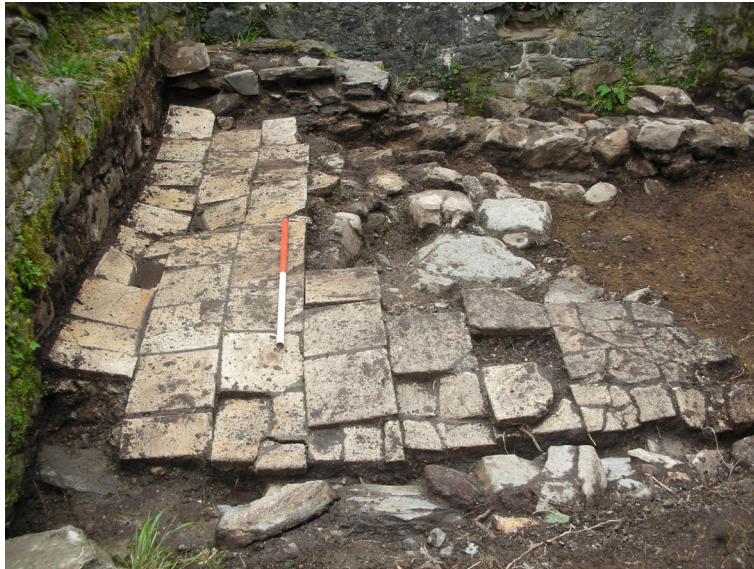
Floor [002]

[002] Floor. Consists of square light grey yellow ceramic tiles measuring 0.30m by 0.30m by 4cm

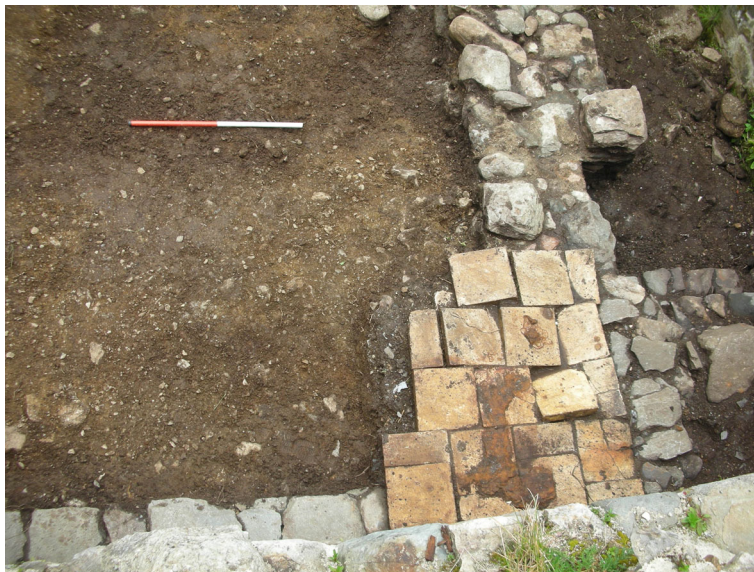
Floor [003]

The tile (and brick) floor at the W had a distinctive rusting pattern on its surface, suggesting a box or container had previously lain on the surface. Apart from being incomplete the tiles within the floor were very uneven and slumped, suggesting they once overlay a now rotted suspended wooden floor as indicated by a dark brown loam [004] situated directly under the tiles. The presence of a wooden floor was also suggested by a sill or scarcement of stone slabs seen lining the inner face of the SW wall of the building [005]. Any such floor would also have required cross supports or sills within the centre of the building but this was so badly disturbed that none were identified. Delineating the edge of the tiled floor was evidence of a wooden partition, beamslot [006] and two opposing post holes [007] and [008]. To the N of the beamslot the S

[003] Floor. Consists of square light grey yellow ceramic tiles as described above, the floor also incorporates some bricks in the surface these measuring 0.24m x 0.11m x 60mm. The upper surface of the floor has a dark red brown ferrous rust stain suggesting a box or container sat here.

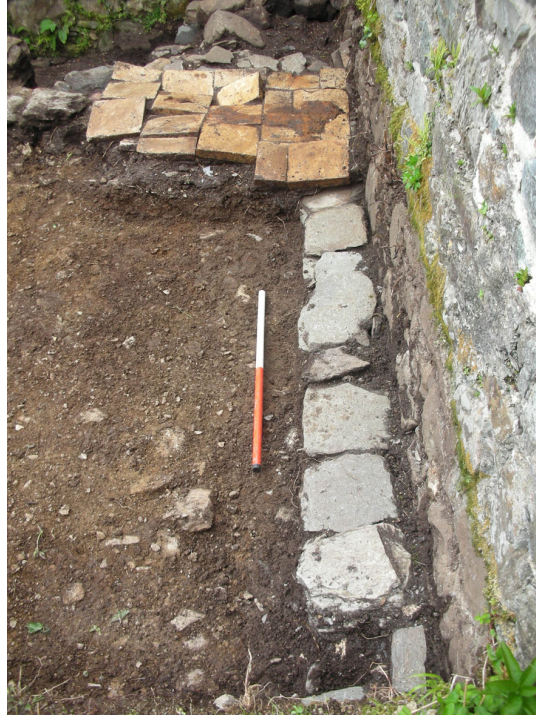
Sill [005]

[005] Ledge. Length of exposed sill or scarcement running along the NW wall. Consisted of a line of levelled stones measuring 0.30m wide.

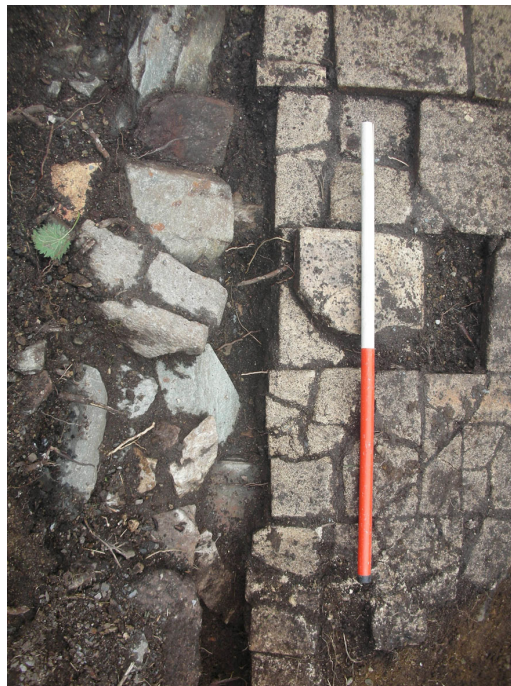
Beam-slot [006]

[006] Beam-slot. Linear void measuring 0.13m wide running across building, traceable at SE but less apparent at NW.

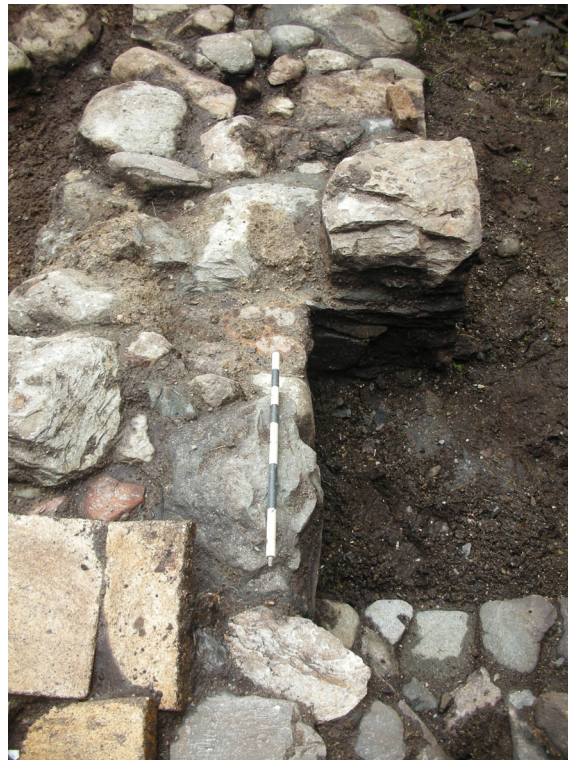
Step [014] in gear pit wall

[014] Steps? The upper extent of a likely access step into the gear pit built of roughly coursed rubble blocks (maximum size 0.47m x 0.40m x 0.20m).

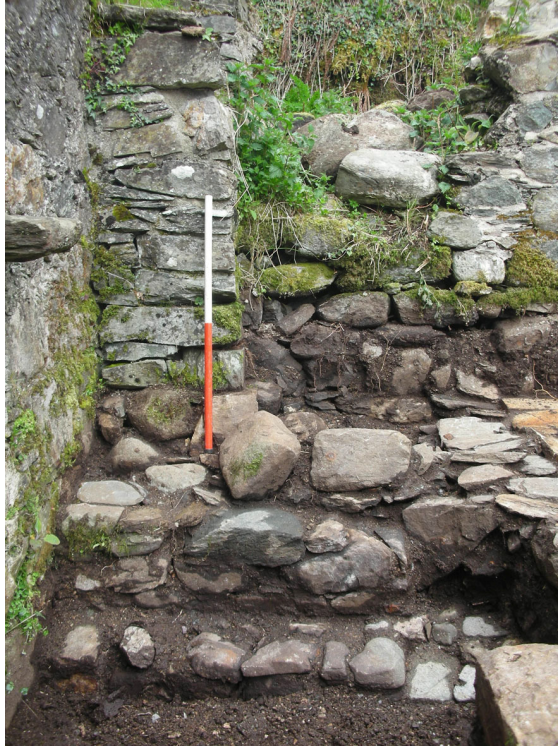
Pier/pillar base [015]

Rubble was also removed around the base of a pier support within the SW corner of the building [015] and this revealed that this corner of the building and the gear pit had been used as a midden [013], presumably when the structure had stopped being a mill but continued in use as a house. Clearance of this corner also revealed the top of what is likely access steps down into the gear pit as represented by a gap in the internal gear pit wall [015]. The midden material continued down into the gear pit and was left in situ.

[015] Pier Base. Rubble built foundation of internal floor support. The main column measured 0.50m by 0.52m, stepping out at the base in successive steps by 0.5m, 0.55m and 0.3m over a height of 0.33m.

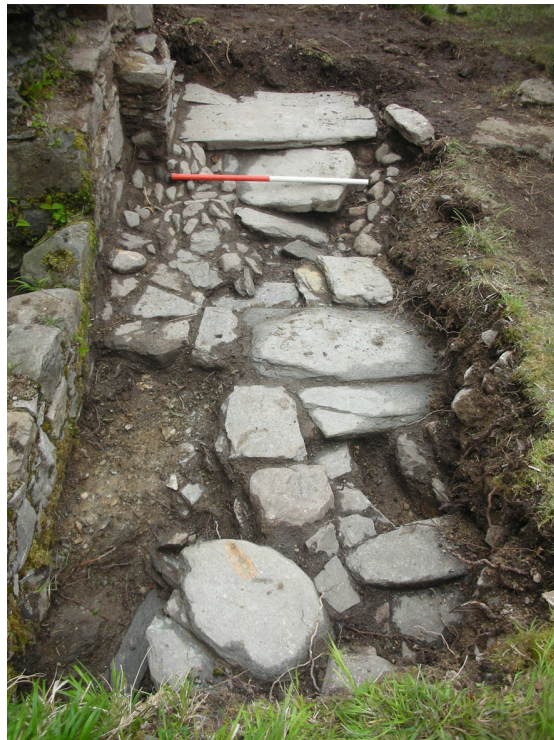
Surface [016] and Drain [017]

[016] Surface. Consisted of closely set water rolled cobbles and schist slabs running either side of drain [017].

[017] Drain. NW/SE aligned stone built drain. Comprised two rows of stones forming the sides of a channel 0.22m wide and 0.12m deep overlaid by a schist capping, forming the floor surface that corresponds to [016].

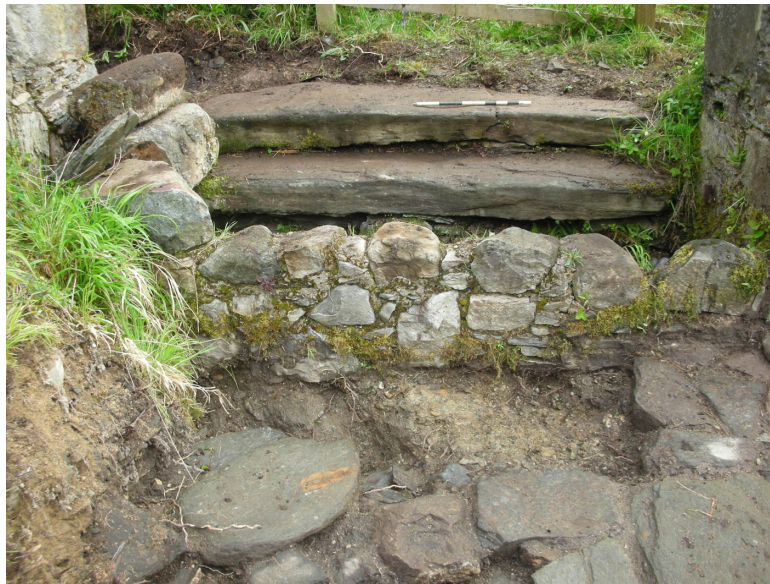
[019] Wall. Stone and mortar footings of former entrance blocking standing 0.56m high.

Blocking [019] with reused millstone within surface [016] in foreground

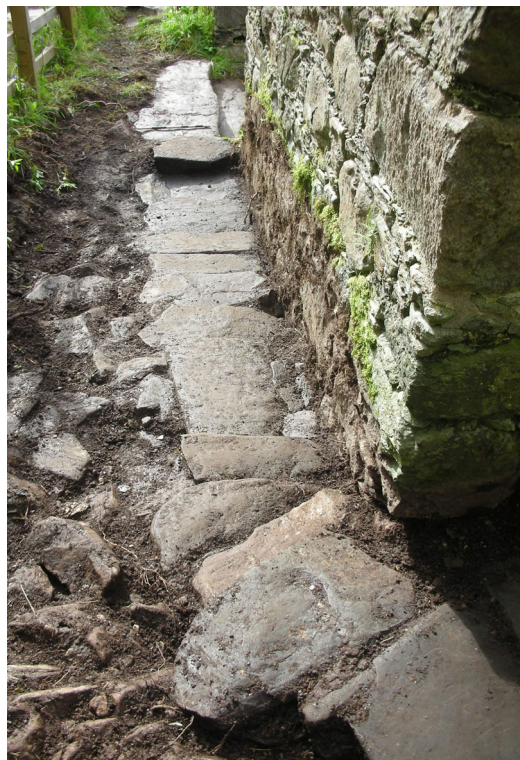
Drain [020]

[020] Drain. Line of capped drain running along the NW side of the building, consisting mainly of large to medium schist slabs.

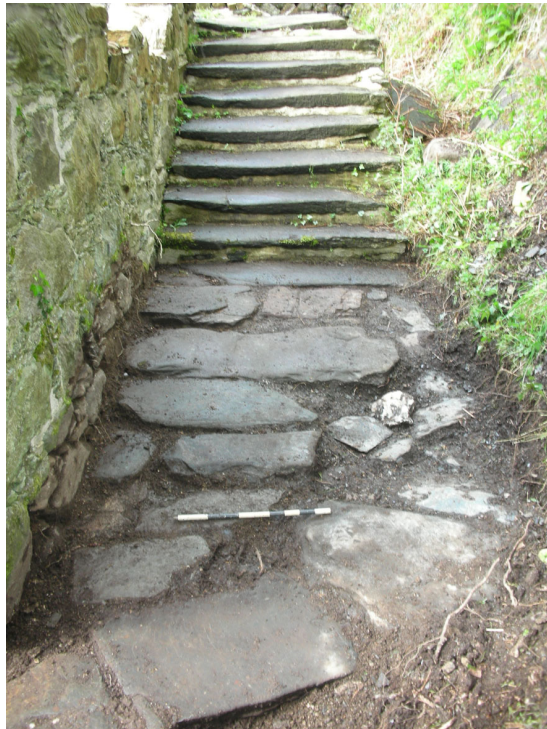
Surface [021]

[021] Surface. Stone slab surface running up to stairs along the NE side of the building.

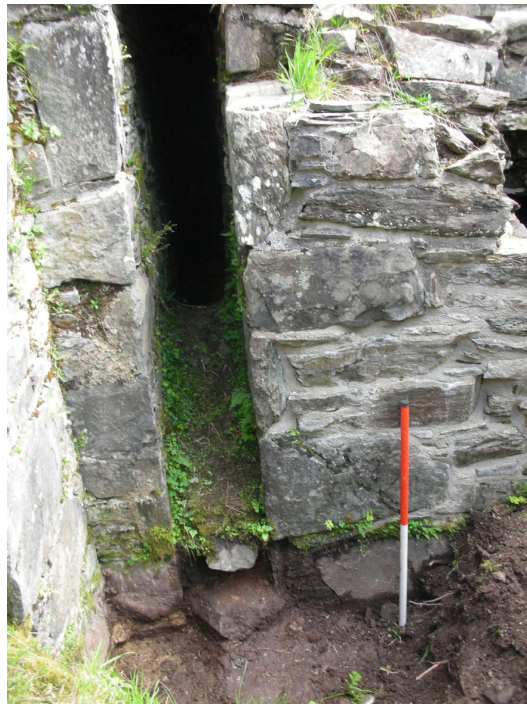
Clay floor [022] Trench 3

[022] Floor. Red brown silty clay.

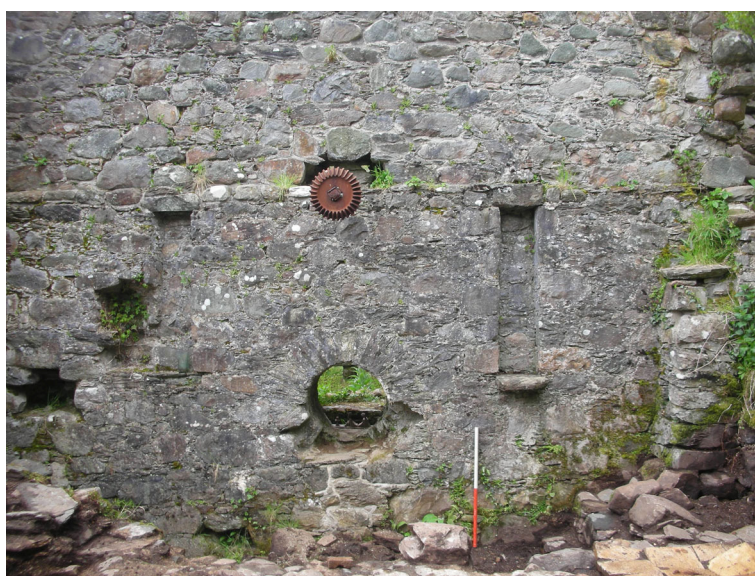
The axle passed through a 0.7m circular aperture in the end-wall, which retains some iron bolts for the axle-bearing, and on the SE perimeter of the wheel there is a recess for access to the rim, whose lintel is a truncated runner-stone with a four-winged rind (cf. No. 631. Latterly the wheel was evidently fitted with a rim-gear, driving a cast-iron spur-wheel connected by a shaft to a small bevel-gear inside the mill, both of which remain intact. The stone-floor was carried on a timber framework supported by vertical slots in the end-walls and sockets in the side-walk as at Aironn (No. 227), and additionally by an internal masonry pier in the NW angle.

Vertical timber slots, axle hole and upper gearing

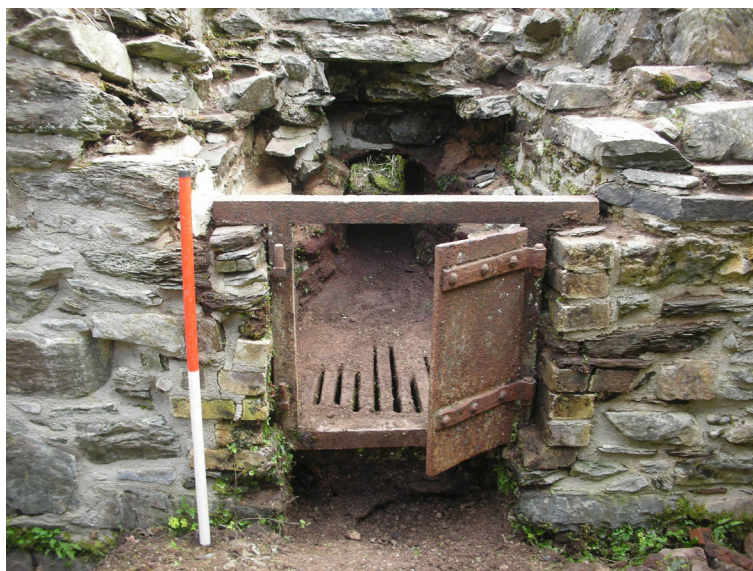
Fire box

1) Of major note within this rubble removal was the access gained to the firebox. Once access was made in here the ash pit area was totally cleared, showing the depth of grate, and as excavation continued the grate became visible - in one piece, and the second door to the firebox was excavated from within the firebox itself. The doors to the firebox are cast and of heavy form, both have corrosion, but this could be removed/reduced through restorative techniques.

The RH door is seized in place, and it may be of some concern that someone will come along and try and force this to move; possibly resulting in breakage at the hinge. The LH door has one hinge bracket missing, a new one could be fashioned by a blacksmith for replacing in its original position. The infill into the firebox was removed and cleared overhead, this has exposed a very good example of a brick lined firebox, leading away into a tapered flue within the kiln, This merits further examination, possibly from above, Exploratory trenches were also dug in other areas of the site, largely for future recommendation; (numbers are taken from 'excavation sites' map-marked in red).
