Excavation and Recovery of the Carpow Logboat, Perth and Kinross.

Data Structure Report

David Strachan BA MIFA FSA Scot

February 2007

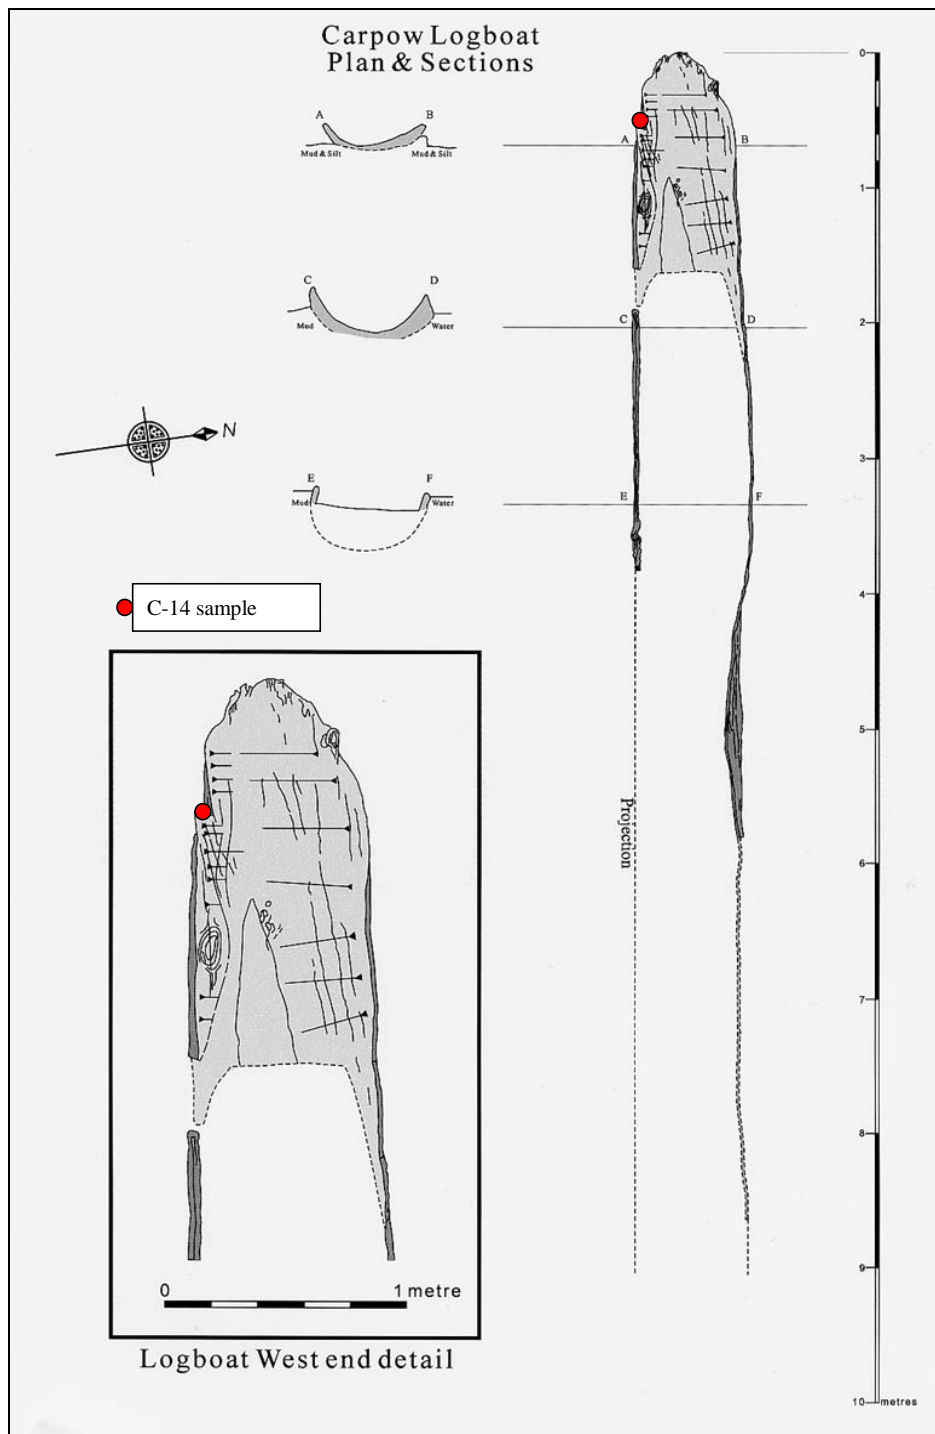
The first evaluation excavation was carried out in October 2002 (Strachan and Glendinning 2002) and aimed to assess the condition of the buried section of the vessel at the bow. It was recognised that the exposed portion of the vessel would be more eroded than the buried section as a result of relatively recent tidal action, presumably over a period of at least decades. As result, the aim of the exercise was to establish whether the buried section had been exposed for a significant period in the past, resulting in erosion across the entire vessel, or whether the condition of the buried portion suggested that the vessel had become buried prior to erosion as result of exposure over a significant period of time. The evaluation showed that the buried portion of the vessel at the bow was considerably better preserved than the exposed part suggesting that the boat had been remained *in situ* for a considerable period of time and had not suffered erosion across the entirety of the vessel before deposition.

Illus 4: Plans and sections from the initial evaluation in October 2002 and showing the C-14 sample from 2001 (GU-9597).

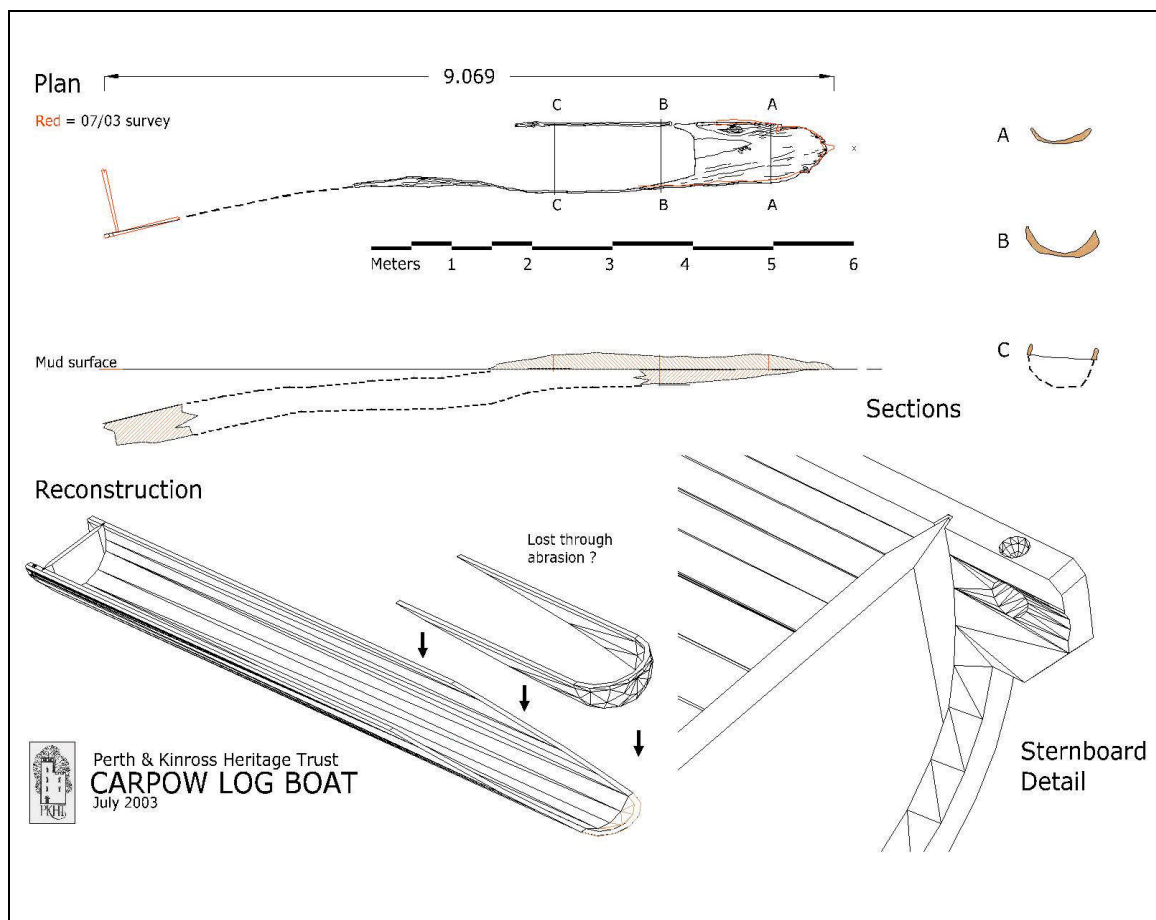
The full length of the vessel was shown to be *c.*9.25m and the top of the buried stern was found to be *c.*0.75m below the ground surface. The width of the vessel was shown to be *c.*0.9-1m. The evaluation also revealed the condition of the stern, which was found to be excellent, having suffered little erosion from either tidal action or regular exposure to the air. In particular, the survival of an *in situ* transom board was confirmed (Strachan and Glendinning 2003, Strachan 2004).

The plans and sections (Illus. 5) suggested that the vessel may have been broken or warped in some way in the central section. In particular, in plan the vessel appeared to have a kink in the projected line. The middle section of the vessel was deliberately not investigated, however, as this could have resulted in the vessel becoming freed from the inter-tidal deposits and the possibility of transportation of the boat by the tide.

Illus 5: Plans and sections from the July 2003 evaluation with schematic detail of the buried stern.

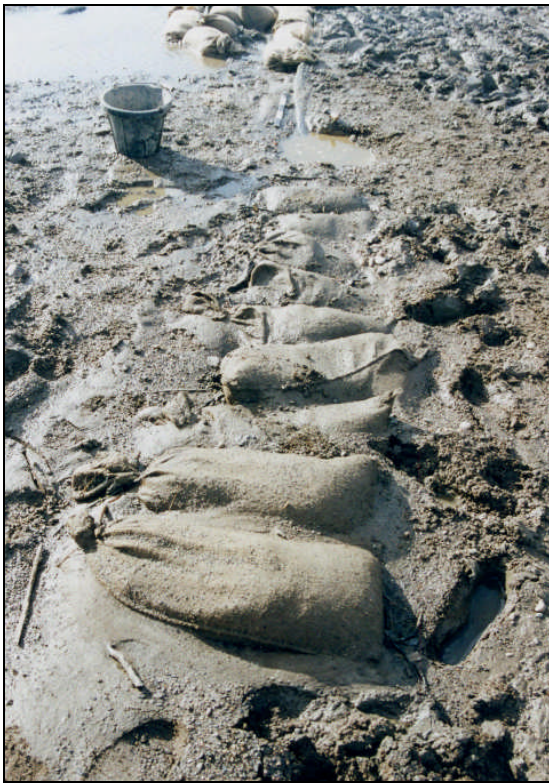
Further to the excavations in 2002 and 2003, the vessel was sand-bagged as an interim measure of protection against further erosion, transportation or damage from objects carried by the tide (Illus. 6 and Strachan 2004). In addition, sand-bagging also minimised the negative effects of exposure of the water-logged timber to air and sunlight at low tides. As the site was a Special Site of Scientific Interest (SSSI), permission was obtained for excavation work by Scottish Natural Heritage (SNH), with the condition that only hessian sand-bags were used to protect the vessel and for site reinstatement subsequent to excavation.

Illus 6: Sand-bagging of the evaluation excavation of 2003.

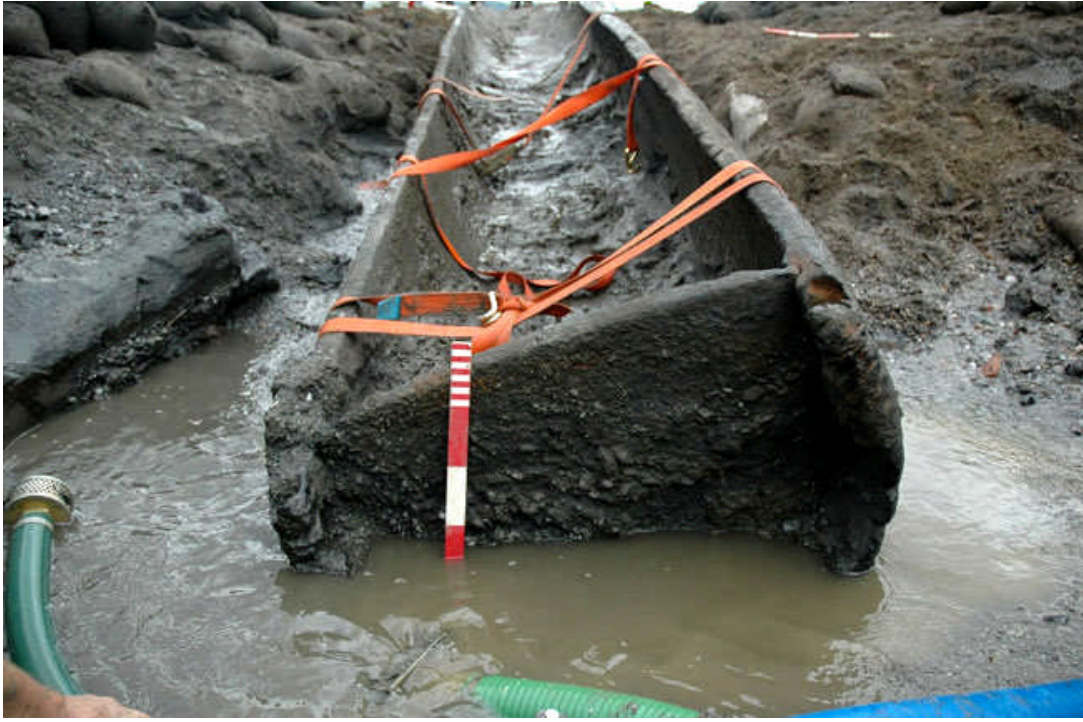
Illus 14: The stern of the vessel during excavation showing the angle at which the boat was positioned with the port (south side) considerably lower than the starboard (north side).

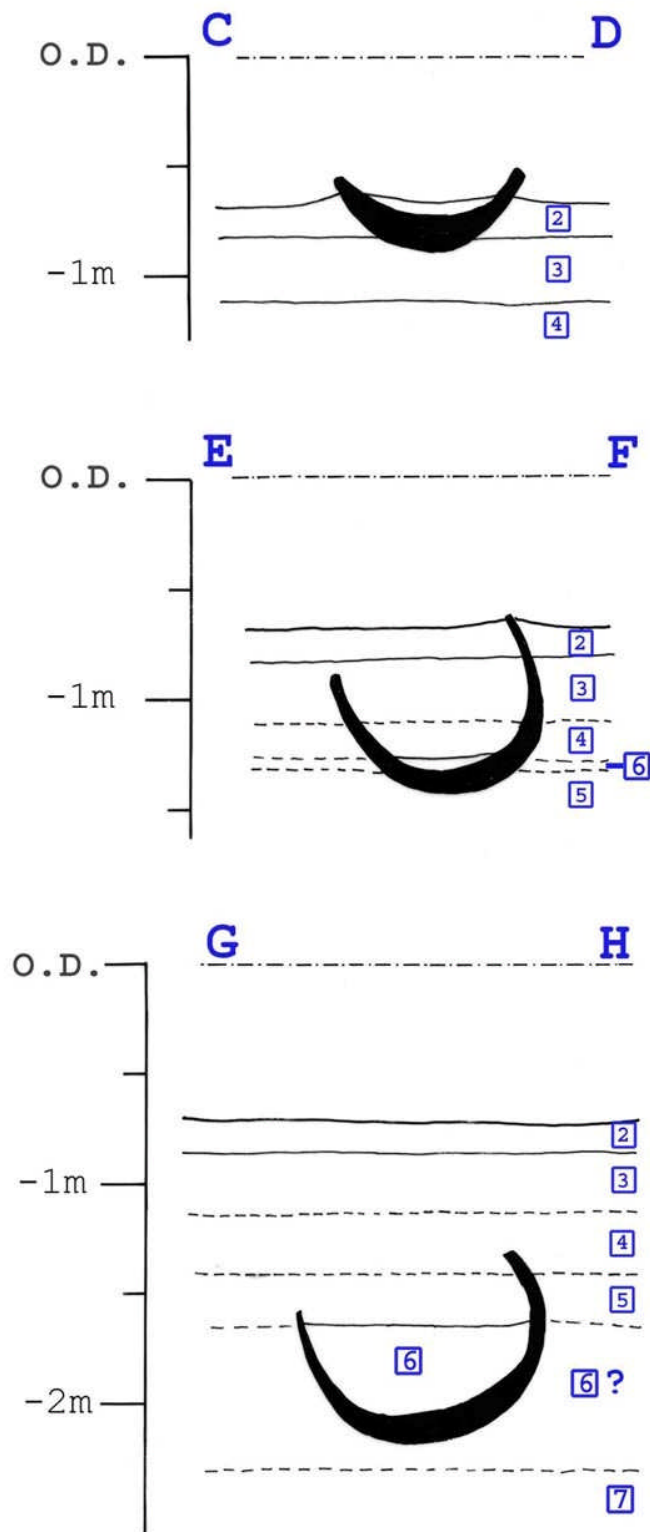
Illus 16: Sections C-D, E-F, G-H as shown in plan in Illus X. The sections show the angles at which the vessel was sitting, with the starboard (north) side of the vessel much higher than the port (south) side. C-D also illustrates how the exposed bow has been truncated by erosion.

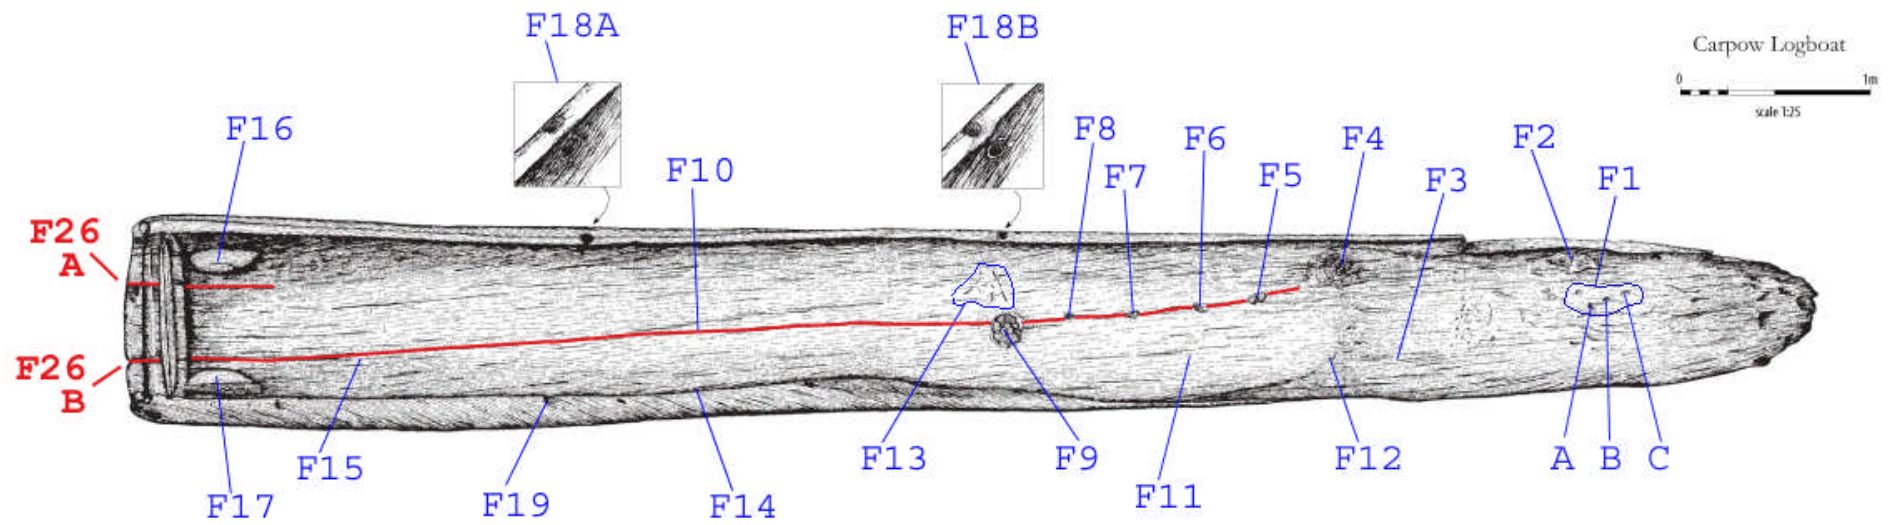
There are two significant basal splits in the hull (F26 A and F26 B) both originating at the stern (Illus. 23). In addition to the possible repairs to the stern discussed above, split F26 B has a total of seven repairs over the length of the hull, taking the form of small patches of tar-like material, possibly tree-sap, which has been applied to the split. Notably F5 to F9 are all roughly equally spaced, which may suggest that they were contemporary. Of these F9 is exceptional in its size and appears to have been made up of several patches applied over time.

Illus 23: Above: Annotated Drawing 1 showing Features F1-F19 and F26 and 27. Below: Photo mosaic of the boat.

Feature No.	Description	Measurement
F1	group of three (?) dimples A-C. A is much more prominent.	A: 45mm diameter, 12mm deep B: 45mm diameter, 4mm deep C: 50mm diameter, 3mm deep
F2	knot with hairline crack running towards prow. Knot is evident on outside of the vessel.	350mm diameter
F3	possible raised feature. Darker in colour than surrounding wood. Trapezoidal in shape.	90mm (vertical) by 50mm and 70mm (horizontal)
F4	pronounced knot. Raised on inside of vessel, hollow on exterior.	170mm diameter, 30mm raised (interior) 120mm by 80mm, 50mm deep (exterior)
F5	resin repair (along basal split). Pronounced repair, sub rectangular in shape.	140mm by 70mm, 30mm raised (distance between F5 and F6: 240mm)
F6	resin repair (along basal split). Sub circular in shape.	60mm in diameter, 10mm raised (distance between F6 and F7: 250mm)
F7	resin repair (along basal split). Amorphous in shape.	80mm by 50mm, 15mm raised (distance between F7 and F8: 290mm)

F8	resin repair (along basal split). Sub circular in shape.	40mm in diameter, 4mm raised (distance between F8 and F9: 240mm)
F9	resin repair (along basal split). Large repair. Sub circular. Made up of smaller composite repairs.	230mm by 180mm, 30mm raised
F10	'plug' feature. Possible gauge hole. Circular in shape. Raised circumference and depressed centre.	50mm by 40mm
F11	resin repair. Sub circular in shape.	35mm by 20mm, 5mm raised
F12	resin repair. 'Figure of 8' in shape.	40mm by 30mm in shape
F13	various linear marks – possibly excavation damage	
F14	possible repair made up of accreted material on the inside of vessel.	40mm by 50mm, raised 7mm Position: 400mm down from top of strake
F15	resin repair on basal split.	40mm by 50mm, raised 5mm
F16	support/mount (?) feature at stern of vessel (port side)	390mm by 130mm, maximum height 90mm
F17	support/mount (?) feature at stern of vessel. (starboard side). Top of support has been sheared off.	380mm by 130mm, maximum height 80mm

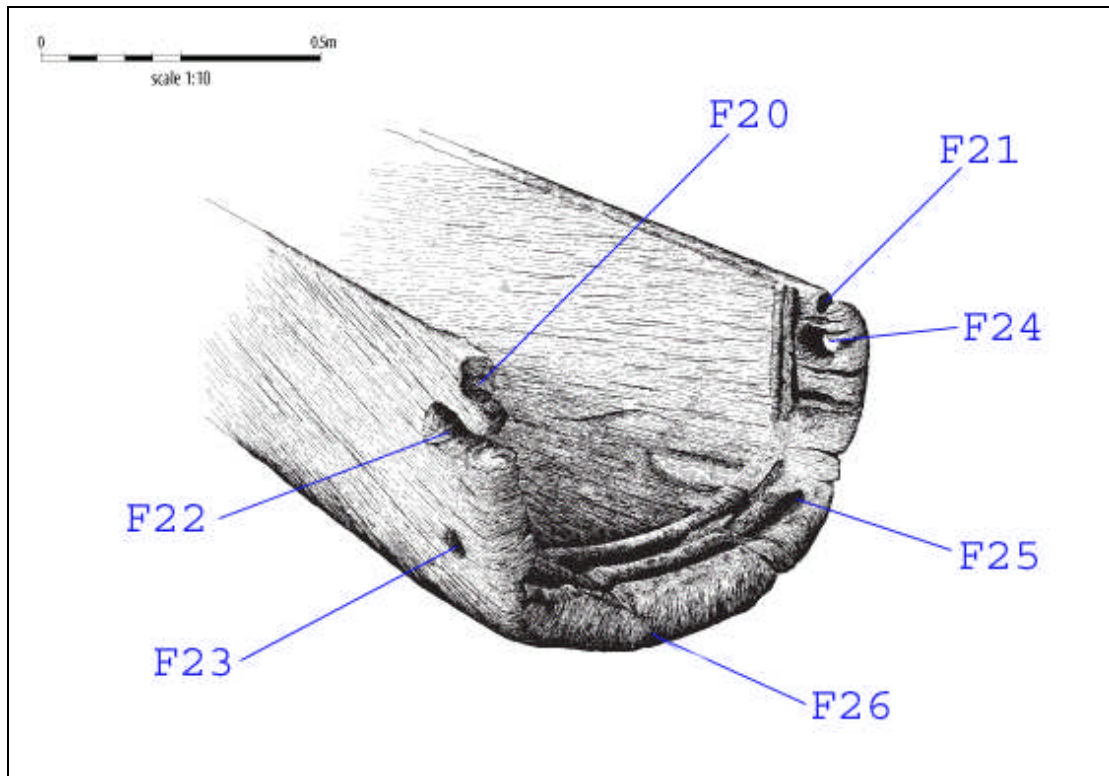
The third pair of cut features (F23 and F25) may also be beam ties holes, but notably relating to the outer transom groove, the holes being positioned directly above the terminal of the outer transom groove (Illus. 24). As outlined above it is considered probable that the outer transom groove represents the position of a second, smaller and additional transom board, possibly added in response to leakage resulting from the basal splits F26 A and B. With the configuration of outer groove and beam tie

Illus 24: Annotated isometric drawing of the stern showing features F20-F26 (beam tie holes and basal split).

Feature No.	Description	Measurement
F20	a vertically cut retaining feature (port side). It appears as a deep sub circular depression and is paired by F21.	65mm (port to starboard) by 40mm (stern to bow), 65mm deep
F21	a vertically cut retaining feature (starboard side). It appears as a deep sub circular depression eroded on the after side and is paired by F20.	65mm (port to starboard) by 60mm (stern to bow), 65mm deep
F22	a circular hole cut horizontally through the sheer-line aft the transom (port side). The afterside is missing and it is paired with F24 and together they are the larger and upper of four such holes (the others being F23 and F25).	80mm (top to bottom), 90mm (stern to bow), 100mm thick at base of hole.
F23	lower hole (port side). Triangular in shape. Angled downwards (exterior to interior)	50mm (top to bottom), 45mm (stern to bow), 110mm thick.
F24	upper hole (starboard side). Large circular feature.	80mm (top to bottom), 100mm (stern to bow), 90mm thick at base

F25	lower hole (starboard side). Circular feature. Angled downwards (exterior to interior)	60mm (top to bottom), 60mm (stern to bow).
F26 A	basal split at the stern.	The split runs for around 80cm
F26 B	basal split along the boat which appears to have been repaired several times (see F5-10 and F15).	The split is around 7m long

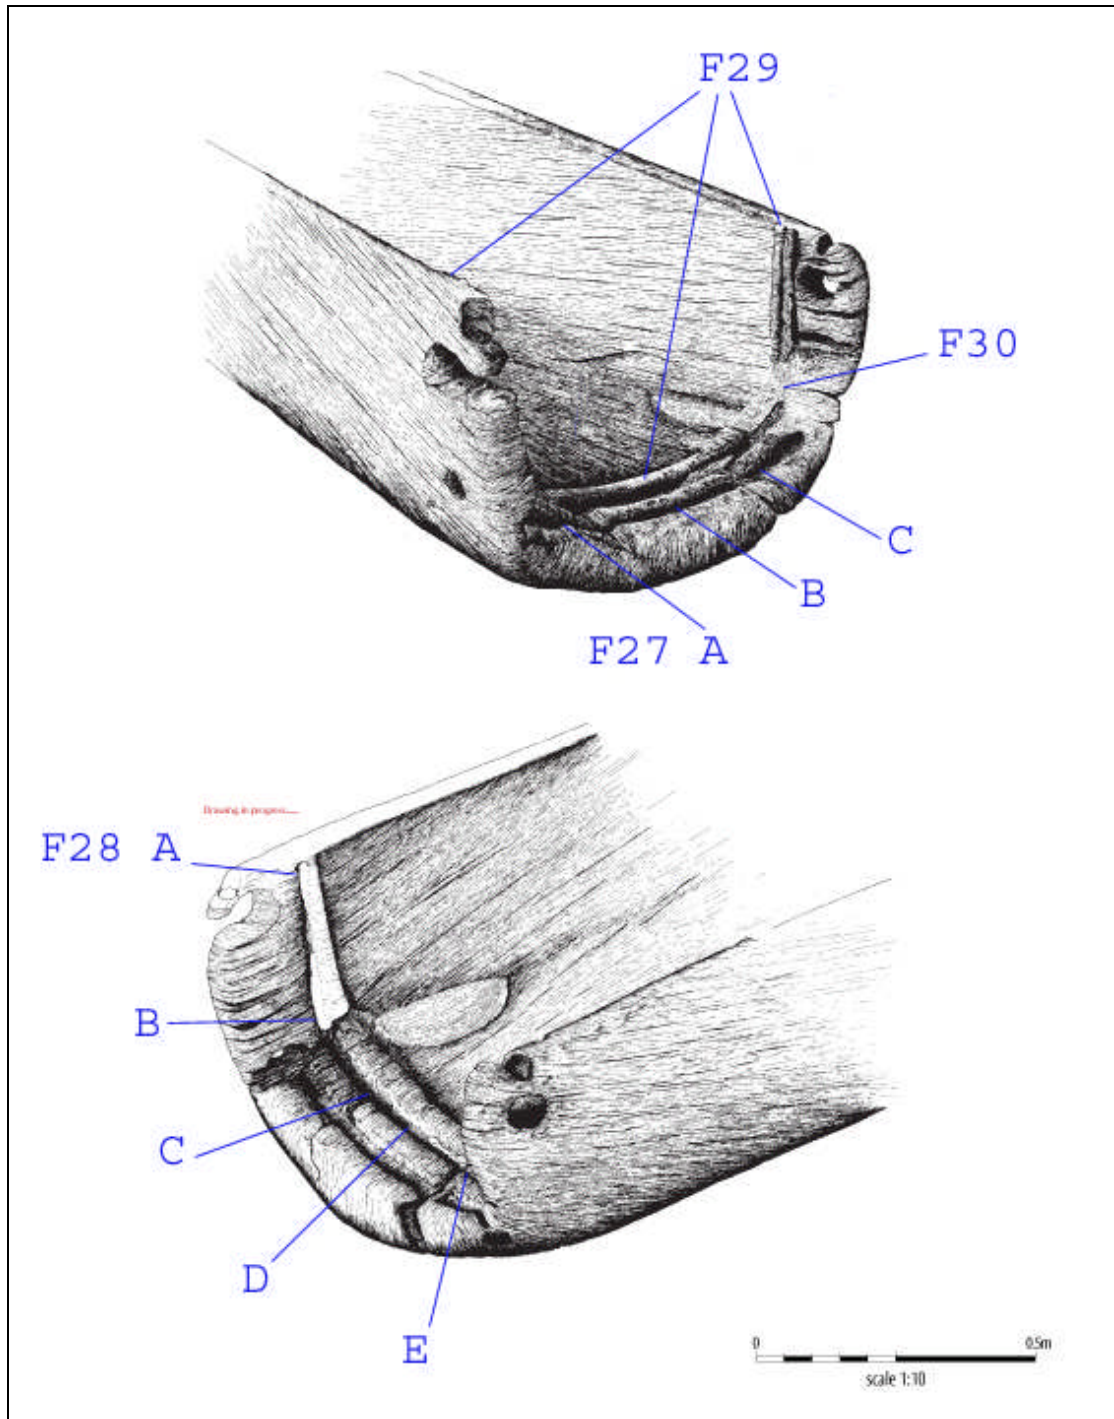
Illus 25: Annotated isometric drawing of the stern showing features F27–F30 (transom grooves, inner ridge and repair).

deep, forward side 50mm deep D: 45mm wide, aft side 30mm deep, forward side 50mm deep E: 45mm wide, aft side 40mm deep, forward side 50mm deep
F29	inner transom 'ridge'. Large band of wood parallel to inner transom groove.	60mm thick at port side, 50mm thick at starboard side
F30	a section cut across the inner transom groove. During excavation, a an eroded timber block (SF015) would found <i>in situ</i> between the transom board and this slot. It is suggested as a repair - a similar feature having been found on the Hasholme vessel.	240mm of inner transom groove and ridge have been removed. Wedge: 10mm by 20mm head, 100mm tail

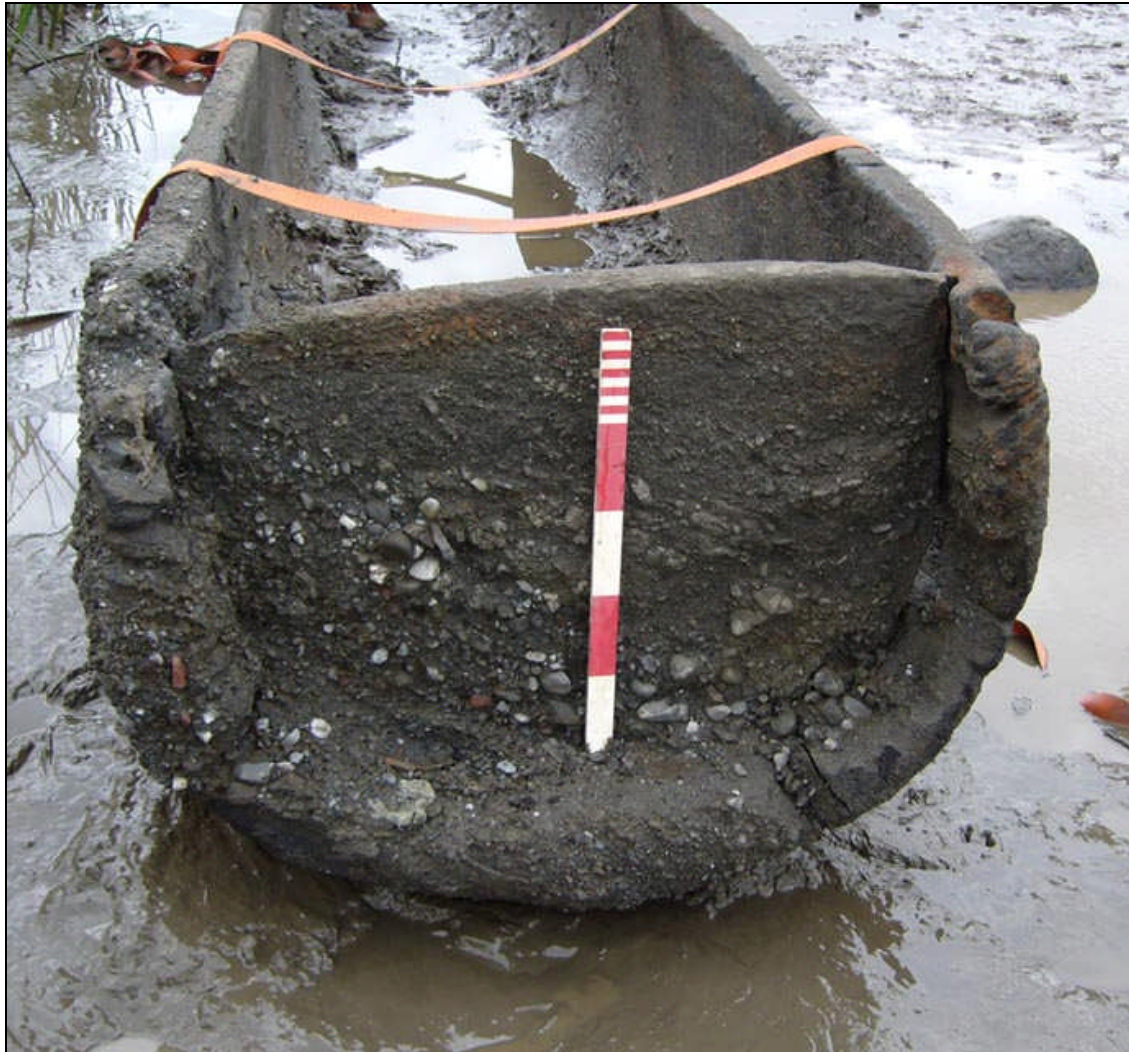
A major problem that immediately became evident is the conglomerate concretion adhering to the surface (Illus. 27). This is composed of gravel overlying a layer of fine silt, bound, according to scanning electron microscope (SEM) analysis, with iron and sulfur compounds. It is worse on the outside of the boat, but is also present on the inside. While it is possible to soften the concretion with dilute hydrochloric acid, this can only be done with small pieces in a fume cupboard, as the process produces highly toxic and flammable hydrogen sulfide. The concretion has therefore been removed where necessary to reveal detail, mainly around the stern, by mechanical means. This is laborious and time-consuming, and it has not yet decided whether or not to treat the whole logboat in this way – it may be possible to do it gradually during the polyethylene glycol (PEG) impregnation phase of the treatment.

Illus 27: The stern of the vessel showing gravel concretion.

The SEM analysis of the concretion was carried out on a small sample removed from a damaged area of the side of the hull. The presence of sulfur and iron compounds in the concretion is of some concern: these can oxidise in air to produce sulfuric acid, and this is a matter of major international concern in marine conservation. It was important to determine the nature and distribution of these compounds within the wood itself. Core samples were taken with an increment borer and analysed at the Swiss Light Source using X-ray spectroscopy. This is a synchrotron-based technique which enables us to identify the type of sulfur compounds in the wood, and in a core sample, their distribution.

There is a significant possibility that these compounds will oxidise into sulfuric acid once the conservation process is complete, although it may take several years for the problem to become apparent, as happened with the Swedish warship the *Vasa*. However, NMS have been working on this problem, in collaboration with the Mary Rose Trust, and have found at least one potential solution: treatment with calcium phytate. This is a compound found in seeds, and acts as an iron-chelating agent to prevent oxidation in the seeds, enabling them to remain dormant and viable for considerable periods of time. Results with a modern respirometer indicate that treatment of marine wood with low levels of calcium phytate dramatically reduce the oxidation rate, and should prevent acid generation. This treatment may be easily incorporated in the PEG impregnation phase.

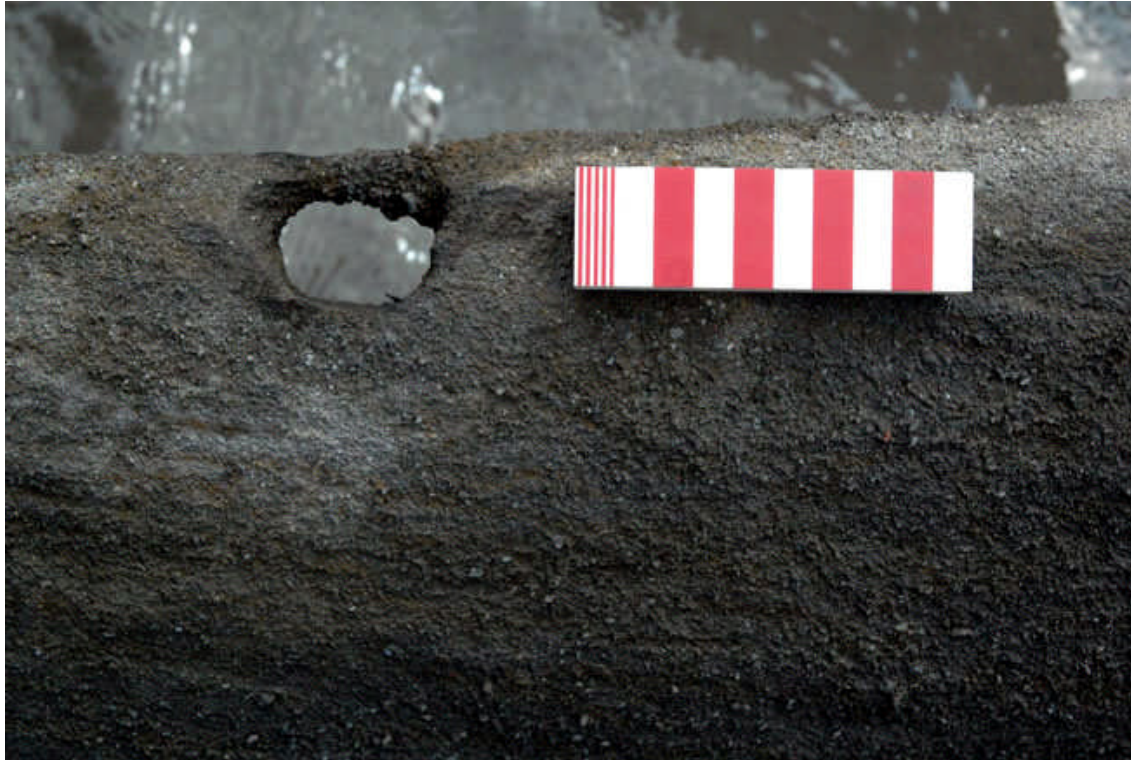
Illus35 : Detail of the F19.
