Archaeological Watching Brief and
Photographic Record
Kindrochit Castle
Braemar
ABERDEENSHIRE
BM02

**ARCHAEOLOGICAL WATCHING BRIEF
AND PHOTO RECORD
KINDROCHIT CASTLE
BRAEMAR
ABERDEENSHIRE**

BM02

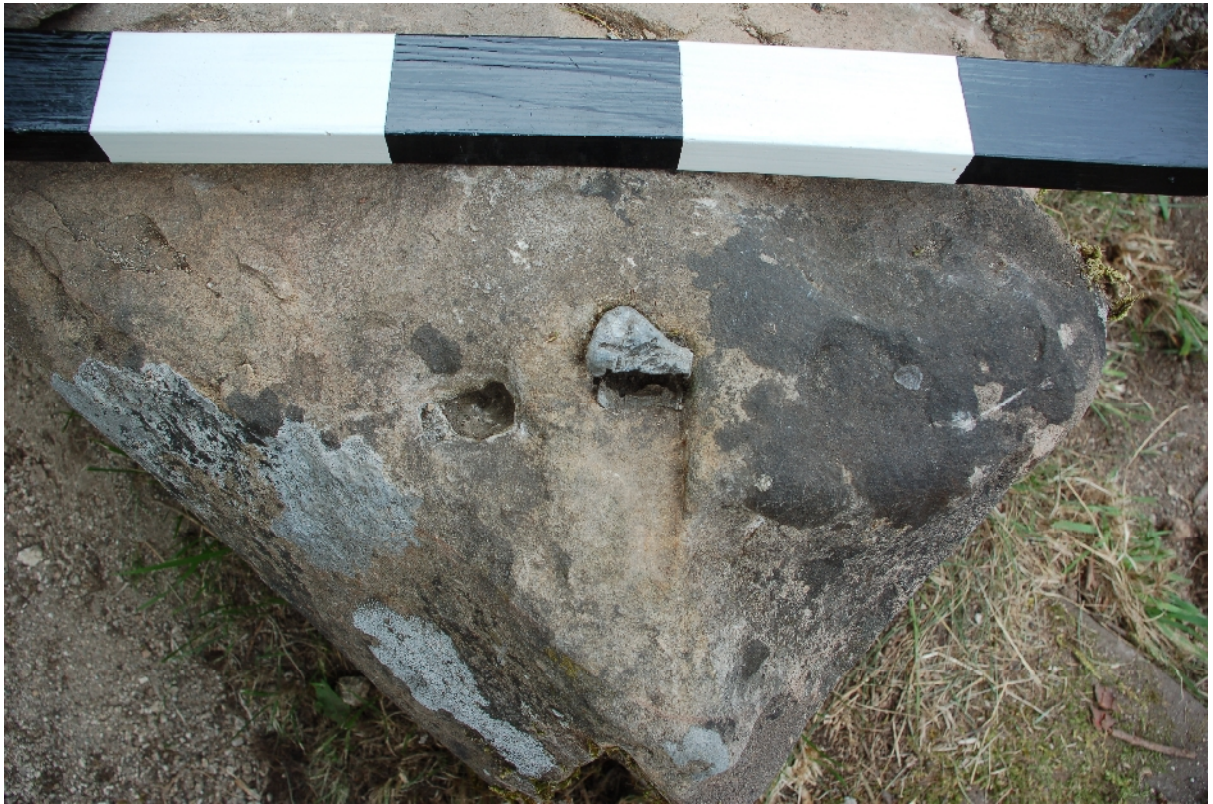
Feature F5

Fixed in the stone forming the north jamb of the outer door of the postern, a plug of lead (Feature F5, 113) was exposed, 3.4cm long and 2cm wide, with a smooth top and what appeared to be an inscribed cross on the capped end. Aligned north-northeast to south-southwest, a portion of the southwest segment was missing where, possibly, an iron bar had formerly extended outwards along a grooved channel to secure an upright iron pivot for the door. An empty hole was set into the same masonry block 2.5cm to the west.

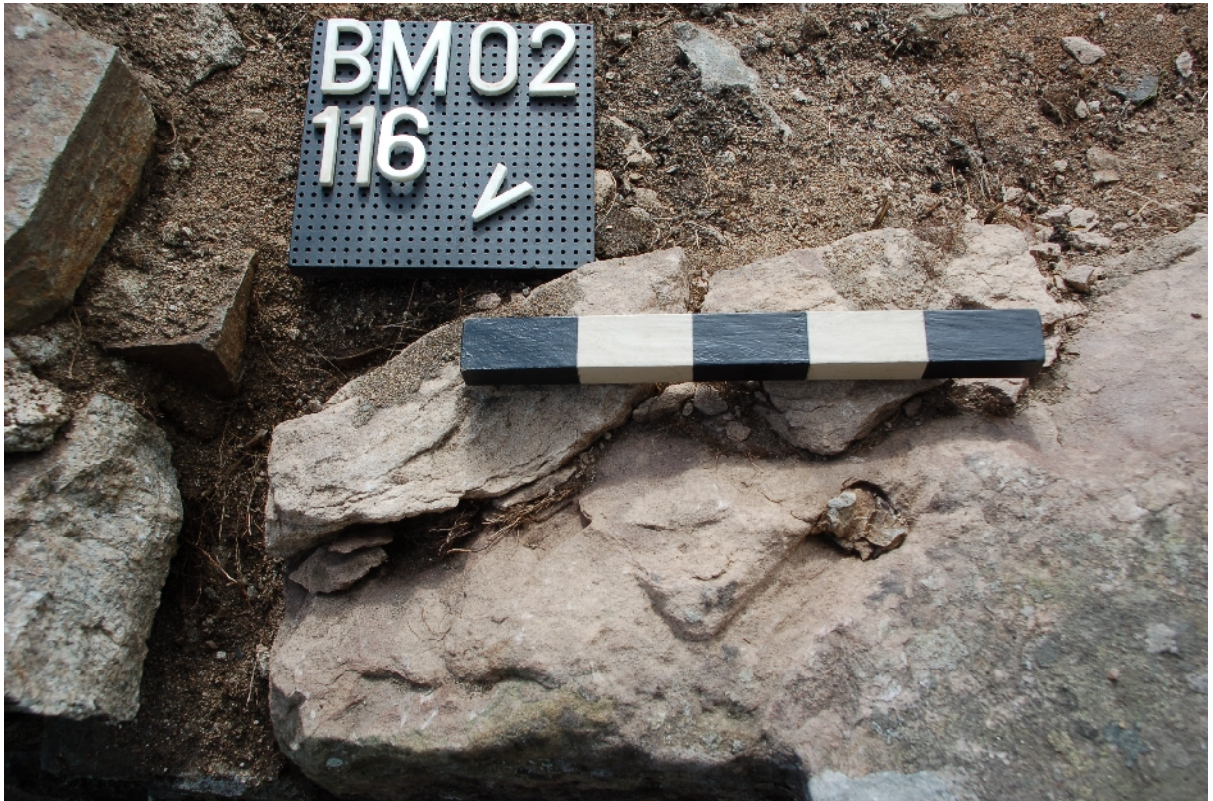
Hinge pin hole 116

A V-shaped recess (115) was noted on the south side of the south jamb of the postern, directly opposite lead plug 113/F5 and at a similar height of 30.5cm above the threshold stone. This is presumed to have held a hinge pin, with two holes also noted in the masonry. A similar recess (116) was present on the topmost stone of the jamb, with traces of lead remaining in the hole, which measured 3cm x 2.5cm.

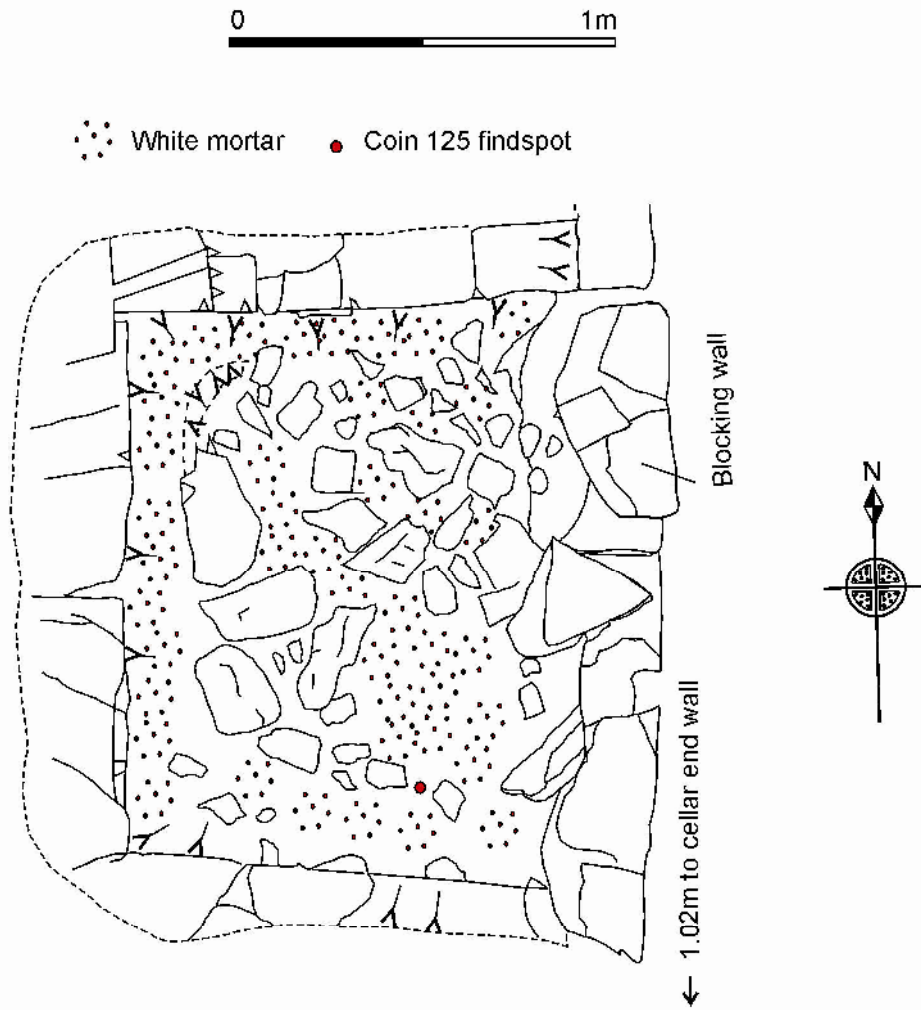
Illus 3 Plan of floor 126 in recess F1

A floor (126) was exposed within a sub-square recess (Feature F1) set into Wall Face 29 (west wall of the tower house). The floor, which sloped gently outwards, was edged with mortared rough-dressed blocks and featured white mortar along its west, north and south edges, with the interior being formed of a core of randomly assorted stone

fragments laid on/in a yellow sand matrix. It was thought that the floor may originally have been covered with slabs, but no indication of these remained. The surviving floor level lay 3-4 courses beneath the upper edge of the recess walling (102- 1.42m long, 103- 1.17m long, 104 – 1.22m long and blocking wall 105 - part of WF29 and here surviving to 0.6-0.65m above ground and 0.18-0.25m wide). Including the edging blocks, the floor measured 1.5m north-south and between 1.2m and 1.8m east-west. A coin, of corroded copper alloy, was recovered from close to the southern edge of floor 126, at the base of silt deposit 125; this measured 1.8cm in diameter and was of presumed medieval date, but was too severely corroded to permit identification. The function of the recess or alcove could not be determined, but presumably included storage, given its location in the centre of the west wall of the central cellar room of the tower house. It was noted that wall 105 was bonded with Portland cement rather than lime mortar and was therefore of later date than the rest of the structure.

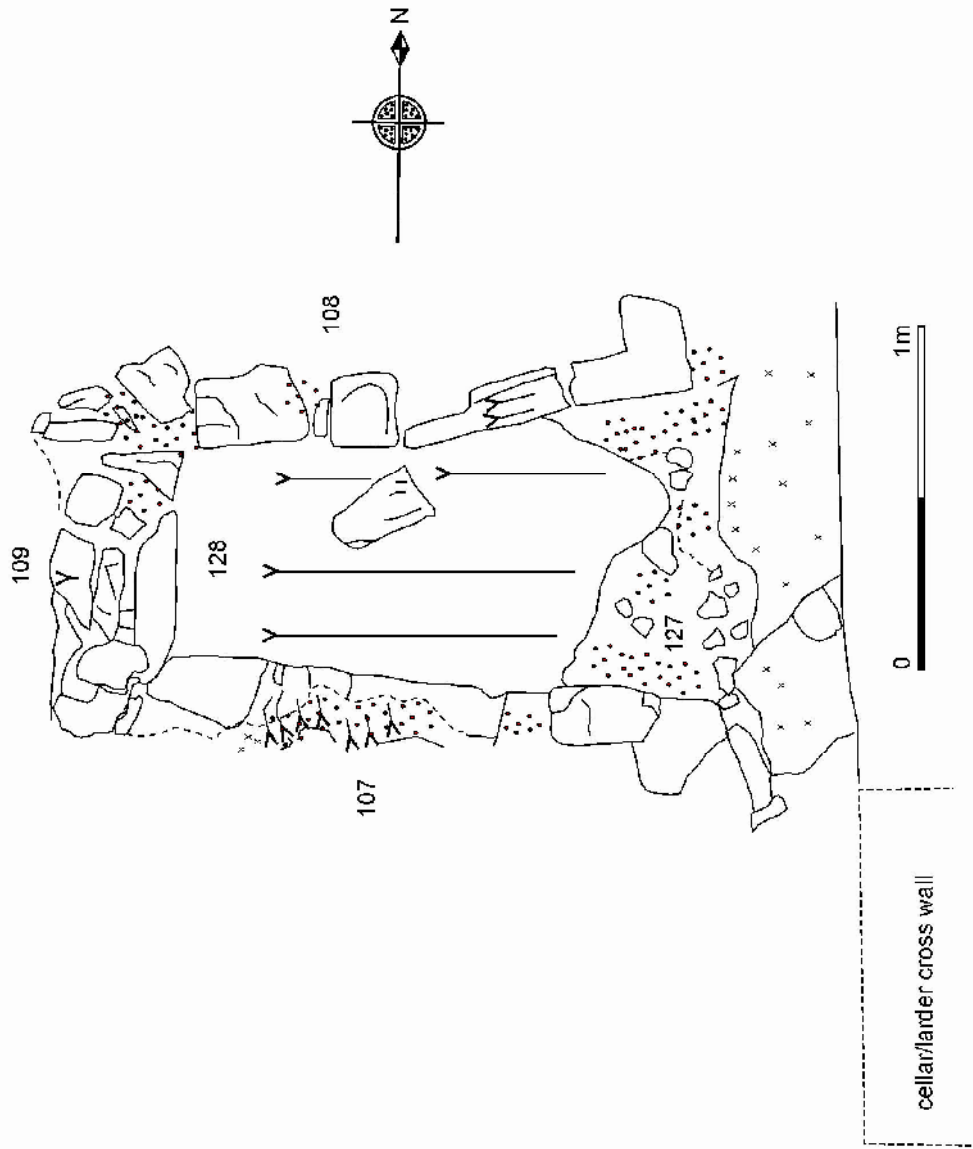
Illus 4

To the north of this recess and separated from it by a partition wall, the base of a window or arrow-slit splay (Feature F2) was exposed, also in the west wall of the tower house and immediately to the south of the postern entrance. The window was located within the surviving wallhead, widening from 0.6m north-south (internal) against the western edge of the wall (Wall Face 11) to 1m north-south (internal) against the eastern edge (Wall Face 29). As with much of the wall fabric, the sides of the window base (south splay 107- 1.74m long, north splay 108- 1.78m long, west end wall 109- 0.6m long) were composed of rough-dressed sandstone blocks of varying sizes and shapes, with traces of lime mortar apparent within the interstices and along some faces. An uneven floor (129) of stone fragments within a mortar matrix lay beneath a primary fill (128) of silt; the uneven nature of the floor suggested it may originally have supported a covering of slabs, since removed. Located close to the postern, the window probably had a defensive function in covering approaches from the south and the river; it presumably also allowed light into the north ground floor room of the tower house.

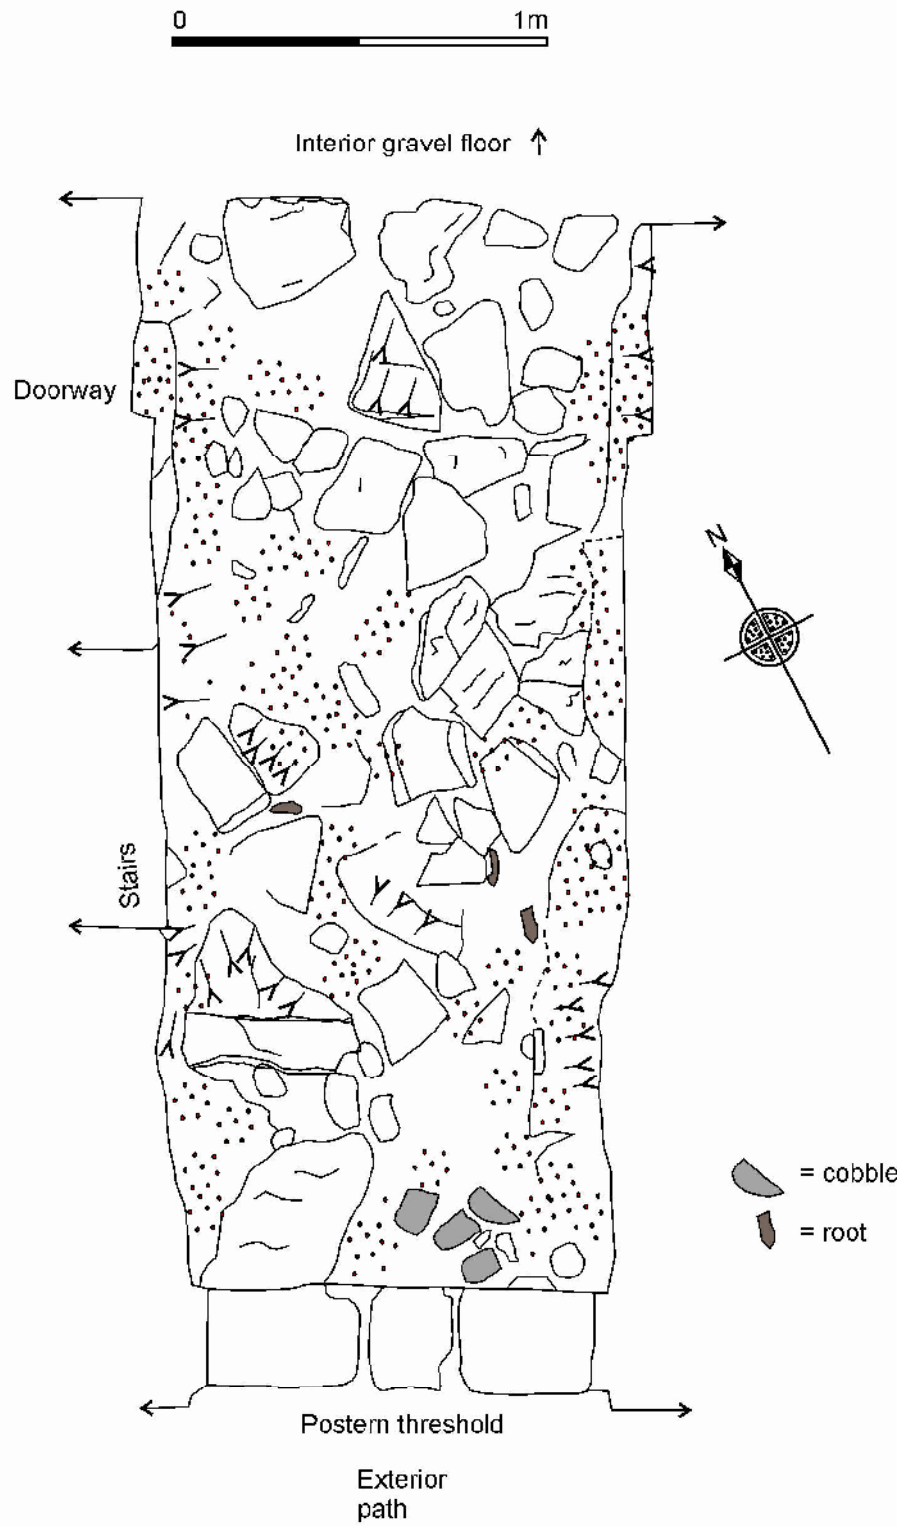
Illus 5

Following stripping, the floor (163) of the postern passageway was exposed between wall faces 27 and 36. This was represented by a generally level stone surface comprising roughly shaped and unshaped random slab fragments set within a matrix of yellow lime mortar. In patches, the mortar had degraded to a gritty silt. In the southeast corner of a the postern a group of split river cobbles had been set into the mortar, possibly representing a repair patch. The cobbles lay just short of the dressed sandstone threshold that marked the external terminus of the postern on the south/southwest side; this was composed of three sandstone blocks set into the ground surface and flush with the finished ground level. Rebates narrowed the passageway and defined the edge of the doorway to either side of this threshold. The north/northeast (internal) terminus of the floor was less clearly defined, with an indistinct threshold of dispersed, undressed stones within degraded mortar and gritty silt. The floor measured 2.96m northeast-southwest (not including the southern threshold; with the threshold the length was 3.22m), 1.32m northwest-southeast at the north terminus and 1.12m northwest-southeast at the south terminus.

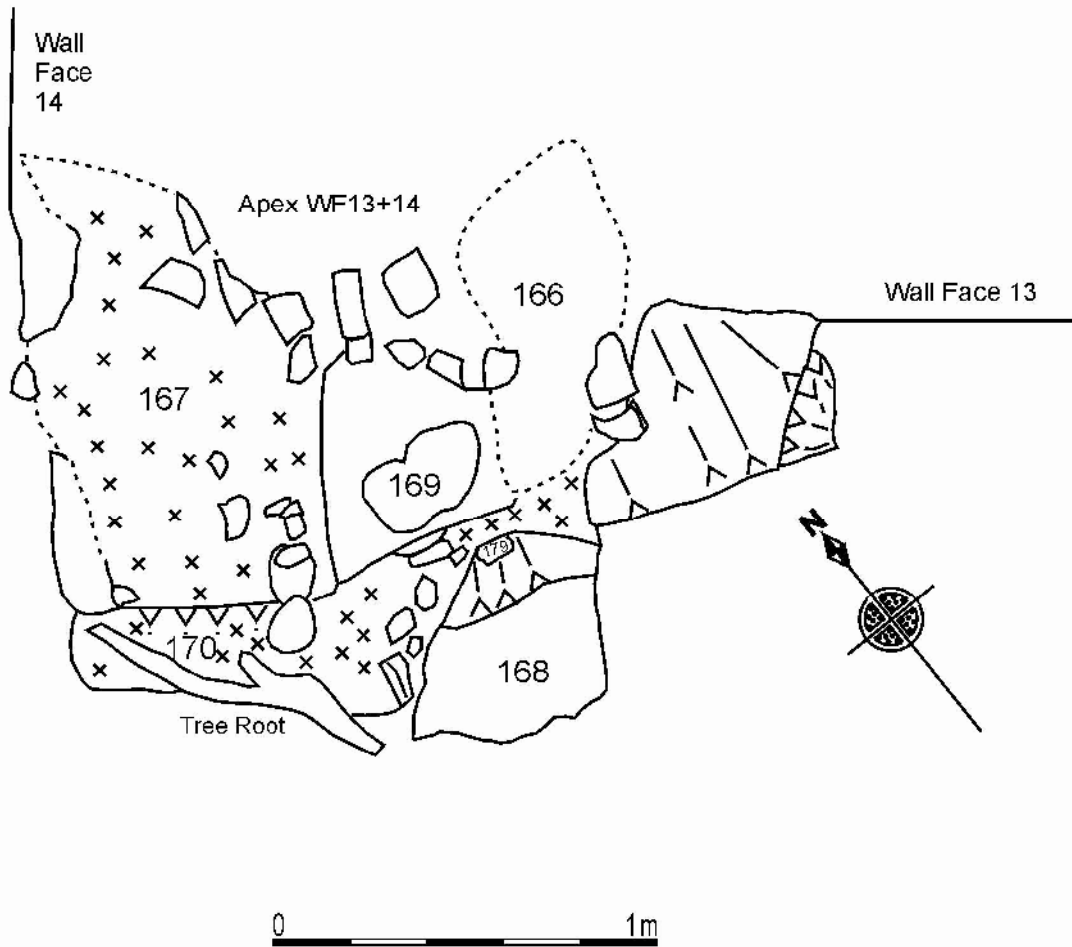
Illus 6 Plan of buttress feature (a)

Feature (a) was exposed at the apex of wall faces 13 and 14, protruding to the southwest from the former. Measuring 1.60m northwest to southeast x 1.15m northeast to southwest, it included an outlying flat, sub-angular stone (168) which was probably part of the original structure and deposits of mortar either overlying the stones- (167), (170)- or adhering to them- (169), (171).

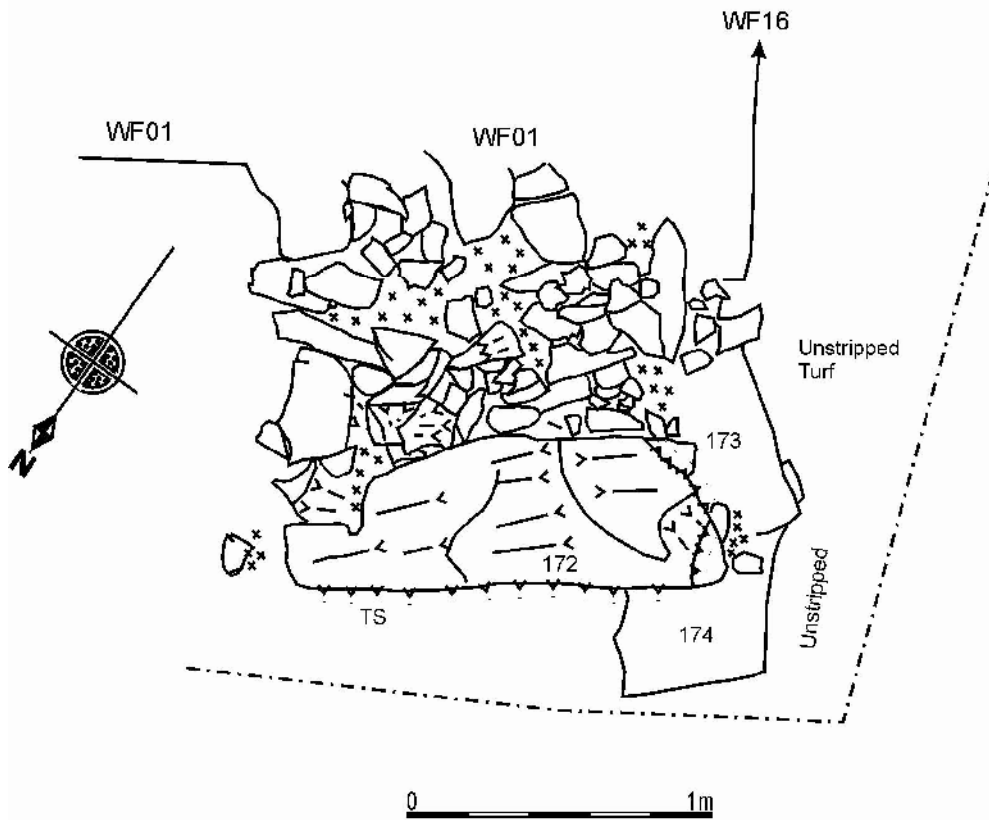
Illus 7 Plan of buttness feature (b)

Feature (b) was located at the northwest corner of the site, at the junction of wall faces 16 and 01 and extending to the northeast. Measuring 1.60m northwest to southeast x 1.10m northeast to southwest, this feature was considerably less compact than (a), with numerous loose stones around a rubble and mortar core. It overlay at least two large, flat stones- (173), (174)- embedded in the present ground surface and appearing to form a paved floor at the northwest corner of feature (b). The exact extent of these stones was undetermined, as they were partially overlain by unstripped topsoil.

Along the northeast edge of feature (b) lay a long (1.61m x 0.48m x 0.25m) grey granite slab, bearing toolmarks and a pronounced notch in the northeast corner. The slab rested on spoil and loose stone chips and therefore appeared to be out of its original position. This may have represented part of a threshold or lintel, displaced from elsewhere in the castle.

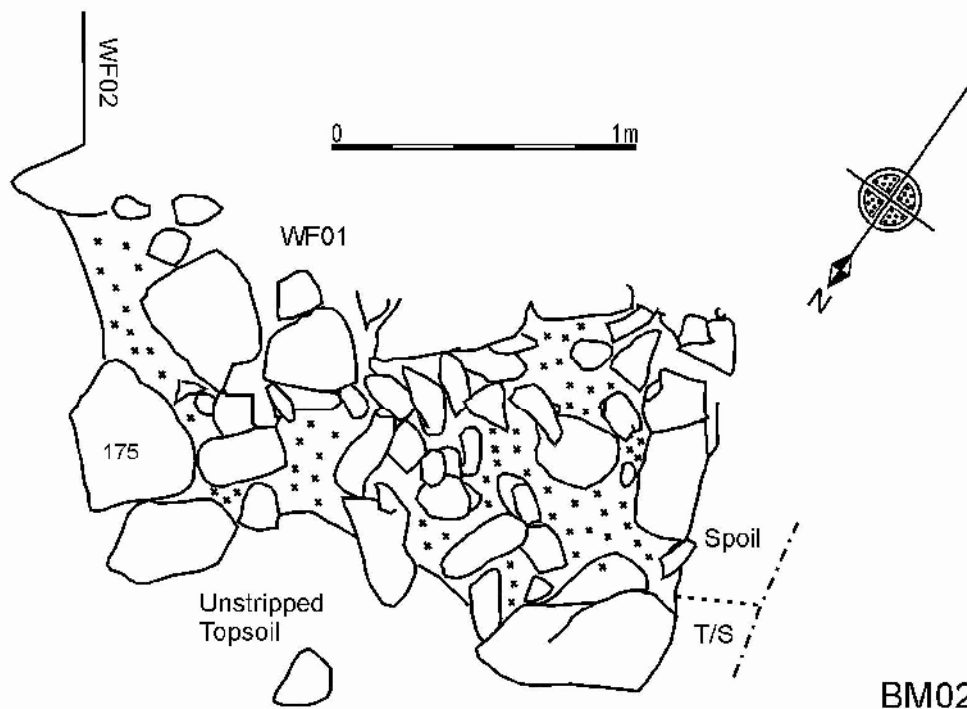
Illus 8 Plan of buttness feature (c)

Feature (c) was exposed at the opposite end of wall face 01, at its junction with wall face 02 in the northeast corner of the site. Lying almost level with the present ground surface, this measured 2.4m northwest to southeast x 1.5m northeast to southwest. This included a large spread of mixed mortar and silt (175) within a rubble core. The edges of the feature were defined by several large (0.40m diameter) boulders or flat slabs.
