Halligarth

Site Survey Report

RCAHMS was asked to undertake a survey of Halligarth, Unst, Shetland by the National Trust for Scotland in spring 2014. The building is listed and currently on the Buildings at Risk Register which also meant that it was a candidate for investigating as part of RCAHMS' Threatened Buildings Survey.

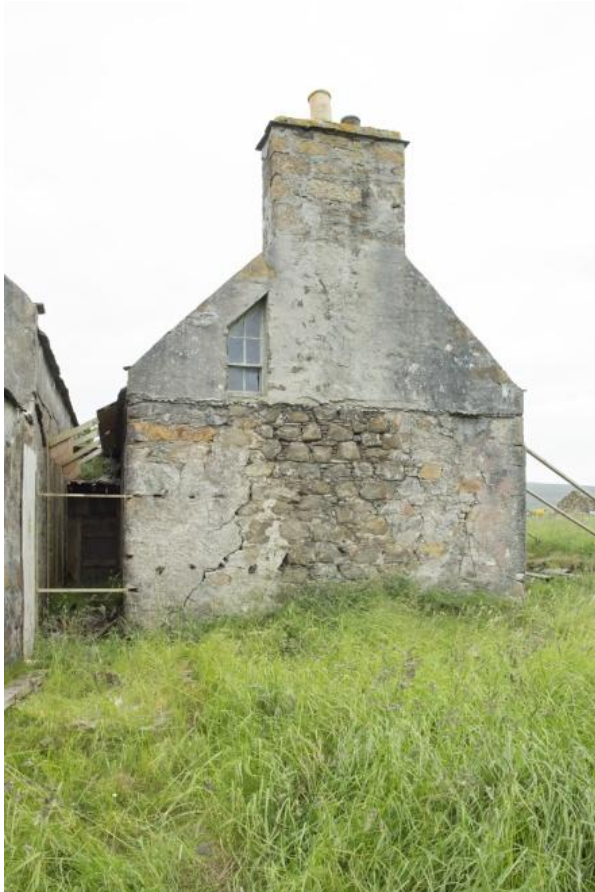
North range, east gable, view from north east showing narrow gap and link (RCAHMS: DP194627)

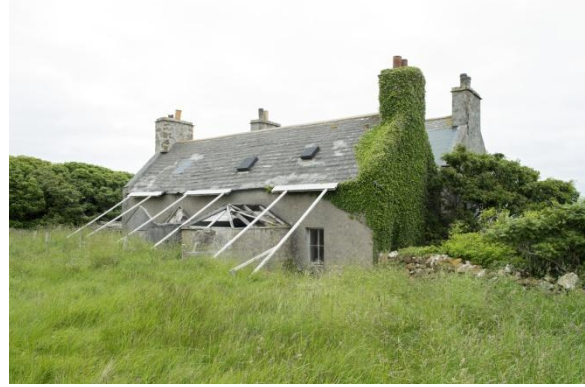
Right: View from west showing timber 'flying buttresses' (RCAHMS: DP 194631)

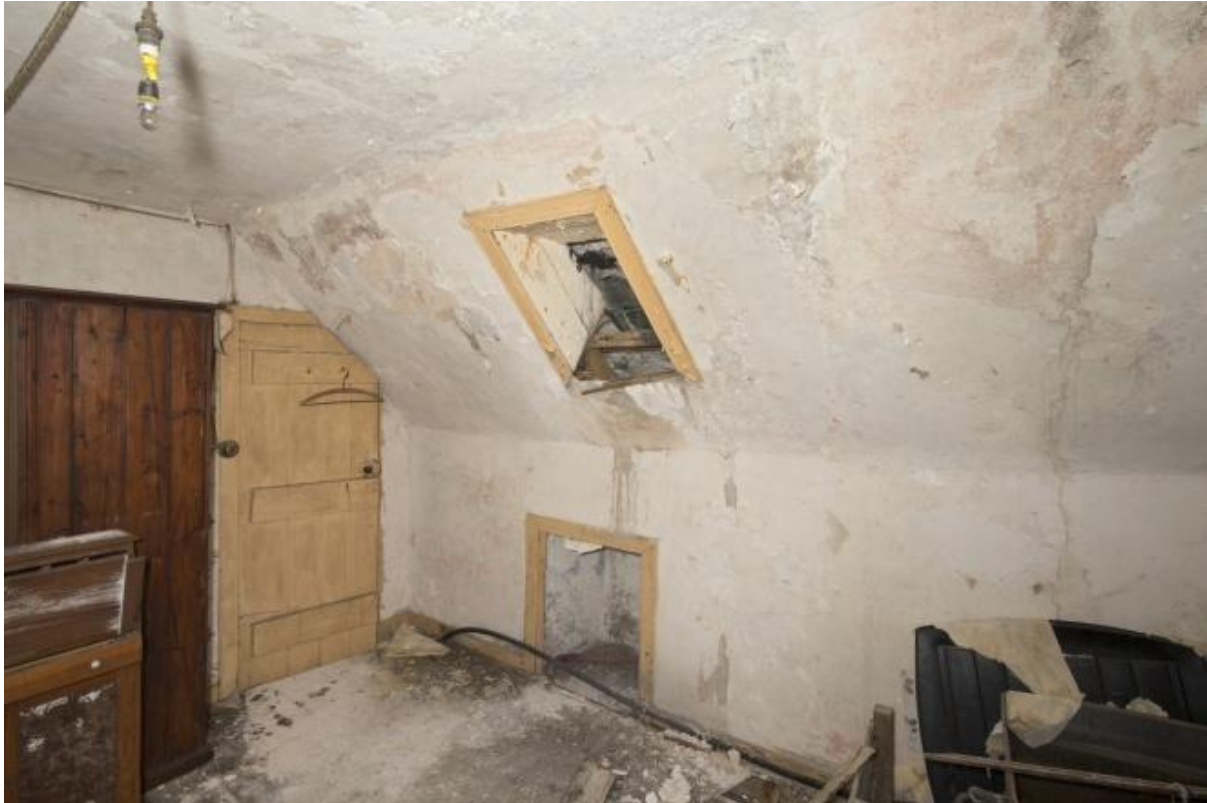
North Block, first floor, north bedroom (1.4), view from east showing blocked window at floor level (RCAHMS: DP194670)

This earlier building, before the 1832 alterations, may have been two storied, hence the survival of a first floor window embrasure in the North Block east bedroom (1.4). These alterations probably included re-roofing, altering the layout, raising the first floor level to improve the headroom on the ground floor, inserting a new staircase, and laying a new flagstone floor in the kitchen (possibly onto the earlier floor, hence the step up to a higher level). Without the removal of the render the extent of these alterations is difficult to determine. The insertion of new interior walls into an existing structure would explain the odd angle of the original door into the sitting room (0.1 and 0.2) at the west end of the block. Money was not lavished on the alterations since soft wood pegs were used for the roof, which have exacerbated the problems in this area.

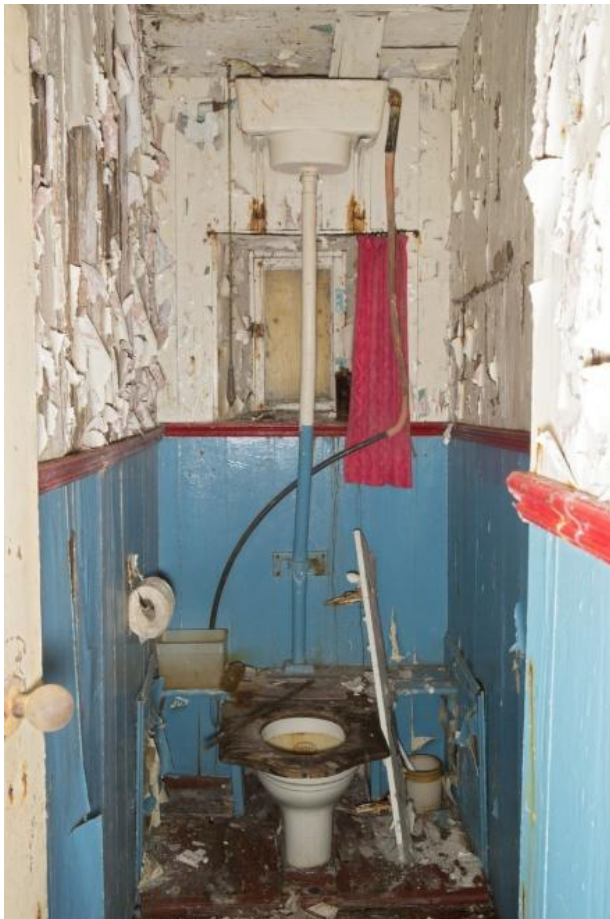
Link between ranges, view of WC (0.10) (RCAHMS: DP 194660)

The link consists of a lobby (0.11) and the WC (0.10). It has a flat concrete roof, in a partially collapsed state, with an iron rail inserted between the walls of the north and south blocks. The flagstone floor of the passageway of the north block extends through the large opening to the full depth of the north block's wall. The remaining lobby floor is concrete. The west wall of the link is built of rubble and contains the small window of the WC. The small WC is accessed by a door which is necessarily narrow due to the projecting masonry wall. It is lined with a timber boarded dado with plaster above. The lavatory is set on a stepped plinth.

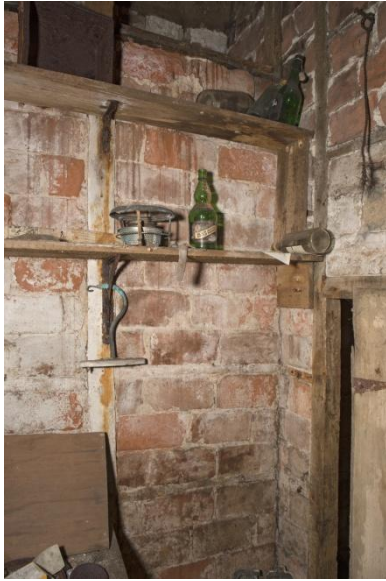
South Block, ground floor, under stair cupboard (0.16), detail of brickwork (RCAHMS: DP 194659)

The staircase is supported on substantial handmade bricks, which are visible under the stairs (0.16). The same bricks are also used to form the walls of the dining room press cupboard (0.18a). The small pantry (0.15) to the rear of the staircase was originally lit by a small window, which is now blocked. The splays of this window are set at a curious angle suggesting that they have been altered yet the opening is still partially blocked by the dining room press cupboard (0.18a).

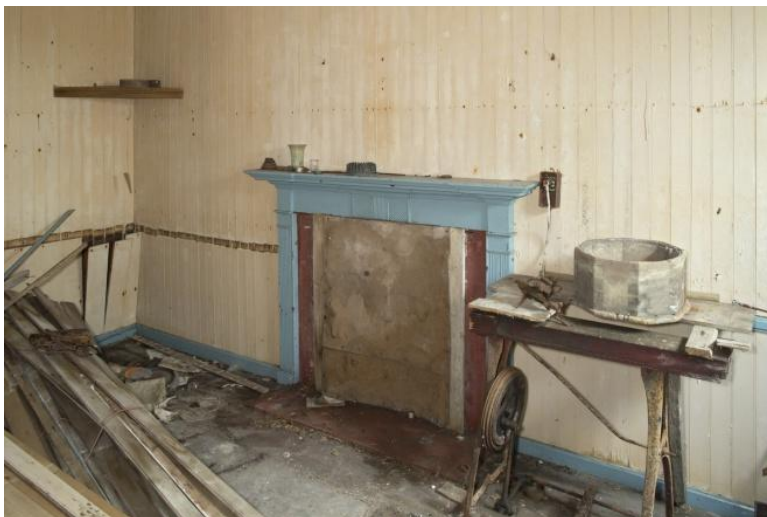
South Block, ground floor, office/den (0.19), north room, view from south (RCAHMS: DP 194647)

The office/den (0.19), in the east extension, has a plastered ceiling and timber vertically boarded walls, some of which have decayed revealing the rubble walls behind. On the north wall is a doorway which gave access to one of the lean-to buildings that have now gone. On the west wall is a large fireplace with reeded decoration, the most elaborate fireplace in the house (DP194648). On the south wall are two windows, the larger of which is original and the smaller one (without splayed ingoes) replaces a door. Both windows are timber two-over-two sash and case.
