HISTORIC  
ENVIRONMENT  
SCOTLAND | ÀRAINNEACHD  
EACHDRAIDHEIL  
ALBA

# Middlefield Beam Engine House, Thornton, Fife [NT29NE 6](#) (NT 29193 97269)

Survey and Recording Section, Heritage Management Directorate, HES, 2018.

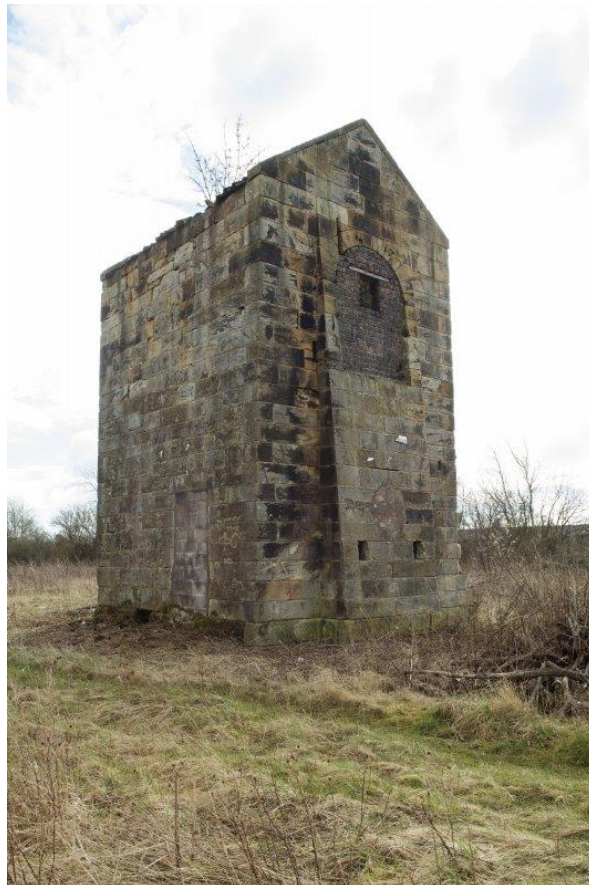
*View from north west [DP 231994, HES]*

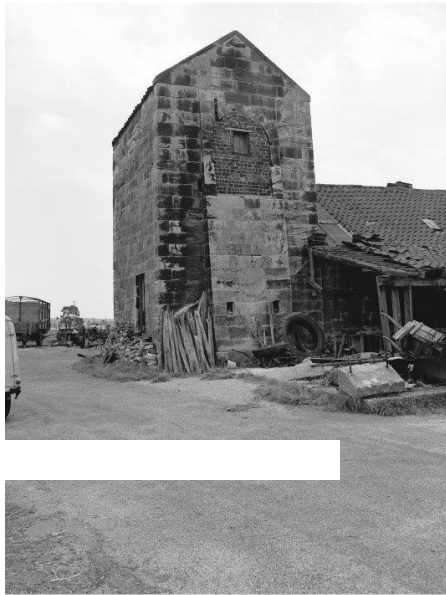
*Left: View of Pump Engine House from west, showing the now demolished south range (right). Some of the now demolished buildings may have been part of the colliery. The low footings visible in front of the west wall is the backfilled shaft down which the pump rods of the engine ran. Men may also have used the shaft to get out of the mine workings at the end of their shift. [SC 454959, 1974, John R Hume Collection, National Record of the Historic Environment]*

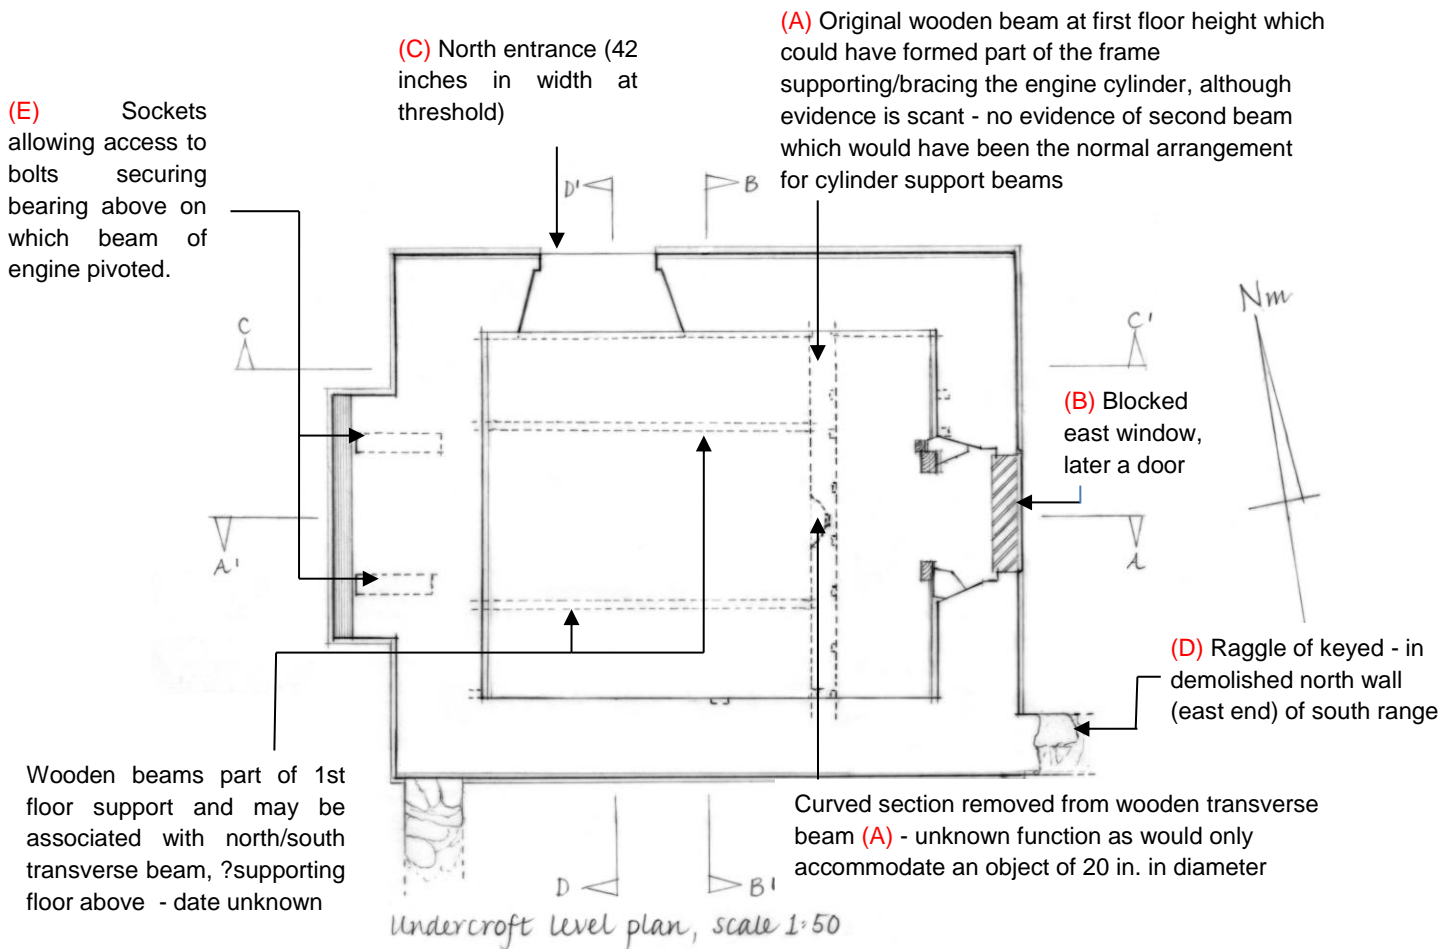
## Ground level floor plan

There is a timber beam (see Ground Level Plan, (A)) running north/ south measuring 3.85 m (14ft 4in.) by 0.24m (9in.) in depth by 0.29m (11in.) in height at this level which appears to be original (and has been kept as part of the conversion into a dwelling). There is a section cut out of this beam which looks very like a collar steadying something against it. When this cut out section is extrapolated, it would have accommodated something of a diameter of approximately 0.5m (20in.). This seems unlikely to have been the cylinder due to its size. Neither is it centrally positioned on the beam to link with the piston in the cylinder and the rocking beam above. It may have cradled some other part of the engine or have nothing to do with the building when in use as an engine house. The other mystery is why there is only one heavy beam at this level. In all historic engravings of early beam engines, the cylinder of the beam engine is always shown supported or braced by two beams (also supporting a working floor/platform) and anchored by a 'collar' bolted to the beams, on either side. There is recently blocked east window (see Ground Level Plan, (B)) at ground level which would have maximised natural light for the engine operator. The north door measures 1.067m (3ft 6in. or 42in.) in width at its narrowest point (see Ground Level Plan, (C)) at ground floor level.

There are sockets visible at exterior ground/ first level in the buttress of the west gable or 'bob' wall (see Ground Level Plan, (E)) which provided access to a bolting system for securing the beam engine pivot bearing onto the west wall at the second level opening (it is through the opening on the second level that the west half of the rocking beam protruded). This wall measures 1.25m (4ft 1in.) in thickness at ground level. The voids extend up into the buttress but the extent of these could not be ascertained. There is a possibility that a separate condenser box could have been located here (see 1877 section drawing above, p.6).

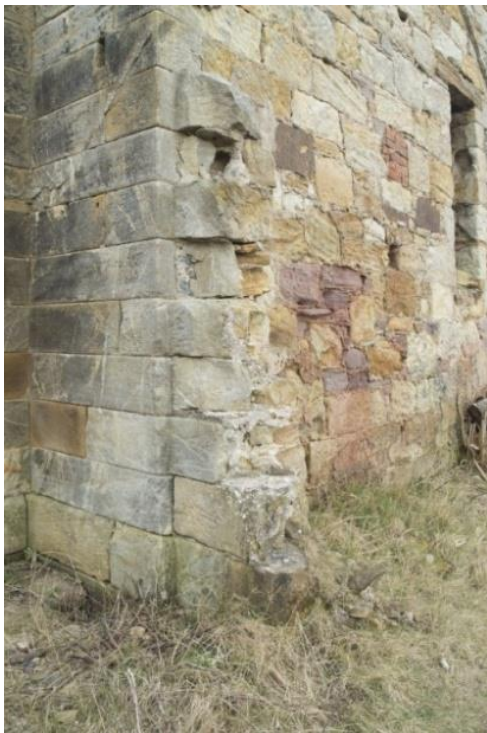
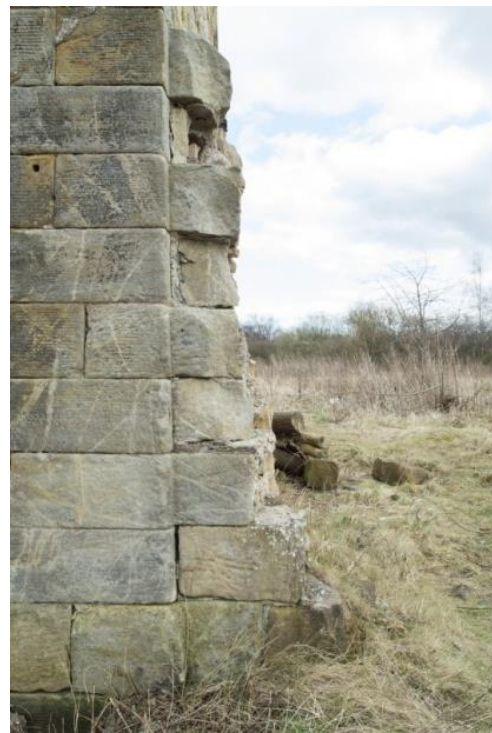
*Above left and right: south west corner of engine house showing raggle wall. The masonry is clearly keyed into the engine south wall of the engine house, suggesting that the south range was built at the same time. [DP232016 and DP232015, HES]*

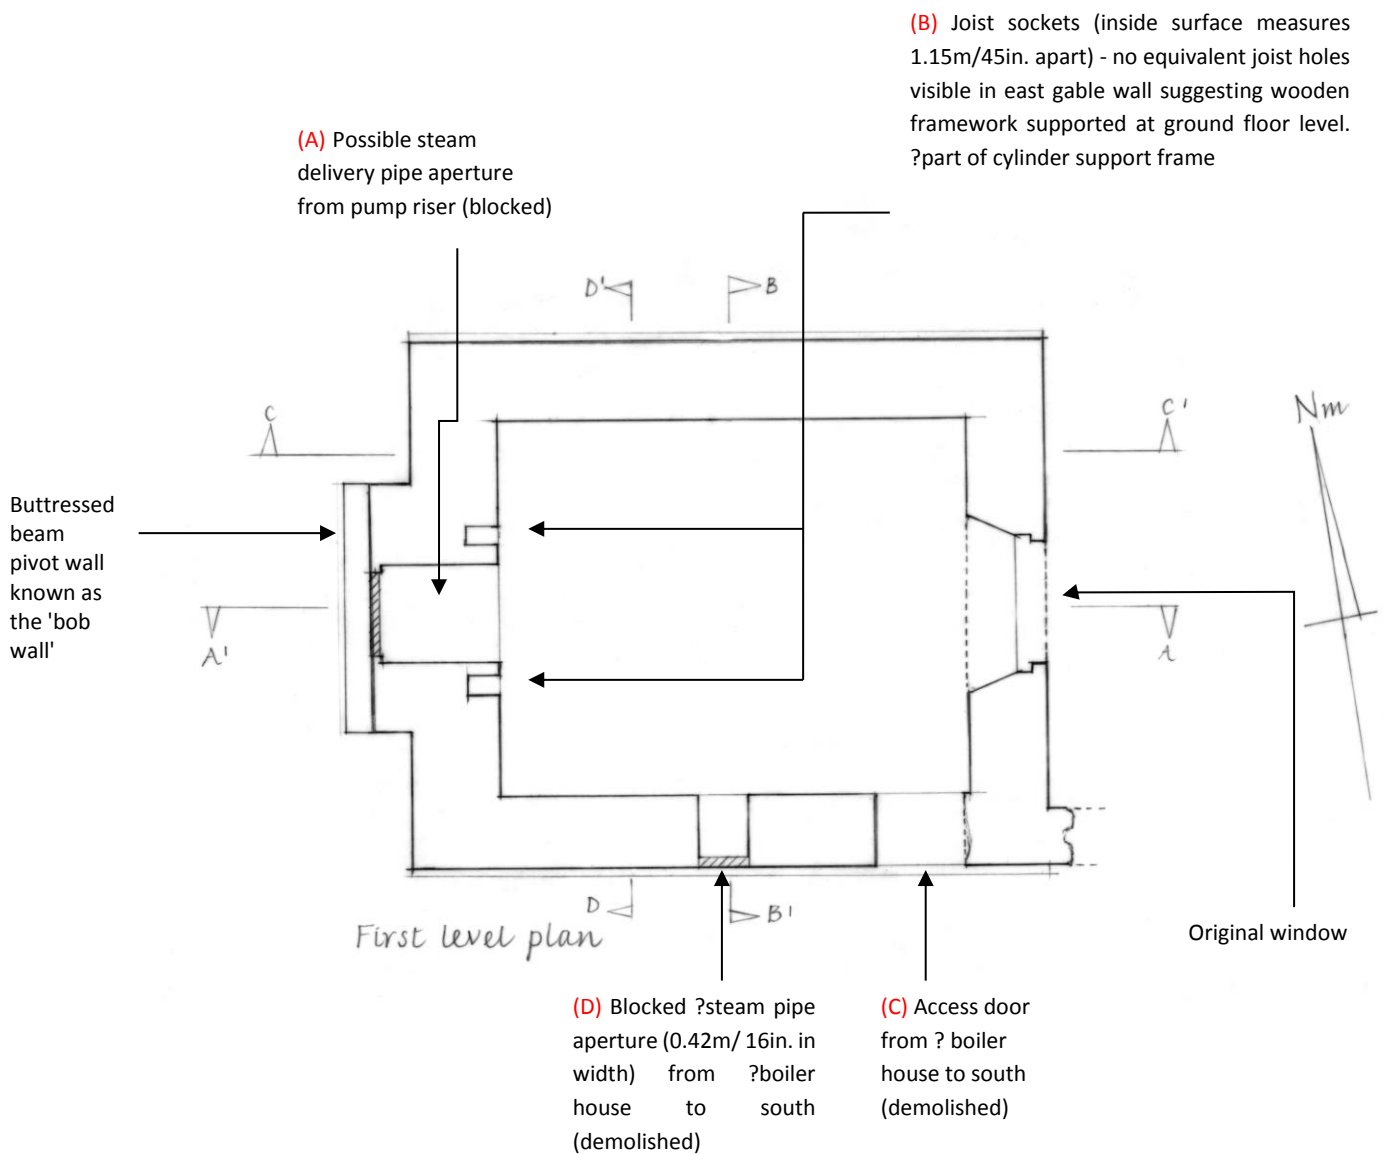
### First level plan

There are two socket holes visible in the bob wall (west gable wall) interior, above the possible steam delivery pipe aperture from pump riser, measuring 0.30m (15in.) in height by 0.19m (7½in.) in breadth (First level plan, (B)). The inside surfaces of these beams sockets are (1.15m/ 45in.) apart. There are no matching socket holes in the east gable. It is possible that these joist sockets held timbers which supported the cylinder on a partial frame all trace of which have now gone.

On the south wall there is an access door (First level plan, (C)) to what would have been the first storey of the now demolished (possible) boiler house. There is also a wall aperture through which inlet steam pipes to the engine's cylinder probably ran (First level plan, (D)). This aperture is not as well executed as the steam outlet in the west gable or 'bob' wall showing possible later modification.

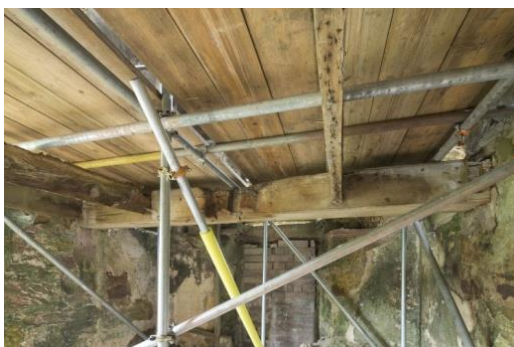
*Left: Interior from west, ground/ 1st level. This beam may be original and could have acted as part of the supporting framework for the engine. It has been utilised to carry floor timbre at some point. The wooden floor is of the modern scaffolding. [DP254031, HES]*

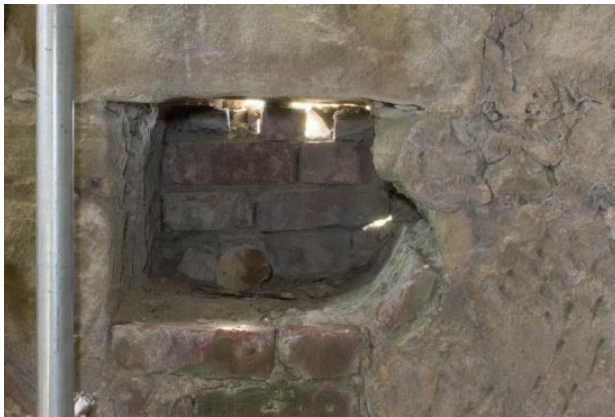
*Left: Interior detailed view of brick-blocked aperture in the south wall connecting with the south range (First level plan, (D)). This is probably where the inlet steam pipe to the cylinder passed through from the boiler house. It has been modified using brick. The brick blocking is later. [DP254041, HES]*

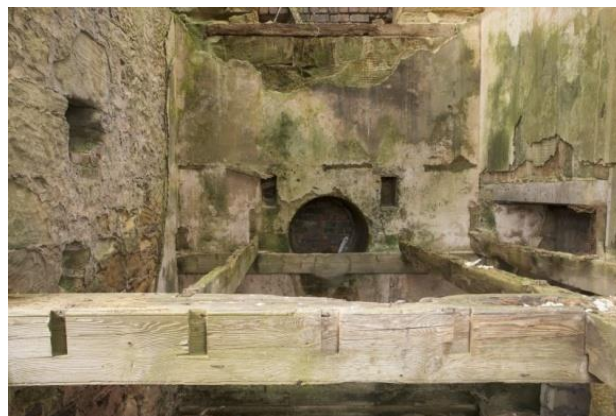
*Above: View of interior, west elevation: Ground/First level. The beam in the foreground may be original and could have been part of the pumping engine [DP231996, HES]*

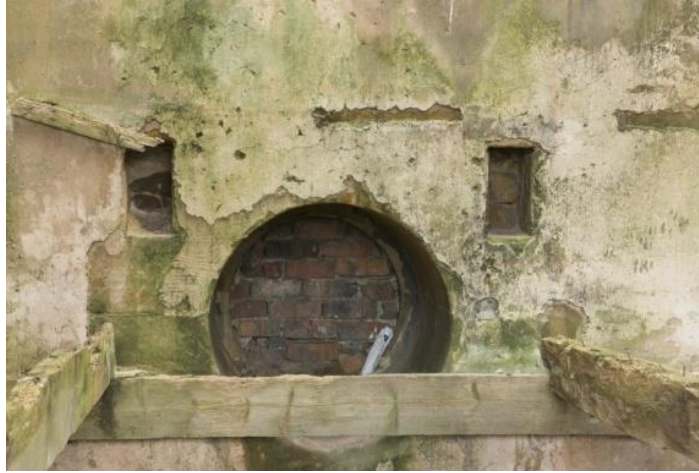
*Above: View of interior, west elevation: Ground/First Level. Detail of socket holes and delivery pipe from the pump riser. [DP231999, HES]*

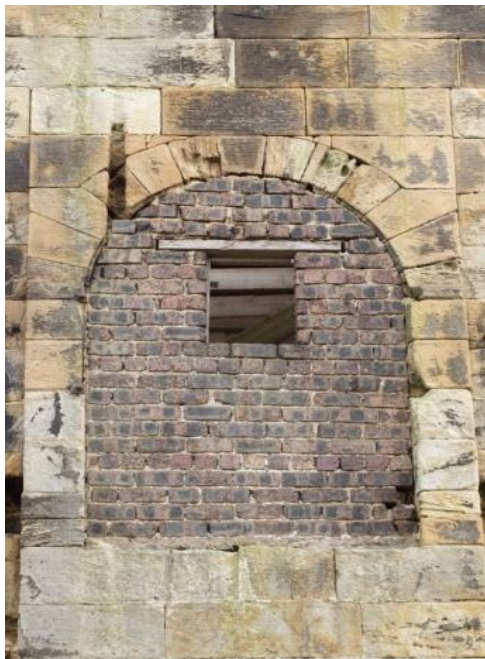
*Left: View of the west or 'bob wall' opening through which the western half of the engine beam would have protruded (at Second Level). Note the remnants of handrail fixings. The groove, top left, may have something to do with bracing for the external maintenance walkway/ beam gantry (now gone). [DP232019, HES]*

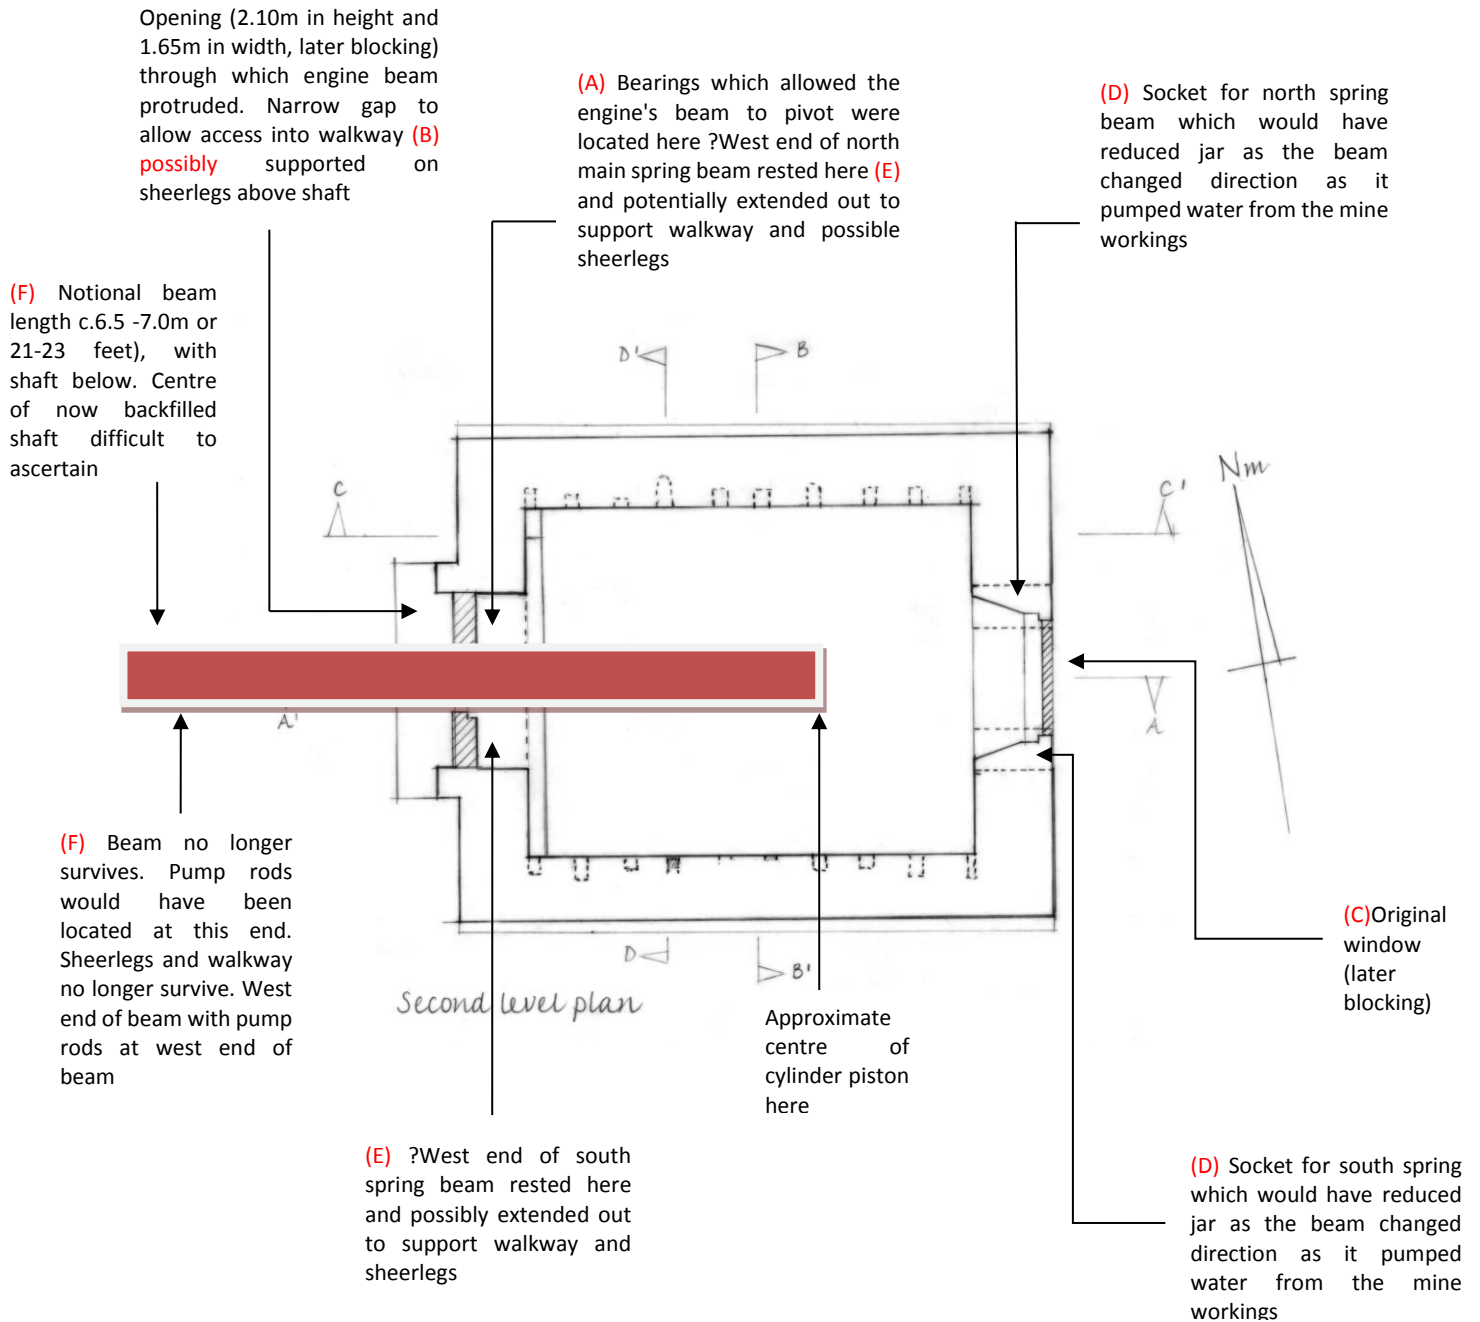
## Second level plan

The second level is where the beam of the pumping engine was located. It would have pivoted on bearings anchored to the west wall (Second level plan, (A)). A walkway (for which there is evidence of surviving railing fittings) would have extended out and around the exposed west end of the beam. Joist holes for the floor survive (although eroded) which would have supported a mezzanine floor or walkway 'wrapped around' the engine (Second level plan, (B)).

On the west wall is an original arched window - the original frame has long since been removed (Second level plan, (C)). The beam sockets on the east wall (Second level plan, (D)) are not mirrored on the west beam pivot wall (Second level plan, (E)). The beams that would have slotted into these holes are often referred to as 'spring beams' as part of their function was to absorb the jar created by the engine changing direction (in a rocking motion). They may have extended to the base of the bottom of the opening in the bob wall (Second level plan, (F)) and continued as the inspection walkway to the framework that would have sat above the shaft. The bearing(s) on which the engine beam pivoted on the 'bob' wall would have allowed clearance for it to rock up and down.

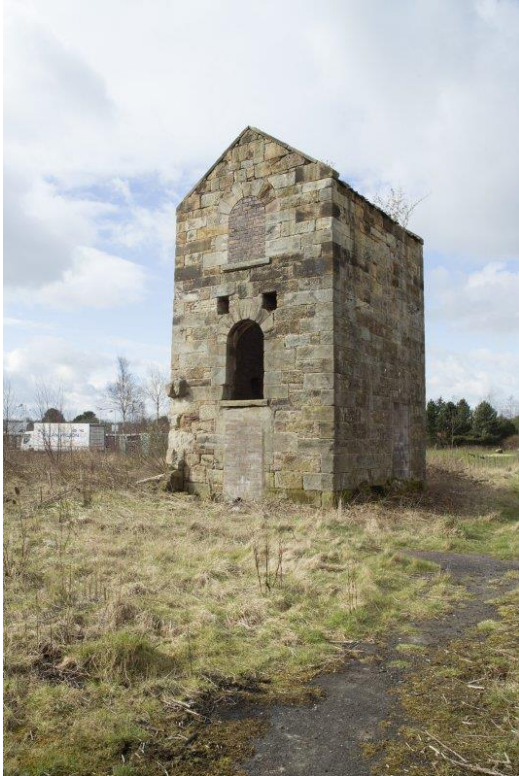
*View of east gable showing the windows (frames and glazing gone) and the east doorway (blocked) at ground level. This doorway may have originally been a window feature. [DP231993, HES]*

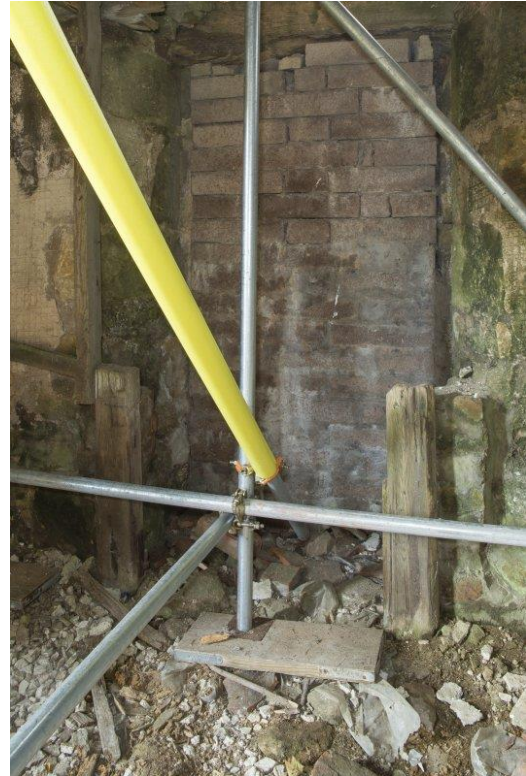
*Above: Interior view of blocked east gable doorway with later brick built wing walls and wood facing. The east doorway may have originally been a window. [DP254023, HES]*

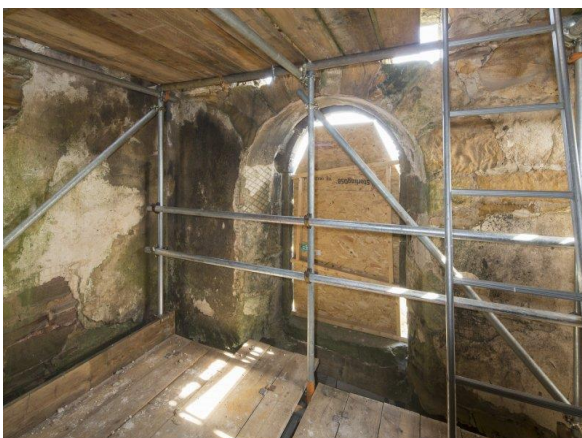
*Left: Interior view of the east wall at 1st floor level, showing deep, splayed window. This would have originally contained a glazed timber window frame, maximising the natural light level. The eastern end of the beam would have bobbed down into this area. You can glimpse the now empty joist holes for the spring or main engine support beams at the top of the image. [DP254043, HES]*

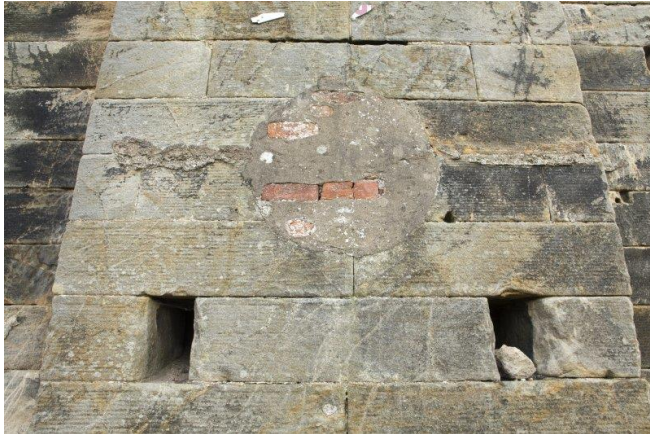
*Above: View of base of west gable or 'bob wall' from west showing the buttress and the two slots in the wall fabric. These do not go right through the wall, but allowed access to the bolts which anchored the bearing on which the engine beam would have pivoted. The brick blocked aperture above is probably the waste steam pipe outlet which may or may not have connected with an external condenser box. [DP23201, HES]*

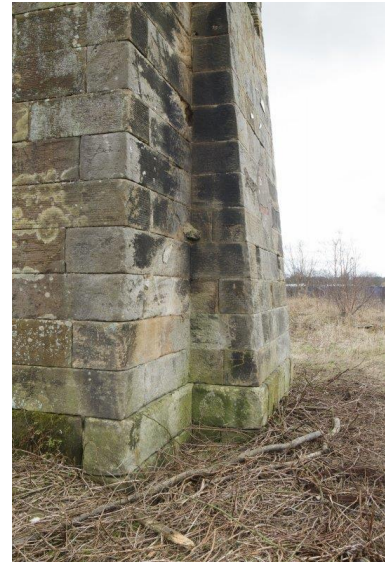
*Above: View of base of west gable or 'bob wall'. The buttress would have strengthened the wall as it bore the weight of the beam of the engine where it pivoted. [DP232009, HES]*

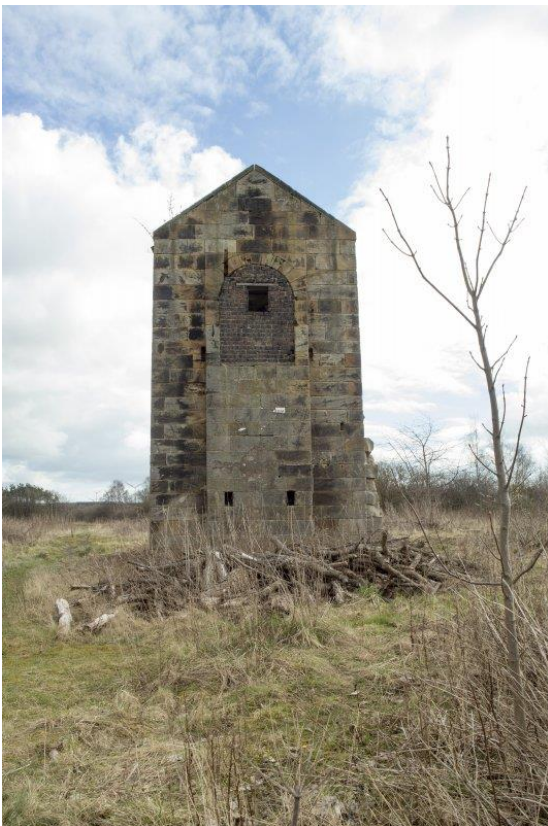
*Left: View of west gable or 'bob wall' showing the quality of the ashlar masonry and the buttressed masonry which strengthened the wall as the beam of the engine would have pivoted on this wall as it pumped water from the mine workings below. [DP231995, HES]*

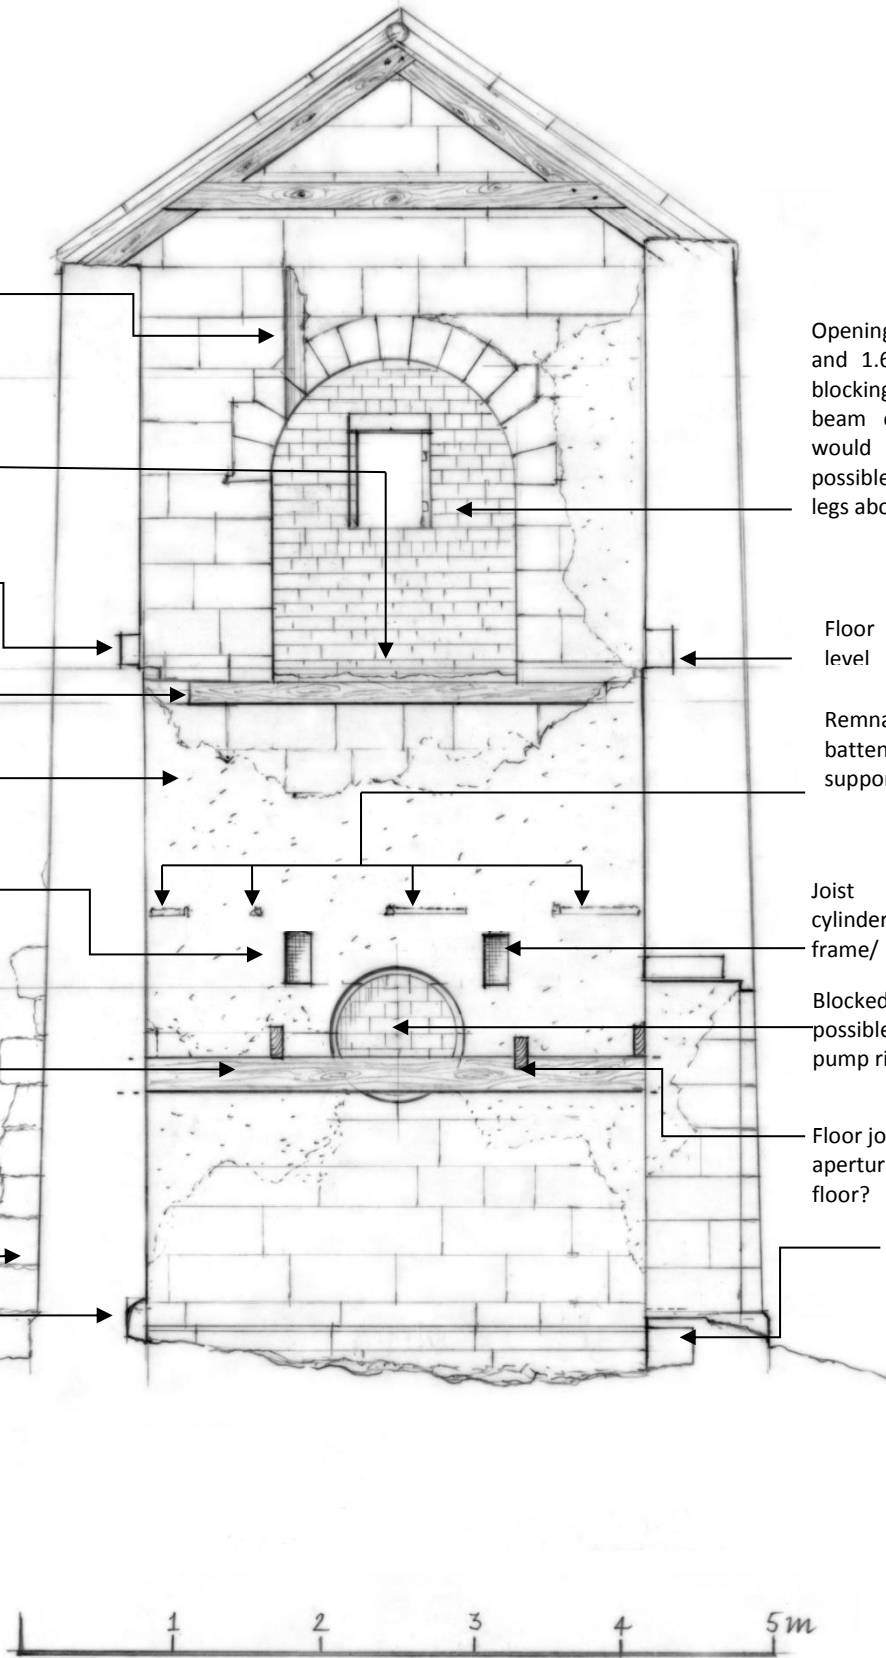
# Interior facing west - section

Groove in wall face of unknown date and function - possibly associated with external walkway/ sheerlegs/ gantry?

The beam pivot bearings on which the pumping engine beam would have rocked sat here

Joist socket for ?engine support frame/ working floor or internal condenser box

Narrow timber beam perhaps part of floor support but obstructs aperture - so post engine removal

Opening (2.10m in height and 1.65m in width, later blocking) through which beam of pumping engine would have protruded, possible walkway and sheer legs above shaft, beyond

Blocked aperture for possible delivery pipe from pump riser

Floor joists - later than aperture indicating a later floor?

*Right: Interior view of west gable or 'bob wall' from east showing (top of image) the now blocked opening through which the west end of the engine beam would have protruded. Two floor levels can be identified, plus two joist slots (empty) in which wooden beams would have rested. These could be part of an engine frame but there are no matching joist holes in the east gable wall interior. The timbers that can be seen at the bottom of the image appear to be part of a ?later floor, now mostly gone. The round aperture is possibly accommodated the delivery pipe from the pump riser which provided the engine with condensed water. [DP231998, HES]*

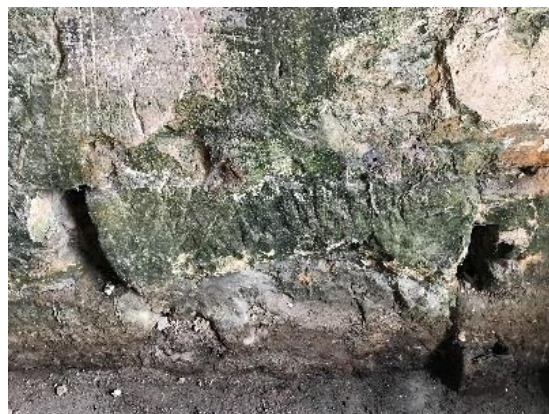
*Right: The internal evidence for the partial drain outlet feature was found by the owner during building work. [copyright: M Bruce, 2017]*
