HISTORIC
ENVIRONMENT
SCOTLAND | ÀRAINNEACHD
EACHDRAIDHEIL
ALBA

Middlefield Beam Engine House, Thornton, Fife [NT29NE 6](#) (NT 29193 97269)

Survey and Recording Section, Heritage Management Directorate, HES, 2018.

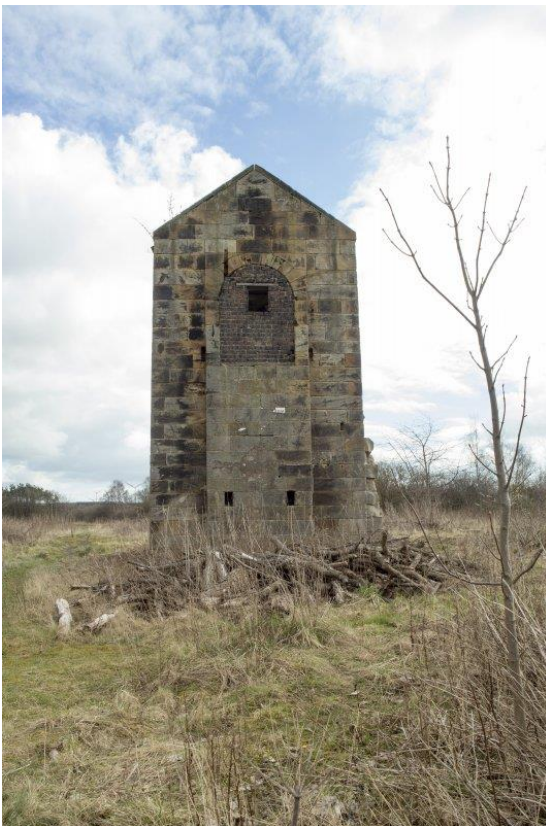
Left: View of west gable or 'bob wall' showing the quality of the ashlar masonry and the buttressed masonry which strengthened the wall as the beam of the engine would have pivoted on this wall as it pumped water from the mine workings below. [DP231995, HES]

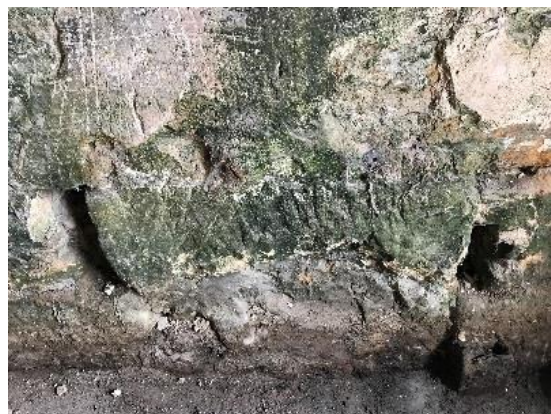
Right: The internal evidence for the partial drain outlet feature was found by the owner during building work. [copyright: M Bruce, 2017]
