HISTORIC
ENVIRONMENT
SCOTLAND | ÀRAINNEACHD
EACHDRAIDHEIL
ALBA

Middlefield Beam Engine House, Thornton, Fife [NT29NE 6](#) (NT 29193 97269)

Miriam McDonald, Industrial Survey, Survey and Recording Section, Heritage Directorate, HES, 2018.

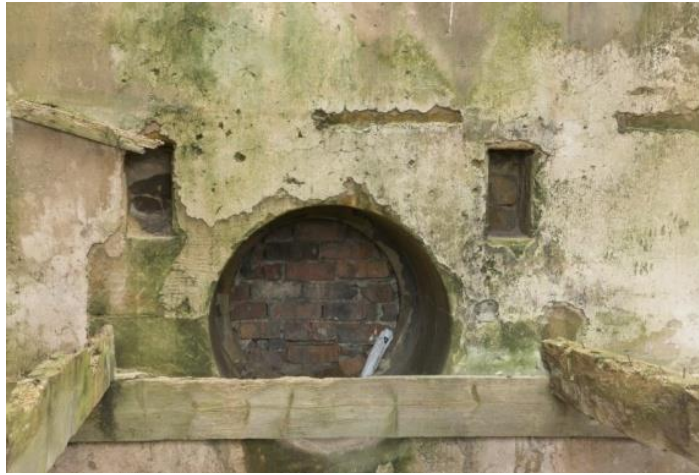
There are two socket holes visible in the bob wall (west gable wall) interior, above the possible steam delivery pipe aperture from pump riser, measuring 0.30m (15in.) in height by 0.19m (7½in.) in breadth (First level plan, (B)). The inside surfaces of these beams sockets are (1.15m/ 45in.) apart. There are no matching socket holes in the east gable. It is possible that these joist sockets held timbers which supported the cylinder on a partial frame all trace of which have now gone.

Above: View of interior, west elevation: Ground/First Level. Detail of socket holes and delivery pipe from the pump riser. [DP231999, HES]

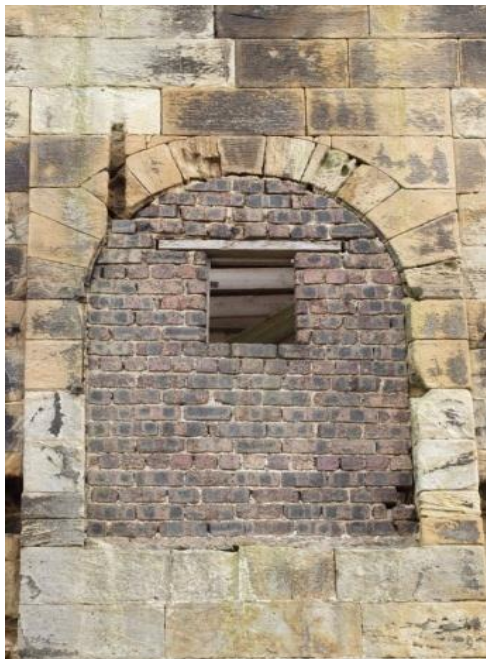
Left: View of the west or 'bob wall' opening through which the western half of the engine beam would have protruded (at Second Level). Note the remnants of handrail fixings. The groove, top left, may have something to do with bracing for the external maintenance walkway/ beam gantry (now gone). [DP232019, HES]

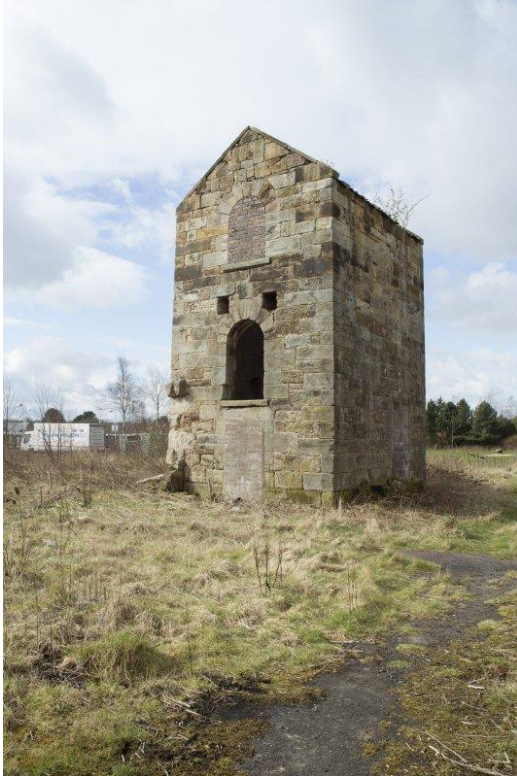
View of east gable showing the windows (frames and glazing gone) and the east doorway (blocked) at ground level. This doorway may have originally been a window feature. [DP231993, HES]

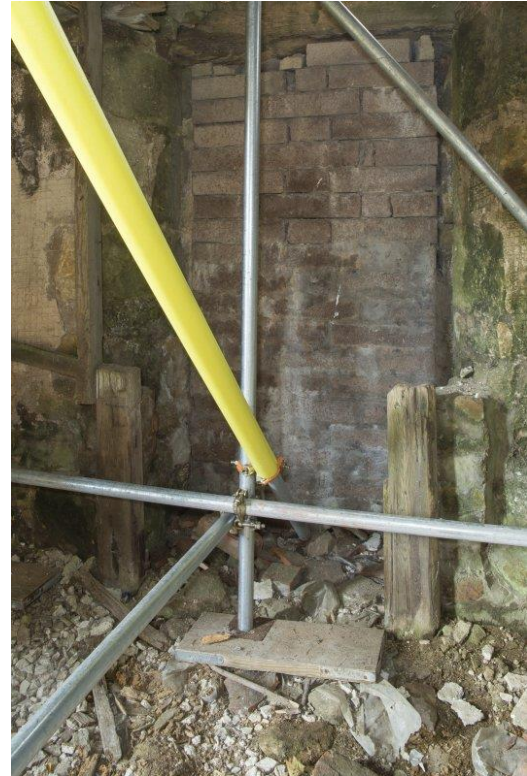
Above: Interior view of blocked east gable doorway with later brick built wing walls and wood facing. The east doorway may have originally been a window. [DP254023, HES]

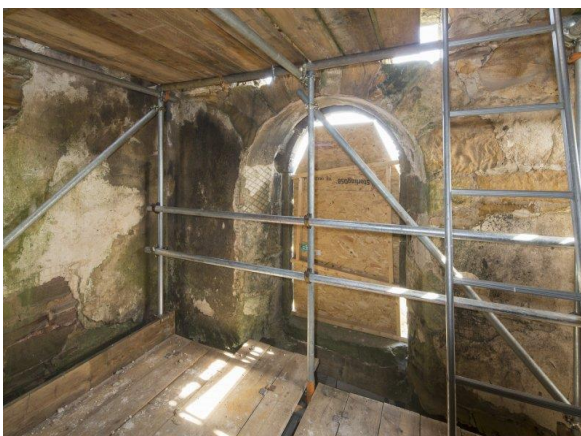
Left: Interior view of the east wall at 1st floor level, showing deep, splayed window. This would have originally contained a glazed timber window frame, maximising the natural light level. The eastern end of the beam would have bobbed down into this area. You can glimpse the now empty joist holes for the spring or main engine support beams at the top of the image. [DP254043, HES]

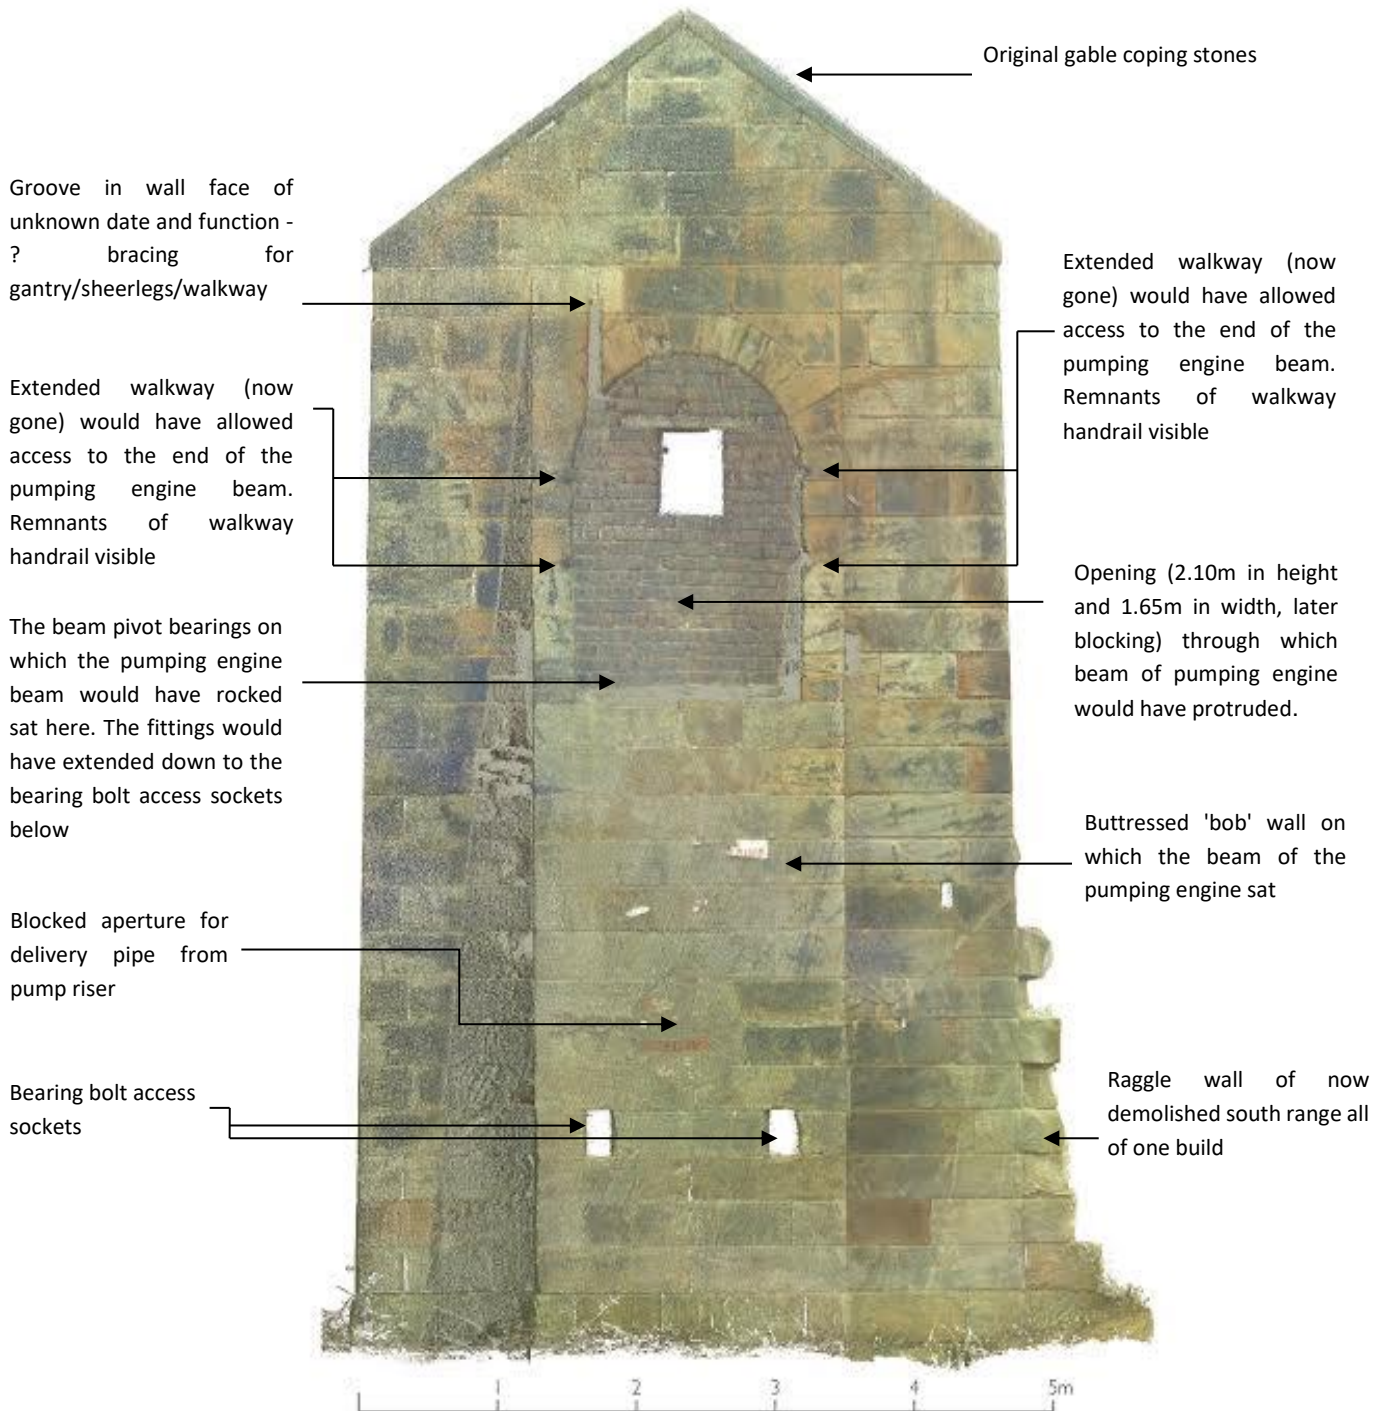
West elevation

Original gable coping stones

Groove in wall face of unknown date and function - ? bracing for gantry/sheerlegs/walkway

Extended walkway (now gone) would have allowed access to the end of the pumping engine beam. Remnants of walkway handrail visible

The beam pivot bearings on which the pumping engine beam would have rocked sat here. The fittings would have extended down to the bearing bolt access sockets below

Blocked aperture for delivery pipe from pump riser

Bearing bolt access sockets

Opening (2.10m in height and 1.65m in width, later blocking) through which beam of pumping engine would have protruded.

Buttressed 'bob' wall on which the beam of the pumping engine sat

Raggle wall of now demolished south range all of one build

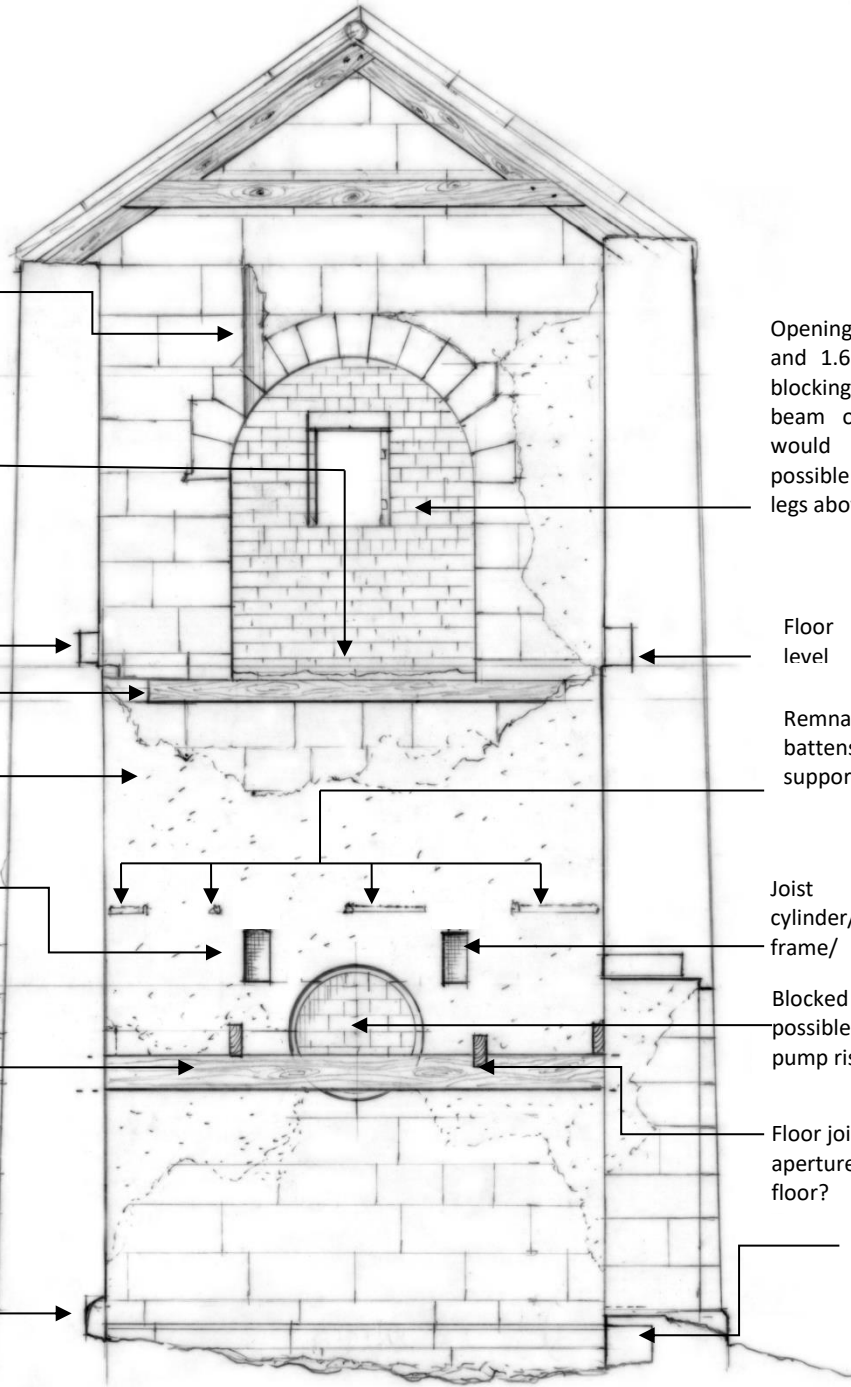
Interior facing west - section

Groove in wall face of unknown date and function - possibly associated with external walkway/ sheerlegs/ gantry?

The beam pivot bearings on which the pumping engine beam would have rocked sat here

Floor joist socket / floor level

Original wooden beam at sill level

Original plaster

Joist socket for ?engine support frame/ working floor or internal condenser box

Narrow timber beam perhaps part of floor support but obstructs aperture - so post engine removal

Raggle of wall of now demolished south range

Floor joist socket

Opening (2.10m in height and 1.65m in width, later blocking) through which beam of pumping engine would have protruded, possible walkway and sheer legs above shaft, beyond

Floor joist socket/floor level

Remnants of slight wood battens - ? part of engine support frame or later floor

Joist socket for cylinder/engine support frame/ working floor

Blocked aperture for possible delivery pipe from pump riser

Floor joists - later than aperture indicating a later floor?

Right: Interior view of west gable or 'bob wall' from east showing (top of image) the now blocked opening through which the west end of the engine beam would have protruded. Two floor levels can be identified, plus two joist slots (empty) in which wooden beams would have rested. These could be part of an engine frame but there are no matching joist holes in the east gable wall interior. The timbers that can be seen at the bottom of the image appear to be part of a ?later floor, now mostly gone. The round aperture is possibly accommodated the delivery pipe from the pump riser which provided the engine with condensed water. [DP231998, HES]

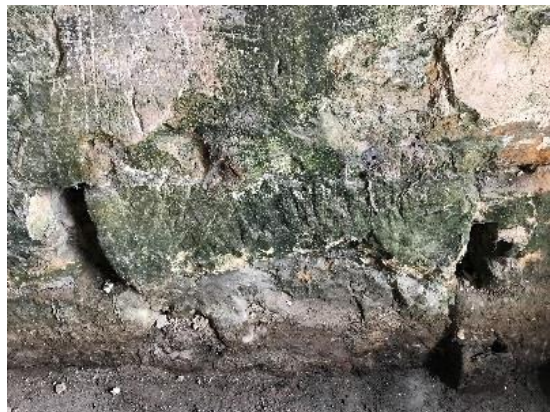
Right: The internal evidence for the partial drain outlet feature was found by the owner during building work. [copyright: M Bruce, 2017]
