Project Code: BCB06
Date: 13th November 2006
Client: J Knuckles

Braigh Cottage,
Kilfinichen and Kilvickeon, Island of Mull
Historic building recording and archaeological evaluation

PROJECT SUMMARY SHEET

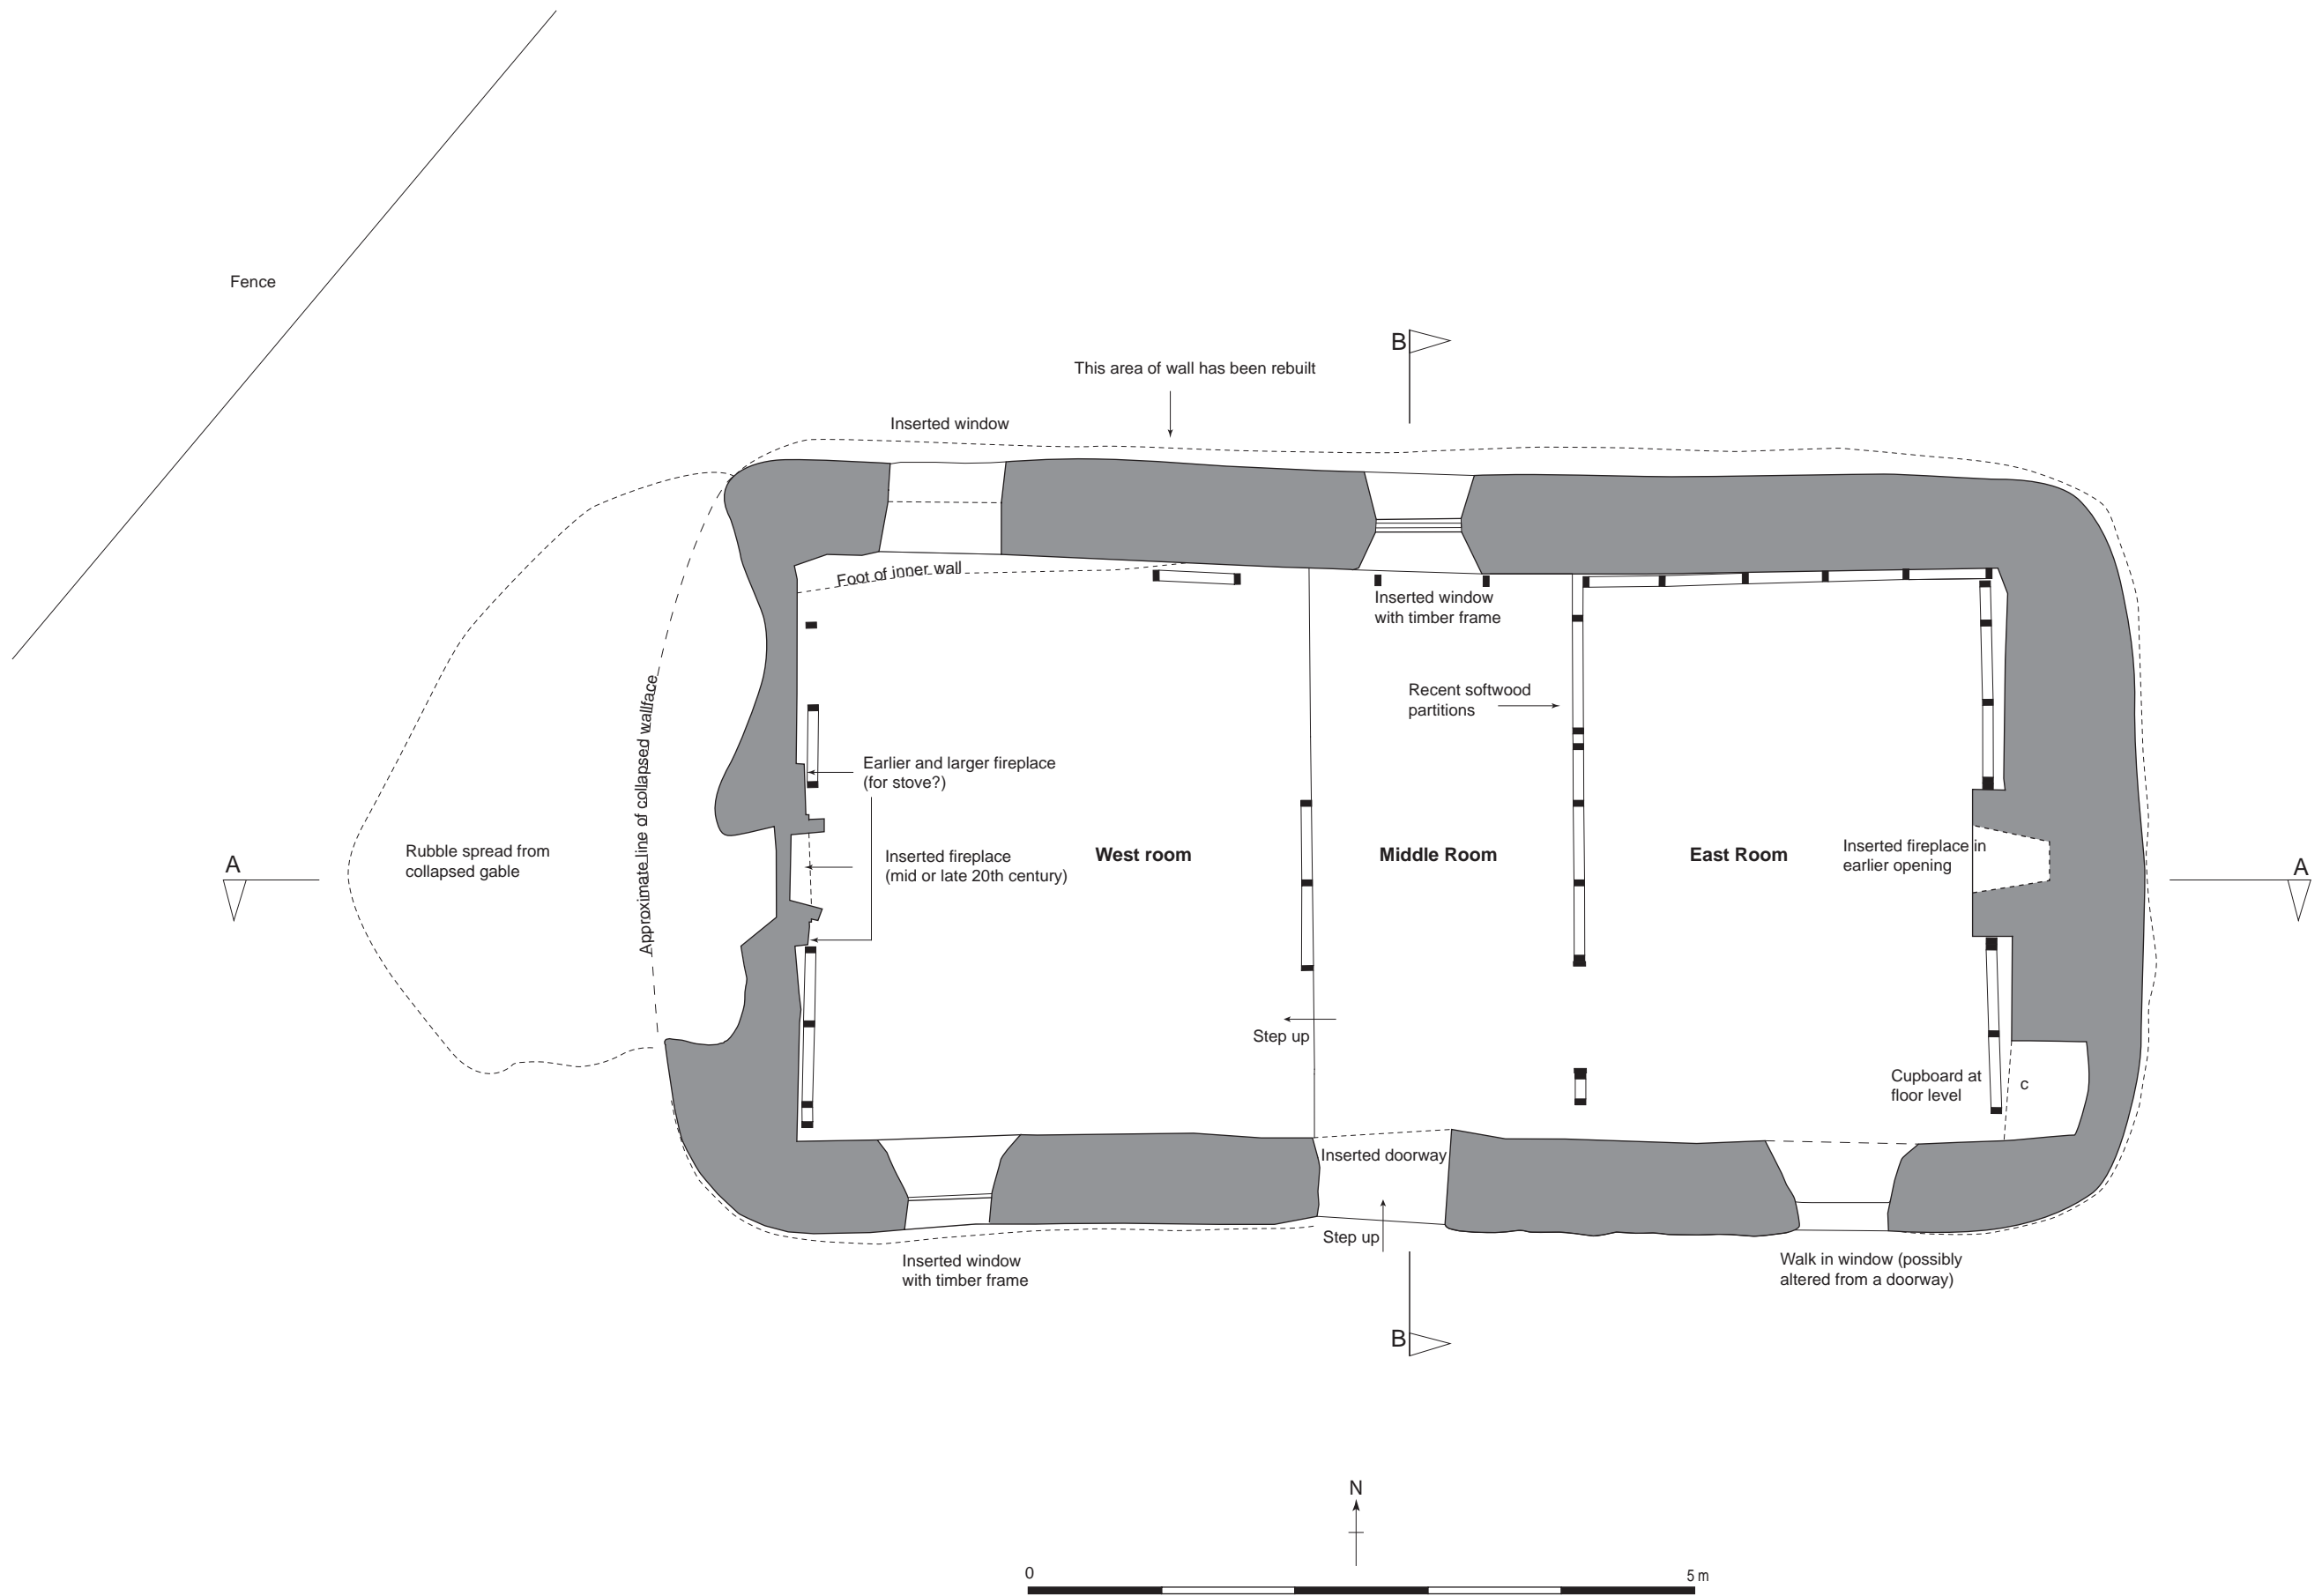
Figure 4 - BCB06: Braigh Cottage ground-floor plan (1:50 @A3)

Braigh cottage is a small single storey 3-bay rectangular building in a ruinous condition (Figures 4 – 7). The interior floors and partitions are late 20th century and the roof, although thatched, has a framework of late 20th century sawn timber and the thatch itself may be from the 1980s (see section drawings Figure 5 and 6). Underneath these fairly recent alterations, the building retains a few features from its earlier use and is almost certainly 18th century or early 19th century in origin. The building measures 9.3m by 4.3m internally, similar to as most of the other ruined buildings of the township, and aspects of those can certainly be used to help interpret the cottage. The wallhead at Braigh Cottage is considerably higher than those in the surrounding ruins, which are commonly about 1.4m high, and this suggests it has been raised.

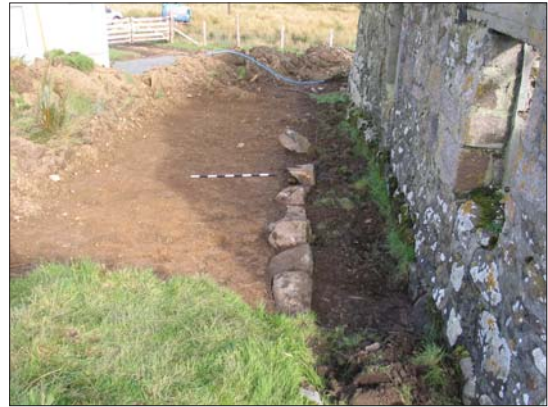
10. Area N of Braigh cottage from W

The area to the rear of the building had only one feature (Figure 3, Plate 10). A kerb of boulders [003] visible on the surface marked the outer edge of a soak away [001, 002]. This ditch, 30cm deep and 50cm wide, was filled with rubble which contained modern glass. It runs down the length of the building in the area where the extension will be built. There were no other features, and the subsoil was orange/yellow clay only 10 – 20cm below the surface.

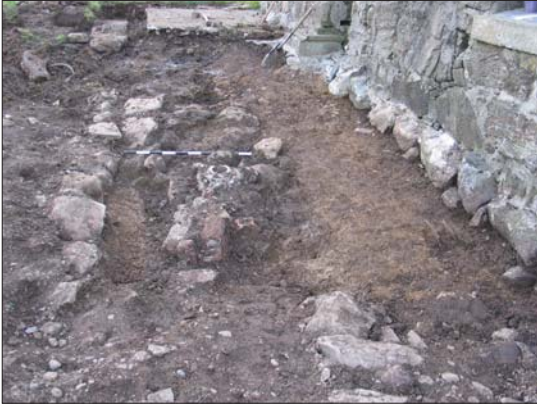
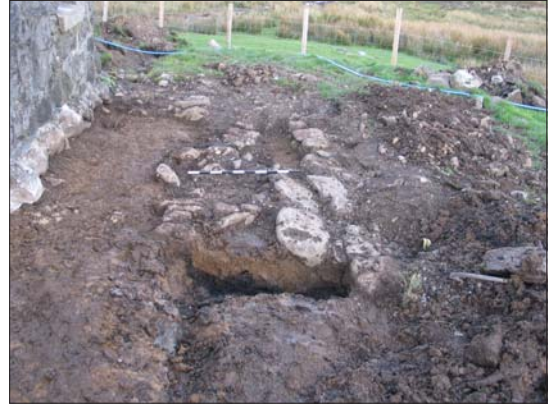
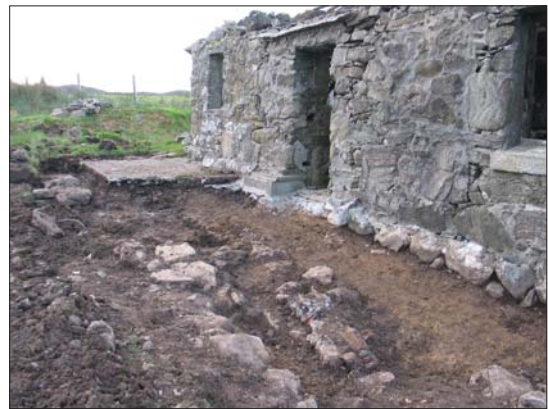
The area at the front of the building revealed a number of features (Plates 13, 14 and 18). The whole area was covered in concrete slab with the remains of 20th century partitions suggesting three areas. Oral testimony suggested there had been a kitchen/bathroom/porch extension here, possibly constructed in the mid-20th century. The central concrete plinth and the east part were both lifted, exposing an area considerably larger than that which will be disturbed by the new porch.

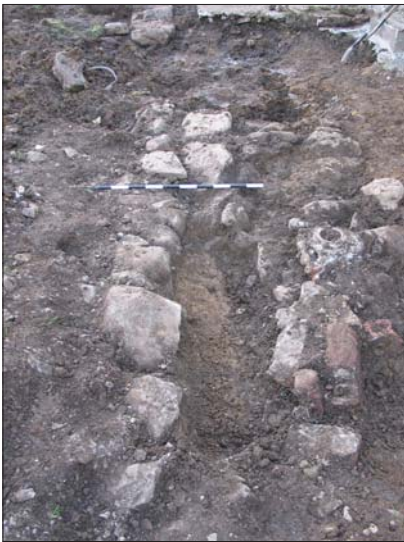
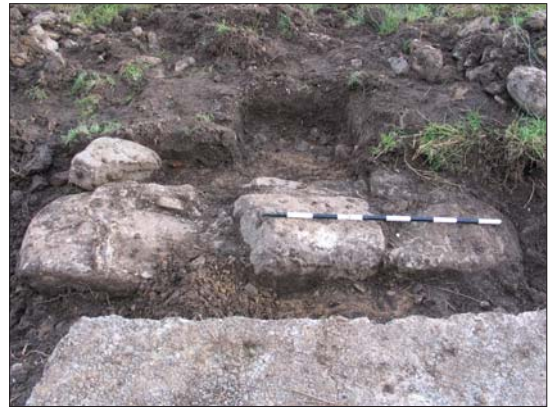
Probably later, a substantial lime-mortared wall [013, 008, 007] survived in parts around the extents of the concrete slabs (Plate 15 and 16). This wall, which respects the concrete, and is lime-mortared, is probably 20th century, and certainly post-dates the Ordnance Survey of 1881. The

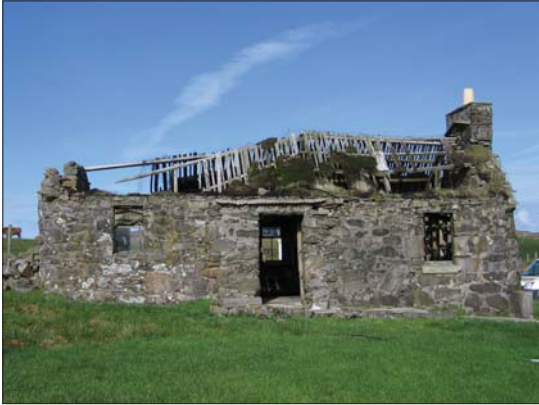
19. View from S

The main elevation of the building faces south (Plate 19), and, as shown by the excavation and the remains on the ground, a later extension used to lean against it. The main doorway looks inserted and no others in the settlement have a lintel, again suggesting that the walls may have been raised (Plate 23). There is noticeable mortar re-pointing obscuring detail around the doorway which may reflect repairs in the 1980s. The wallhead is fairly level which is contrary to the other similar buildings in the group which have a wallhead that follows the line of slope. Both south-facing windows are also later. They are at slightly differing heights, reflecting the stepped concrete floor inside the building. The E window has a projecting concrete lintel (Plate 24) and is 'walk-in'; it may have been altered from an original doorway (Figure 4). A concrete fillet above the current door used to direct water over the porch, roofed with corrugated iron. Some of the south elevation, particularly the corners, has been re-pointed with grey cement, probably in the later quarter of the 20th century. The whole elevation shows a slightly earlier whiter cement re-pointing, possibly mid-20th century.

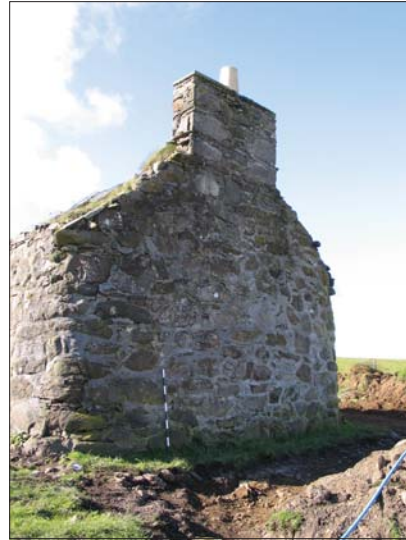
20. E gable from SE

The east gable still stands to its full height and supports a broad chimney with a very plain concrete cope, thackstones and a single ceramic pot (Plate 20). The chimney is almost certainly later and it is likely that the whole gable has been raised, though no evidence for this is visible behind the later cement re-pointing. Various phases of pegs in the gable wallhead have been used to tie the roof down. Two metal shoes inserted in the chimney stack look like they have held a rope – though their actual purpose is unclear (Plate 25). Ridges of cement on the inner face of the chimney stopped water running down the edge of the thatch.

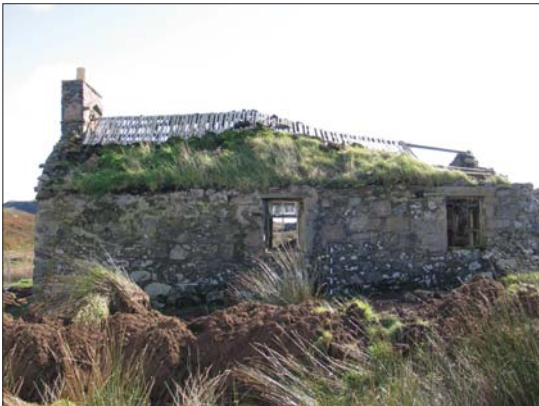
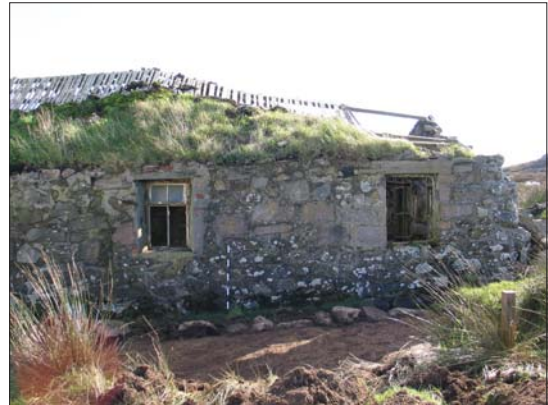
The north elevation is similar to elsewhere, with much later cement pointing obscuring the lime mortar from the early 20th century and, therefore, the detail of 20th century phasing (Plate 21 and Plate 26). The rubble is similar to elsewhere and the boulder foundation and the batter of the wall are also similar. The wall is slightly less regular and the area between the two inserted windows looks almost entirely rebuilt. The pink granite, found here and round the windows and not elsewhere in the elevation, is testament to this. Both windows incorporate cement and concrete in their construction and are probably mid-20th century. There is no evidence in the boulder foundation course for an earlier opening in this elevation, a feature that is common in other buildings of the township and probably suggests use as barns.

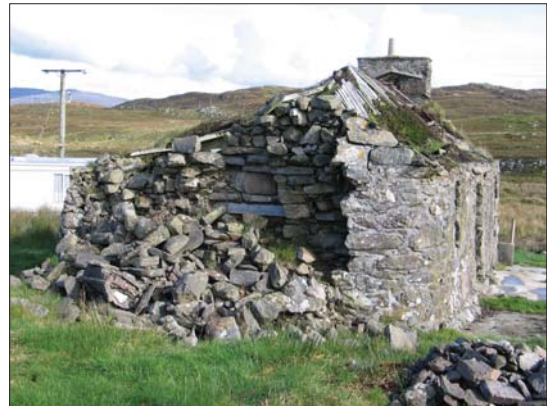
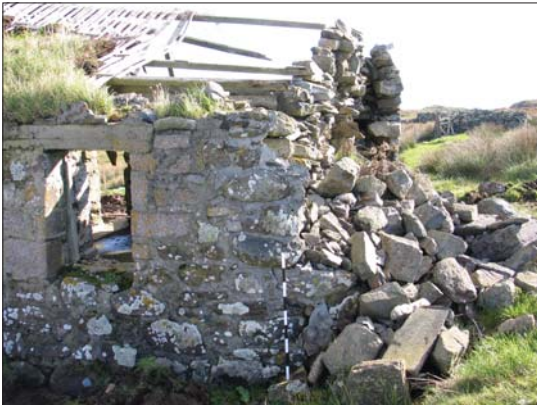
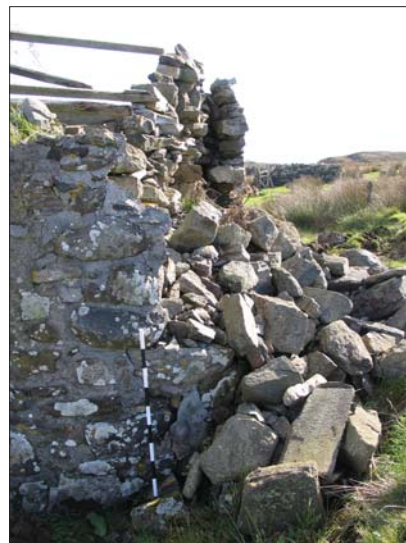
The west gable of the cottage has collapsed outside the building (Plate 22, 27 and 28); the chimney stack and pot (matching the east gable) lie smashed *in situ* on the edge of the rubble pile. The broken chimney stack has well-made brick in its construction as well as the same plain concrete cap. The collapse is partly fortuitous as it shows the earlier construction of the wall (Plate 29). The later lime pointing can be seen pushed in between the stones of the outer wall face. Behind, the inner rubble fill is in dry stone as it was built. The collapse also exposes the rear of the fireplace, showing the later inserted lintel and the original curved sides of the large hearth area (Plate 30).

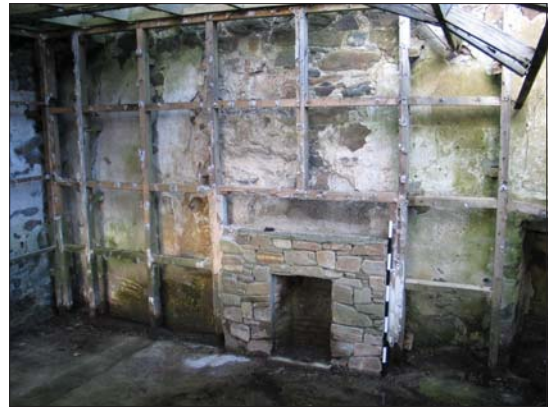
32. E internal wall from W

Behind the frame in the east room, the wall has been plastered on the hard over at least one phase of lime pointing (Plate 32). There are a number of modern nails in this plaster which may have held boards or paper to the wall. The fireplace in this room is late 20th century but there is a large granite lintel behind from the earlier fire. The wall plaster follows into the window in this east room (Plate 33).

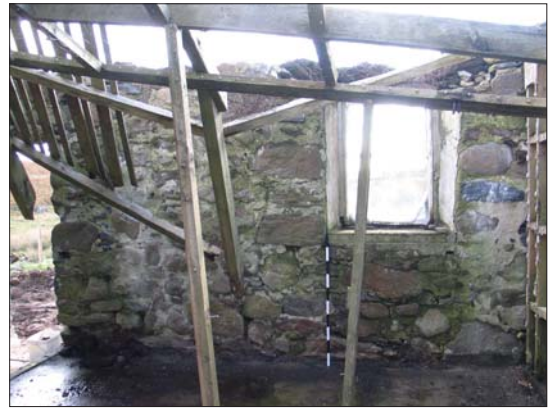
34. W window and doorway in south wall from N

The west room has two windows. The window at the south has plaster on the hard following into

the opening from the surrounding wall (Plate 34). The north window does not suggest it is almost certainly later. The fireplace in this room has clearly been heavily altered (Plate 35). The larger earlier opening may have held some kind of small range or stove, but has been altered to hold a later 20th century fireplace.

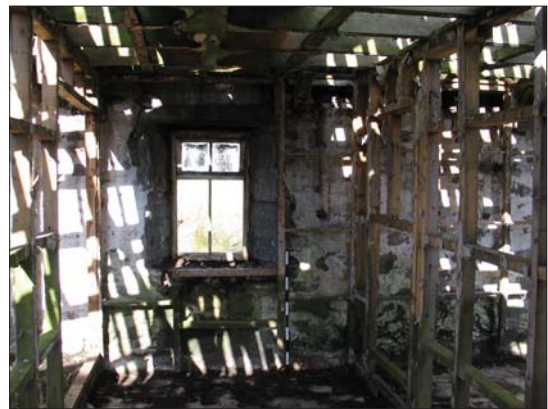
36. Central window in north wall from S

The middle room is lit by a single window, very roughly inserted through the wall with cement and concrete (Plate 36). Paper is stuffed around it for insulation. Above this room, a large water tank sits on the ceiling joists in the roof space. There is a hatch to the roof above the front door. The area around and above the front door is clearly altered and some late cement repointing has been done above the door.
