**THE CILLE-BHARRA CHURCH-GROUP,
EOLIGARRY, BARRA, WESTERN ISLES:
HISTORIC BUILDING SURVEY OF
ST BARR'S CHURCH & THE SOUTH CHAPEL**

Client: Benjamin Tindall Architects, on behalf of Andrew Kerr

31 May 2002

Christopher Lowe, Magnar Dalland & Mike Middleton

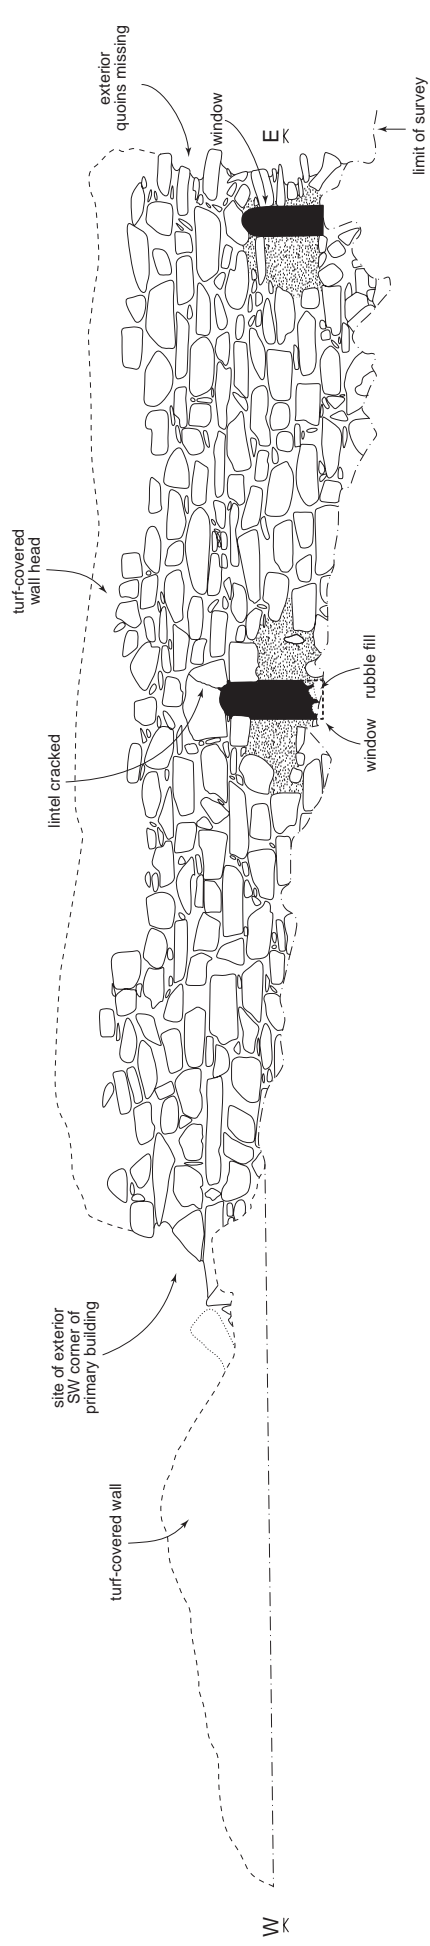
(a) South wall: exterior.

Building No.3: south wall, exterior face: condition (Figure 5a)

Wall-fabric (primary structure): large scale loss of pinnings; extant pinnings loose; deep voids between surviving stones, mortar recessed 100 – 200 mm.

Vegetation: wall-head turf-covered; moderate grass-colonisation at W end of wall-face; occasional grass and weeds in wall-face to E.

Quoins (primary E): quoins missing; adjacent masonry loose and tipping to E.

Quoins (primary W): quoins missing, presumed robbed. Site coincident with area of collapsed rubble at W end of standing masonry.

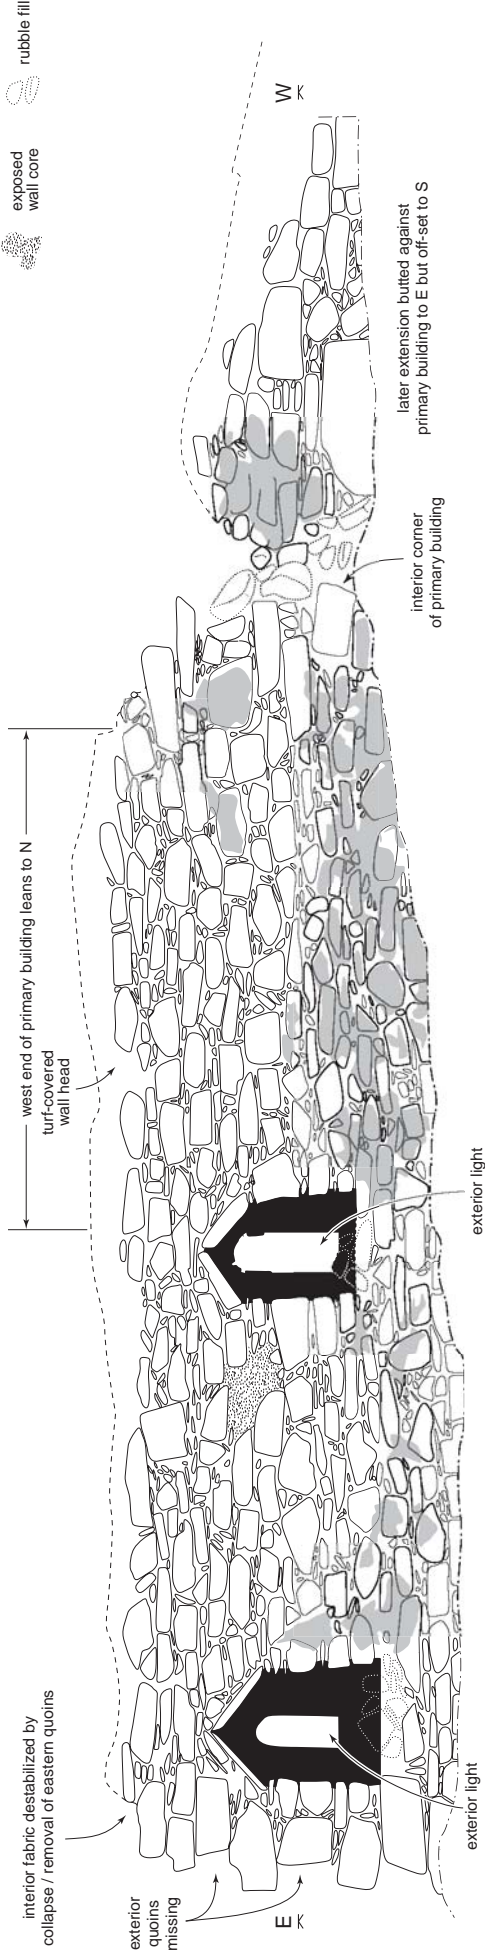
(b) South wall: interior.

Building No.3: south wall, interior face; condition (Figure 5b)

Wall-fabric (primary structure): mortar and pinnings generally sound; mortar recessed 20 – 60 mm. Marked lean observable; W end of wall leans to N (Figure 9a). Void in fabric up to 0.5 x 0.36 x 0.30 m deep, located between the two windows. Although there are occasional loose stones around edges of void, the mortar in the exposed wall-core is generally firm and sound. Similar void is present in N wall opposite, suggesting removal of former chancel screen.

Wall-fabric (secondary work): masonry is off-set to S from line of primary structure to E. Green-slate pinnings evident, and voids between surviving stones 150 – 300 mm deep without visible mortar.

Plaster / harling: fairly extensive patches of plaster present along lower wall-face, up to 0.7 m above present ground level; occasional patches survive higher up the wall-face, particularly towards the E end, between the two windows. Plaster also survives on E side of head of westernmost window; and on E and W reveals of easternmost window. Hard pinkish plaster also survives on the secondary work, to W.

Quoins (primary E): relatively intact to wall-head (visible basal quoin loose) but destabilised by absence of exterior quoins and loose masonry in exposed wall-core behind.

Quoins (primary W): intact at base but destabilised by loose masonry in exposed wall-core behind. Site coincident with area of collapsed rubble (Plates 7 & 8).

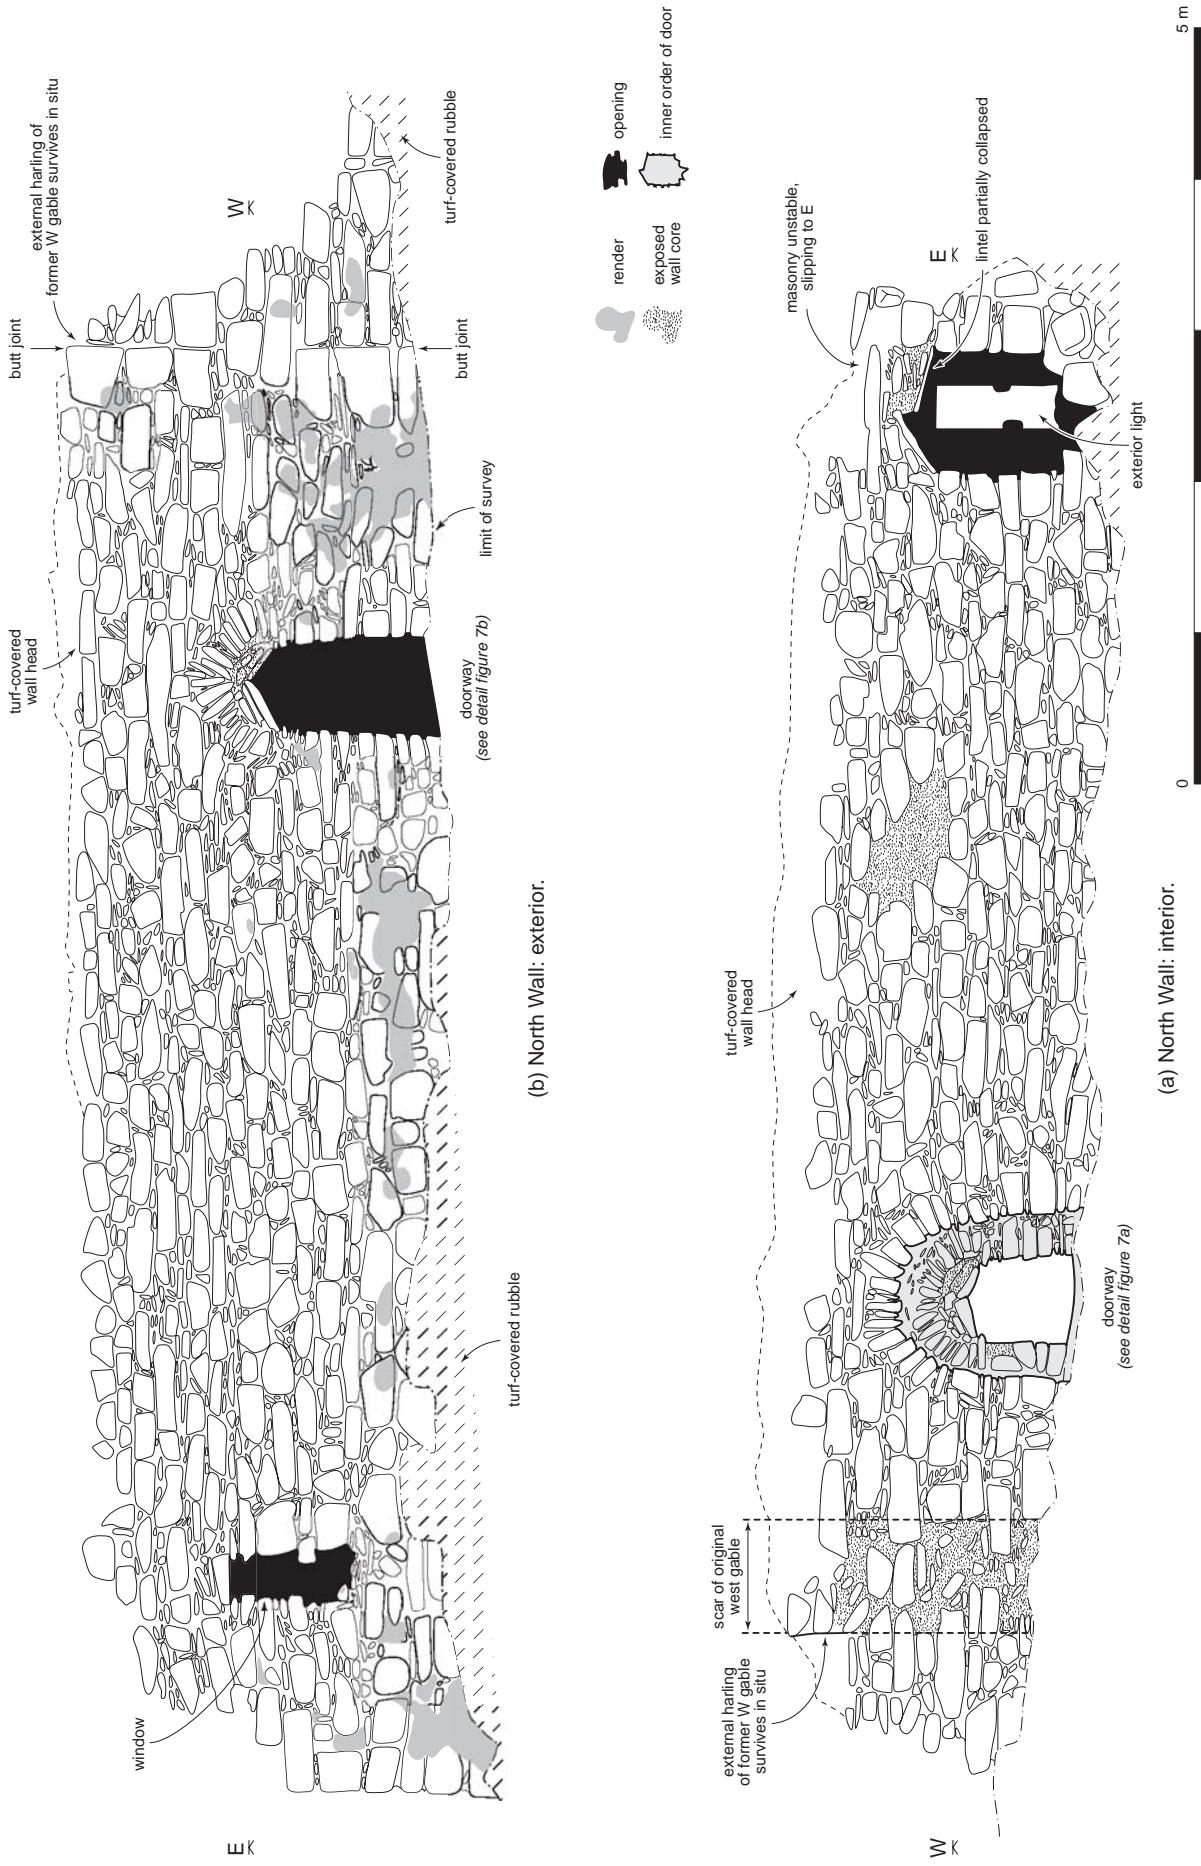
Figure 6 - Building No 3, interior & exterior elevations of North wall.

Building No.3: north wall, interior face: condition (Figure 6a)

Wall-fabric (primary structure): mortar and pinnings generally firm and sound; mortar recessed 60 – 120 mm. Occasional loose pinnings; occasional green-slate pinnings also noted. Void in fabric up to 0.8 x 0.5 x 0.25 m deep, located between entrance and window. Although there are occasional loose stones around edges of void, the mortar in the exposed wall-core is generally firm and sound. Similar void present in S wall opposite, indicative of removal of former cancel screen. Voids at W end of primary fabric represent scar of former W gable (Plate 9).

Wall-fabric (secondary work): short stub of upstanding masonry, the rest surviving only as a low turf-covered stony bank. Large stones to W of masonry scar probably represent reused quoin stones from interior NW corner of building. Mortar and pinnings generally firm and sound to E; loose masonry and wall-core to W, adjacent to reduced turf-covered bank.

Building No.3: north wall, exterior face; condition (Figure 6b)

Wall-fabric (primary structure): mortar generally sound and pinnings firm; mortar recessed 40 – 60 mm. Occasional green-slate pinnings noted. Loose masonry at NE external angle of building; slippage to E, destabilising window below.

Wall-fabric (secondary work): short stub of upstanding masonry, the rest surviving only as a low turf-covered stony bank. Butt joint between fabrics clearly evident (Plate 12). Large stones to W of butt joint probably represent reused quoin stones from exterior NW corner of building. Loose and missing pinnings; deep voids (150 – 200 mm) where mortar is absent. Loose stones in turf-covered wall-head.

Plaster / harling: extensive patches of harling survive along lower wall-face, up to 0.9 m above present ground level, with occasional patches higher up. Head of round entrance arch also plastered. Original external harling of former W gable also visible in present exterior fabric; harling here is loose and has come away from former external W wall-face.

Window: stone missing on upper E side of light; overlying masonry loose and slipped to E. Destabilised by collapse of upper quoins to E.

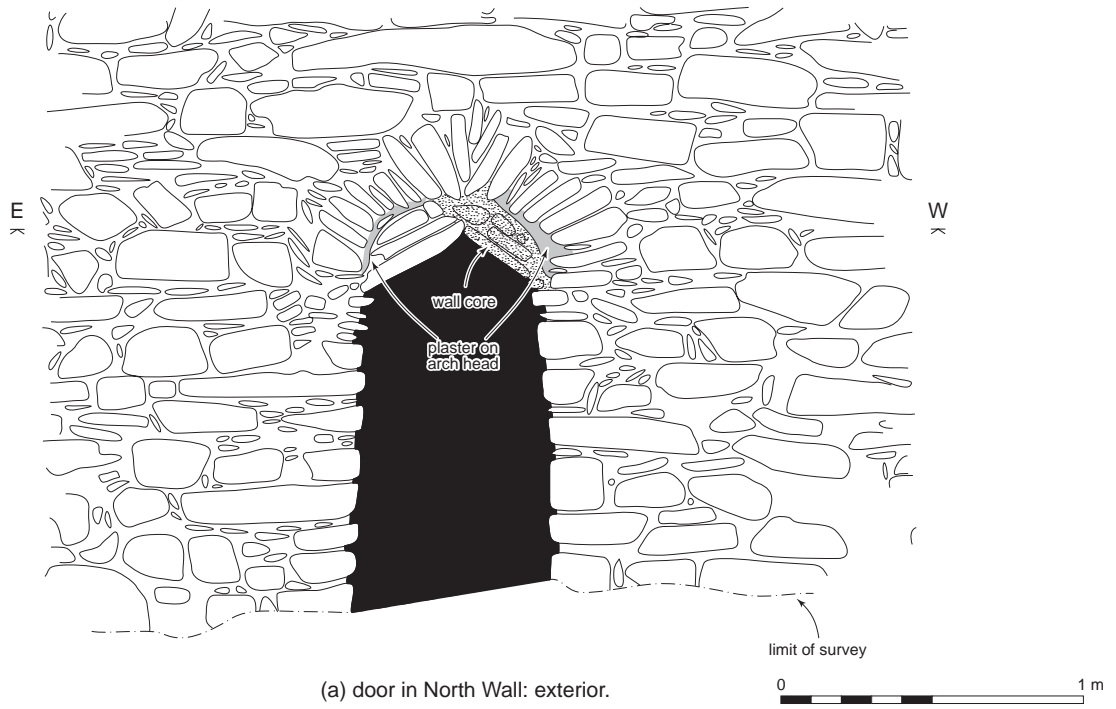
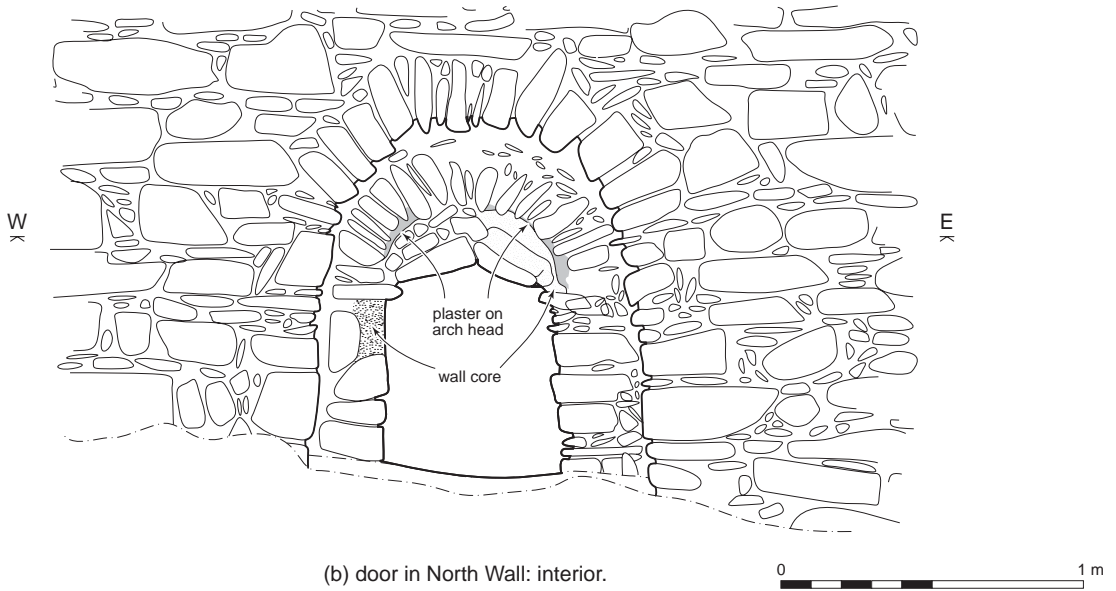
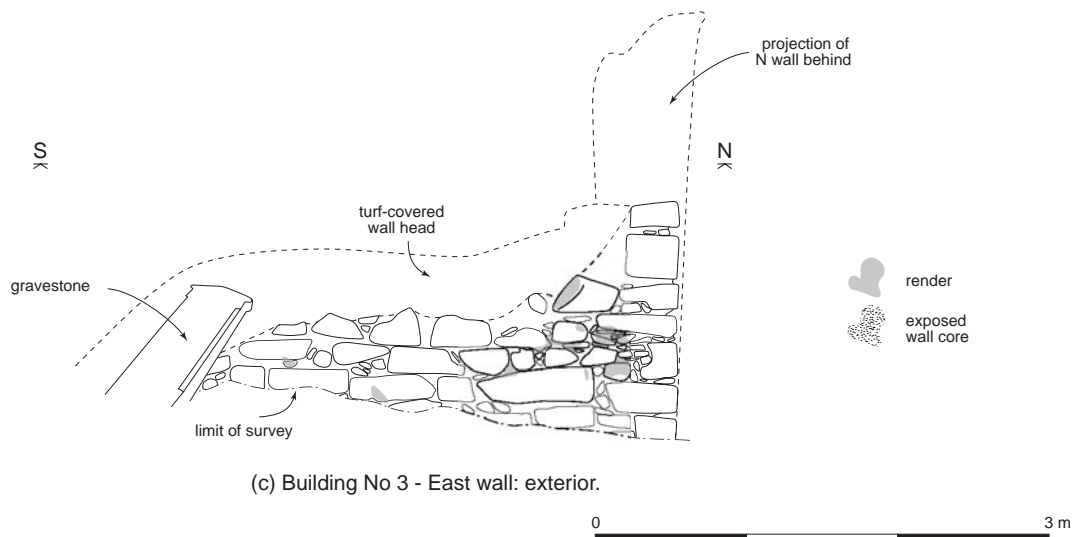
Figure 7 - Building No 3 - detail of doorway in North wall; East wall, exterior elevation.

Entrance: round arched doorway of two orders, rebated 0.3 m on either side, with later triangular-headed arch inserted (Figure 7b). Entrance 0.87 m high, from impost to present ground level; jambs are inclined, 0.60 m wide at base, 0.47 m wide at impost. Stone missing on W side of jamb below impost but sides otherwise intact. Round arch of rubble voussoirs intact, set back at the impost to accommodate temporary wooden centering. Underside of round arch plastered; smooth plaster survives *in situ* behind later rubble infill. Triangular-arch head intact, springing from impost; small rubble and green slate pinnings fill space between triangular arch-head and round arch above, sealing plastered underside of the latter. Void on E side of rubble infill (Plate 10).

Entrance: round arched doorway with later triangular-headed opening inserted (Figure 7a). Entrance 1.10 m high, from impost to present ground level. Sides and round arch of rubble voussoirs intact, set back at the impost to accommodate temporary wooden centering. As noted on interior wall-face, underside of round arch is plastered; smooth plaster survives *in situ* behind later rubble infill (Plate 13). Triangular head intact on E but exterior face and rubble infill missing on W; slab of green slate forms W side of arch-head (behind missing facing stone).

Exterior face (Figure 7c) generally survives up to four courses high (seven courses at NE corner). S end of wall, together with SE quoins and upper quoins at NE corner, missing. Collapsed gable evident as low stony mound to E with probable apex exposed 3.5 m from wall-face. Large-scale loss of pinnings and mortar, with voids between stones up to 150 mm deep. Occasional small patches of harling survive, particularly near NE corner of building. Extensive vegetation cover on present wall-head and in wall-face.

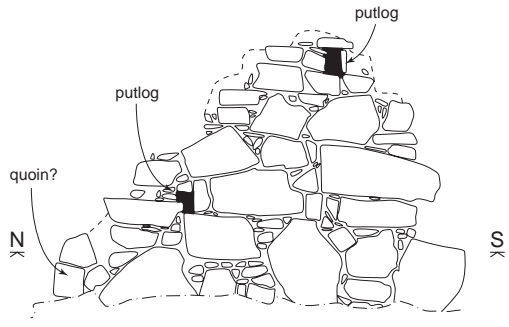
(a) Building No 4 - West wall: exterior.

Building No.4: west wall, exterior face: condition (Figures 8a & 9b)

Wall-fabric: remains of stepped-gable survive in upper part of elevation and on N side. Lower part of gable missing on S side at interface with wall-head. Mortar generally sound but recessed 60 – 90 mm, with occasionally deeper voids. Some pinnings loose. Loose stones on N end of gable; others seemingly recently removed, leaving regular outline in mortar. Gable leans to E (Figure 9b). Two put-logs evident in exterior fabric: upper is 0.18 m high, 0.08 – 0.12 m wide and 0.19 m deep; lower 0.12 m high, 0.10 m wide and 0.23 m deep.

Buildings Nos. 3 & 4 are in a poor condition. Although much of Building No.4 clearly survives below ground level, its W gable is in a perilous state and its surviving wall-fragments are equally vulnerable. The present condition of Building No.3 is variable; the external south wall-face has suffered a massive loss of pinnings and mortar and the west end of the wall leans markedly to north; the exposed NE and SE corners of the building are equally vulnerable to slippage. The east lintel of the window in the north wall, in particular, is in danger of complete collapse. The cracked head of the west window in the exterior fabric of the south wall is similarly unstable.

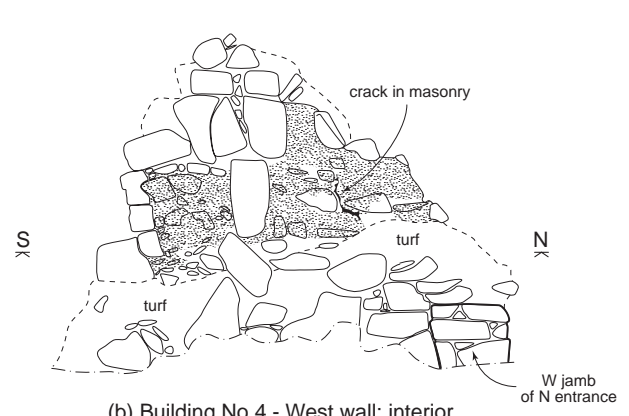
(b) Building No 4 - West wall: interior.

Building No.4: west wall, interior face: condition (Figures 8b & 9b)

Wall-fabric: large proportion of the interior face has collapsed, leaving extensive areas of exposed wall-core and mortar. Marks of large edge-set stones up to 0.15 m thick evident in exposed mortar. Large-scale loss of mortar and pinnings; others loose; deep 'frost-crack' or similar to N. Masonry unstable, leaning to E (Figure 9b).

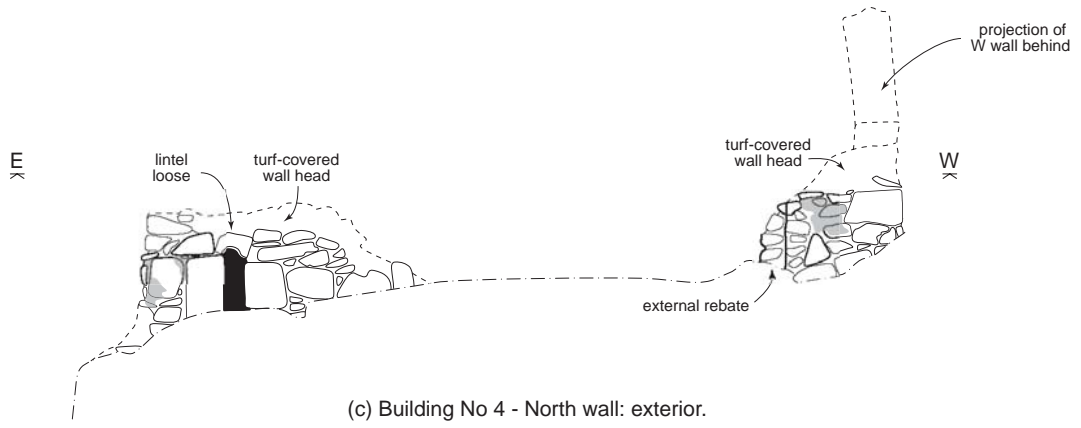
(c) Building No 4 - North wall: exterior.

Building No.4: north wall, exterior face: condition (Figure 8c)

Wall-fabric: small fragments of exterior wall-face, up to 0.5 m high, survive at E and W ends of building. Mortar and pinnings generally sound but becoming loose at surviving wall-head; mortar recessed 20 – 40 mm. Window-head loose.

Window: visible sides of external light intact; round-headed lintel carved from single stone and externally rebated. Stone is loose, having recently been replaced roughly in position (Andrew Kerr, pers comm.).

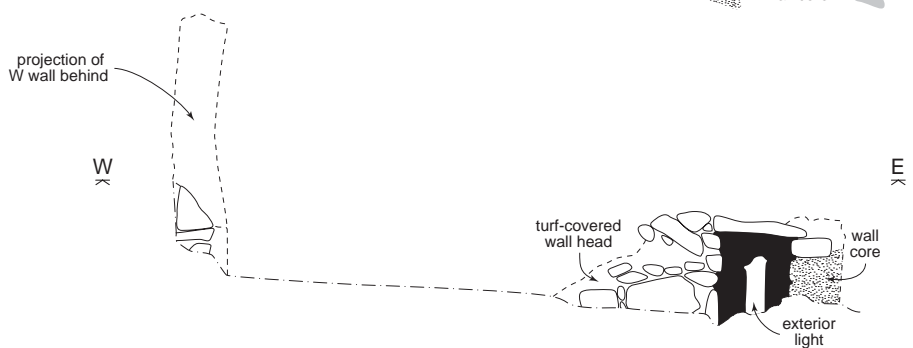
(d) Building No 4 - North wall: interior.

Building No.4: north wall, interior face: condition (Figure 8d)

Wall-fabric: vestigial fragments of interior wall-face survive at E and W ends of building. Mortar loose and friable; occasional loose pinnings; loose stones on wall-head. Window-head loose.

Window: sill of green slate visible below loose stones; W reveal essentially intact, although basal stone cracked; most of E reveal missing, former edge-set stone evident only as impress mark in surviving mortar surface.

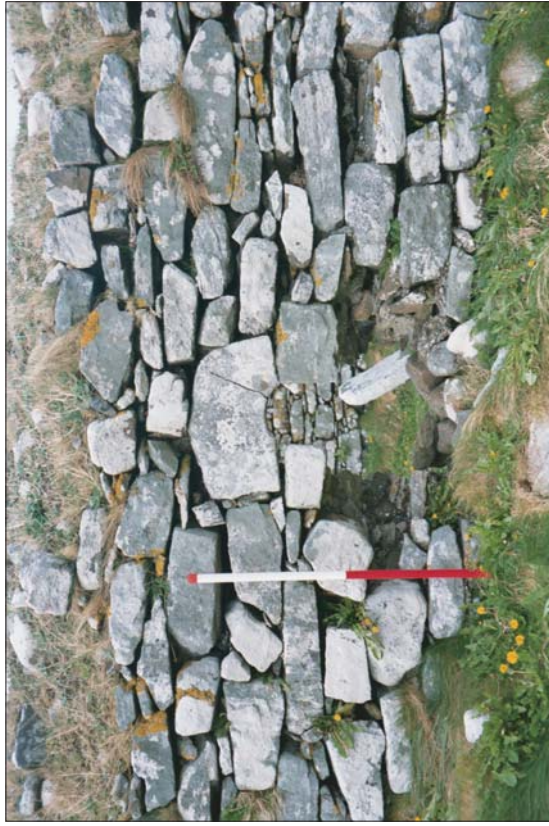
Window (west): round-headed lintel split on E side; single pair of side-stones survive immediately below arch-head but sides otherwise missing; voids in masonry. Sill traceable under loose rubble (Plate 3).

Plate 3: Building No.3, South Wall exterior; detail of west window, facing N.

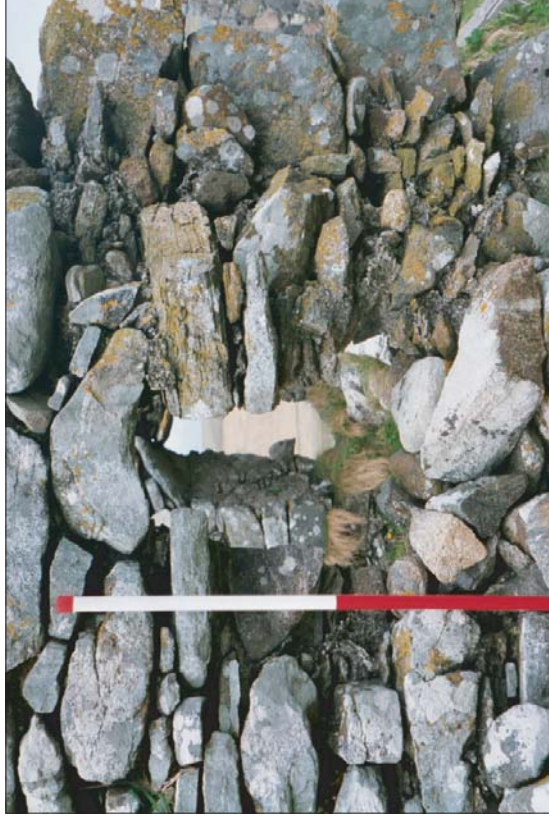
Window (east): round-headed lintel supported by single stone on W, two stones on E; sides otherwise missing, with voids to E and W. Sill not traced (Plate 4).

Plate 4: Building No.3, South Wall exterior; detail of east window, facing N.

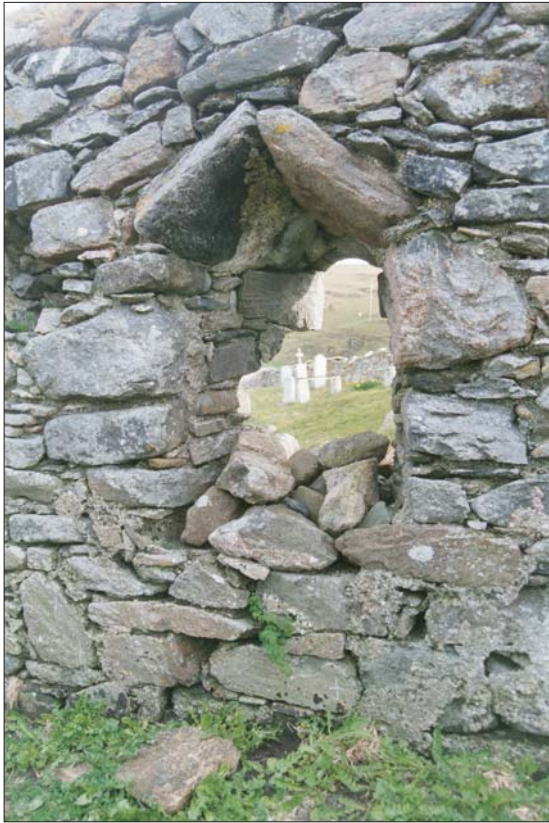
Window (west): sides and head of window intact; plaster survives on E side of window-head. Loose stones on sill (Plate 5).

Plate 5: Building No.3, South Wall interior;
detail of west window, facing S.

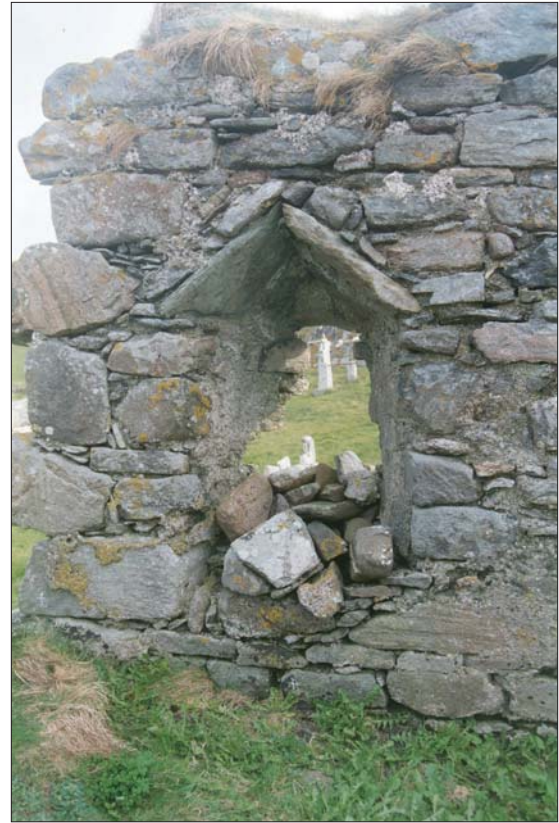
Window (east): sides and head of window intact; plaster survives on E and W sides of window. Loose stones on sill. Stone forming E side of window-head is of green slate (Plate 6).

Plate 6: Building No.3, South Wall interior;
detail of east window, facing S.

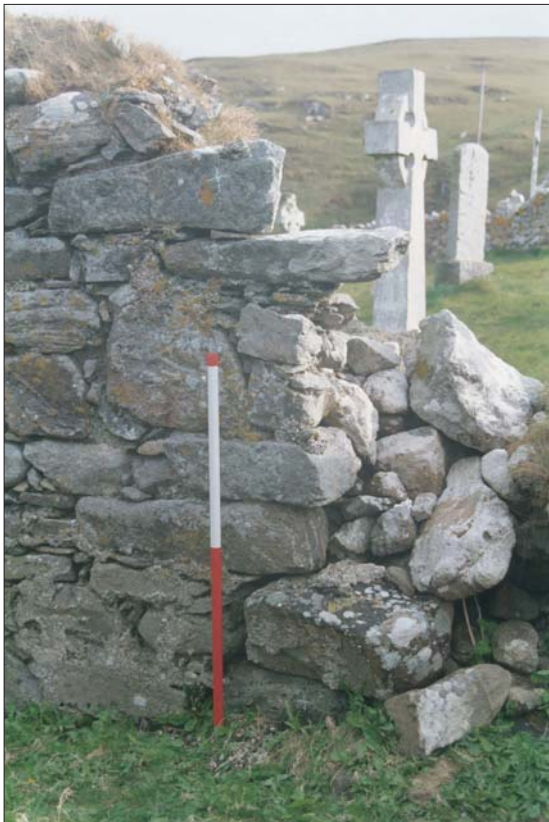
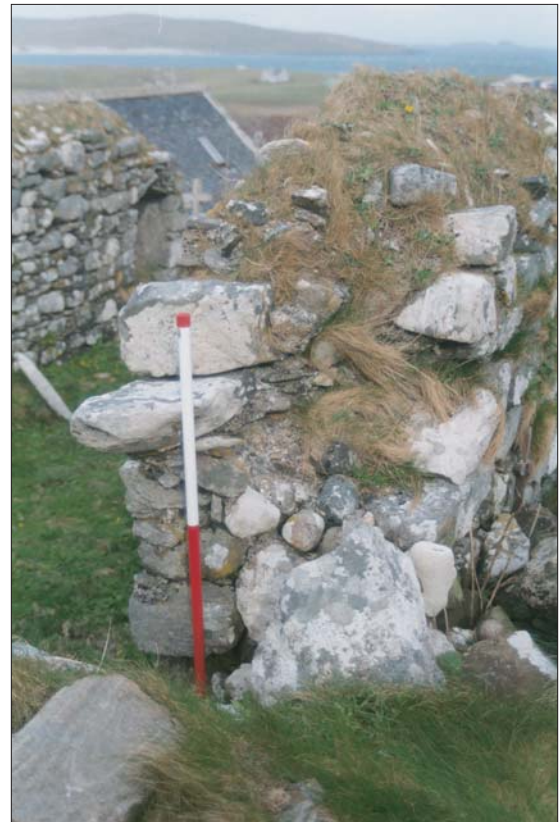
Plate 7: Building No.3, South Wall interior;
collapsed masonry and internal quoins
at SW corner of primary building, facing SE.

Plate 8: Building No.3, South Wall interior;
collapsed masonry and internal quoins
at SW corner of primary building, facing NE.

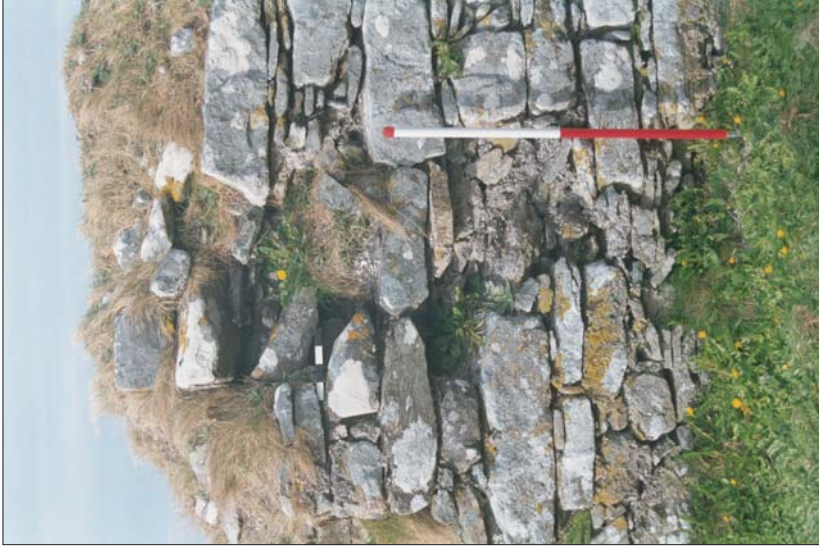
Plate 9: Building No.3, North Wall interior;
site of primary W gable, facing N.

The masonry voids towards the east end of the interior, interpreted here as possibly the site of the chancel screen, should be conserved and retained; they are potentially an important feature of the building. Similarly, the scar at the west end of the primary building should remain visible after consolidation. The site of the former SW internal corner of the building, represented by loose masonry and tumble, should similarly be identifiable after consolidation.

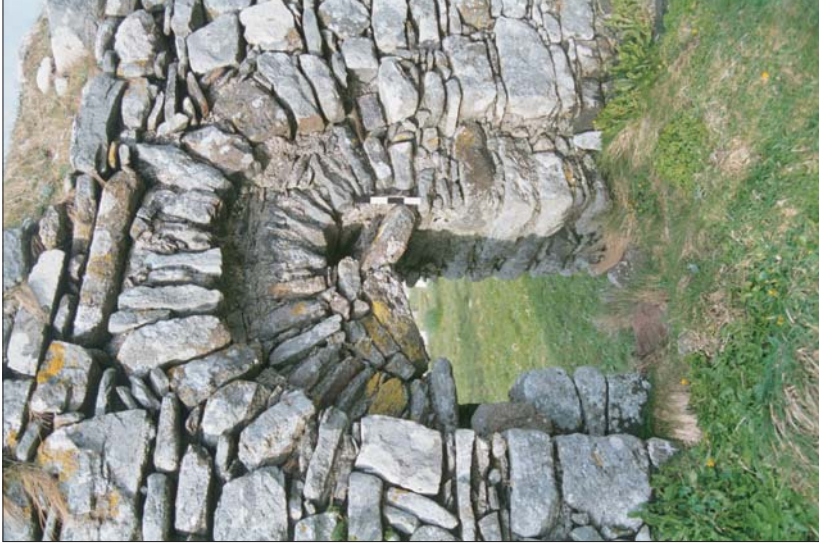
Plate 10: Building No.3, North Wall interior;
detail of entrance, facing NE.

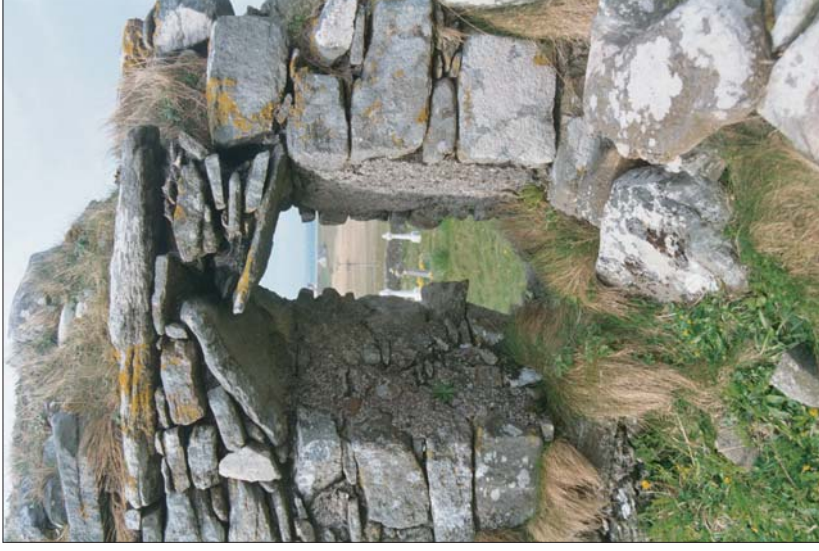
Window: sides intact but E lintel has slipped; overlying masonry loose. Firm and sound shelly plaster survives on E and W reveals. Sill also partially plastered but destabilised by incursion of vegetation (Plate 11).

Plate 11: Building No.3, North Wall interior;
detail of window, facing N.

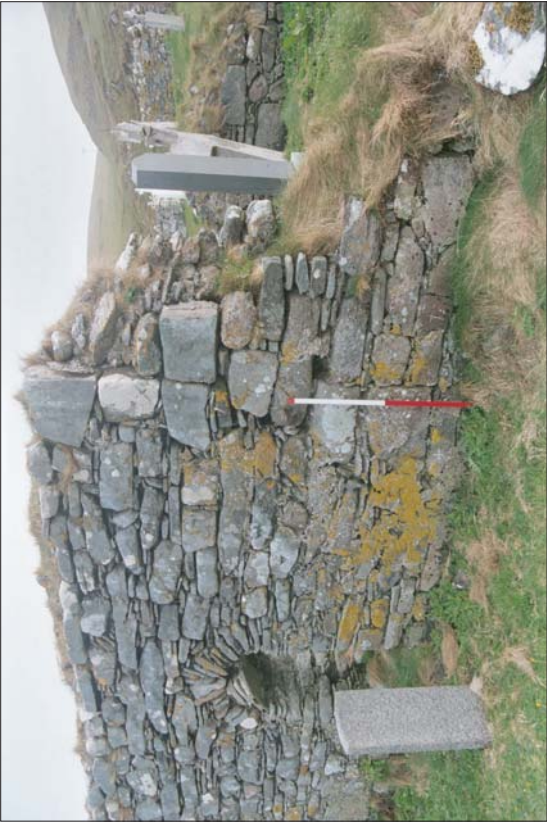
Plate 12: Building No.3, North Wall exterior; detail of butt joint between primary and secondary wall fabrics, facing SE.

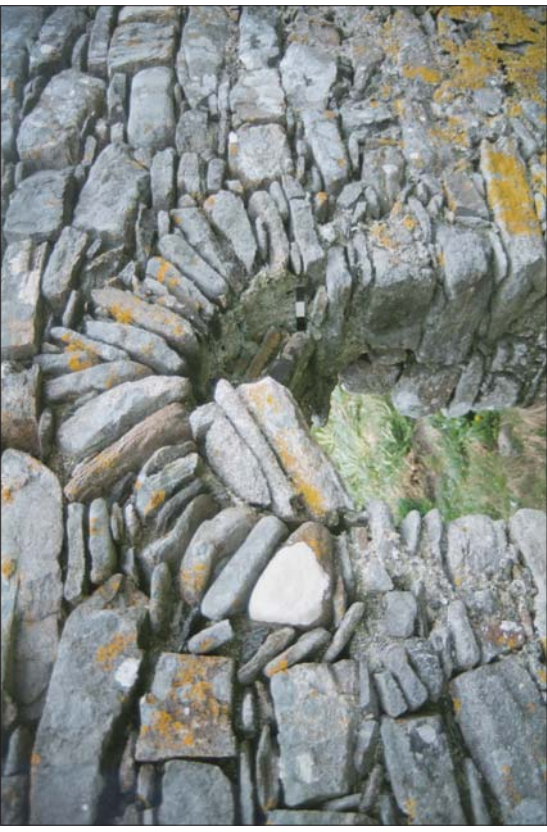
Plate 13: Building No.3, North Wall exterior; detail of entrance, facing SW.

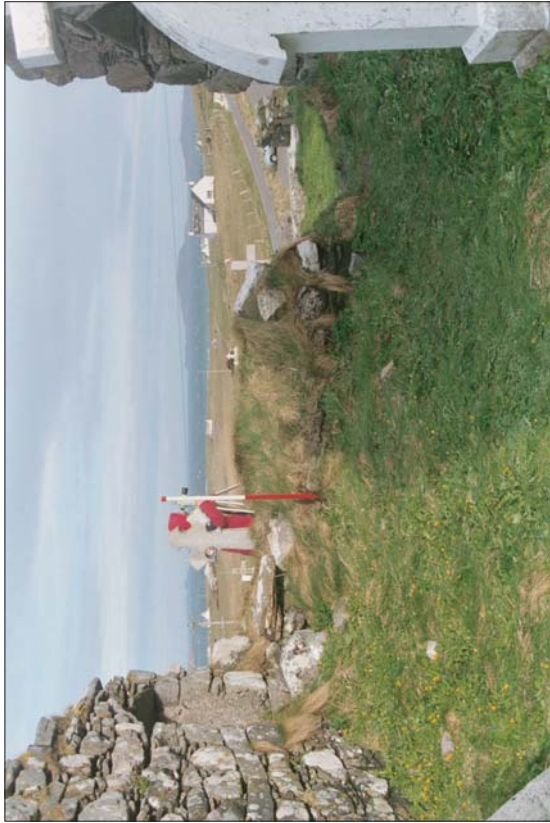
At the centre of the east gable are the rubble and turf-covered remains of an altar. Constructed of coursed, lime-mortared masonry, the altar is 1.50 x 0.90 m and up to 0.60 m high overall. The visible face on the west is 0.35 m high. Plaster survives on all faces of the altar but is best preserved on the north where it is overlain by a pile of stone tumble.

Low, turf-covered stony bank up to 0.6 m high internally and 0.75 m wide. Interior face obscured by altar (Plate 14) and pile of loose stones in NE corner of building.

Plate 14: Building No.3, interior facing E, with detail of altar.

AREA	RECOMMENDATION	COMMENTS
BUILDING No.3		
Altar	treat as per wall-head turf	
Interior ground level	reduce by 200 mm; lay suitable aggregate over 'Terram'-type membrane	
Wall-head	removal of wall-head turf as per Pendery 2001, 1.3, 1.4	
General	excavate collapsed masonry along N & S exterior wall-faces and in NE corner of building	to retain stones for repair / consolidation of masonry
BUILDING No.4		
Interior ground level	reduce by 200 mm; lay suitable aggregate over 'Terram'-type membrane	
Wall-head	removal of wall-head turf as per Pendery 2001, 1.3, 1.4	
General	excavate collapsed masonry along N exterior and W interior wall-faces	to retain stones for repair / consolidation of masonry
OTHER		
New cemetery extension	Geophysical survey and archaeological evaluation of possible site of enclosure ditch	to determine position of enclosure ditch & if possible clarify its chronology
Building No.1 (site of)	monitor grave-digging on site of Building No.1	to clarify position of building and its condition
