**Date: 8<sup>th</sup> October 2004**

**Project Code: MNB03**

**Marine Hotel, 18 Cromwell Road, North Berwick,  
East Lothian: Desk-Based Assessment and  
Historic Building Survey**

**MARINE HOTEL, NORTH BERWICK**  
**DESK-BASED ASSESSMENT AND STANDING BUILDING SURVEY**

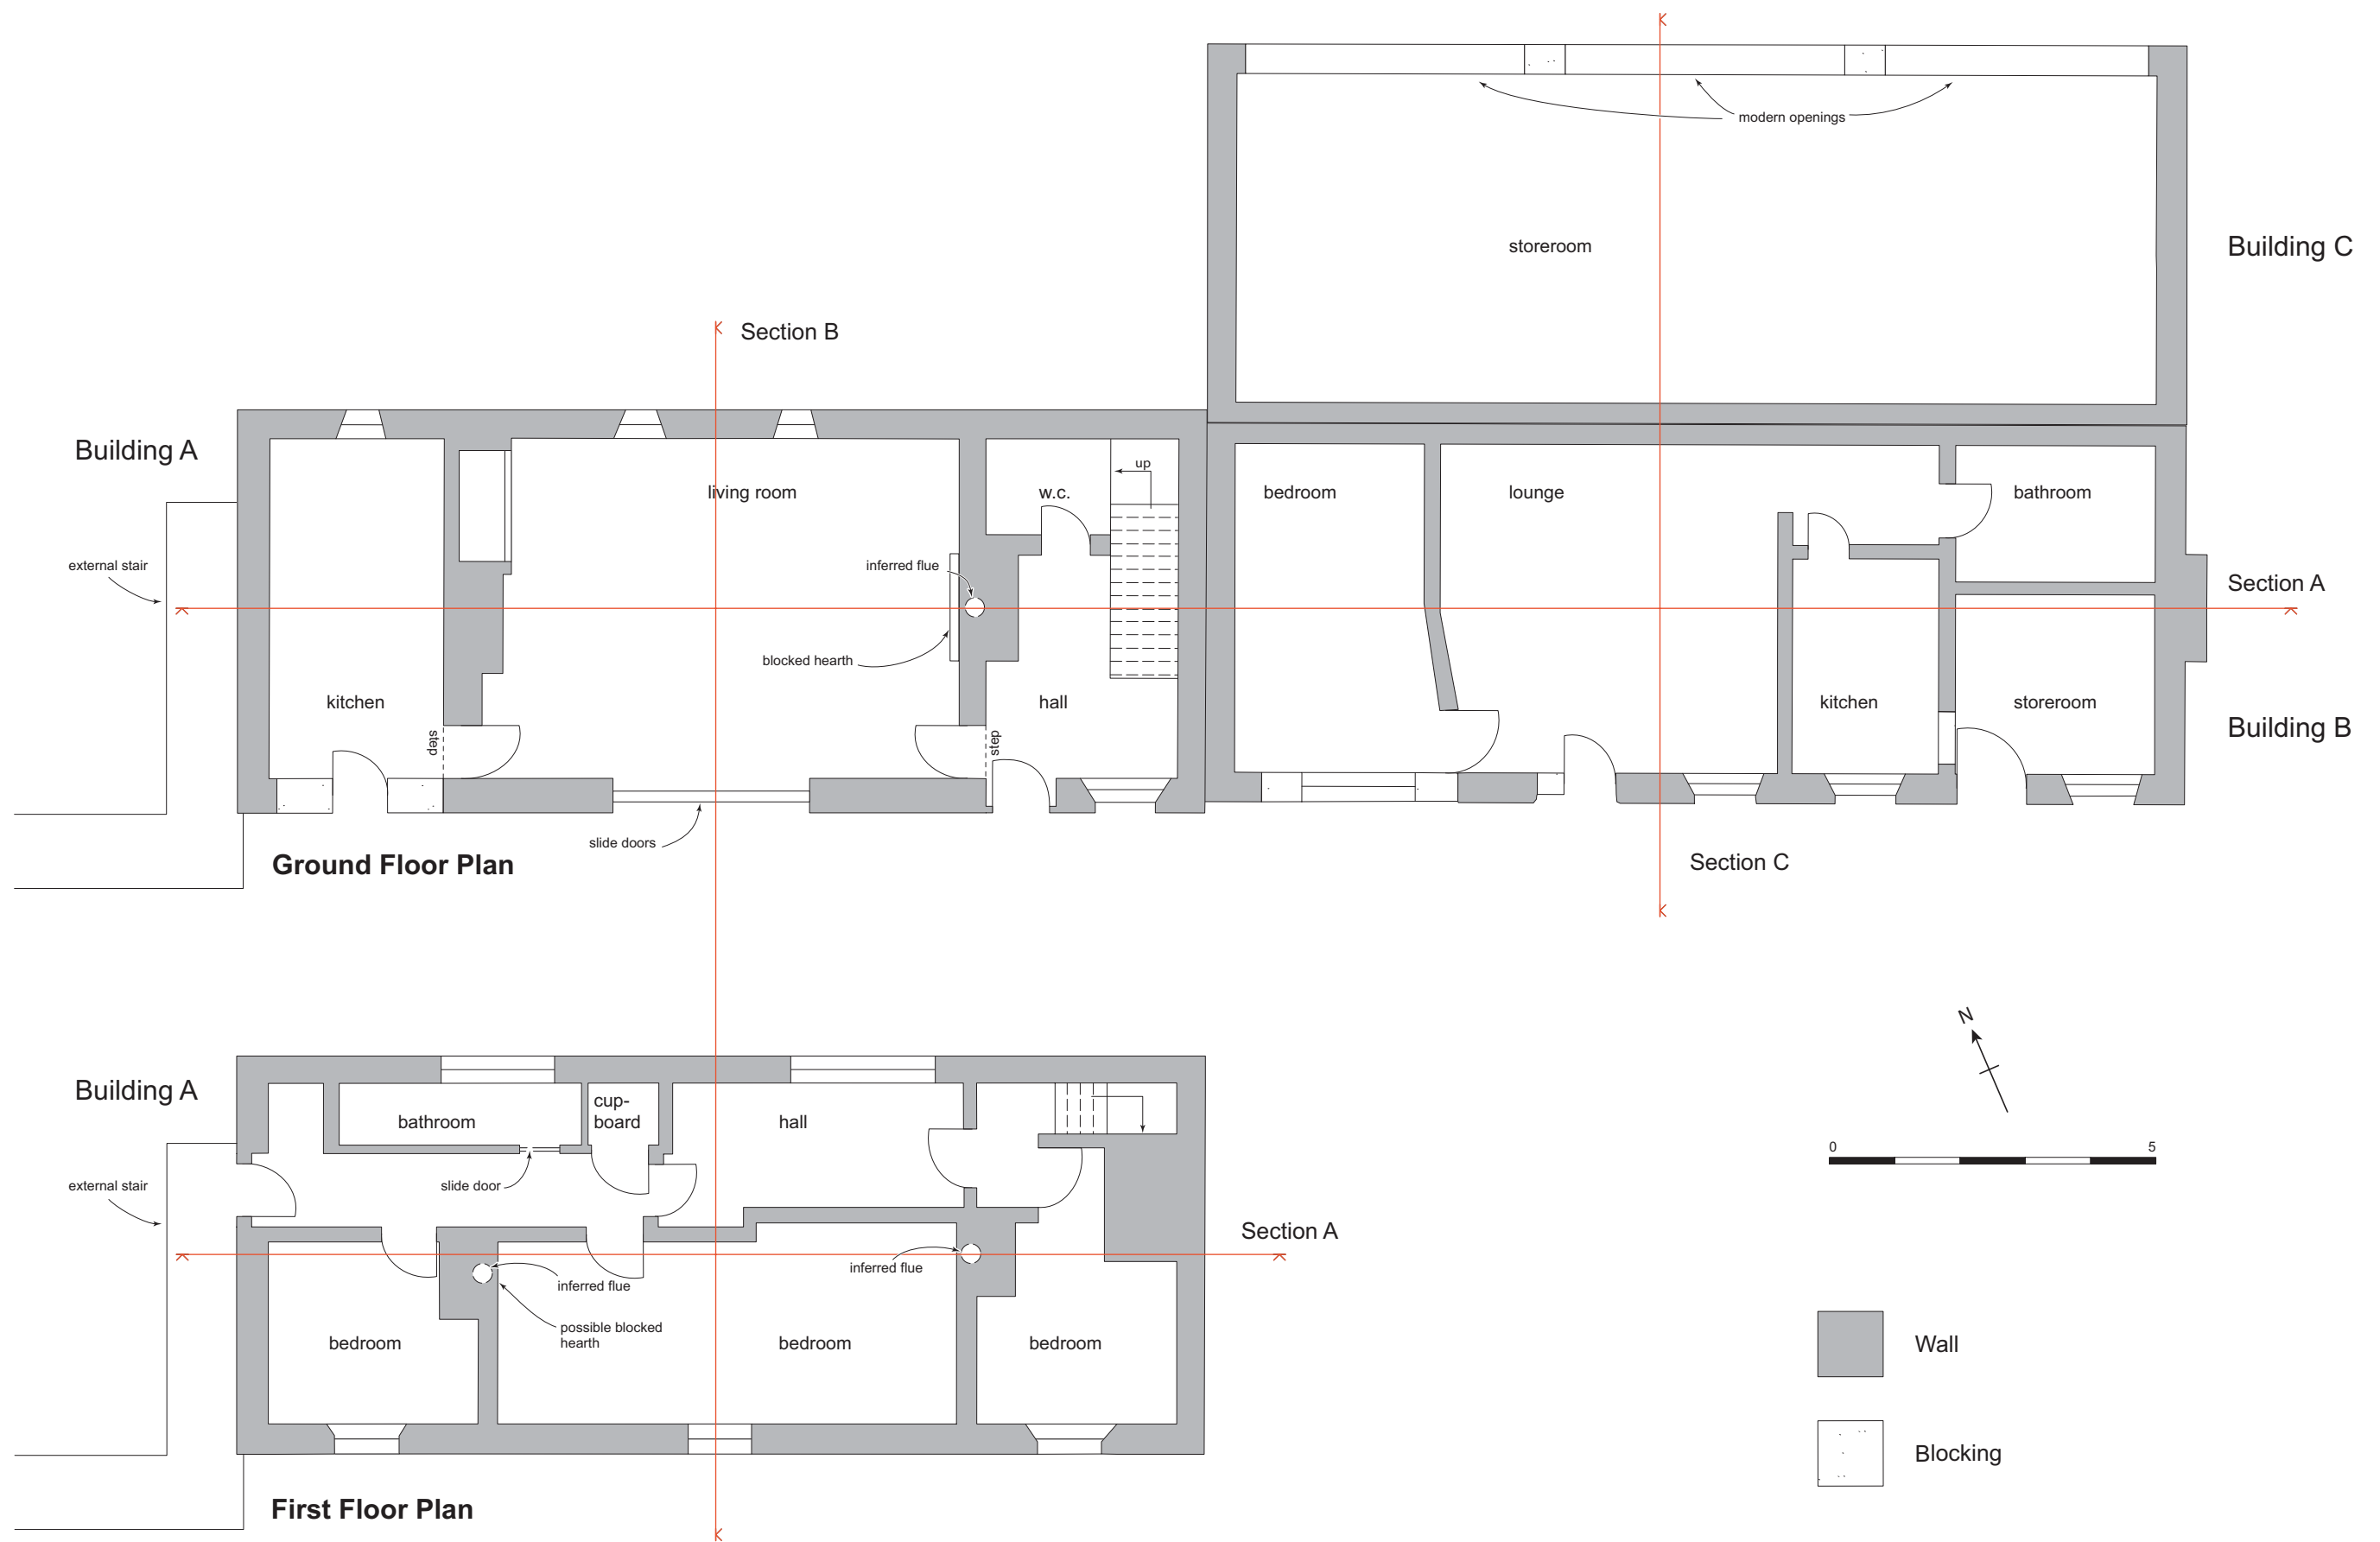
Figure 2: Plan of Carriage House and Stables

Building B is a single storey rectangular building, built in a similar style to Building A (see Plate 2). Originally part of the carriage house complex, this building, like Building A, has been largely converted into accommodation (see Figure 2). The walls are constructed of the same squared and occasionally snecked sandstone masonry, and the openings are edged with dressed sandstone. The roof is double-pitched, constructed of close-butted Scottish slate with zinc flashing and with crow-stepped skews and scrolled skewputs at the eastern gable. A slight flair is apparent to the line of the roof (see Figure 3, Section C), but this may be due to slippage of the slates. The eaves are plain with iron gutters and down-pipes. The roof is seated upon an iron girder, which extends the length of the building, and also forms the lintel for the largest opening in the southern wall. The western end of Building B appears to abut Building A (see Figure 2).

Most of the interior of Building B has been extensively remodelled into living accommodation, consisting of a western bedroom, a central lounge and kitchen and a bathroom and storeroom at the eastern end (see Figure 2). The partition between the bedroom and lounge is brick and probably original. It has a slight change of alignment at the southern end, where a doorway gives access to the lounge. The lounge space occupies the full width of the building but the small kitchen in the southeast corner is formed by recent stud partitions. At the eastern end of the building there is another original brick cross-wall, the resulting space has been recently partitioned into a bathroom at the rear and a storeroom to the front. The storeroom is largely unmodified, and the original floor is visible, showing the presence of large surface drains (see Plate 11). There is a bricked up doorway in the cross-wall, between the storeroom and the current kitchen. At the eastern end wall traces of an earlier original lath-and-plaster ceiling reveals the roof at this point was once hipped (see Figure 3; Plate 12). There is no evidence for a hearth associated with the external chimneystack.

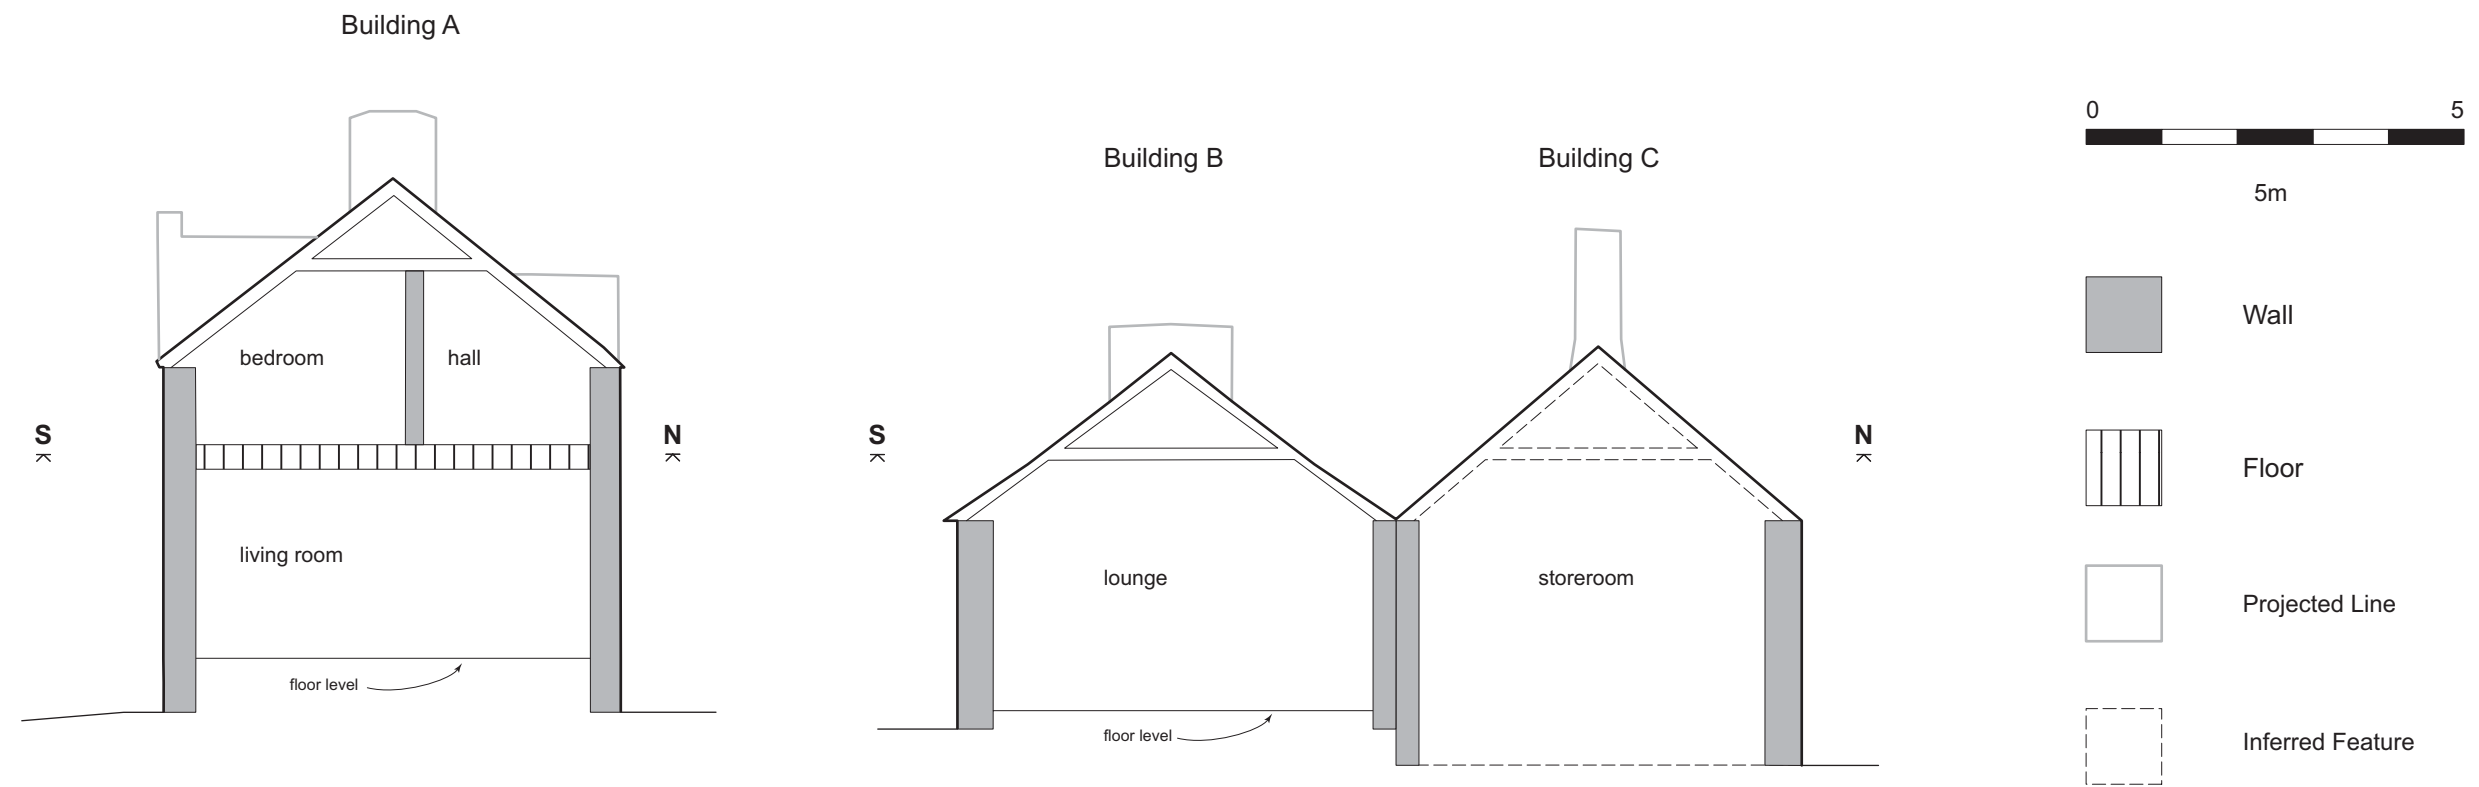
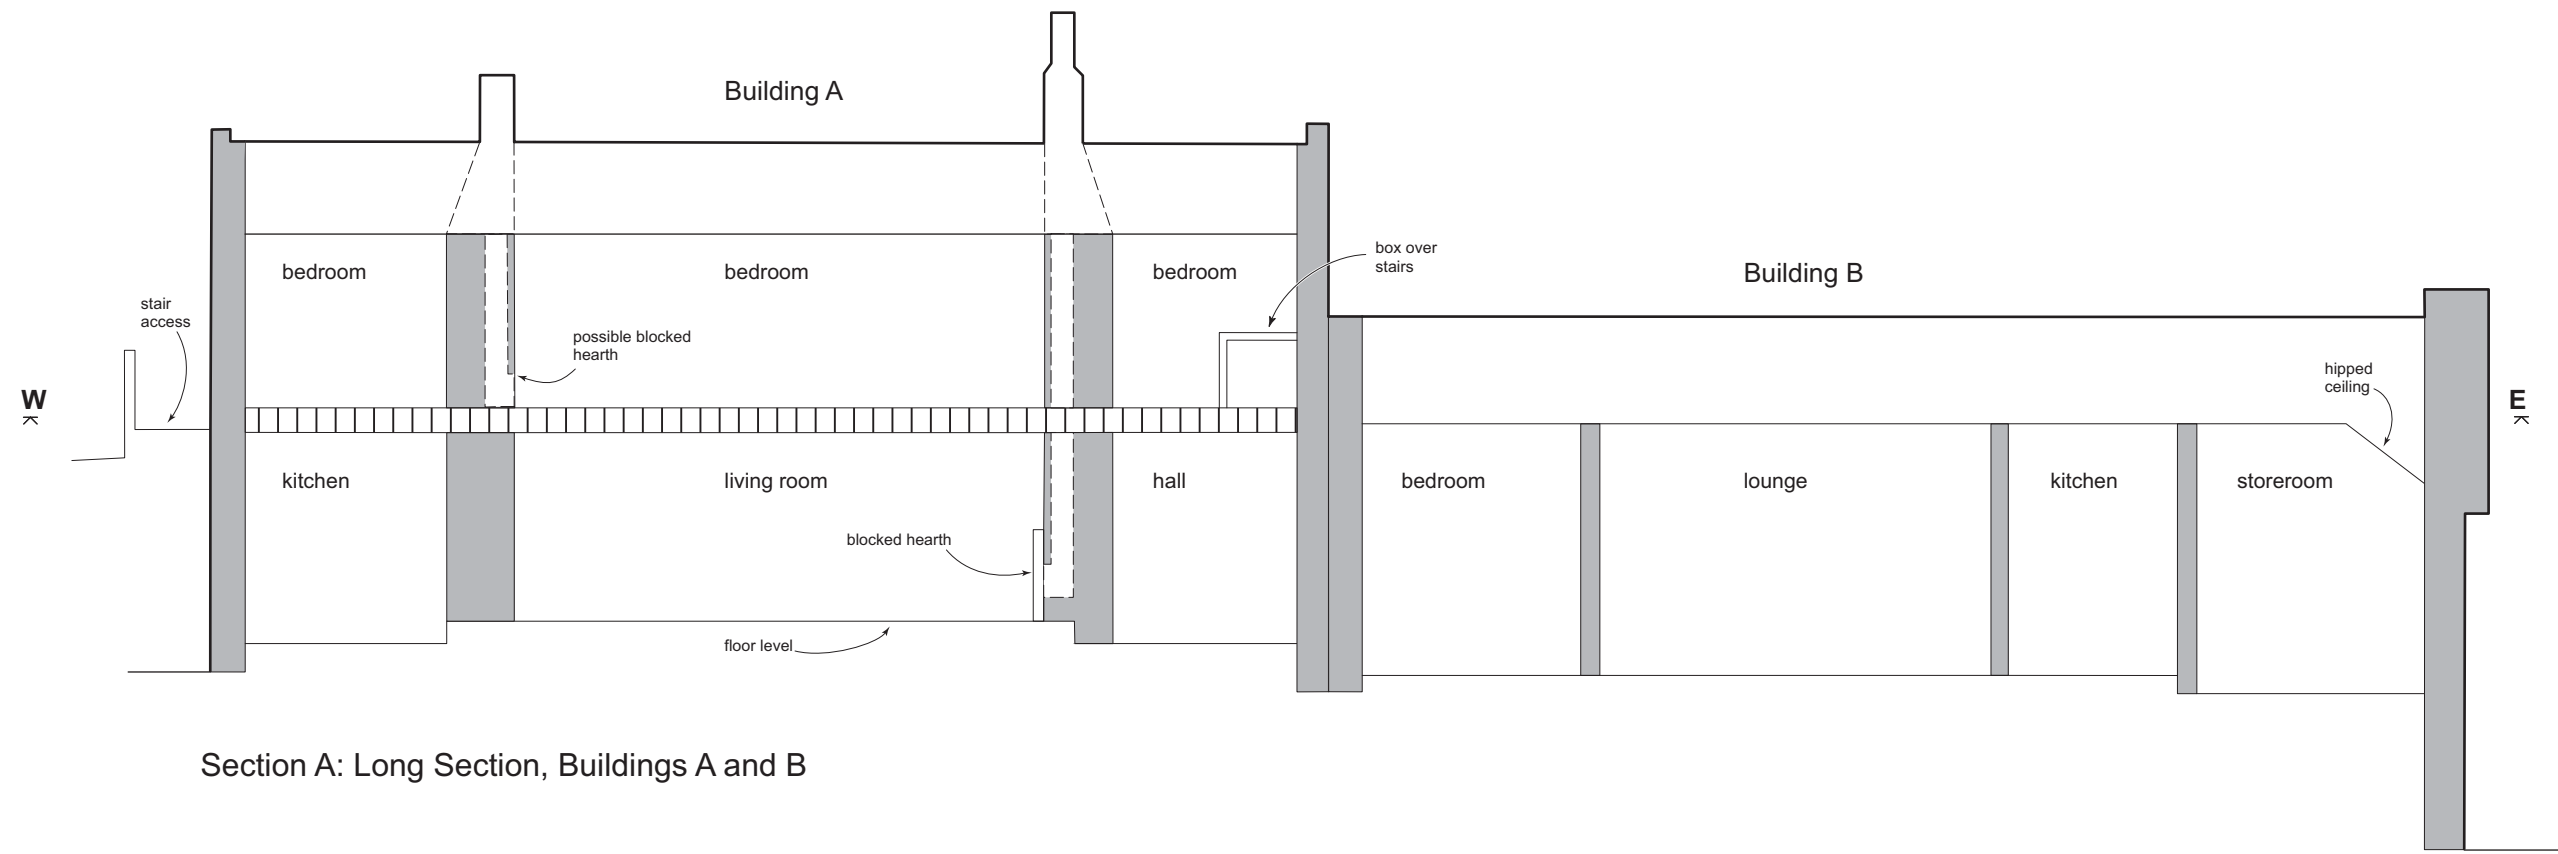
Figure 3: Sections of Carriage House and Stables

Building C is the most extensively remodelled of the carriage house complex. A modern brick and girder frontage has replaced almost the entire north wall of this building and presently accommodates three large openings (see Figure 2; Plate 4). In plan the building essentially mirrors Building B, which it abuts to the south. The walls and roof are of similar materials and build. The crow-stepped skews at the eastern gable end are keyed into the skews of Building B (see Plate 8) and the western gable is also crow-stepped. There is a tall, single flue chimney in either gable end (see Figure 3, section C; Plate 6) and a number of modern vents

have been inserted through the slate roof. Because the ground slopes down to the north the northern frontage is somewhat higher than Building B (see Figure 3).

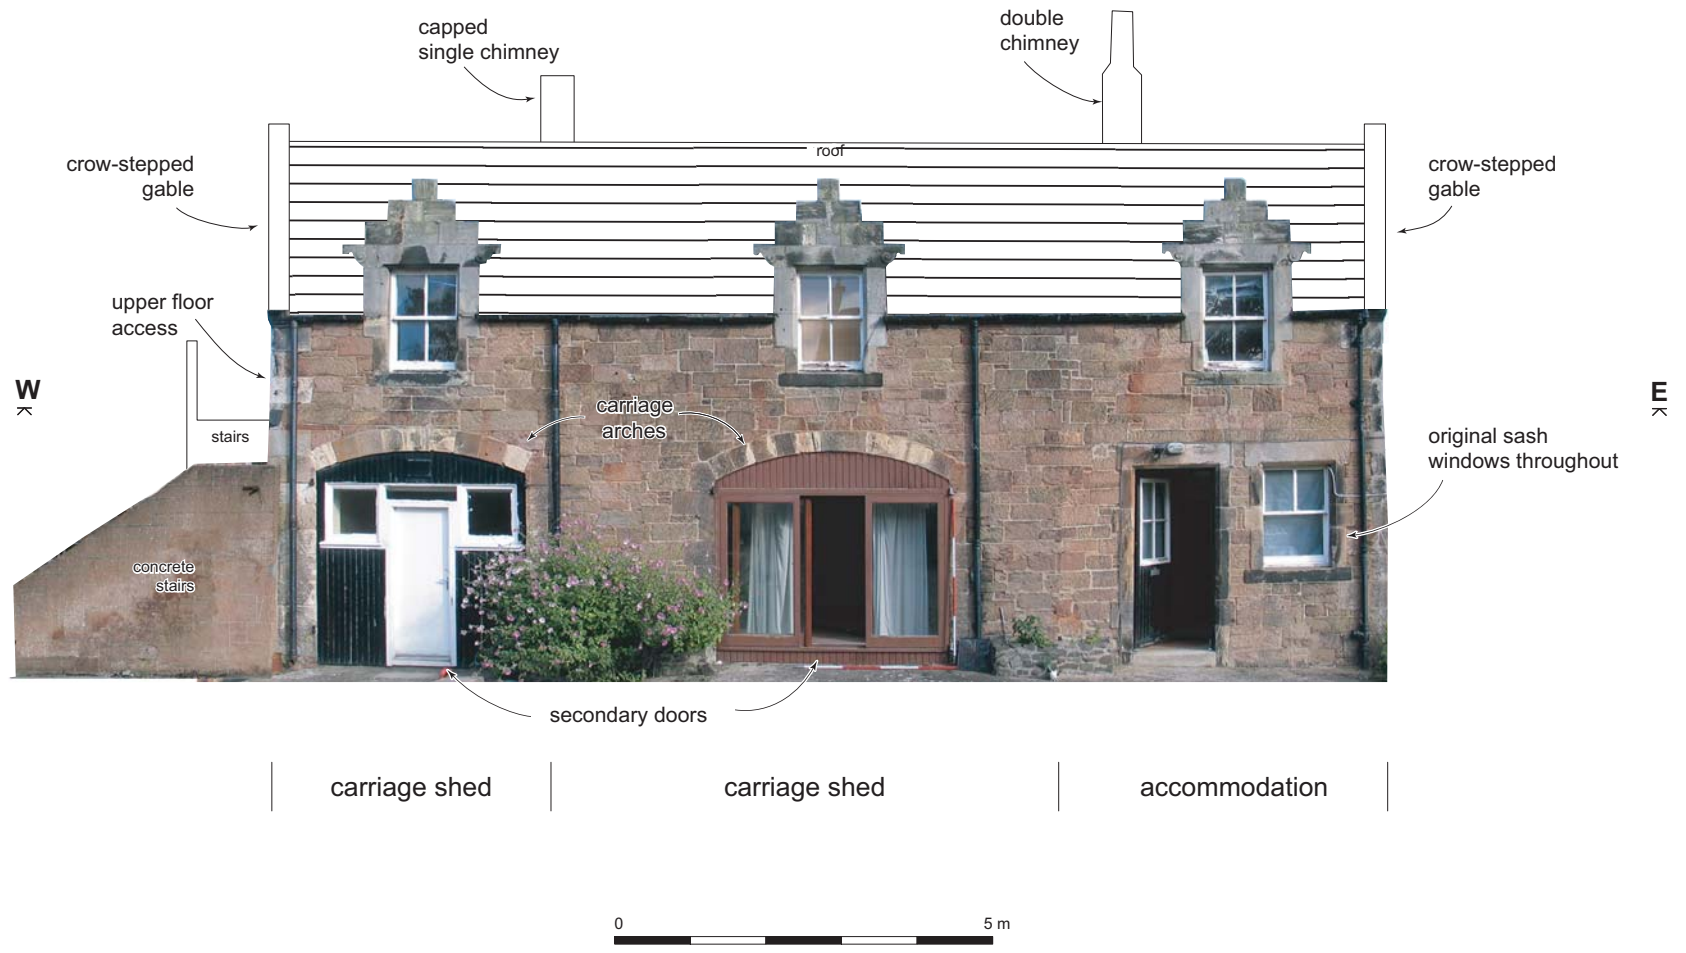
Figure 4: Rectified Photographic Elevation of Carriage House

The upper floor is accessed by an external two-rise staircase to a sandstone edged loft door on the western wall (see Plate 7), and by an internal staircase at the eastern end. In the upper part of the southern wall there are three gabled dormer windows with crow-stepped skews, 'swirl' pattern skewputs and original sash window frames (see Figure 4). Two ungabled ashfelt roofed dormers at the rear of the building are recent additions.

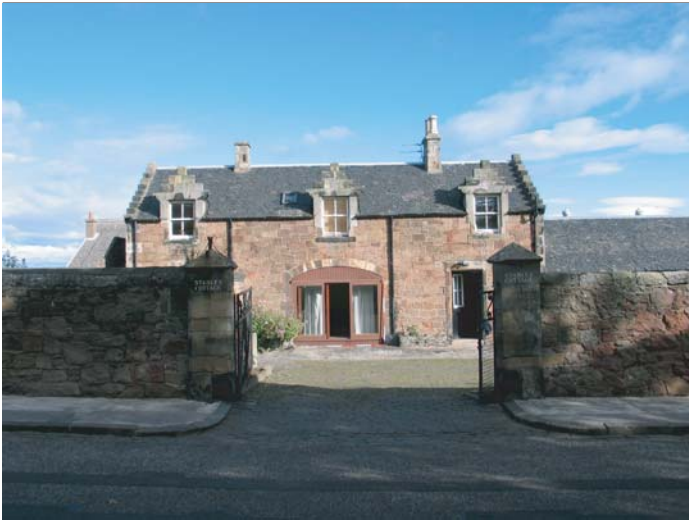
Building A is a stone-built structure, rectangular in plan and aligned on an approximately east-west axis (see Figure 2; Figure 3; Figure 4; Plates 1 & 3). It comprises a one-and-a-half-storey gabled structure originally built as a carriage house, but this was converted into a residential property some time in the mid-late 20<sup>th</sup> century. This conversion involved extensive internal remodelling and the addition of two large dormer windows overlooking the sea to the rear of the property.

Plate 1: Building A, south elevation

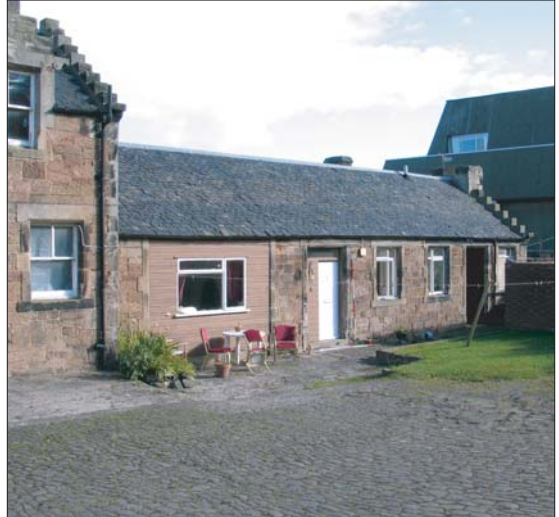
Plate 2: Building B, south elevation

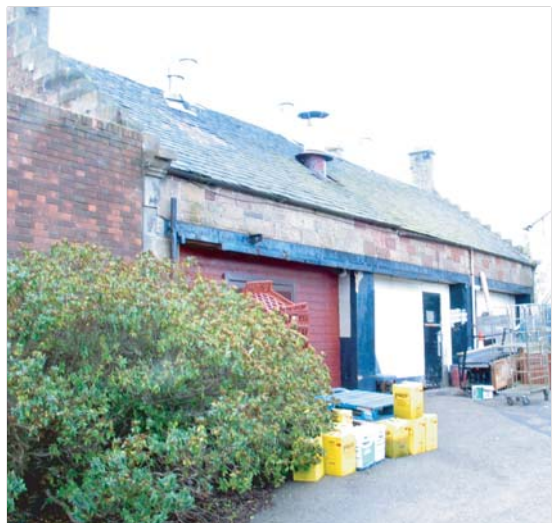
Plate 4: Building C, north elevation

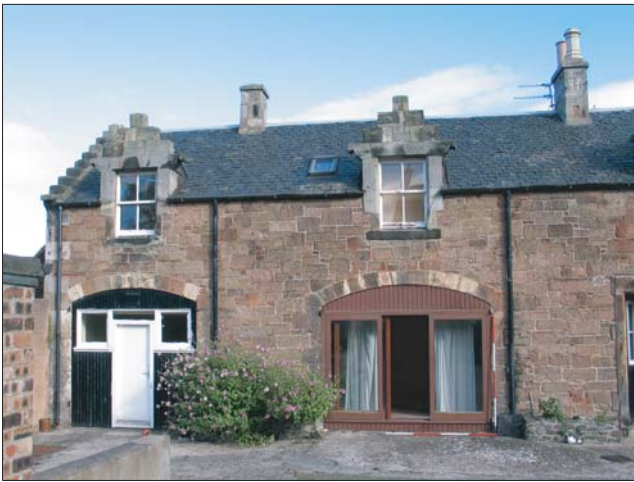
The building abuts the western end of Building B. Access to the ground floor is by two partially blocked carriage arches to the kitchen and lounge, and an original doorway into the present hall. The carriage arches are edged with dressed sandstone blocks. The western arch has been blocked by a timber framework accommodating a central door with flanking windows (see Plate 5). The central arch has been fitted with modern glass sliding French windows (see Plate 5). The eastern door is potentially original and is half-timbered, half glass, within an original dressed sandstone post and lintel doorway (see Plate 3). The ground floor window to the east of this retains its original sash window. At a high level in the north ground floor wall there are three small windows/ventilation holes. These are thought to be original features associated with the carriage shed (see Plate 9).

Plate 5: Blocked carriage arches in Building A

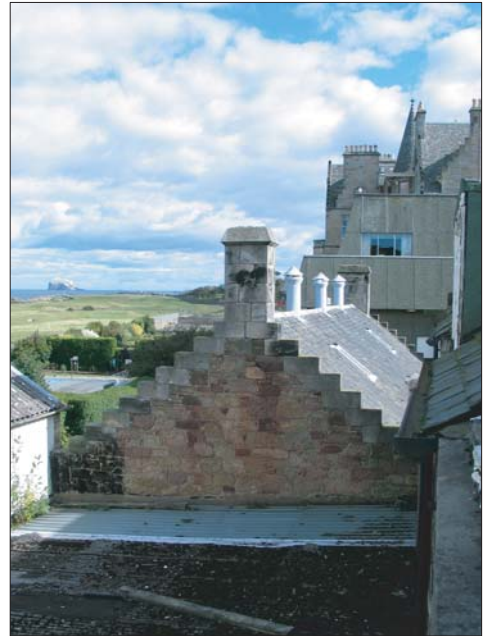
Plate 6: Building C, western elevation

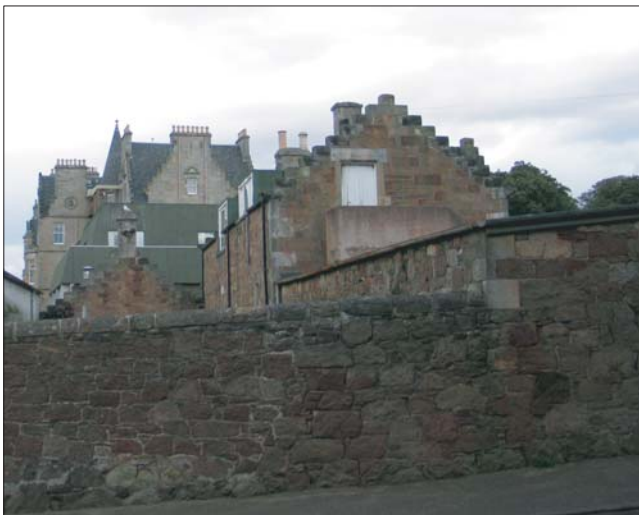
Plate 7: Building A, western elevation

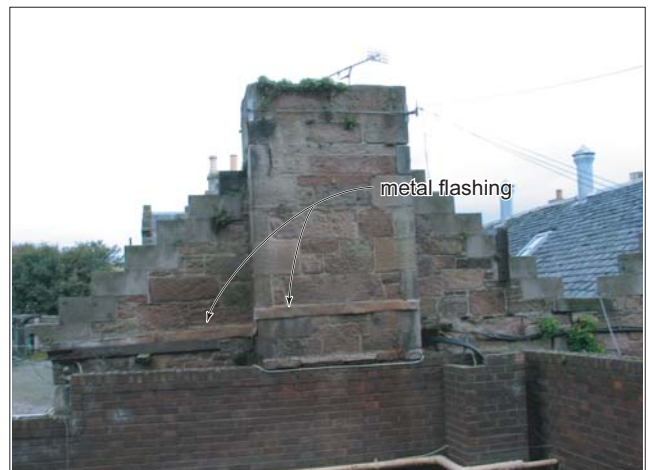
A short, wide chimneystack is present at the eastern end of the building (see Plate 8). The stack protrudes from the side of Building B. Here, at the east end of the building the ground level has been considerably reduced to accommodate the 20<sup>th</sup> century extension to Marine Hotel. This chimney has therefore had to be consolidated approximately 4.5 m above the ground where it is supported with modern brickwork (see Figure 3; Plate 8). On the outside of the eastern gable a small area of flashing is visible suggesting that a single pitch roof was attached to the gable end at some point (see Plate 8). The rear or northern side of Building B abuts the adjoining Building C.

Plate 8: Building C, chimneystack and flashing

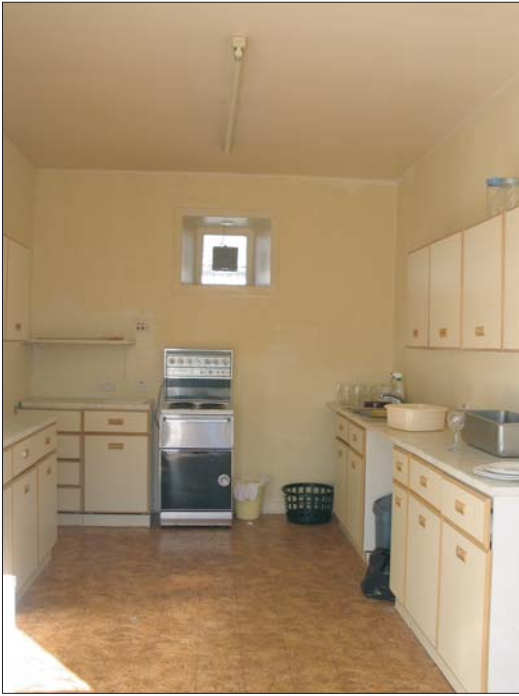
Plate 9: Building A, ground floor rear window/ventilation hole

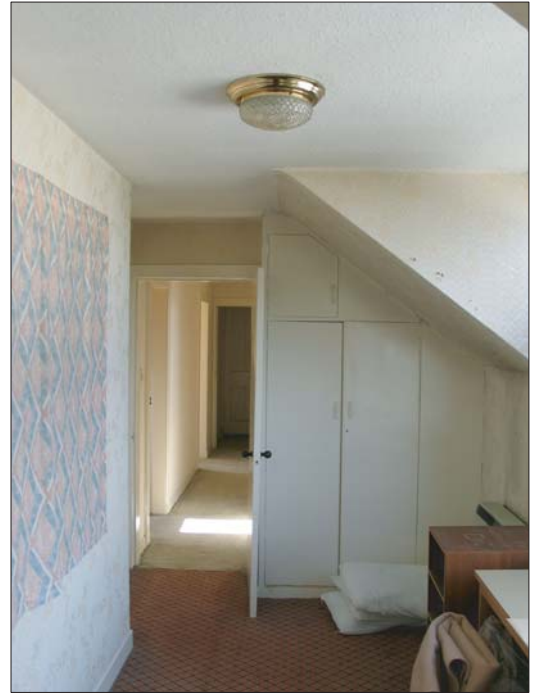
A hall/passageway runs the full length of the upper floor (see Plate 10). To the south of this are three bedrooms. A bathroom is located north of the hall at the western end of the building. The two lateral partition walls between the bedrooms contain the chimney flues and are brick built. All the other partitions on this floor are 20<sup>th</sup> century stud partitions.

Plate 10: Building A, first floor hallway facing west

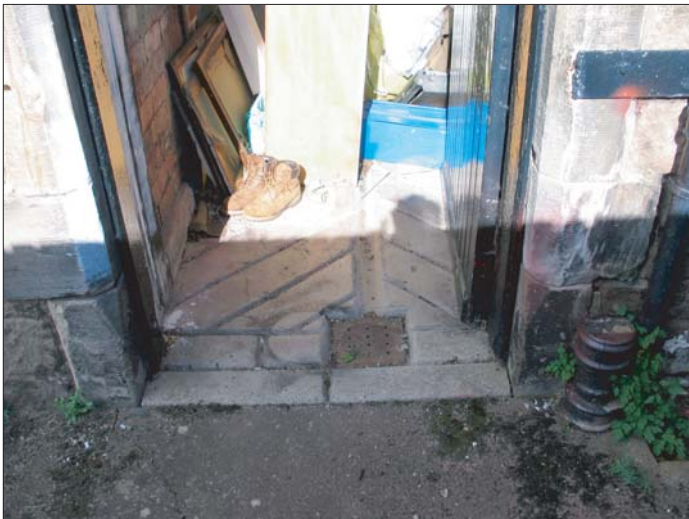
The other two doorways in Building B are significantly wider than standard doors and were probably intended for horses, rather than for people. The scratch marks on the sandstone edging of the central door, which may have been caused by horses in harness passing through, and the drains in the floor of the eastern storeroom support the interpretation that this was a stable. The presence of the large eastern chimney is somewhat enigmatic. The size of the chimney suggests an industrial type of function, and it may originally have been connected to a small forge, possibly for the shoeing of horses and the repair of other metal equipment. However, as access to this end of the building was restricted there is no definitive evidence that this was the case.

Plate 11: Drains in floor of Building B

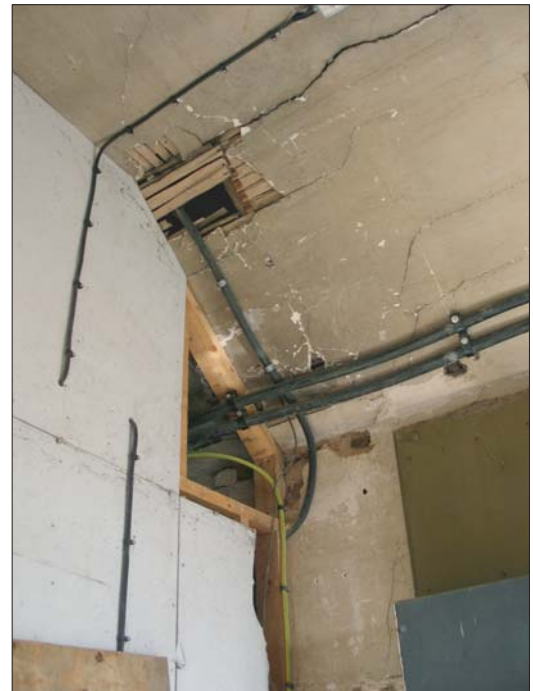
The survival of internal features in Building B is rather better than elsewhere, and in conjunction with external evidence suggests that this building has seen a degree of remodelling prior to its modern conversion. The presence of a hipped lath-and-plaster ceiling at the eastern end suggests that the eastern gable of this building was not an original feature. The crow-stepped gable is therefore a later addition. Given the map evidence of a fourth building on the site, this makes sense if there were originally two sloped roofs butted together

Plate 12: Hipped ceiling in Building B

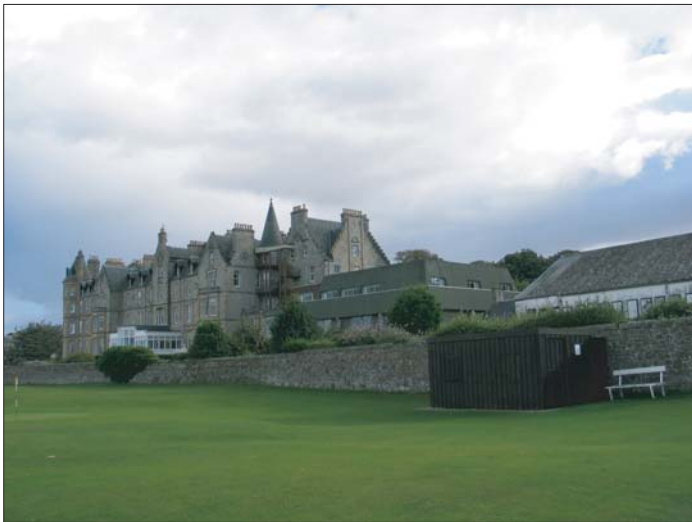
Attached to the north-west end of the Marine Hotel is Building D, a later 20<sup>th</sup> century conference suite (see Figure 1; Plates 14-16). This extension is constructed mostly of concrete, and is raised above a car-parking area by concrete piles. Building E (see Figure 1; Plate 13) is a later 20<sup>th</sup> century squash court, constructed of brick, breezeblock and concrete cladding, with a corrugated iron roof.

Plate 13: Buildings D, E and Marine Hotel from north-west
