Date: June 2007

Client: Prentice Kennedy Architects on behalf of Kenmore Homes Ltd

Project Code: AHC07

**The Old Wet Dock, Alloa Harbour, Clackmannanshire:
The results of a Desk Based Assessment and
Archaeological Evaluation**

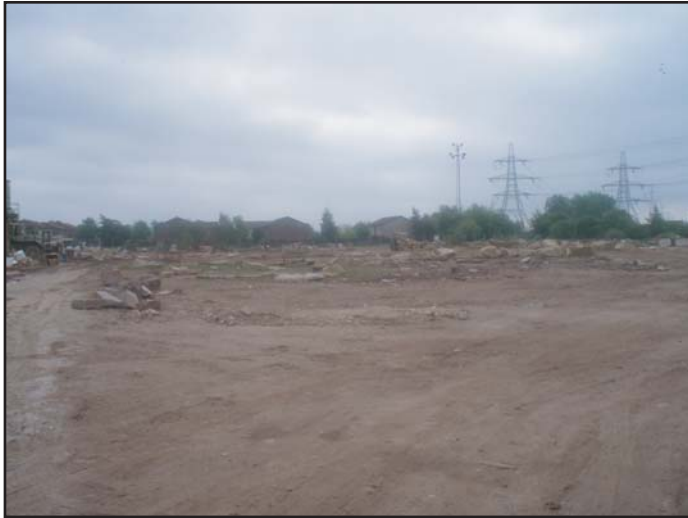
The site of the old wet dock lies on the north bank of the Forth in the locality of the old harbour. The site is presently occupied by Sterling Stone; the area of the in-filled wet dock is currently flat, open land used as a storage area for stone (Plate 1). In addition, there are a number of small spoil heaps located along the southwest margin of the proposed development area; the periphery of the proposed development is scrubland bounded by a wire security fence; and the old wet dock entrance and associated quay structures were noted along the river waterfront along the western margin of the site (Plate 2).

Plate 1:
General view of infilled dock - looking east.

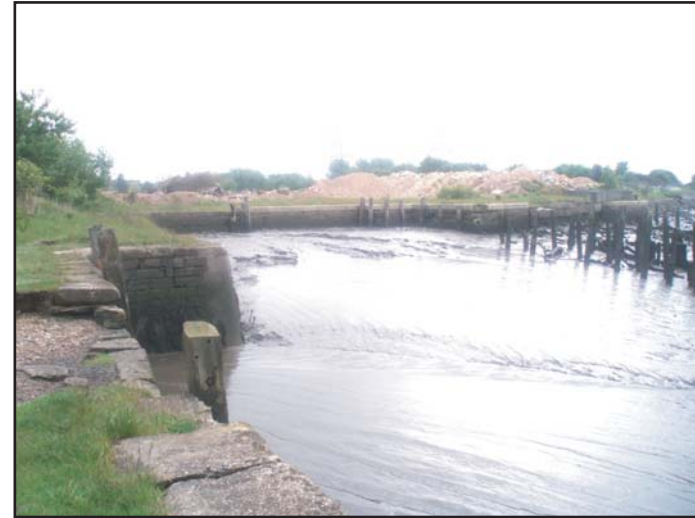
Plate 2:
Entrance to wet dock - looking east.

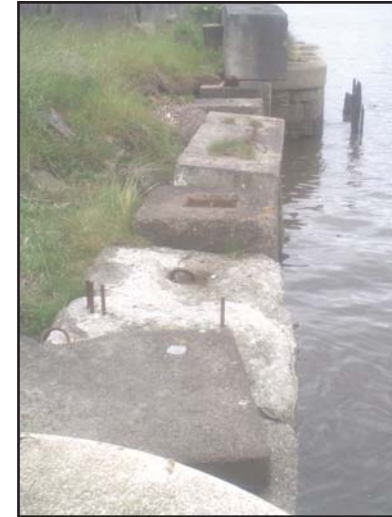
Plate 5a:
Blocked 1880's gate - looking south.

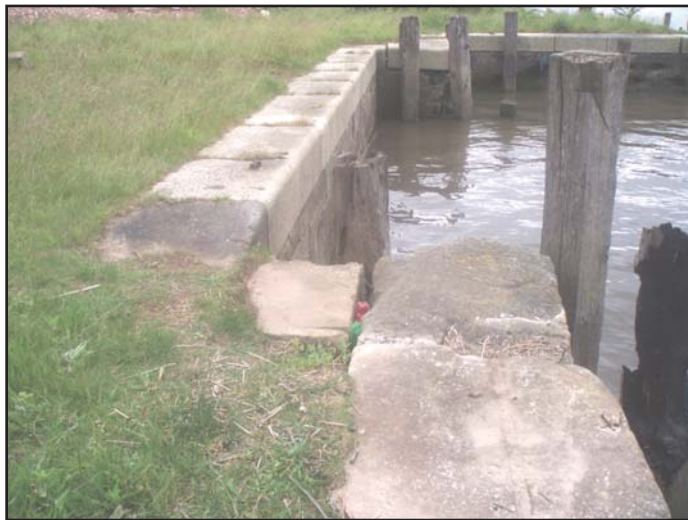
Plate 5b:
Blocked 1860's gate. Note the difference in the cope stones - looking south (1860's in the foreground & 1880's beyond).

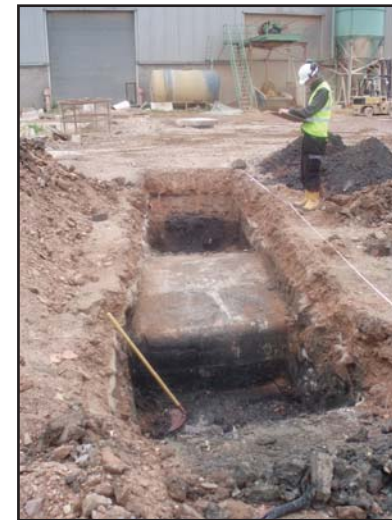
and concentrations of compacted stone fragments and clay (contexts 002 & 005). This deposit comprises the back-fill material used to fill in the dock in the 1960s. Above this was noted a layer of terram fabric covered by a layer of blaes [001]; constituting the present ground surface for the stone-works storage area (Plate 1). The depth of the deposits above the buried quay varied, becoming gradually deeper from west to east (0.7m to 1.3m; Plate 6).

Plate 6:
Working shot of excavation of Trench 2 - looking north.

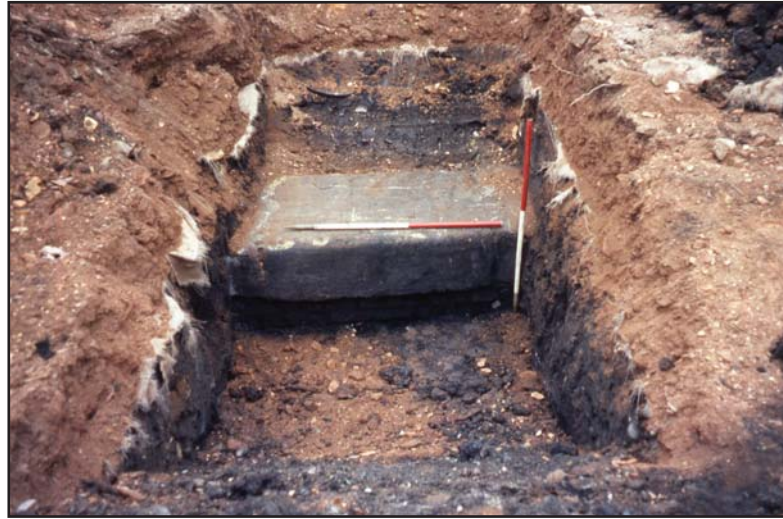
Trench 1 revealed the remains of the former northeast corner of the wet dock quay approximately 1.10m below the present ground surface. Large coping stones [003] were noted above a quay wall constructed in brick [004]. It is uncertain whether the bricks represent the type of construction along this section of quay, or evidence of repair work. It is possible that this section of wall represents the extension to the north wall of the dock in the 1860s (Plate 7 & 8).

Plate 7:
Trench 1 - General shot - looking north.

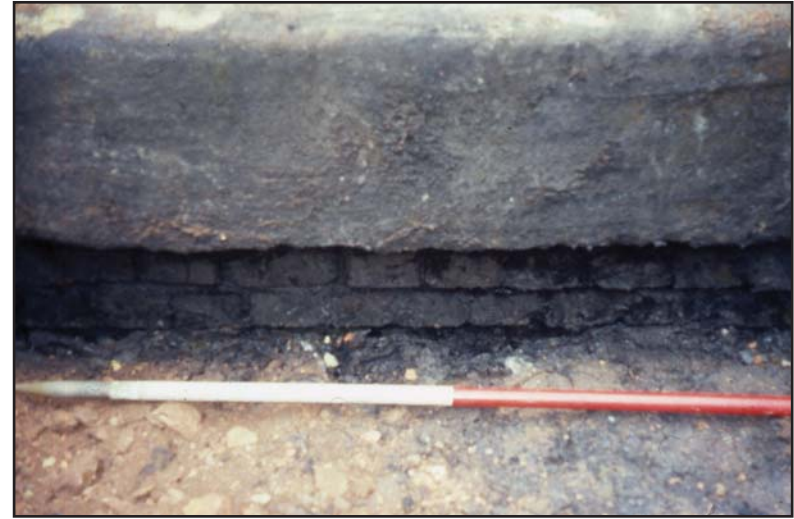
Plate 8:
Trench 1 - Detail of brickwork on quay wall.

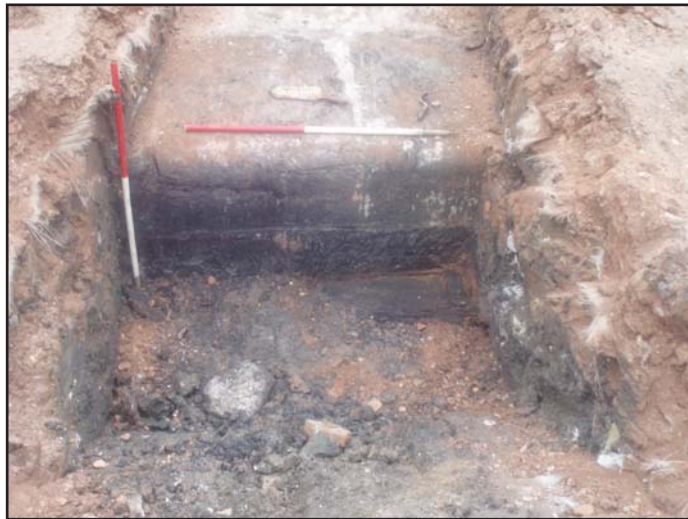
Trenches 2 and 3 were excavated to the west of Trench 1 along the north quay wall of the former wet dock and highlighted similar characteristics of the former quay and associated surfaces. The surface of the former quay was noted approximately 0.70m below the present ground surface in both Trench 2 and Trench 3. The coping of the quay wall comprised large stone blocks with a curved lip along the front edge (Plate 9). The quay wall beneath the coping comprised tightly laid ashlar blocks with coarse decoration on the front face. Attached to the quay wall below the coping was noted the remains of squared wooden timber baulks, employed as brandering to act as fenders to protect the quay structure and the vessels berthed alongside (Plate 10; see also Plate 5). Also of note was evidence for what appeared to be a worn groove situated along the front edge of the coping and the upper courses of the quay wall noted in Trench 2 (a similar groove was noted in Trench 7 – see below). It is possible that these represent the grooves left from the continued rubbing of the cables and hawsers used to attach the berthed vessels alongside the quay.

Plate 9:
Trench 2 - Coping with possible groove (next to scale) cut by rubbing of cables from berthed vessels.

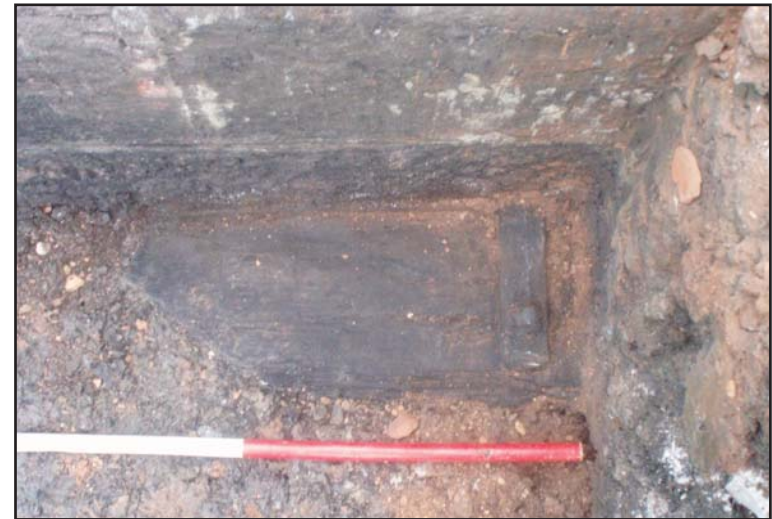
Plate 10:
Trench 2 - Brandering on quay wall.

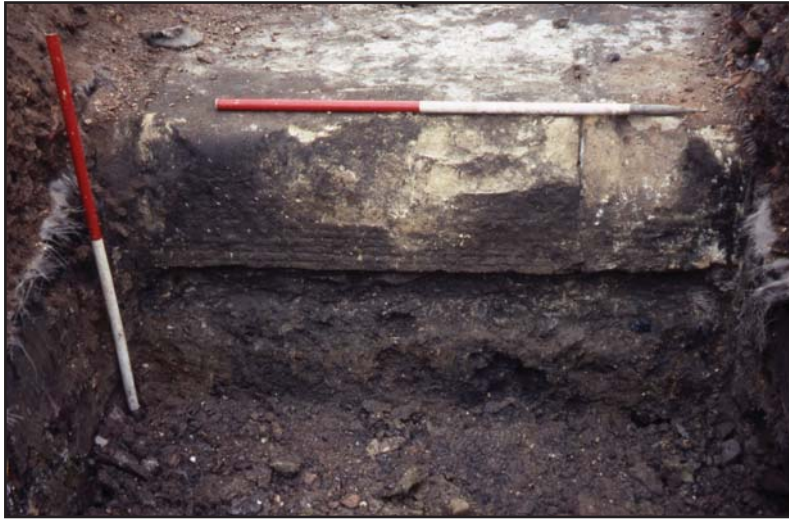
Trench 4 revealed the top of the former south quay of the wet dock approximately 0.80m below the present ground surface. The coping was well worn and fractured yellow sandstone, revealing evidence of decorative droving on the outer face. Beneath the cope was noted coarse concrete, possibly indicative of the construction of this part of the quay, or repairs (Plate 11). Of note is the similarity with the north elevation of the north wall to the new dock gate introduced in the 1880s, possibly indicating the period in which this section of quay might have been repaired. Evidence for rubble in-fill behind the wall and a cinder surface to the rear of the quay was also noted.

Plate 11:
Trench 4 - Cope and stonework of quay - looking south.

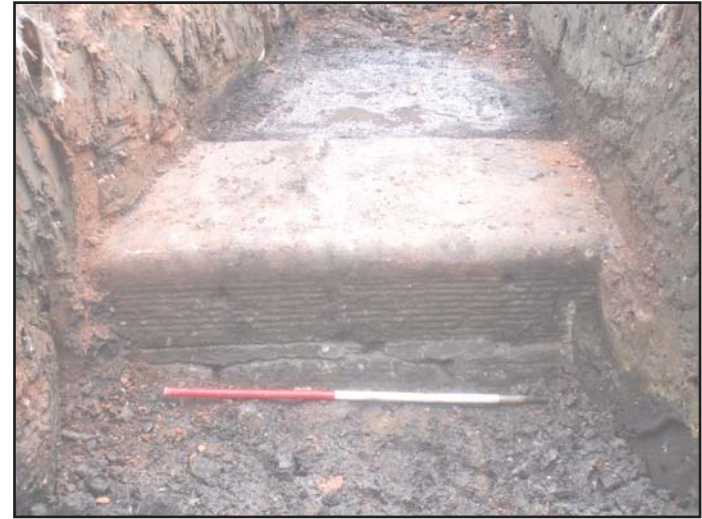
Trenches 5, 6 & 7 revealed similar characteristics comprising large tightly laid cope stones with a curved lip and droved tool marks on the front face. The top of the quay was noted approximately 1.3m below the present ground surface in Trench 5; 0.95m in Trench 6; and 0.70m in Trench 7. The cope stones noted in Trench 5 revealed evidence of small holes in the face of the stone, possibly indicating the presence of lifting holes. The quay wall beneath comprised roughly squared rubble blocks, where the quay noted in Trench 5 displayed a distinct batter, differing from the quay structures noted in Trenches 1-4 and 6-8 (Plate 12). The wall in Trench 5 comprised the eastern quay of the dock, blocking what was once the area of the sluice gates and pond. Behind the quay wall in Trench 5 was noted a compacted, metallated surface. Trenches 6 and 7 were located along the southeast corner of the dock, where the surviving quay structure is likely to represent the extension of the south quay of the wet dock in the 1870s (Plate 13). Also of note were the remains of what appeared to be a worn groove situated along the front edge of the coping [017] and the upper courses of the quay wall noted in Trench 7 (a similar groove was noted in Trench 2 – see above) (Plate 14). Trench 6 revealed evidence for the continuation of the cinder surface [016] noted behind the quay wall in Trench 4.

Plate 12:
Trench 5 - Cope and stonework of quay - looking south.

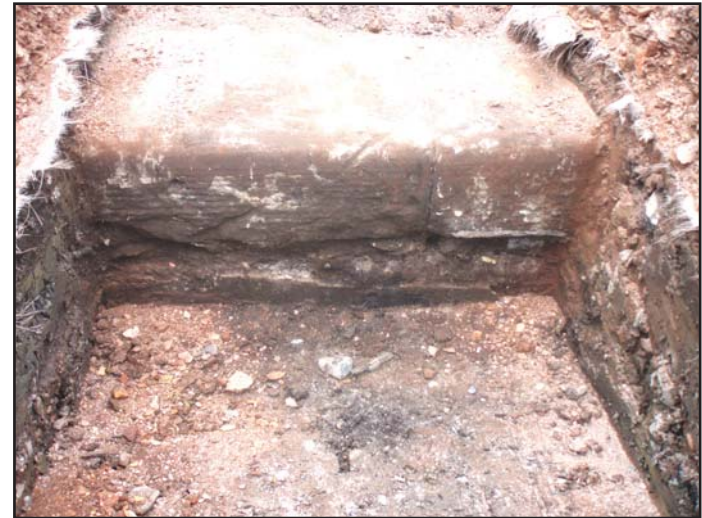
Plate 14:
Trench 7 - Cope and stonework, and possible groove from cable - looking south.
