Date: November2007  
Client: Kenmore Homes Ltd  
Project Code: AHC07

## **Development Site, the Shore, Alloa Harbour, Clackmannanshire**

**Historic Building Recording**

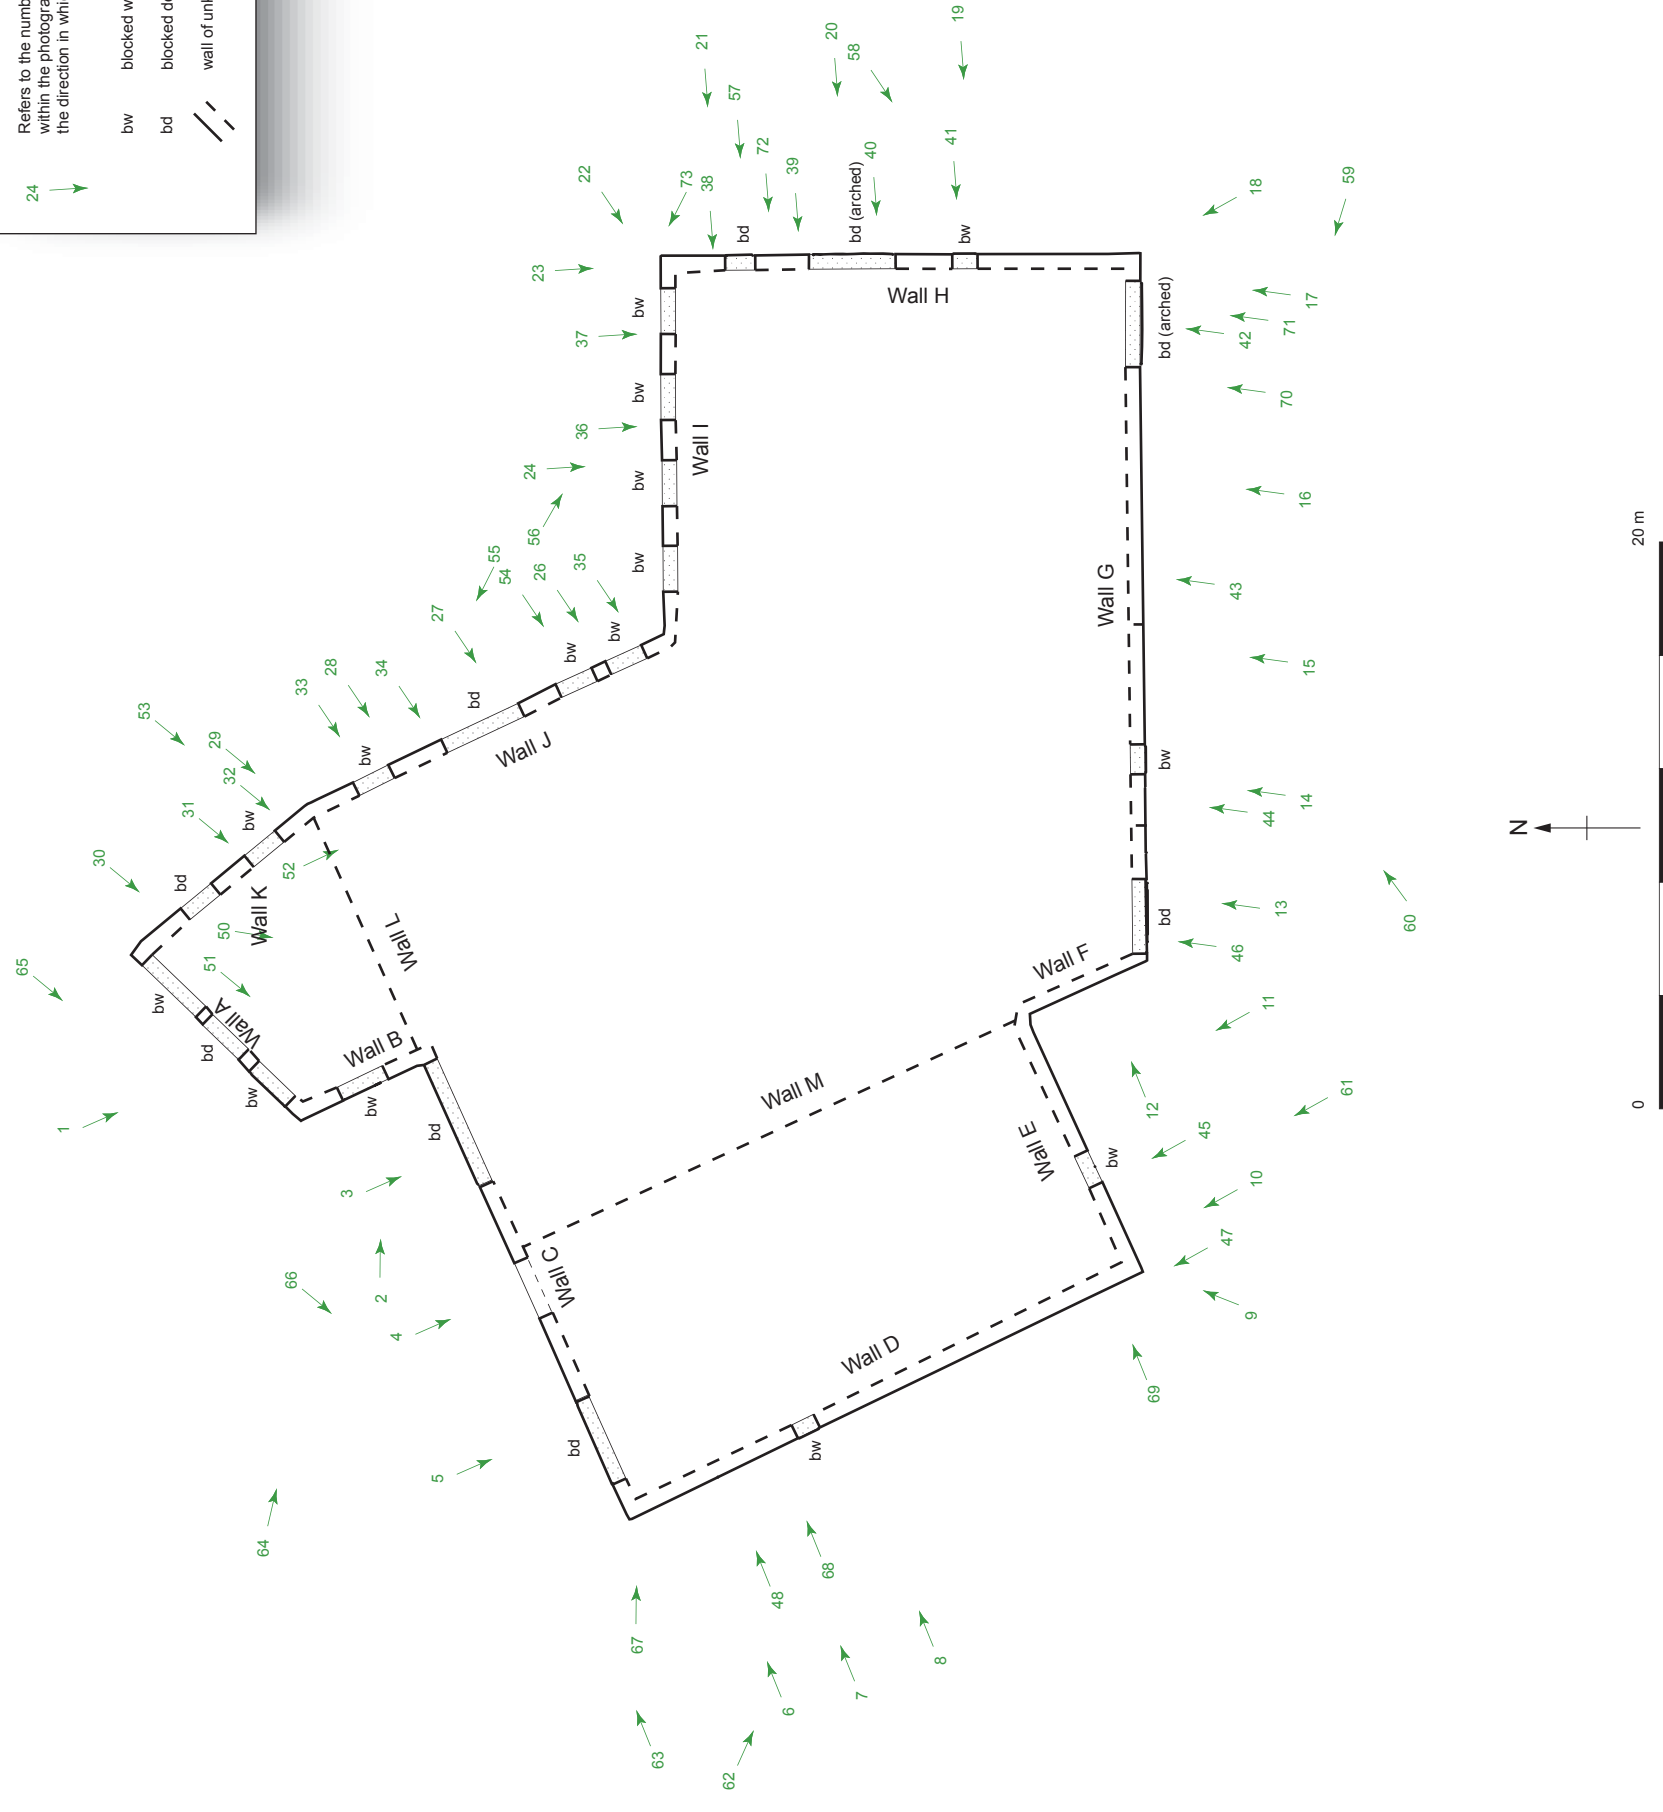
Figure 3 : AHC07, Alloa Harbour  
- Ground floorplan and photo locations

The current building is composed of 13 walls (2 internal), labelled A-M. The walls were surveyed externally and photographed; the results are presented in Figure 3.

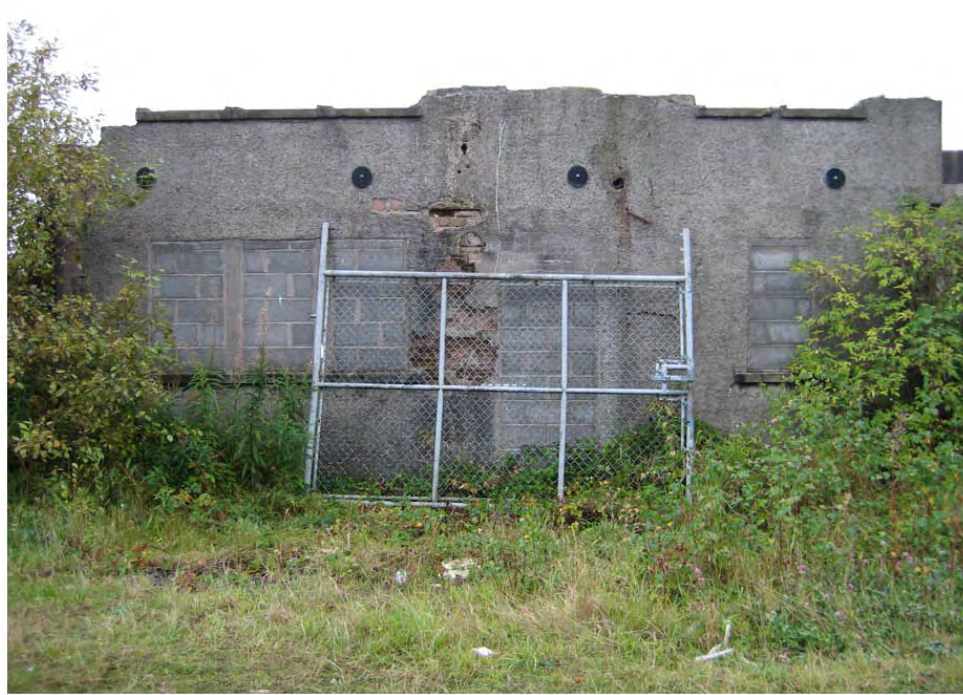
AHC07-Phase2-01.JPG

Wall A is cement rendered, with rubble behind (Photo 1). There are door and window openings (blocked) with concrete cills and evidence for a first storey. There are tie plates from an internal floor. The wall was built by 1900, but the fenestration is later 20<sup>th</sup> century, relating to a final phase of use.

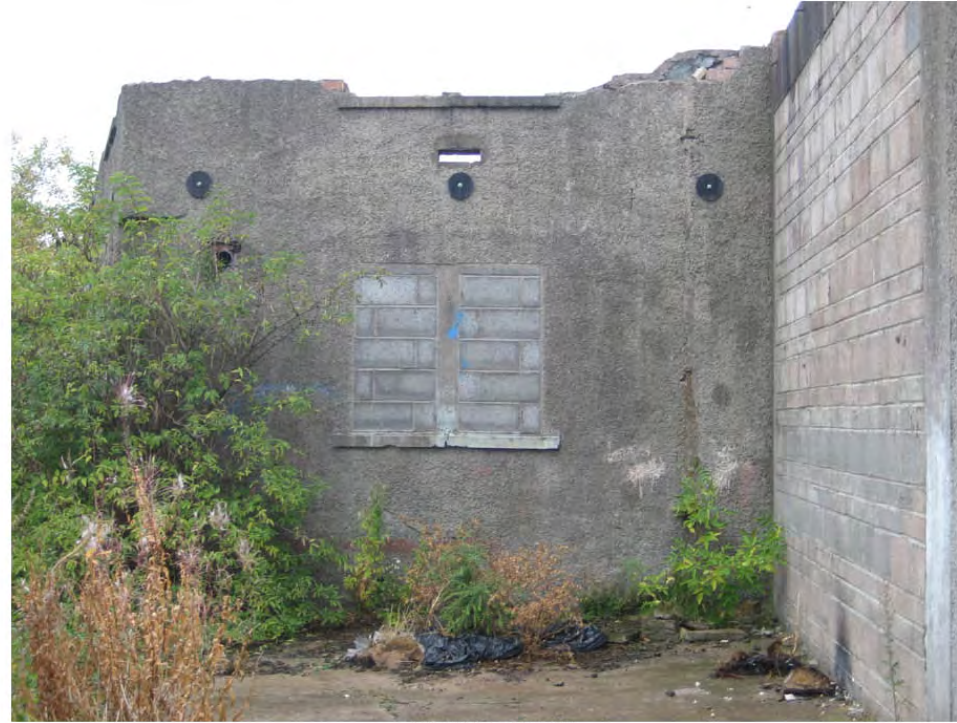
AHC07-Phase2-02.JPG

Wall B is also cement rendered with the same pattern of windows as Wall A (Photo 2). It is probably the same phase as Wall A with similar later alterations.

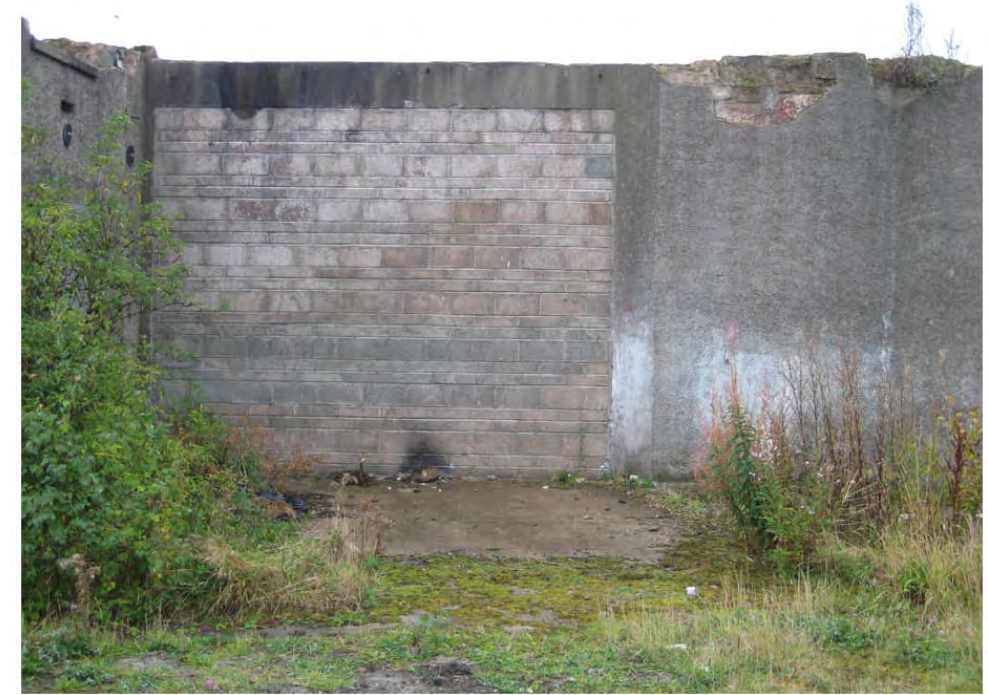
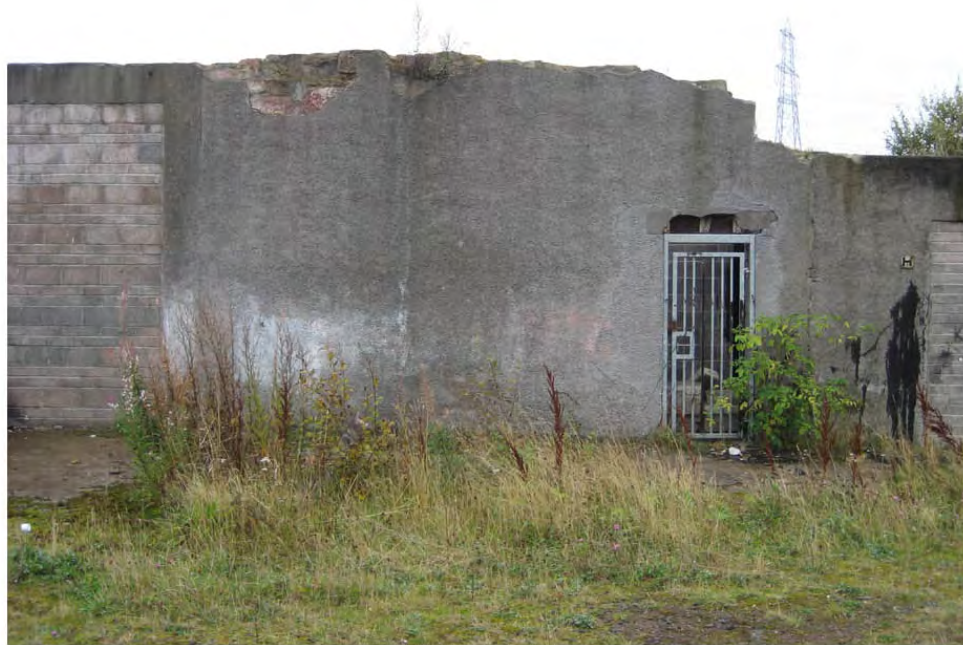
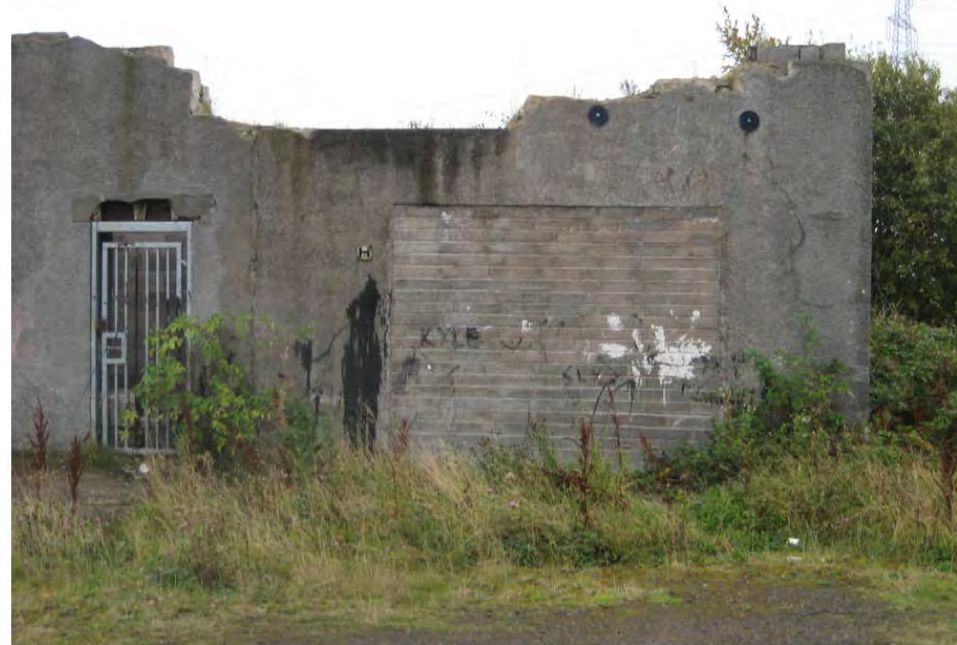
Wall C (shown in Photos 3-5) is also cement rendered, obscuring detail, with later inserted openings. Fragments of squared sandstone blocks are visible behind the render and maps suggest the SW part of this wall is probably amongst the earliest on the site. It has however been rendered in the late 20<sup>th</sup> century and later fenestration has been inserted.

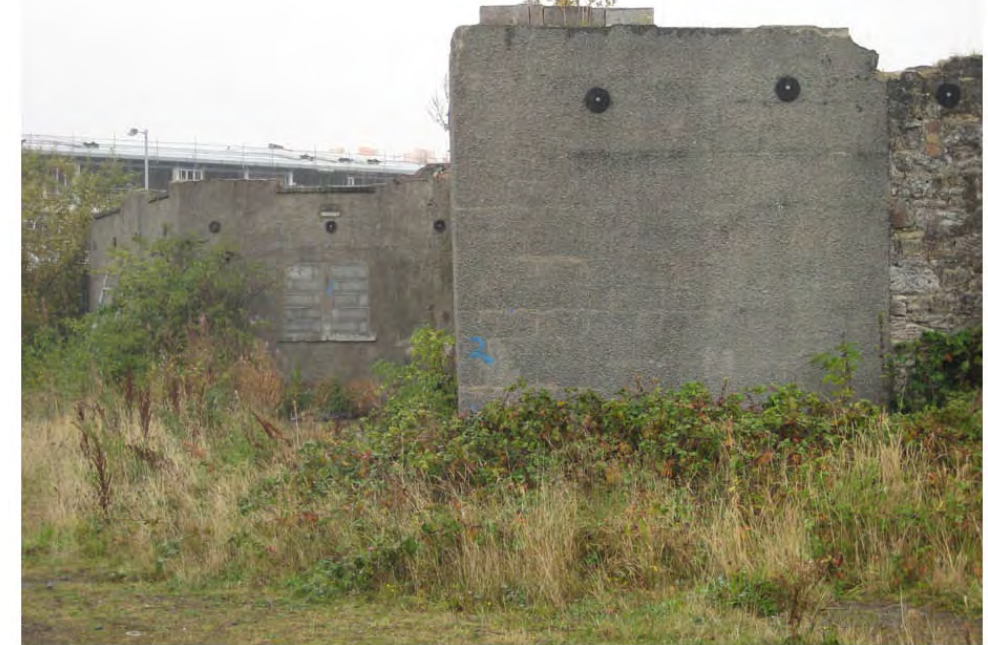
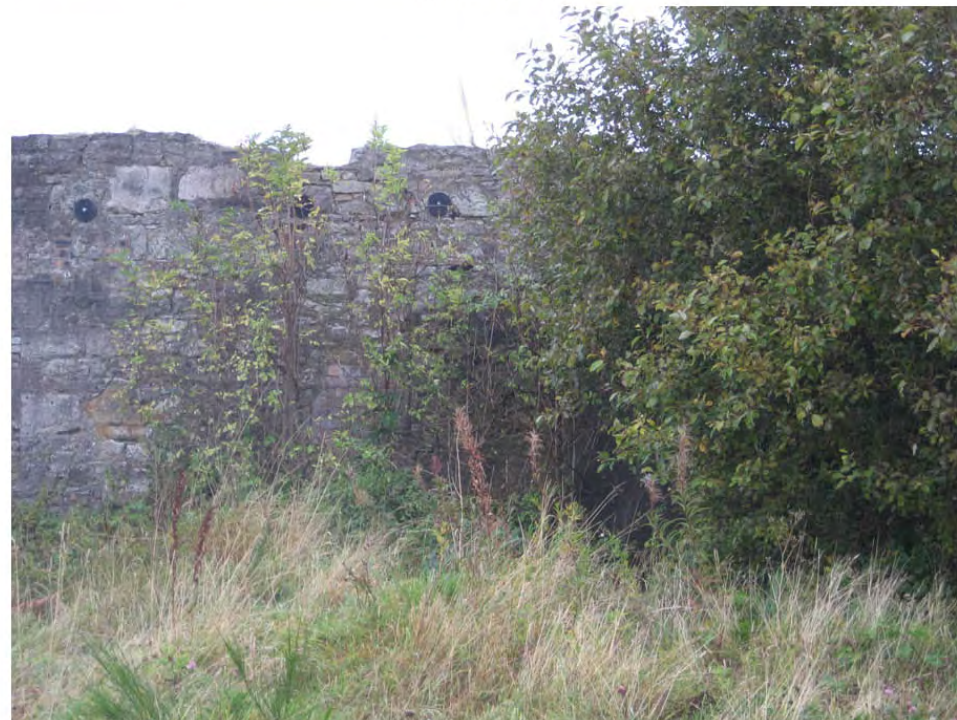
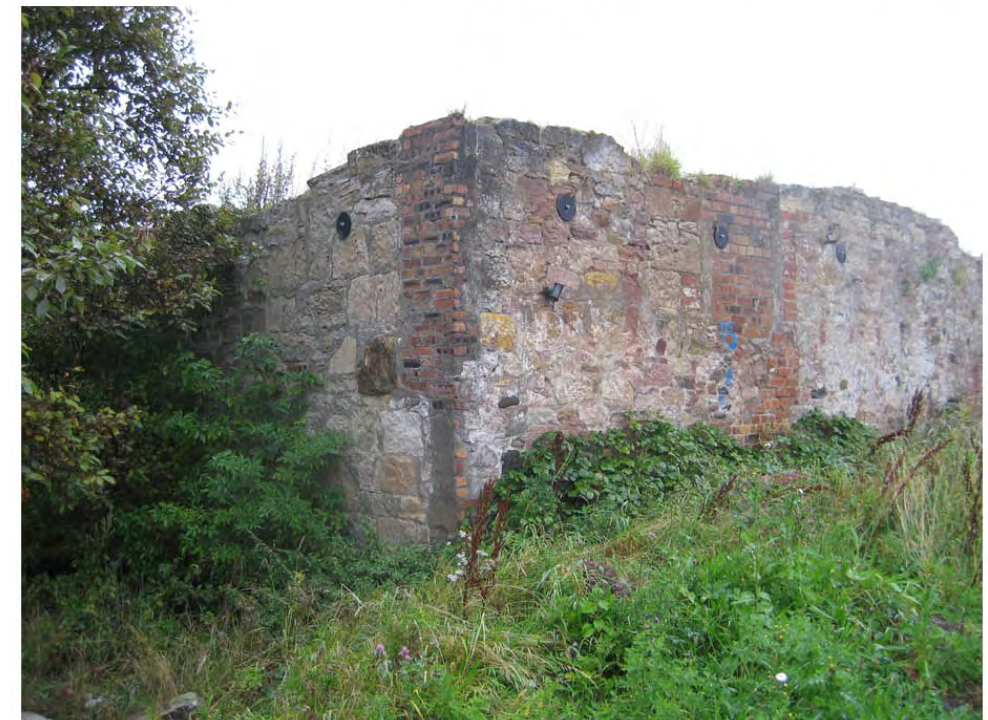
Wall D is partly obscured by vegetation and the NW area is cement rendered (Photos 6-9). It is built in squared rubble brought to courses with modern brick patching (in joist holes) and tie plates. There is at least one blocked opening, probably original, with a heavy droved lintel (Photo 7). The corner to Wall E has been rebuilt in brick. The wall is depicted on the 1860s maps and later buildings have been constructed against it, hence the joist holes.

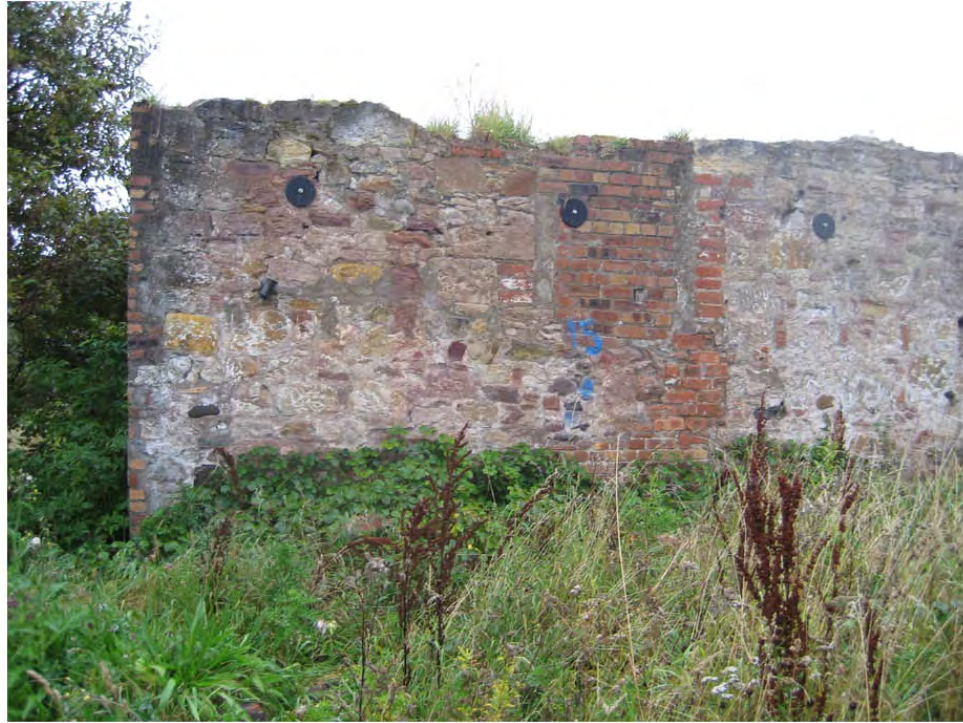
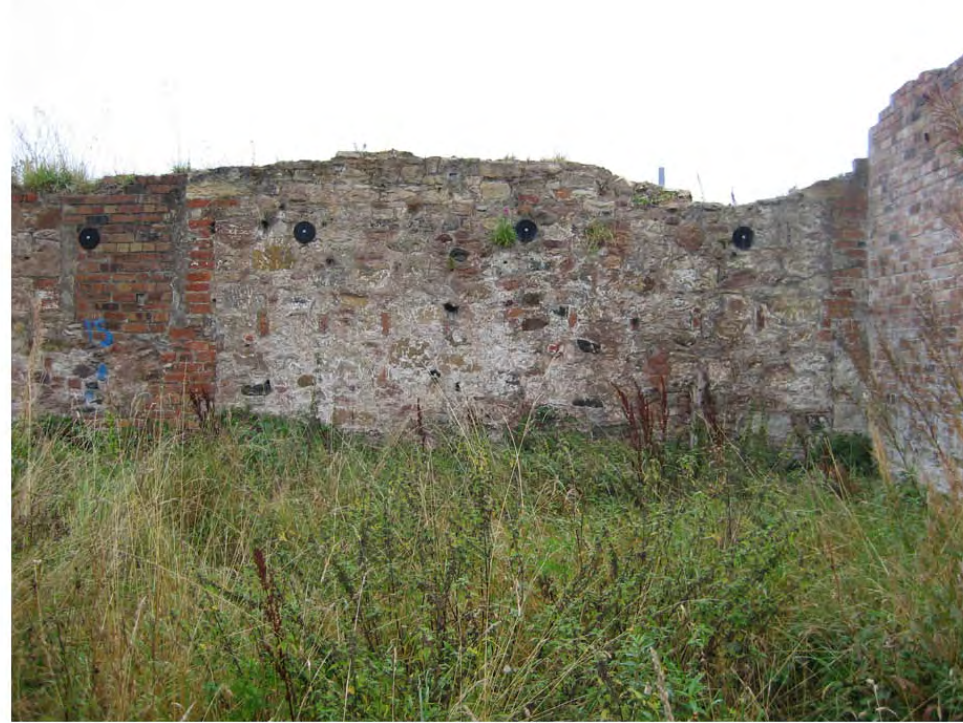
Wall E is in more random rubble with some squared stones and a mixture of pink and yellow sandstone (Photo 10 and 11). The joist holes at a lower level (suggesting ground level changes) and a blocked door opening at first floor height. The maps suggest the wall may have been present by the 1860s, and this face may have been internal, hence the lack of dressed stones around the aperture.

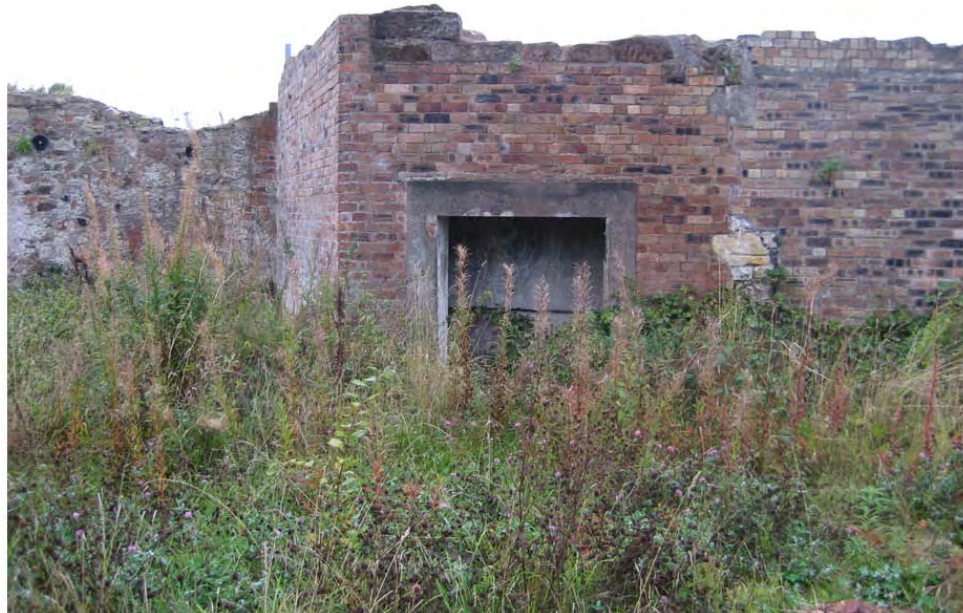
AHC07-Phase2-13.JPG

Wall G is long and composite, modern brick (in 3 phases) changes to masonry at the E (Photos 13-17). The W part matches Wall F and includes a large doorway (Photo 13). Fragments of masonry suggest a possible 19<sup>th</sup> century corner here. The brick changes to a different build though of a similar phase, probably reflecting historic differences in the masonry walls. A low blocked opening was a window (Photo 14).

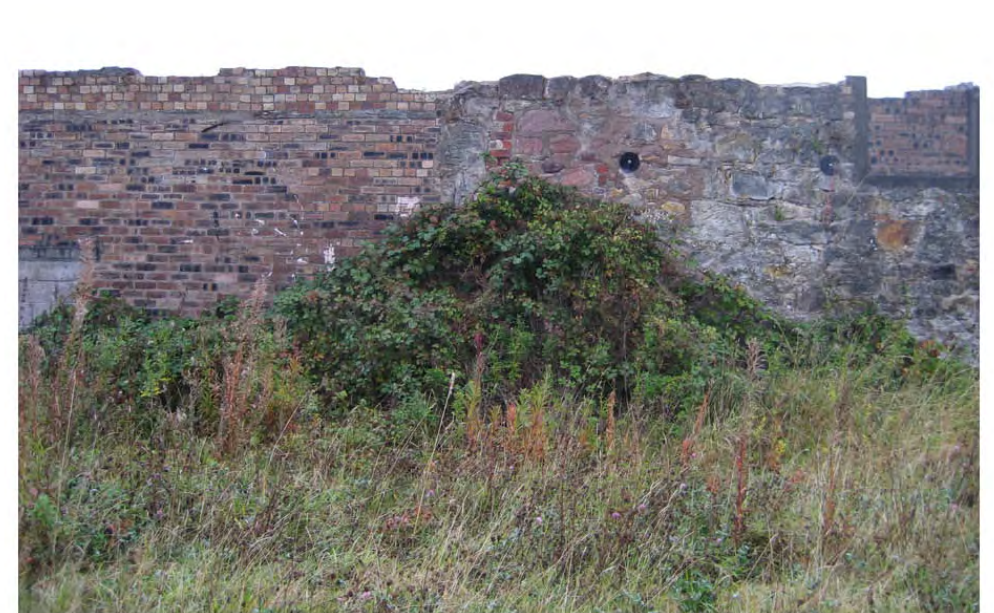
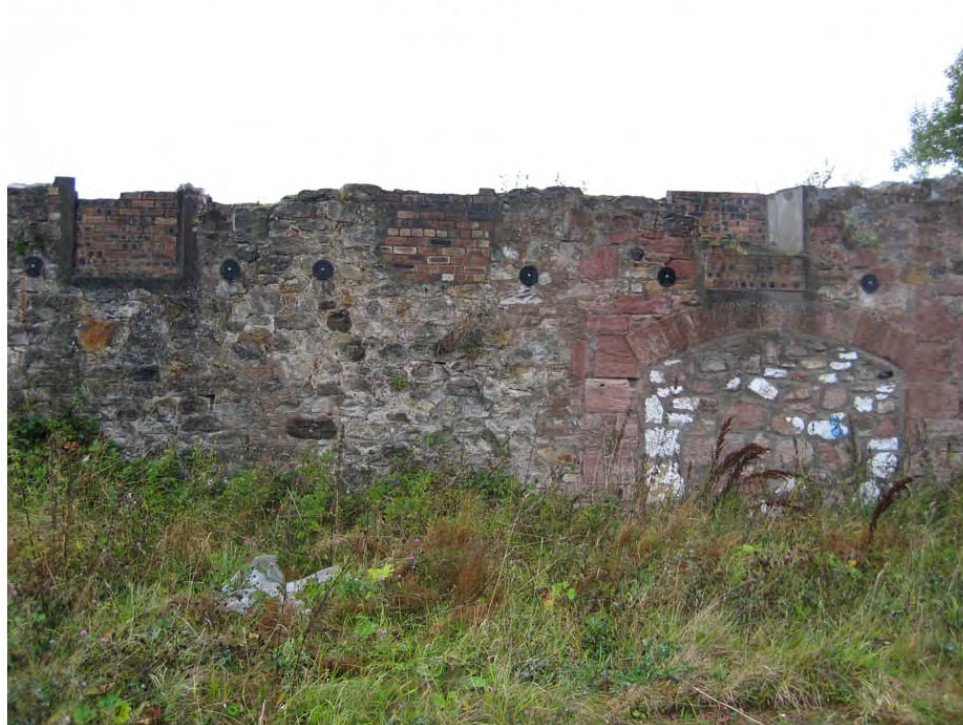
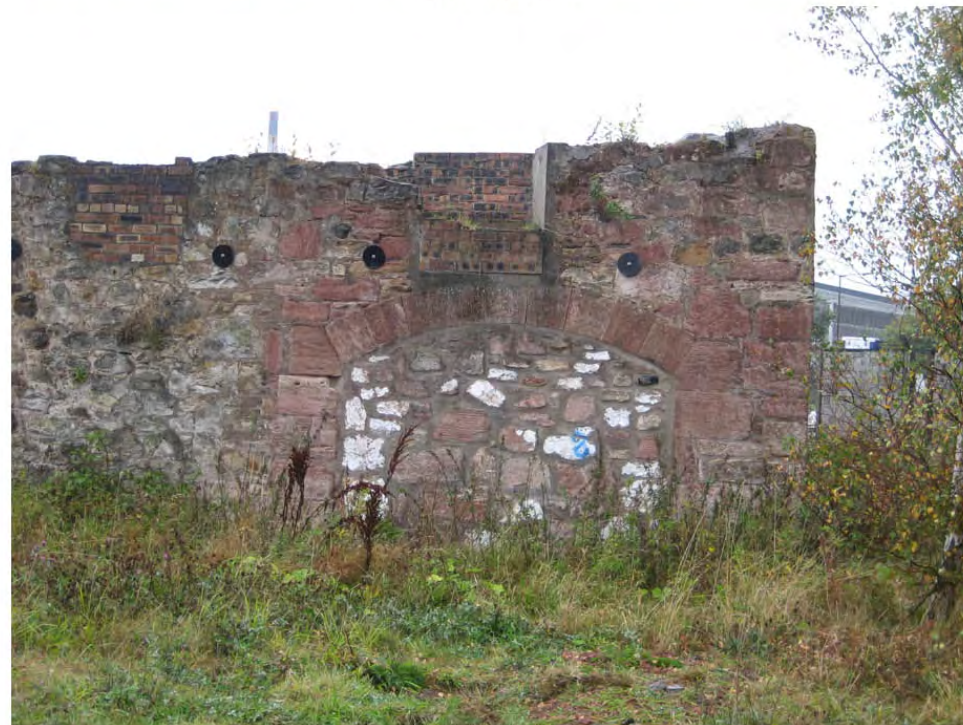
The walling changes raggedly to masonry half way along; this is half coursed and roughly squared, a mixture of yellow pink and grey limestone and sandstone, partly obscured by cement pointing; it is similar to Wall E. The upper window openings are later, inserted at first floor height. A cart arch at the E has a segmental arch formed with droved voussoirs and jambs with draft margins (Photo 17). The arch is original and external, though it has been altered slightly and the masonry to the W may be slightly earlier. The arch is keyed into the corner to the W. Maps suggest this was probably a mid-wall by 1862 but almost certainly built by 1825, though the site plan doesn't fit well on this less accurate survey.

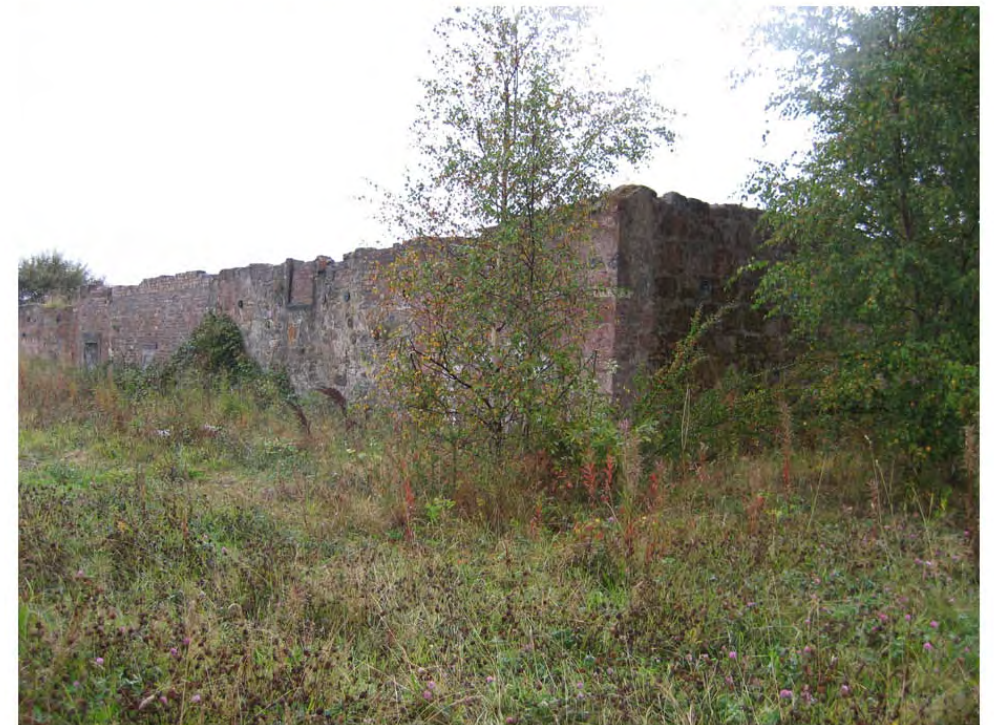
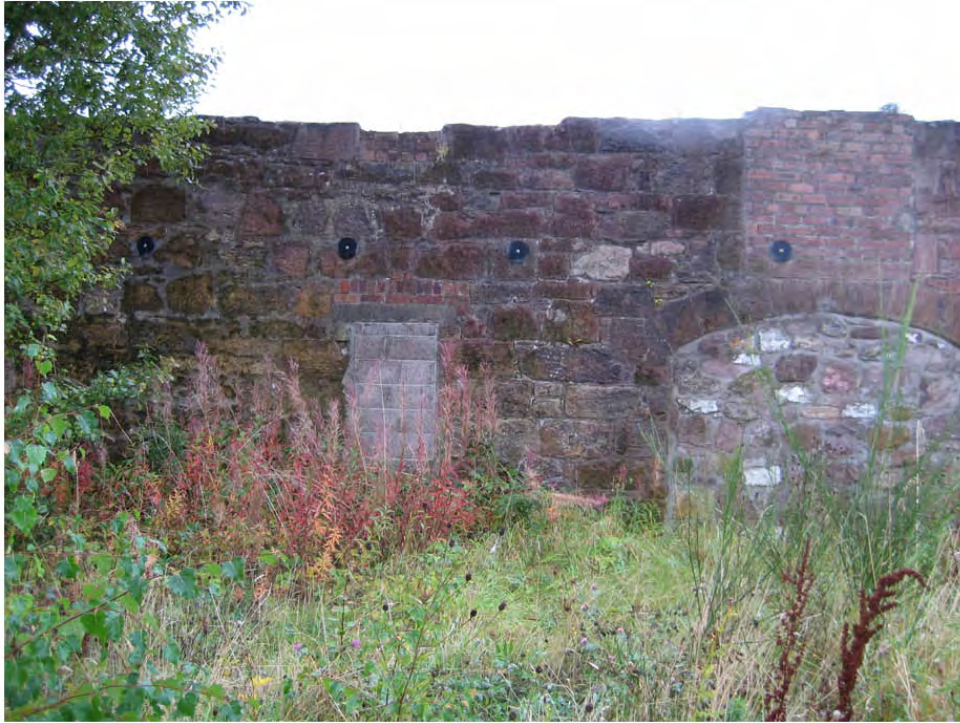
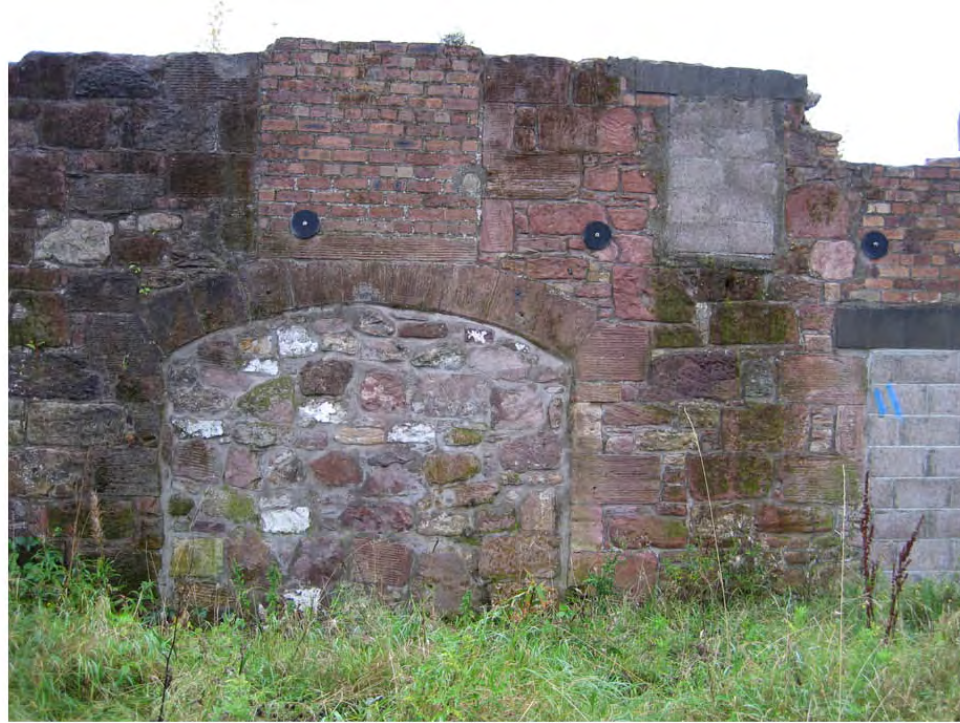
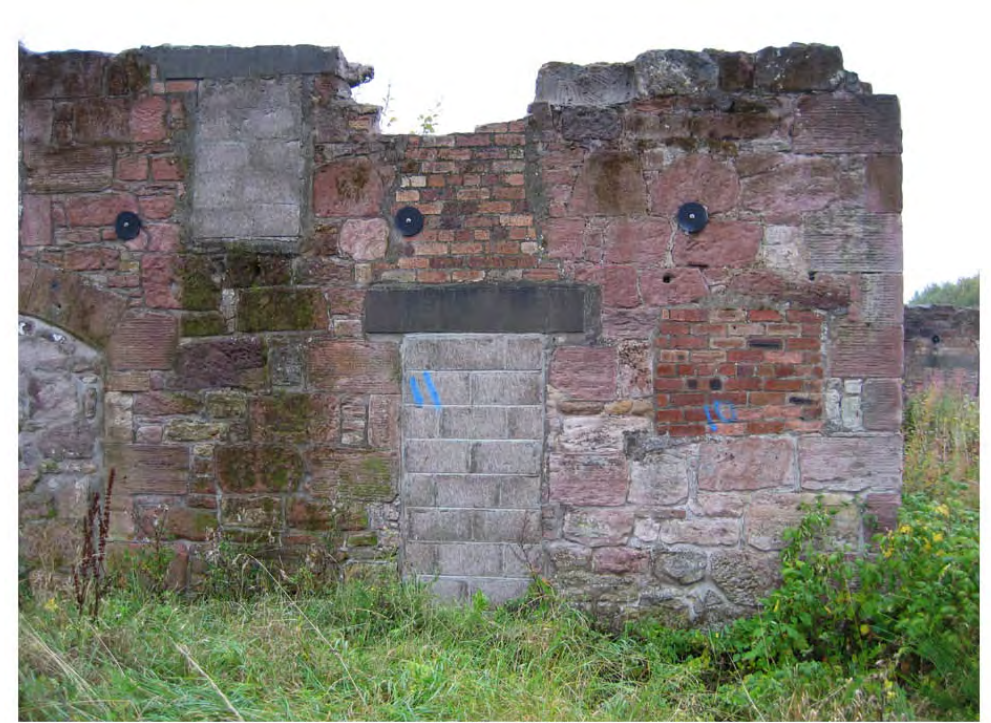
Wall H is masonry, partly obscured at the S by vegetation (Photos 18-21). The S part is in squared rubble which is probably keyed into Wall G, suggesting they are the same phase. Further N, the masonry continues as roughly squared blocks brought to courses, slightly neater and probably later than elements of Wall G and Wall E. The openings visible in Photo 19 are probably all original, with pink sandstone dressings, droved with draft margins. Brick blocked openings at the N of the elevation are later (Photo 21). The maps suggest that the S part of H is built by 1825, though the whole elevation was probably rebuilt before the 1900 survey and after 1866.

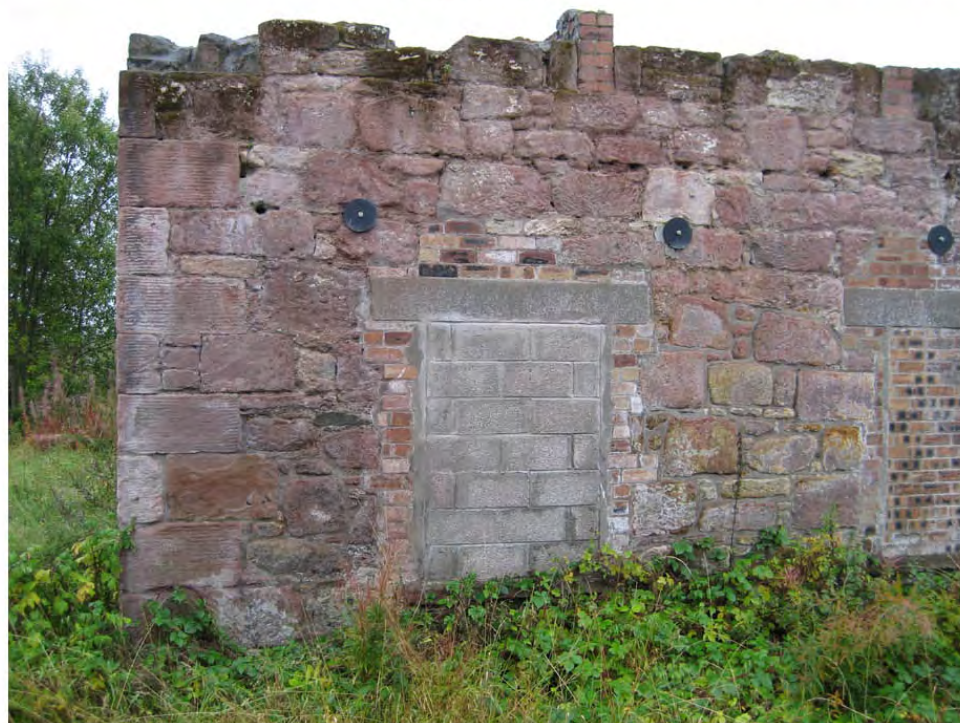
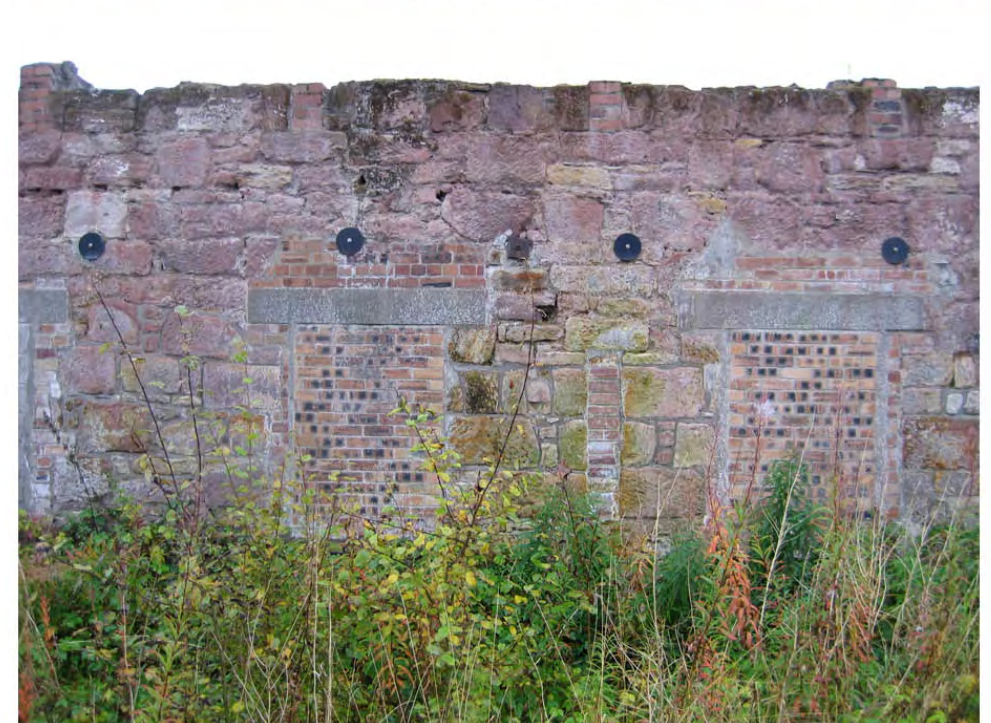
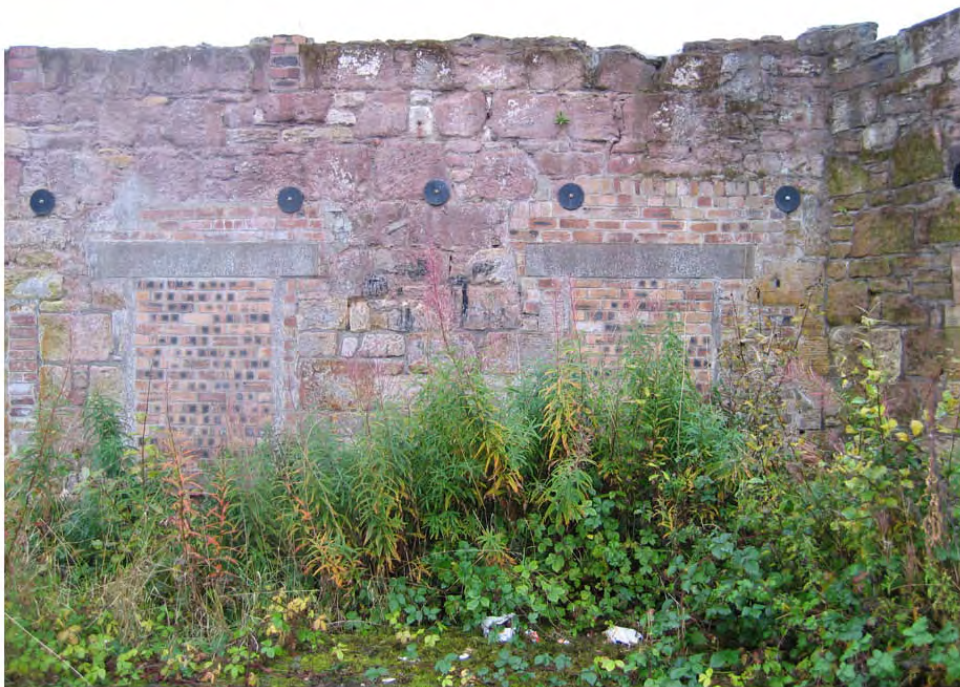
Wall I returns from H in the same style of walling with matching dressed quoins (Photos 23-25). The four door openings are all 20<sup>th</sup> century insertions. Maps suggest a later 19<sup>th</sup> century date, which is likely to be contemporary with H.

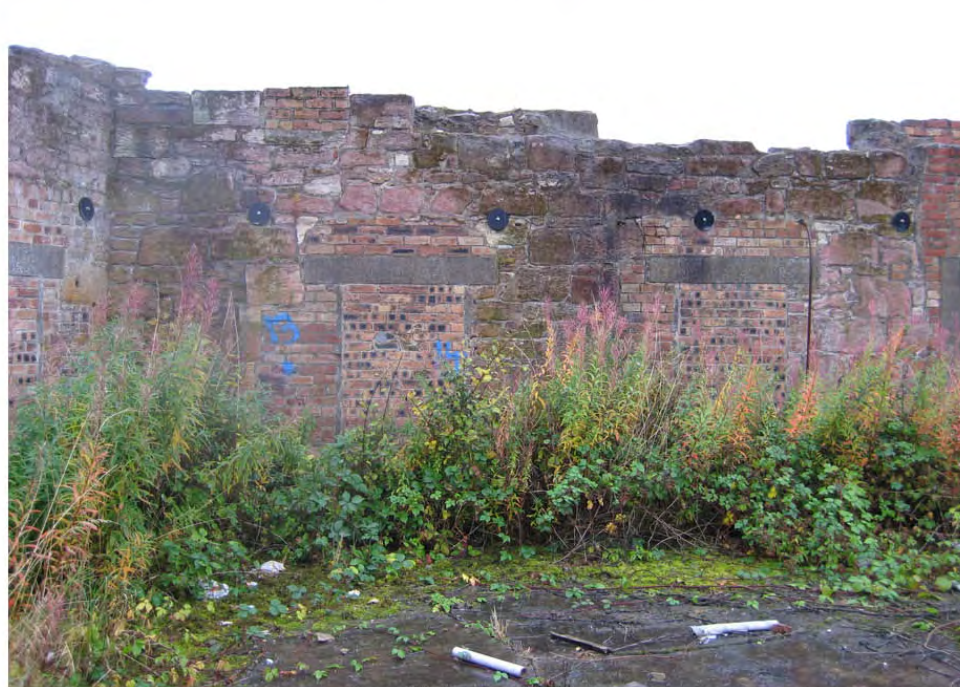
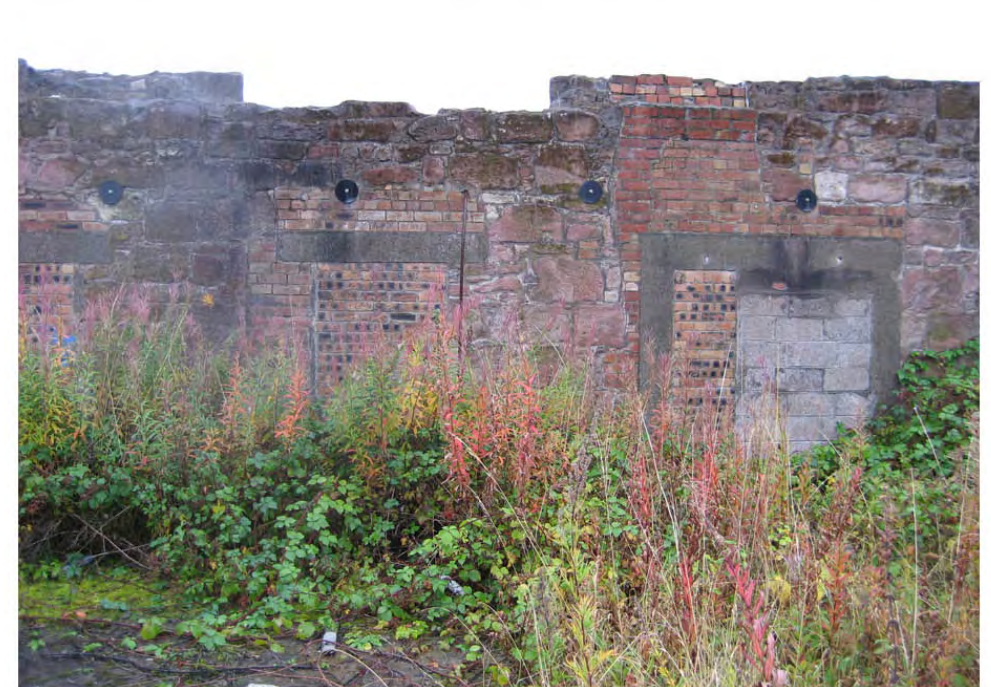
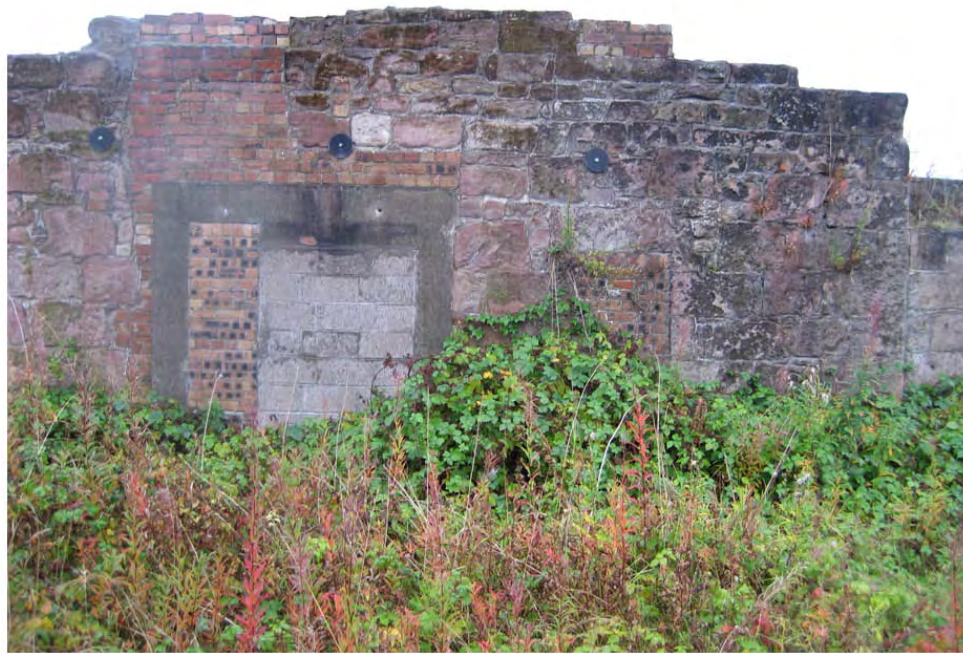
Wall J (Photos 26, 27, 28) is in similar squared and half coursed rubble, again with inserted openings resulting in patches of brickwork. There is a straight joint between J and K and the quoins here are different to the H/I pattern, so it may be a slightly later wall. Again, maps show this wall built between the 1866 and 1900 editions.

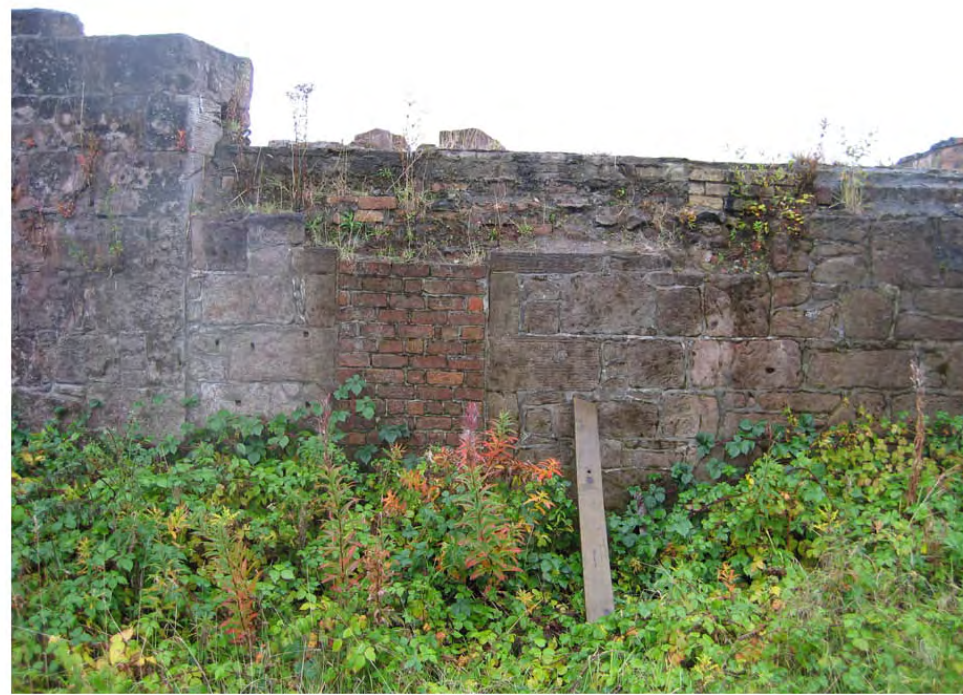
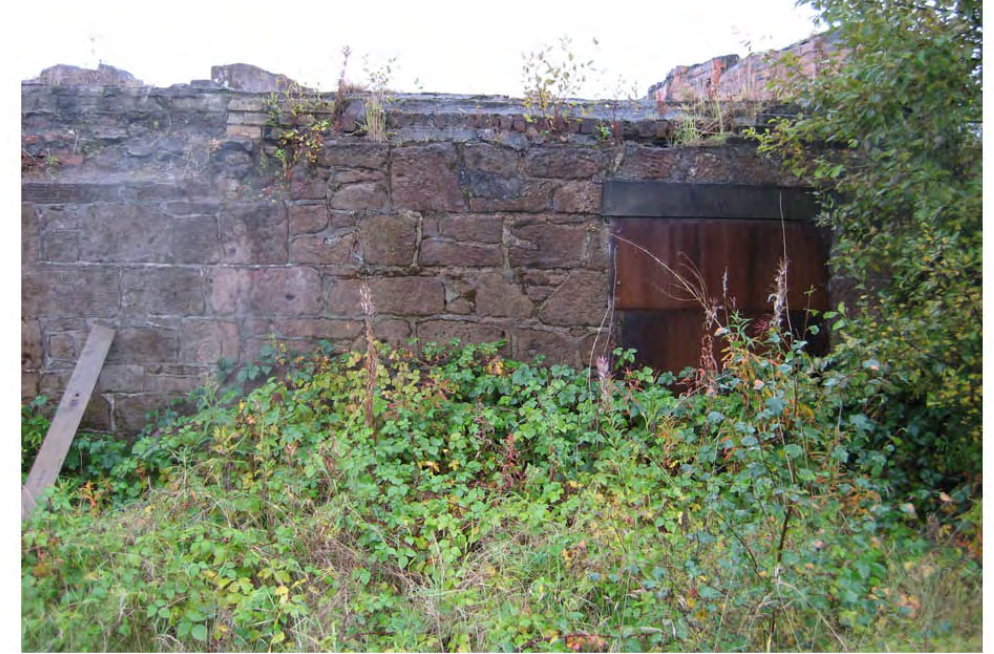
Wall K (Photo 29/30) is also in squared coursed rubble, and is probably of a broadly similar phase to J, H and G. The SE doorway re-uses some dressed jambs but is probably 19<sup>th</sup> century, the NW is later. Maps again show this as a 1866-1900 feature.
