Kelton Mill Kennels, Threave : Historic Buildings Recording.

HISTORIC BUILDINGS RECORDING

KELTON MILL KENNELS

PROJECT SUMMARY SHEET (KKM 03)

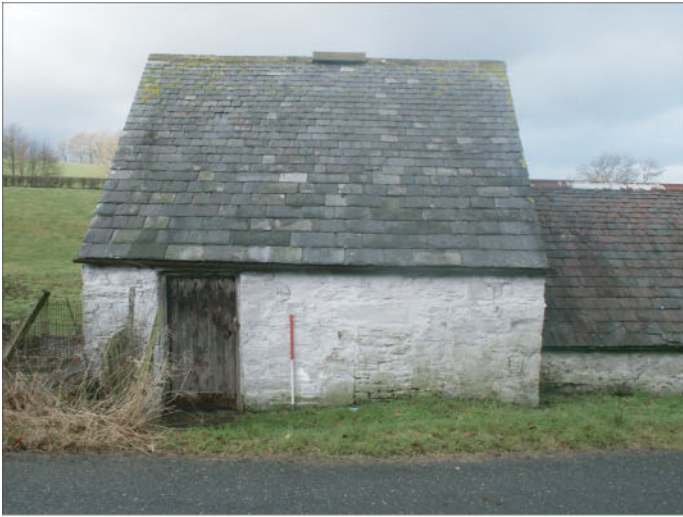
The upper floor of Building A, Room 2, is entered through a doorway at modern road level on the east side with a blocked window opening in the same elevation (*Plate 1*). Internally the space is open to the rafters.

Plate 1 : Building A - Room 2. South exterior elevation showing doorway and blocked window. The building has been recently re-roofed. The modern ground surface may be higher than contemporary with the building.

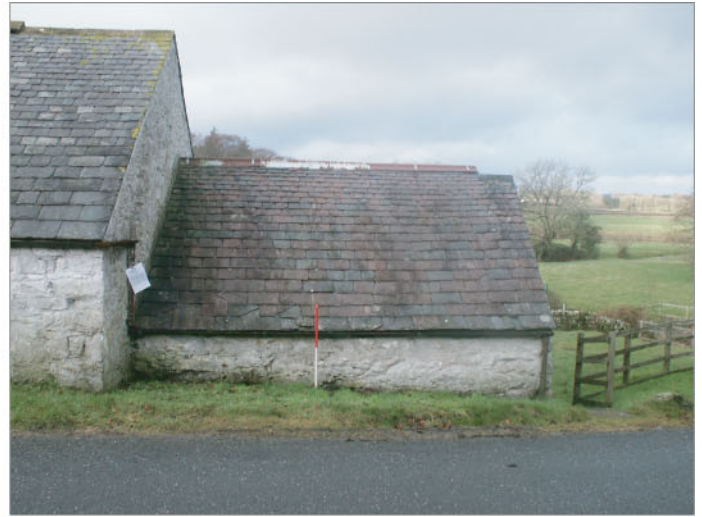
Plate 2 : Building B loft, Room 4. South exterior elevation. Blocking for chute is central and partly obscured by modern ground surface. Compare colour of tiles with those of Building A.

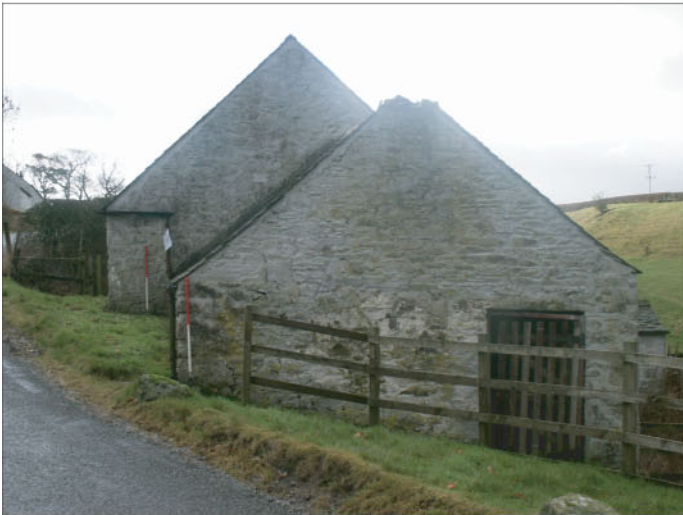
Plate 3 : Buildings A and B. East exterior elevation shows doorway and level courses in gable masonry. The chimney stack is missing and the flue has been sealed.

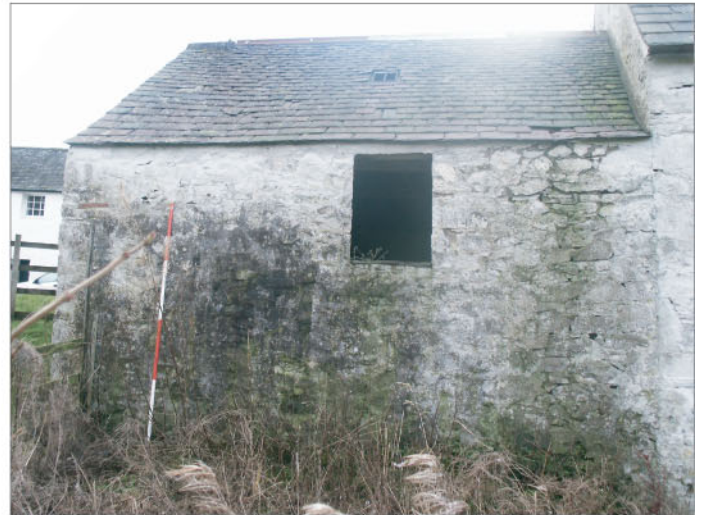
Plate 4 : Building B Room 3. North exterior elevation showing window. Kelton Mill is to the rear.

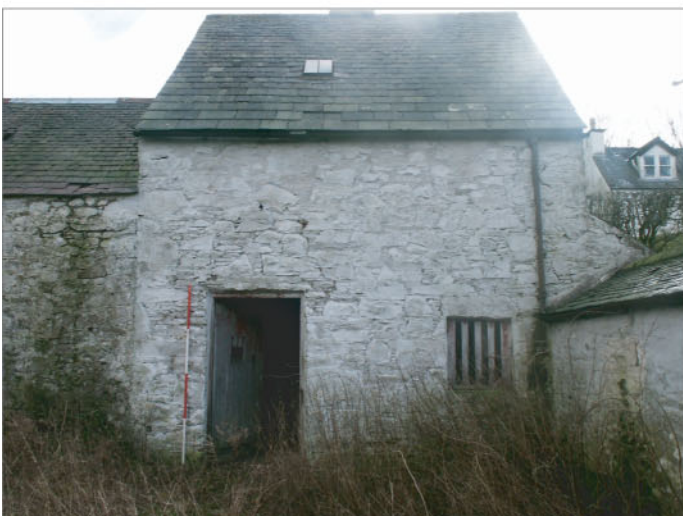
Plate 5 : Building A. North exterior elevation showing doorway, original door and window. Building D is shown part butted on the right.

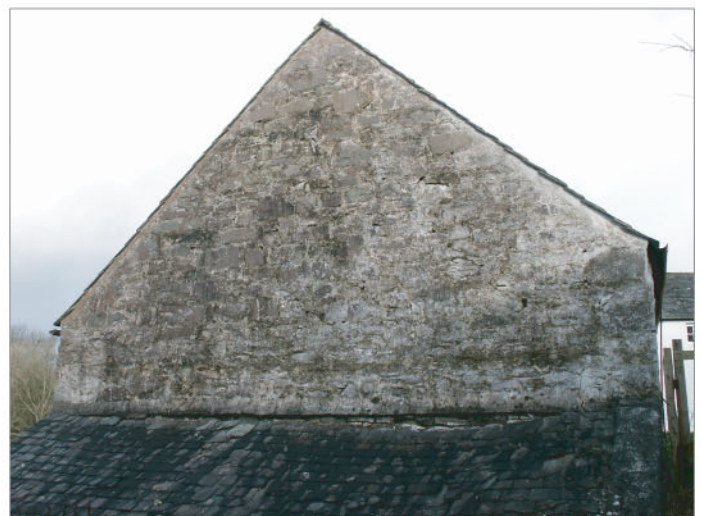
Plate 6 : Building A. West exterior elevation, gable (Room 2) above Building C the earlier kennels. The single-pitch roof is part bonded with the wall and sealed with flashing.

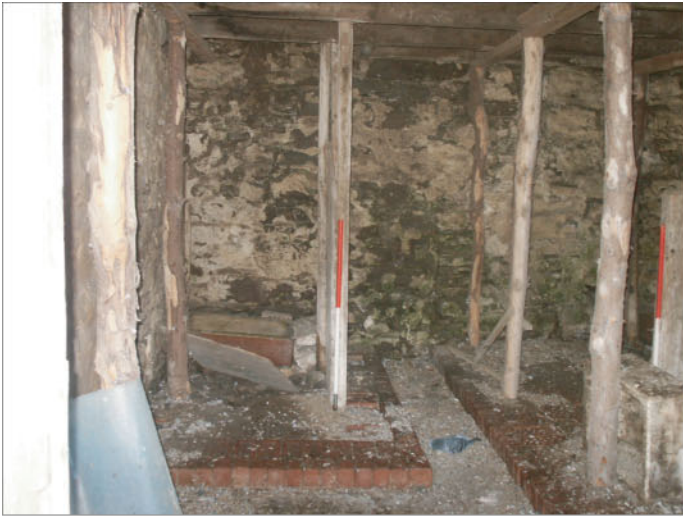
Internally the space is divided up into four stalls defined by wooden trevises of an apparently single pattern. The spaces are further defined by the cobble and brick floor surfaces and the T-shape floor drain; cobbles are confined to within the stalls (*Plate 7*).

Modern additions are the provision of rough lumber supports for the floor joists of Room 2 above.

Plate 7 : Building A, Room 1. South interior elevation showing cobble and brick floor and blocked opening. Note the rough timbers, which are recent additions, supporting the joists of the upper floor.

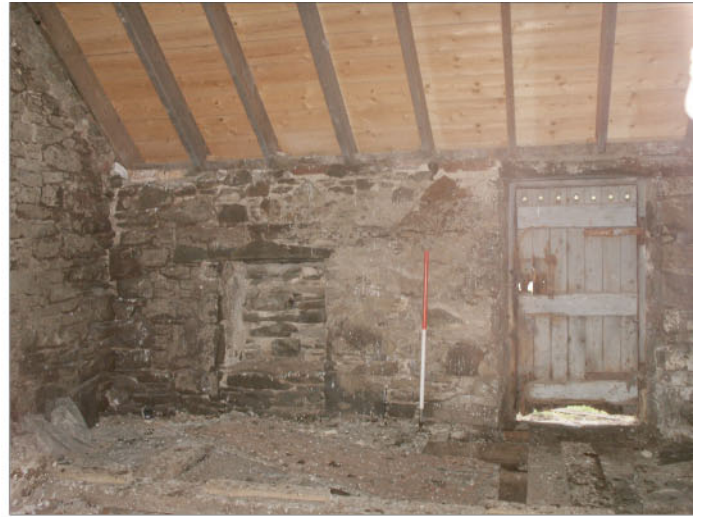
The original upper floor of Building A, Room 2 was of single planks laid across floor joists inserted into the walls. The existing floorboards are very rotten and supplemental timbers have been laid in places in order to make it safe. The surviving floor is now reinforced from below by rough timbers supporting planking beneath the joists (*Plates 7 and 8*).

The poor condition of the floor boards is also likely to be due to water introduced via a previously leaking roof.

Plate 8 : Building A, Room 1. South interior elevation showing doorway and blocked window. The original floorboards are rotten and in a dangerous state. The roof construction is a modern replacement.

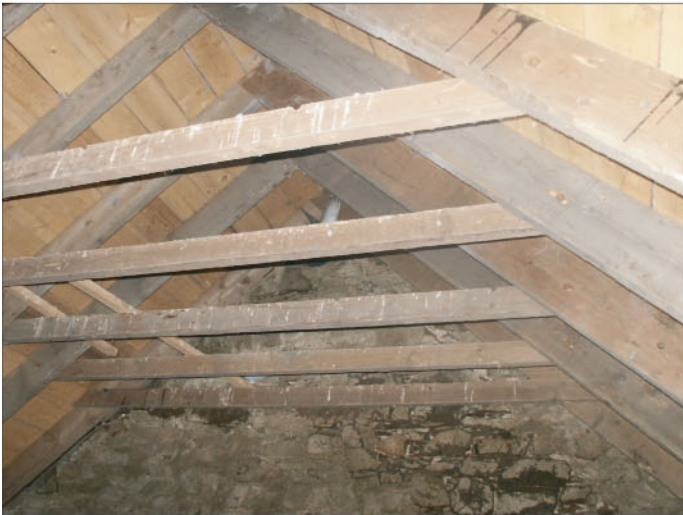
The present roof construction is not original the whole having been re-roofed recently. It is of typical A-frame type consistent with the original fabric of the building but of entirely new materials utilising the original wall head (*Plate 9*). There is a ceramic roof vent central to the ridge and a two pane single light in the west side of the slated roof.

Plate 9 : Building A Room 2. View of modern roof trusses and sarking showing bolted together collar beams and rafters.

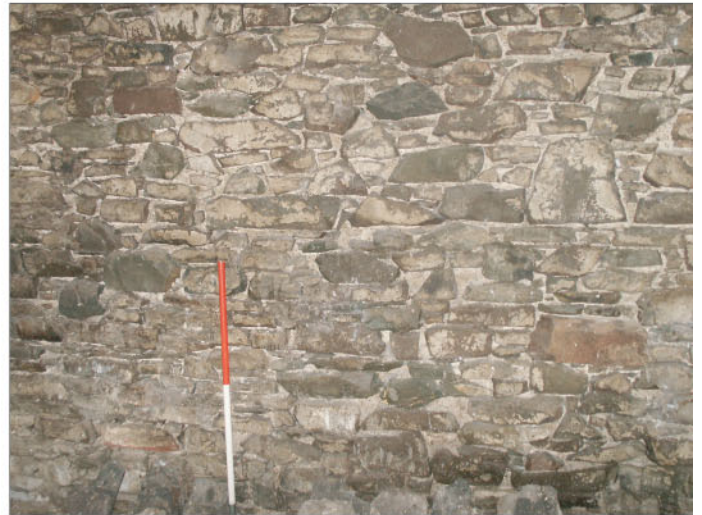
There is good evidence for coursing within the masonry here due to the limewash having been largely removed and the pointing subsequently raked out. Particularly noticeable is the difference between coursing at the continuous wall head level and that of the south gable (*Plate 10*). The lack of surviving limewash may in part be due to weathering from when the roof was previously derelict.

Plate 10 : Building A, Room 2. West interior elevation. Note the set course at wall head height and the raked out pointing.

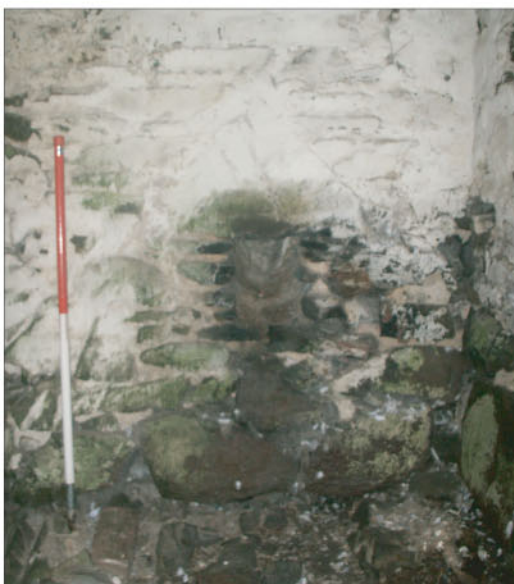
The north gable of Building **B** contains the only evidence of there having been a hearth in any of the buildings; the location of an opening for a narrow flue in the north wall suggests an original corner location (*Plate 11*). No hearth survives but it seems improbable that the original purpose of Building **B**, provided with a chimney and hearth is conducive to its latter use as a byre. The chimney is now missing and it may have been demolished when the hearth was no longer in use.

Plate 11 : Building B, Room 3. East interior elevation. The chimney flue. Note triangular arch and narrow opening.

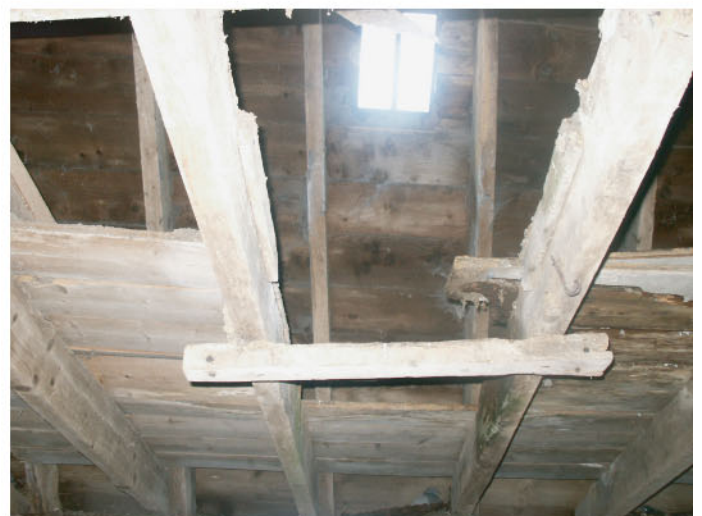
The loft, Room 4, is accessed via an open trap adjacent to the window, originally by ladder (*Plate 12*). The loft floor is laid directly onto the tie beams of the A-frame trusses but has an additional single course of angled planking spanning floorboards to sarking, thus effectively creating a distinct compartment within the loft space. The east side of the loft floor incorporates a wooden chute constructed between two of the trusses (*Plate 13*). The chute angles toward the face where it terminates. There is some evidence in the external wall face to suggest that the chute originally extended beyond its present limits.

Plate 12 : Building B, Room 3. Location of trap access to loft space, Room 4. Note sawn floorboards and batten to support ladder.

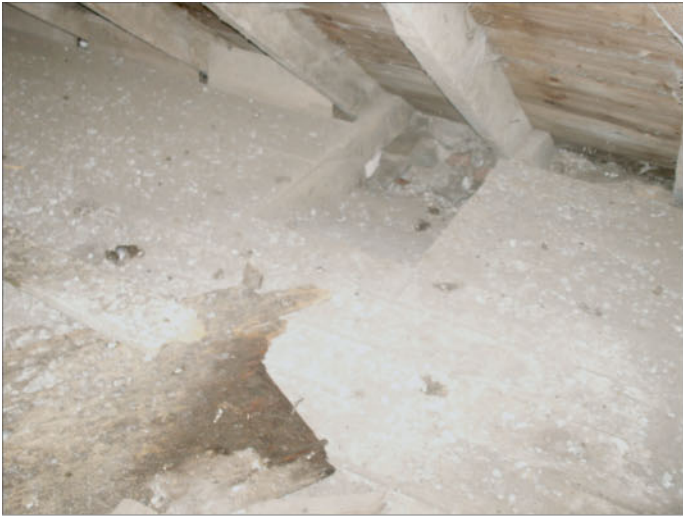
The loft, Room 4 Building **B**, was perhaps a grain store with access to the chute through the wall face, subsequently blocked (*Plate 13*). If this were so then an earlier ground surface or passage may exist below that of the modern ground surface. Similarly the blocking seen in the east wall of Room 1 Building **A** may once have provided some form of access to the of the building exterior. Correspondingly, entry into Room 2 at the existing ground level may not be an original feature of the building.

Plate 13 : Building B loft, Room 4. South interior elevation. Detail of chute. Floorboards directly overlie tie-beam of trusses. Note angled plank between floor and sarking in eaves space.

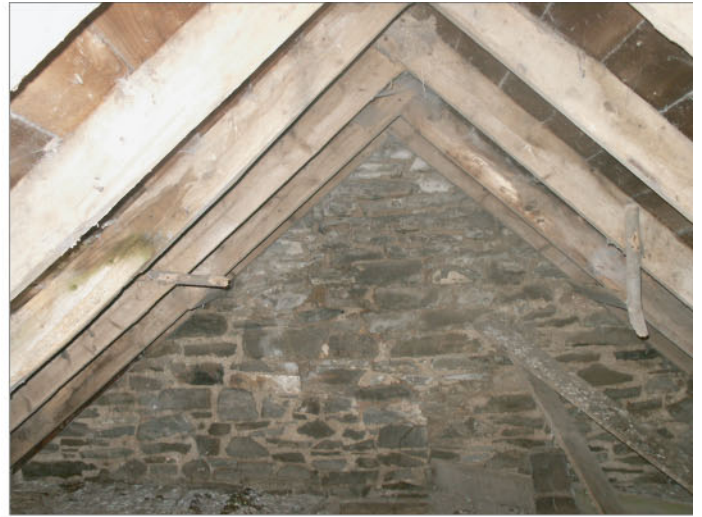
The internal gables of the loft space are completely free of lime-wash and the original rubble masonry can be seen. Clearly lime-wash was never applied here (*Plate 14*).

Plate 14 : Building B, Room 4. East interior elevation. The loft space appears never to have been lime washed. The roof trusses and sarking are original.

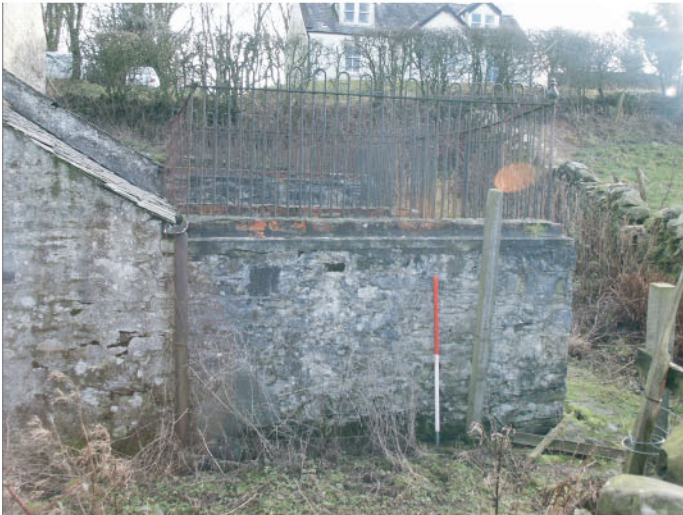
Plate 15 : Building D. North exterior elevation. The loop-headed railings are set into bricks over a concrete coping.

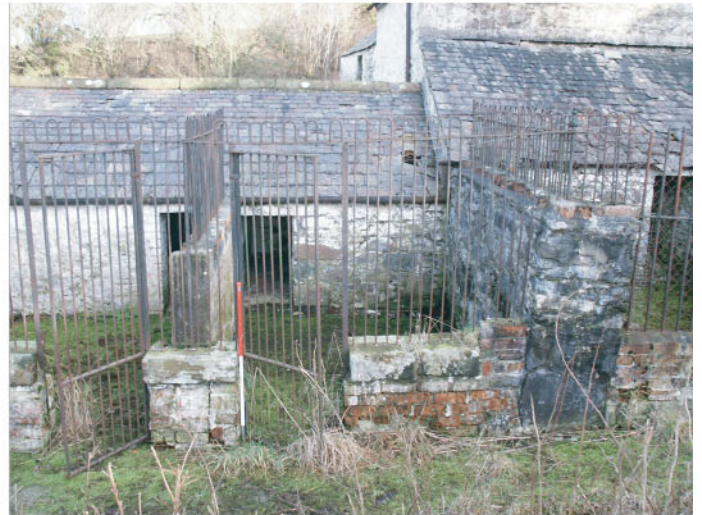
Other features peculiar to Building **D** are the sandstone coping stones above the front brick wall and the looped railings (*Plate 16*).

Plate 16 : Buildings C and D. The kennels, west exterior elevations. Note the contrast between the two types of railings and the different brick types between the two phases of construction.

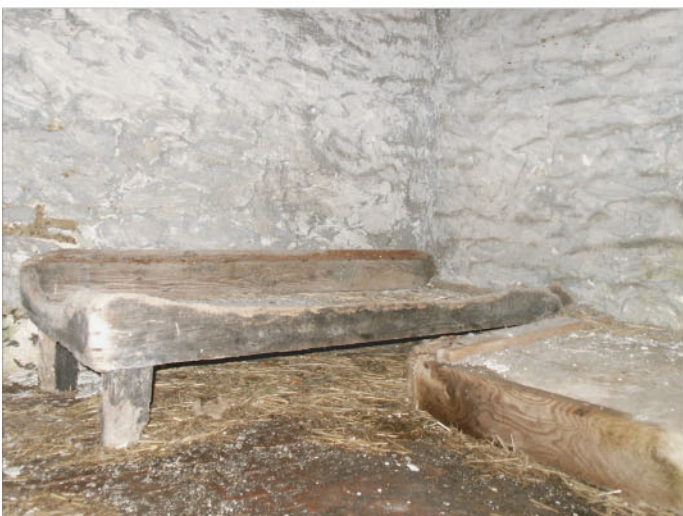
Plate 17 : Building D, Kennel 4. Interior. Detail of wooden 'cots'.

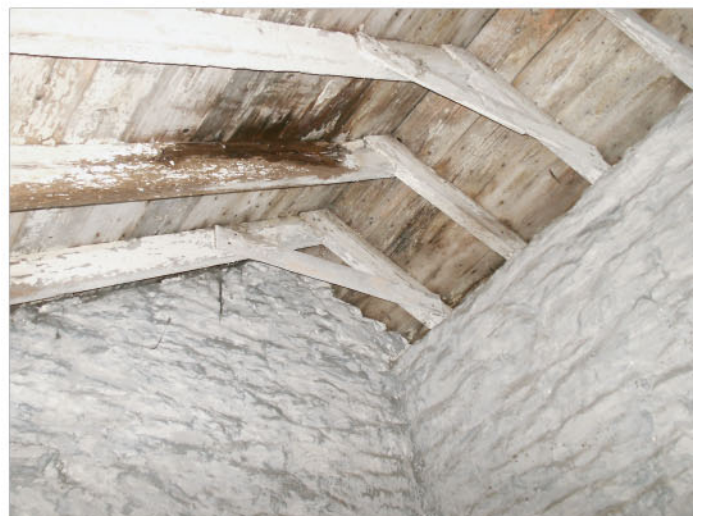
Plate 18 : Building D, Kennel 4. Interior. Detail of twin-pitch roof construction.
