Minor Archaeological Services Call-off Contract East Range, Stanley Mills, Stanley, Perth & Kinross (PIC043)

Historic Building Survey, April and May 2022
Report No. HES-PIC043-2022-01

Author	Graeme Carruthers MA MCIfA
Illustrator	Sam Griffith BA MSc PhD
Approver	Bruce Glendinning BSc PgDip MCIfA
Commissioned by	Historic Environment Scotland
Date issued	September 2022
Version	2
OASIS Reference	cfaarcha1-437611
Planning Application No	21/02111/LBC
Grid Ref	NO 11473 32800
CFA Report No.	4189
HES Report No.	HES- PIC043-2022-01

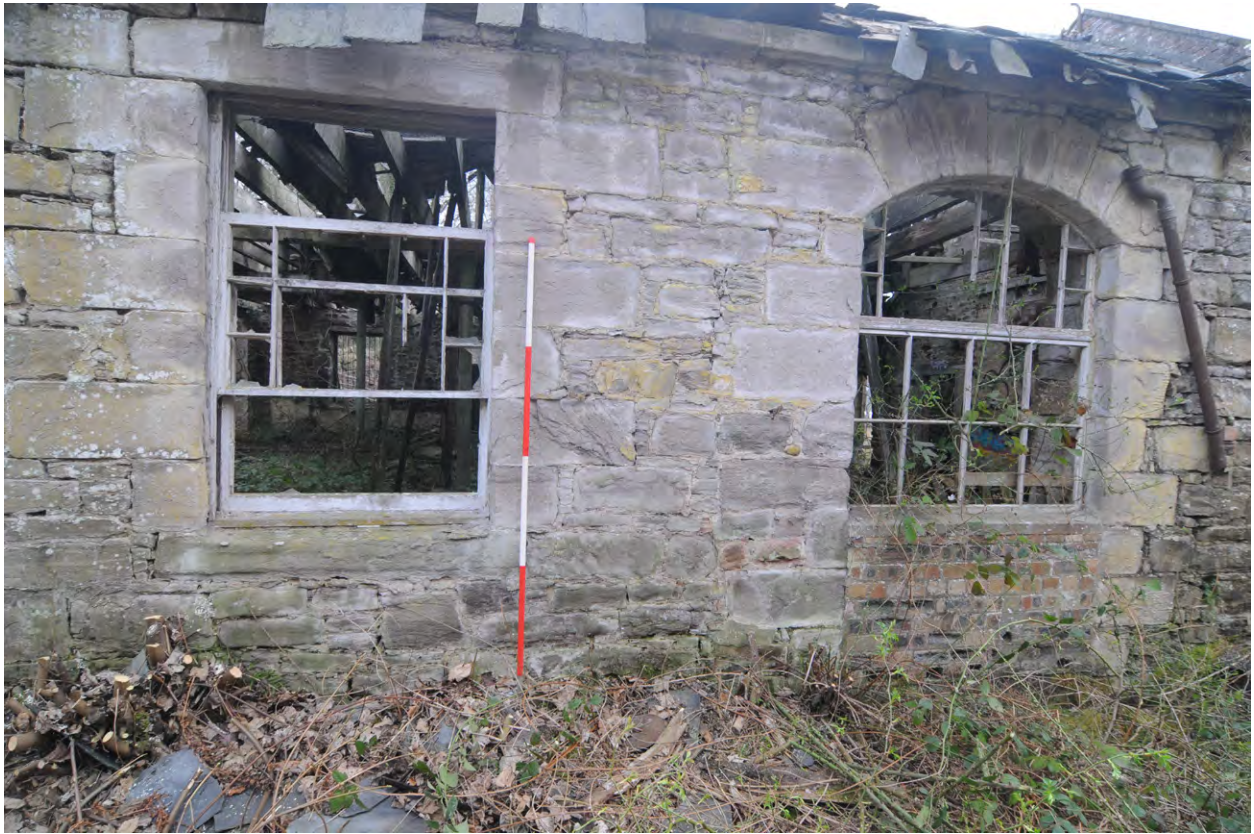
Fig 7: Phase 1, blocked doorway (031) and window (033)

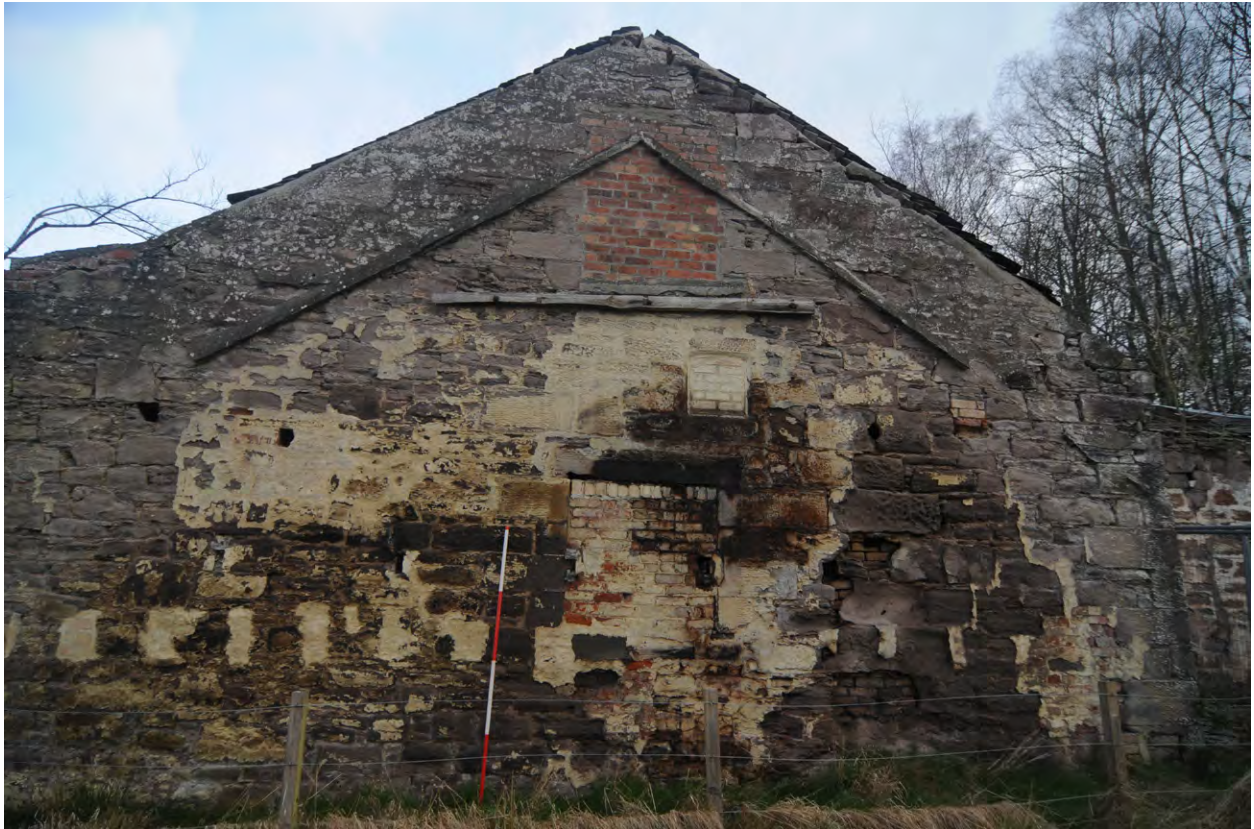
A raggle line (**004**) for the gable of the now missing building was visible, lower than but as wide as the gable for Unit 1 (Fig. 10). Windows (**003**) would likely have been blocked to facilitate the construction of the missing building, as the raggle line (**004**) cut across the window (**003**). Ten blocked floor joist holes were also present on this elevation to the west side, which must also relate to the now missing building.

Fig 10: Phase 2 remains of raggle line of missing building and blocked windows (003) and (007)

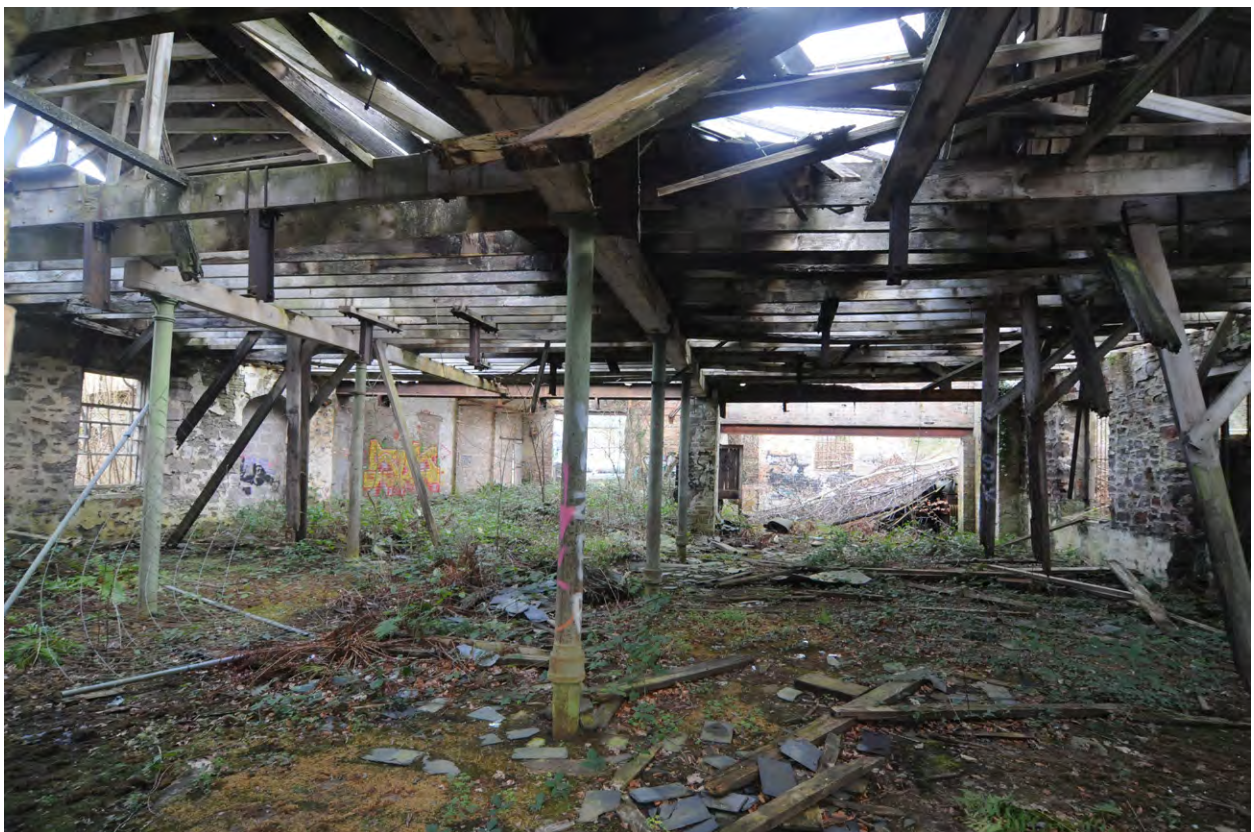
Fig 12: Phase 3 line of internal columns supporting roof when Phase 3 removed eastern wall of Unit 2

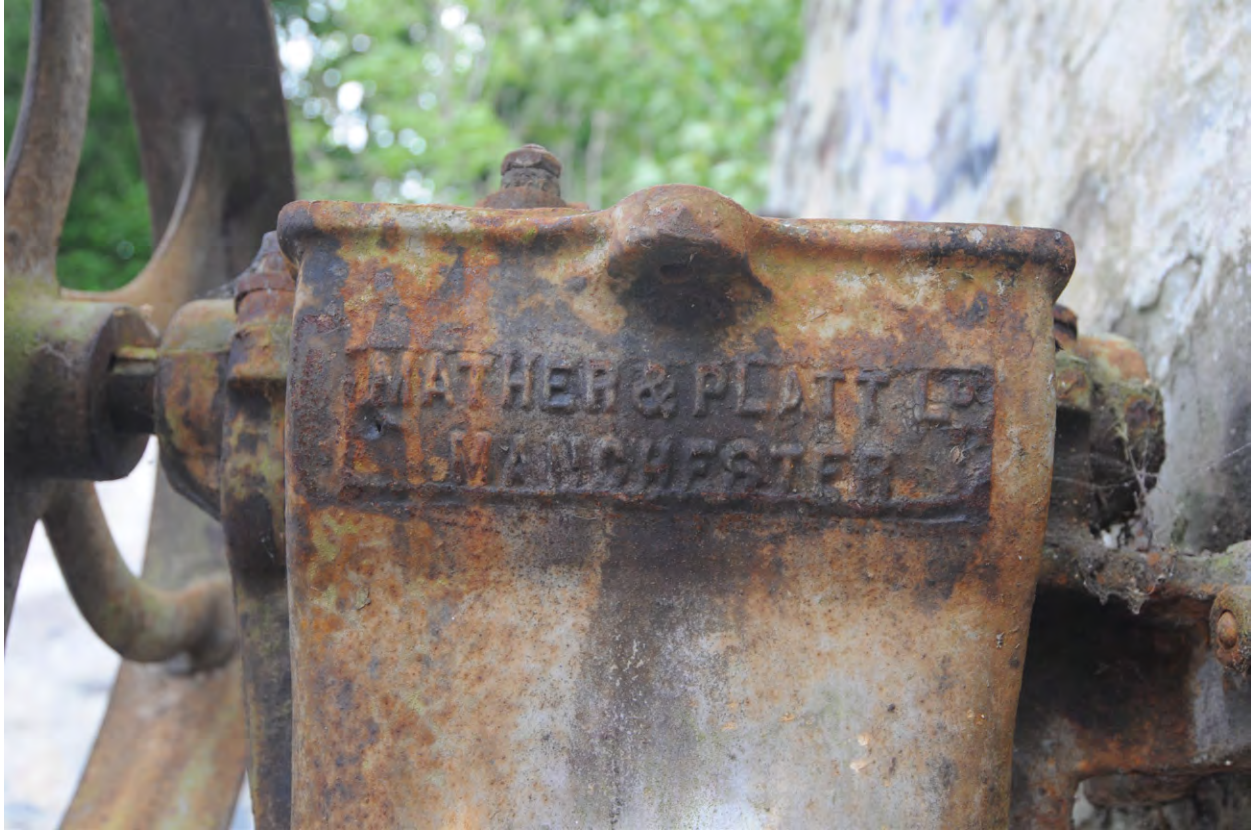
In the eastern side of the north-facing wall of the Phase 3 portion of the Unit was a single doorway (**012**) that was built against the end of the earlier boundary wall (**023**). A set of L-shaped brackets (**057**) projected from the wall; these had supported a now missing piece of machinery. Adjacent to (**057**) and bolted to the wall was a cast iron belt drive flywheel with a fluted cast iron body (**058**) (Fig. 13-14). Cast into the body was the maker's name 'Mather & Platt Manchester' who formed in 1845 and exhibited textile finishing equipment at the Great Exhibition in 1851 (Fig. 15).

Fig 15: Phase 3, detail of makers name on flywheel (058)

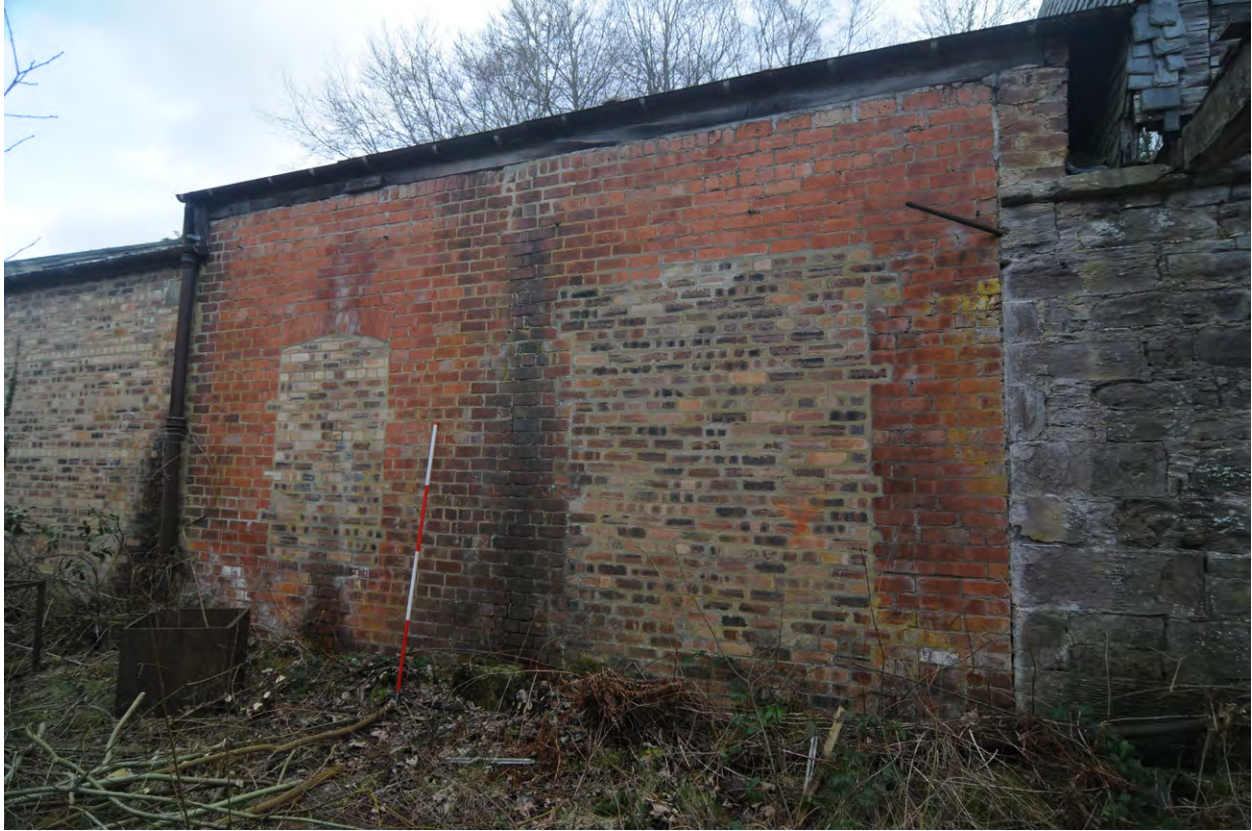
Fig 17: Phase 4 external west-facing elevation, Unit 3, showing window (038) and doorway (039) both blocked in Phase 5

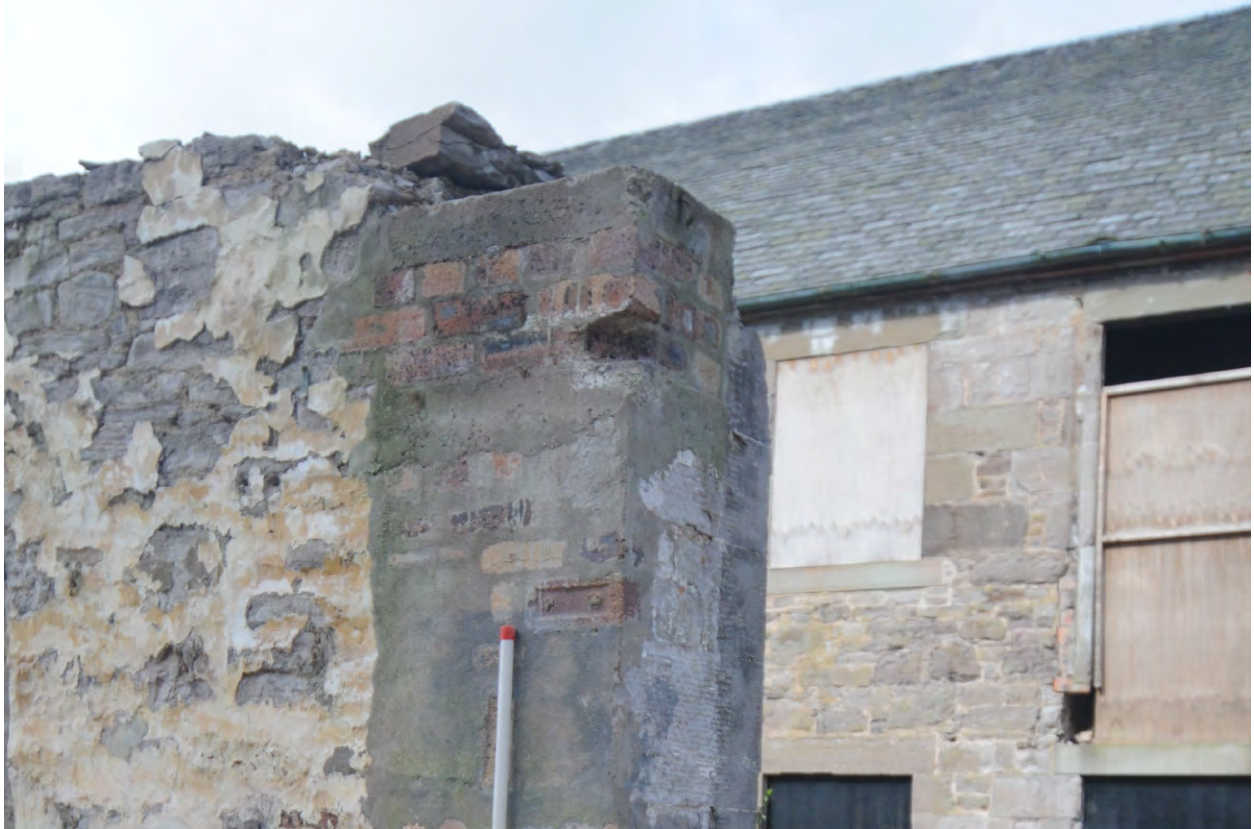
054	Weaving Shed	Unit 2-3, rubble-built buttress with brick repair/facing, opposite 053 - both form the support for new upper gable and roof support.	
055	Weaving Shed	Unit 4. A rectangular room with rubble built eastern wall and a brick built western and northern wall with a smooth concrete floor.	7.1m x 8.8m
056	Weaving Shed	Unit 5. Smooth concrete floor with rubble-built western wall, brick built northern and eastern walls with an open southern side.	5.66m x 6.66m
057	Weaving Shed	Unit 2, two adjacent L-shaped iron brackets 0.28m apart projecting 0.56m from rubble built southern wall. Presumably they would have held a now missing piece of equipment.	
058	Weaving Shed	Unit 2, iron brackets and fluted shaped cast iron gear unit 0.67m tall and flywheel for leather drive belts on southern rubble-built wall. Flywheel has a diameter of 0.63m. On gear casing is cast the manufacturer's name of 'Mather & Platt Manchester'.

Fig 19: Phase 4 Unit 2/3, remains of brick support column (054) for roof support I beam

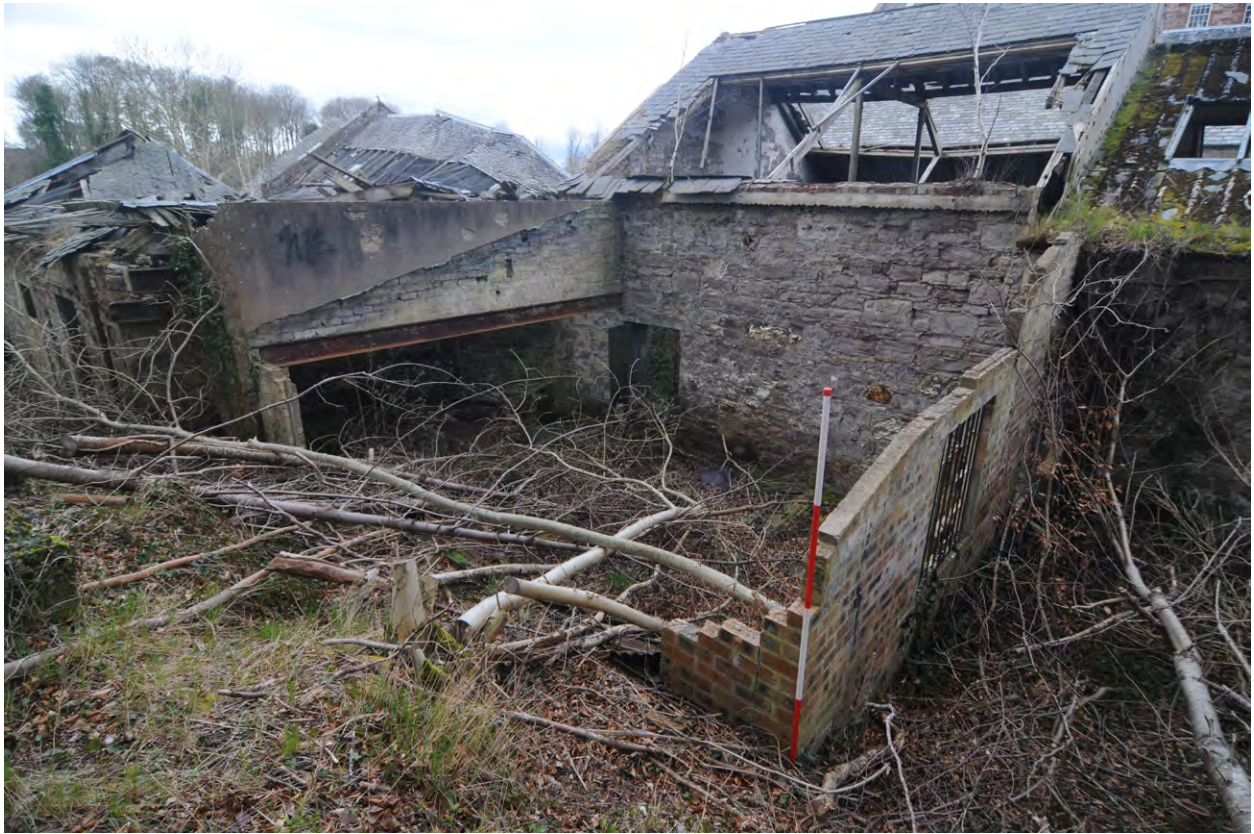
wall (**023**) which forms the internal west wall of the structure and on the internal north-facing wall (Fig. 27). A single row of edge-on bricks (**025**) was visible on the wallhead of **023**, possibly to heighten or level the wallhead during a roof repair for Units 3 and 4 behind.

Fig 27: Phase 7 Unit 5, external east and north-facing elevations showing damage caused by vandalism and raggle line for sloping corrugated roof

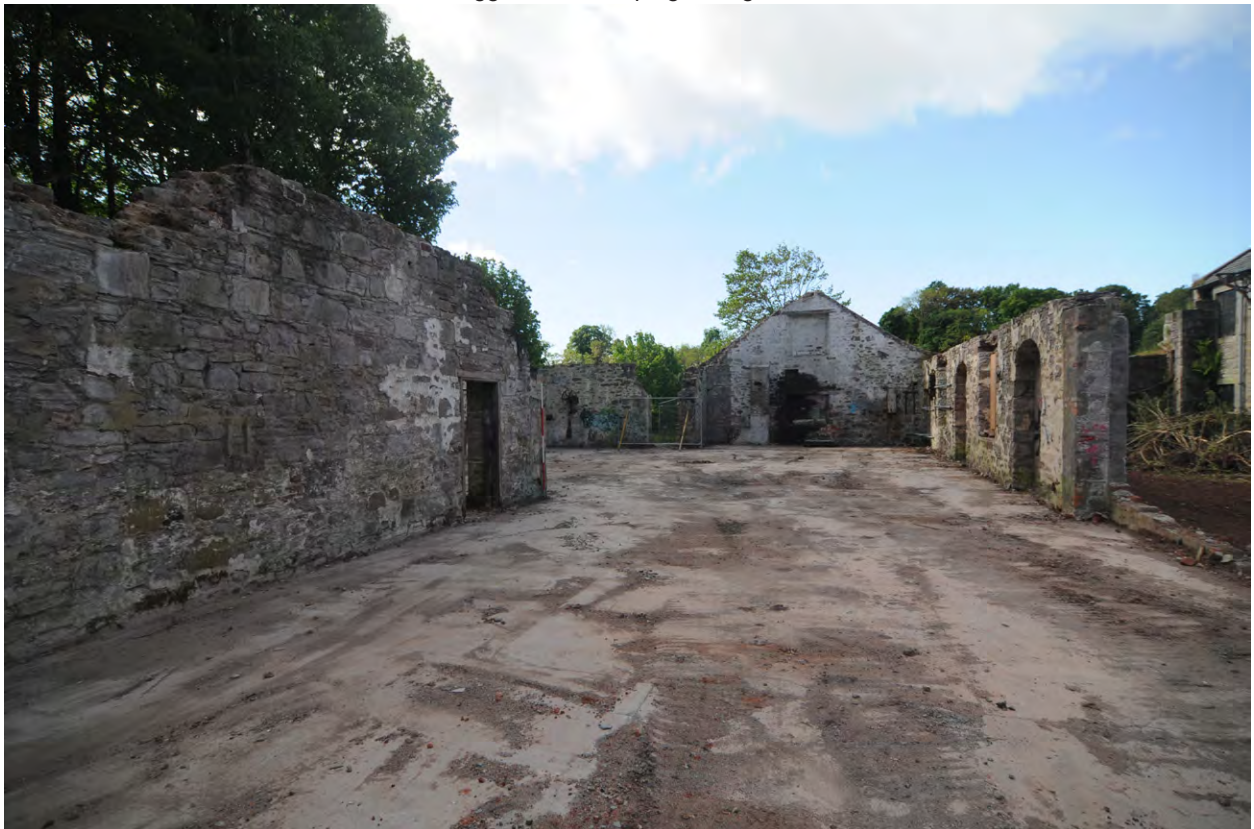
The second phase recorded the buildings' interiors after the removal of the unsafe roofing, after the cleaning out of any debris from within, and after the demolition of the brick-built buildings that formed Units 3, 4 and 5 (Fig. 28). Any observations about any of the roofs construction could only be made by examining any trusses or beams retaining after the demolition, (Figs. 30-34).

Fig 28: Site post partial demolition

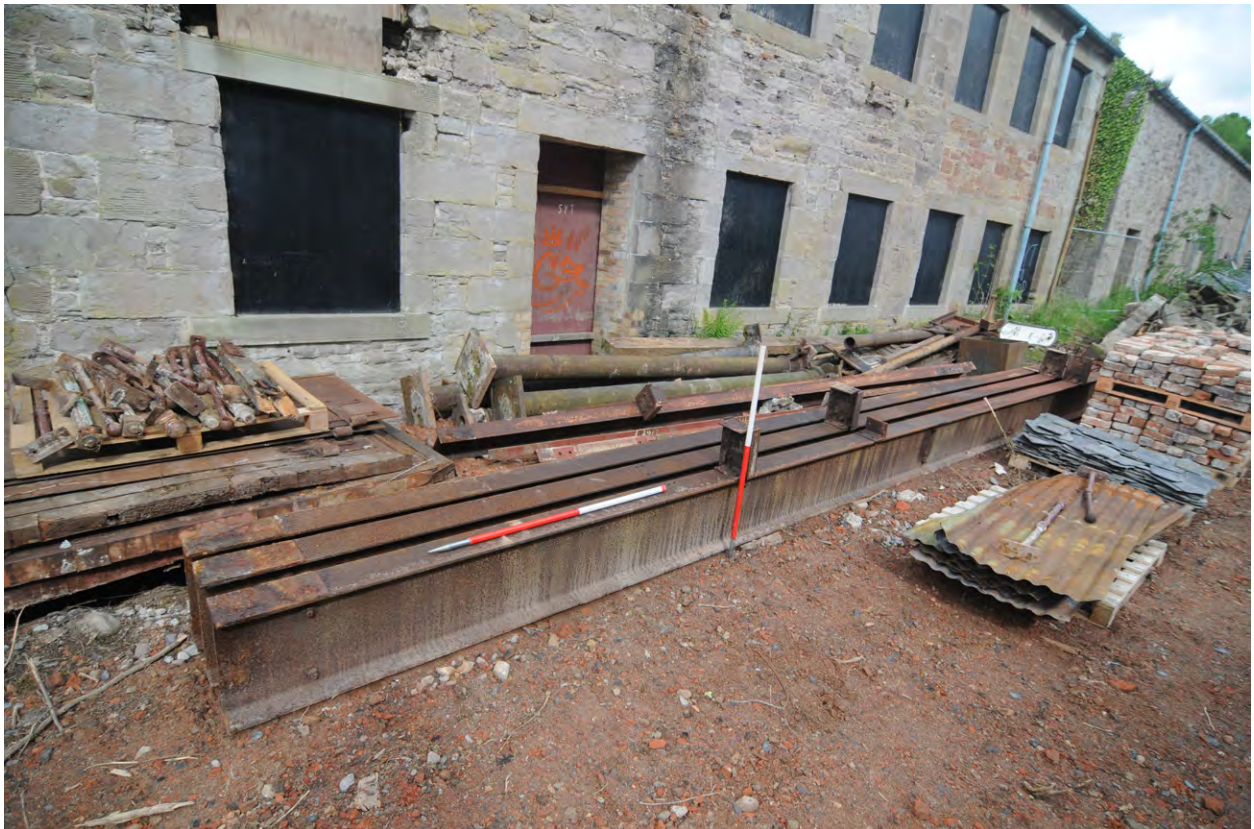
Fig 30: I beams salvaged from demolition

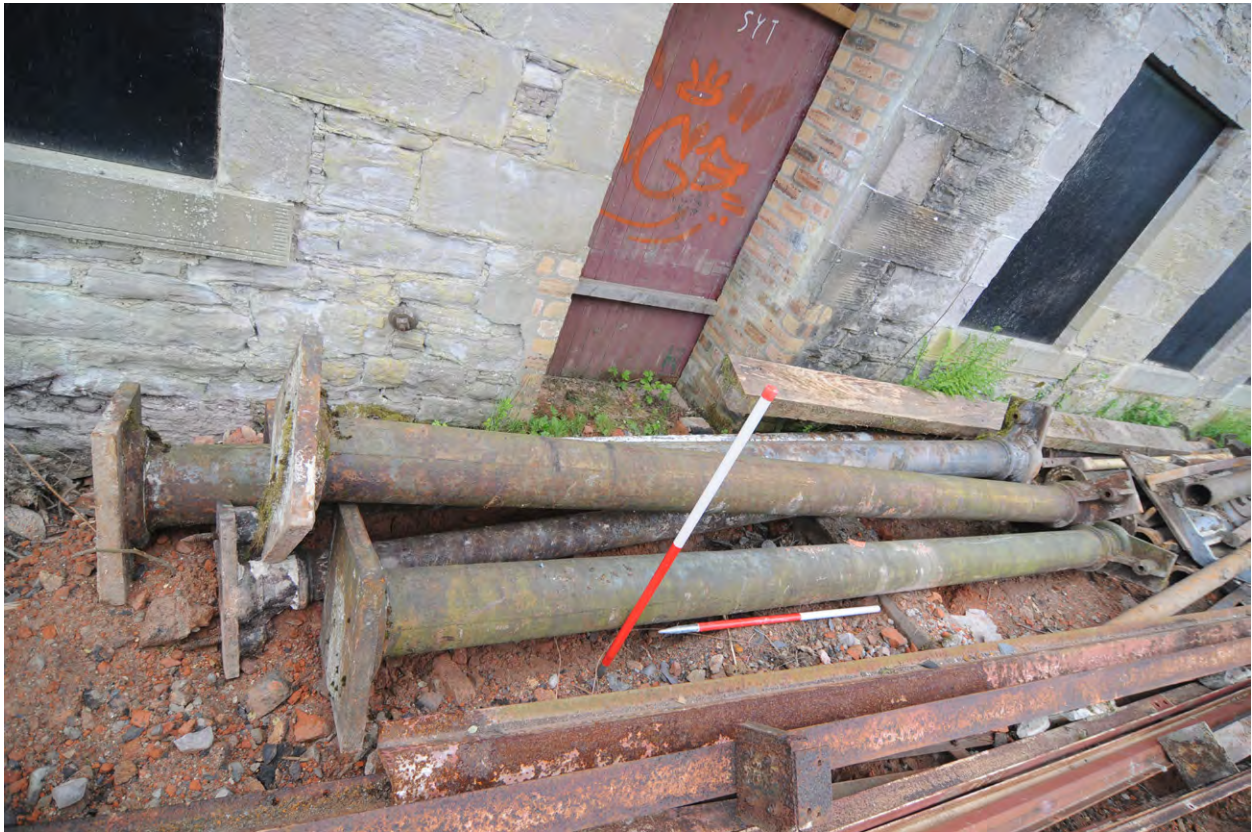
Fig 31: The Phase 1 cast columns salvaged from the demolition of Unit 2

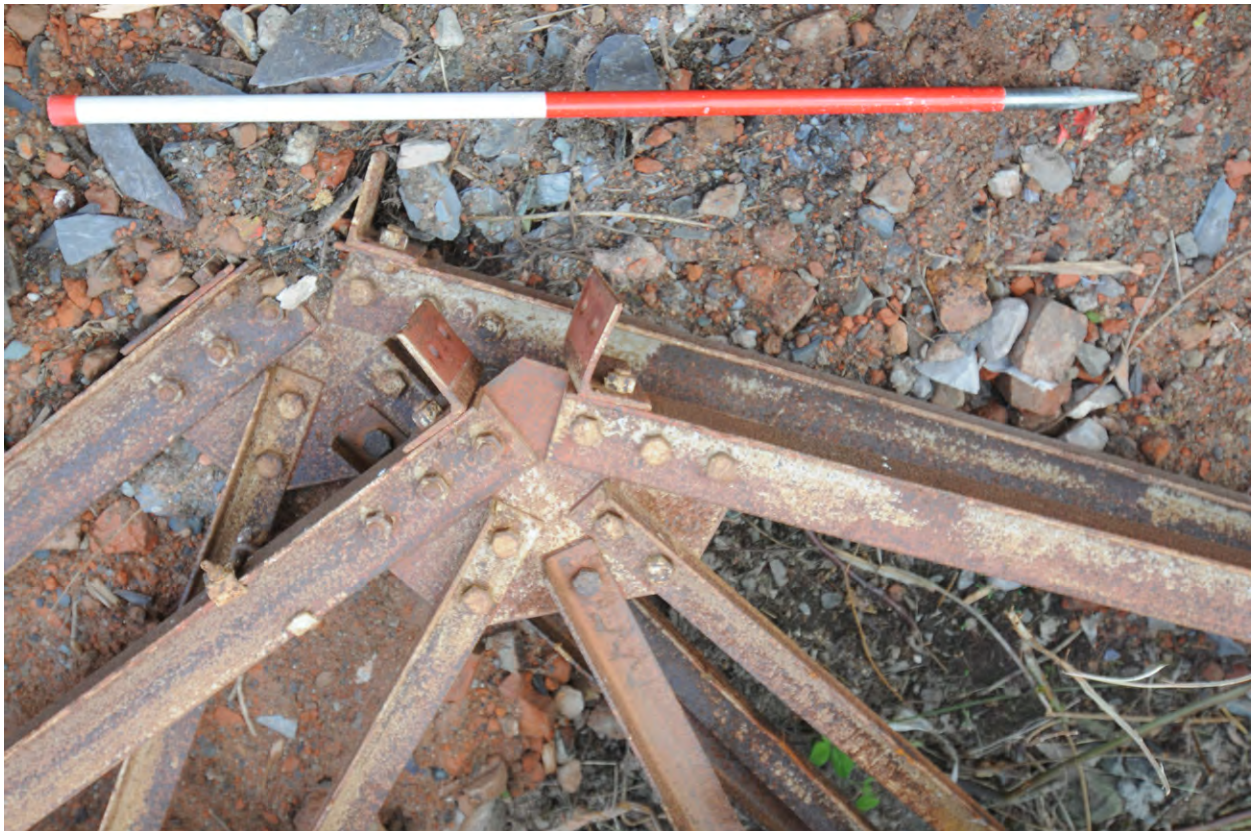
Fig 34: Detail of the Phase 1 metal roof trusses salvaged from the demolition of Unit 2 showing where they would have bolted onto a ridge beam
