**Land At Balmuirfield, Balmuir, Strathmartine,  
Angus, DD3 0NU  
Report on Level 1 Standing Building Survey**

**Angus Council planning application 21/00245/FULL**

**Alison Cameron  
Cameron Archaeology  
3 March 2022**

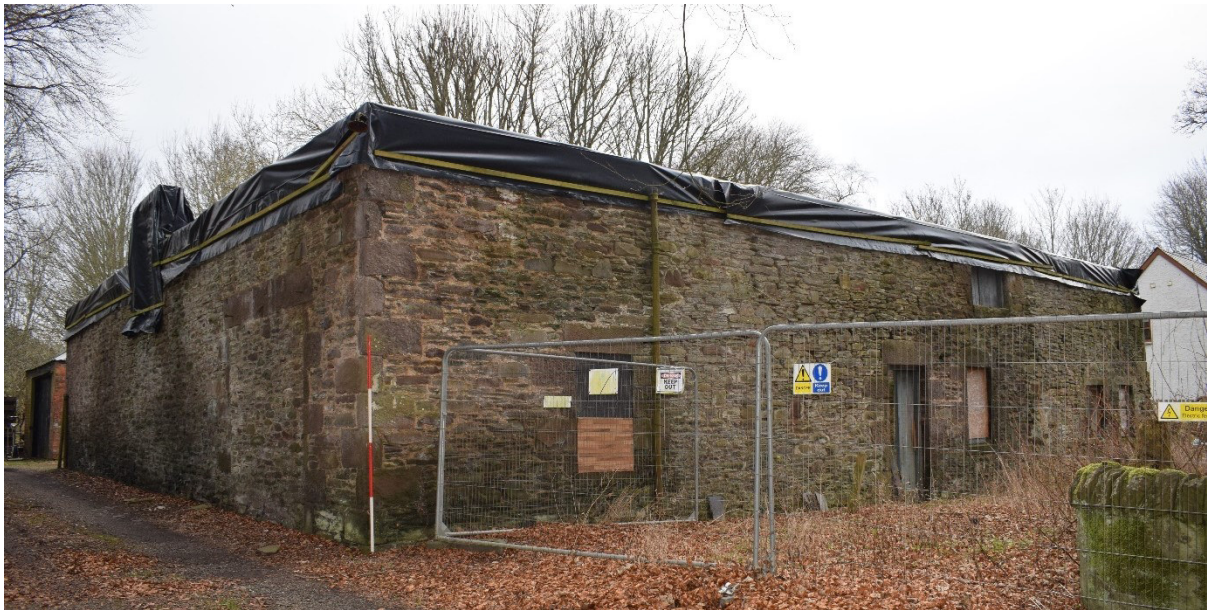
The first phase of building appears to be a grey rubble constructed building seen on the SSE wall of the mill (F14; Illus 6, 7); it was difficult to photograph because of the large holes adjacent caused by Rooms 5 and 6. The surviving wall forms the ENE end of the SE wall but is a little unclear due to variety of pointing and some possible repairs to the wall (see F14, Illus 11). There is also an earlier grey sandstone phase in Wall F27 (Illus 9, 10) and it is possible that this is the remains of a wall of an unroofed structure seen on the 1<sup>st</sup> Edition OS map (Illus 3) which was then heightened with red sandstone quoins (Illus 8) and rubble in Phase 2. Window W10 may date to this phase and was blocked with stone in Phase 2.

Illus 6 SSE façade showing grey fieldstone wall (F14; centre); facing NE

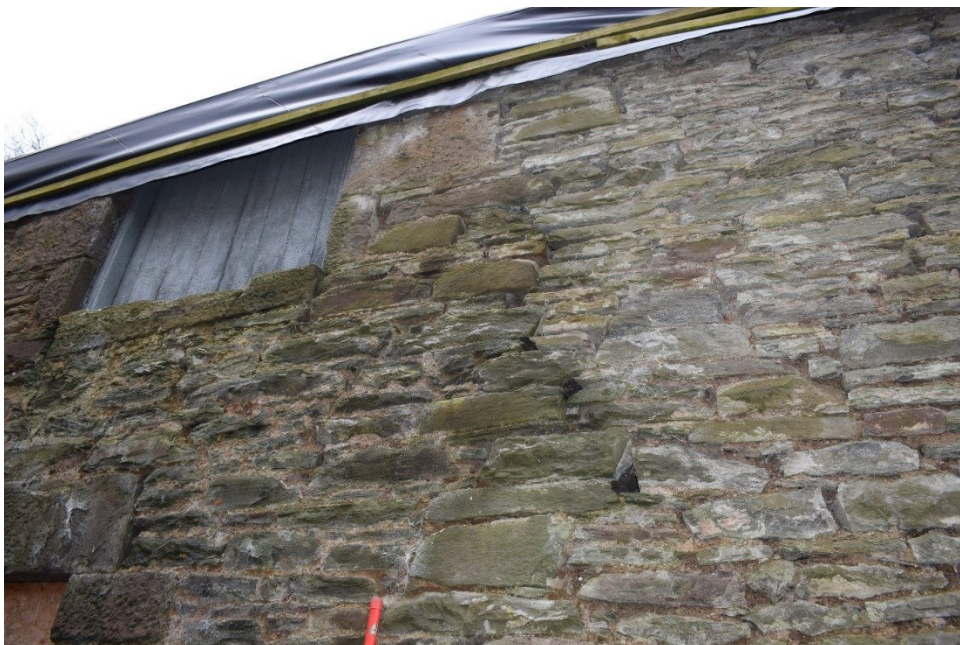
Illus 7 F14 scar with W3 (top left) and W4 (bottom left); facing NW

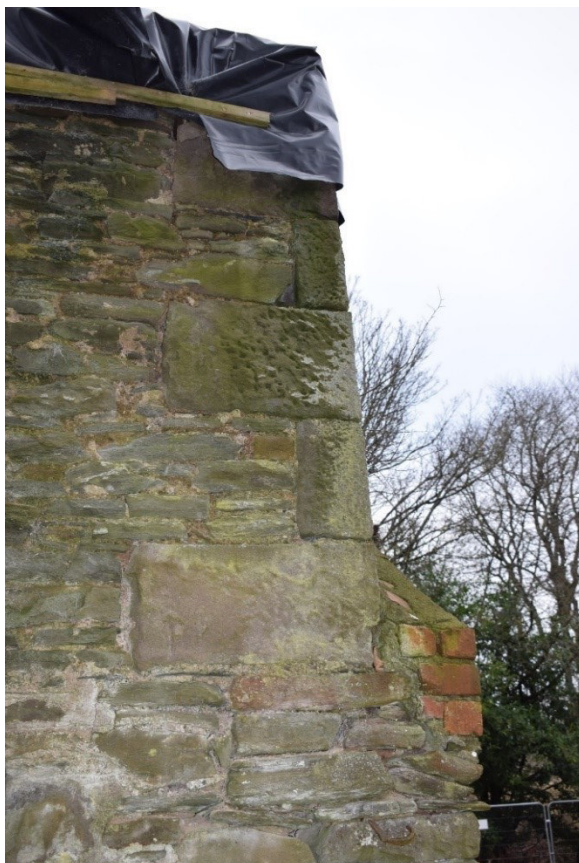
Illus 8 Phase 2 quoins SE corner above Phase 1 grey sandstone rubble wall; facing NNW

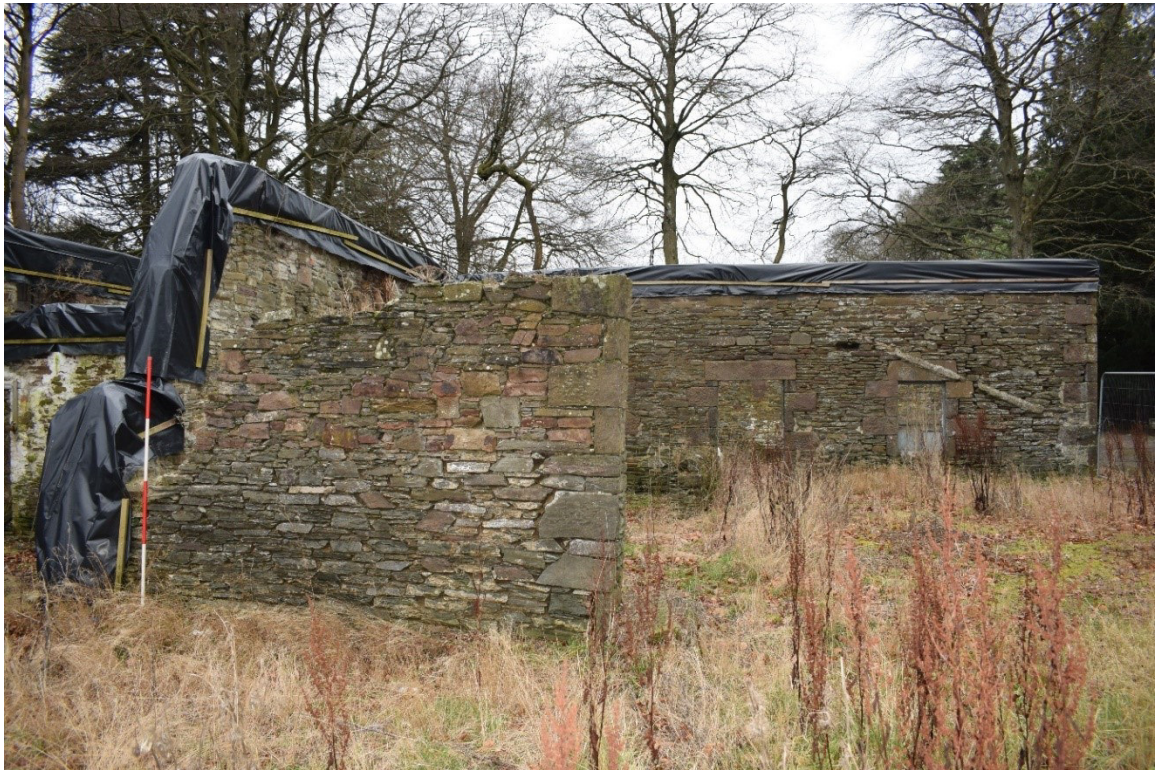
Illus 9 Wall F27 (left) showing lower (earlier) half grey sandstone and upper half with quoins and red sandstone rubble; facing WSW

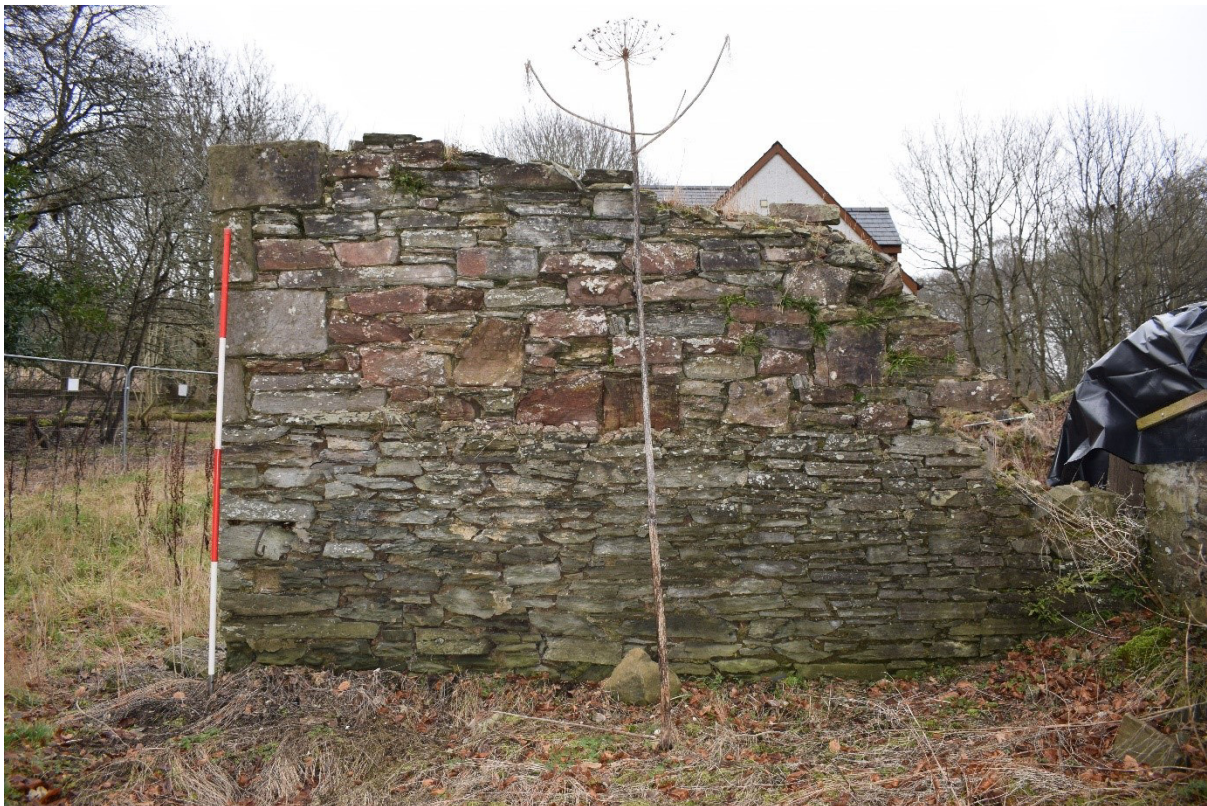
Illus 10 Wall F27 showing lower (earlier) half grey sandstone and upper half with quoins and red sandstone rubble; facing ENE

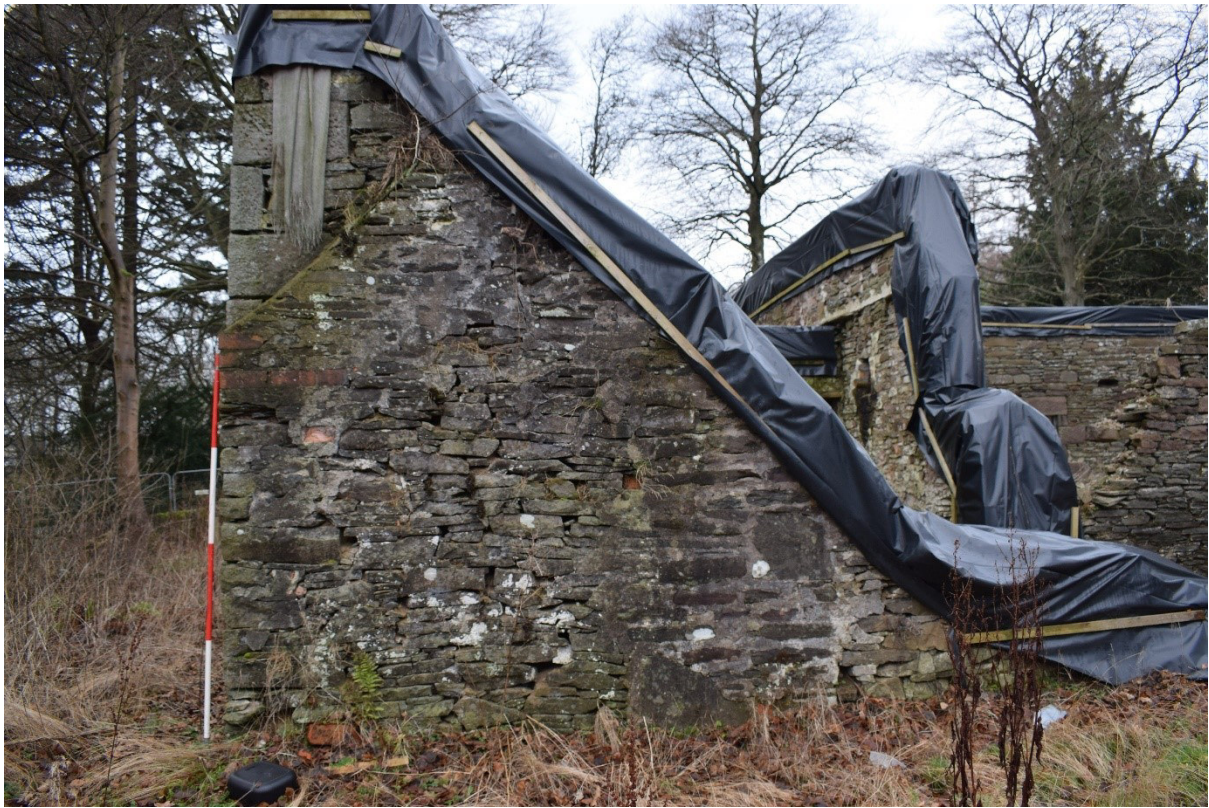
Illus 11 ENE wall Room 3 in poor condition, partially demolished, possible infill in Phase 2; facing WSW

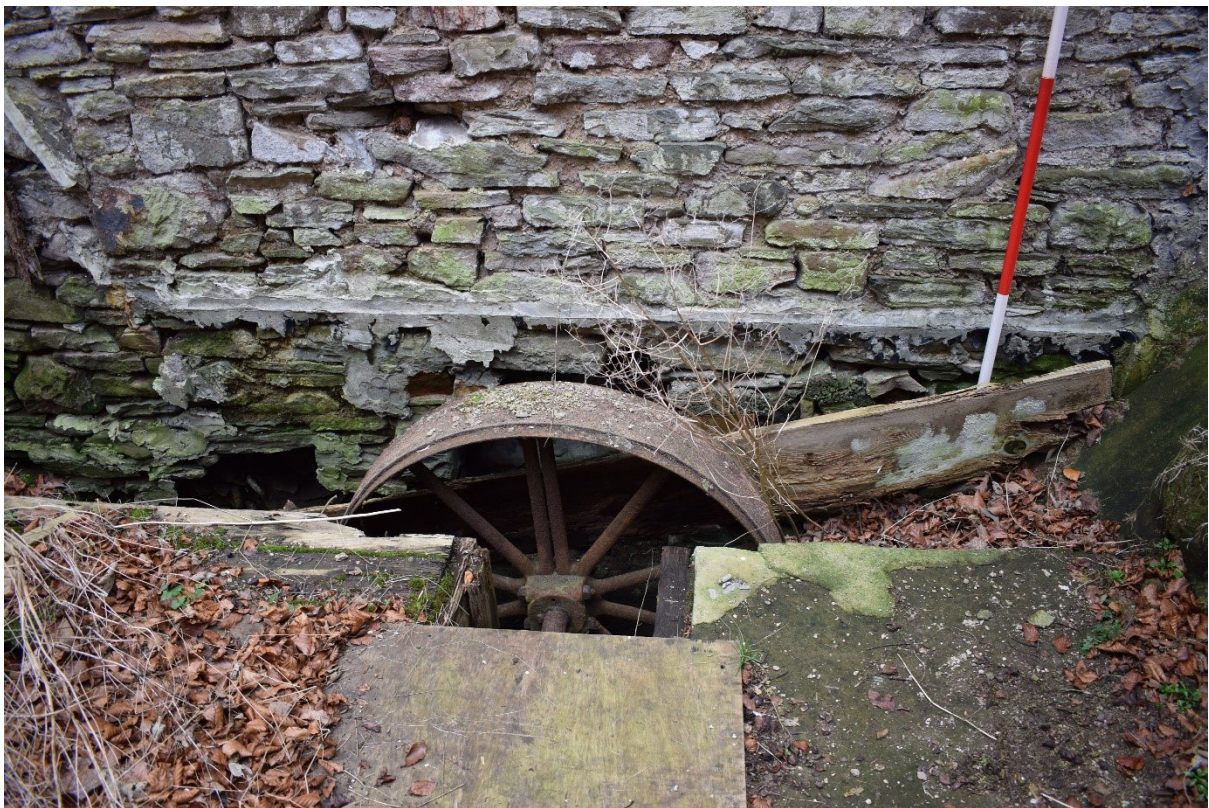
Illus 12 Room 1 wheel F4 in wheel-pit F2; facing NNW

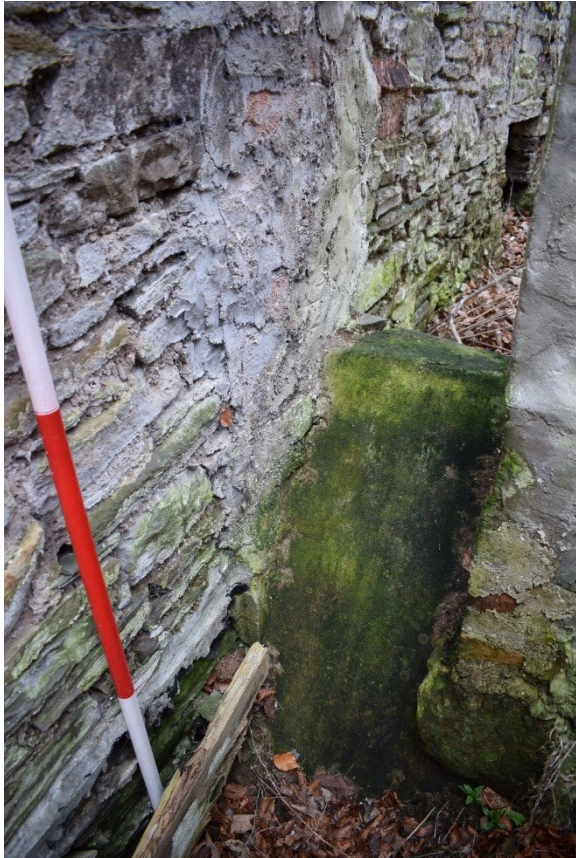
Illus 13 Concrete wheel-pit ENE of F4 within F1; facing NE

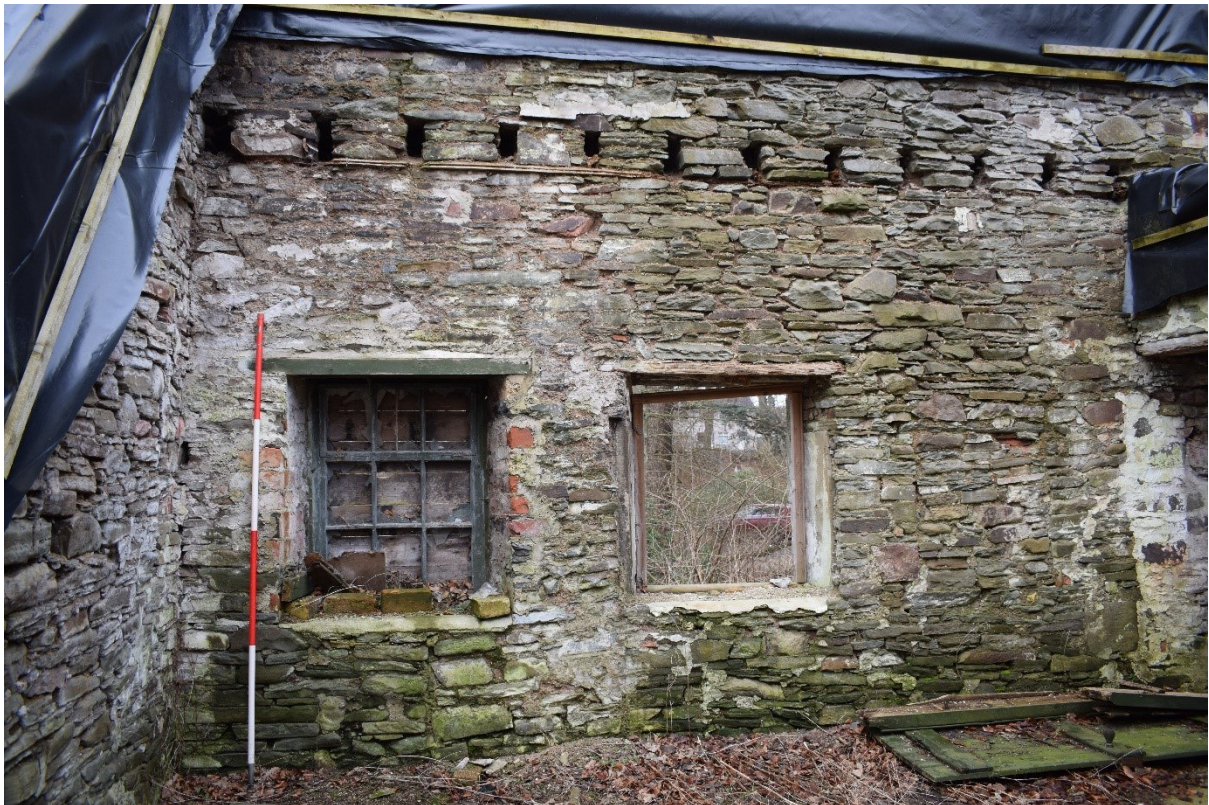
Illus 14 Interior SSE wall Room 3 W6 (left) W5 (right) with beam slots above; facing SSE

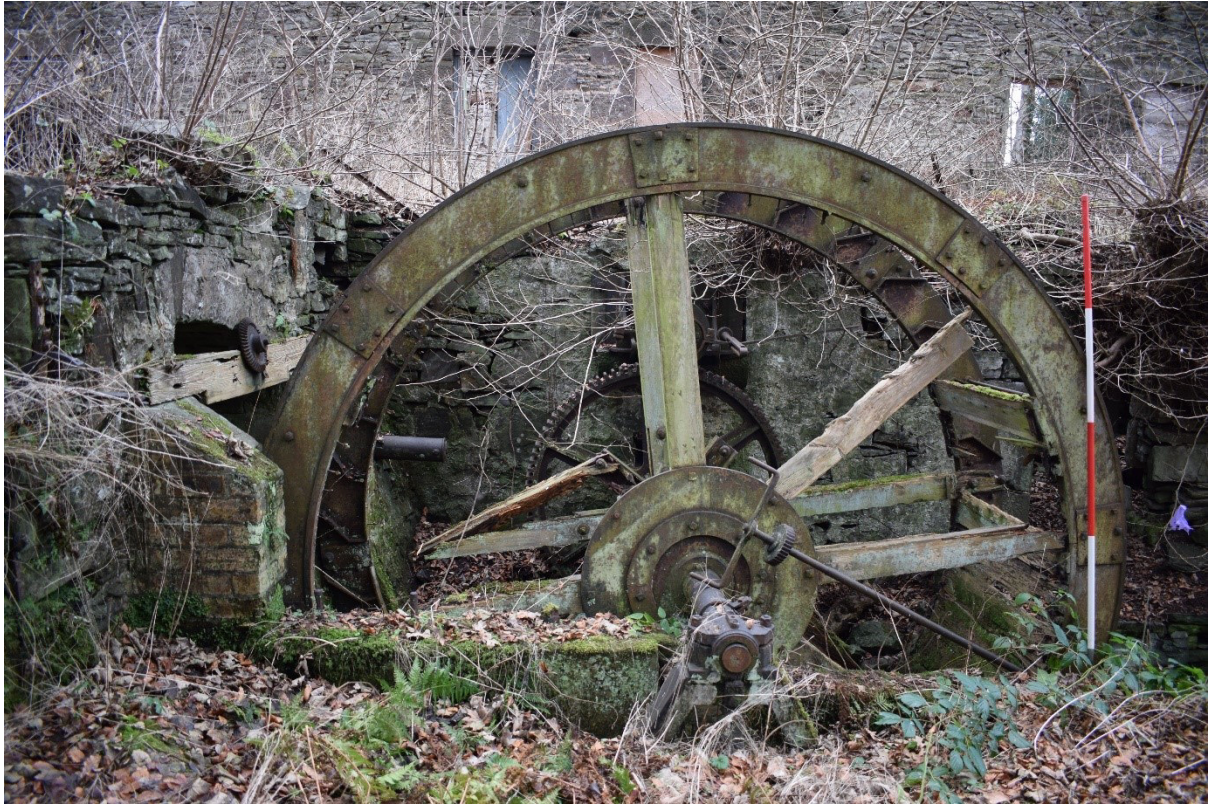
Illus 15 Mill wheel F17 in wheel pit Room 6; facing NNW

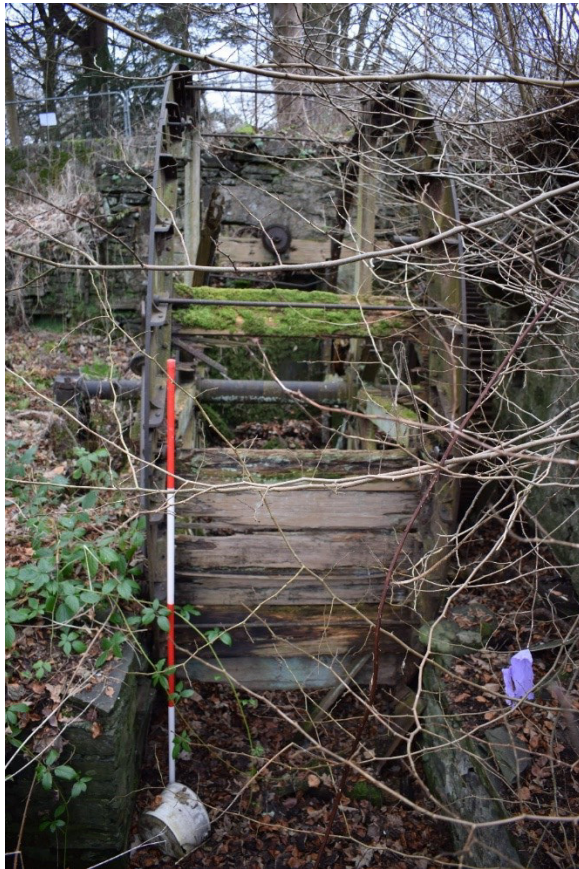
Illus 16 Mill wheel F17 in wheel pit Room 6; facing WSW

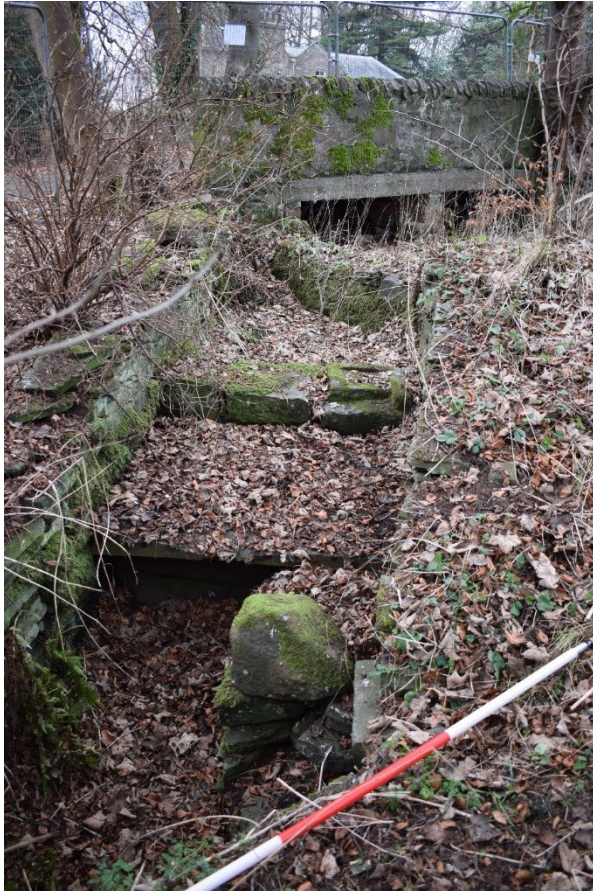
Illus 17 Lade F21 with bridge F19 (top) divided into lade to wheel (right) and overflow lade (left); facing NW

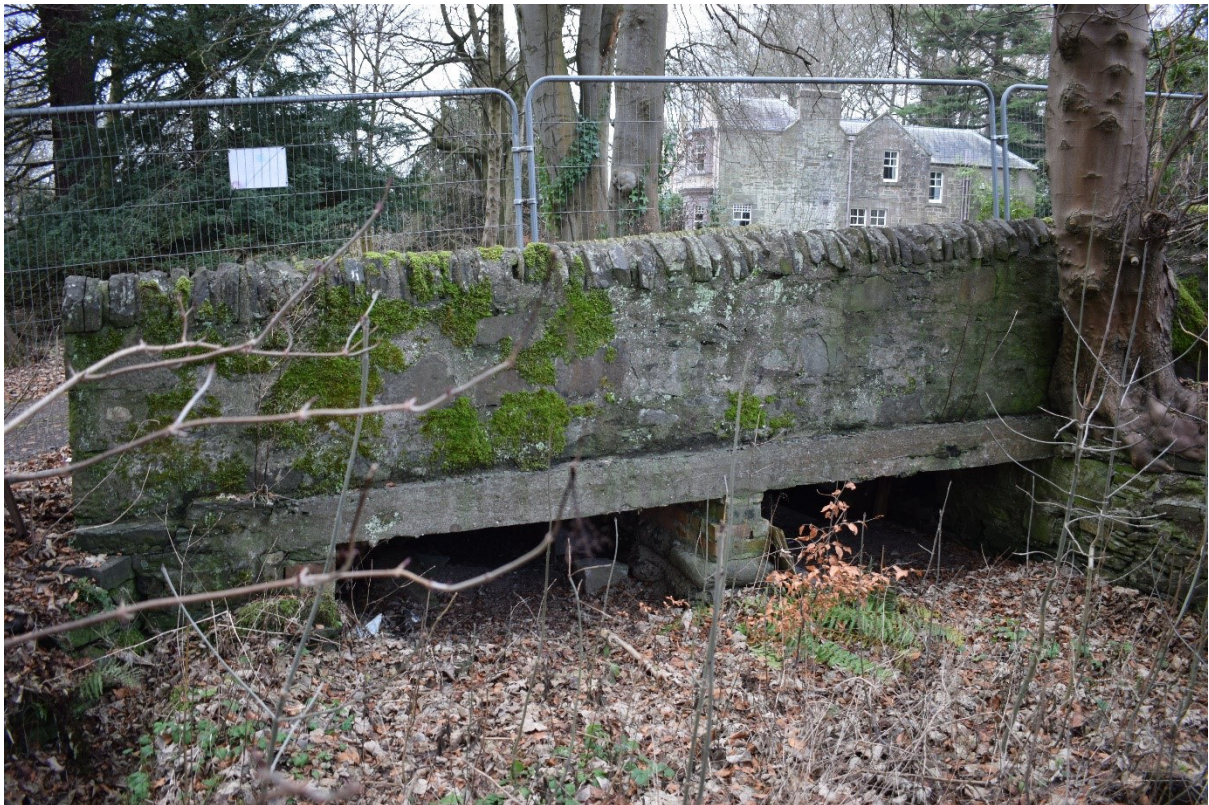
Illus 18 Detail of bridge F19 divided into lade to wheel (F18; right) and overflow lade (F21; left); facing WNW

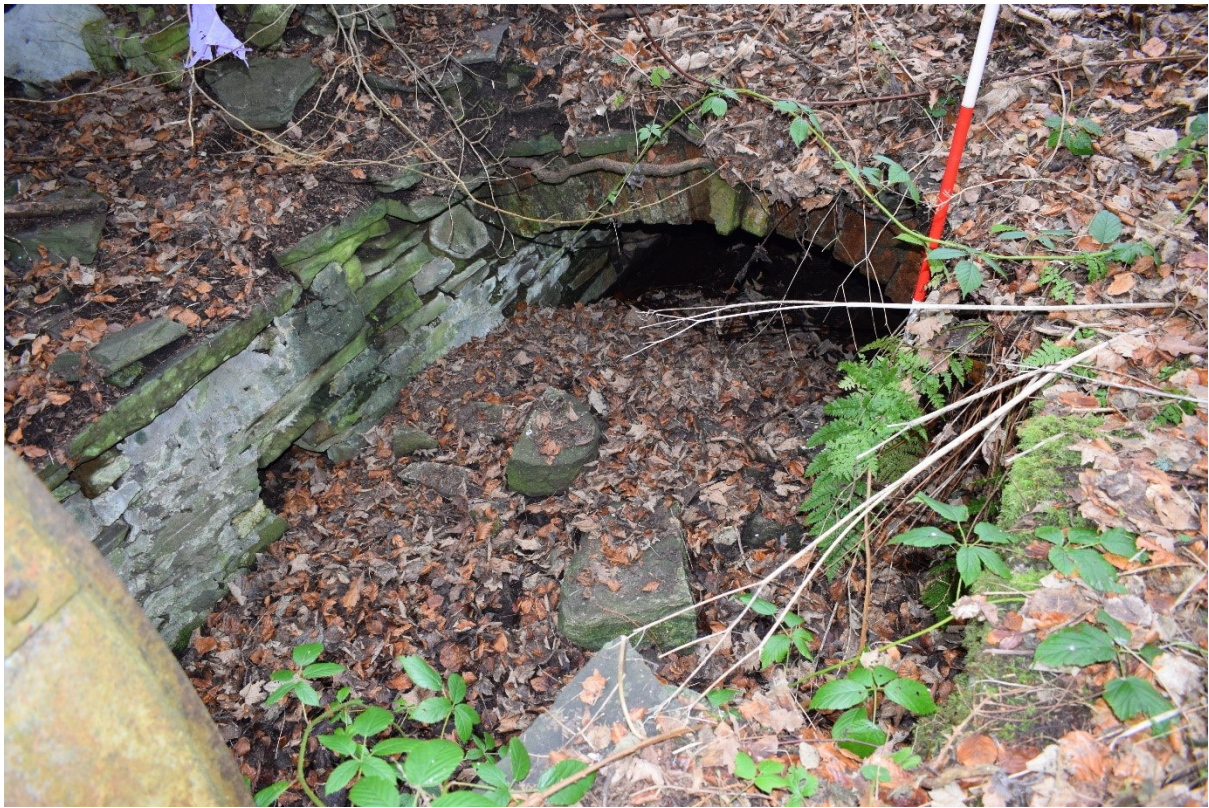
Illus 19 Lade F18 infilled and no access; facing NE

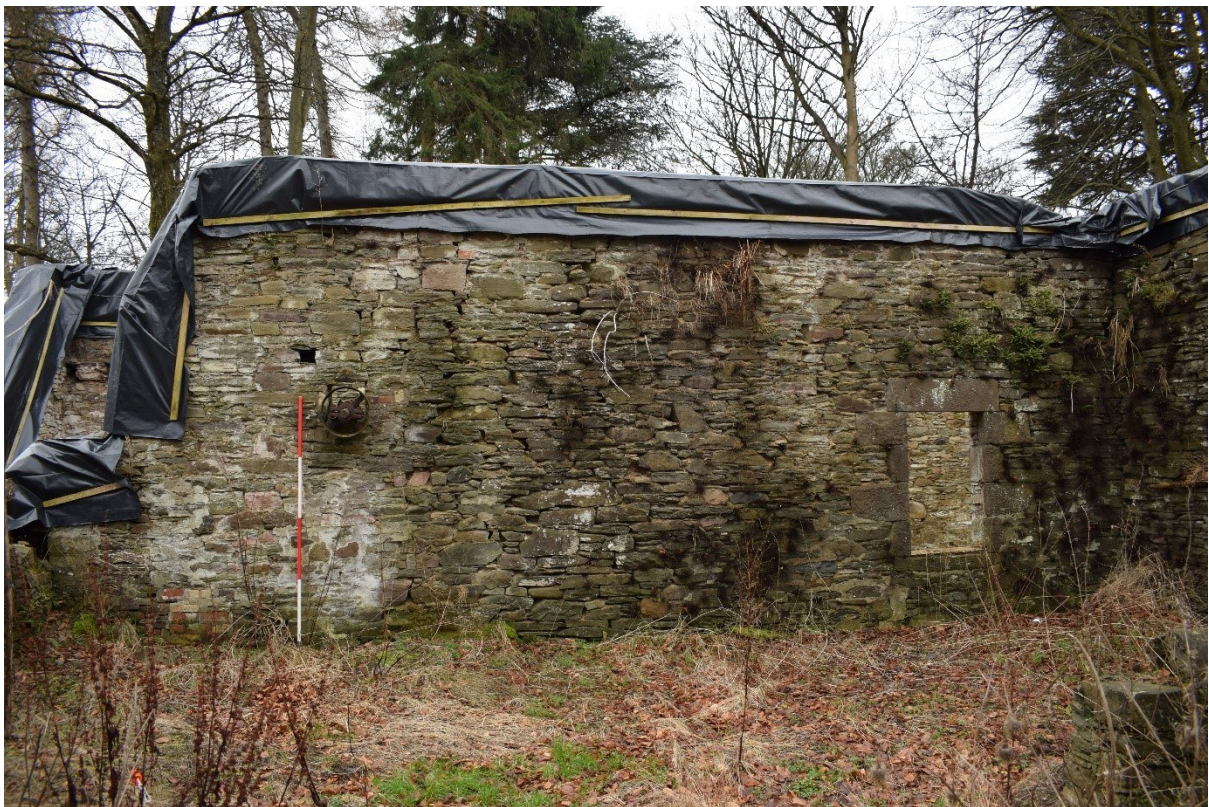
Illus 20 NNW face of Room 1/Room3 wall with vent F16 (top left), F6 and W7 (right); facing SSE

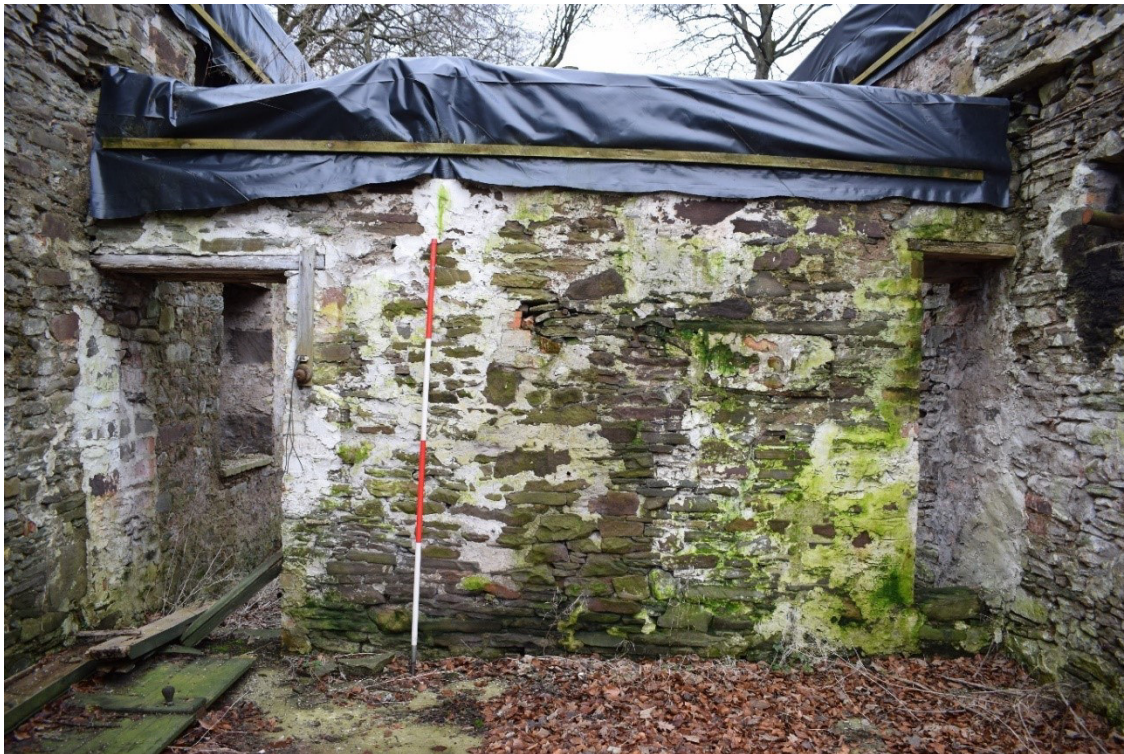
Illus 21 Wall between Rooms 1 and 3 with D5 (left) and F1 (right) and blocked aperture F5 (centre); facing WSW

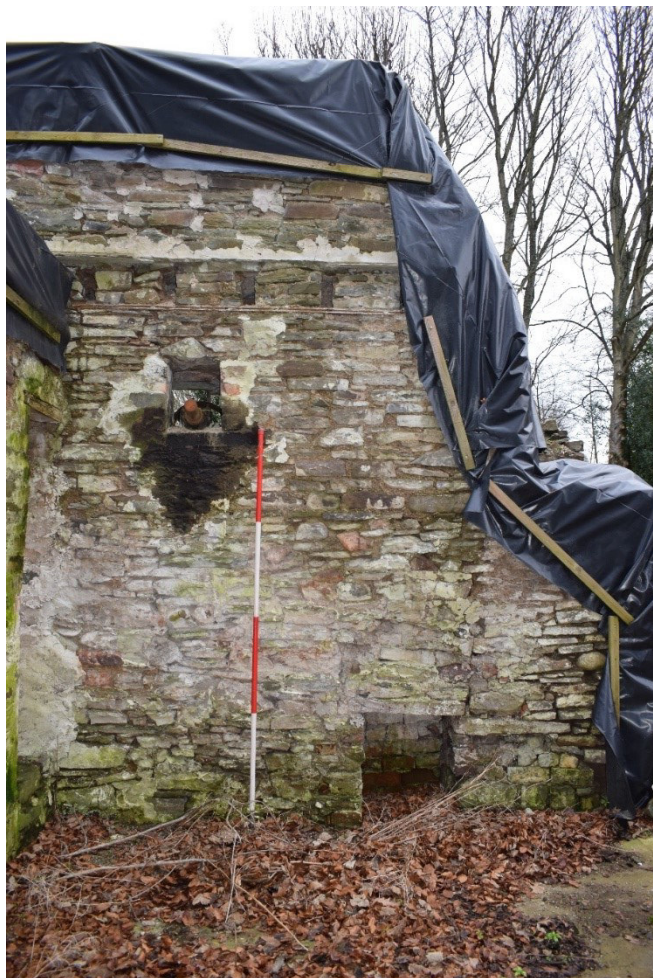
Illus 22 Room 3 NNW wall with wheel mechanism drive shaft F6 (top left) and aperture F7 (bottom right); facing NNW

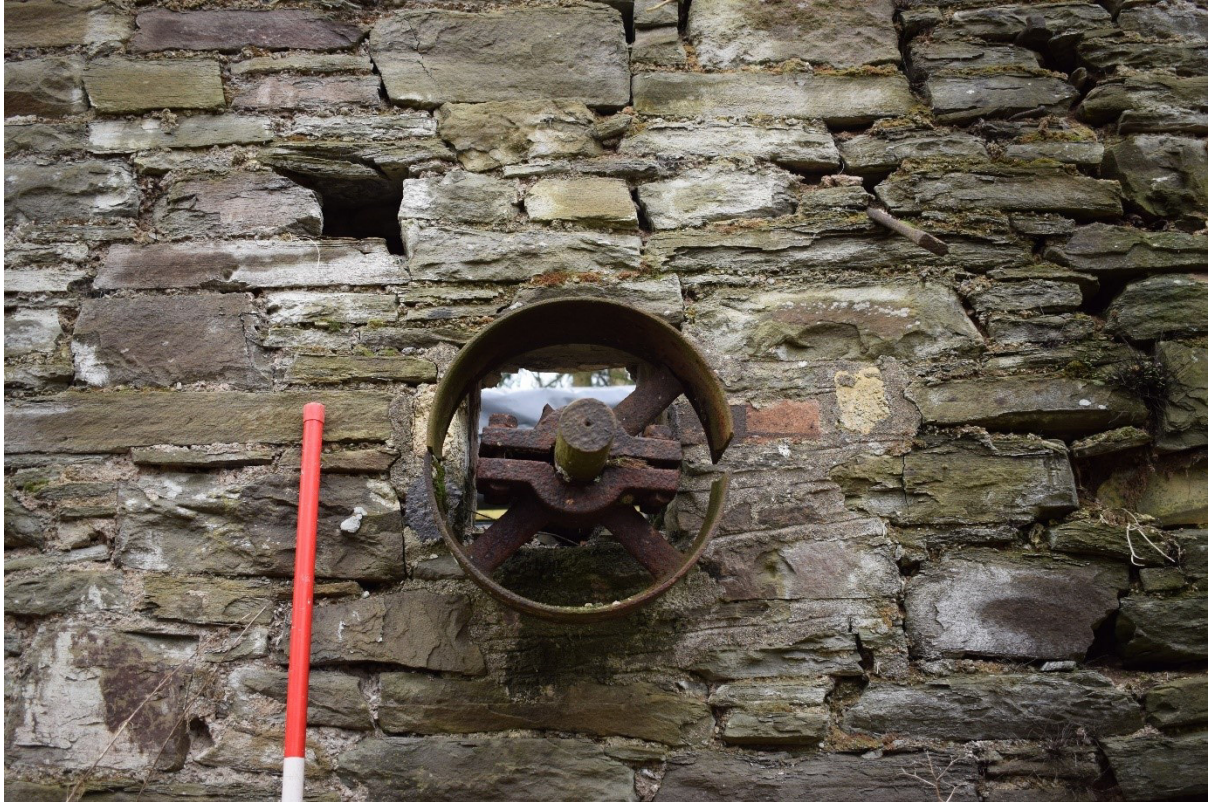
Illus 23 F6 wheel mechanism NNW side of wall; facing SSE

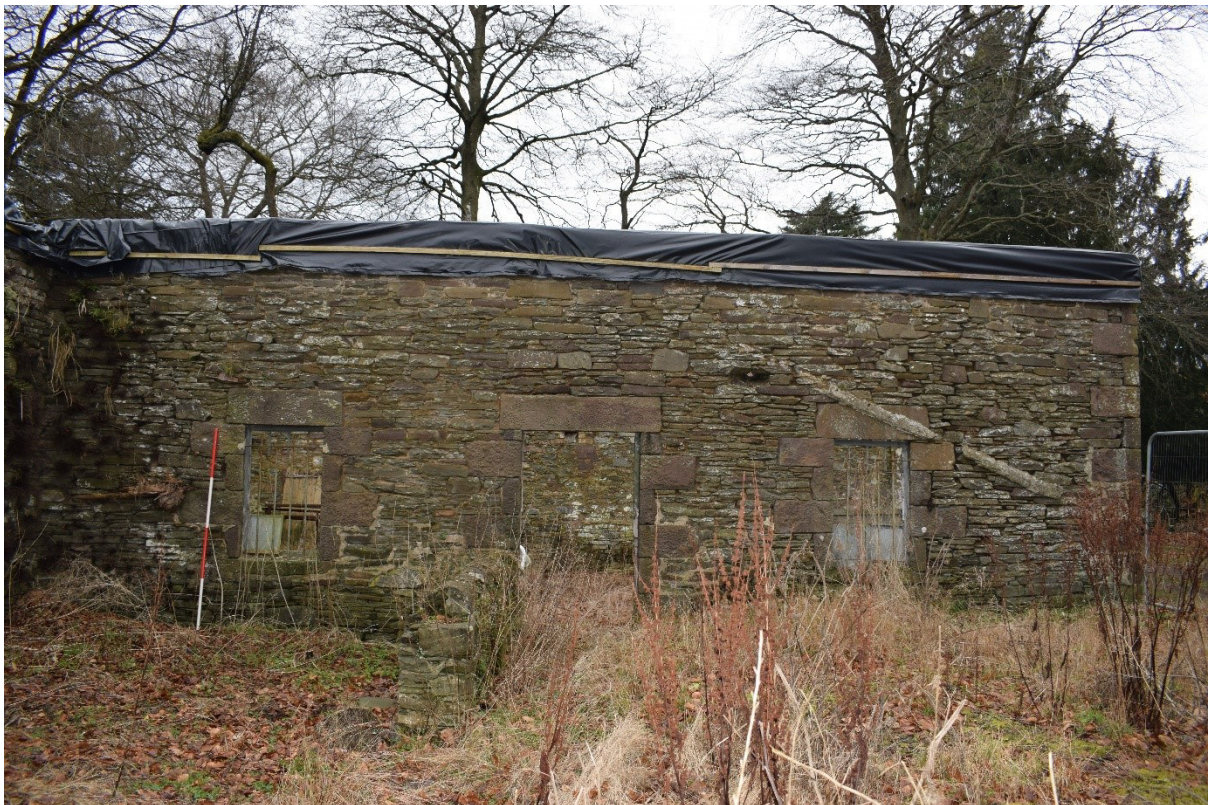
Room 4 may be partially an open courtyard and the area N of wall F8 was covered at one period as there is a roof scar (F22) on the ENE exterior wall of Room 2 above W9 (Illus 24).

Illus 24 ENE wall Room 2 former stables with W8 (left), D6 (centre) W9 (right with roof scar F22 above; facing WSW

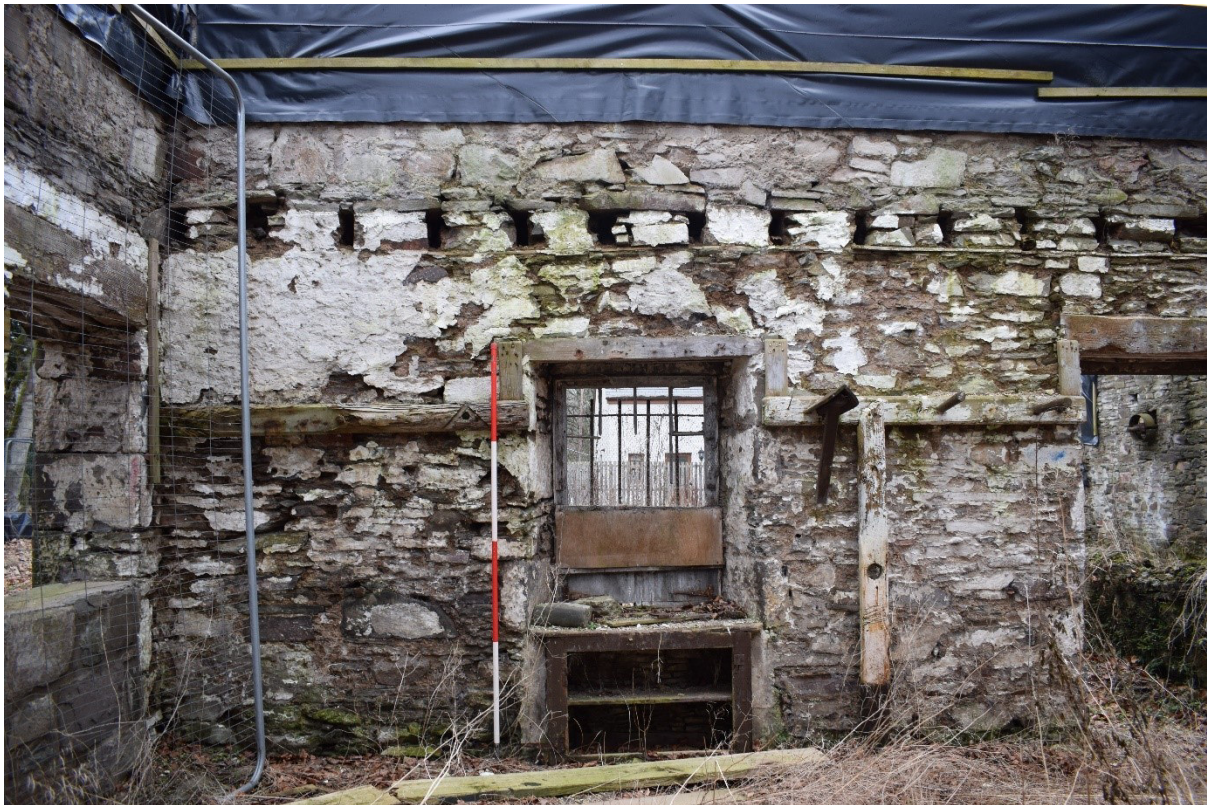
Illus 25 ENE wall Room 2 with W9 (centre) with cupboard in situ below and wooden saddle and harness storage F10 (right); facing ENE

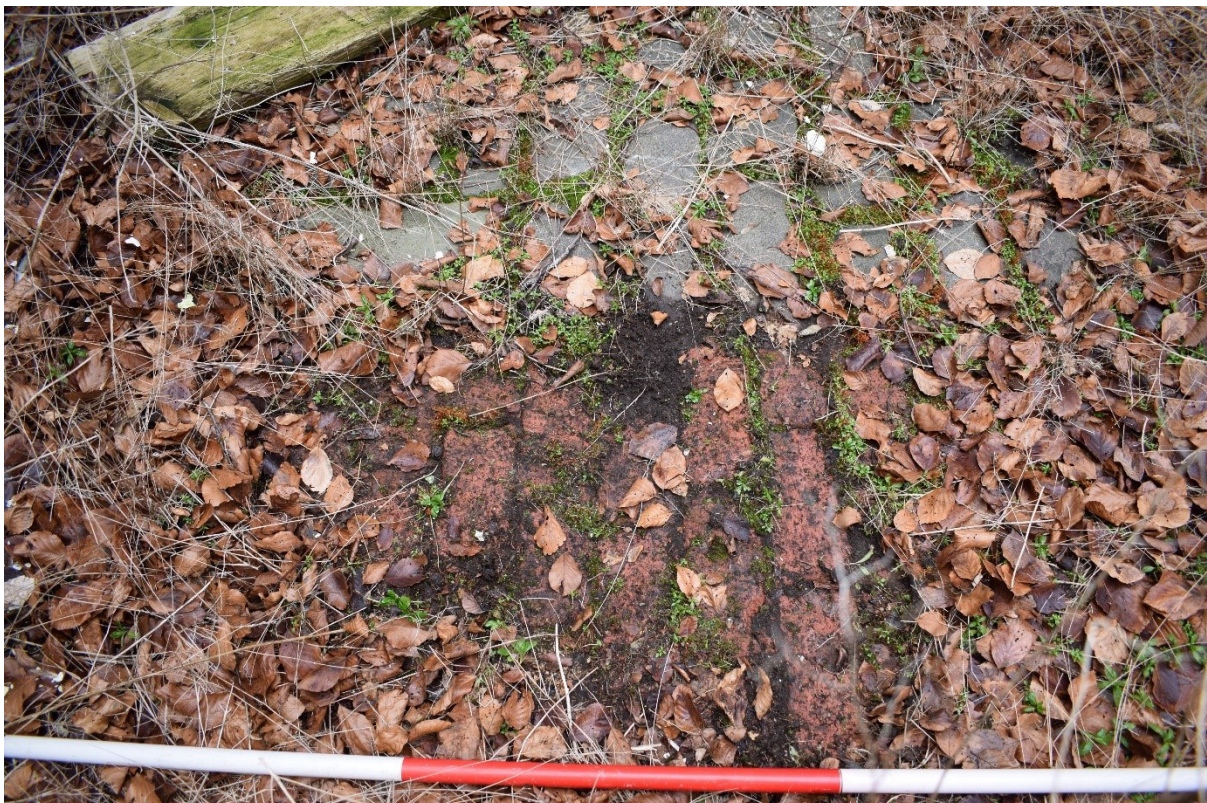
Illus 26 Room 2 former stables floor F9 granite cobbles (top) and hand-made bricks (bottom); facing ENE

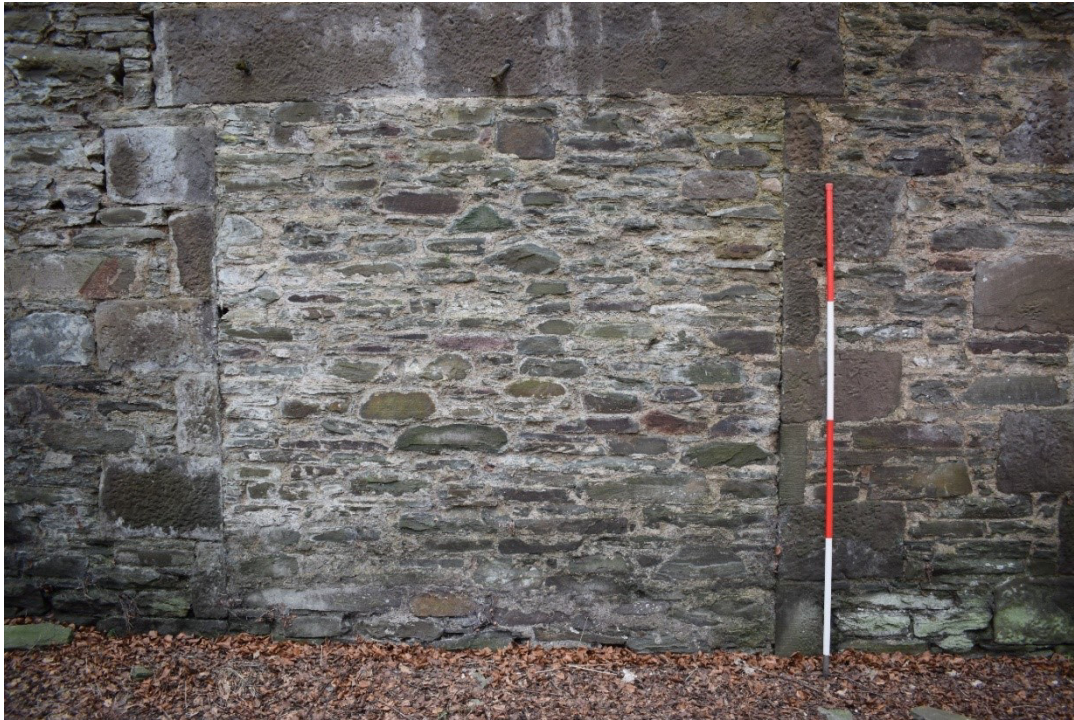
In Phase 3 the buildings were adapted slightly with the blocking of D1 on the WSW wall of Room 1, half blocking D2 (Illus 28) converting to a window in the NNW wall of Room 2. The exact phasing of Phases 2 and 3 may be overlapping.

Illus 27 D1 blocked cart door WSW wall Room 1; facing ENE

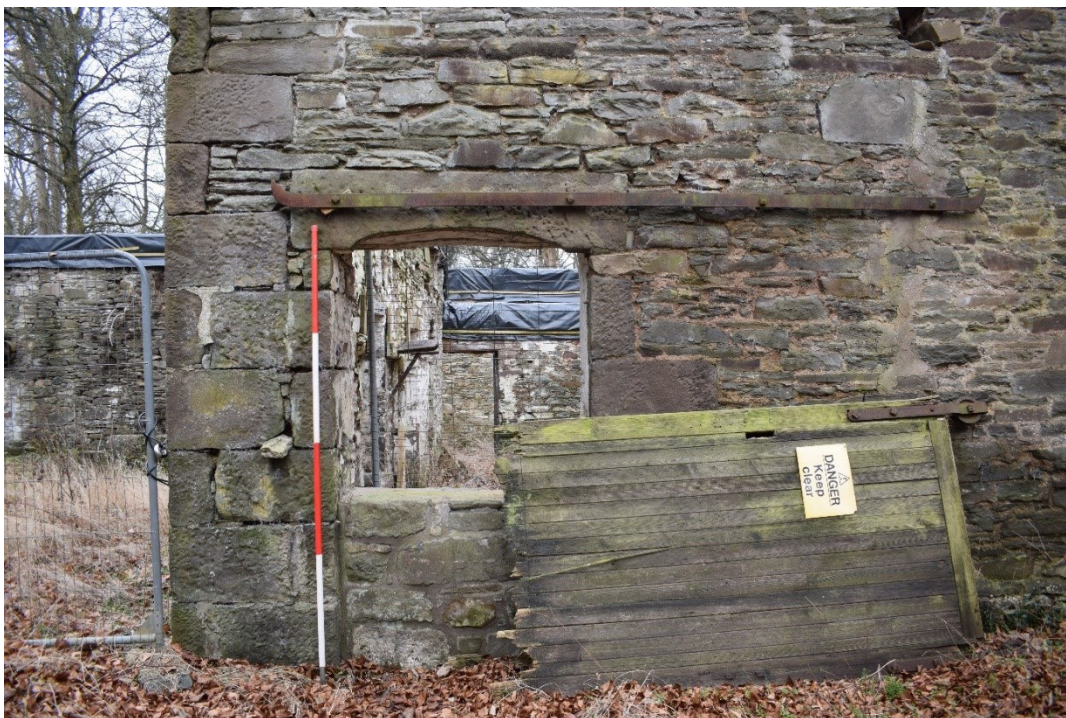
Illus 28 NNW wall Room 2 D2 with arched sandstone lintel and lower half blocked; facing SSE

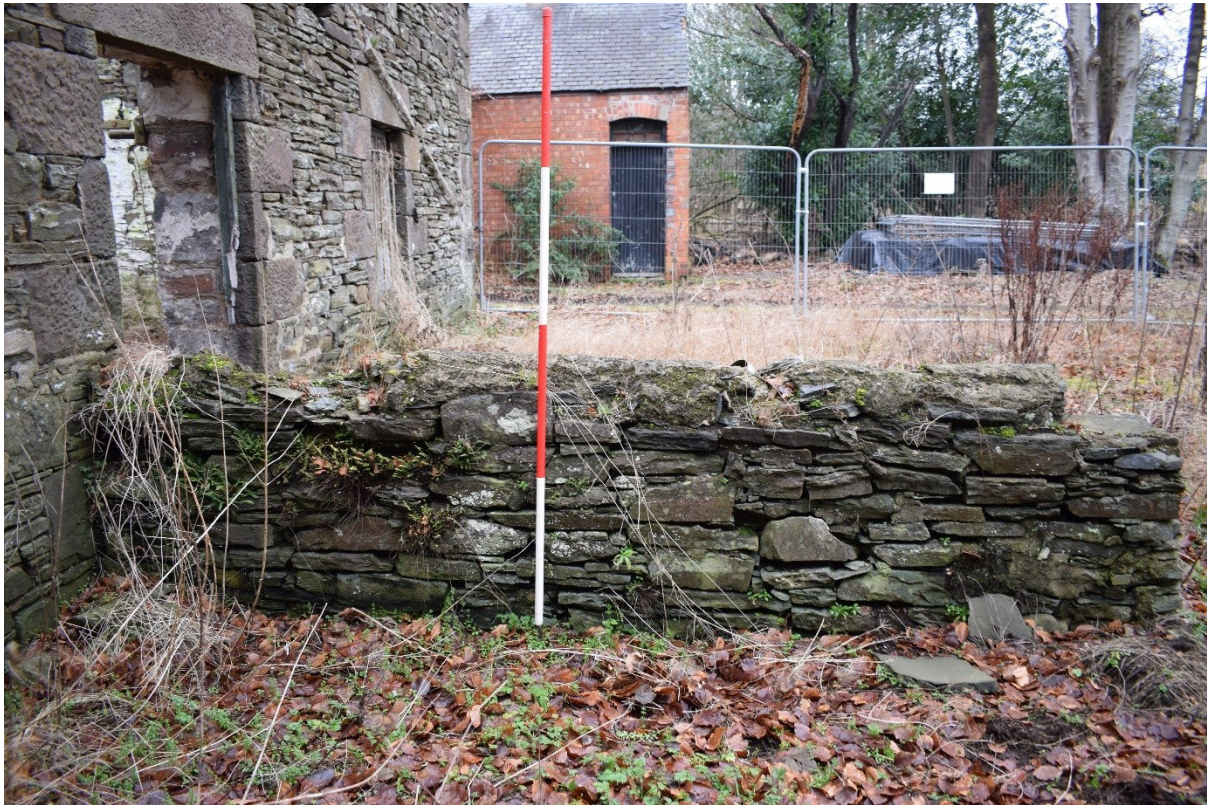
Wall F8 (Illus 29) may have been part of a building seen on the 2<sup>nd</sup> and 3<sup>rd</sup> Edition OS maps which has been reduced in height in Phase 3.

Illus 29 Wall F8; facing NNW
