## Information on Vacant Properties and Land Report

For  
Broadford Works

Aberdeen

May 2017

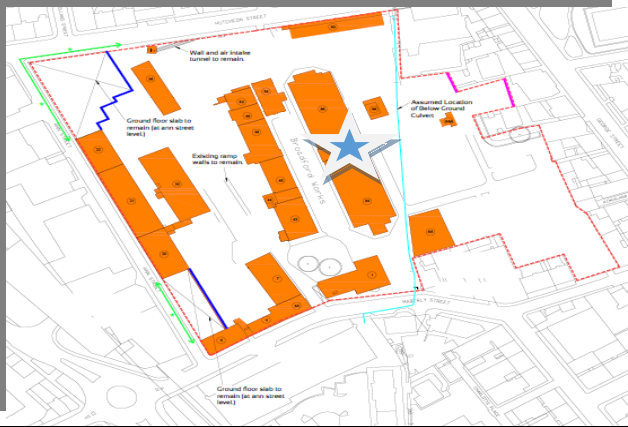
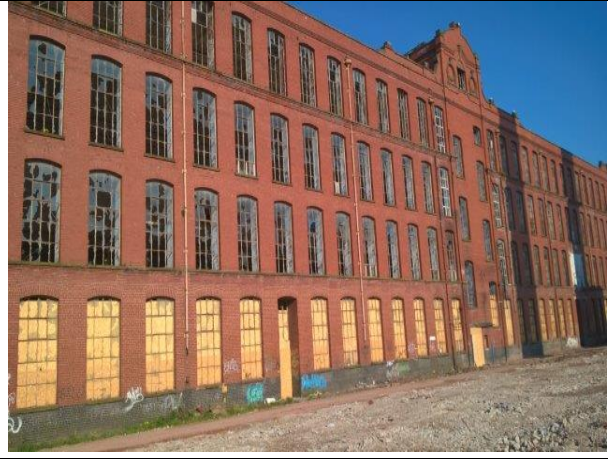
**Building 84, 85 and 86 (Red Mill)**

**This building is free from asbestos**

**Treat building/structure as having pigeon infestation and preventative measures to protect from Psittacosis**

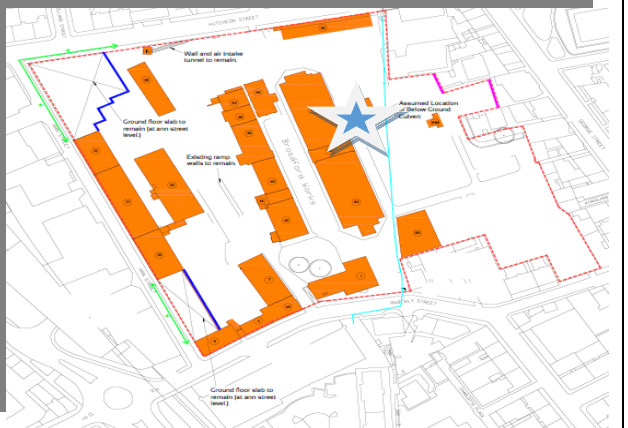
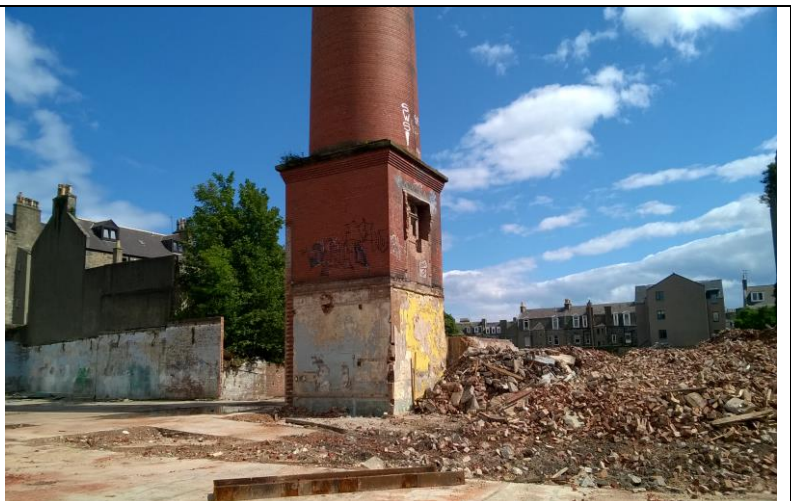
**Lite dust extraction Chimney**

**Treat building/structure as having pigeon infestation and preventative measures to protect from Psittacosis**

**A detailed survey of this structure has not been conducted whilst it is not thought to contain any asbestos products it must be treated as such until proven otherwise**

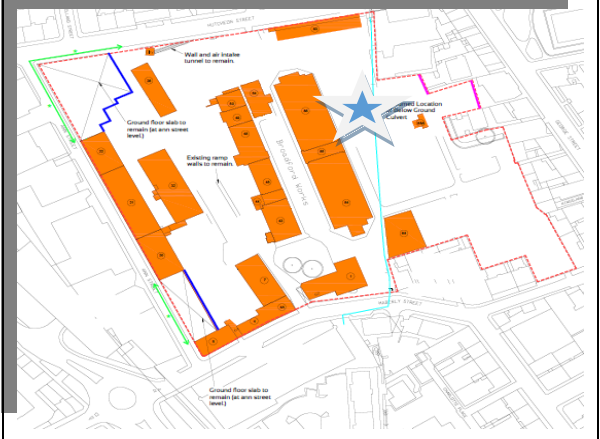
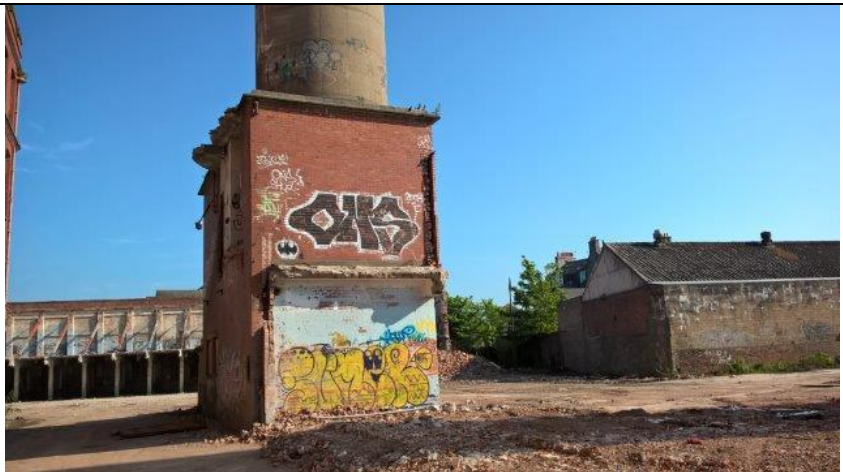
**Structure Fire House Tower**

Treat building/structure as having pigeon infestation and preventative measures to protect from Psittacosis

A detailed survey of this structure has not been conducted whilst it is not thought to contain any asbestos products it must be treated as such until proven otherwise

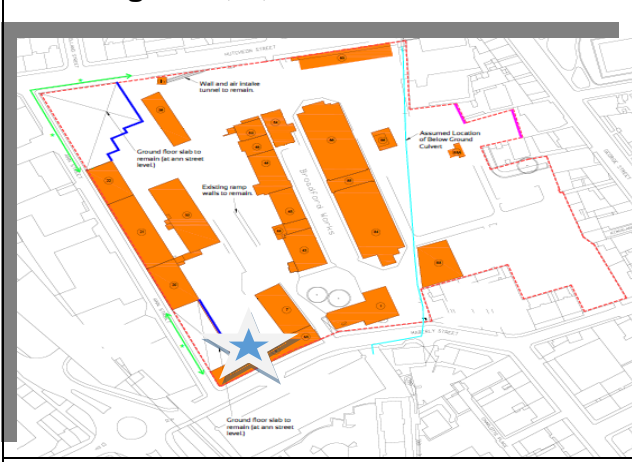
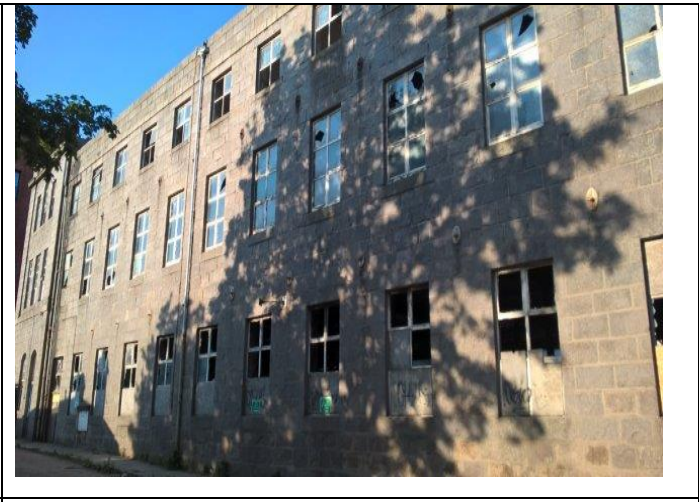
**Building 4. 4a, 5, 6 & 7**

Treat building/structure as having pigeon infestation and preventative measures to protect from Psittacosis

Building 4 is not accessible currently due to excessive amounts of pigeon guano. This is in the process of being removed.

This building is asbestos free

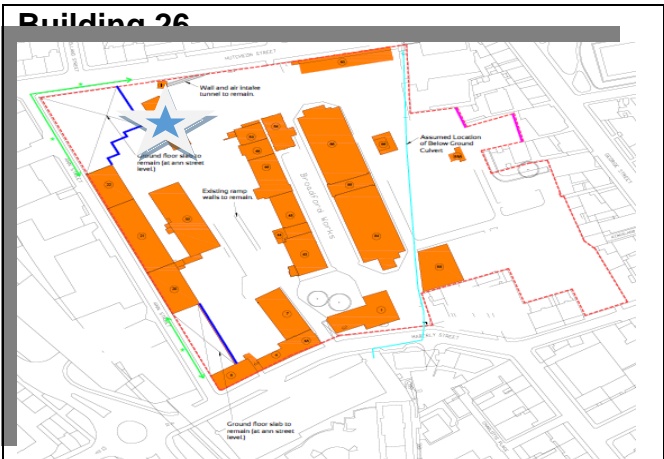
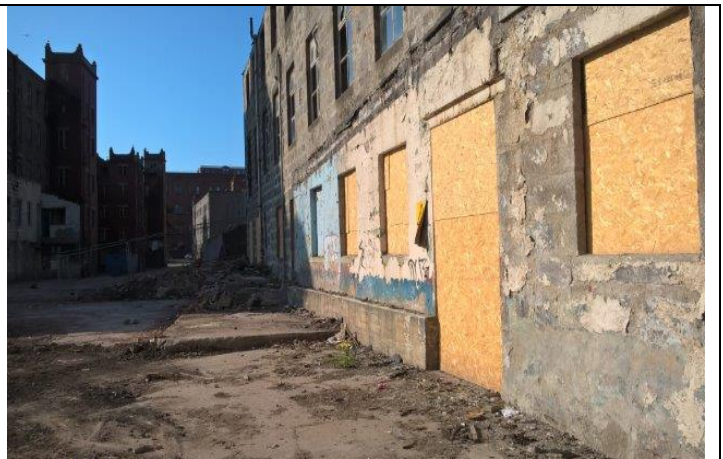
**This building has not had asbestos survey work conducted and is also in a dangerous state and should not be entered under any circumstances.**

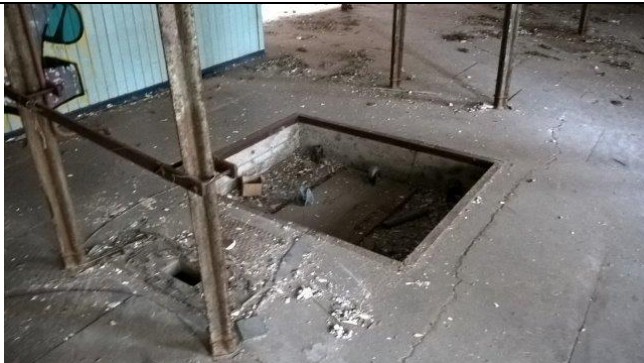
Potential trip hazard on slab

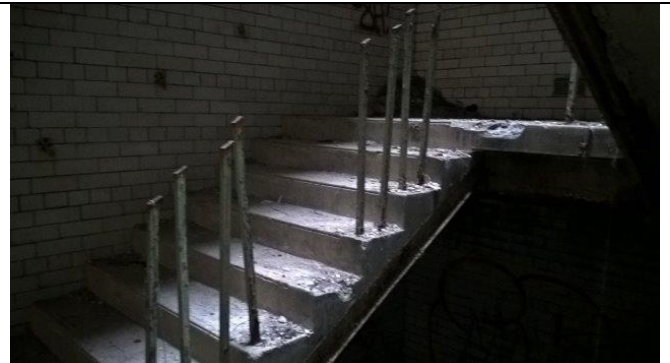
No edge protection on many flights of stairs

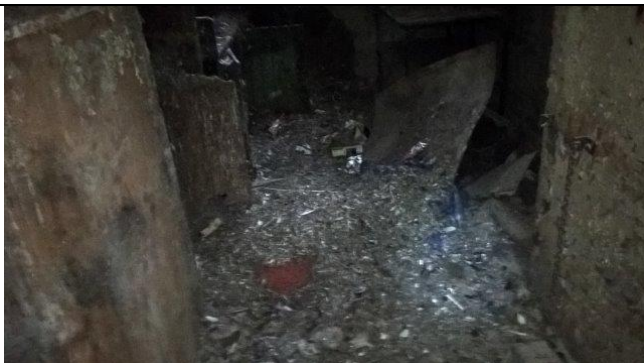
Condition of burnt out areas on ground floor

**This building has had asbestos removal conducted on it and is asbestos free in all open areas, less for the burnt area on the ground floor which due to conditions may well have some fuse box type materials within the debris.**

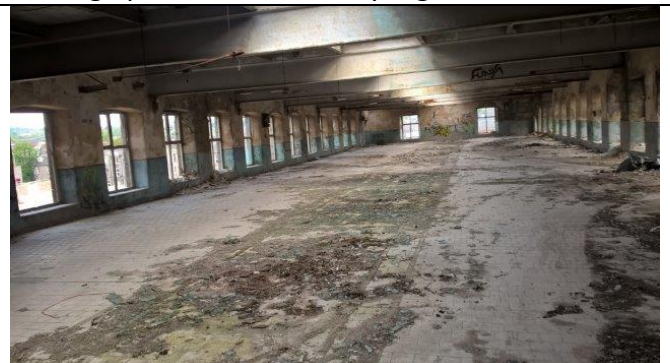
Where window frames are missing potential for fall from height.

**Remove any fall from height residual risks from unauthorised entry.**

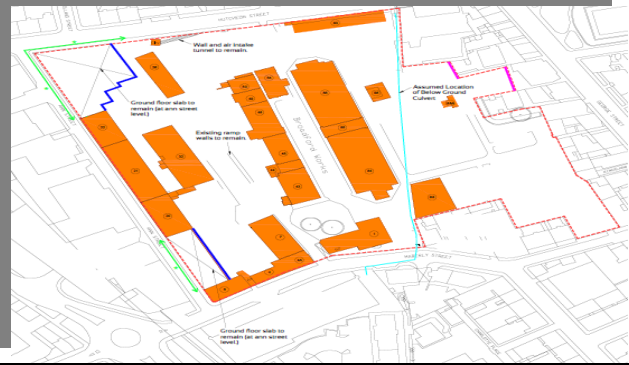
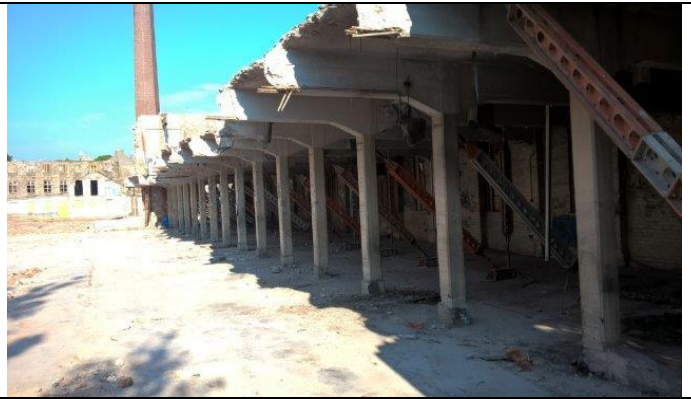
**Facade retention building 82**

**No asbestos in this structure**

**Treat building/structure as having pigeon infestation and preventative measures to protect from Psittacosis**

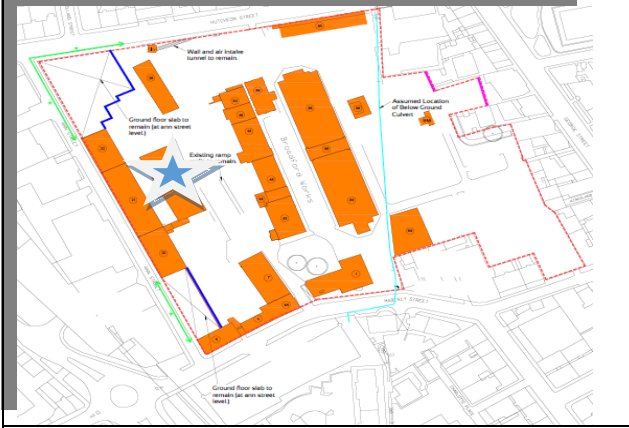
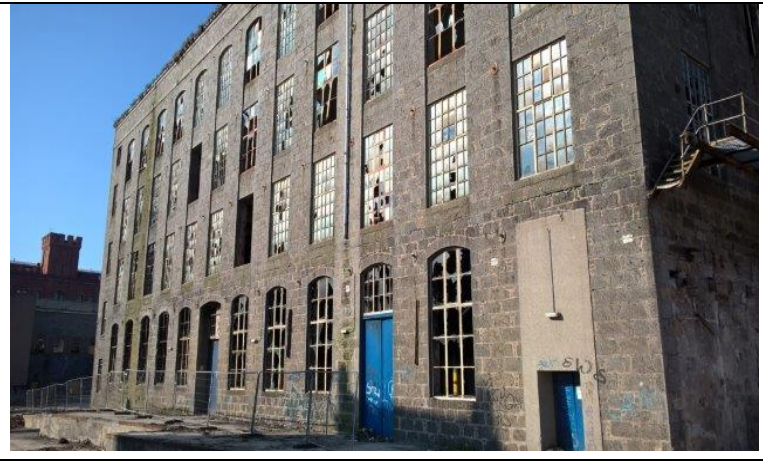
**Building 32**

**This building is asbestos free.**

**Treat building/structure as having pigeon infestation and preventative measures to protect from Psittacosis**

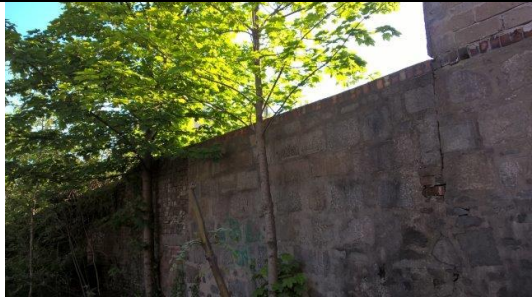
Vulnerable point (VP)

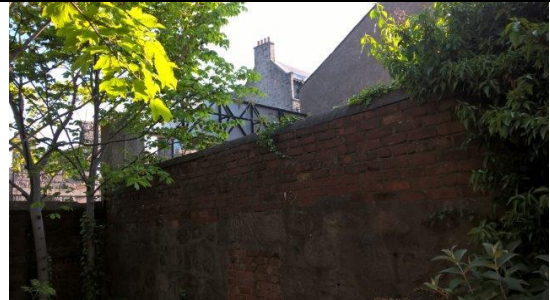
Vulnerable point (VP)

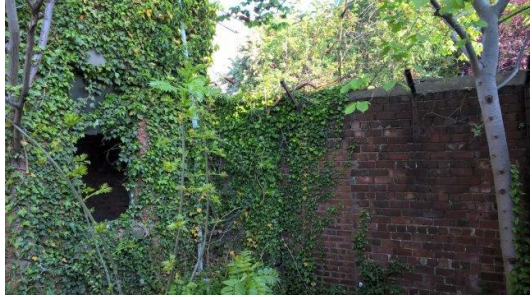
Vulnerable point (VP)

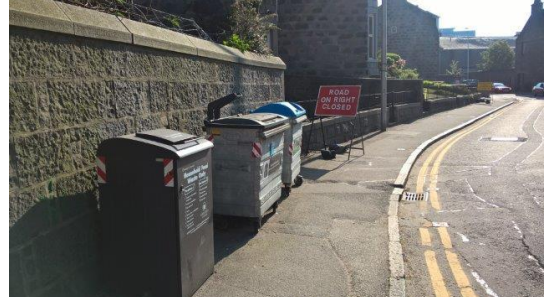
Vulnerable point (VP)

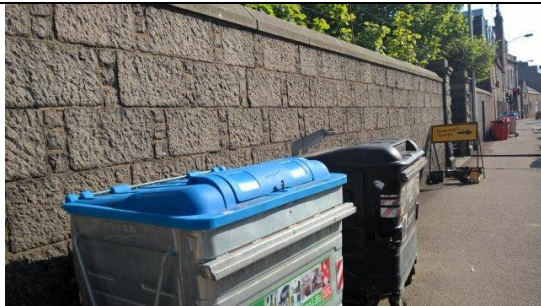
Vulnerable point (VP)

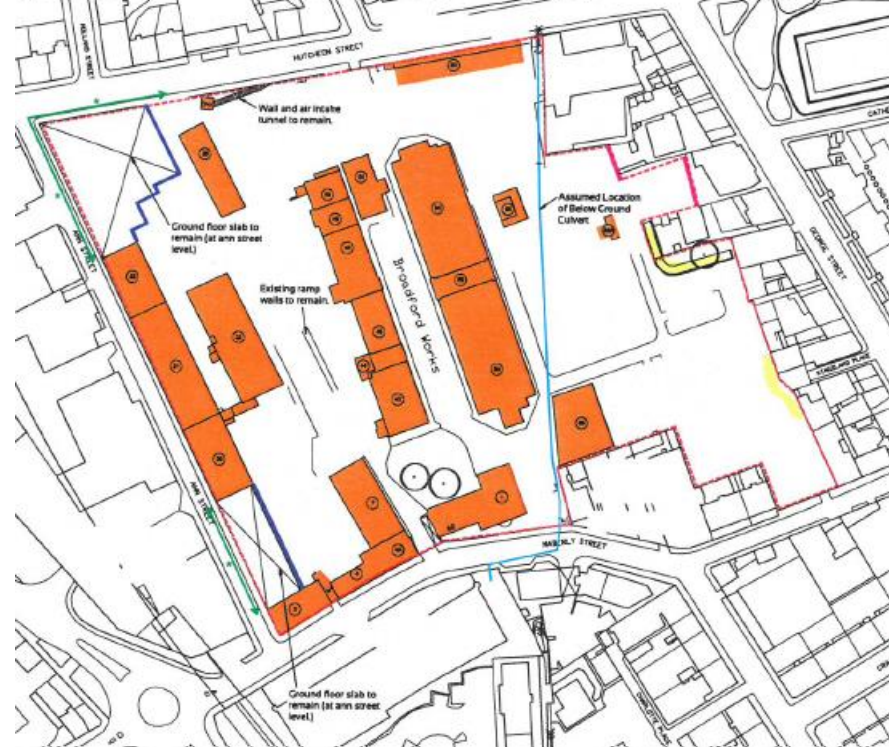
Yellow highlighted areas showing Japanese Knotweed

Areas have been demarked and are now no entry areas. Treatment of these areas has now been started.
