# EDINBURGH CASTLE CABLE REMEDICATION WORKS

ASSESSMENT AND RECORD OF ARCHAEOLOGICAL IMPACTS

**PROJECT NAME** Edinburgh Castle Cable Remediation, Edinburgh  
**CLIENT REF** -  
**HEADLAND REF** ECCR18  
**SERVICE** Assessment of archaeological impacts

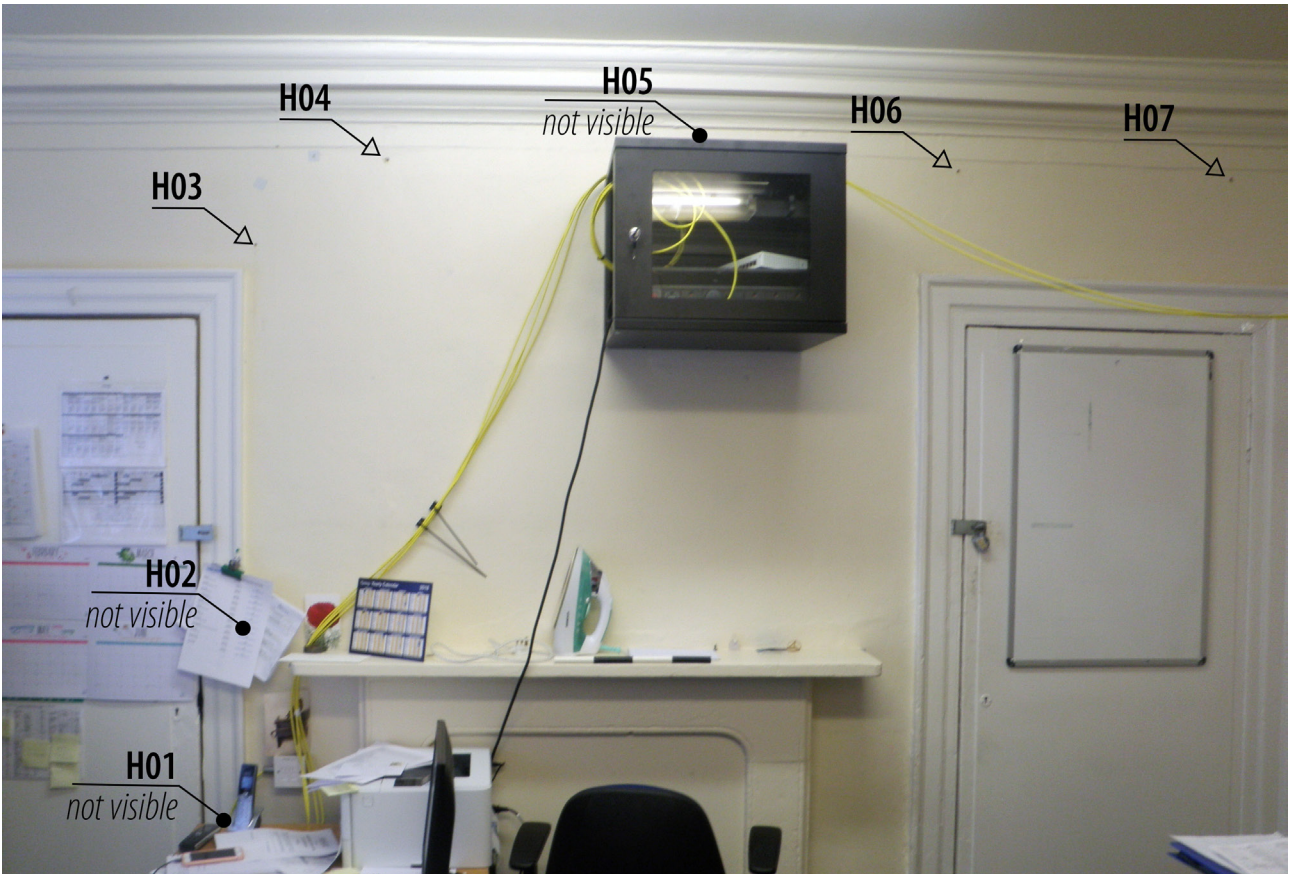
ILLUS 1 Holes 1–7 on the south-east wall

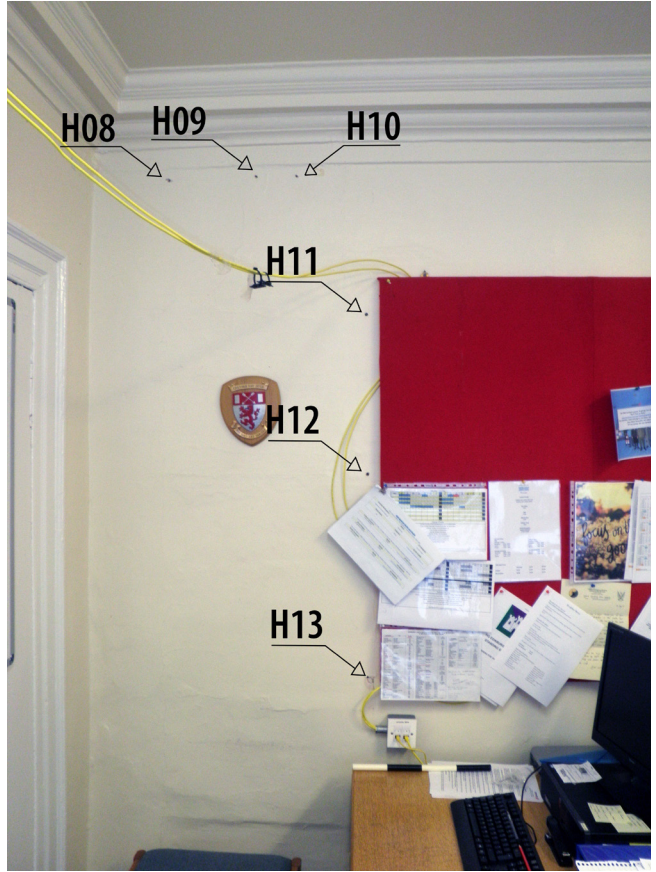
**ILLUS 2** Holes 8– 13 on the south-west wall

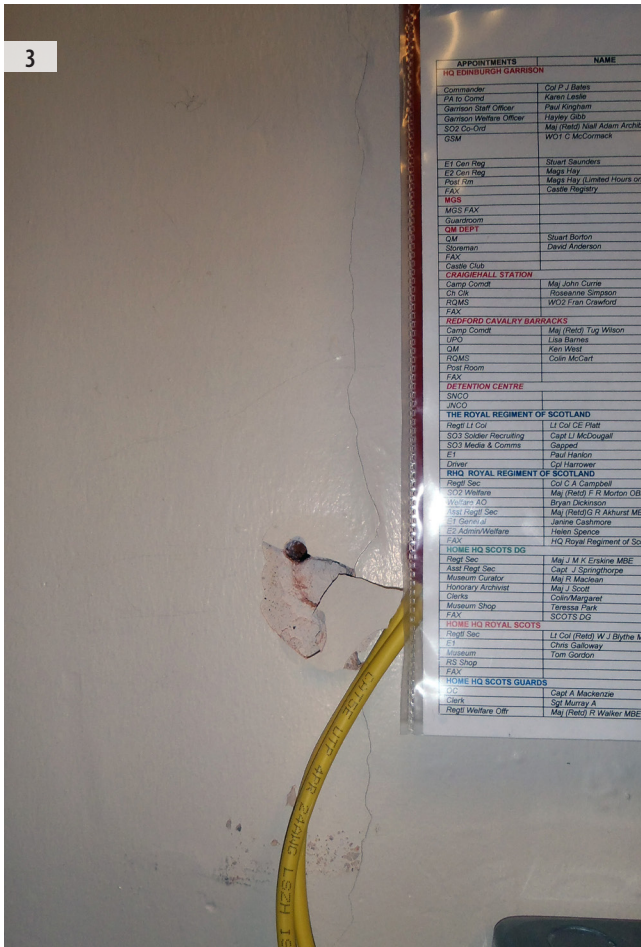
A second visit was conducted on 8<sup>th</sup> March 2018 to monitor the removal of the rawl plugs from the drill holes, as requested by Historic Scotland, and to record their depth. During this process additional damage was caused to the upper layer of plaster in the lowest hole on the south-west wall (Hole 13), adjacent to the noticeboard (Illus 3). Measurements of the depths was achieved by the use of a depth gauge and a metal probe to feel for the nature of the material the drill had impacted upon.

**ILLUS 3** Additional damage to the plaster after removal of the rawl plug from the bottom hole on the south-west wall **ILLUS 4** Exploratory hole into plaster around Hole 11 showing area of damage **ILLUS 5** Exploratory hole into plaster around Hole 12

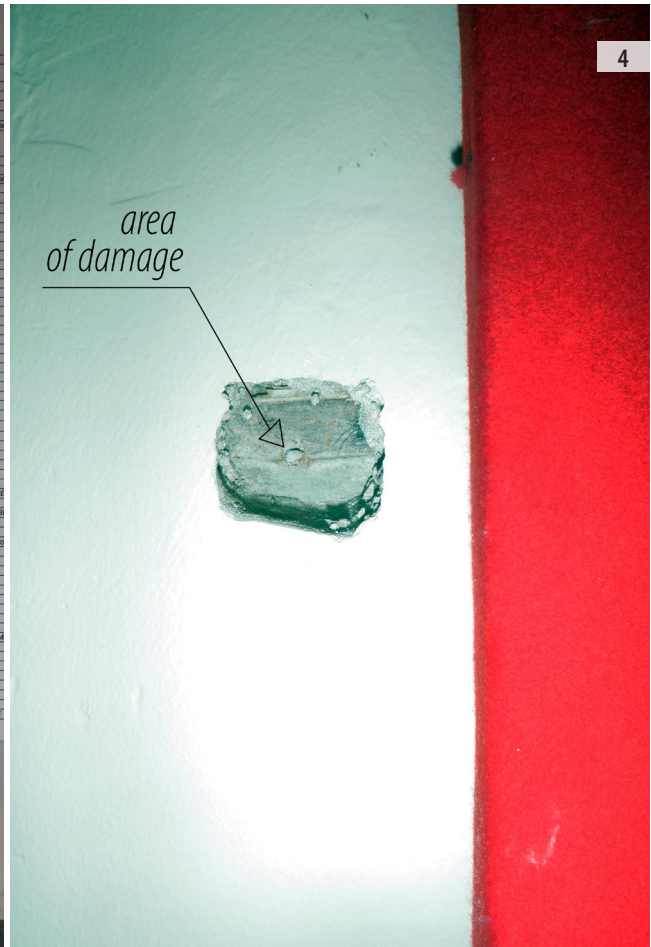
The maximum depth of drilling observed was 60mm, seen in two of the holes, both on the south-west wall. In both of these cases the drill bit had fully penetrated the plaster and it was apparent that stonework had been encountered at the back of the hole. Excavation of the plaster from around Hole 11 (Illus 4) revealed that the drill bit had penetrated between what appeared to be a wooden beam and masonry. The drill had made a c 4mm hole into the wooden beam which itself protruded approximately 3mm from the face of the masonry where the damage was approximately 1mm deep. Excavation of Hole 12 (Illus 5) revealed that the drill had made a minimal impact to the face of the stone beneath. The tip of the drill had caused some scuffing which was easier to feel due to the change in texture than it was to see. The other holes varied in depth between 38mm and 54mm with the average depth being 50mm. In all other cases the holes had not broken through the plaster which appears to have a uniform thickness of 60mm.

From the inspection it appears that the drilling has resulted in some minor damage to the underlying structure in two instances. The largest impact is in Hole 11 where the drill encountered a wooden beam and penetrated to a depth of approximately 4mm through the wood and 1mm into the stone. The damage in Hole 12 is minimal and comprises scuffing to the surface of the stone. There has been a minor impact to the visual appearance of the plaster surface within the room, however, there does not appear to have been any further impact on the structural fabric of the building in the other 11 holes.
