396–410 GORGIE ROAD, EDINBURGH

Historic Building Recording

commissioned by 3DReid Architects

November 2014

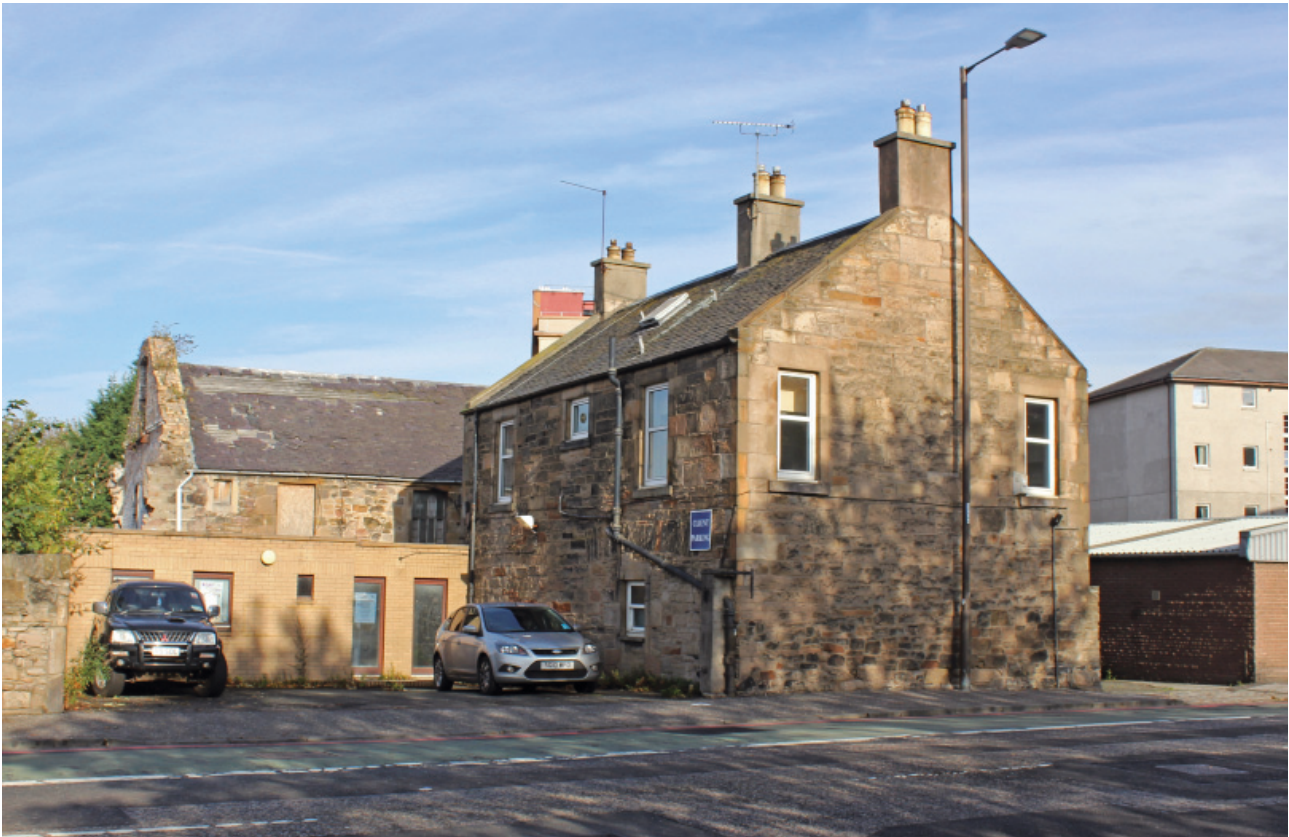
ILLUS 3

Gorgie Mill House (398 Gorgie Road), facing north

The building comprised a simple two-storey sandstone house (Illus 3 & 4), L-shaped in plan, measuring 10.9m x 7.2m, facing with gable end onto Gorgie Road. The first floor housed a self-contained dwelling accessed by a stairwell from a door on the north-eastern elevation (Photo 022). The ground floor layout was more in keeping with an office space or other non-domestic function, with two connected rooms at the front and a separate space behind. It was not clear to what extent the ground floor interior had been altered during conversion into a veterinary centre as all internal coverings were still in place.

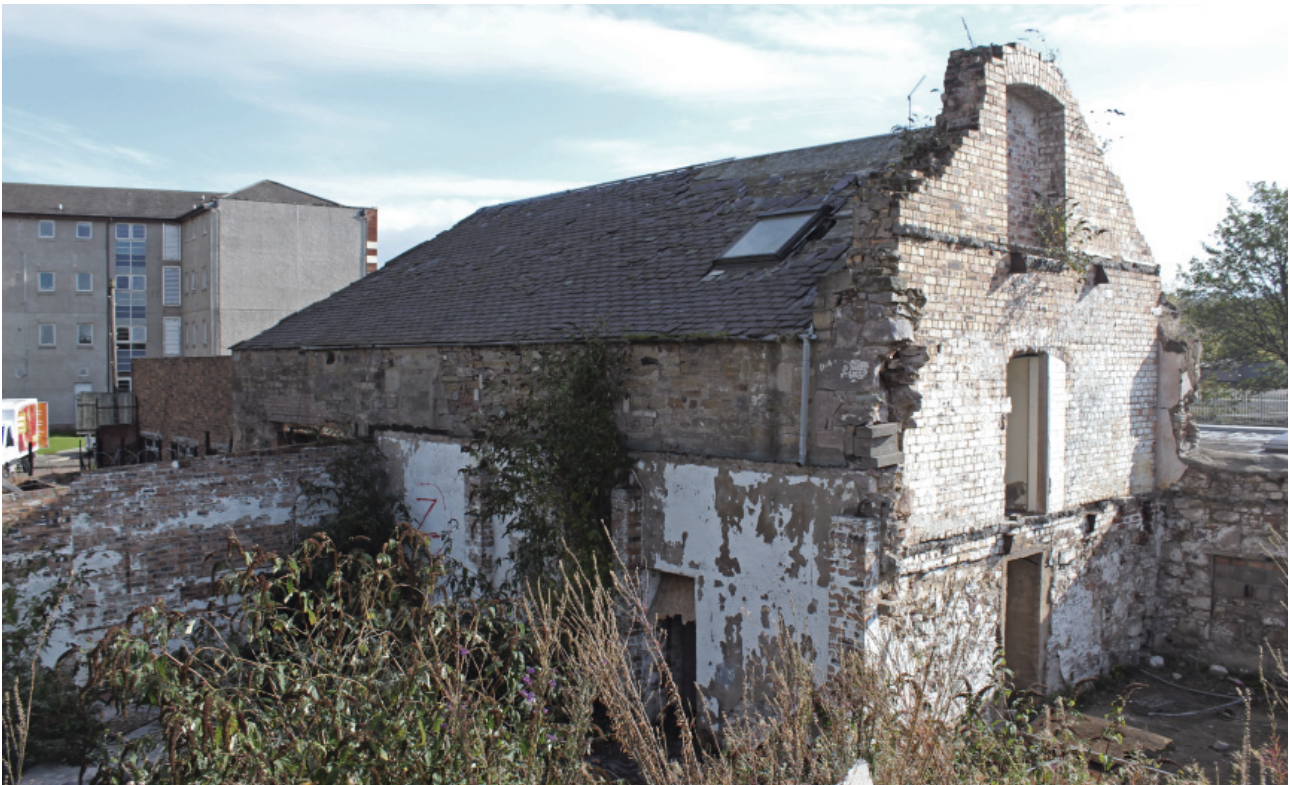
ILLUS 5

This structure (**Illus 5-7**) consisted the two-storey north-eastern section of an originally longer rectangular stone mill building. The three-storey south-western section (photographed during the 2007 desk-based assessment prior to demolition) appeared to be of very similar character in terms of construction suggesting contemporaneity either as a single build or a rapid expansion. The surviving section measured 15.6m x 6.8m, and appeared to have been central to the mill's operation, with single-storey brick extensions to the north-east and north-west, the mill lade below and easy access to Gorgie Road to the south-east via a cobbled yard.

Gorgie Mill, facing east

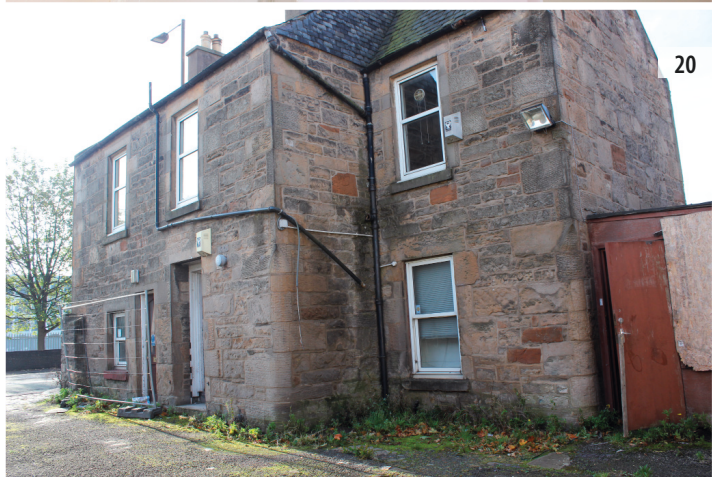
PHOTO 20

window surrounds of broached ashlar sandstone. The rear corners had been swept at ground floor level (Photo 020). Some of the stonework was in poor condition, especially where it had been tooled. Some of the masonry was of a different character (described below), but the whole appears visually consistent due to a fairly recent re-pointing. The three chimneys, one on each gable and one off centre, laterally (serving a fireplace on the ground floor) also appear to have been re-rendered. The pitched slate roof was in good condition, formed to a steeper angle to cater for the recessed north-eastern corner (Photo 021). Modern uPVC sash windows had been installed to replace timber originals.

398 Gorgie Road, oblique view of north-east external elevation

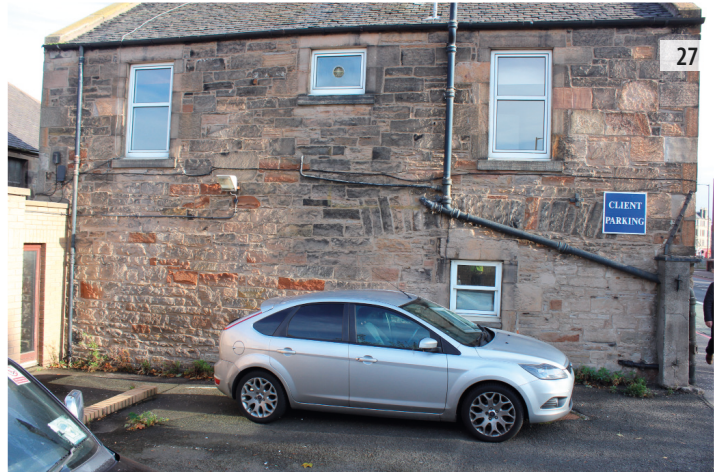
PHOTO 27

The south-western elevation (Photo 027) featured a small ground floor window, which had been converted from a narrow doorway, and three on the first floor; the middle of which was smaller and lit the bathroom. This may have been a later insertion but appears well integrated. The masonry towards the front of the building at first floor level made greater use of larger blocks which may indicate repair, although the stone appeared to have weathered no less than elsewhere. A wide stone relieving arch was centred above the ground floor window/door. The structural purpose of this was not clear – the building as it stood would not require such a device for bearing load, nor would the very wide, flat arch suit that purpose well. It is suggested that the arch had framed a shallow recess or a projecting structure which was subsequently infilled or removed. This would explain the lighter colour of the masonry below the arch, which otherwise appeared to be of similar character as the rest of the elevation.

398 Gorgie Road, general view of south-west external elevation

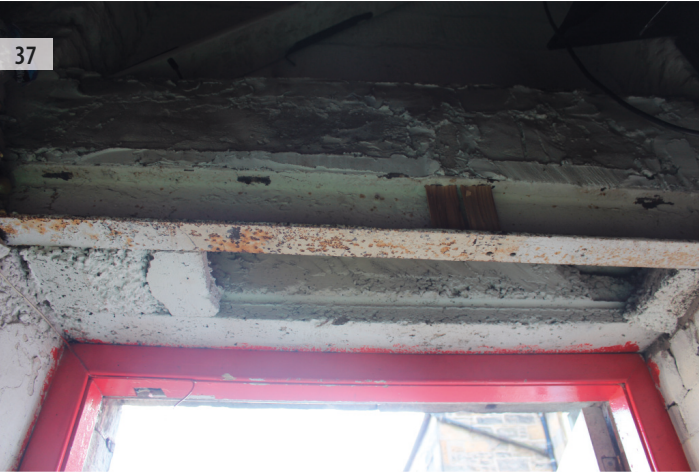
PHOTO 37

Gorgie Mill, detail view of store room interior – replaced lintels above door on south-east elevation

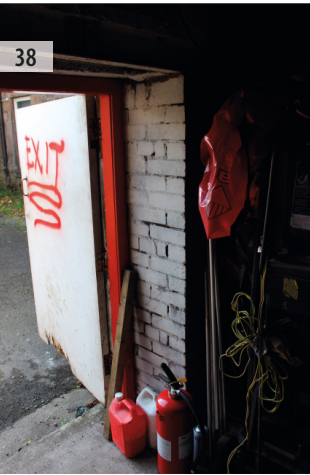
PHOTO 38

Gorgie Mill, detail view of store room interior – brick infill adjacent to door on south-east elevation

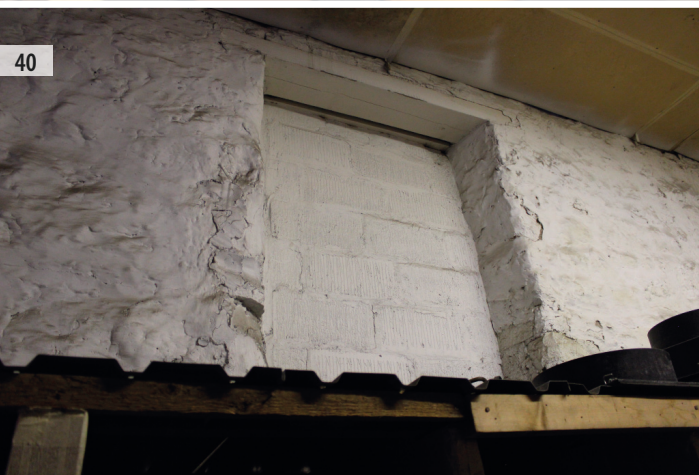
PHOTO 40

Gorgie Mill, detail view of store room interior – first floor blocked window on south-east elevation

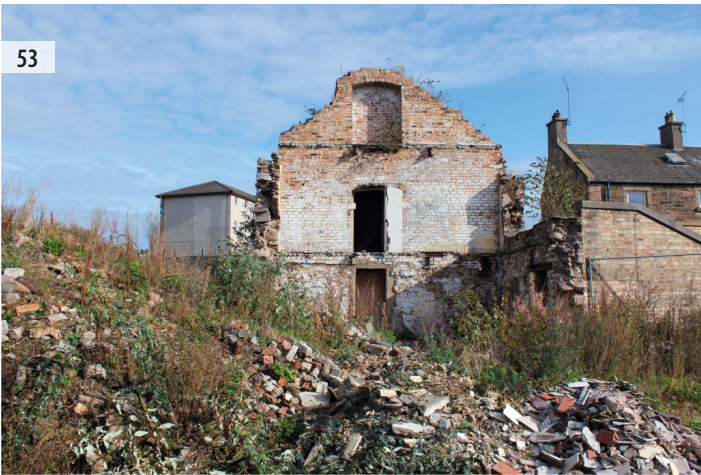
PHOTO 53

The extant south-west elevation (Photo 053) was both an internal dividing wall which separated the two- and three-storey sections of the stone mill building and the gable end of the three-storey building. The base of the wall was of masonry similar to the other external walls and supported the iron beams holding up the first floor. The wall above this was of brick and must have been a later replacement as it supported two reinforced concrete floors (Photo 076) suggesting a 20th century date. This would have been a considerable effort structurally as the short section of exposed gable above the roof of the two-storey section was also replaced in brick (Photo 072), having most likely been stone originally. A modern door had been inserted through the ground floor masonry, although it may have been a replacement for an earlier opening here. Two wider doorways with gentle brick arches were positioned vertically above, on first and second floors; the former had been narrowed and the

Gorgie Mill, general view of south-west external elevation
