Replacement Overhead Line (YX route) Ben Cruachan Hydro Power Station to Dalmally Substation

Walkover Survey and Archaeological Excavation

Report No: 3303

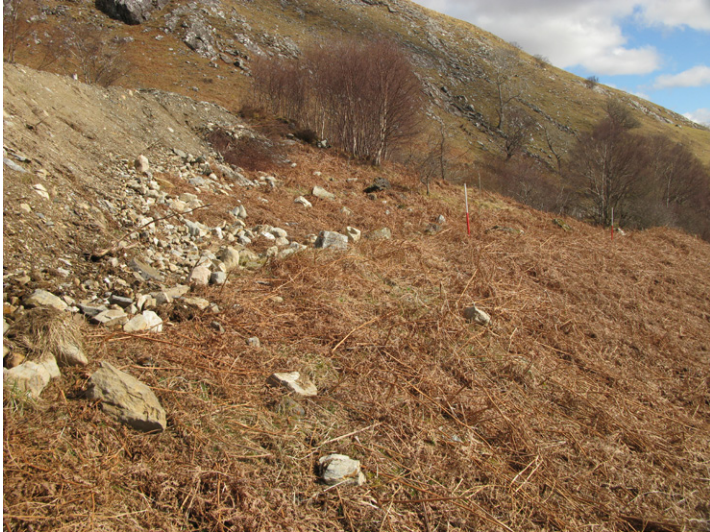
Site 12 (NGR: NN 0916 2652) (Fig. 2) is a bank aligned roughly east to west. It traverses a steep hillside which is covered in grass, heather and bracken, just to the north-east of Tower YX07. The bank runs from the edge of a deep water-cut gorge to the east and merges with a timber post and wire fence c.50m to the west which runs parallel with the existing road. The previously constructed access track between the road and Tower YX07 was found to bisect the site, and had destroyed a roughly 3.5m long segment as it crossed the bank at an oblique angle (Fig. 3).

Fig. 2 - General view of Site 12 looking east

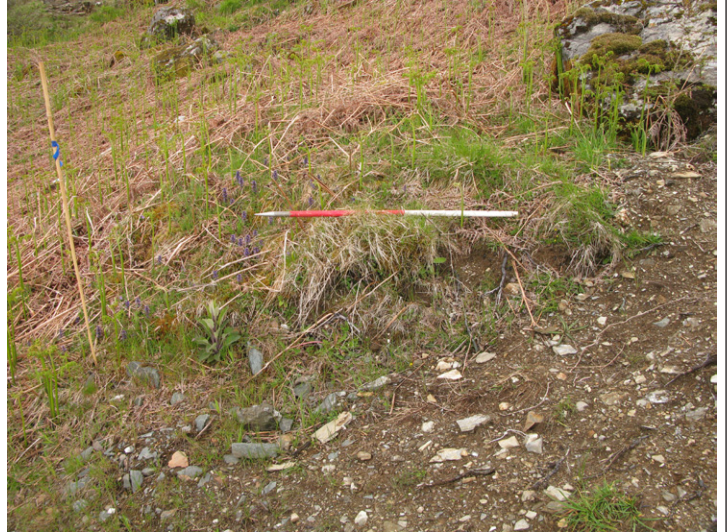
A single trench measuring 3.6m by 1m was excavated across the bank at the point where the access road for Tower YX7 bisected the bank (Fig. 3 & 6), showing the bank's section down to natural (Fig. 7).

Walkover survey along the edges of previously constructed access tracks discovered a bank, Site 12, which had been bisected and truncated by the access track to YX07. A section of the bank was excavated and recorded and deemed to be a post-medieval field boundary.

Fig. 3 - Site 12 showing truncation by Tower YX07 access track and proposed location of excavation

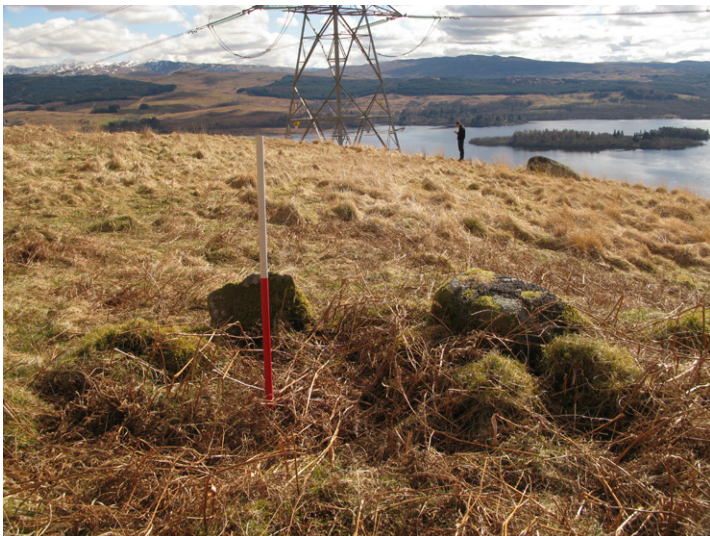
Site 13 (NGR: NN 0947 2642) (Fig. 4) is a possible cairn in the vicinity of Tower YX08. It is a sub-oval setting of stone 2m by 3m in area and surviving to a height of 0.5m. The stones making up the possible cairn are a mixture of upright and recumbent, and heavily overgrown. The topography of the ground consists of relatively level rough pasture and bracken. It is likely this feature is related to field clearance in the area, as the surrounding area is fairly free of loose stones. The site was demarcated with canes and tape allowing for a ten metre buffer.

Fig. 4 - Possible clearance cairn (Site 13)

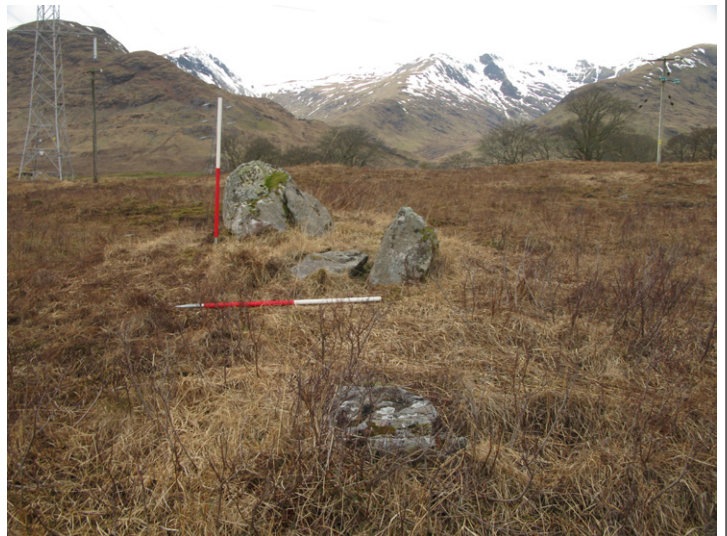
Site 14 (NGR: NN 1418 2951) (Fig. 5) is a possible small cairn around 100m north-west of Tower YX25 and Dalmally Substation. It was identified to be a sub-circular setting of stone around 3m in diameter and surviving to a height of 0.8m, in a level area of rough pasture and heather on the floodplain of the River Strae. This could be

evidence of field clearance as the surrounding area is fairly free of loose stones. The site was demarcated with canes and tape allowing for a ten metre buffer.

Fig. 5 - Possible clearance cairn (Site 14)

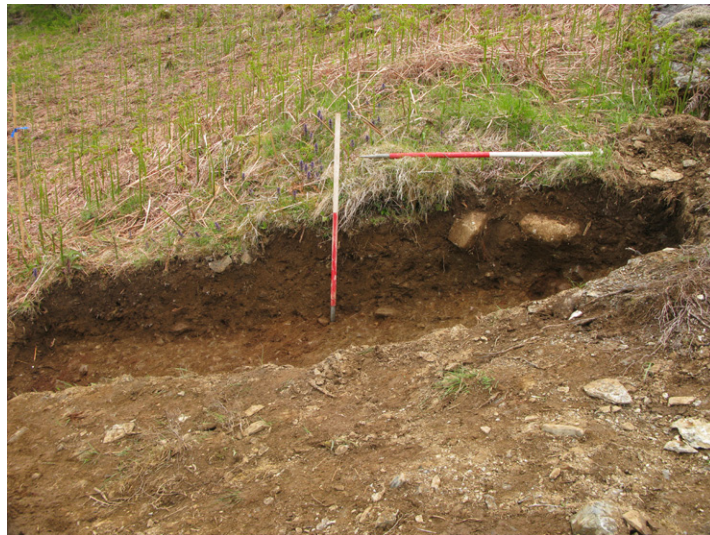
The section showed the bank to comprise loosely piled soil, turf and stones (003, 004). No structure using turves or coursed stone was evident. At this point it measured 2.2m wide and up to 0.4m high, although it survived up to 0.8m high at other points where it had not seen any impact from the development. The bank appeared to overly an old ground surface.

Fig. 7 - SE-Facing section of Site 12
