**High Mingarry (Mingaraigh Ard), Moidart, Inverness-shire
(NM 68827 70315)**

**A survey undertaken by the Moidart History Group,
Comann Eachdraidh Mùideart, in Spring / Summer 2008**

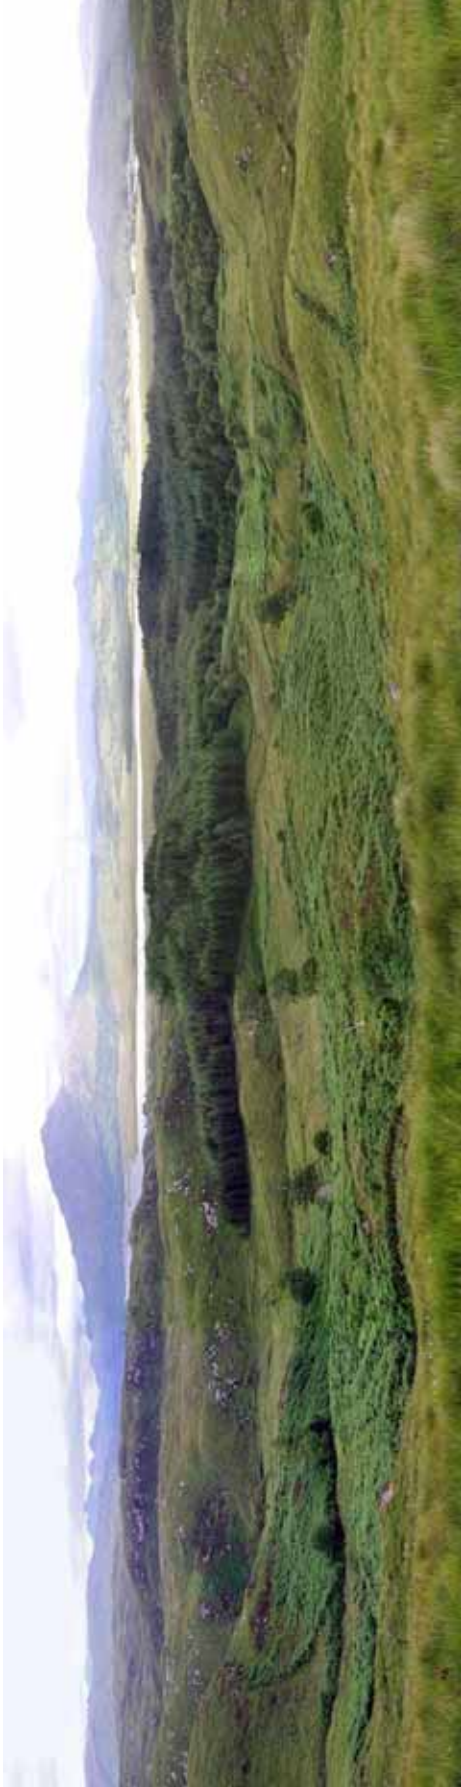
Panoramic View of High Mingarry viewed from the northwest.

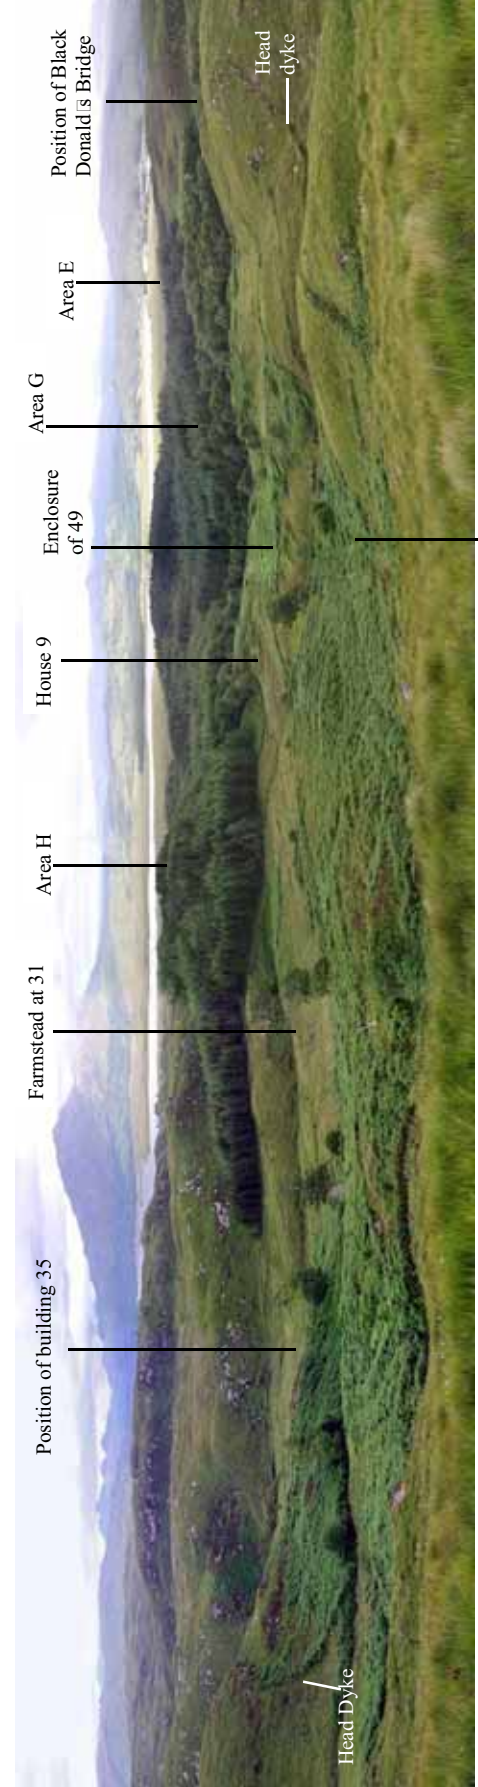
Position of building 35

Farmstead at 31

Area H

House 9

Enclosure of 49

Area G

Area E

Position of Black Donald's Bridge

Head Dyke

Position of building 43

Head dyke

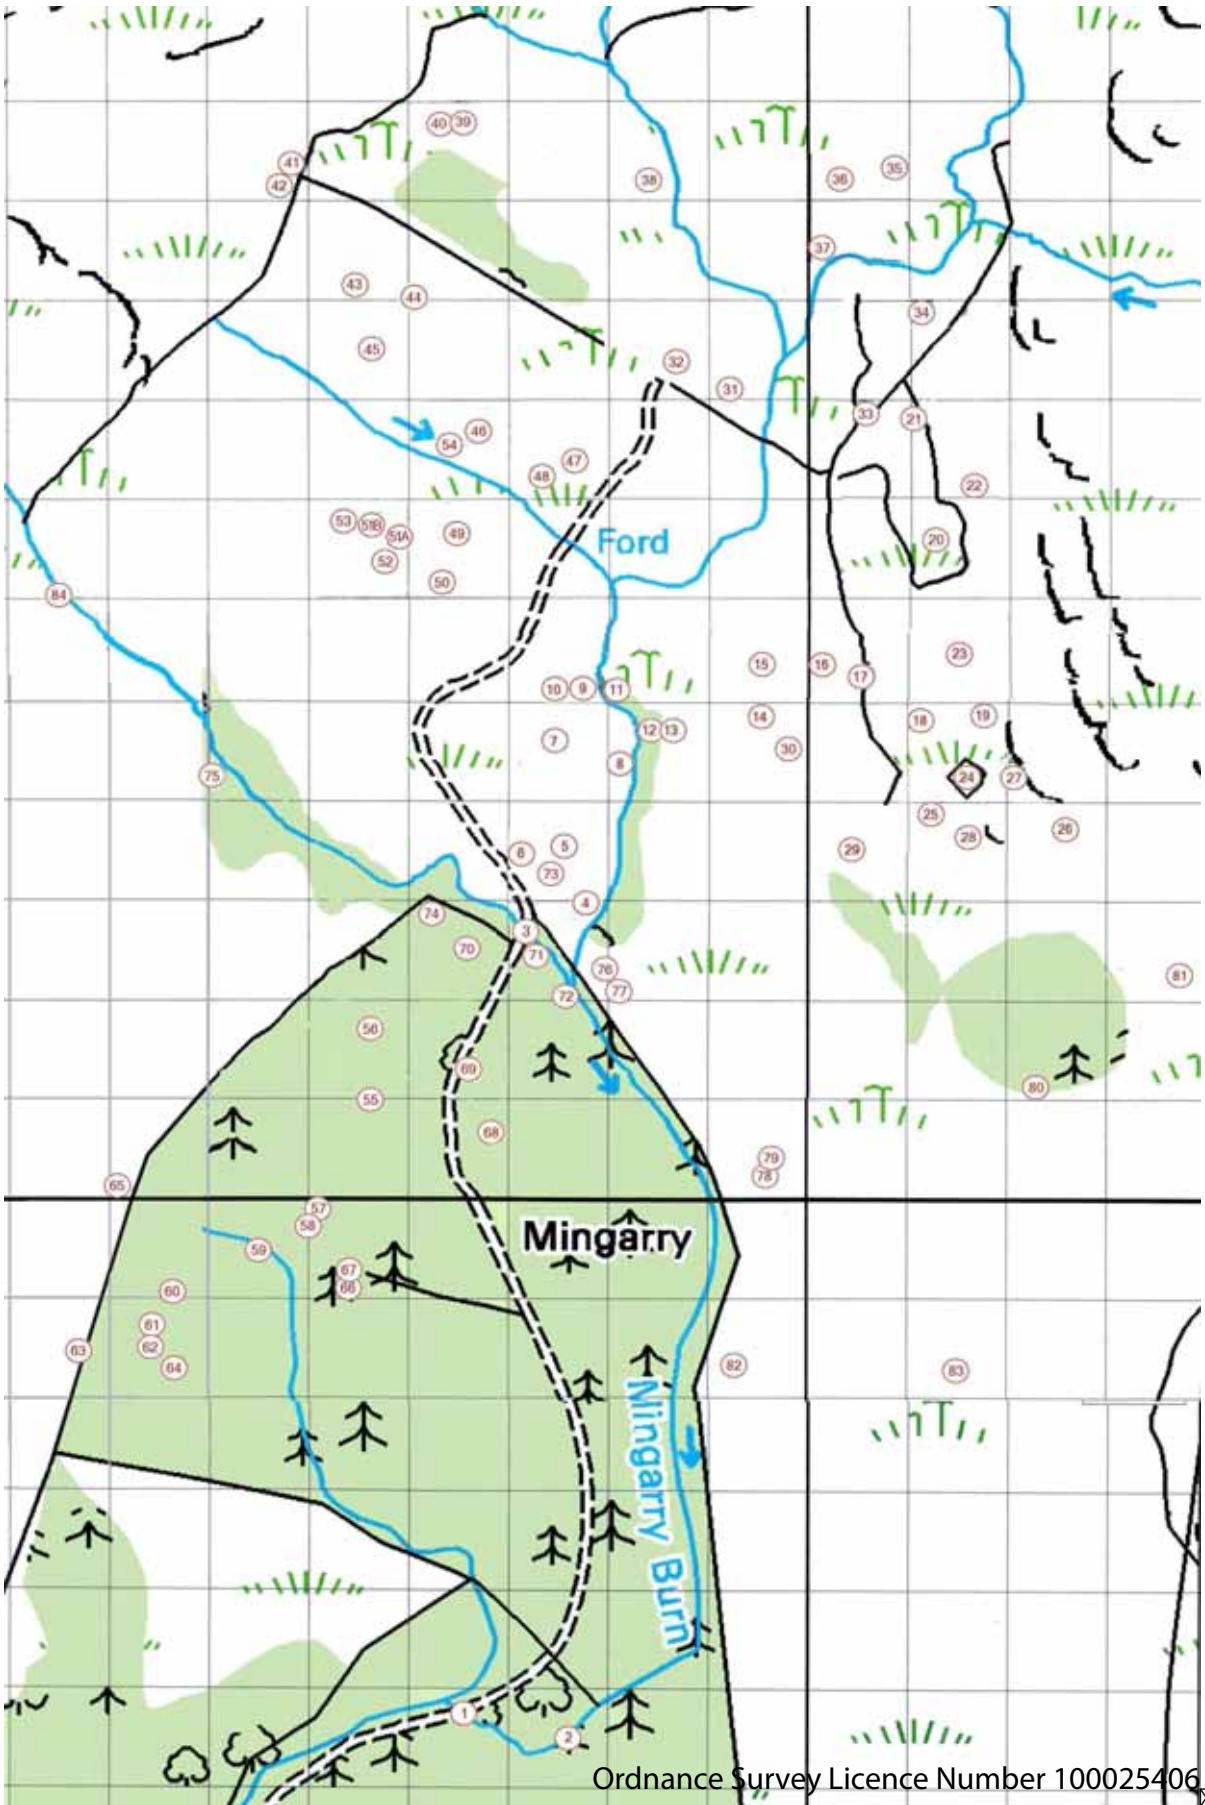
Figure 2 shows the area split into eight groups (A to H) and the sites are reviewed below in those groups. Sites which do not readily fall into the eight groups are described immediately below.
