CROFTS 40 AND 33 LONEMORE CROFTING TOWNSHIP.

CROFTS 40 AND 33 LONEMORE TOWNSHIP.

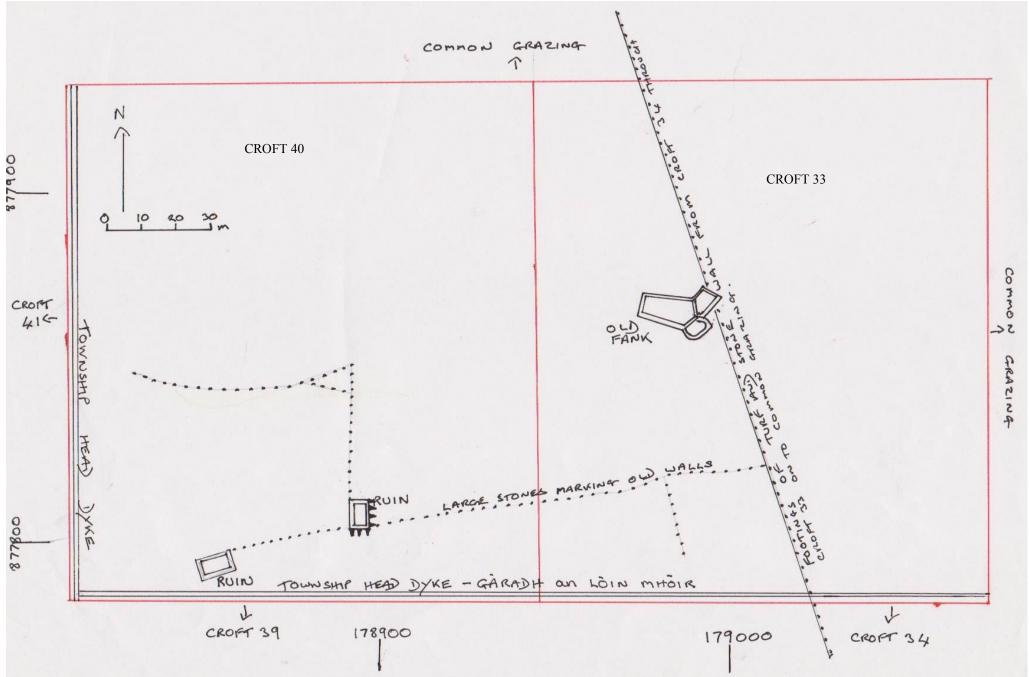
These two crofts ,although designated and given a total acreage of 11 acres on the estate map ,were not included inside the township head dyke probably due to the extremely poor quality of the ground considered to be unsuitable for either good grazing or arable use.

There are lines of large stones/boulders marking pre crofting walls and the visible line of an old turf and stone dyke stretching through the crofts up onto the common grazing (see plan) To the W side of croft 40 and along the S boundary of both crofts runs the township head dyke.

On croft 33 lie the ruins of the old sheep fank, which contain the robbed ruins of a house and some footings of a circular structure with very large boulders and smaller boulders making a curved structure. (see plan)

On croft 40 are the ruins of two precrofting buildings.One lies just N of the dyke and is shown as unroofed on both the first and second OS.(see description).The other, from its structure, is a much older building and is un-

marked on either map. (see description). Only sheep graze the land

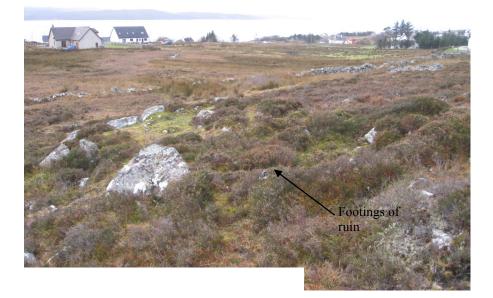
RUIN ON CROFT 40 LONEMORE TOWNSHIP

This ruin is situated on a slope with man made steep banks on its S and E sides. It has a southerly aspect overlooking Loch Gairloch.

All that remains are the footings of the walls and therefore no evidence of windows or doors although there is an opening on the E side. Into this opening runs a drain from the lower part of the building. The S half of the building is on a lower level than the N side.

There are small boulders marking the footings of an internal division with a gap for a step on the W side.

There are no selected or dressed stones evident just a selection of boulders.

The floor level is lower than the walls in both parts of the building.

Large boulders run along the S bank and these are part of a precrofting wall that runs through crofts 40 and 33.

This building is not shown on any OS map.but is shown on the estate map, so predates the crofts.

S edge of building with old wall extending into distance

S edge of building showing large boulders

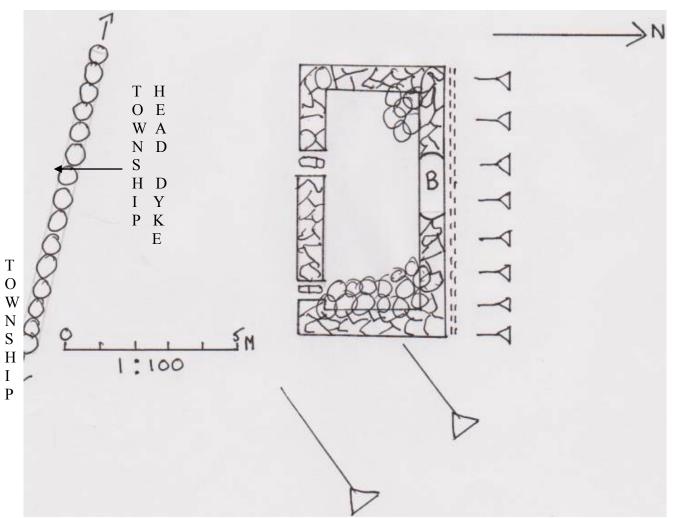
RUIN JUST BEYOND TOWNSHIP HEAD DYKE,LONEMORE GAIRLOCH. NG 78852 77782 GPS ELEVATION 53M FUNCTION NOT KNOWN SURVEYED ON 26-07-2008

This ruin shown as unroofed on both the first and second OS maps lies just outside the Township Head Dyke. It has a southerly aspect on a gentle N to S slope. Just behind the N wall of the ruin is a ditch.

The remaining walls are constructed of boulders and some selected stone with smaller stones as infill.

On the N wall, and spanning the full width of the wall is a large boulder measuring 1.75mx0.75m which is part of a pre crofting wall which runs on a W to E axis ,extending in both directions from the run. There are other similar walls on this croft.

The walls in the ruin are up to 0.75m in height, and there are two possible openings on the S wall. No evidence of windows can be seen in the ruin, and there is tumble inside the walls at both the NW corner and along its E wall.

Floor level inside the ruin is the same as the external ground.

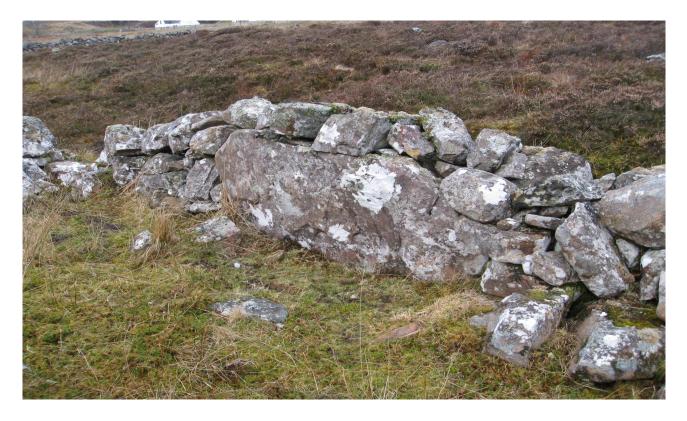
LARGE BOULDER IN NORTHERN WALL OF RUIN NG78852 77782 GPS

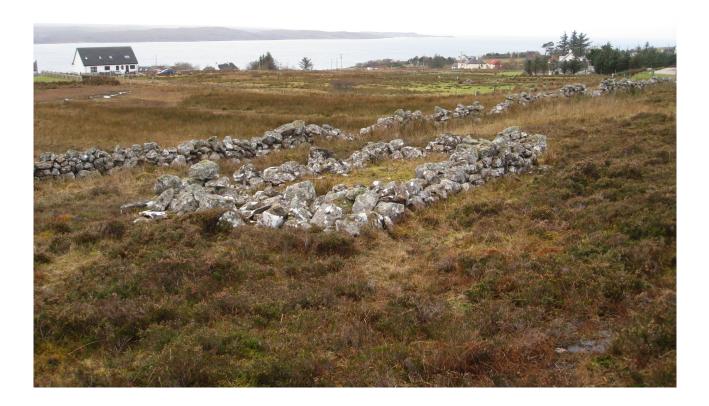
SAME RUIN SHOWING ITS PROXIMITY TO TOWNSHIP HEAD DYKE

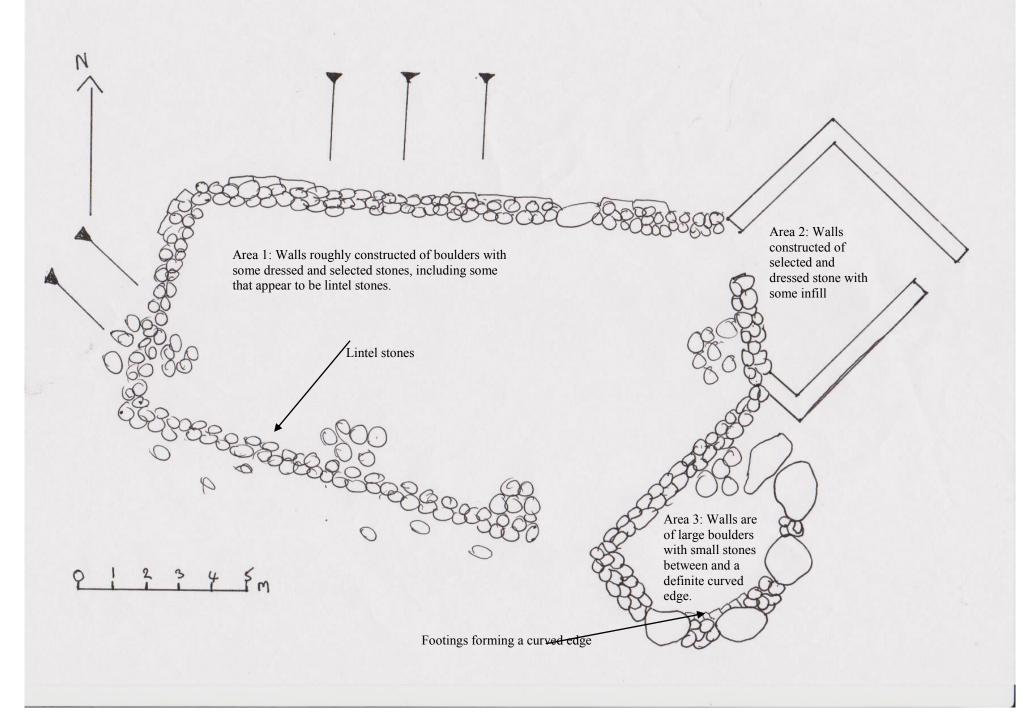
OLD SHEEP FANK, CROFT 33, LONEMORE CROFTING TOWNSHIP. NG 78987 77855 GPS ELEVATION 64M SURVEYED ON 31-07-2008

The old sheep fank is situated on what was designated croft 33,although the croft was not included within the head dyke as the ground was unsuitable for cultivation. consisting of heather, moss and rough grass. It is shown on both the first and second OS as a circular structure unlike its present construction (see plan) It is situated on a drier piece of ground that slopes gently from N to S at an elevation of 64m. There is no adjacent water supply to the fank, the nearest being two wells/springs lying 320m to the NW.

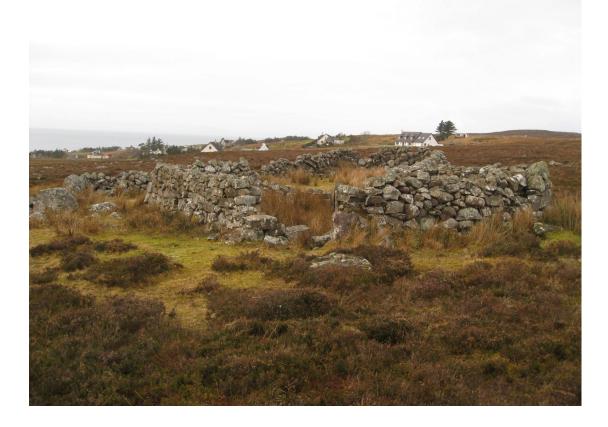
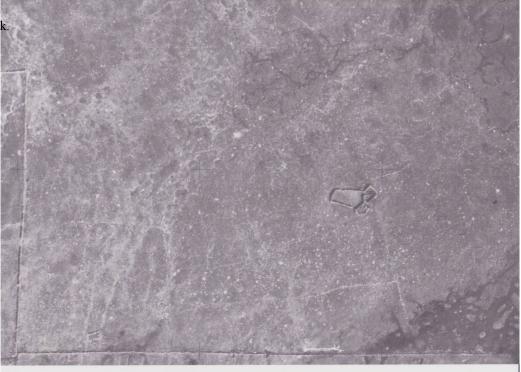
Photo and aerial photo showing old sheep fank.

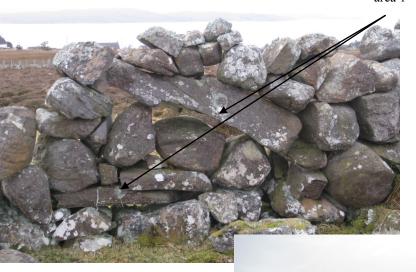
Area 1 is roughly constructed of boulders with occasional selected and dressed stones including what appears to be lintels amongst them. The walls are broken down and range in height from 0.5m to 1.5m with an average width of 0.40m.

Showing apparent lintel stones in boulder wall area 1

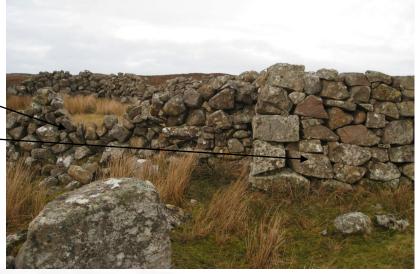
Area 2 has walls that are constructed with dressed and selected stones with infill. They range in height from 1.0m to 1.40m, with an average width of 0.55m.

Showing contrast between boulder wall Area 1

And

Selected and dressed stone in area 2

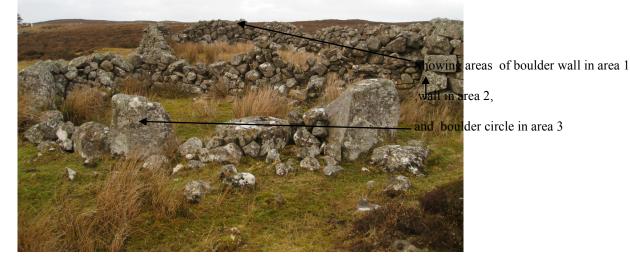
OLD SHEEP FANK CROFT 33 LONEMORE TOWNSHIP.

The census and estate records record a family paying rent for croft 33 from 1841 to 1871 and living on the croft in 1861 and 1871. As there is no evidence of any other buildings on this croft it is possible that area 2 was part of a house that was later robbed to form part of the walls in area 1. Area 3 although a definite circular shape, does not have any obvious function. It may have been used for storing fleeces, or as a spring time henhouse, or may have even been part of a stone circle that was used as the circular sheep fank shown on early OS, and later altered when the house and newer fank were constructed.
